Norstar/Companion  
Alarm & Event Code Manual

August 1994

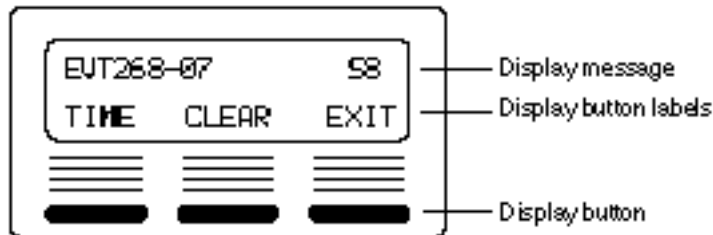
Event messages appear as items in the System Administration Log, the System Test Log, System Event Log or the Network Log, during a Maintenance session. The 3-digit event number follows the letters EVT. The following figure shows an event message as it appears on a Norstar telephone display.

In addition to the event number, a series of up to six digits may appear after a hyphen to further define the appropriate port number, directory number, filter or other event parameters. An event message can display up to three 2-digit parameters. For example, in EVTXYZ-011104:

01 = parameter 1, 11 = parameter 2, and 04 = parameter 3.

Each event is assigned a severity number from 1 to 9, with 9 being the most severe. An 'S' preceding this number, 'S8' for example, appears in the event message. The severity number is assigned so that if a log is full, new event messages with a higher severity replace existing messages of a lower severity. For this reason, the event messages should be checked at regular intervals.
