Sea to Sky Road Cycling Infrastructure and Programs

A. Summary of Sea to Sky Road Cycling Infrastructure

B. Recommendations for Improvements to Road Cycling Infrastructure

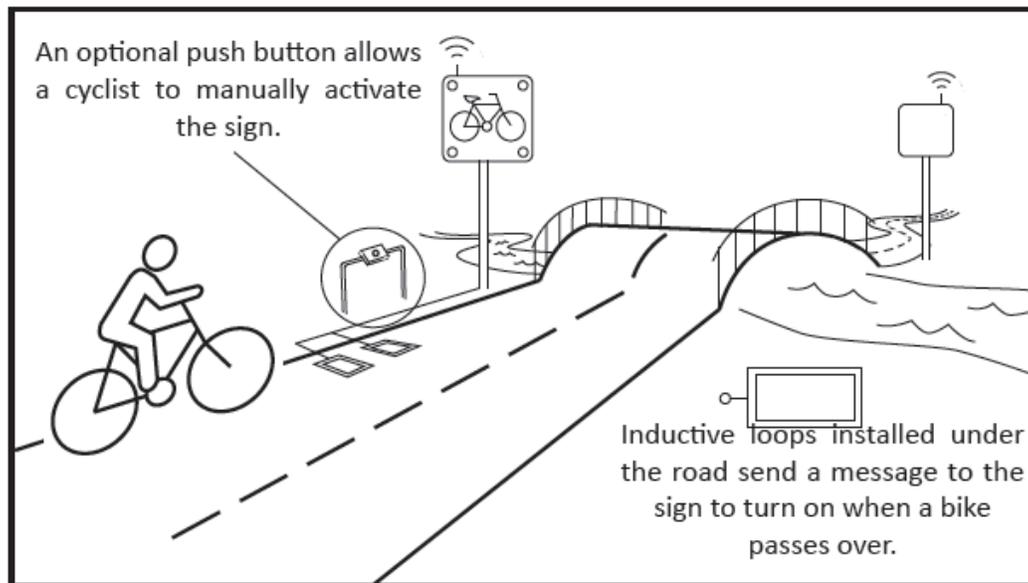
Figure 3: Sketch of Cyclist-Activated Warning Signs (HMI Technologies, 2012)

As the section of highway in Porteau Cove is the most dangerous for cyclists, it is critical to address appropriate mitigation methods specific to the area. As discussed, shoulder widening is not a feasible mitigation method due to cost and topographic circumstances; therefore, it is recommended that cyclist-activated signals are installed at each end of Porteau Cove for the respective directions. Such signals can be automatically activated - through the use of detection loops - by cyclists when passing the sensors. Upon activation, the signals will function as a beacon to notify motorists of the cyclist(s) on the shoulder; the signal will flash repeatedly for a preconfigured length of time before returning to a standby state. When cyclists are not present in the area, the signal will remain deactivated and have no impedance on the flow of traffic. To

purchase and install two cyclist-activated signals, there is an approximate total cost of \$45,000 (California Department of Transportation, 2002; Edwards, 2009; Gardener & Kortegast, 2010). The approximate cost includes two loop detectors; this expense can be significantly reduced if button-activated signals are installed in lieu of automatic detectors (Figure 3).
