Los Angeles Times

Berkeley Balcony Collapse Puts New Focus on Wood Dry Rot

June 17, 2015

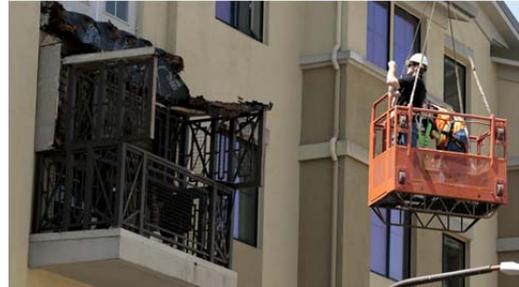
Investigators on Wednesday were trying to determine how the wood beams of the balcony that failed — killing six people — had deteriorated so thoroughly in the eight years since the apartment was built.

On Wednesday, they announced that the balcony on the floor below was also in danger of collapsing and ordered it to be removed immediately.

Outside engineers who visited the site and examined photographs said there were clear signs that the beams supporting the deck had rotted due to water exposure.

“You can see evidence of water at the front, some staining at the front face of the lower balcony,” St. Onge said. “There's some brown staining in the front.”
