Stormwater Treatment System Project Terminal 18 Port of Seattle

Kelly Garber SSA Marine

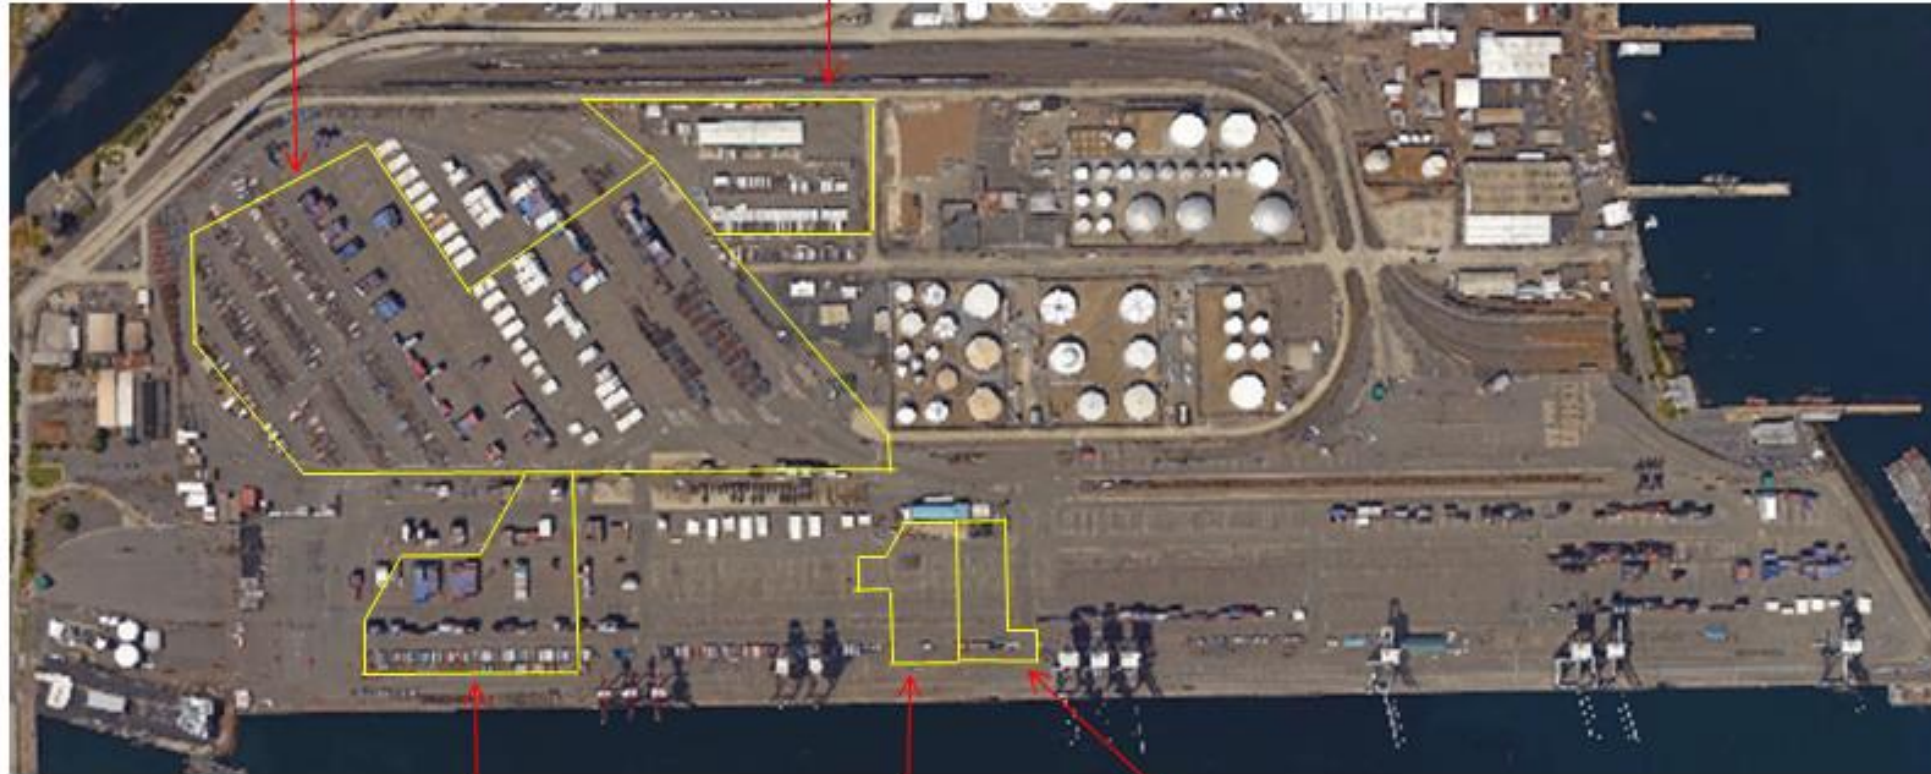
Phase One Treatment

87.2 Total Acres

Basin 19 / Expansion Area (Matson yard). 56.9 acres.

Basin 3 / CEM and Roadability 13.5 acres. Includes OWS.

Basin 20. Combines with Basin 19 due to proximity of outfall. 10.3 acres.

Basin 15 / MNR. 4.2 acres. Includes OWS.

Basin 14 / MNR. 2.3 acres. Includes OWS.

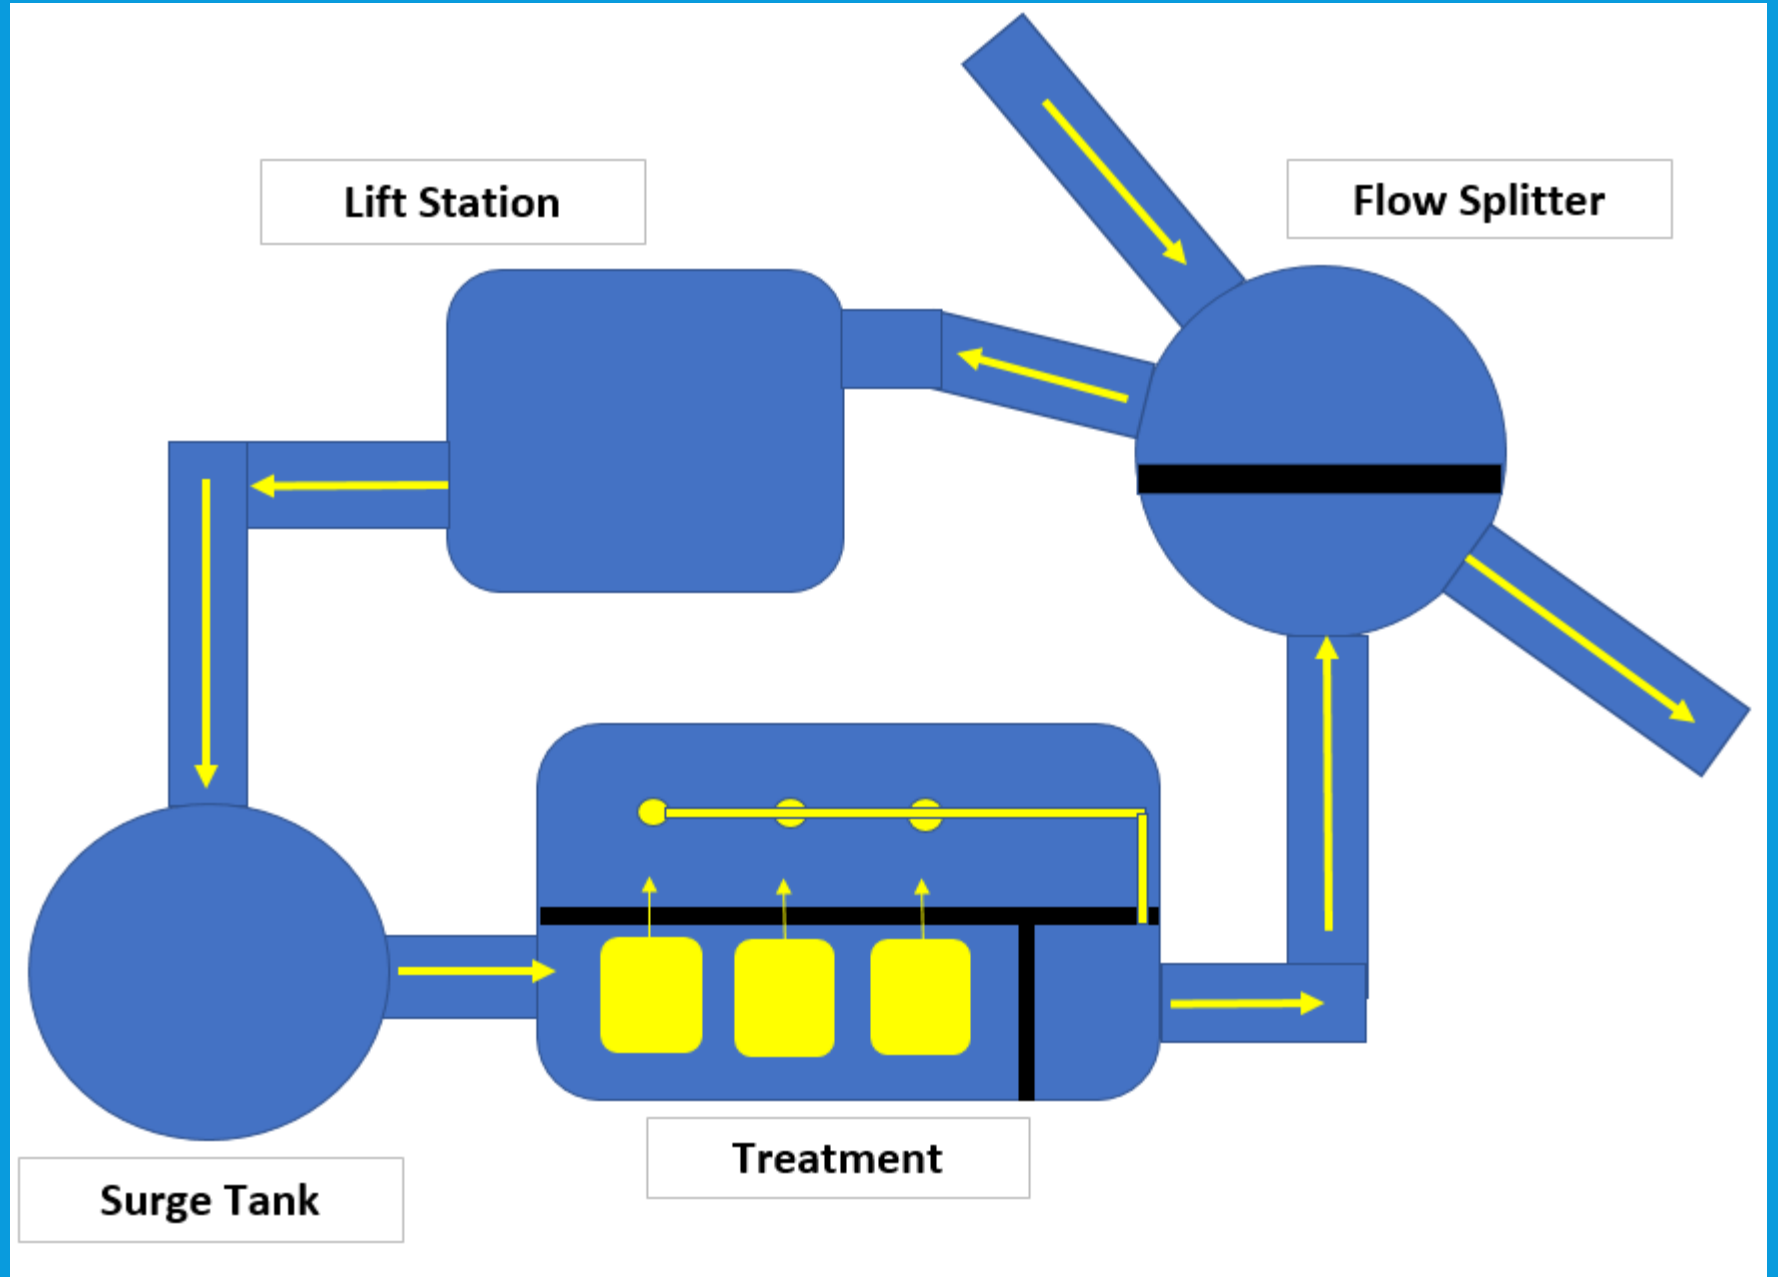
Basic System Components

Modular Wetland

Basin 14

Modular Wetland systems

11/15/2016	Turbidity	Ph	Zinc	Copper	TSS
Bench	25 NTU	5.0-9.0 su	117 ug/L	14 ug/L	30 mg/L
Raw Average	24.8	7.3	298	17.7	52.7
M15	8.44	7.6	76.4	1.87	0
% Reduction	66		74	89	100

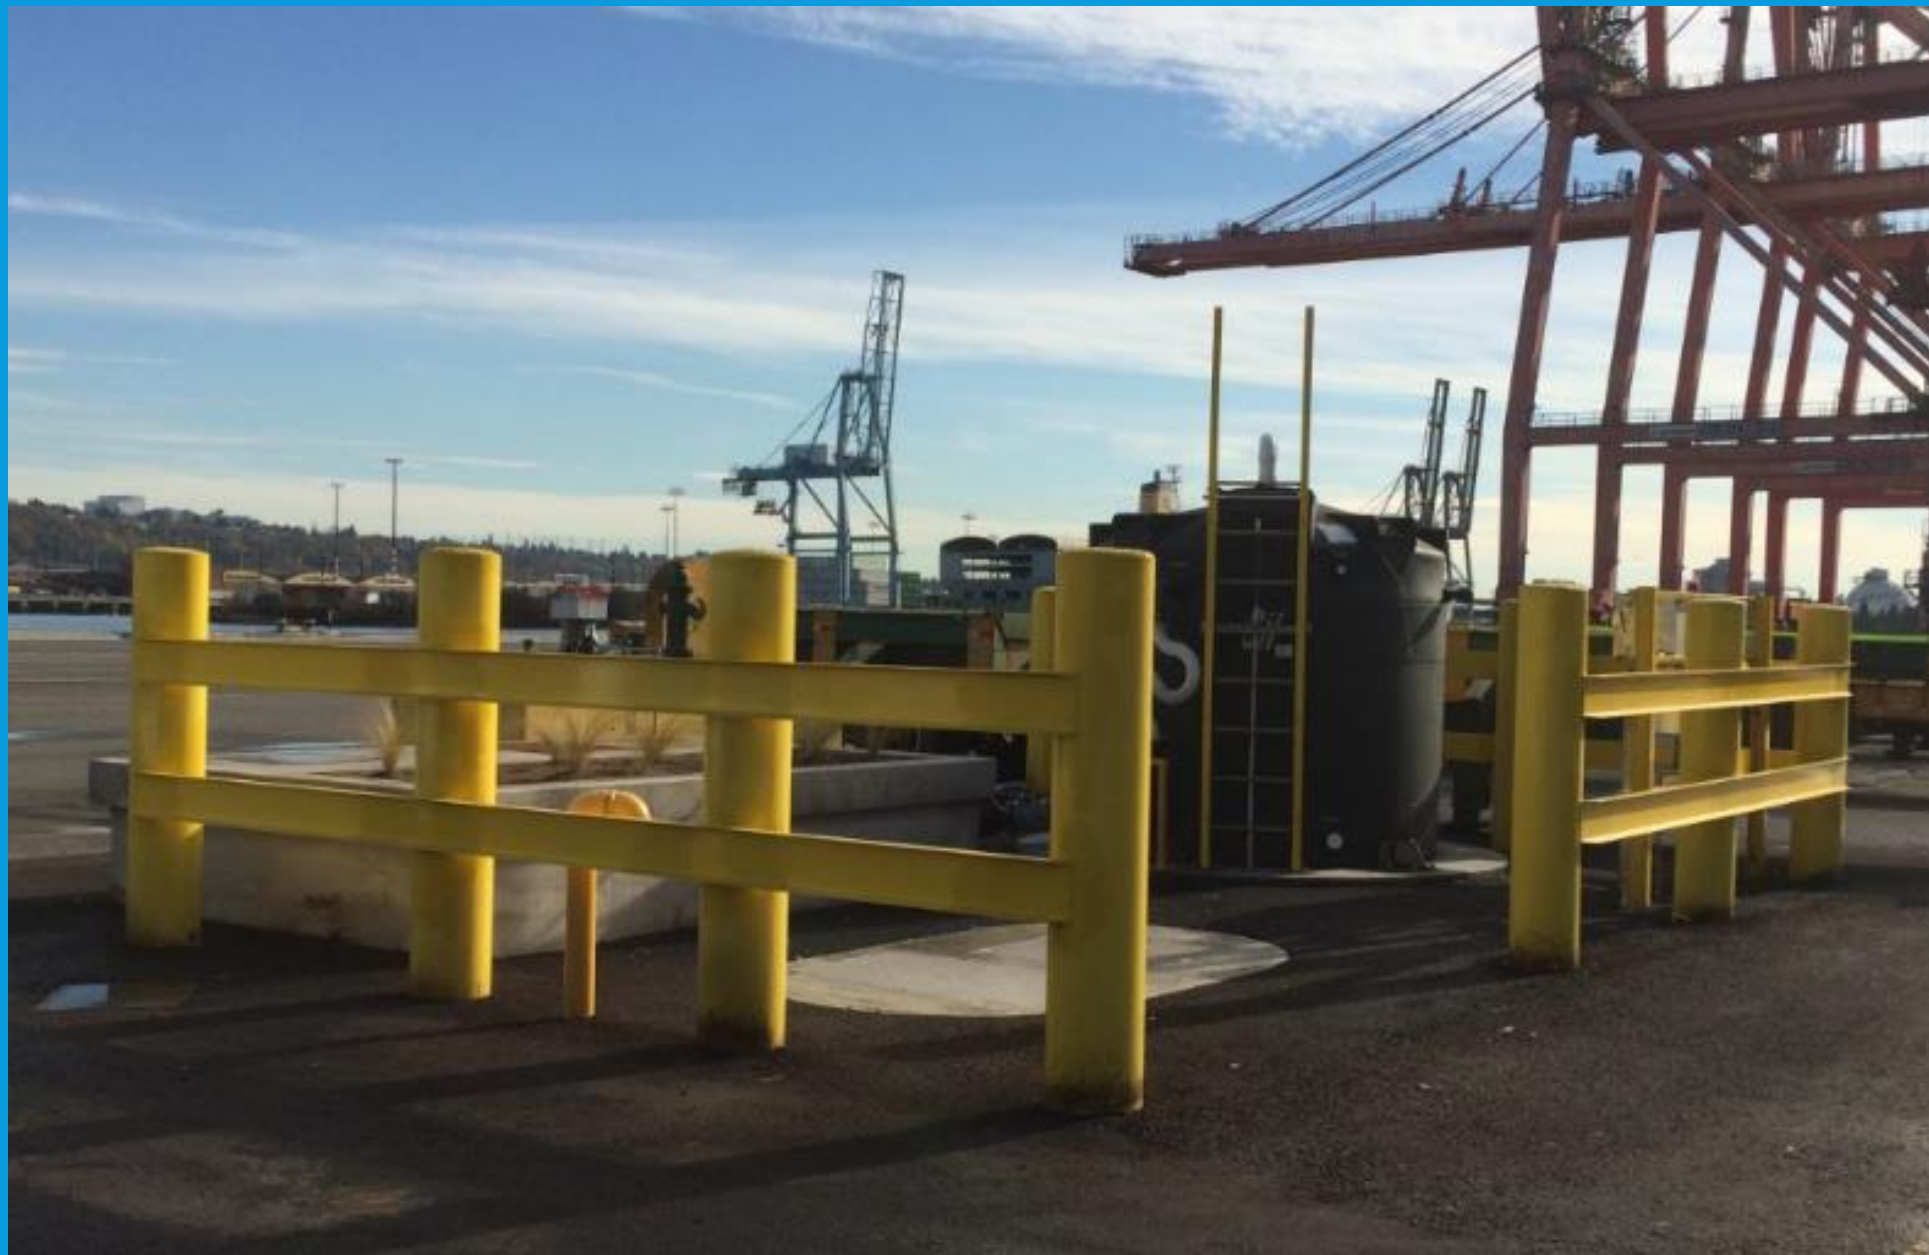
Chitosan Enhanced Sand Filtration System Basin 19/20

Chitosan Enhanced Sand Filtration System

11/14/2016	Turbidity	Ph	Zinc	Copper	TSS
Bench	25 NTU	5.0-9.0 su	117 ug/L	14 ug/L	30 mg/L
M19 Raw	20.6	7.23	279	72.6	43.7
M19 Treated	0.31	6.93	40.9	5.46	0
% Reduction	98		85	92	100

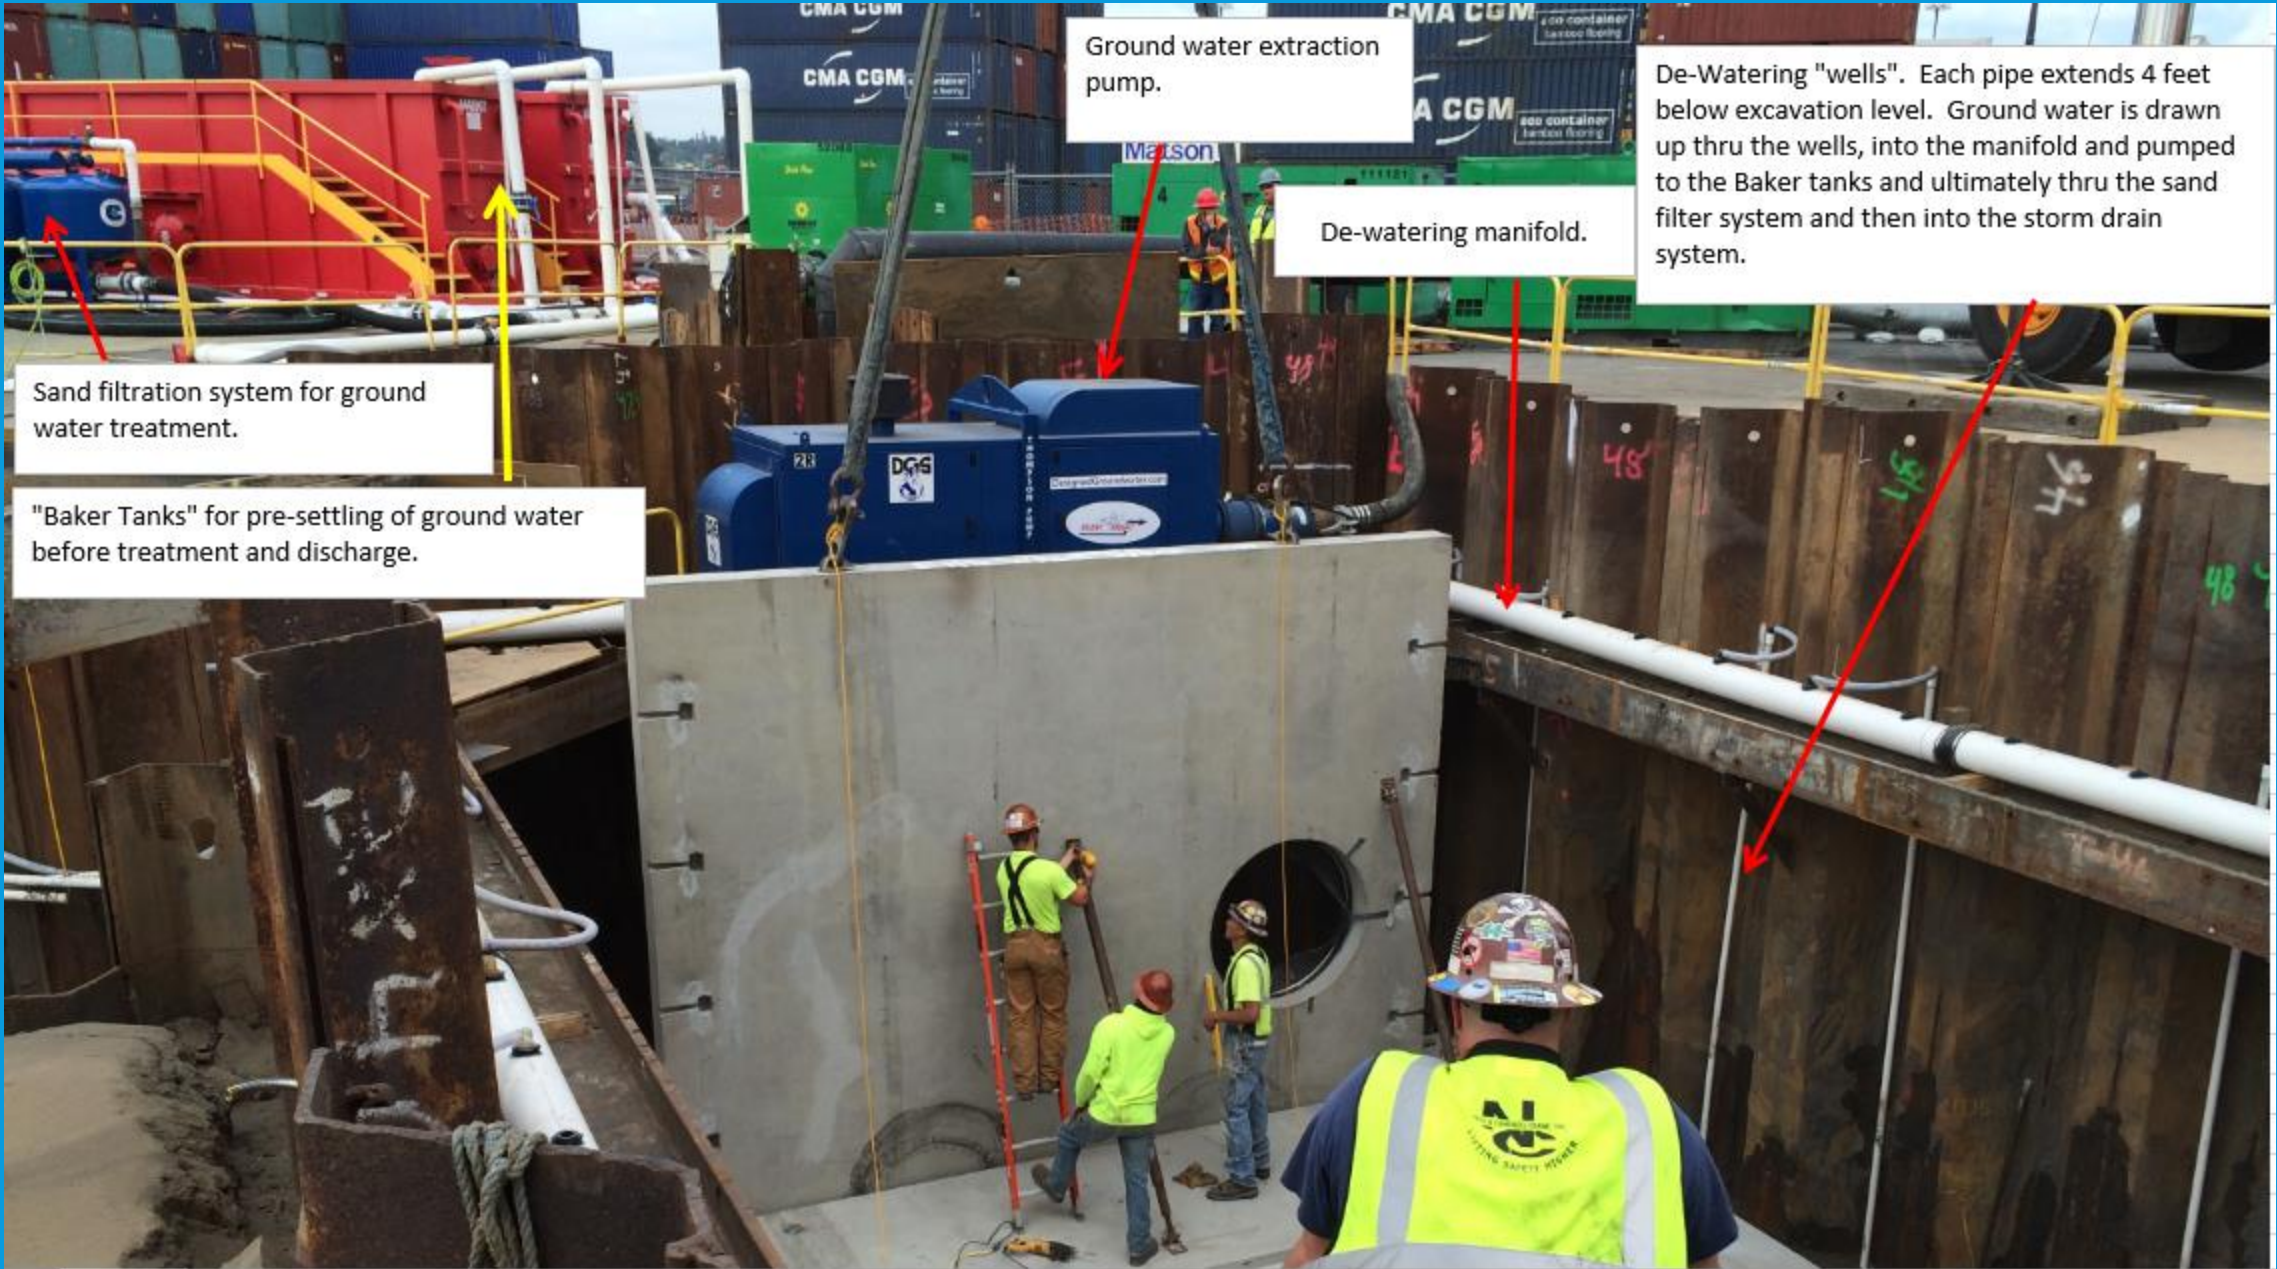
Ground water extraction pump.

De-watering manifold.

De-Watering "wells". Each pipe extends 4 feet below excavation level. Ground water is drawn up thru the wells, into the manifold and pumped to the Baker tanks and ultimately thru the sand filter system and then into the storm drain system.

Sand filtration system for ground water treatment.

"Baker Tanks" for pre-settling of ground water before treatment and discharge.

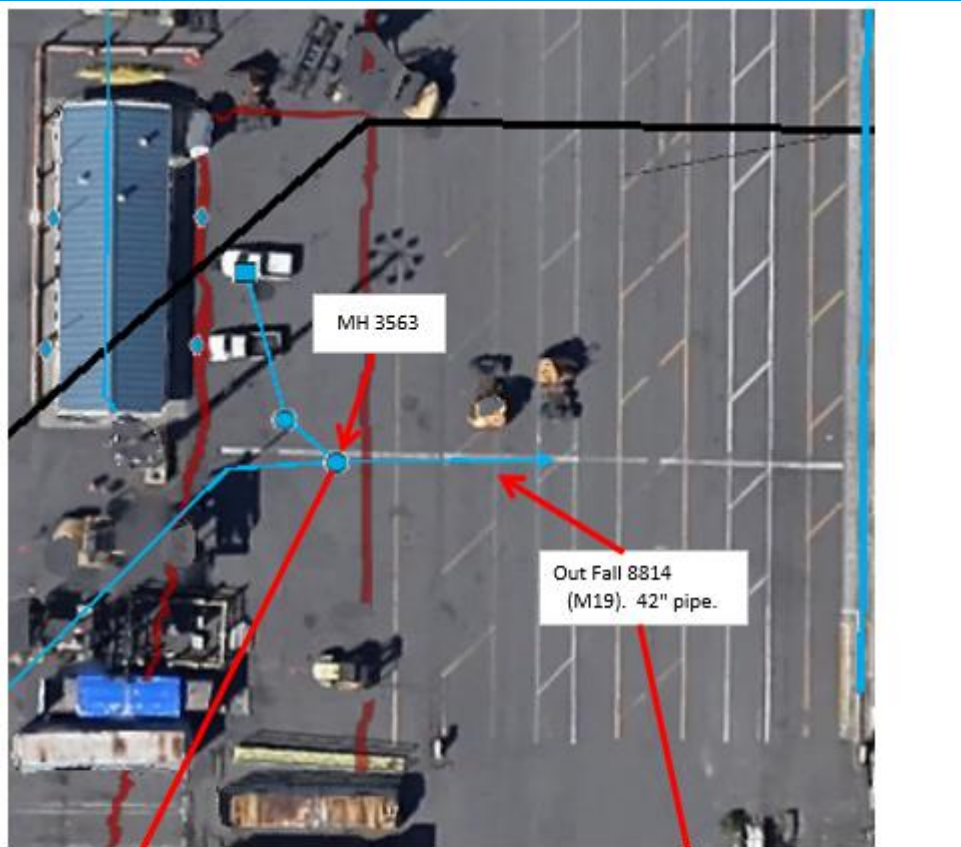
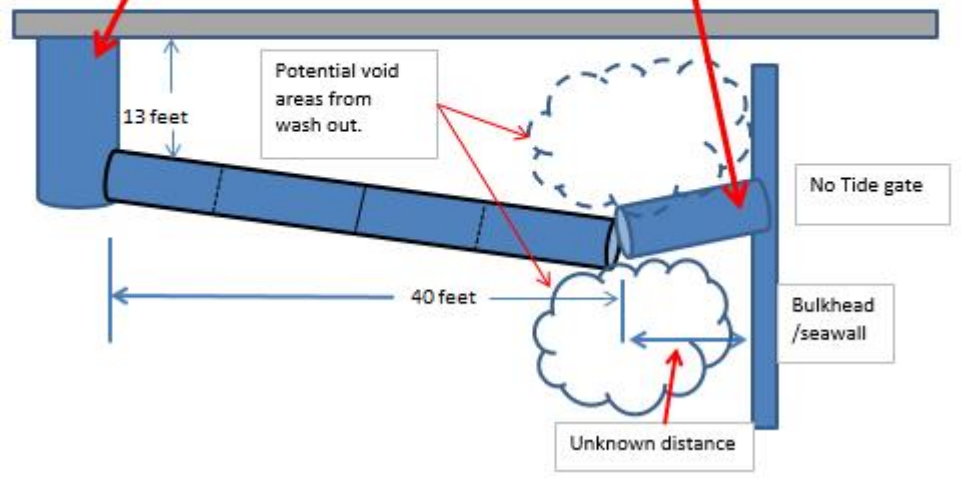
07-08-15. Outfall pipe in Basin 19. Video inspection reveals break in pipe approximately 40 feet from the manhole. Pipe has settled and the joints along it's length are opening. Ground water infiltrates all along pipe. Tidal influx is substantial. There are likely significant voids above and below the break.
