Preface and Acknowledgements

This document is the publication, result of the papers presented at the 22nd IIWC International Symposium, held in Bilbao between September 29 and 2 October 2019, under the umbrella of the Summer Courses of the University of the Basque Country.

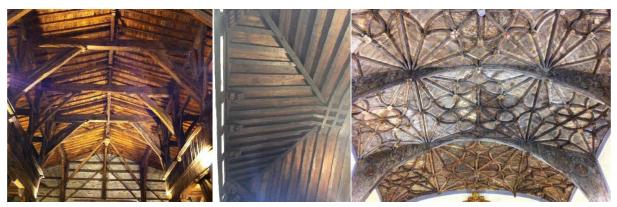
Image 2: From left to right, La Antigua, San Miguel de Elexabeitia and San Andrés de Ibarrangelu. Source: author

- 1) The oldest one is a Post and beam construction, of which "La Antigua of Zumárraga" is one of the best examples.
- 2) Flat structure roof with exposed beams, which is "techo plano a cinta y saetín" in Spanish San Miguel de Elexabeitia is a good example of it.
- 3) Wooden vaults, which are exempt structures that do not generate lateral tensions on the masonry walls, usually without foundations, absorbed by different elements on case by case basis that can be: hidden bracings in the sinus of the vaults, exempt posts attached to the inner side of the walls, stone brackets or hang the boss to the roof by nailed sticks to the rafters.

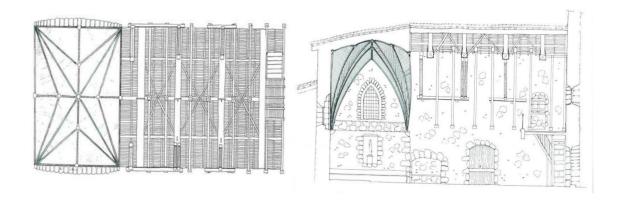
Image 4: Plan and longitudinal section of the church. Source: Ars Lignea (Santana, 1996)

The oldest one is San Bartolomé de Olarte a church with a single nave, built after 1500 A.D reusing the elements of a previous construction. The original cover is from 1520 A.D with four open trusses reinforced with bracing laying over stone brackets in the walls. Fifty years later the barrel vault was completed for the nave and a rib vault was constructed for the presbytery. The eight arches were made by four curved elements that support a longitudinal beam. Between the arches there were wooden boards with plaster to simulated stone. This building also has an elevated choir and a porch. (Santana, 1996)

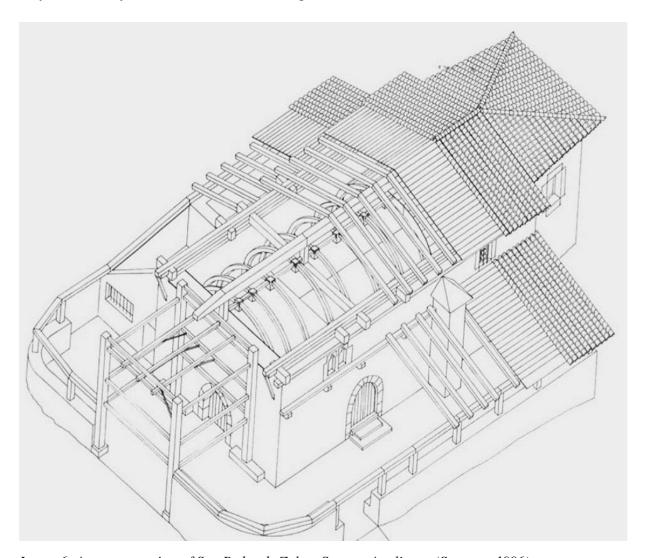
Image 6: Axonometry view of San Pedro de Zaloa. Source: Ars lignea (Santana, 1996)

Three kilometres away we can find San Pedro de Zaloa from 1530 built in a similar way. As you can see in the axonometry view below eleven curved arches support a central beam to which they are fixed by carved bosses (six still original).

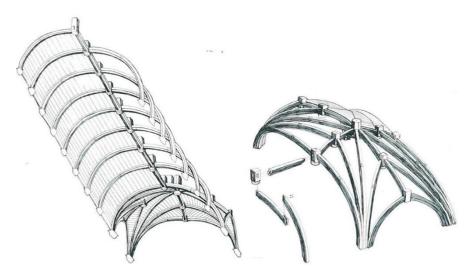
Image 8: Santa M^a de Goikouria, details of its roof structure. Source: Ars lignea (Santana, 1996)

Sta Maria de Goikouria is only 4.5 km away from San Bartolomé. This is an anachronic design, a copy of Olarte's ceiling made in 1770 commissioned by a neighbour who made money in South America and sent it from Mexico. (Historic church archive of Bizkaia. Account books 1766-1959). It was located in slope and its masonry walls haven't had any foundations. Since they already had the money the construction was finished in just one year. Again, the same scheme, barrel vault with 9 curved arches made with oak wood and covered with oak and chestnut boards (Santana, 1996).

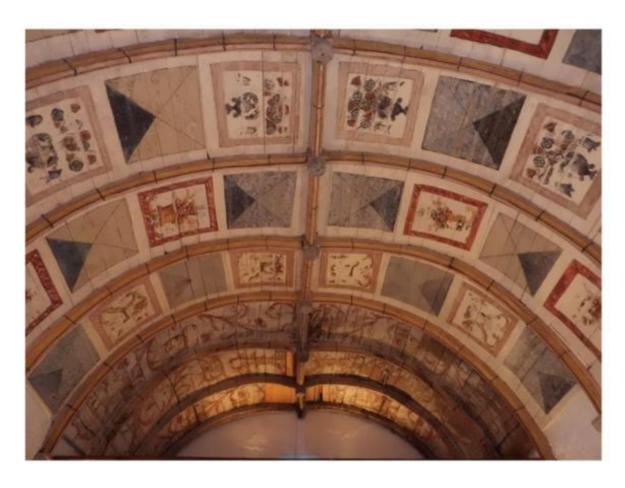
Image 9: Detail of the paintings in the barrel vault. Source: author

The singular thing this time are the paintings, a tempering technique with vegetal motifs. In 2013 the painting was restored by a private company designed by the Cultural Council of Bizkaia. We knew that the neighbours had to pay for at least half of the arches and that costed around $20.000 \in$.

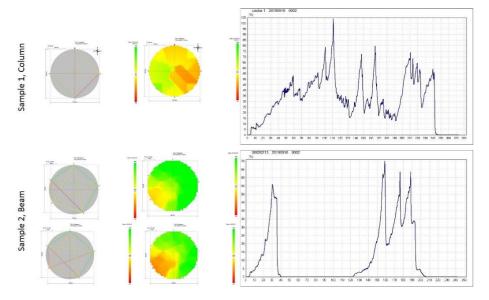
Fig.3. Diagrams an ultrasound images in S-1 column and S-2 beam.

Ultrasound. To detect and quantify wood internal decay was used the Rinntech ARBOTOM, an impulse tomography unit that enables an inside view of condition of timbers and trees and round wood. A series of sensors are placed around the structural elements, each one connected to the next and then to a computer. Each sensor is tapped, which sends a stress wave across the wood to the other sensors, and produce an image (fig.3).

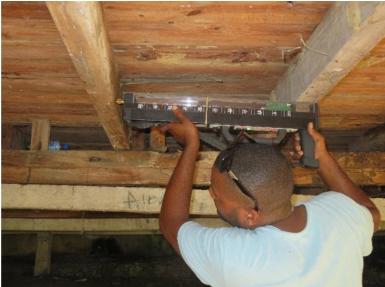
Fig.4. Using the resistograph (Flores, 2018)

Electromagnetic. Rinntech Resistograph model R650-ED, is an electronically controlled, drill that provides unsurpassed accuracy in measuring the relative density of wood in trees and timber structures. Use DECOM software to analyses the data and produce credible charts that properly reflect actual wood conditions (fig.4).

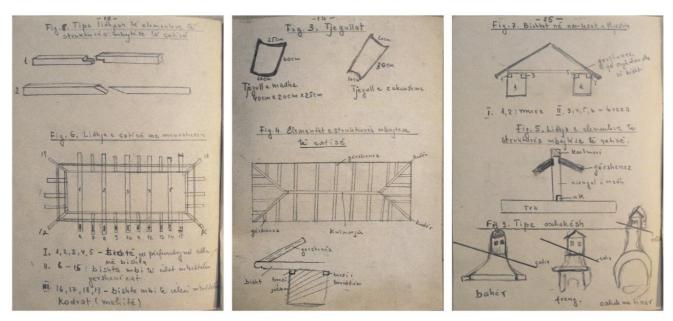
Figure 1 – Example of the sketches made by the IKP collaborators in compiling the Muka's questionnaire about traditional timber roofs. (Source: (Source: IAKSA, Arkivi i Etnografisë (AE), Dos. no. 1256/3 (D77), Doc. no. s.d., dt. s.d.1985)

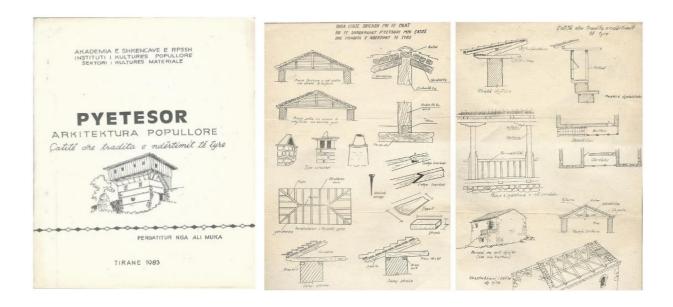
Figure 2 - The Muka's questionnaire titled "Roofs and their building tradition" (Çatitë dhe tradita e ndërtimit të tyre) and its graphic annexes (Source: Muka, 1983).

The complete paper containing the answers to the questionnaire had to be mailed to the former IKP, Department of Material Culture. The section "Çatitë" was divided into two headings. The first was composed of 12 questions concerning the building materials supplying and their characteristics; the second was composed of 23 questions on the roof construction work organization and its building technique. In the end of the section "Çatitë", was attached an annex containing a few representative sketches on roofs' common structural elements and joints' details.

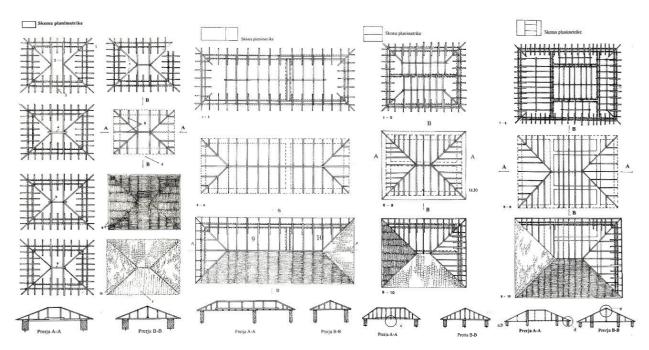
Figure 3 – The common Albanian traditional timber roof and its development according the spans increase (Source: Muka 2007).

The configuration of an ancient timber structure is often the result of the skilful hands of workers, craftsmen and carpenters who did not base their work on scientific knowledge but on their empirical experience. Albanian traditional roofs were built with structural elements obtained by the woodwork processing of lumber locally available and, usually, the common roof was a pitched roof (cati me kullime or *çati me flegra*) having the shape of a gable roof and hip roof (Muka 2001b: 62, 64; Muka 2007: 373). According to Muka (1999: 102; 2001b: 64; 2007: 373), the Albanian traditional roofs in rural areas could be divided in domestic and auxiliary constructions' roofs and dwelling houses' roofs. The latter were more complex and accurate because were built by carpenters or skilled builders. Muka, basing his investigation on the plan arrangement of the pitches from the outside, identified 3 possible roof morphologies. The first two, arranged to cover a rectangular shape plan, had a span usually not exceeding the length of $4 \div 5$ m. The simplest could be found in distinct types of dwelling houses and was called two-pitched roofs (catia me dy kullime) or gable roof. Carpenters used to call it "roof without hip and/or valley rafters" (cati pa mahi), or also gable roof (cati me kallkan). The structure was quite simple and, besides the missing of the hip/valley rafters, the main vertical posts and the horizontal or inclined jetting beams forming the eaves were also missing. In some cases, when thin collar purlins belt was transversely put in place under the hip/valley rafters or under the common rafters at about 1/2 or 1/3 of their length, the ridge beam was missing too. Consequently, the common rafters were joined together at their top by means of a half-lap joint. This simple roof structure was diffused both in the North and in the South of the country (Muka 1999, 104; Muka 2007, 375). The second one was similar to a gable-hip or halfhipped roof (*çati me tri flegra*, *çati me dy mahi* or *çati me tri faqe*). According to Muka (1999: 104; 2007: 375) this type was common in the rural mountainous areas of Elbasan province, central Albania. The last roof morphology was the most consolidated and diffused in the Albanian countryside (fig. 3). It was the typical hip or cross-hipped roof (cati me katër flegra, cati me katër kullime, cati me katër faqe or cati me katër mahi) (Muka 1999: 104; Muka 2001b: 69; Muka 2007: 376). In this case, the total span to be covered was wider than the previous ones (Muka 2001a, 247; Muka 2001b, 70). The number of intermediate spans and supports could vary along the transversal and longitudinal axis or both, always maintaining the rectangular shape of the overall plan. The inner wooden structure was always the same, allowing simple partial modifications and new additions when needed. Thus, to an articulated plan scheme corresponded a more complex pitched roof shape but the same wooden structure and structural members.

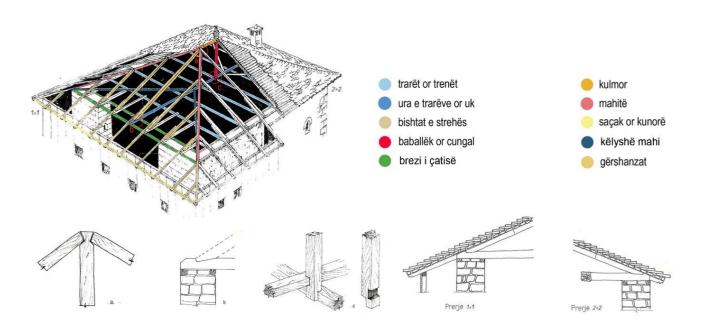
Figure 4 – Structural timber elements identified by Muka and few joints details (Source: Muka, Riza & Thomo, 2004; Graphic processing: Pompejano 2018)

The construction process started with the placement of the thin plates composing the horizontal timber ties system (brezi i çatisë), which were lengthways positioned on the top of the stone masonry bearing walls. Usually, there were 2 lengthways positioned elements, but when the wall thickness was greater a third one was added in the middle. These elements created a sort of horizontal wooden belt, embedded in the masonry, where each element was tied to the next one to guarantee stability to the entire timbertie system. Joints between two consecutive thin plates were usually ensured by means of nails. Horizontal main beams (trarët) were put in place directly on the masonry timber-tie system along the span transversal direction. Then, horizontal or inclined jetting beams (bishtat e strehës) were nailed on the external thin plate of the timber-ties system (brezi i çatisë), to create the eaves. The distance between these elements depended on the distance between the trarët. Muka noted that the projection and the length of those elements with respect to the external face of the bearing masonry wall, was as much at least as the thickness of the wall itself (65÷75 cm). On the trarët, an horizontal beams (ura e trenëve) is orthogonally placed, parallel to the longitudinal axis of the roof plan. Carpenters paid attention to shaping and levelling this element in correspondence of its points of contact with the *trarët*. Often it was composed of two nailed elements to extend its length throughout the longitudinal direction. The extension joint was realized in correspondence of one of the below-placed horizontal beams by means of a simple scarf splayed joint. This structural element is present within almost all Albanian traditional roof morphologies.

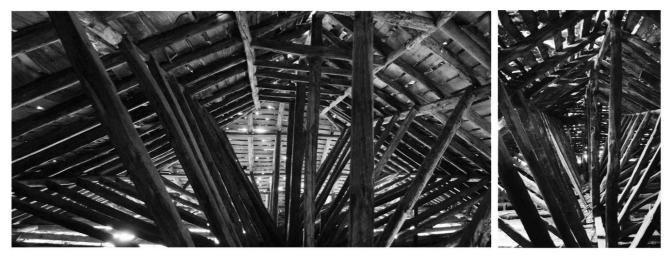
Figure 5 – Traditional timber roofs in Gjirokastër, Albania (Source: Pompejano, 2018)

Gjirokastër traditional timber roofs constitute a peculiarity if compared to the main framework described by Muka' studies, as well as the specific case of the Alpine region of Theth (Shkreli, 2018). The structural framework complexity of these wooden roofs increases depending on the number of minor spans to be covered and accordingly to the number of available supports. The greater the total transversal span to cover, more articulated is the wooden roof structure. According to the number of supports available and the spans to be covered, I have identified 4 timber roof frameworks. These roof frameworks have in common the large number of timber elements placed at a close distance and cooperating to support the

heavy roof stone slabs covering. The arrangement of the members reflects the spatial structural behaviour of these timber roof frameworks (fig. 5).

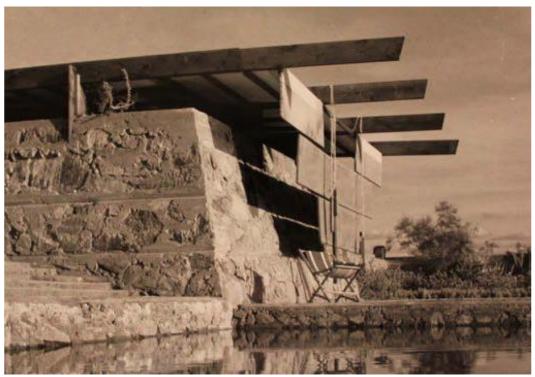
Figure 2 - Exterior view of the Original Dining Room ca.1939, The Frank Lloyd Wright Foundation, Taliesin West Archives, Scottsdale, AZ.

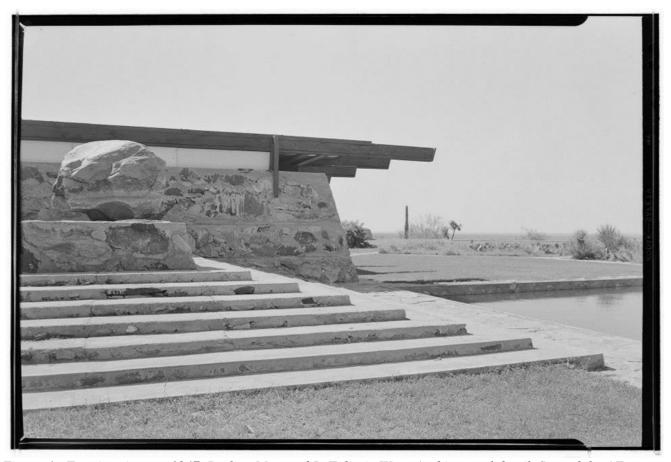
Figure 4 - Exterior view, ca.1947, Parker, Maynard L, Taliesin West. Architectural detail. Scottsdale, AZ. 1940s. The Henry E. Huntington Library, San Marino, California.

Four beams spaced approximately 8 feet apart serve as the primary support system of the roof. Each consist of one continuous 2-by-12-inch board which runs from north to south the entire depth of the Original Dining Room and extend 8 feet out from the clerestory windows on the south wall. On the exterior, two decorative wooden icicles hang from the center of the overhanging part of the center two beams. Near the southern doorway on the interior, two desert masonry columns situated approximately 3.5 feet from the door serve as additional supports for the two center beams. Wide decorative boards and cove lighting sit beneath the two center beams.

The ceiling between the westernmost two beams and between the easternmost two beams consists of plywood with recessed lighting. The two center beams form the frame of a 7.5 foot wide skylight composed of ten fiberglass panels, beginning at the fireplace and spanning for 17.5 feet towards the southern door. A laylight consisting of twenty triangular panels (tri-panels) connected to thin diagonal wooden members hangs beneath the skylight. Small decorative wooden pyramids adorn the skylight frame below the laylight, above the dentils and lighting.

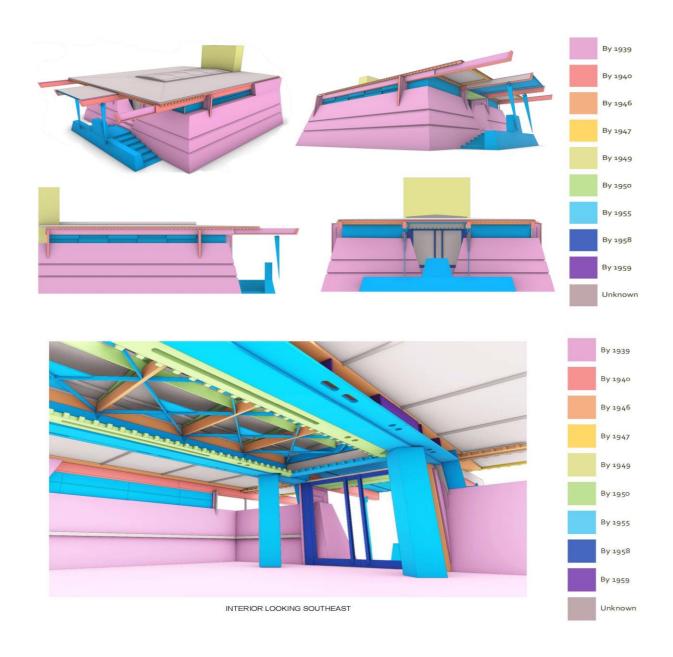
Figure 6 – By creating a three demensional model featuring every individual wooden member used to construct the Original Dining Room, each element could be color-coded to the period in which it first appeared in the space.

To illustrate the complex building chronology, each element in the Rhino model has been color-code to the period in which it first appeared. The coloring of an element means the specific feature first appeared in that location at that time, but it does not mean that the present fabric of that element dates to that time period. A board may be color-coded to a year even though the element was recycled from an earlier period or replaced at a later date. The process of digitally reconstructing the structure piece by piece meant that the interior structure had to be carefully considered. Photographic evidence of the structure's earlier forms helped to inform what exists beneath the surface, and consequently led to a better understanding of how and when elements were added, removed, and altered (fig.6).

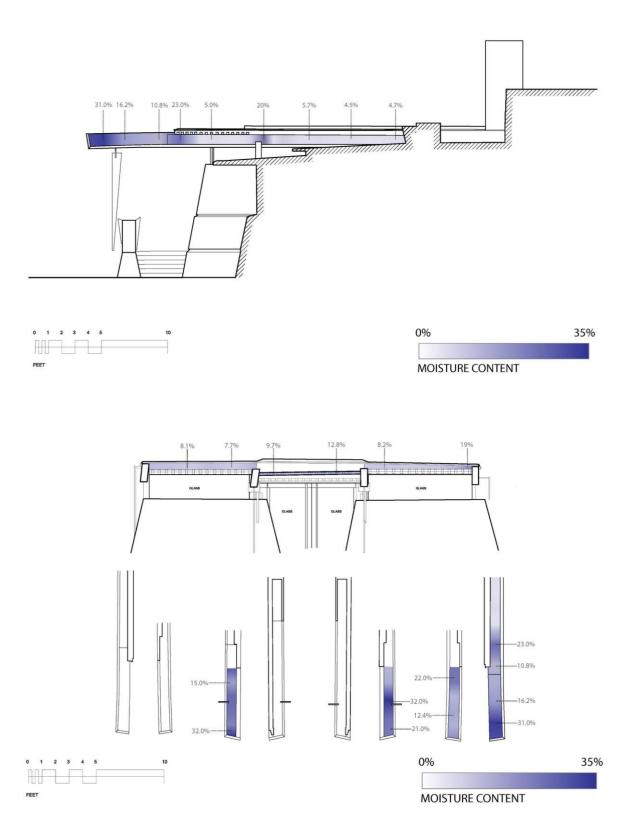
Figure 7 – High levels of moisture were found in nearly every exterior member tested with a moisture meter, revealing a significant risk for insect infestation and fungal decay.

site within 48 hours prior to obtaining the readings. The results of these moisture readings were mapped on drawings using a gradient to represent the percentages (fig. 7).

Readings were taken along the lapped boards on the exterior elevation of the easternmost beam, which is original to the 1938-39 construction. The highest moisture content was found at the beam's south end, with readings up to 31.0%. This puts the member at a significant risk of decay and insect infestation. Though it is not unusual for a board's moisture content to be higher near the end grain where moisture is absorbed most easily, the increased moisture retention in this portion of beam may also be caused by the lapped structure of the beam trapping moisture and restricting evaporation, particularly because this area is directly exposed to precipitation. Readings decreased to 10.8% where the roofline begins, but rose to 23.0% at the end grain of the next board. Most of the remainder of the measurable area of the board was dry, having a moisture content between 5.7% and 4.0%, except for where the beam comes into contact with the roof support element approximately 6' 8" from its southern end. Here, the moisture readings increased to 20.0%, nearly as high as the readings at the end grain. Additional readings were taken on of the three easternmost beams. The moisture content of these members ranged between 12.4% and 32.0% with no consistent pattern. Each of these boards were found to be wet, with nearly all of the readings taken of these boards being greater than 15.0%. Measurements were taken on the fascia boards along the south elevation. Except for the westernmost end of the facia board where it meets the westernmost beam, all readings for the southern fascia boards were below 12.8%.

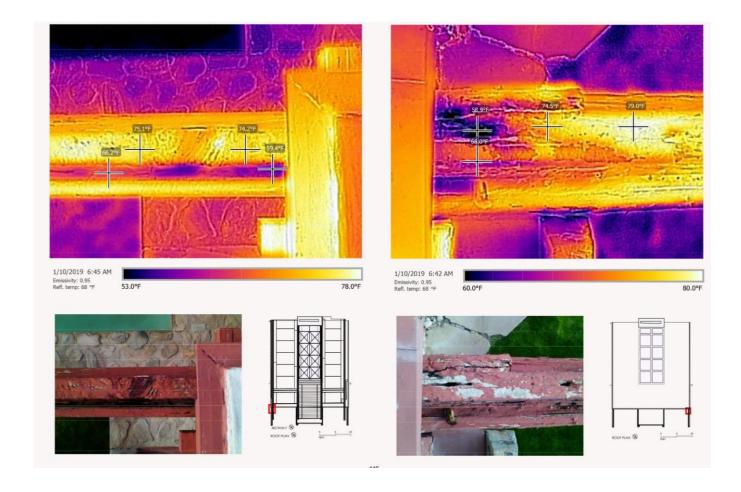
Figure 8 – Infrared thermography revealed areas of high moisture on the tops of the beams, suggesting that moisture-related decay was still and ongoing process.

Using a FLIR C2 camera, infrared thermography was used to map temperature and moisture patterns of wooden members of the Original Dining Room. This was especially helpful in investigating the inner members of the exterior beams where decay was present but measurements could not be taken with a moisture meter due to size restraints. Thermographic images of the tops of the outermost beams showed that the areas of severe decay had temperatures as far as 15°F below that of surrounding wood, confirming that moisture is still a severe issue in the inner members of the beams (fig.8).

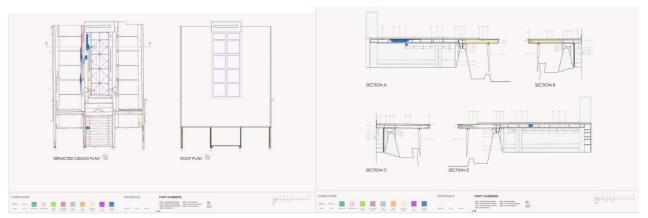
Figure 10 – The majority of the conditions observed on the interior were concentrated near the skylight and along the second easternmost beam. On the exterior, the worst conditions were found on the overhanging portions of the beams.

The interior is in overall good condition, with water staining and cracks being the most prevalent concerns (fig. 10) both conditions are found primarily on the mural, ceiling and cove lighting. Because moisture appears to be entering across a wide area of the elevated portion of the skylight, the moisture is most likely a result of precipitation. However, a series of mechanical systems run across the roof near the chimney, and water has been observed to pool on the northwest corner of the roof. Fungal decay and pest activity accompany the moisture infiltration near the fireplace. Though the damage resembles that of subterranean termites, drywood termites are most likely responsible for the deterioration, as they can survive with no access to the ground and require as little as 13% moisture content, which is less than that of subterranean termites. While moisture content readings were not taken in this area of the Original Dining Room, infrared thermography suggests that the affected areas are holding more moisture than surrounding members.

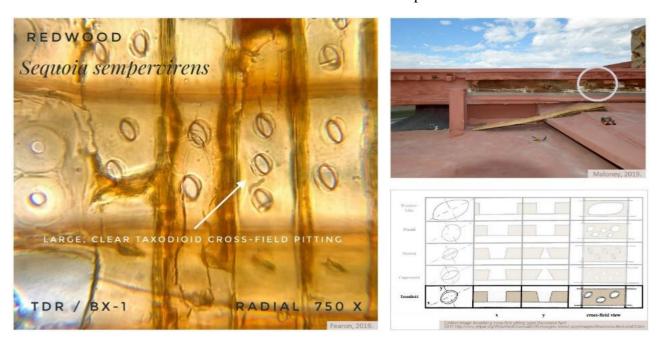
Figure 11: Photomicrograph of wood sample taken from location of beam identified with taxodioid cross-field pitting.

Taxodioid cross-field pitting was the most defining feature of the samples. When a sample is viewed radially, cross-field pitting is visible as the area of intersection between ray parenchyma cells and the axial tracheid walls. There are five types of cross-field pitting which may be used in wood identification: fenestriform (or window-like), pinoid, piceoid, cupressoid, and taxodioid. *xii Taxodioid cross-field pitting appears in several species other than redwood including Japanese Cedar (*Cryptomeria japonica*) and bald cypress (*Taxodium distichum*). *xxii The presence of taxodioid cross-pitting in conjunction with other characteristic anatomical features confirmed that the samples are all redwood.

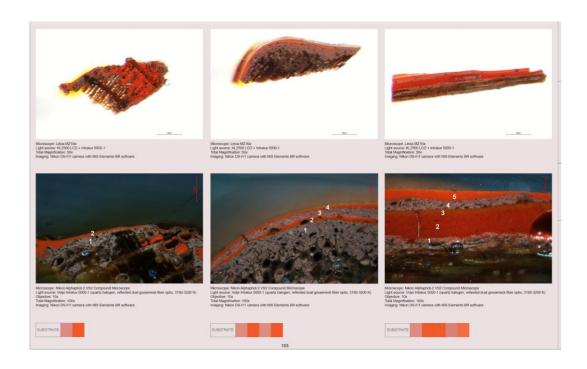
Figure 12- Photographs of finishes samples taken from tripanels (left and center) and a pyramid (right). Microscopic analysis revealled differeing stratigraphies of Taliesin Red and Mandarin Red in each.

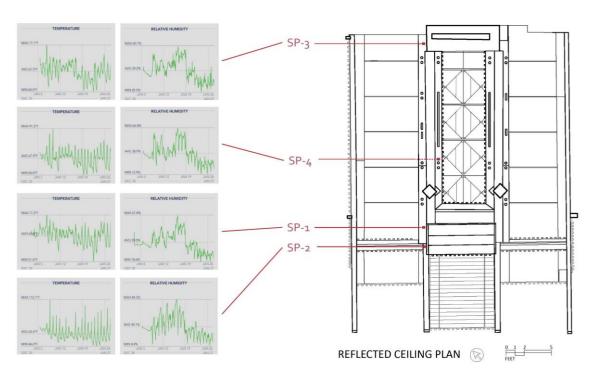
Figure 13 – For SensorPush data loggers were placed along the second easternmost beam, where rapid and extreme daily fluctuations in temperature and relative humidity were observed.

Four SensorPush Humidity and Temperature Smart Sensors were placed in the Original Dining Room to monitor temperature and relative humidity on January 10, 2019. Data was analyzed using 15 minute intervals starting at noon on January 11, 2019 to noon on April 26, 2018. Monitoring for this research was limited to 106 days. For consistency, all four sensors were installed along the second-westernmost beam. On the interior, SP-1 was installed near the doorway and clerestory window, SP-3 near the fireplace and mural, and SP-4 near the skylight. SP-2 was placed on the exterior between the door and clerestory window.

Overall, SP-4, located in the skylight, had the greatest daily changes of temperature and relative humidity of the interior dataloggers, though the three interior loggers followed similar patterns. Each had an average relative humidity of around 33%, with a range from about 10% to 60%. This range in relative humidity was not just seasonal, as it changed by approximately 20% throughout the day, instigated by the changing interior and exterior temperatures. Such changes in relative humidity can cause rapid cycling in the moisture content of wood, causing it to shrink, swell, and crack. Though the average falls near the recommended 35-40% relative humidity range for wood in the southwestern United States, each interior logger was only within the 35-40% relative humidity range for 13-14% of the time data was collected.**xxvii** Only a tenth of the exterior data collected fell within this range. A relative humidity fluctuation from 10% to 60% at great frequencies can result in splitting and related deformation. Just over a third of the readings from each monitor fell well below 30% relative humidity, which can cause adhesives to desiccate and finishes to become brittle. As temperatures increase in the summer, the wood is likely to be further exposed to a relative humidity below 20% for an even greater period.

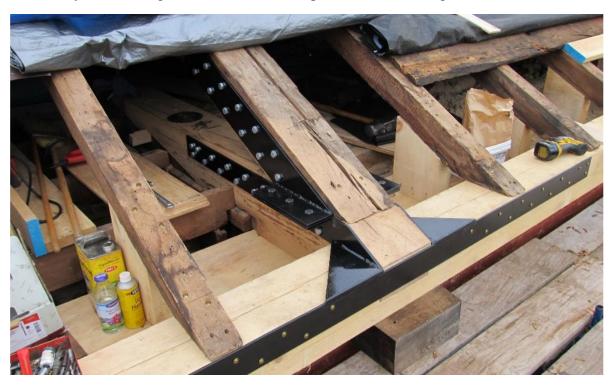
Figure 1. Modern high-tech materials may have their place in repairs to timber framed buildings, but only after all other traditional carpenter's techniques have been considered. The decayed eave end of this early nineteenth century roof truss required some custom fabricated steel reinforcing to make the wooden repairs structurally sound.

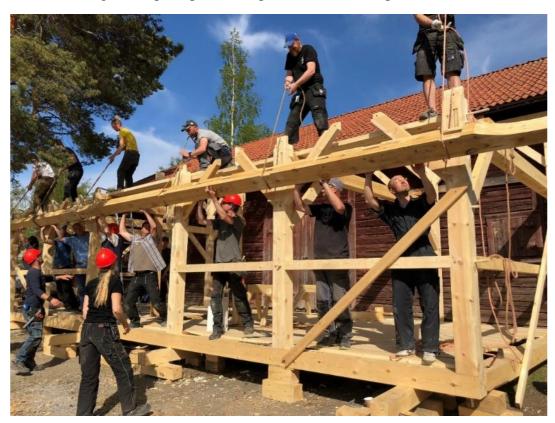
Figure 2. "Hands-on" courses should be required for all professionals involved with repairing old timber framed buildings as well as constructing new ones. Here at Jamtli Museum, Sweden, students with a variety of professions and trades are learning the timber framing craft. The long plate timber is being raised using an efficient and safe traditional technique called "parbuckling".

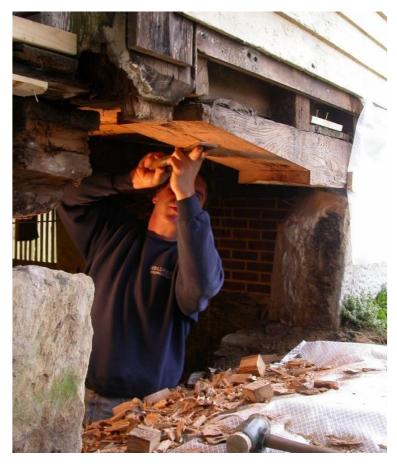
Figure 3. Rather than blindly following an architect's specifications, a well-trained craftsman can better interpret the structure, its needs, and the approach to repairing it. He can bring this knowledge to the architect's attention and improve the project's overall outcome. This craftsman is fashioning a scarf joint on an existing sill timber, a traditional carpentry repair.

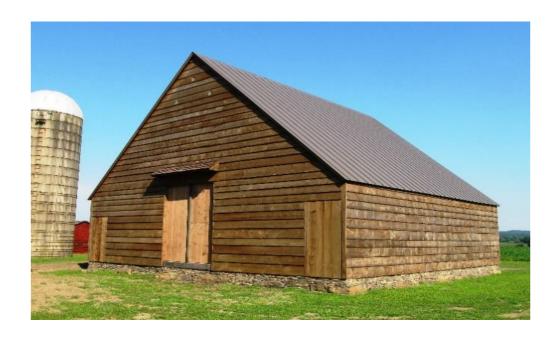
Figure 4. This New York State Dutch barn is a reconstruction of the original 18th century barn that graced this historic farm property. Many of the original barn's timbers survive re-framed in an adjacent mid 19th century barn and were documented for the re-construction.

There is a growing market for such new "historic" structures to stand along with other truly historic ones both in the private sector and in the public (museums). (Figure 4, 5) While these new structures aren't historic, they serve as examples of how the historic ones might have appeared when they were new, in their pure, original form. The built environment will improve overall when there are more traditional, vernacular structures in a given area, even if some are newly built. As old ones are lost, the newer ones keep up the vernacular appearance of the area. Working in both preservation and reproduction of historic work should be encouraged and perhaps even required, as it will keep the craftsman in his best form.

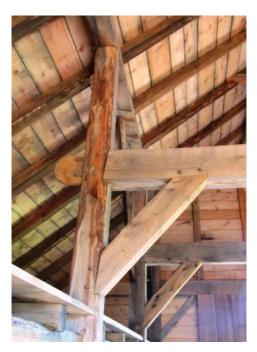
Figure 5, Virtually all of the timber, siding, and flooring for this barn was harvested out of the farm's woodlot, matching species as much as practical. Traditional scribing methods and hand tools were used to fashion the joinery.

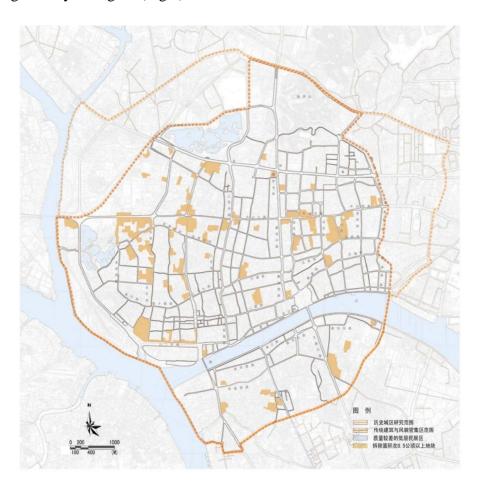
Fig.1. Schematic Diagram of Demolition Area in Historic District.

Guangzhou's city site has never experienced changes since it was built over 2,000 years ago. Under the impact of market forces, the process of hollowing out traditional villages and gentrification of historic districts has gradually emerged. (Fig.1)

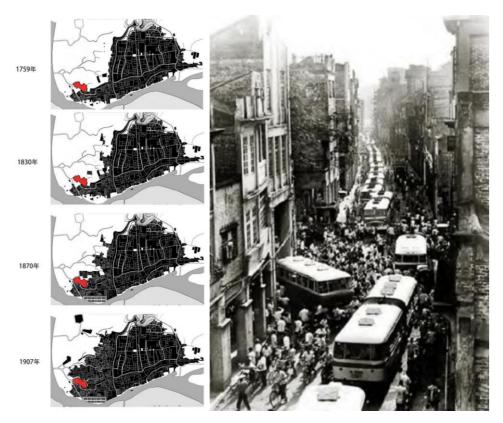
Fig. 2. Historic Information Map of Guangzhou City Layout-The red area is En-ning Road Historic and Cultural District.

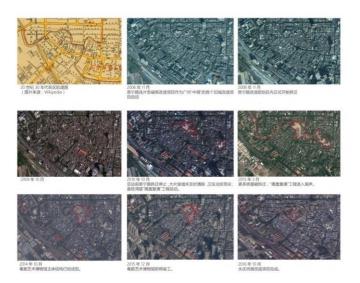
Fig.4 –Review of Conservation Planning for En-ning Road Historic and Cultural District and fabric Comparison

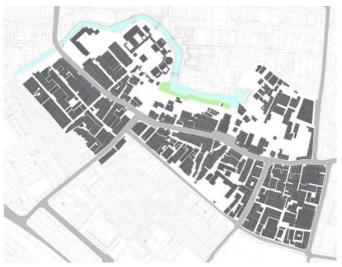
Fig.7. Present Building Fabric of En-ning Road Historic and Cultural District

texture and replaced the original openings of the gable wall with closed commercial bay windows, losing authentic historical details. (Fig.7, Fig.8)

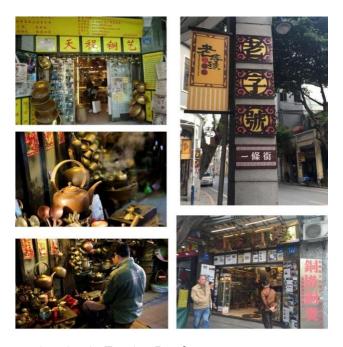
Fig.8. Photo of the current situation in En-ning Road

The first phase of the En'ning Road renovation was completed prior to the compilation of the En'ning Road Plan, and the renovation design of a vernacular building called Vanke Cloud in Yongqingfang Community lacked sufficient control. The transformation of the roof changed the traditional urban

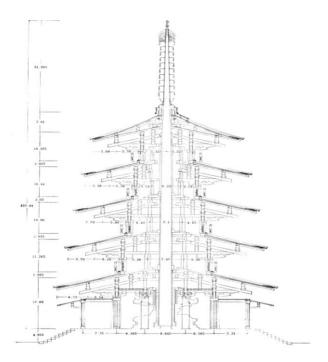
Fig.1. Five-storied pagoda of Hōryūji temple (Ōta1984)

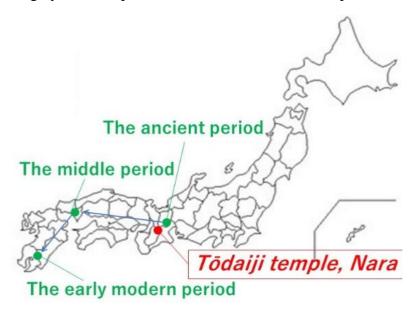
Fig. 4. The location of mountain area to fell the wood

Each *Great Buddha Hall* were also grand in scale and were made of many large diameter, long logs. In the case of 8th century structure, we can obtain information about the log size from historical documents. These indicate that the pillar size was about 1.2 m in diameter, and 20 m long. In 8th century, there was generally a considerable amount of wood in the mountains, because human construction was still not very active. Accordingly, it was easy to obtain large members from mountains close to *Nara*. So historical documents show that members of fist *Great Buddha Hall* were obtained from the forest of *Shigaraki* area, 40 km away from *Nara*. But large trees became fewer until 12th century then to secure members of second *Great Buddha Hall*, carpenters had to search far and wide for forests that could supply the pillars, procuring trees from the ancient province of *Suō* in southwestern *Honshu*, 500 km away from *Nara*. For the third version, the Buddhist monk *Kōkei* started the construction project in 1684, and ground was broken for the current *Great Buddha Hall* in 1688. But *Kōkei* was unable to obtain one of the most important types of members, 23.5-m long beams²⁾. Eventually in 1702, he found huge trees at *Shiratori* shrine in *Hyūga* province, southeastern *Kyūshū*, 900 km away from *Nara* (*Fig.3*, 4).

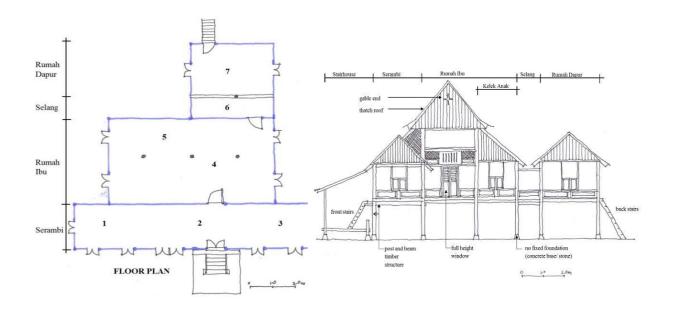
Figure 2. Original layout plan of Rumah Tukang Kahar, Negeri Sembilan (1-Serambi Hujung, 2-Serambi Tengah, 3-Serambi Pangkal, 4-Rumah Ibu, 5-Kelek Anak, 6-Selang, 7-Dapur)-(left) and side elevation (right)(Source: Sulaiman, 2014)

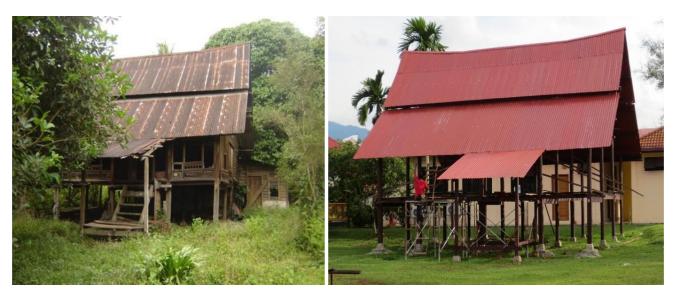
Figure 4. Rumah Tukang Kahar, Negeri Sembilan before dismantle (left) and after reassembled (right) (Source: Negeri Sembilan Museum)

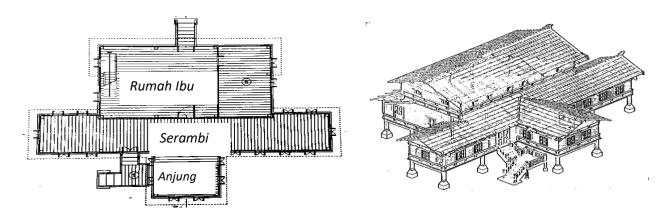
Figure 6: The layout plan and perspective of Rumah Maimunah Yaakub without Rumah Dapur based on measured drawing produced by university. Source: KALAM (2014), Sulaiman (2017)

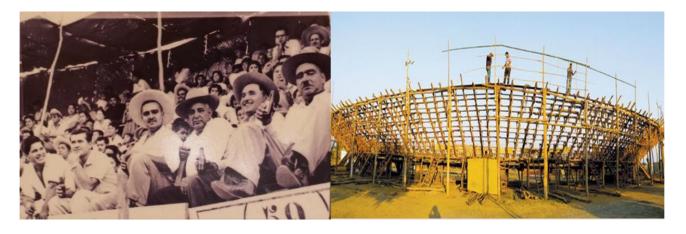
Image 1. construction of the structure of the bullring "La Petatera", 2016.

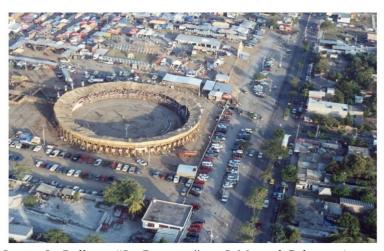
Image 5. Bullring "La Petatera" on J. Merced Cabrera Avenue: Historical Archive of Villa de Álvarez, 2015

It is composed of 70 sections, each with 7 trunks, 4 cans, 56 squares, 7 brackets, 2 platforms, 16 wooden poles and 3 veils, with all structural elements made from different woods. It also contains 36 petates, ropes, otates (type of bamboo), 2.5 kg of nails and 8 hooks. In total, this structure contains 490 trunks, 630 cans, 3,920 squares, 490 brackets, 70 platforms, 1,120 wooden poles, 2,520 petates, and 576 hooks.

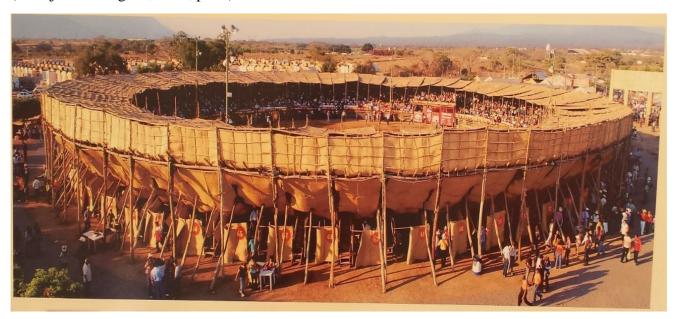
Image 6. Bullring "La Petatera" as it is built today. Historic Archive of Villa de Álvarez,

Today, this cultural symbol is built near one of the main ring roads of the city, near its modern limits. It maintains the traditional structure, shape and size and previous years, as well as the construction process involving wood, "Y" shaped tree trunks and metal cans that support all of the weight of the seats and walkways above.

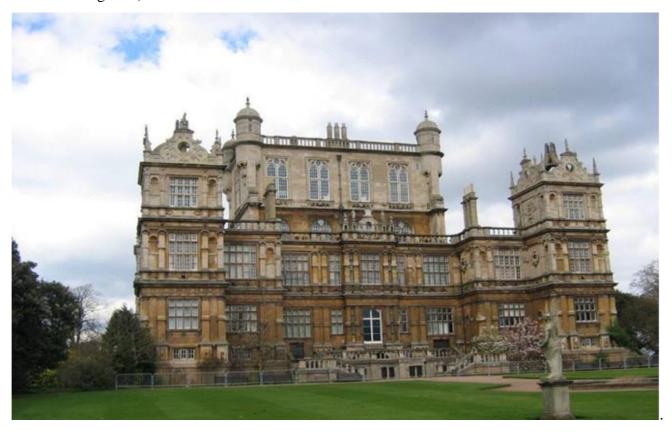
Figure 1. Wollaton Hall (by author)

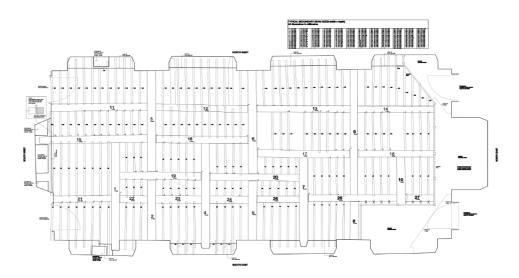
Figure 2. Survey plan of Prospect Room floor showing main beams marked 1-27 (The Morton Partnership Ltd.)

Due to uniqueness of the floor a number of options for repair had been put forward prior to our involvement. Amongst others these included a new raised floor over the existing with an external stair though one of the windows! A further option was suggested in 1999 in a paper in 'The Structural Engineer' by C Jolley and K Brown of The University of Southampton which suggested continuous steel angles on the top and to the sides and then with matching tension cables to the underside to take the tension. These were suggested to the three 'continuous' lines of beams (beams 2 and 3, 5 and 6, and 8 and 9 – see figure 2).

We also took advantage of the three lines of beams (beams 2 and 3, 5 and 6, and 8 and 9 – see figure 2) which are in line and continuous across the building, where we built up layers of Kerto plywood over the beams, being glued and a screwed down, essentially increasing the effective depth and using the depth of deflection which had occurred. Plywood was used over the small section levelling joists, but with numerous inspection hatches, and floorboards over.

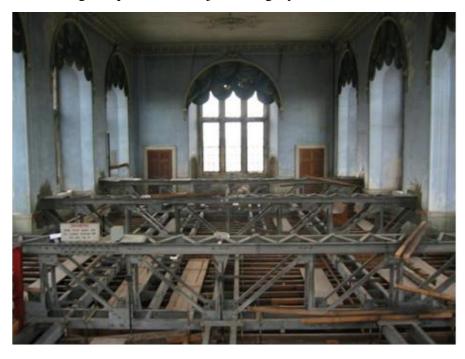
Figure 4. Steel lattice trusses introduced in the 1950's (by author)

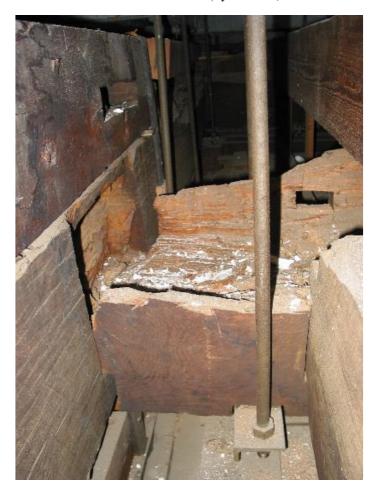
Figure 5: Hacked main beam (by author)

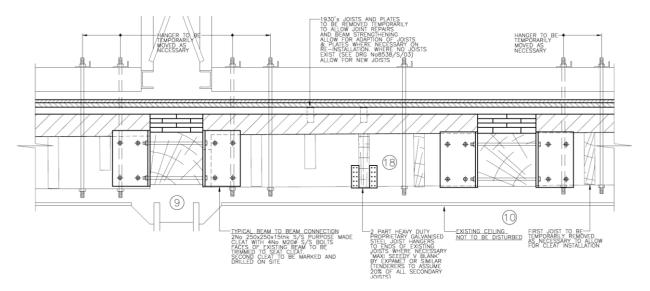
Figure 6 – Repair details for floor (The Morton Partnership Ltd.)

The actual improving of the integrity of the joists was simply by using bolted angle cleats to either side of adjoining beams (figure 6).

In this respect the results of the repair work far exceeded our expectations being inherently stiff with no signs of reverberations or deflections (figure 6).

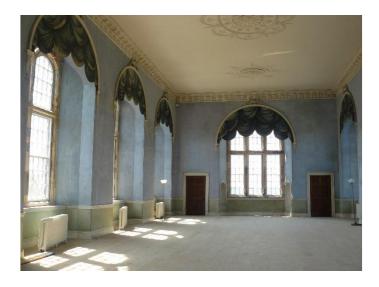
Figure 7 – The completed Prospect Room (courtesy Liz Hirst)

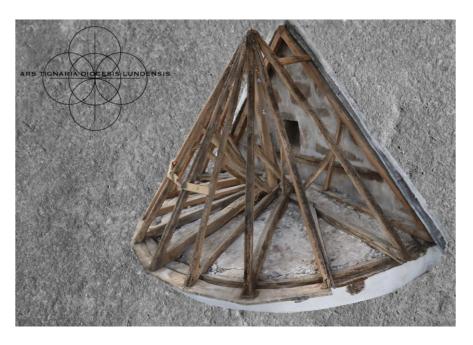
Fig. 1. Apsis roof truss in Tåstarp church. 3D-model produced with photo scanning by Camilla Melin. The 3D model is uploaded on sketchfab.

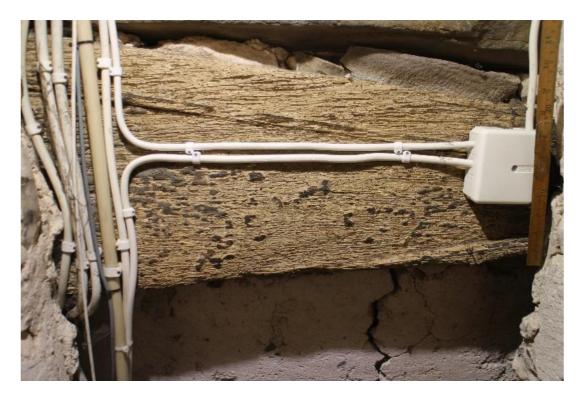
Fig. 3. The old church in Stora Hammar has the only other known decorated plank reused from a presumed wooden church. Contrary to the plank from Brågarp this plank has not been valued but instead used by electricians to install electrical wires. In cooperation with the parish we removed the wires and it could be done with minimal harm to the invaluable plank.

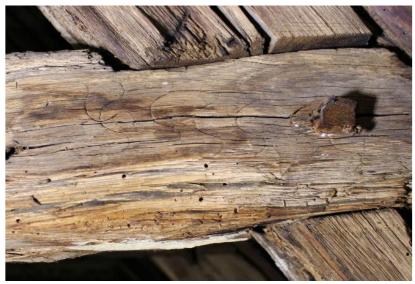
Fig. 4. Carpentry marks, in Särslöv church, on reused timber. Dendrochronological dating 1470s. The marks were made with a stamp and the system is additive. The same stamp has been used in Bodarp church by the same

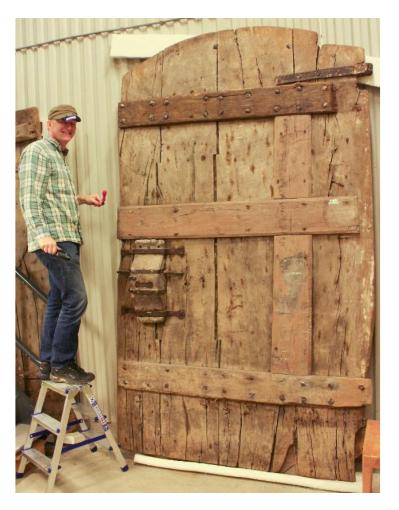
Fig. 5. A counter rebated door from Skanör church during dendrochronological sampling. Non- invasive methods were used where only a minimal amount of wood were removed on end grain in order to use a USB microscope to document the year rings for later analysis.

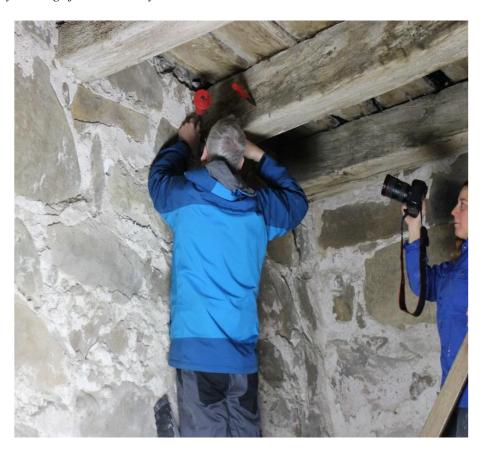
Fig. 6. Mortar sampling in Norra Åsum church. The church was first investigated thoroughly before dendrochronological sampling and analyse. In connection to dated beams mortar sampling were done to calibrate the two methods of dating. The samplings weres documented by video and photography.

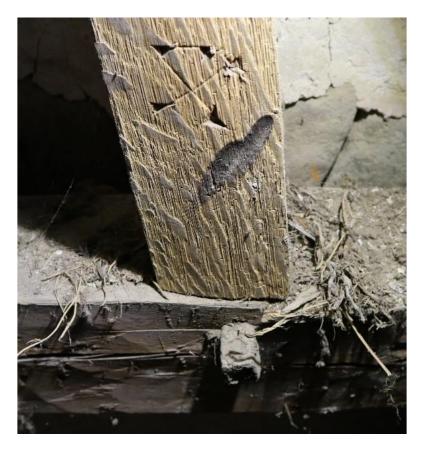
Fig. 9. Taper burn marks on a reused, now vertical, oak timber from the 12th century. Notice the carpenter markings on the same timber that also is secondary but older than the current construction. The horizontal beam is of pine and probably from the 19th century. Before taking dendro sampling it is essential to do ocular dating in order to have a hypotesis before sampling.

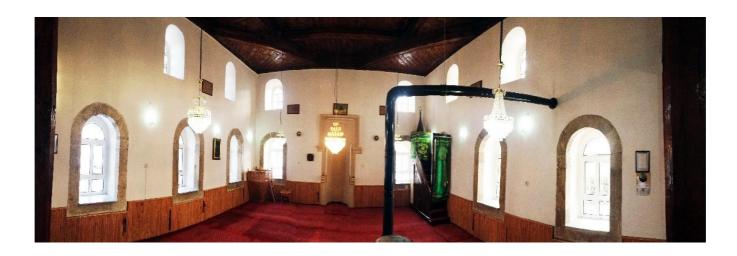
Figure 1. The mosque before the fire (SRDFA)

Fuadiye Mosque is the only mosque in Fuadiye village of Çekerek District of Yozgat since the civilization of the village. The ceiling covering in the mosque, built-in 1910, is an overlapped ceiling, dating back to the 12th century, over the masonry walls. In terms of design, exterior walls are arranged very merely and unpretentiously, except the northern façade. The mosque does not have a portal, which means there is no monumental entrance arrangement. The mosque has typical 19th-century First Turkish national architectural period features in terms of facade features, such as acanthus leaves and volute-curved leaves used in keystones on the facades, round-shaped windows, the capitals in the Ionic order, and ornamental elements on the mihrab. The interior architecture is particularly interesting in terms of wooden craft, overlapped ceiling, mahfil, minbar, and sermon chair, which carry the regional features of the wooden craftsmanship (fig 1).

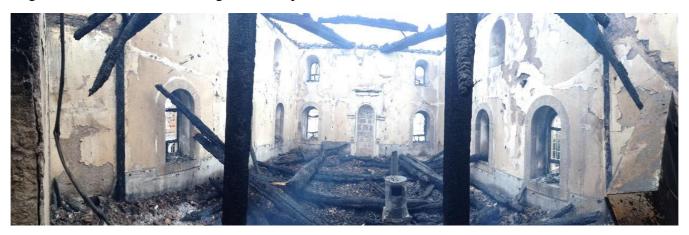
Figure 14. The mosque after the fire (SRDFA)

On 15 January 2014, the mosque suffered a major fire, and all the wooden elements from the floor to the ceiling were burned after the fire (fig 2). The villagers communicated the situation in the mosque to Sivas Regional Directorate of Foundations and placed cement finish on the floor in order to protect the structure. Sivas Regional Directorate of Foundations has appointed architect, civil (structural) engineer and art historian experts to conduct on-site inspections. As a result of the pre-fire situation of the building and the data that emerged during the fire, it was proposed to register the building and conservation works were initiated as soon as possible. As per their suggestions, firstly the burnt timber was removed in a way that would not damage the structure, and then the structural strength was tested by core sampling from the walls. Upon the registration of the structure by the conservation board, the Sivas Directorate of Foundations started a tender for the building's survey, restitution, and restoration projects and electrical and machinery projects of the mosque. The firms or companies who want to participate in the tender

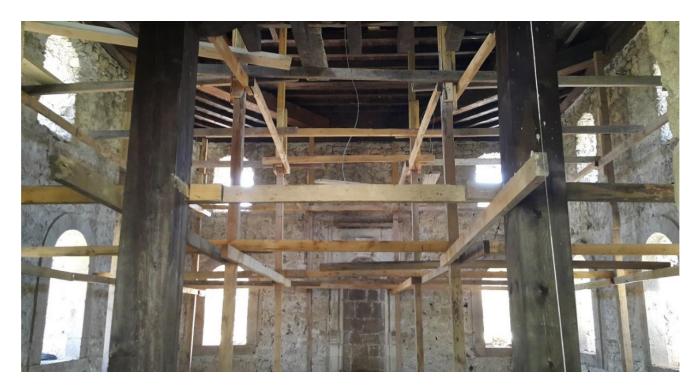
Figure 3. 15 The mosque during the repair (SRDFA)

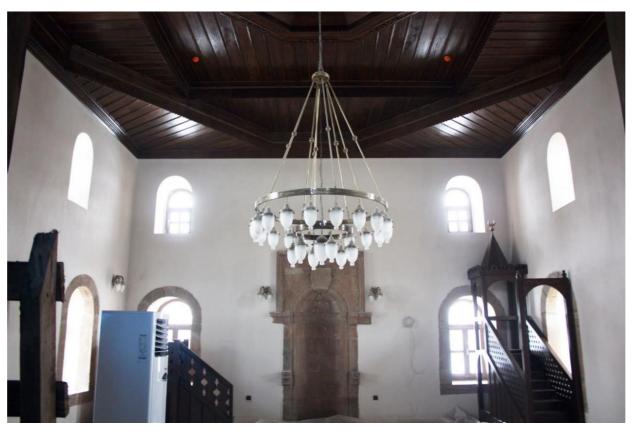
Figure 16. The mosque after the repair (SRDFA)

The ceiling and roof system was implemented one to one in the details described in the project (fig 6). The first-class pine timber from the Samsun, where is the neighboring region to the village, was used as the wood material. Due to the bearing characteristics of the wood, the attention was paid to obtain large size wood from one tree. The woods were impregnated before use, and water-based preservatives were applied. Water-based varnish, which has been tried and determined successful before, has been applied to the woods exposed to weather conditions on the exterior façade to protect from the effects of cold and rain. The wooden elements in the structure, especially in the pillars and beams bearing the women's section, dovetail technique were used for joints (fig. 3). Modern techniques have been used to cut wood ornaments in the wooden ceiling core; parts are cut out on CNC instead of hand carving and nailed. Also, bolts shown in the project were used in joining large wooden beams. All these applications were carried out under the supervision of civil engineer from Sivas Regional Directorate of Foundations at every stage. After all the applications were completed, experts from the Sivas Regional Directorate of the Foundations (architect, civil engineer, art historian, electrical engineer, mechanical engineer) examined the implementations in line with their expertise, and after approving, the building was put into use (fig. 4).

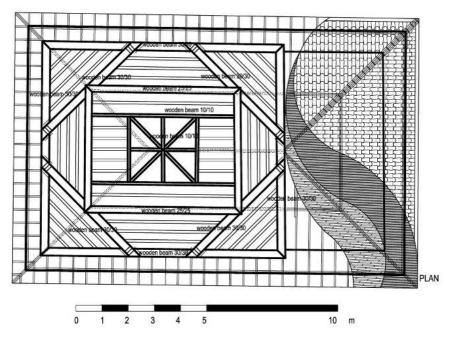
Figure 17 The suggested overlapped ceiling and roof solution (ART-DEM Archive)

The ceiling and roof system solution in consonance with the traces of the missing wooden elements is the essential point that needs to be analyzed in the structure. First, the positions of the struts and beams were determined in line to the traces in the structure. According to the comparisons made with the old photographs, the height of the facade was calculated, and the amount of stone wall to be built, and the seat of the wooden beam was determined. After fitting the main beams, the size and location of the beams to be used for the overlapped ceiling must be determined. The mosque is covered with an internal overlapped ceiling and externally hipped roof covered with tiles. The ceiling of the women's section is flat. Both the entire roof and the interior ceiling require a mutual solution. For this purpose, the middle point of the rectangle obtained by excluding the women's section was found, and at the same time a roof solution was made, and the ridge position and height were compared with the highest point of the ceiling. It has been deemed appropriate to obtain the wooden ceiling core by hanging it on the ridge post, both technically and as a technique observed in similar structures previously, and beam analyzes have been

made in the light of this information. First of all, 30x30 cm beams placed on the wall and 30x30 cm beams are connected at a 45-degree angle, and the transition from rectangle to octagonal form was made. However, since the main form is rectangular, the edges of the octagonal form are not equal. Then a smaller rectangle was obtained with 25x25 cm beams placed from the middle of these diagonals. In the middle of this rectangle, 250x250 cm in size with a square space of 10x10 cm beams are placed at 50 cm intervals. At the edges of the square gap formed, eight ridge purlins sitting from the main post was placed, and the gap between the post and the truss were formed with a horizontal element. All these beams were covered with a bottom covering board (fig. 5). The ceiling rose is suggested to make by nailing. It has been proposed to use bolts in the combination of beams of 30x30 cm and 25x25 cm for both the difficulty of finding the carpenter who knows the traditional techniques and to strengthen.

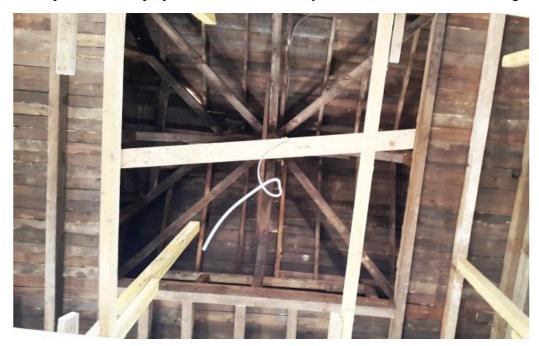
Figure 6. The implementation of overlapped ceiling (SRDFA)
