Preface and Acknowledgements

This document is the publication, result of the papers presented at the 22nd IIWC International Symposium, held in Bilbao between September 29 and 2 October 2019, under the umbrella of the Summer Courses of the University of the Basque Country.

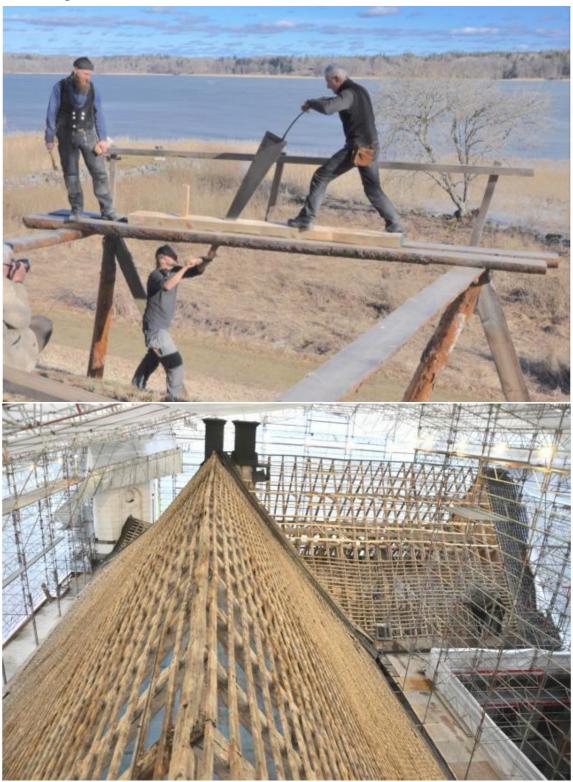
Fig. 4 - Tile laths work like a flexible net.

The roof has 12 km tiles lath that had to be changed because of leaking tiles (fig. 4). We found interesting tooltraces related to the production method on one third of the laths. Normally you see laths made with saw, but we were puzzled to see that they had used a 3 mm plane making grooves on both sides of the board and then cleaved it apart into a lath. The last piece of the board still had

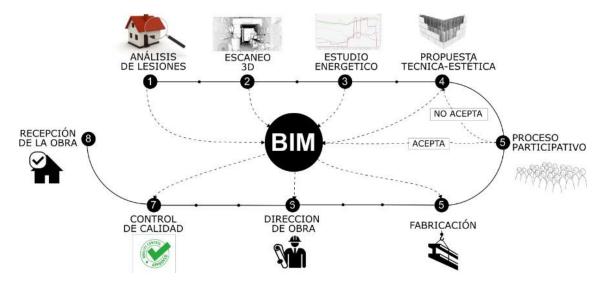
Illustration 2. BIM software interaction in an architectural project

However, more than two decades ago BIM software were developed in order to facilitate a real control of all the information generated and collected during the whole process of any architectural process. The main aim is to insert that info into a virtual model of the building.

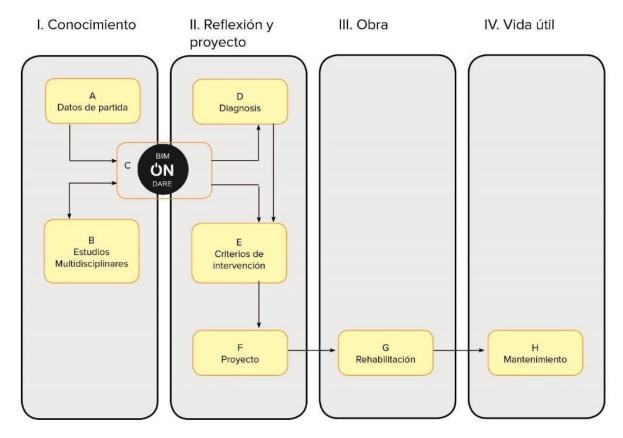
Illustration 3. New structure for scientific procedure

To get that purpose, basing on scientific procedures a new main structure is proposed:

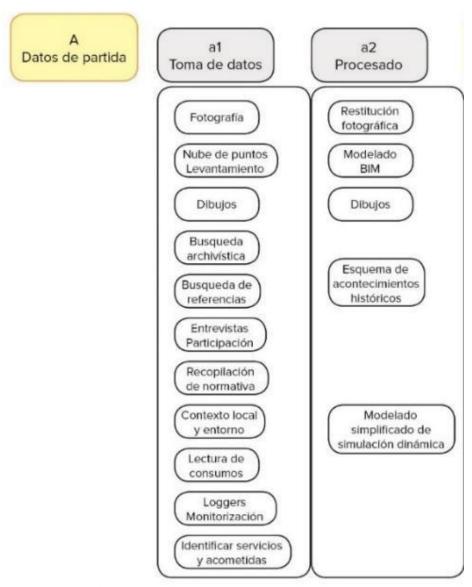
Illustration 4. 1st stage. Data gathering

- A1. Data gathering: This based on multidisciplinary readings of the building. There is no processing
- A2. Processed. In this phase the readings of the previous subphase are processed.

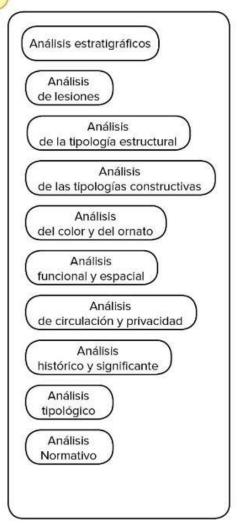
Illustration 5. 2nd stage. Multidisciplinary studies

- Stratigraphic analysis will help to understand the historical phases of the buildings.
- Existing damages analysis will conclude in the constructive state of

- each constructive element.
- Structural typology analysis: Many different buildings can be supported by the same type of structure. This analysis can help to understand the structural behaviour of the building or to detect the lack of any important piece which should constitute the structure.
- Constructive typology analysis
- Colour and aesthetic analysis
- Functional and special analysis
- Circulation and privacy analysis
- Historical and significance analysis
- Regulations analysis.

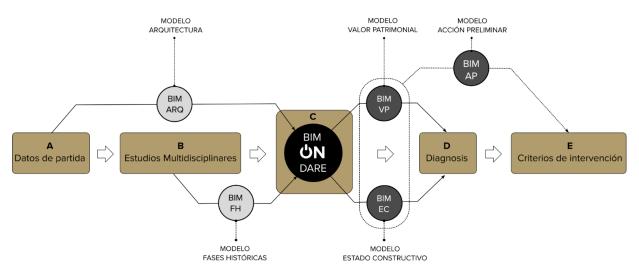
Illustration 6. New workflow for BIM ONdare integration into the scientific process

The current scientific restorations are based on detailed procedure. The modification of the stablished stages must be clear, and the data management must be well defined. For this reason, a specific workflow is proposed:

To get the main purpose of this research, the proposed workflow requires to create specific new BIM models before opening the new digital tool. These models provides a better understanding of the historical transformation of the buildings and its current architectural state.

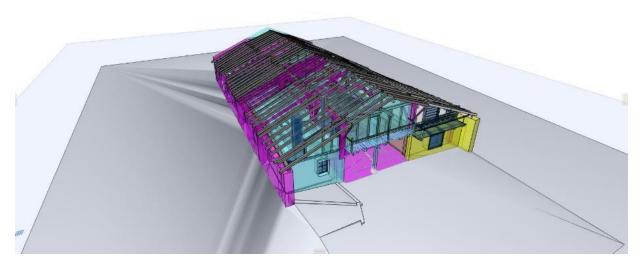
Illustration 7. Historical phases model of Garai Urtuena

After processing the gathered information in the first stage a historical phases model of the building is developed in the BIM software. To get this purpose properly is recommended to finish to model it after inserting all the needed data to BIM ONdare software.

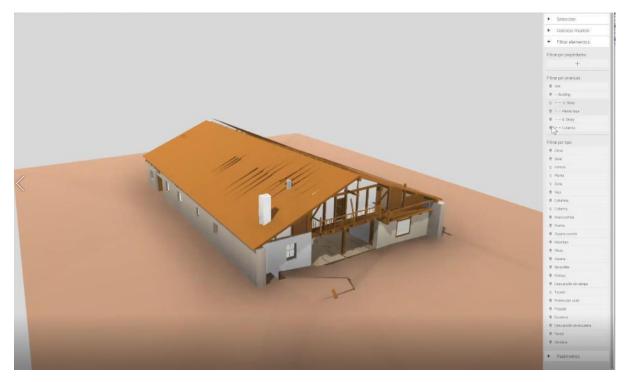
Illustration 8. BIM model integrated in BIM ONdare

Once the architecture model is exported, afterward it is imported into BIM ONdare software to carry out the next analysis.

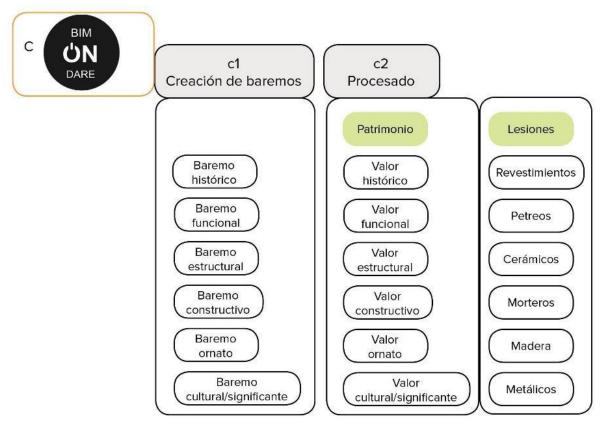
Illustration 9. The scheme of the tasks to carried out by BIM ONdare

- To generate the heritage value of each element. The heritage value is the result of a specific algorithm between the following different values.
 - Historic value
 - Functional value
 - o Structural value
 - o Constructive value
 - o Aesthetic value
 - Cultural/significance value
- To analyse the current damages of the constructive elements. Depending the materiality of these elements, the needed analysis will be different. the following ones are proposed:
 - o Covering
 - o Stone elements
 - o Ceramic elements
 - Mortars
 - Wooden elements
 - Metallic

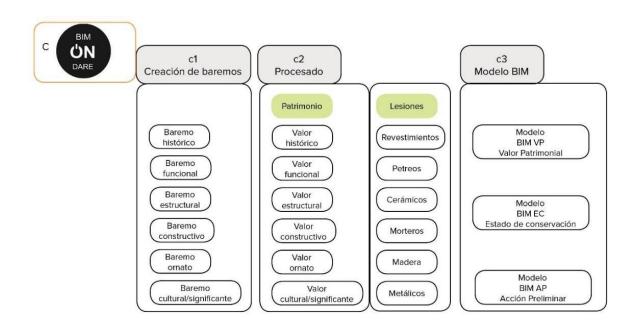
Illustration 10. The 3 different type of BIM model exported from BIMONdare

Once the new info is inside of the main BIM software, three new BIM hypermodels are created.

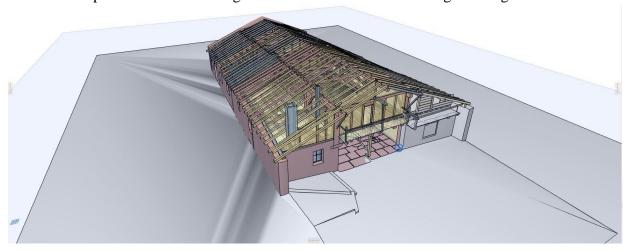
Illustration 11. The heritage values model

This hypermodel exposed the heritage values of each element, which is calculated by BIM ONdare software. With his info the technicians know perfectly the value of all the constructive elements, and it can be decided properly which of them must be conserved, restored or replaced without altering the cultural value of the existing building.

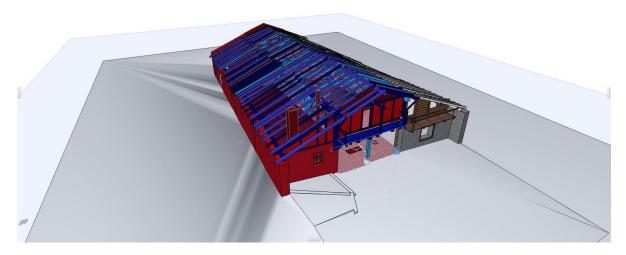
Illustration 12. The constructive state model

This model gathered the conservation state of all the constructive elements. If they have

any damage and if this can or must be restored.

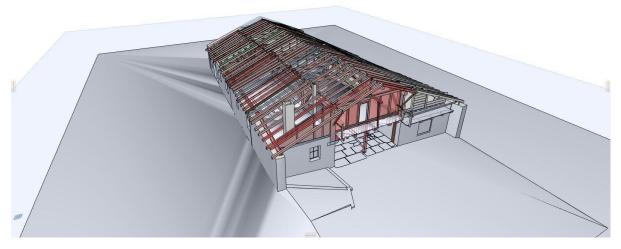
Illustration 13. The heritage values model

This model is the result of the combination of BIM VP and BIM EC. The decision of conserving or not an element must be based on its constructive state value and heritage value of each element. For this reason, this model provides to the technicians an easier and more adequate decision making system.

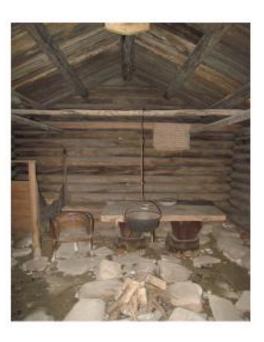
The oldest secular wooden house in Sweden 'Fire House' in Mora from 1237

The house has no chimney and all parts are of wood, the foundation resting on natural ston blocks, the walls as well as the roof. The smoke was released through an opening in the roof.

The oldest timber buildings in Sweden are in Dalarna. The oldest is a house that dates from 1237, and what in Sweden is called a Fire House, since it has no chimney and the smoke from the fire is let out through a hole in the roof. The floor is an earth floor. There are a lot of other medieval buildings in many villages, mostly different kinds of storage buildings from the 13th century onwards. These storage buildings are often in their original form since they have always been used for the same function.

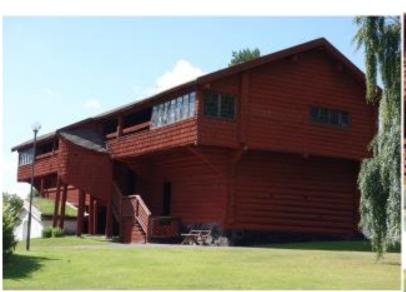
Guest House to richer farm house in Ornäs

Dating from 1503,according to dendrochronologial testing. State monument in 1666 due to its links to King Gustav Vasa

I will not tell this story here, but will mention that this early advertisement and enhancement of the Vasa family to ensure their claims to rule has given us today additional knowledge of medieval timber building techniques. The Ornäs guest house was turned to a museum in the 1760s and is the first museum in Sweden! Due to this it was beautified and clad with wooden shingles as well as painted red, a change that has caused constant problems ever since, due to the roof angle being not suitable for shingles.

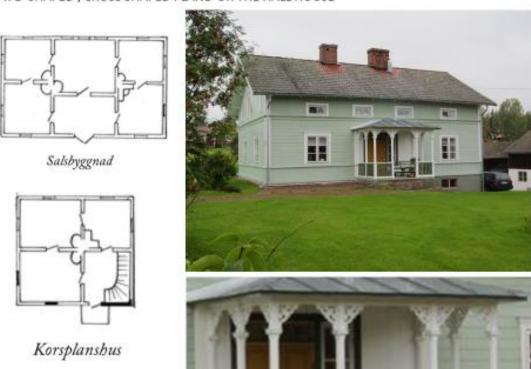
HOUSE TYPES IN DALARNA FROM THE MIDDLE OF THE 19TH CENTURY ONWARDS 4. L- SHAPED , CROSS SHAPED PLAND OR THE HALL HOUSE

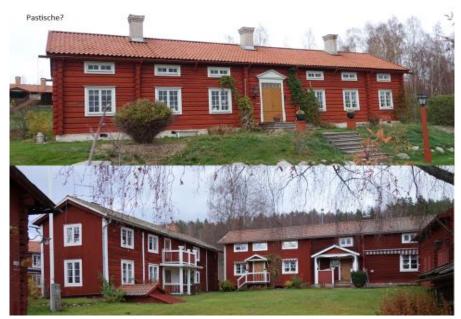
EXAMPLE OF A INDUSTRIALLY PRODUCED HOUSE SUITABLE FOR THIS REGION

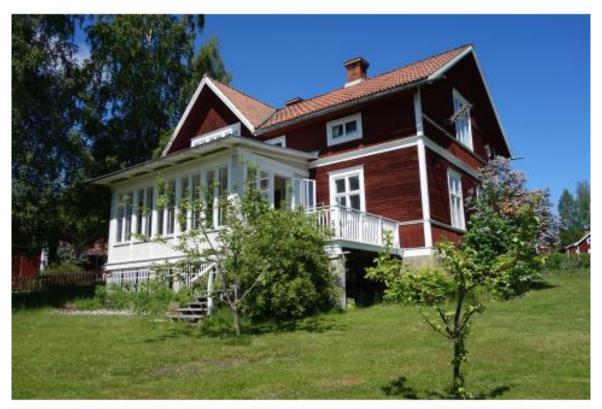
The last example is a completely new house on a spectacular site with views in two directions of Lake Siljan. The client was a wealthy businessman and had clear opinions of what he wanted: a traditional house, based on symmetry and the double room house plan. Still, he

wanted a huge living room for receptions where he wanted to be able to have a folk musician playing from a balcony overlooking the living room. The wife, an artist, also needed a studio somewhere as well. The house looks like a traditional double room house type in one and a half storey, which was also common, towards the street and all the exceptions, the huge living room, the studio, etc, were placed as a grandiose extension towards the garden and the lake view.

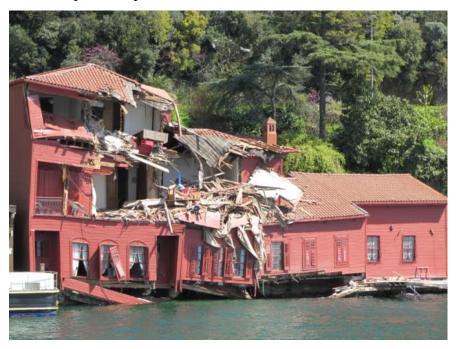
Figure 1. Hekimbaşı Salih Efendi Mansion after a tanker accident, Bosphorus, 2018.

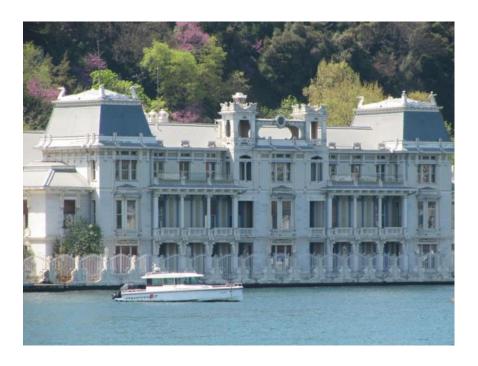
Figure 2. Hıdiva Palace, Bosphorus, 2018.

Aim, approach and principles: The aims of conservation works in wooden buildings vary: in Hidiva Palace, this is "the least intervention is the best restoration". After the conservation of the wooden elements, the survival of the structure was ensured for approximately 40-50 years (fig. 2). For the conservation of Tuzcuoğlu House, the authentic characteristics of the building were preserved, while a new spatial organization was made for its re-use. "The restoration surpassed the sole purpose of "conservation" and became an "information reading" tool". The holistic/integrated conservation approach, authenticity and sustainability by national and global criteria were key choices in the conservation of wooden houses by

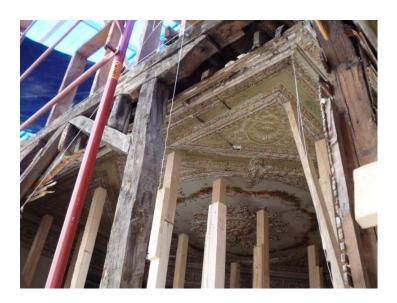
Figure 4. Conservation of Ertuğrul Tekke Mosque, Beşiktaş, 2009.

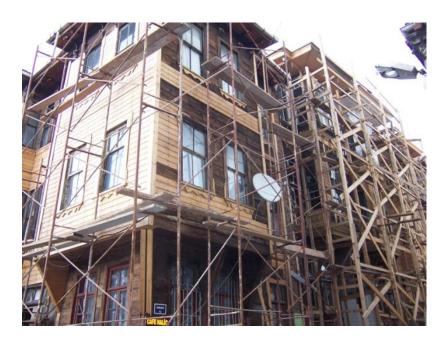
Figure 5. Façade rehabilitation of wooden houses at Süleymaniye by KUDEB, Fatih, 2008.

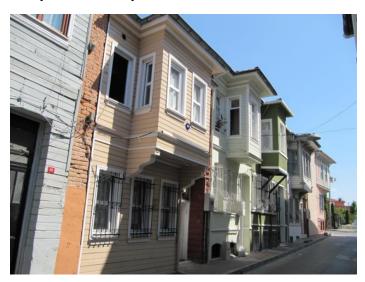
Figure 6. Façade rehabilitation of wooden houses at Kumkapı by KUDEB, Fatih, 2019.

KUDEB in Süleymaniye, and their experiences were shared in 6 volumes for educational purposes. To protect the integrity of the building for future generations and to exhibit clearly the present-day materials and techniques used in reinforcement works were the main aims in the Harem of Yıldız Palace. The decayed wooden elements that were not entirely replaced were conserved to show their historical and technical value. Also mentioned among aims was to provide the highest quality of craftsmanship. Project associates examined the related articles of the national/international laws and charters to determine the methodology of the practice. To remove inappropriate works and to respect the original materials and techniques were the main principles for the conservation of Ertuğrul Tekke Mosque (fig. 4). The aim of façade rehabilitation on the wooden houses of Cemil Meriç and Şehsuvarbey Streets was mainly to overcome bureaucracy, provide technical and economical assistance to the owners for the maintenance and repair of these buildings, and to create a tourist attraction while generating awareness in the community about the conservation of wooden heritage through local administrations (fig. 6).

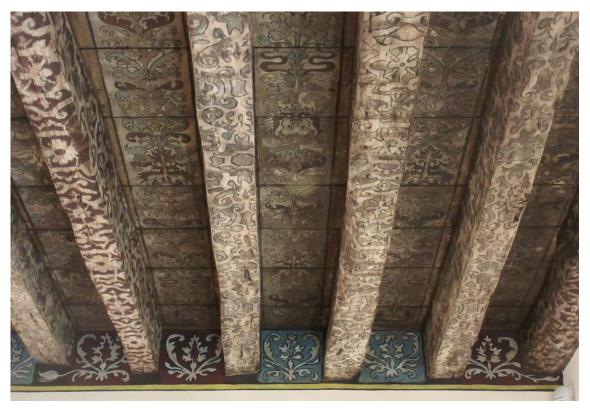
Fig. 1 – Riddle's Court board and beam painted ceiling and frieze.

The ceilings fall predominantly into two structural categories: 'board and beam' construction (Fig. 1); and 'barrel vault' or 'coved' construction (Fig. 2). Open board and beam ceilings, the most prevalent, have designs painted on three sides of their oak or pine support beams and on the pine boards spanning each narrow bay. The reverse sides of the painted boards generally serve as floorboards in rooms above. Board and beam schemes would usually have included a frieze, painted between the beam ends onto timber-lined or plaster walls; however very little frieze evidence has survived. Occasionally the painted decoration extends down entire walls (although, for insulation, sleeping spaces probably had textile hangings below the frieze). The second type of ceiling, the barrel vault, consists of a series of closely fitted boards (tongue and groove jointed) suspended from the roof, creating a continuous surface on which to paint (paintings on the much less common coved ceilings are treated similarly).

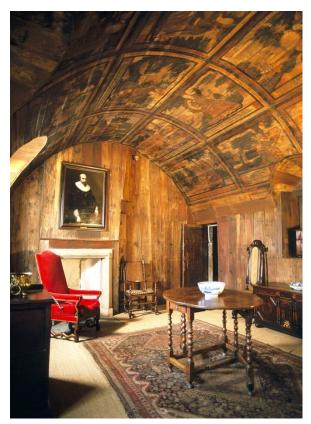
Fig. 2 – Culross Palace barrel vaulted ceiling. Fig. 3 – 302/4 Lawnmarket 'plastic wood' fill.

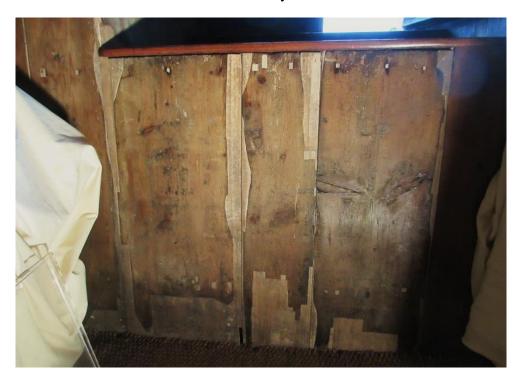
Fig. 8 – Culross Palace 1980s restoration; balsa wood fills.

Over the decades interventions have become more conservation 'conscious'. In the 1980s losses in timber wall linings at Culross Palace were filled using balsa wood (ochroma pyramidale), which is extremely lightweight, soft (despite being classified as a hardwood) and easily shaped. Importantly, it is not affected by environmental changes and so exerts no pressure on the original wood once inserted to fill gaps. In an attempt to 'blend' this material with the surrounding wood, the balsa fills were painted brown. Unsurprisingly they bear little resemblance to the original (fig. 8); also, over time the brown paint has become worn and the

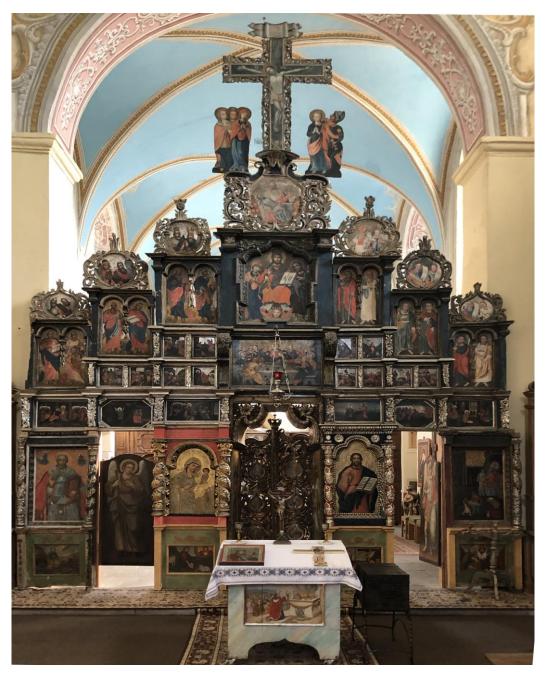
Figure 2, Church of St. Klymenta 1895 - iconostasis circa 18 c.

The investigation and assessment of the 18th century iconostasis of the Church of Nativity of the Blessed Virgin in the Village of Krups'ke, now located in the church/museum of St. Klymenta in Lviv, introduced participants to the inconostasis' unique history and methods of construction; iconography; and carved, painted, and gilded elements.

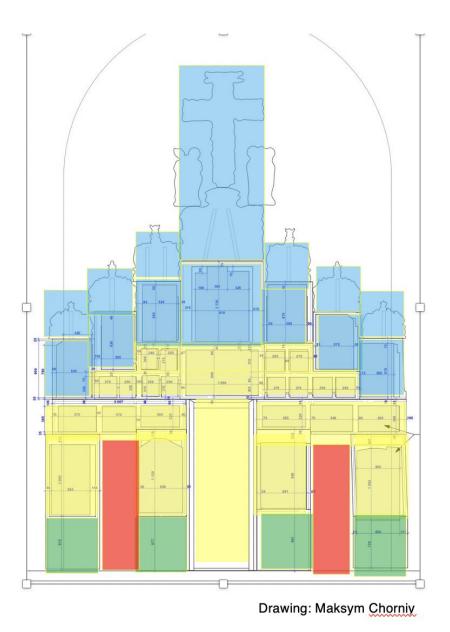
Figure 3, Church of St. Klymenta - this iconstasis is a combination & reconfiguration of iconostasis elements from various sources.

Careful investigation revealed that this iconostasis was composed of elements from several different iconostases, contrary to perceived historical interpretation. This practice was not unusual, whereby iconostases and their parts were re-sited to other churches for various reasons. Among these was the replacement of older churches with new buildings and new iconostases. The replacement iconostases were then often reconfigured and combined with elements from other iconostases to fit the new architectural space. The iconostasis in St. Klymenta is one such example. A comparison of photographs of the installation in the church in Krups'ke with that of the re-installation in the church of St. Klymenta in Lviv. A comparison illustrates that the latter reproduced the configuration of the Krups'ke installation reasonably accurately. However, it became clear that the original Krups'ke installation was a combination and reconfiguration of iconostasis elements from more than one source, as illustrated by measured drawings completed by workshop participants.

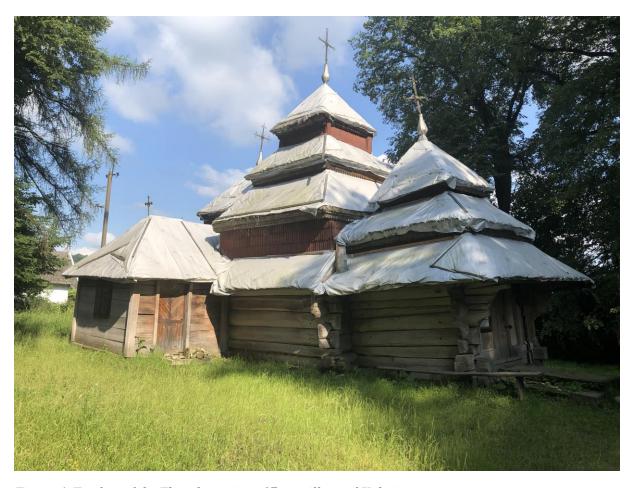
Figure 4, Tserkva of the Theophany circa 17c. - village of Kuhaiv

The tripartite, horizontal log structure with three, open log towers was constructed of hewn and rounded oak timbers with variously notched corner joints. The roof surfaces were originally covered with long, riven, feather-edged and grooved shakes called gonty, mentioned previously.

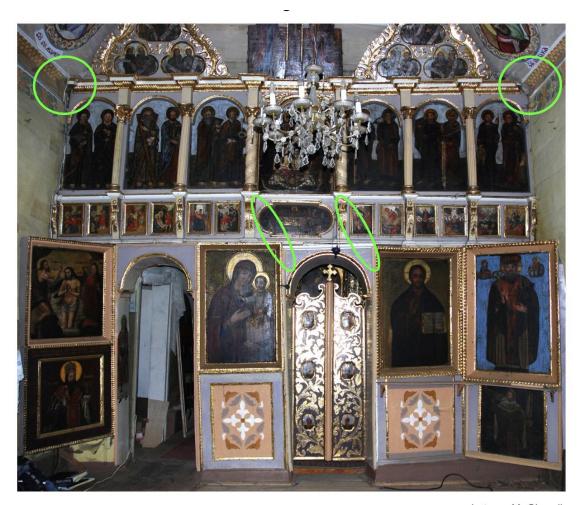
Figure 5, Church of the Theophany circa 17c. – village of Kuhaiv *iconostasis: a marriage of various elements*.

Excavation on elements of the iconostasis revealed original silvering and polychromy beneath multiple paint layers, or in the case of the deacon's doors, of original polychromy hidden beneath later paint layers. Preliminary UV analysis revealed restoration overcoat layers on selective icons.
