White Salmon River Watershed  
**Anadromous Fish Passage Inventory**  
2009-2011 Survey Report

*Prepared by*  
Emily Plummer & Adrienne Zuckerman  
Fish Passage Technicians  
Underwood Conservation District

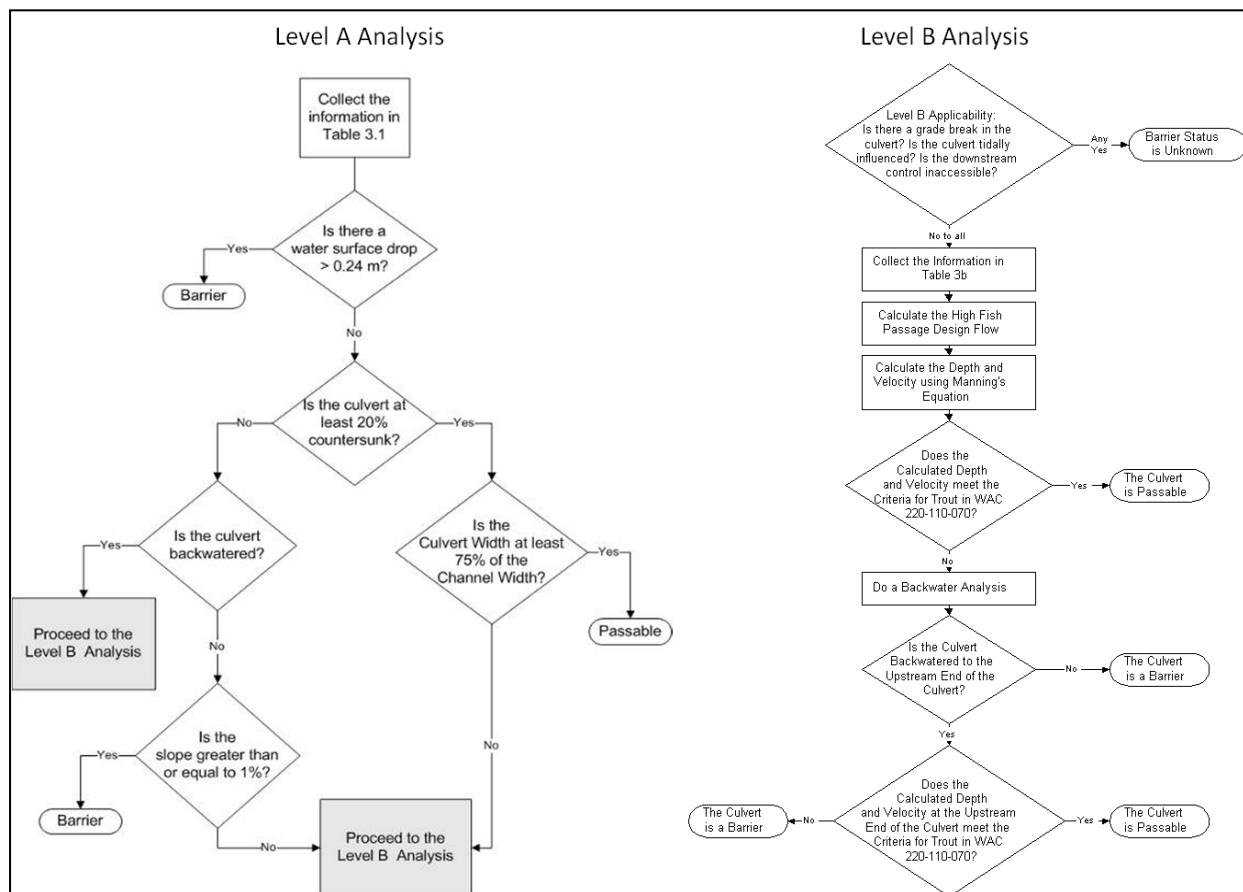
Figure 2 WDFW culvert assessment flow charts detailing Level A and Level B assessment protocols.

In the case that a human-made feature such as a culvert, dam, or irrigation outtake was encountered, Technicians assessed the feature to determine whether or not it poses a fish passage barrier. Depending on the type of feature, WDFW requires different information to be collected. For culverts, a Level A assessment is comprised of measuring physical characteristics and slope of the culvert as well as the outfall drop (change in water surface elevation as water flows through the culvert). Using the WDFW protocol, a Level A survey establishes if the feature is a barrier due to its slope or outfall drop. If the feature is not a slope or outfall drop barrier, a Level B survey is conducted, which determines the passability of the culvert based on high water elevation and the velocity of water passing through the culvert.

The flow charts below illustrate the WDFW protocol for Level A and Level B culvert assessments. This protocol uses simplified methods of establishing passability, and in some cases needs to be supplemented by other surveys to gain a more in-depth assessment. For instance, additional surveys may be warranted when there are multiple culverts transporting the flow or there is a grade break in the culvert.
