Former Tronox/Kerr-McGee Caselton Mine Area and Mill Site, Pioche, NV

# Community Meeting Question-and-Answer Session June 28, 2023 6:00-8:00 PM

Nevada Division of Environmental Protection and Greenfield Environmental Multistate Trust LLC, Trustee of the Multistate Environmental Response Trust

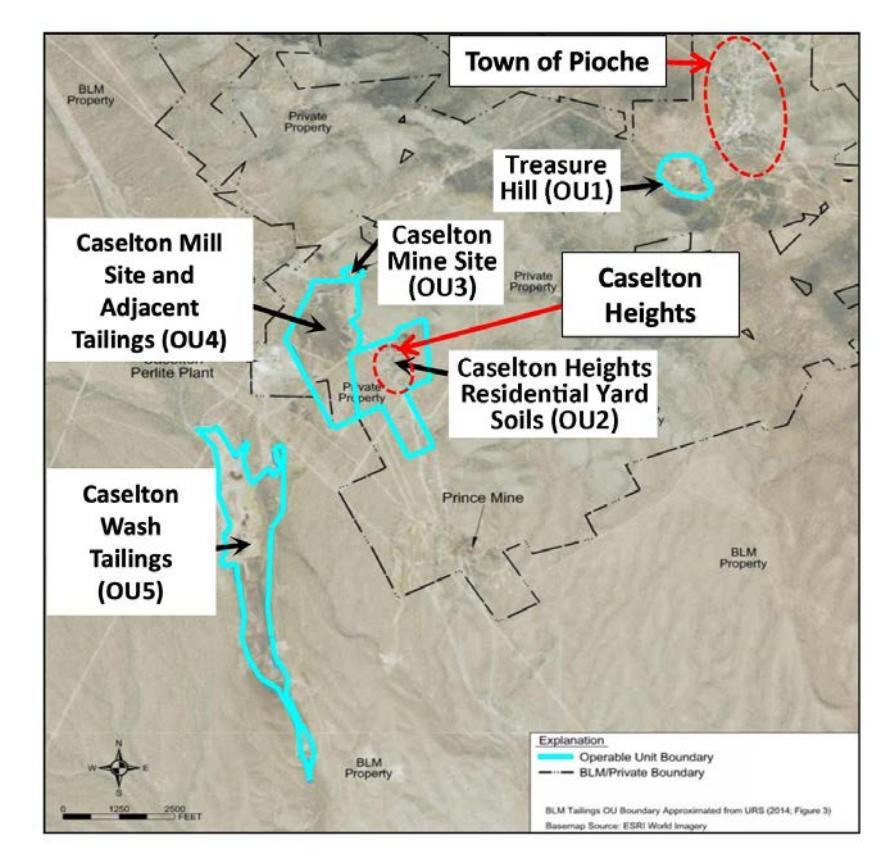
The map shows the Operable Units (OUs) at the Site outlined in blue

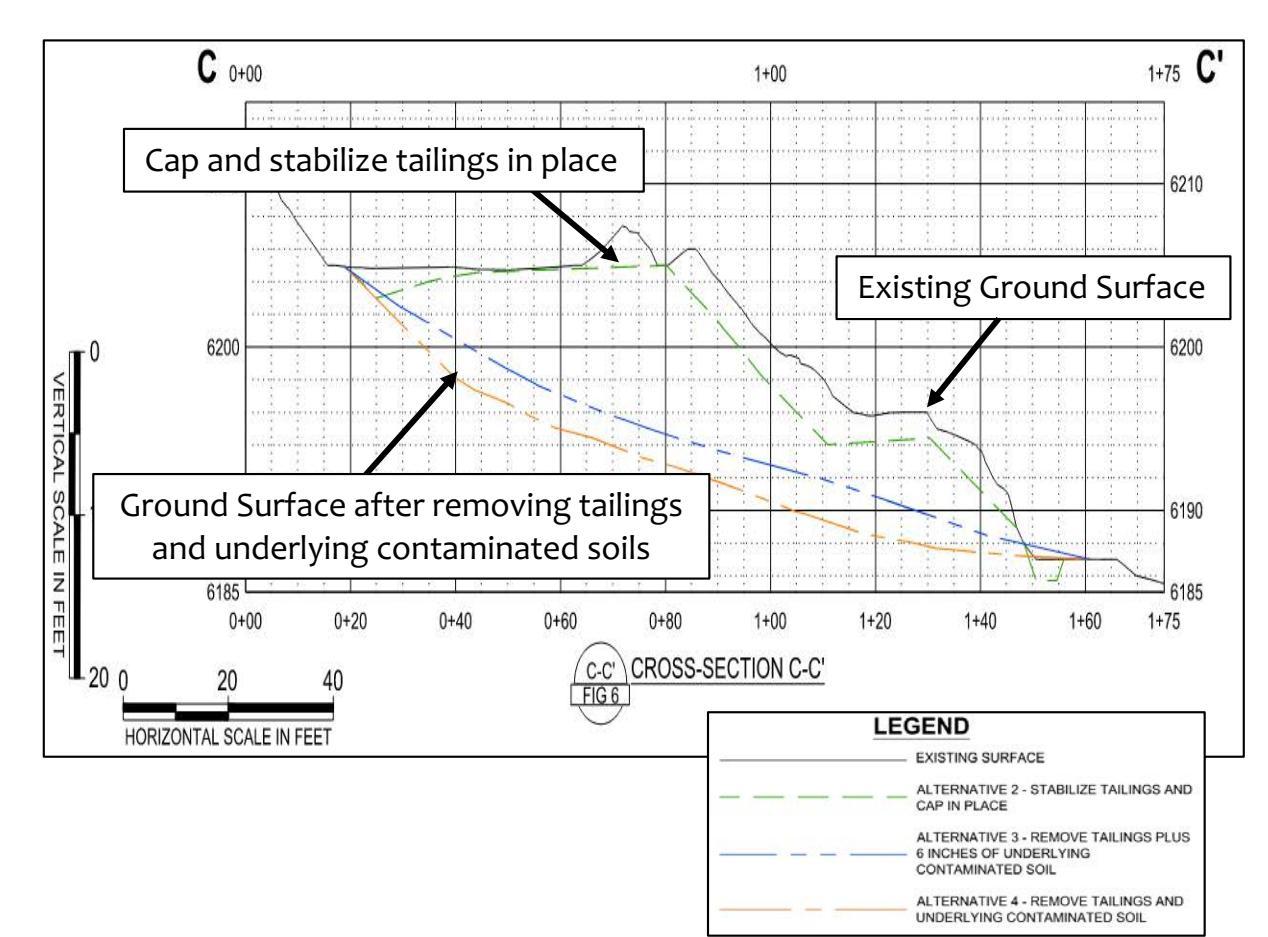
- Depth: 7.6 feet
- Volume: 6,200 cubic yards  $\checkmark$
- Maximum contamination levels
  - Arsenic: 438 mg/kg
  - Lead: 30,000 mg/kg
- ✓ Results within range of previous sample results
- $\checkmark$  Lead and arsenic are above established residential riskbased cleanup levels
  - Arsenic: 60 mg/kg
  - Lead: 400 mg/kg

Tank Road Tailings are consistent in characteristics and concentrations with OU4 and OU5 tailings, as well as tailings found on other public lands managed by BLM

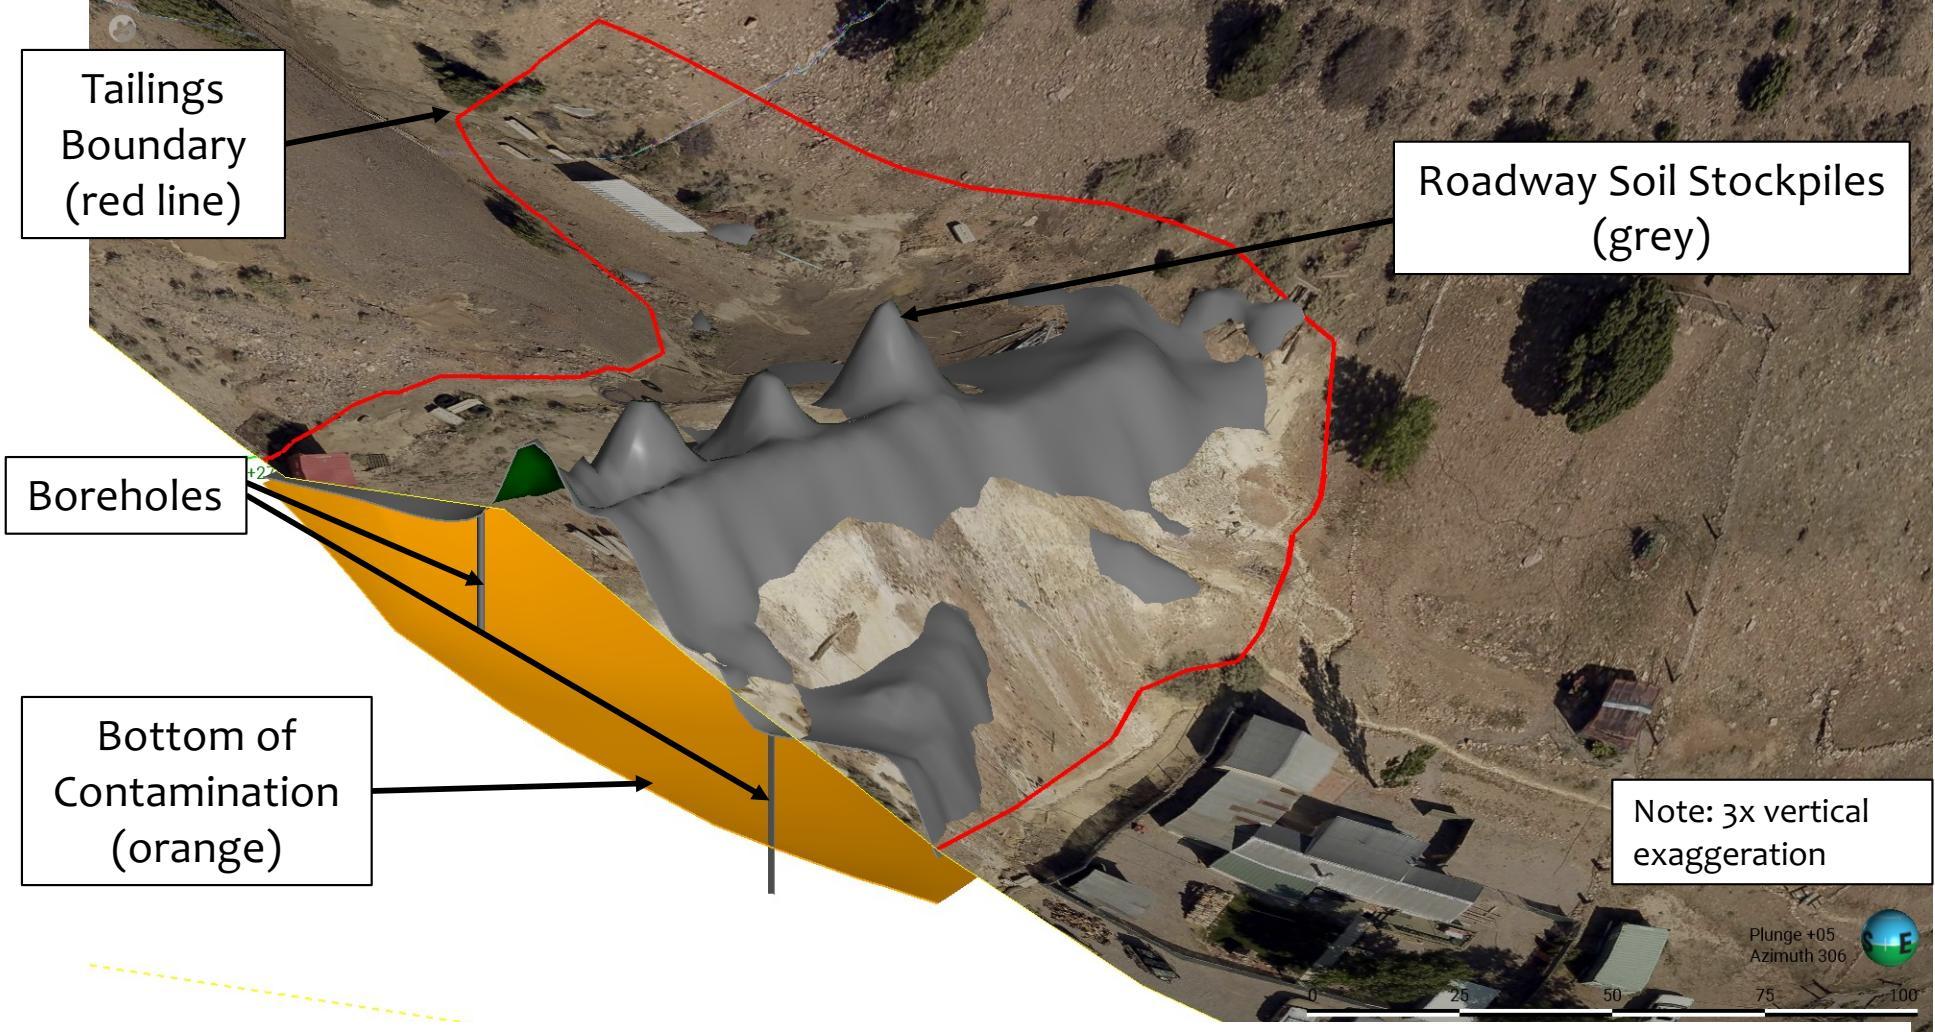
Used results and survey data to develop a Leapfrog 3-Dimensional Model to visualize contamination and support cleanup design options

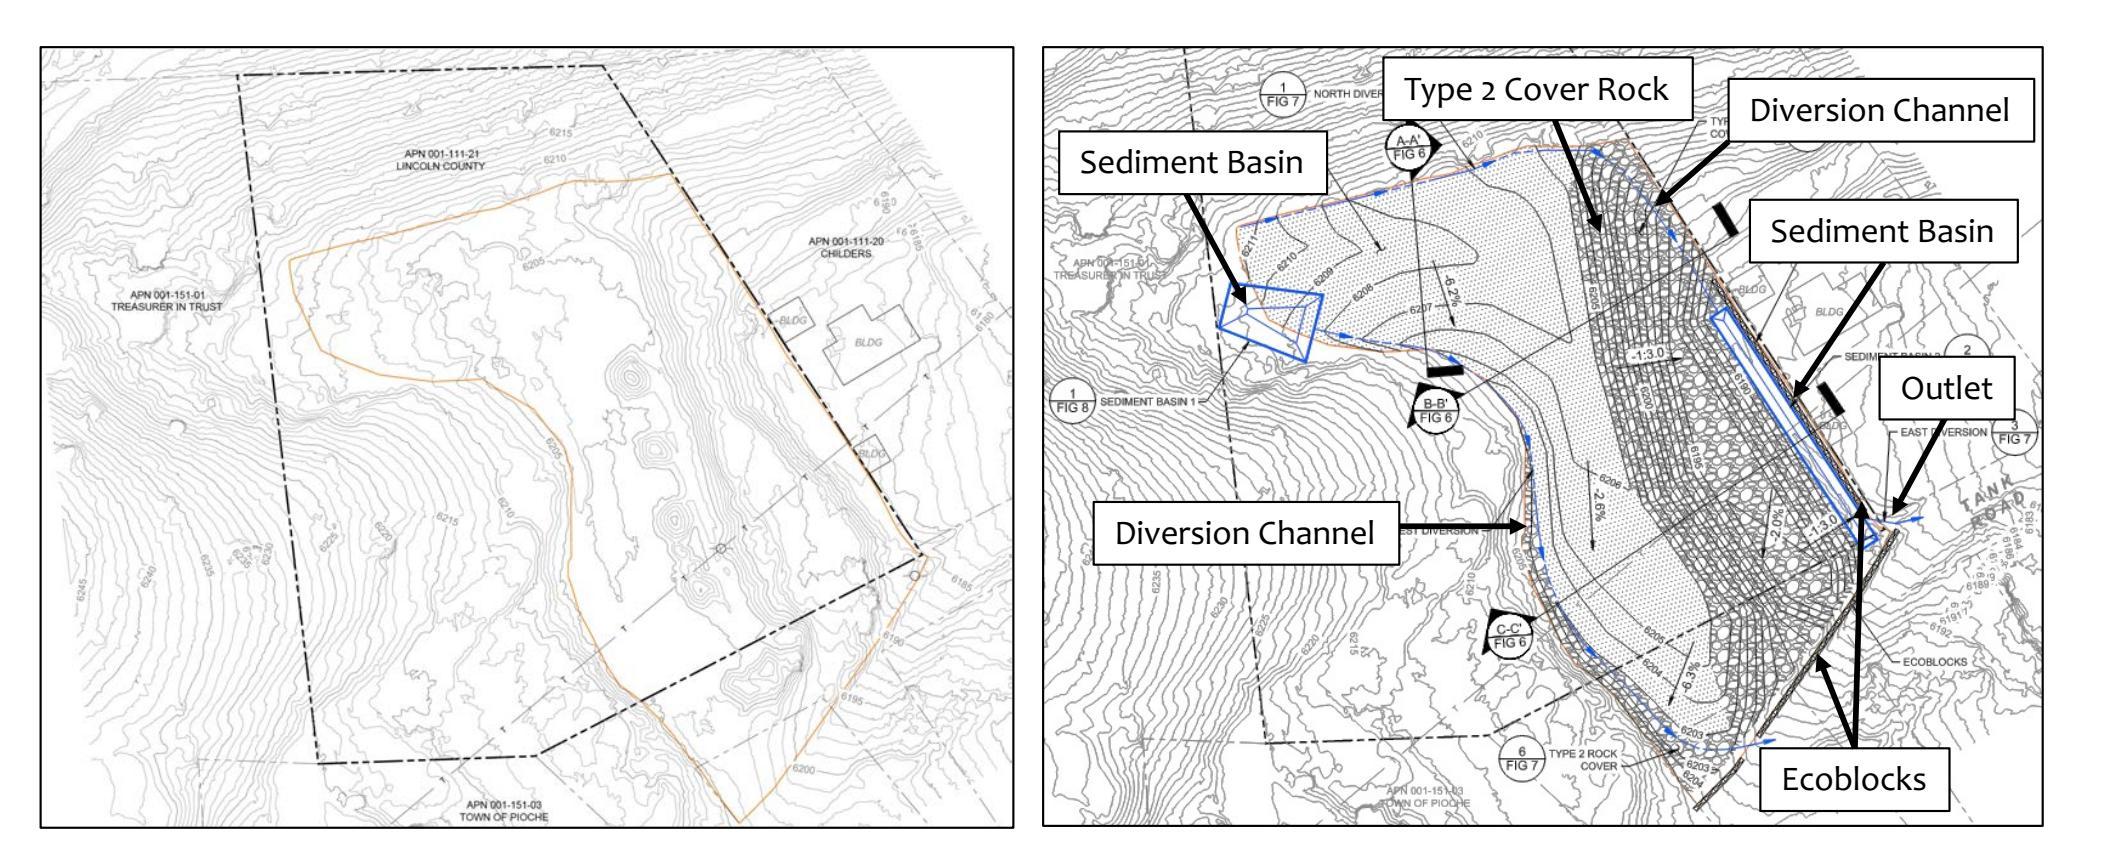
✓ Alternative 1: No Action

✓ Alternative 2: Cap and stabilize tailings in place

- Alternative 1: No Action (or implement short-term maintenance activities)
- Alternative 2: Cap or stabilize tailings in place
- Alternative 3: Remove tailings and transport to BLM North Caselton Repository
- Alternatives 4, 5, & 6: Remove tailings <u>and underlying</u> <u>contaminated soils</u> and transport to BLM North Caselton Repository

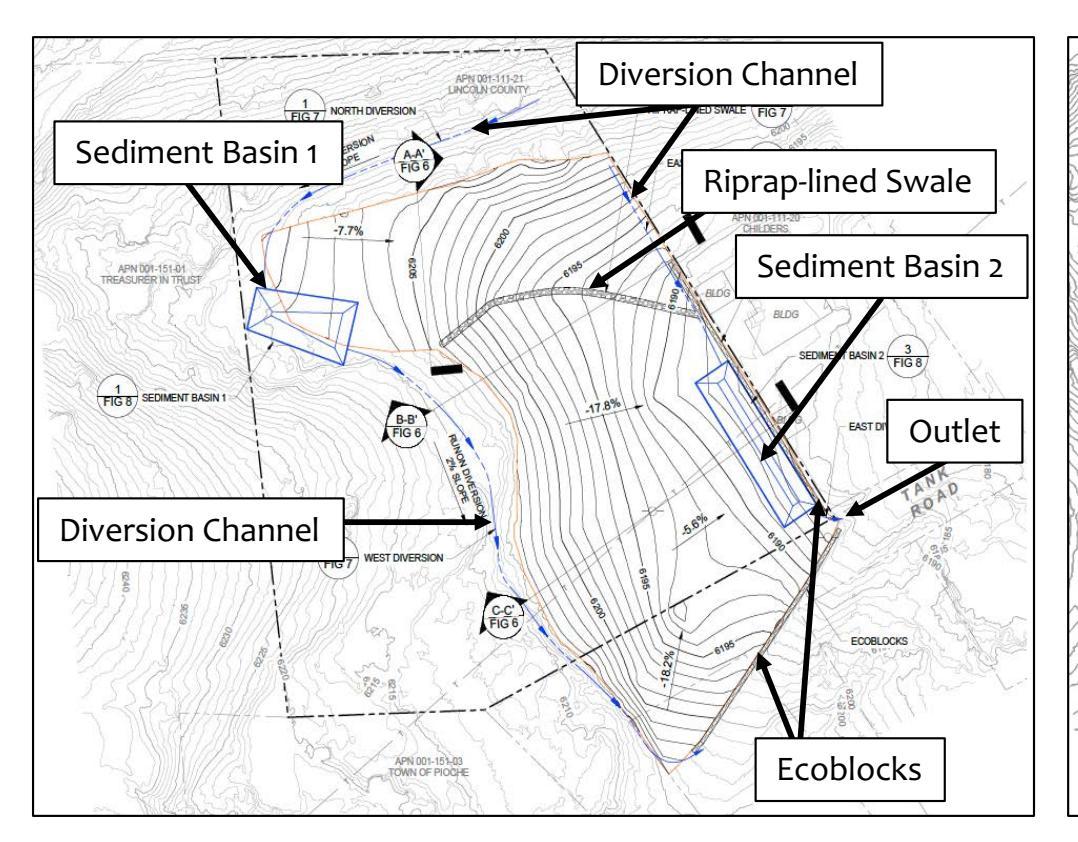
✓ Alternative 3: Excavate tailings and 6-inches of underlying contaminated soils and disposed at the BLM North Caselton Repository

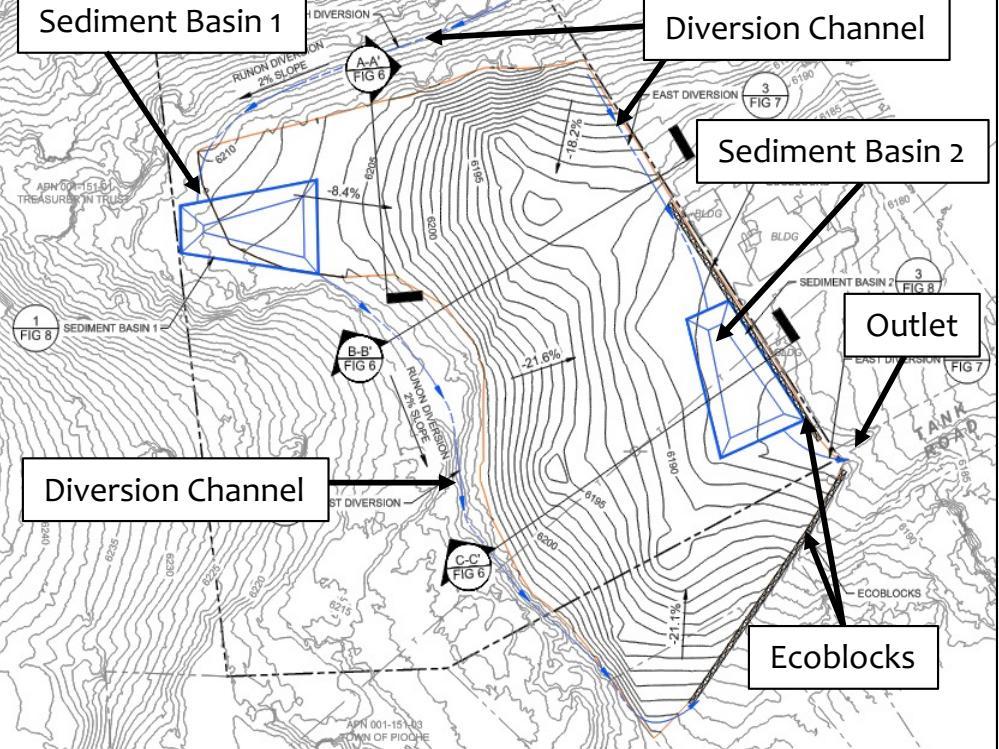
✓ Alternative 4: Excavate tailings and underlying contaminated soils and disposed at the BLM North Caselton Repository

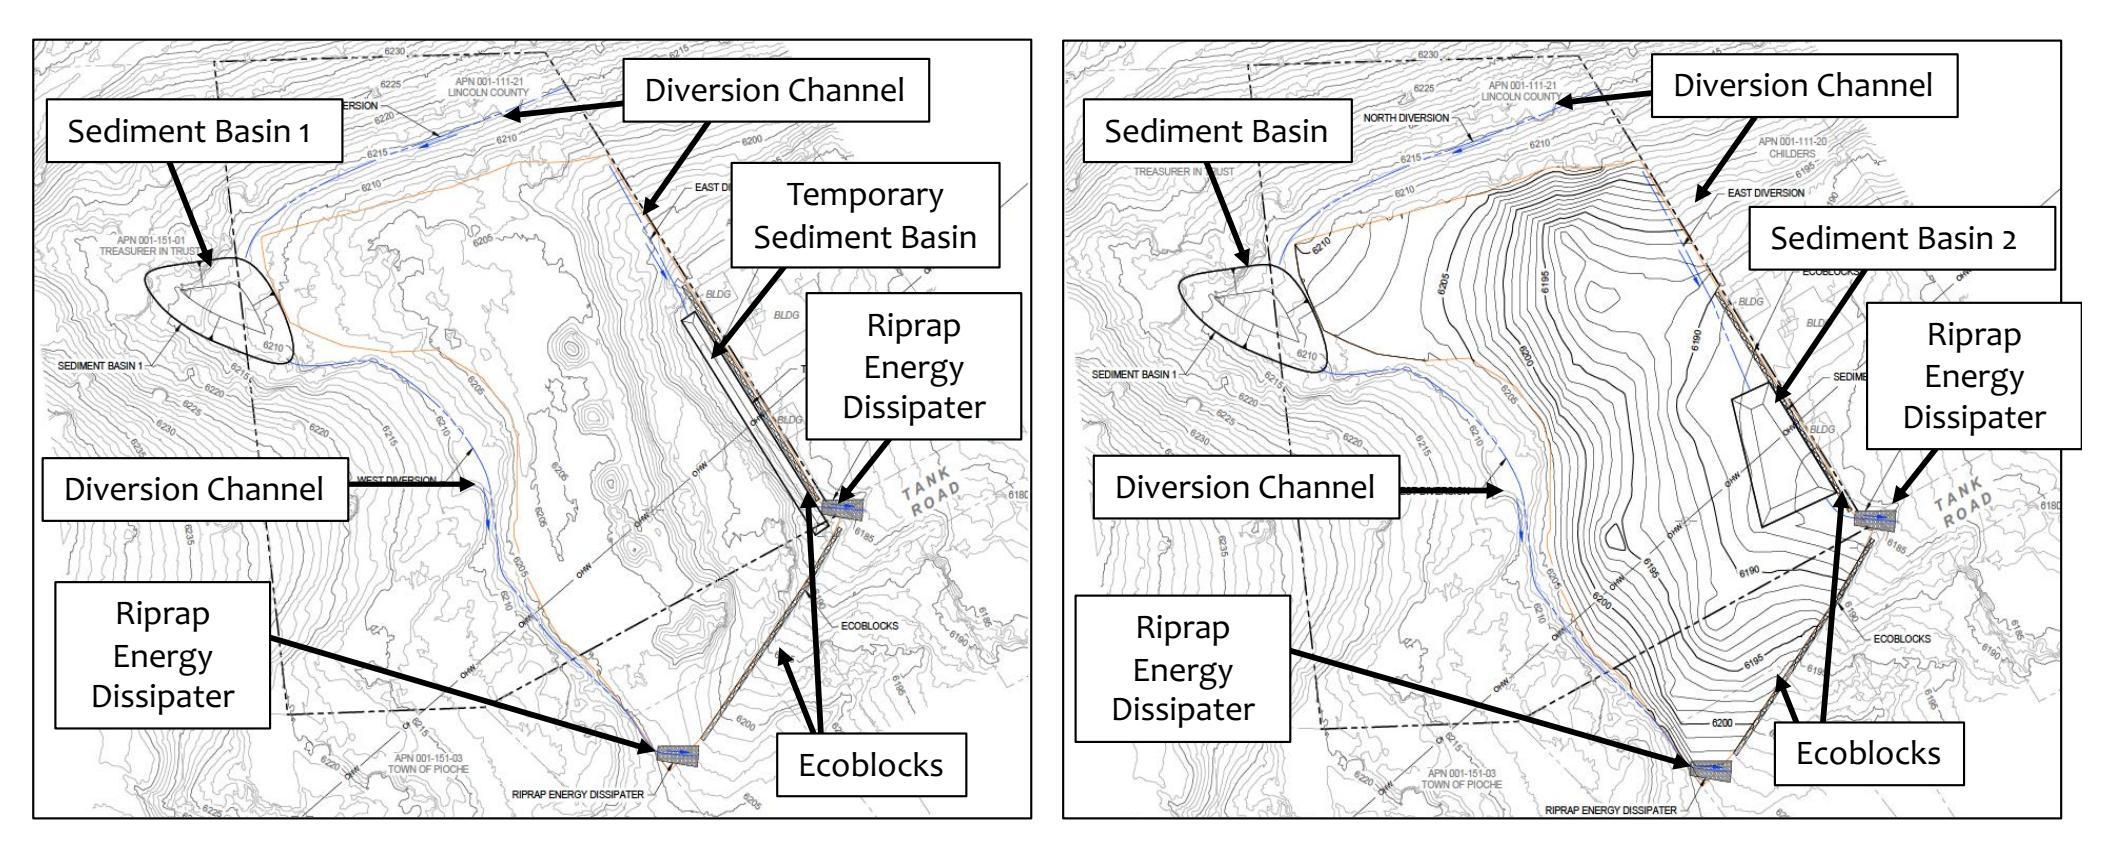
✓ Alternative 5 – Phase 1

✓ Alternative 5 – Phase 2

Note: Similar to Alternative 4, except Sediment Basin 1 is larger and co-located on Lincoln County-owned and privately-owned property. In Phase 2, tailings and underlying contaminated soils are excavated and disposed at the BLM North Caselton Repository; and Temporary Sediment Basin is replaced with Sediment Basin 2.

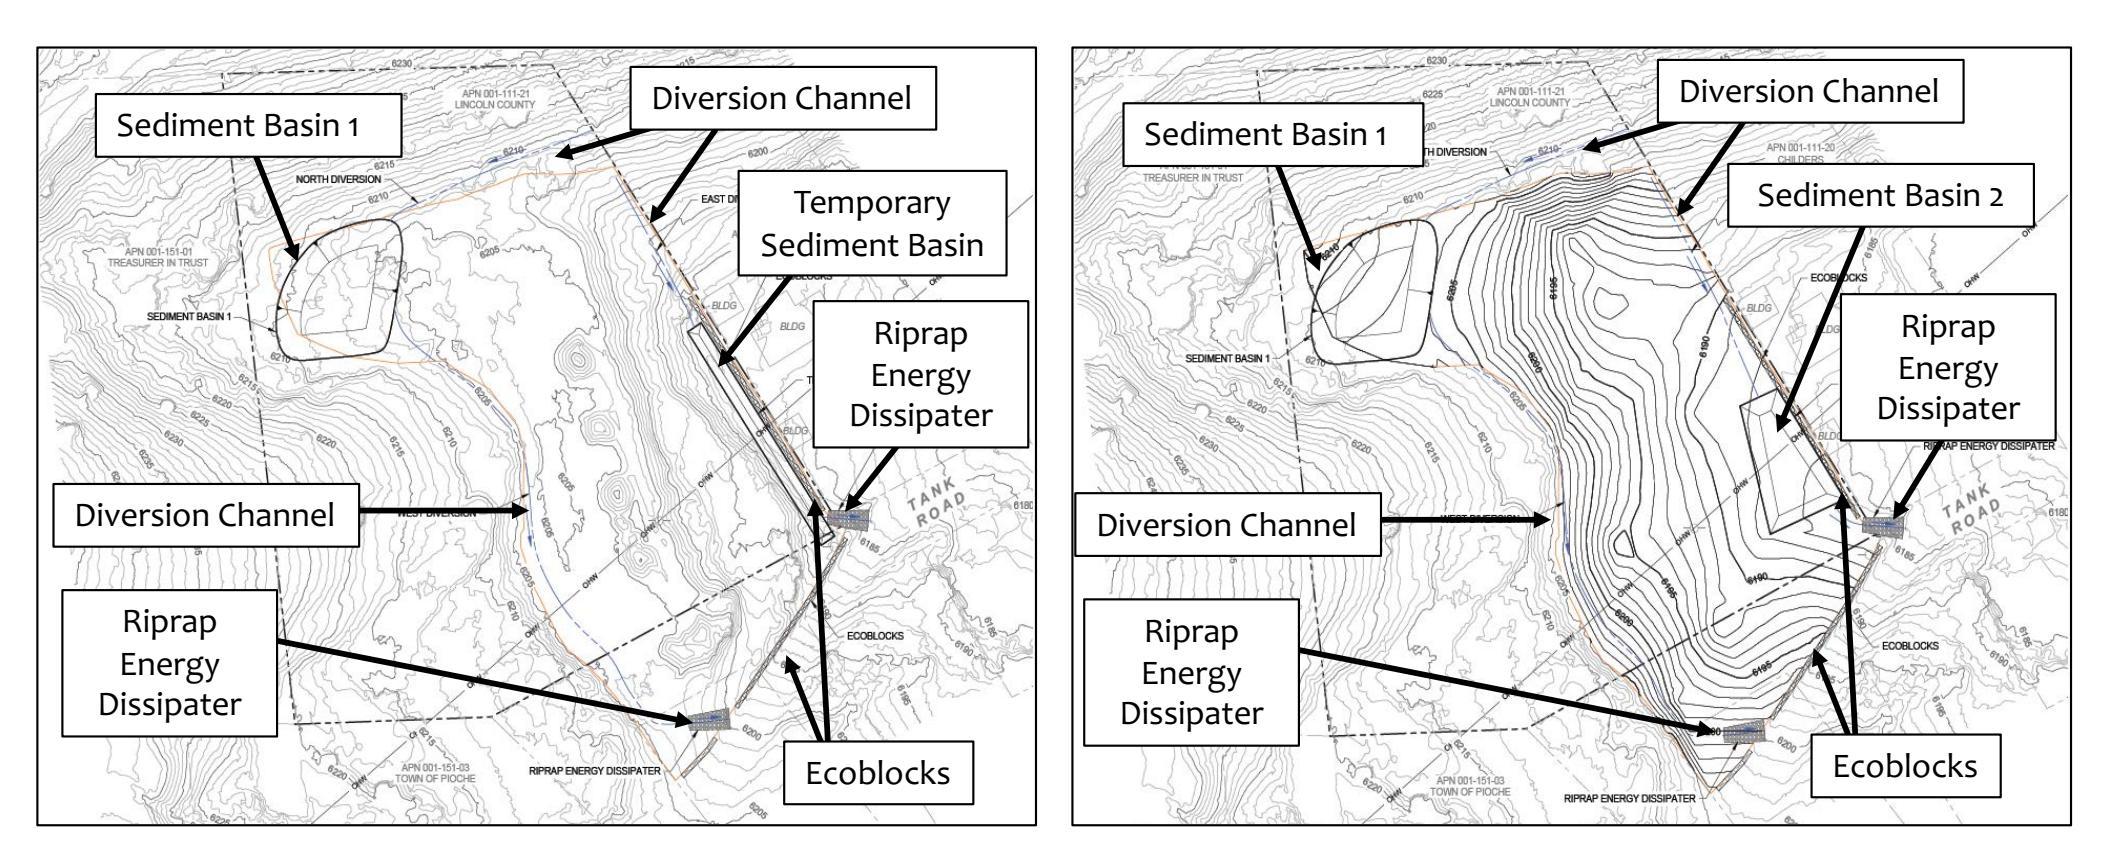
✓ Alternative 6 – Phase 1

✓ Alternative 6 – Phase 2

Note: Similar to Alternative 4, except Sediment Basin 1 is larger. In Phase 2, tailings and underlying contaminated soils are excavated and disposed at the BLM North Caselton Repository; and Temporary Sediment Basin is replaced with Sediment Basin 2.

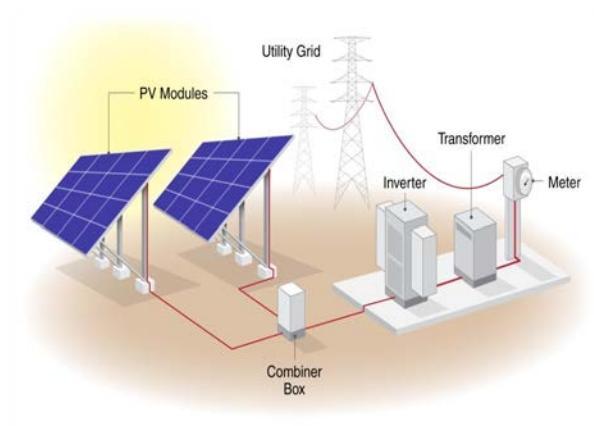
A typical grid-tied ground mount PV system Source: NREL

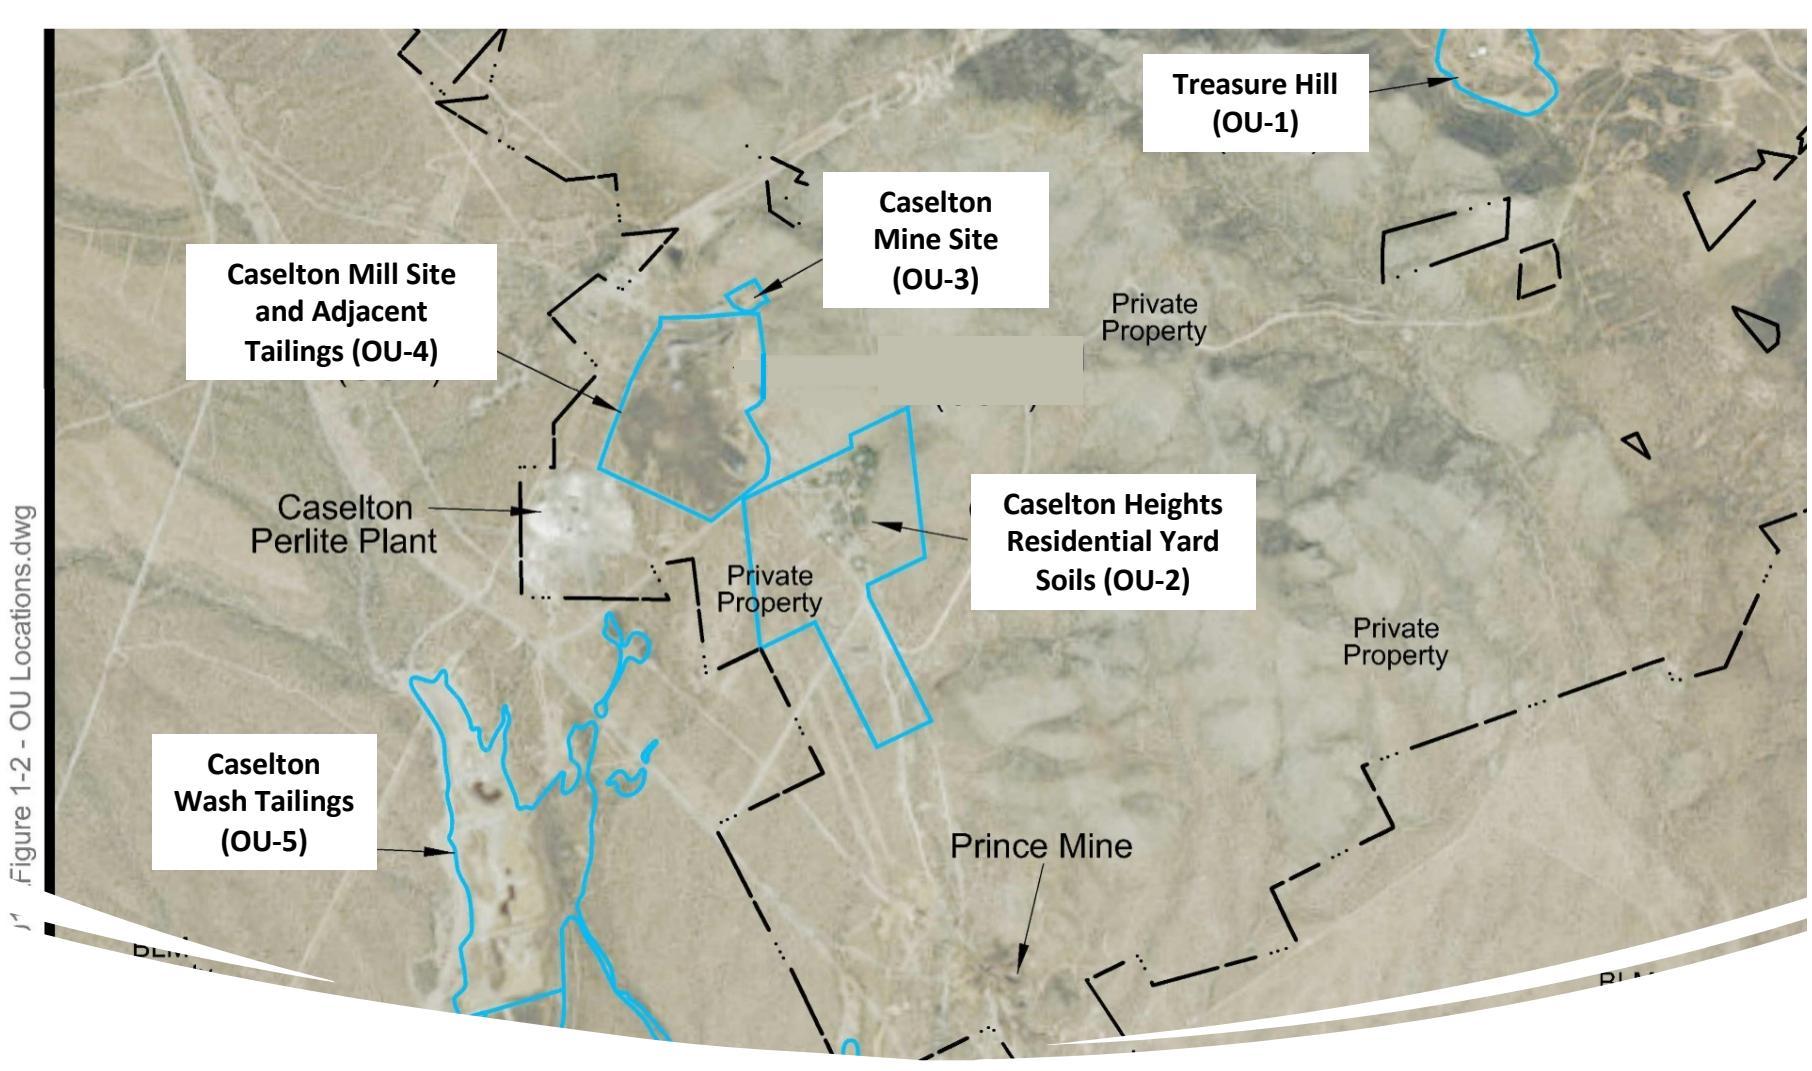
Caselton Mine & Mill Site Operable Units 2015

• Operable Unit 5 Caselton Wash Tailings located on BLM Managed lands with the bulk of tailings material were placed during operating years.

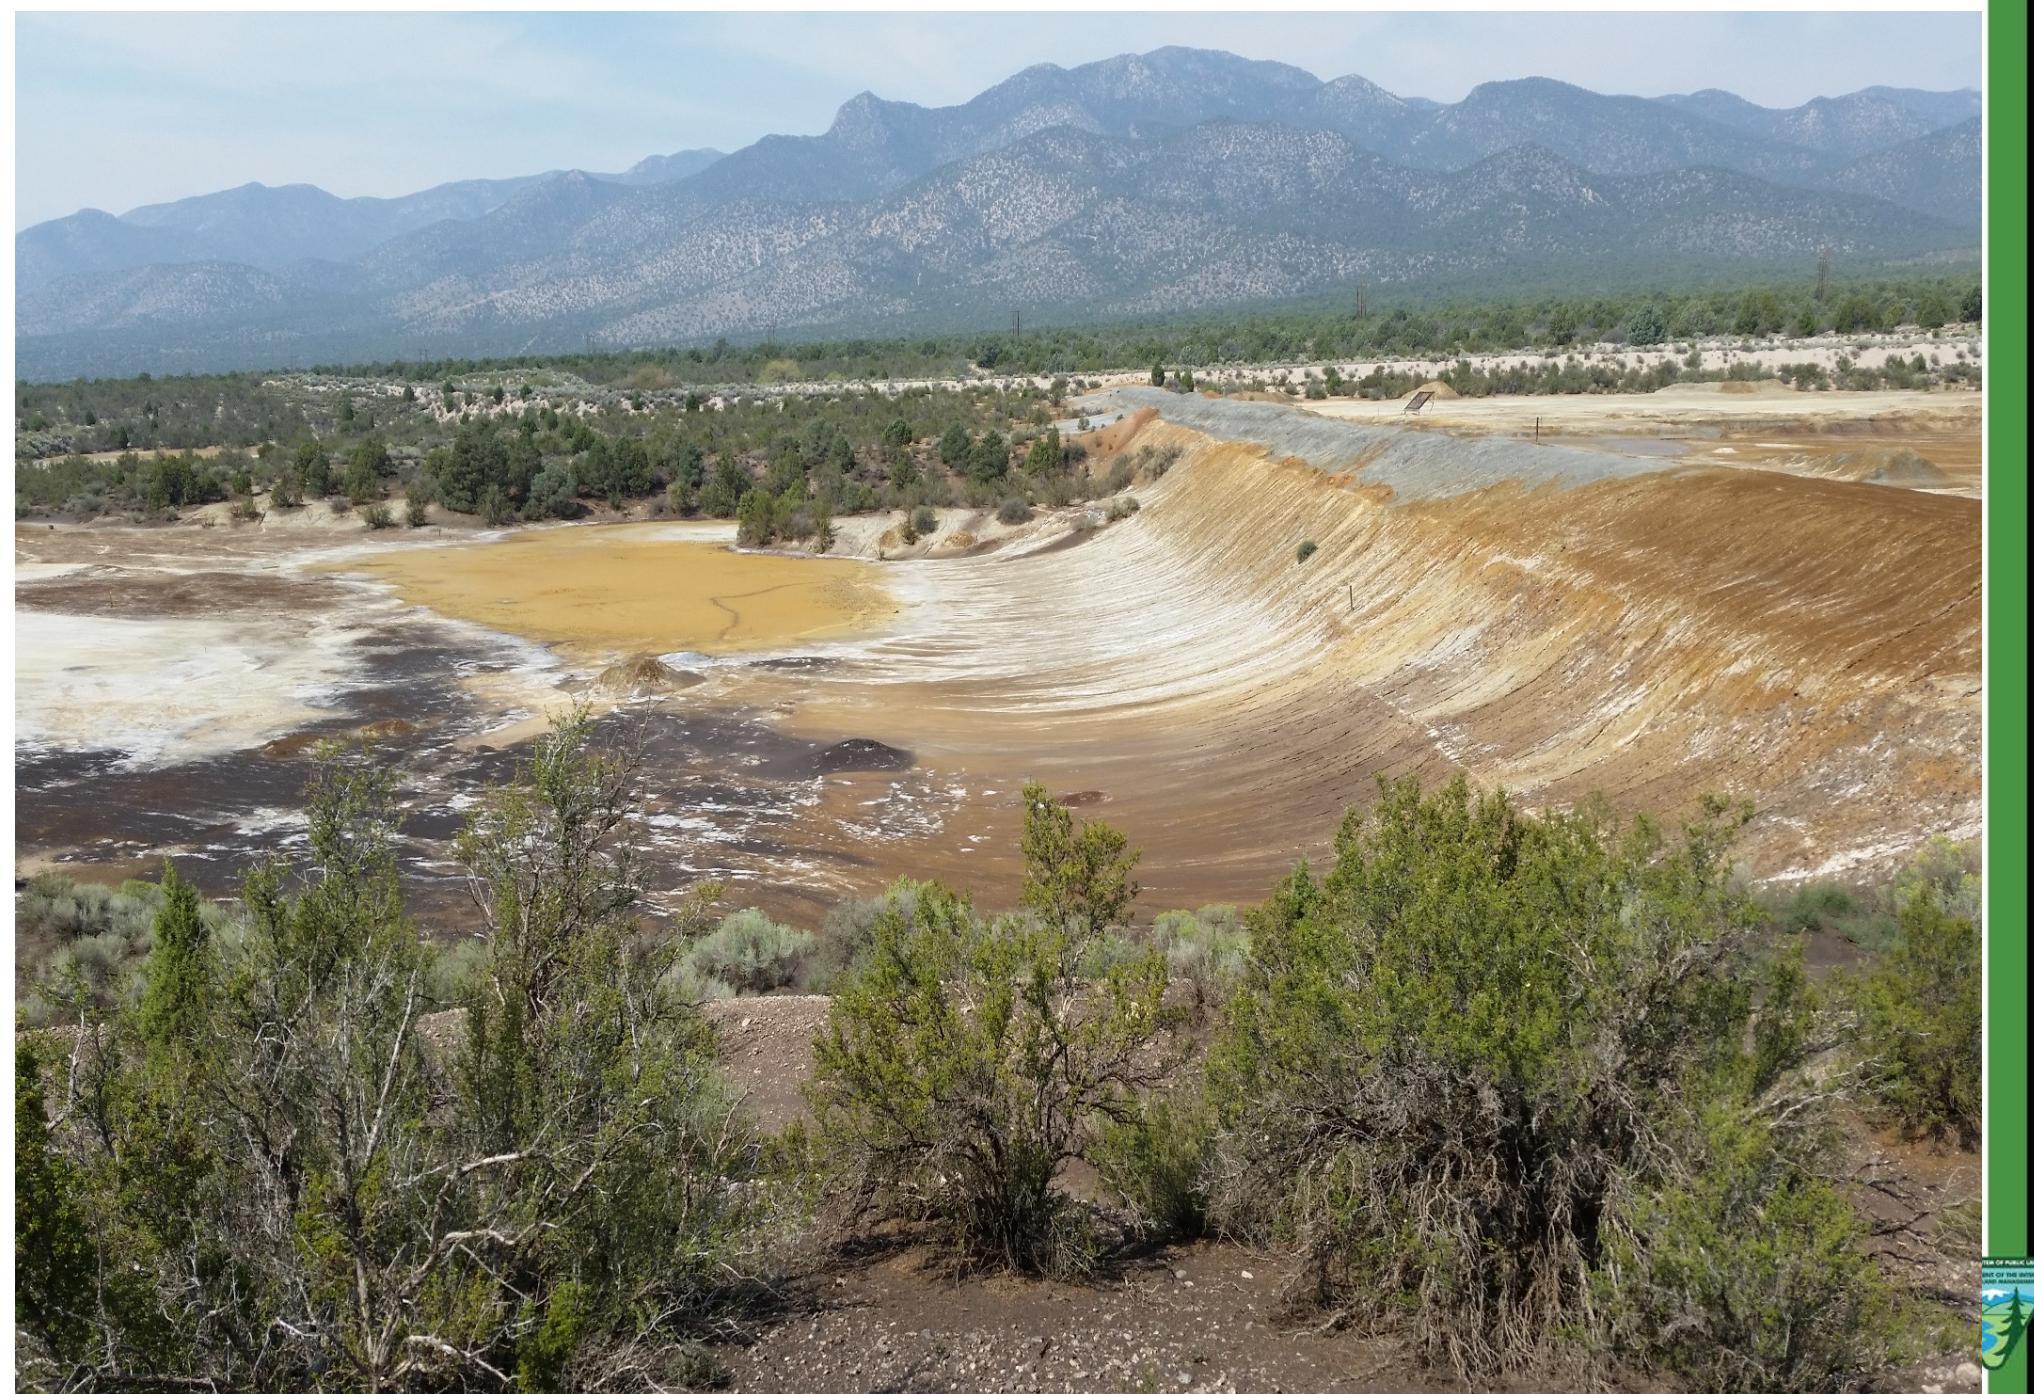
OU-5 Tailings near ponds 4 & 5 August 2015

- The public lands are being managed under the Comprehensive Environmental Response, Compensation, & Liability Act (CERCLA).
- The OU-5 boundary includes an approximate 100 acres of tailings ponds, dams, and drainage features within the Wash that have a combined length of over 1.5 miles.
- However, tailings material have migrated downstream and efforts to determine nature & extent of contamination continues. These pose a low risk under current conditions, but heavy monsoonal rains could move material further downstream.
