Self-made upgrade

Real-world savings from 3D printing

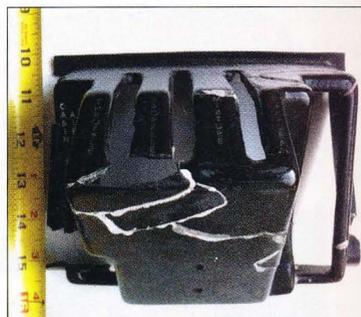
THE OWNERS OF A 36-YEAR-OLD BEECH SIERRA came up with a digital solution to an increasingly widespread real-world problem. They needed to replace a non-structural part (in this case, a cracked and crudely repaired throttle quadrant cover), and new ones were either unavailable or absurdly expensive. Their solution: 3D printing (see “P&E: Control+P,” March 2013 *AOPA Pilot*).

MEASUREMENTS from the cracked and broken original piece (top) were digitized (center) and turned into a perfect replacement (above).

Dennis Moyes, a partner in the 1977 Sierra, removed the old cover and made a digital representation of it using AutoCAD, a drafting and 3D computer modeling program. Such programs are increasingly common. (Others include 3D Studio Max, SketchUp, Rhino, and Blender.)

The printed part arrived two weeks later. Moyes painted and detailed it, and the finished piece adds to the appearance of an already sharp-looking panel. Aircraft owners have wide latitude to create such “owner-produced parts” under FAR 21.303(b)(2) as long as the replacements aren't for sale and are only installed in the owner's airplane. **AOPA**
