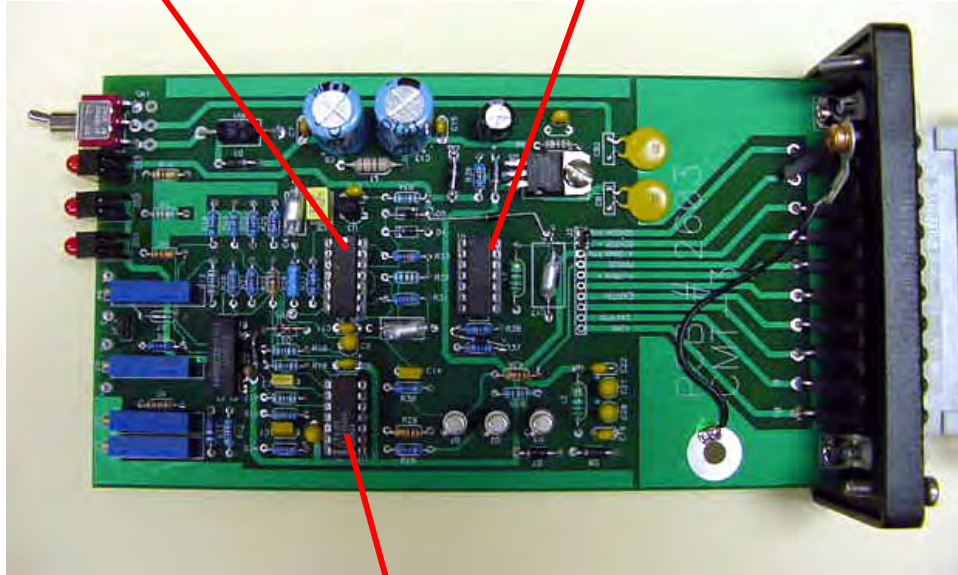
Note notch end for correct chip position

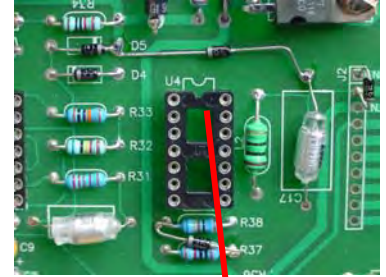
SJI PART # 20185
CA3046 OR LM3086N

Most common chip to fail, we pack three of this chip inside CMT-3 for spares

Existing chip may look like either picture

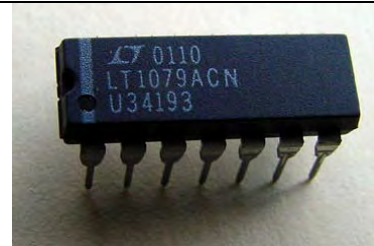
SJI PART # 20186
LT1079ACN
