What should you look for in a molded commutator replacement?

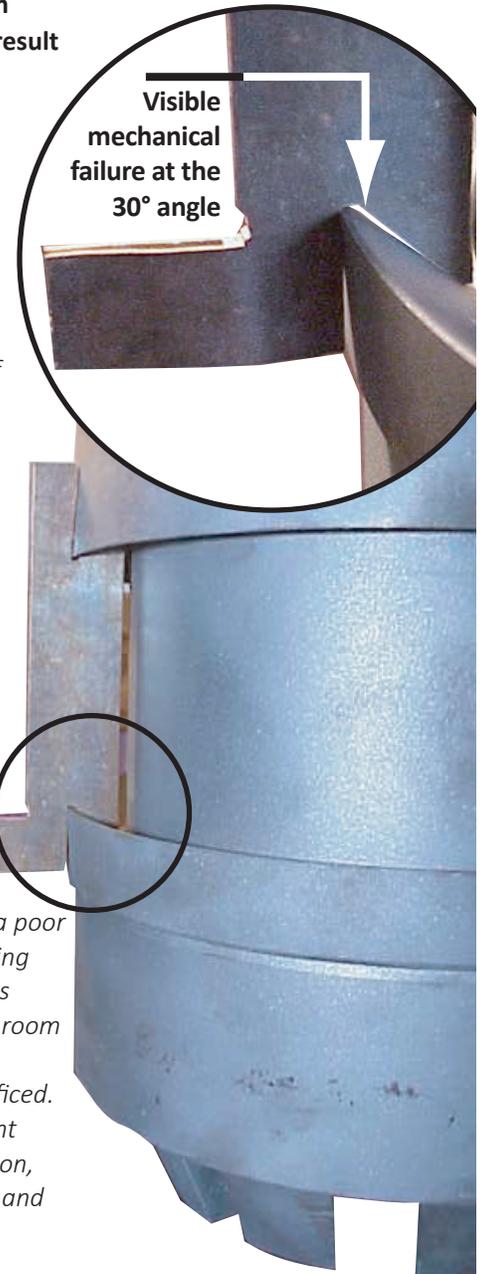
Sample of a comm which failed as a result of a poor design re-using a steel shell from a molded comm.

A well designed v-ring commutator will typically use 1/3 of the bar for each dovetail, unlike the one shown here.

It will also have enough material designed into the interior angle to ensure that the bars will stay tightly compressed in operation.

In this example of a poor design, since re-using the molded comm's steel core left little room for a v-ring design, strength was sacrificed. The flimsy caps bent outward in operation, the bars loosened, and the comm failed.

A commutator has to remain tight in operation. Lifting bars cause serious problems, and evidence of a poor design can show up this way. If a commutator builder re-uses the steel shell from a molded unit, he's not saving you money. A molded comm shell is designed for a molded comm, and doesn't leave enough room for v-ring clamping hubs to hold the bars tight. The comm may arrive looking fine, but will usually soon fail in operation.

Yes. If your "replacement" comm arrives with a hub that has signs of being a casting (i.e. relief, rough surfaces), the chances are that it wasn't machined specifically for your replacement comm. Also, most molded comm manufacturers stamp their names into the steel shells (i.e. Cupex), so if you get a v-ring comm with the Cupex name stamped in the hub, the molded comm's steel core has been re-used. These clues can be important when tracing a failure, and potentially assigning warranty responsibility.
