STAYING
ABOVE
WATER

Property Owner's
Guide

Greater Portland Landmarks

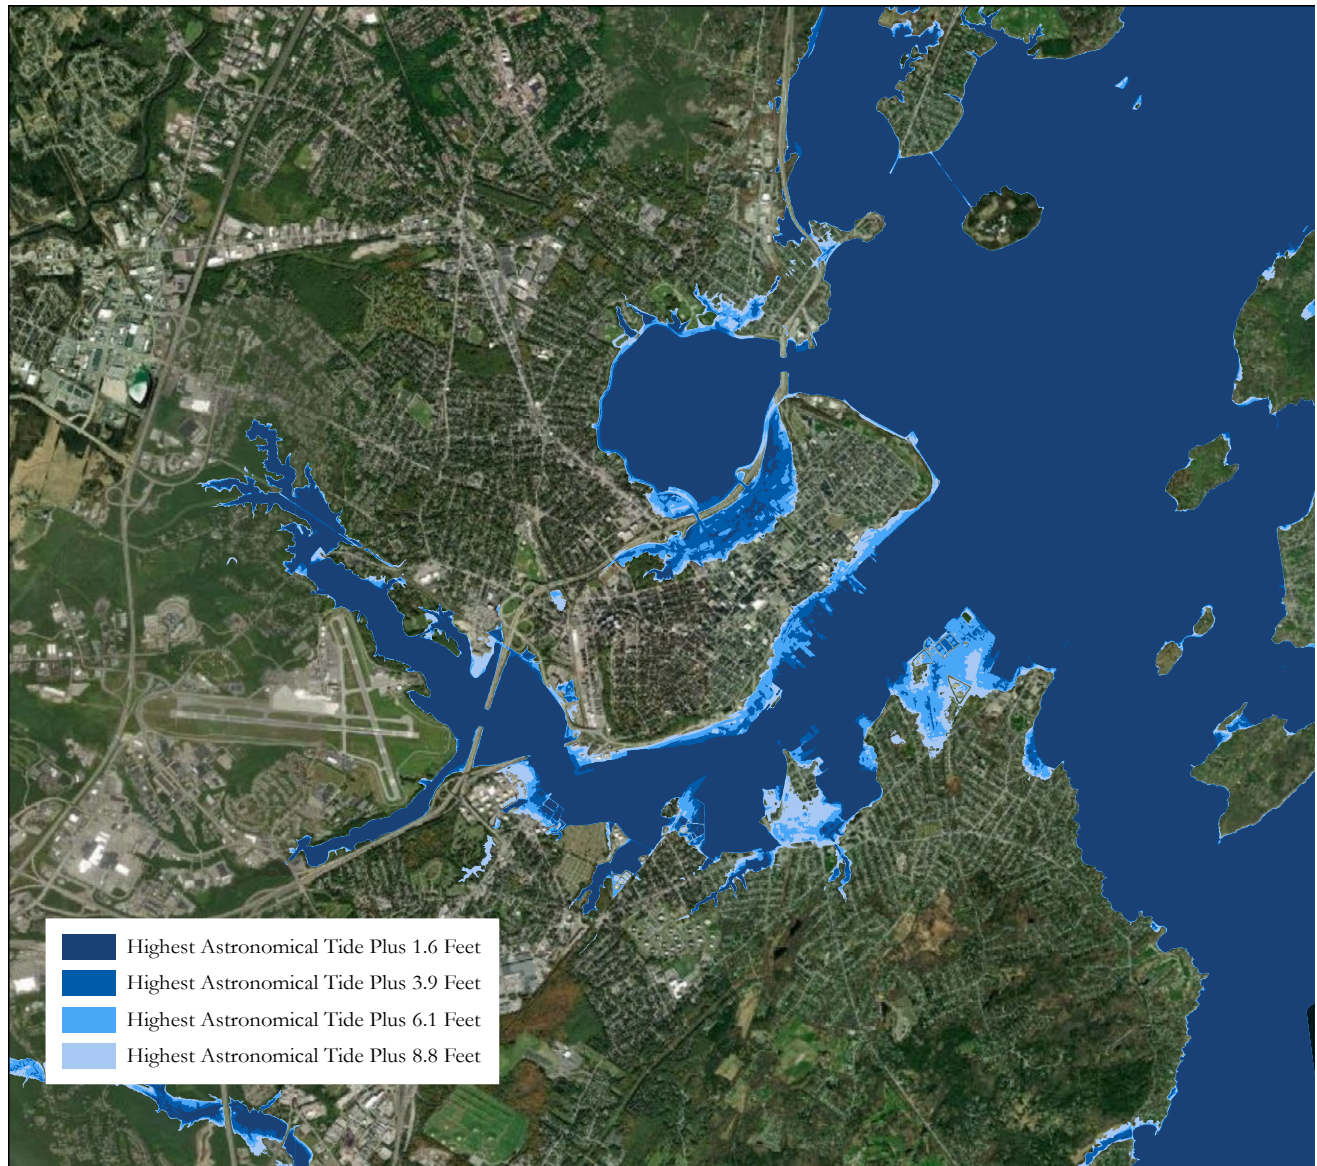
Sea Level Rise and Storm Surge Scenarios in Greater Portland

The Scientific and Technical Subcommittee of the Maine Climate Council recommends committing to manage 1.5 feet of sea level rise (darkest blue) by 2050 and 3.9 feet by 2100. They recommend preparing to manage 3 feet of sea level rise by 2050 and 8.8 feet of sea level rise by 2100 (lightest blue).
(Scientific Assessment of Climate Change and its Effects in Maine, August 2020)

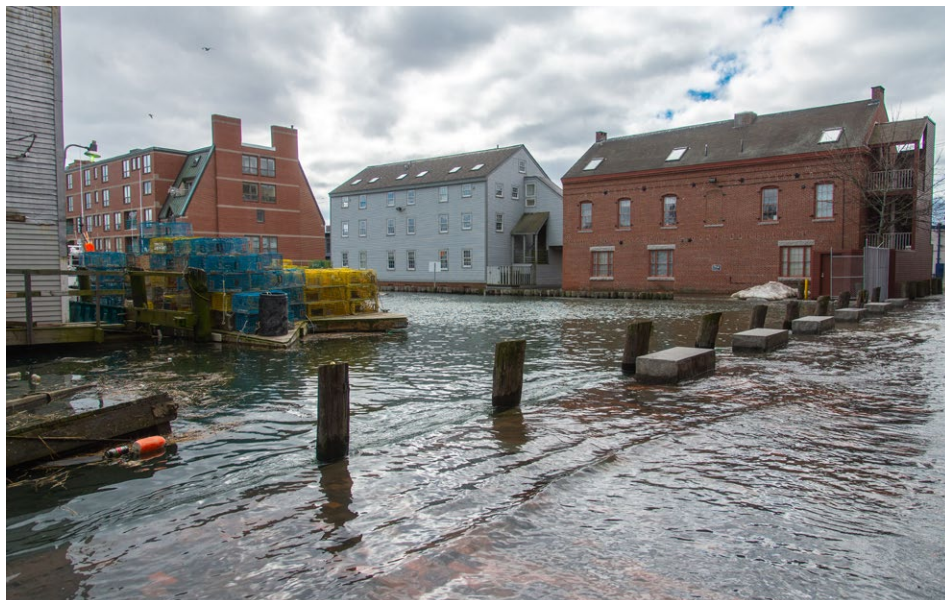
Flooding at Custom House Wharf during high tide, 2018 (Photo by Corey Templeton)

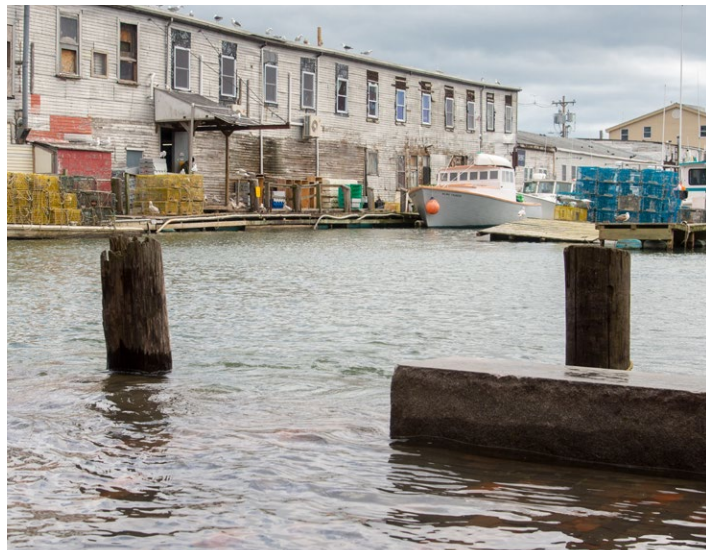
Flooding at Custom House Wharf during high tide, 2018 (Photo by Corey Templeton)

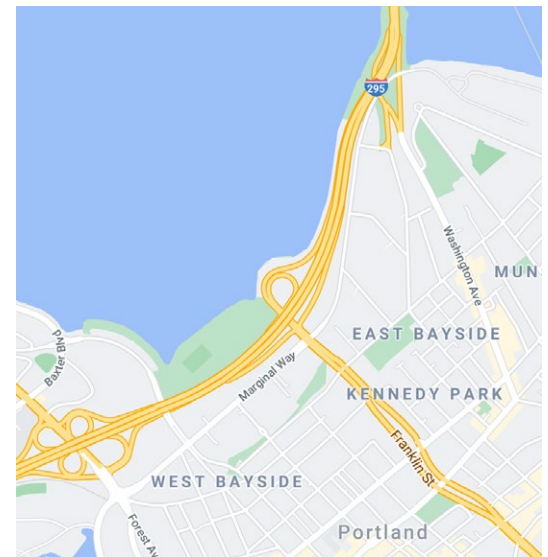
A current map of Portland shows the extent of fill in Bayside, and the neighborhood split in two by Franklin Street.

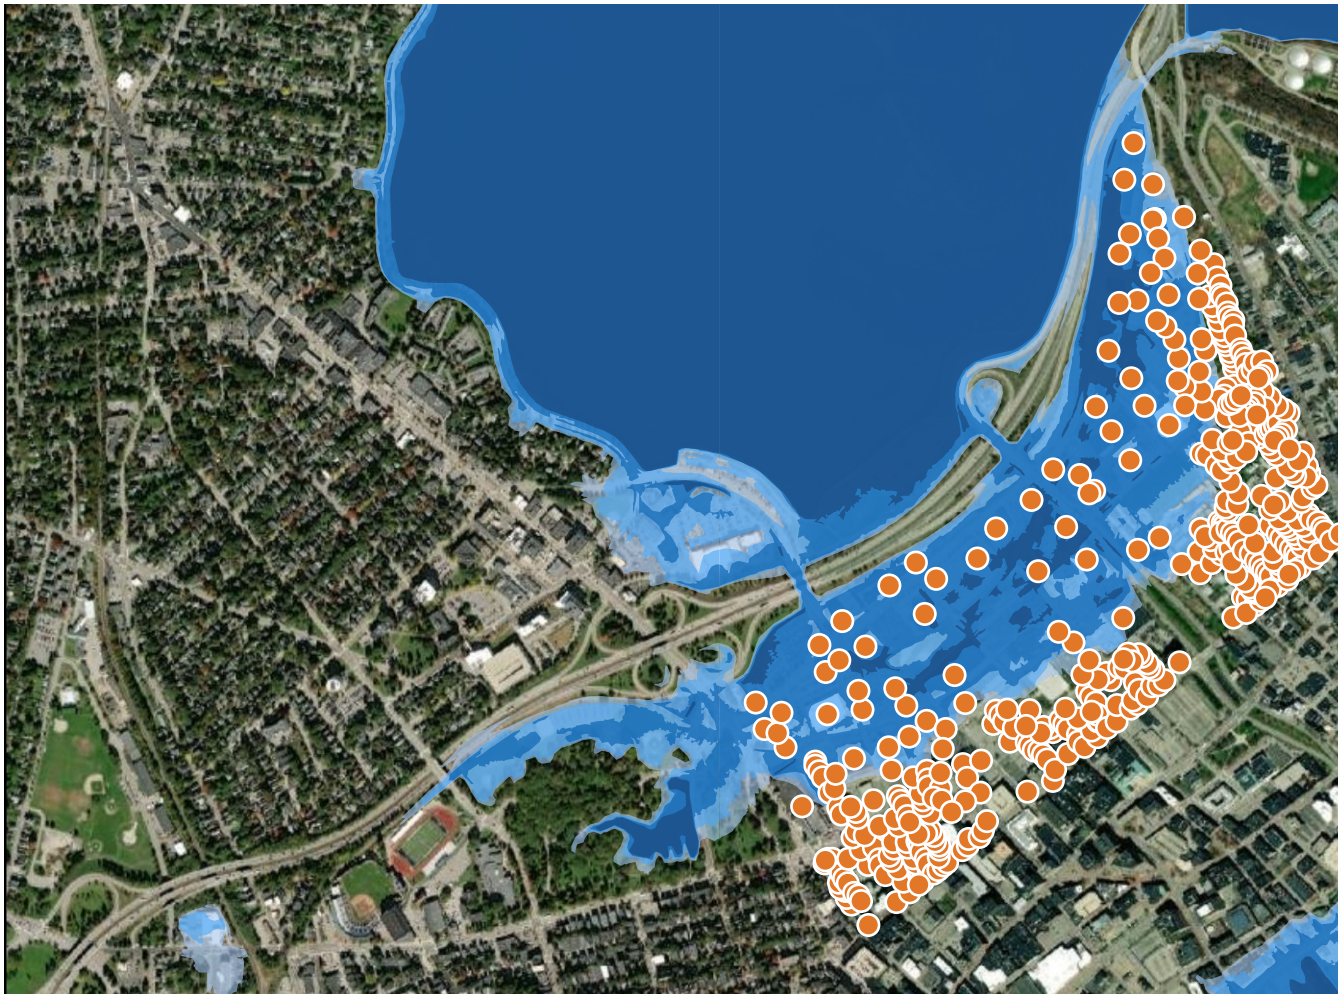
- Highest Astronomical Tide Plus 1.6 Feet
- Highest Astronomical Tide Plus 3.9 Feet
- Highest Astronomical Tide Plus 6.1 Feet
- Highest Astronomical Tide Plus 8.8 Feet

Each orange dot represents a surveyed historic resource in Bayside at risk due to increased flooding and sea level rise caused by climate change.

As the population and economy of East and West Bayside continues to grow, so too does the threat of climate change. Flooding now occurs regularly during heavy rainfall and high tides along Marginal Way and Somerset Street, and is only projected to get worse. Most affected are the buildings constructed on land filled in during the 19th and 20th centuries. Due to sea level rise, Back Cove is slowly creeping back to reclaim those areas of the neighborhood that did not exist 225 years ago.

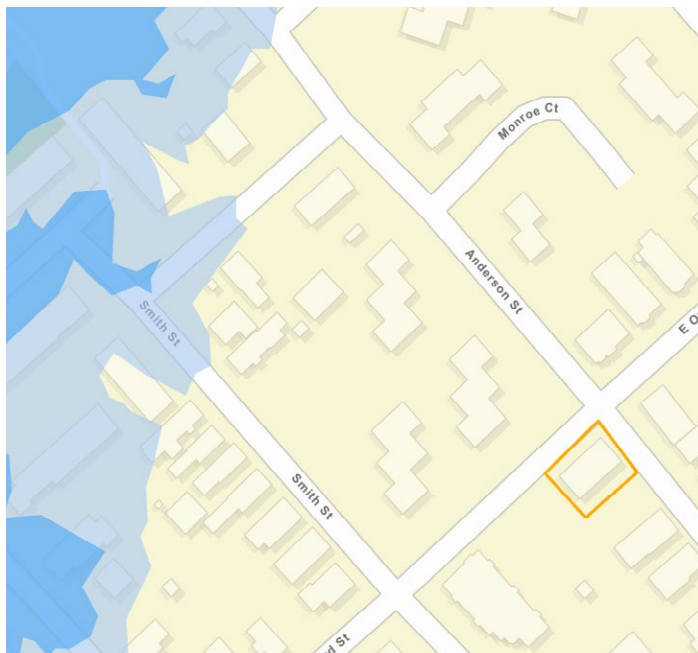
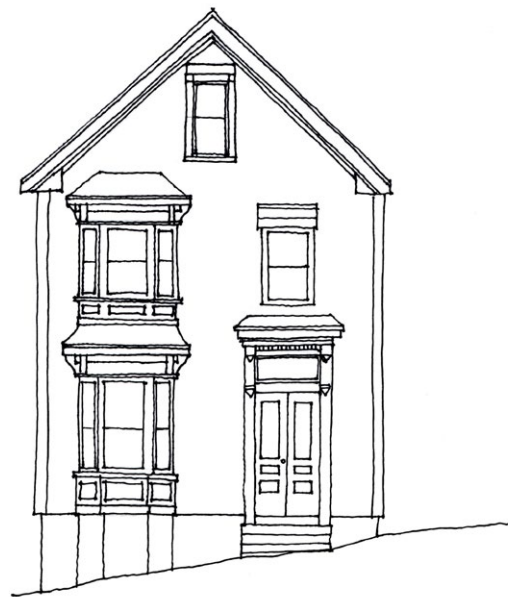
32 Anderson Street

Existing Conditions

This multi-family residence rests on a high foundation in an elevated area in Bayside. Although not identified as at risk to flooding from rain and storm surges, storm water runoff from uphill sites and parking lots to the rear of the dwelling could impact the masonry foundation and at-grade openings. There are few trees to shade the southwest-facing yard. The lot could be improved to encourage site drainage away from the building's foundation.

- Install solar panels on the south slope of the roof, set back from the edge of the gable end
- Elevate critical mechanical systems on the interior
- Resize gutters to handle increasing precipitation loads and drain away from foundation.
- Install rain barrels or integrate gutter runoff into landscaping strategies
- Slope grade and landscaping away the foundation on the uphill side of the house to help drainage
- Install hardware around openings at grade level to accommodate retractable flood shields during storm events
- Reduce impermeable paving, particularly uphill of the dwelling

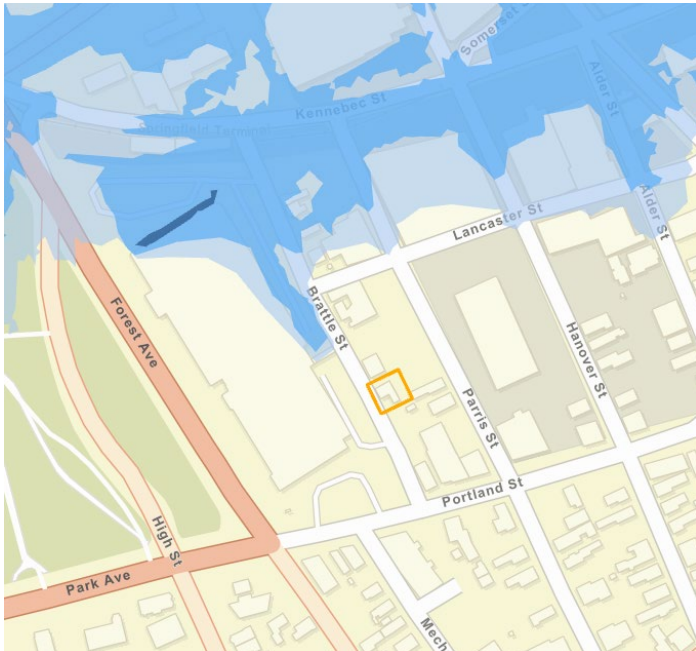
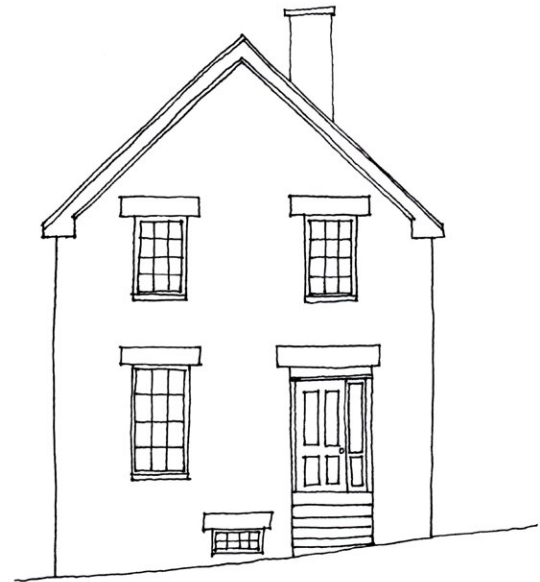
17 Brattle Street c.1849, Greek Revival

Existing Conditions

This single-family residence rests on a high foundation in an elevated area in Bayside. Although not identified as at risk to flooding from rain and storm surges, storm water runoff from nearby paved streets and parking lots uphill and across the street from the dwelling could impact the masonry foundation and at-grade openings. A large deciduous tree shades the south-facing side yard. The lot could be improved to encourage site drainage away from the building's foundation.

- Install solar panels on the ell roof or main roof, set back from the edge of the gable end
- Elevate critical mechanical systems on the interior
- Integrate rainwater run off strategies into landscaping
- Maintain masonry, particularly chimneys to reduce damage from loose falling bricks and water infiltration
- Install hardware around openings at street level to accommodate retractable flood shields during storm events
- Slope grade and landscaping away from the foundation on the uphill side of the house to improve site drainage

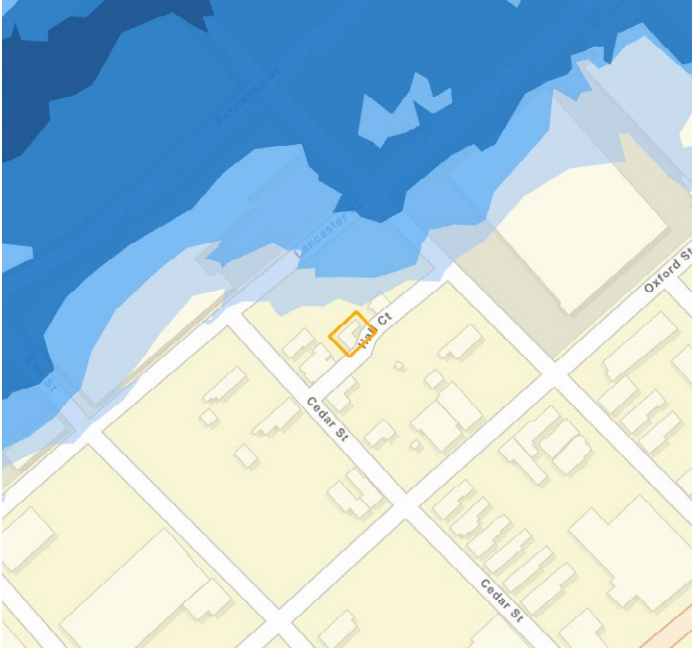
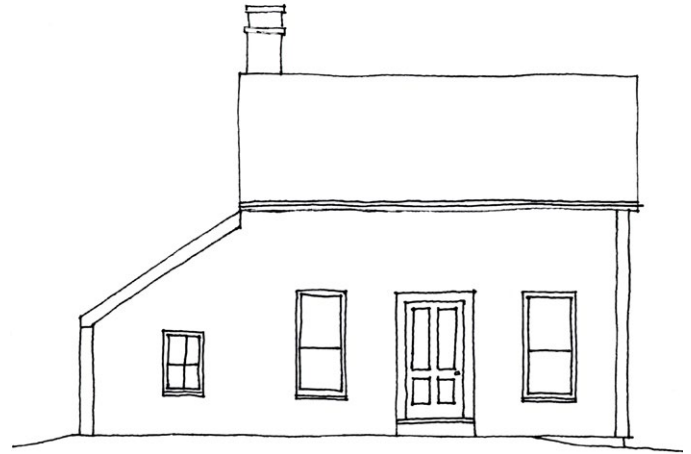
3 Hall Court

Existing Conditions

This historic single-family residence (c.1820) is built very close to grade and located at the edge of a low-lying area of Bayside identified as at risk to flooding from rain and storm surges. The area around the house features many paved surface parking lots where runoff during storm events negatively impacts adjacent properties and the city's storm water system. With the building sill located close to grade, even minimum levels of flooding or storm water runoff would submerge or wet the building's wood framing, siding, and trim. The front entrance is also very close to grade and susceptible to flood waters.

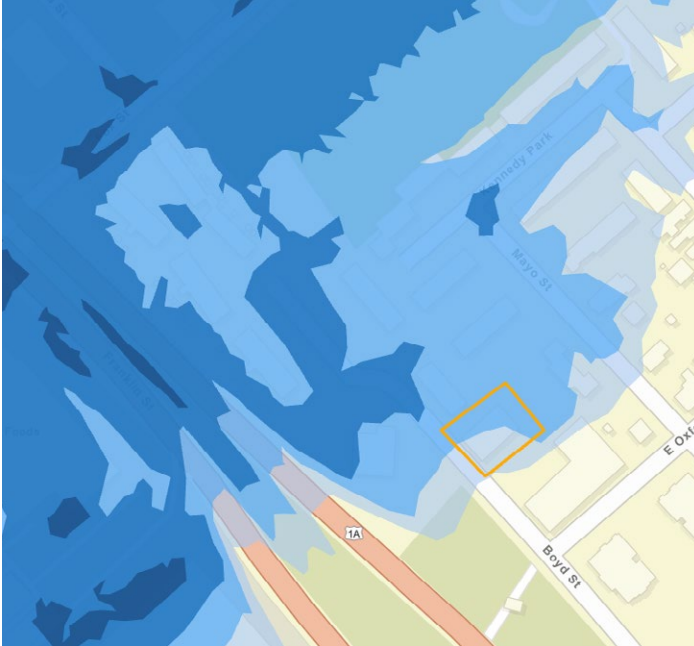
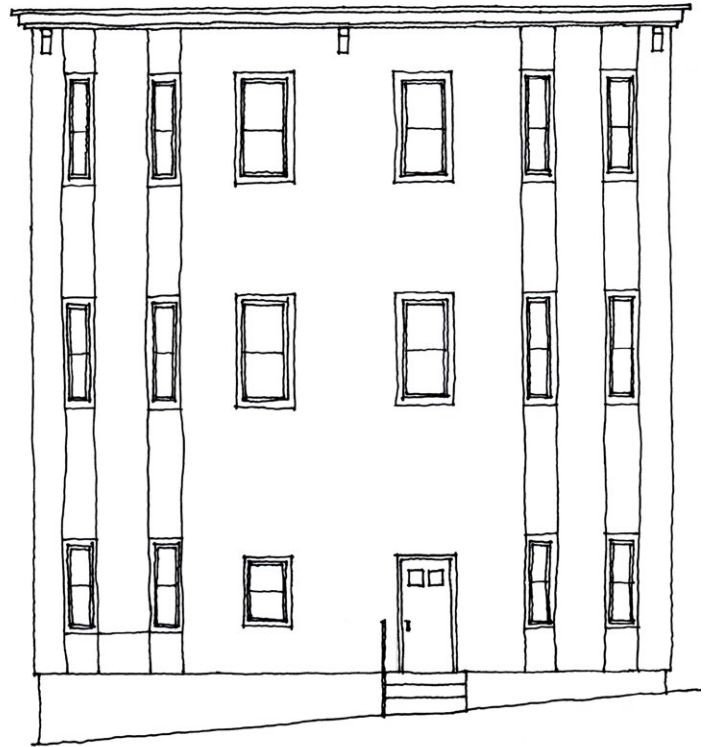
47-49 Boyd Street

Existing Conditions

This multi-family residence rests on a foundation that reflects the topographical change on Boyd Street at the edge of a low-lying area identified as at risk to flooding from rain and storm surges. The area around the dwelling features many paved surface parking lots where runoff during storm events impacts adjacent properties and the city's storm water system. There are limited large trees to shade the yard or building. The relatively flat lot could be improved to encourage site drainage away from the building's foundation, particularly on the uphill side of the dwelling.

- Install a cool roof on flat or low-slope roofs to reduce interior temperature and reduce heat island effects
- Elevate critical mechanical systems on the interior and exterior
- Install solar panels on the roof in consultation with a structural engineer or at the rear of the site
- Size gutters to handle increasing precipitation loads
- Install rain barrels or integrate rainwater runoff strategies into landscaping
- Slope grade and landscaping away the foundation on the uphill side of the house to help drainage
- Add trees where possible to help lower temperature by providing shade.

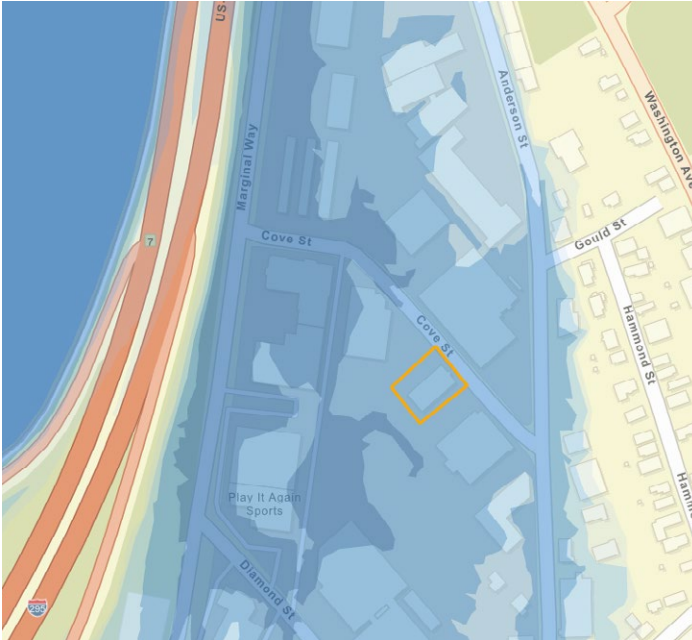
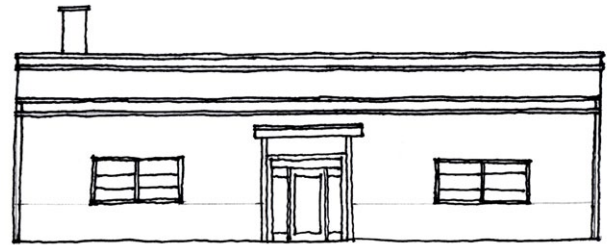
66 Cove Street

Existing Conditions

This industrial brick building (c.1953) is typical of many of its small-scale neighbors, built in an section of Bayside that was once part of Back Cove until it was filled in the first half of the 20th century. The area currently experiences nuisance flooding during extreme storm and high tide events. The at-grade entrance is vulnerable to street flooding. Likewise, mechanicals systems on the exterior, and possibly the interior, are at risk from street flooding. Impermeable paving in the parking area surrounding the building does not allow storm water to penetrate into the ground and raises the temperature more than a vegetated surface would do.

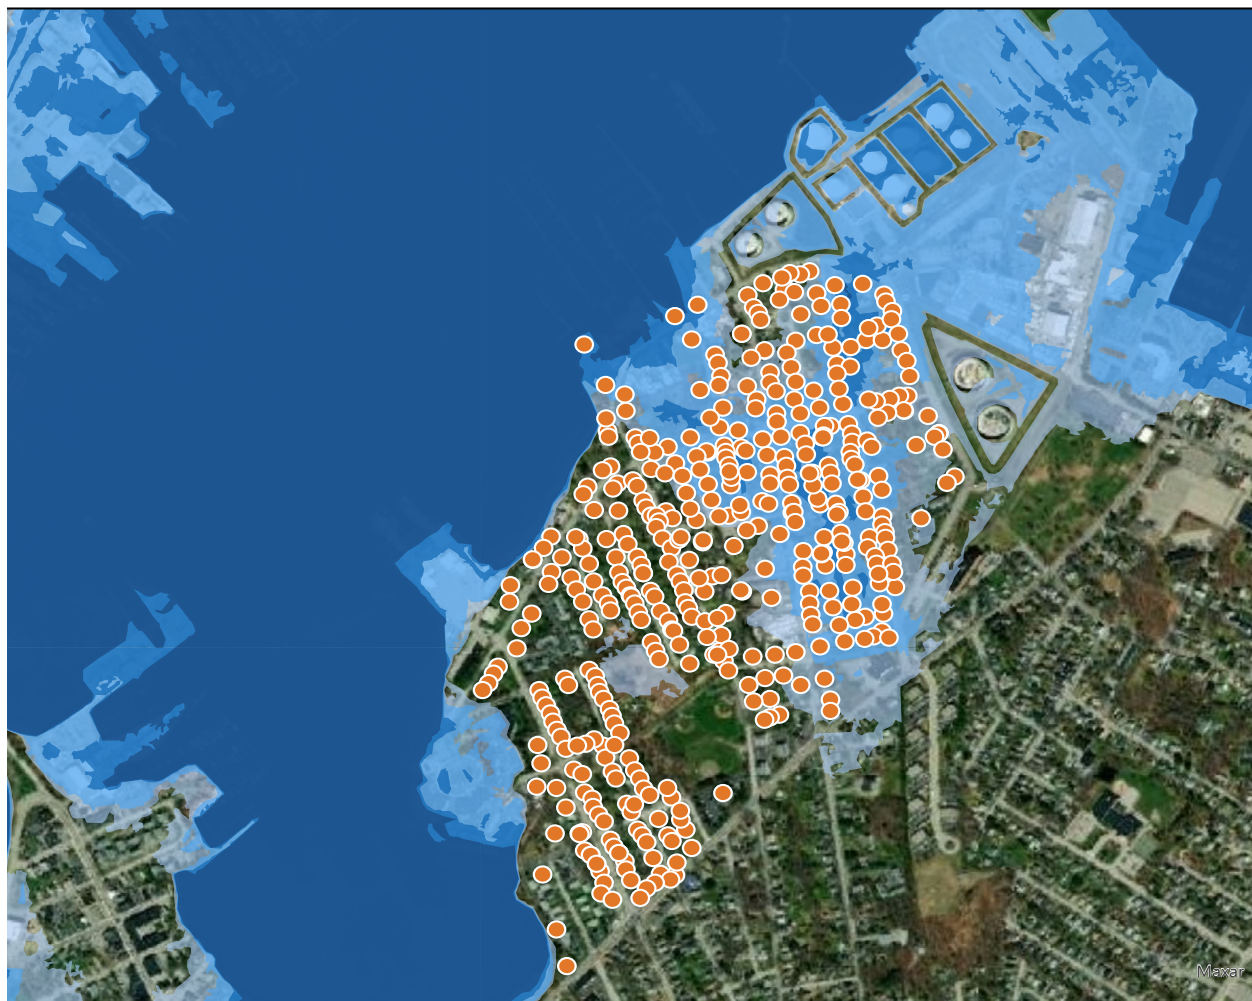
- Highest Astronomical Tide Plus 1.6 Feet
- Highest Astronomical Tide Plus 3.9 Feet
- Highest Astronomical Tide Plus 6.1 Feet
- Highest Astronomical Tide Plus 8.8 Feet

Each orange dot represents a surveyed historic resource in Ferry Village at risk due to increased flooding and sea level rise caused by climate change.

The low-lying character of the shoreline, as well as the fill and subsequent development in areas once part of the harbor, has left Ferry Village vulnerable to the effects of sea level rise. Further risk is posed by a stream that once bisected the neighborhood and is now buried, its former path apparent in flood maps that project flooding in properties far from the shoreline. Historic images depict flooding as far into the neighborhood as High Street, and anecdotal evidence of water in basements in the area of the former stream during extreme rain events corroborates the threat to properties deep into the Ferry Village neighborhood.

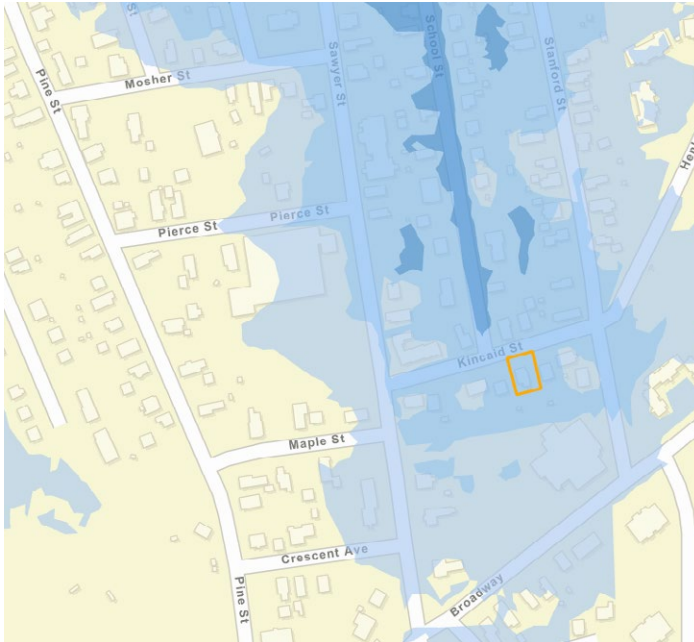
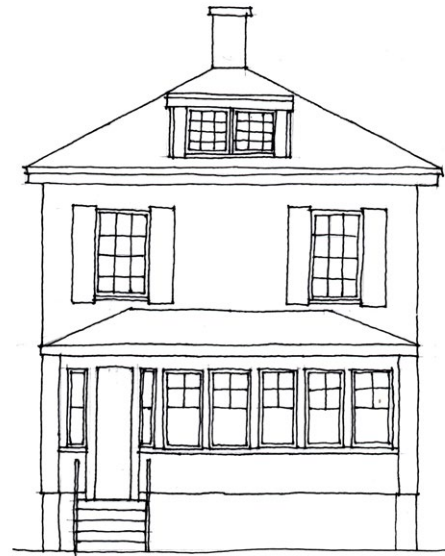
16 Kincaid Street

Existing Conditions

This single family residence rests on a high foundation at the edge of a low-lying area in Ferry Village identified as at risk to flooding from rain and storm surges. Buildings in this area were anecdotally noted during the study to have wet basements during some major rain events. Large trees shade the south-facing rear yard. The relatively flat lot could be improved to encourage site drainage away from the building's foundation.

- Elevate critical mechanical systems on the interior
- Integrate rainwater run off strategies into landscaping
- Maintain masonry, particularly chimneys, to reduce damage from loose falling bricks and foundations to prevent water infiltration
- Slope grade and landscaping away the foundation to help drainage
- Reduce impermeable paving in the driveway
- Add trees where possible to help lower temperature by providing shade
- Install solar panels on the rear roof slope

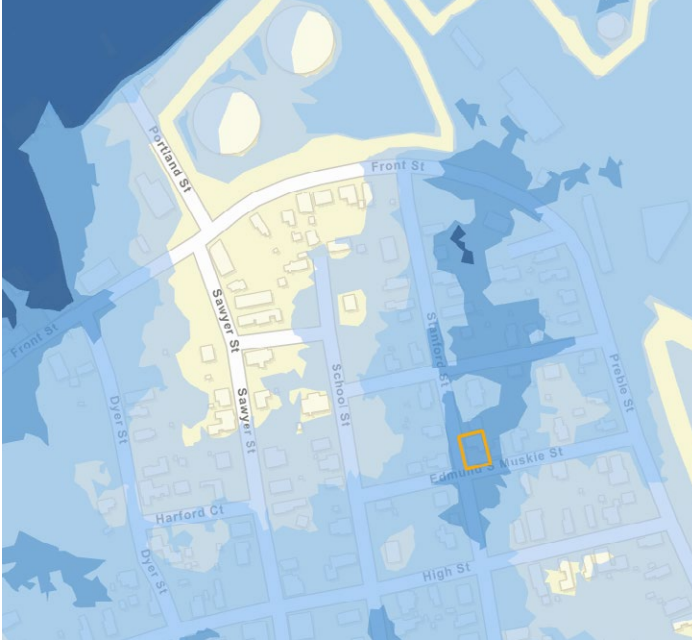
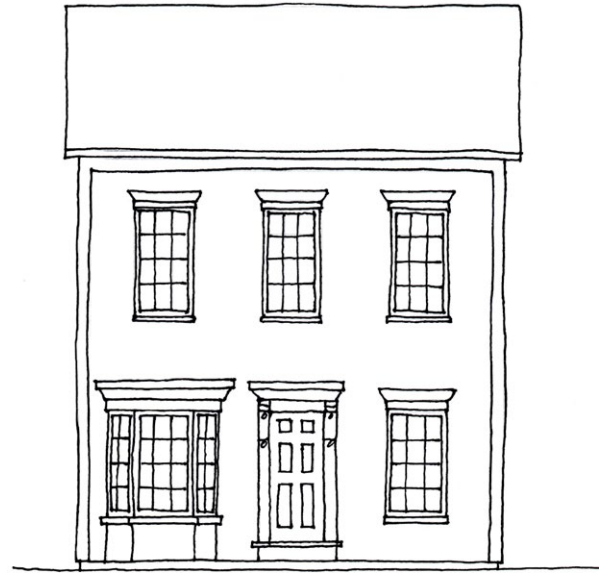
Benjamin W. Pickett House

Existing Conditions

This historic single family residence (c.1865) is built very close to grade and located in a low-lying area of Ferry Village identified as at risk to flooding from rain and storm surges. With the building sill located close to grade, even minimum levels of flooding would submerge the building's wood framing, siding, and trim. The front entrance is also very close to grade and susceptible to damage from flood waters. Elevated levels of ground water could impact the basement, damaging critical mechanical systems.

- Elevate critical mechanical systems on the interior
- Size gutters to handle increasing precipitation loads
- Install rain barrels or integrate rainwater runoff strategies into landscaping
- Slope grade and landscaping away the foundation to help drainage
- Install solar panels on the ell roof, garage, or at the rear of the site
- While a last resort, elevating the entire structure to raise the wood sills and entry above projected flood levels is an option. It would be prudent to raise the surrounding site where possible to mask the visual impact of the structure's elevation.

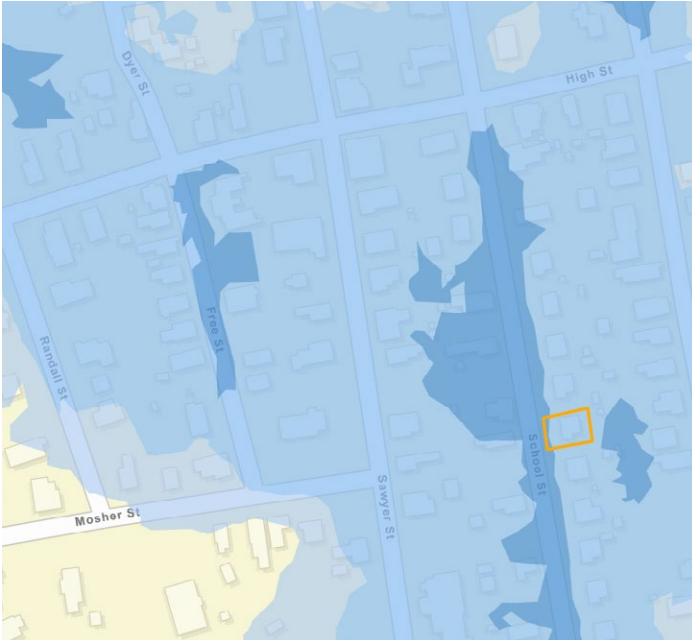
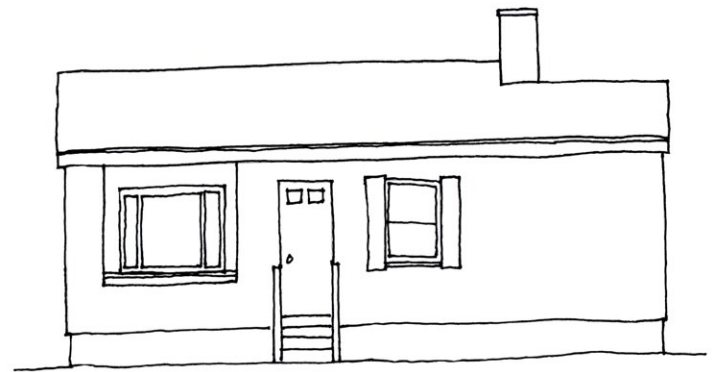
154 School Street

Existing Conditions

This single-family residence is slightly elevated above street level, in a low-lying area of Ferry Village identified as at risk to flooding from rain and storm surges. Buildings in this area were anecdotally noted during the study to have wet basements during some major rain events. Basement windows on the side elevations are at or near grade and are potentially vulnerable to flooding. Elevated levels of ground water could also impact the basement, damaging critical mechanical systems.

- Install solar panels on the roof or site
- Elevate critical mechanical systems on the interior
- Integrate rainwater run off strategies into landscaping
- Maintain masonry, particularly chimneys to reduce damage from loose falling bricks
- Slope grade and landscaping away the foundation to help drainage
- Reduce impermeable paving in the driveway
- Add trees where possible to help lower temperature by providing shade
- Install hardware around basement windows to accommodate retractable flood shields during storm events

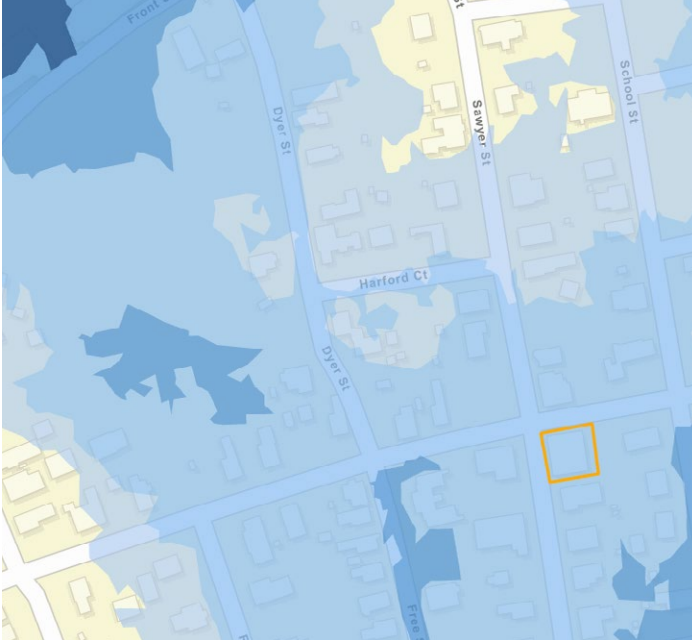
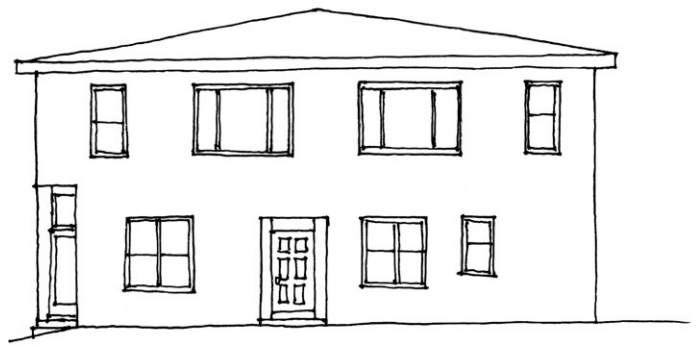
124 Sawyer Street

Existing Conditions

This mixed-use building at the corner of two major streets is located close to the sidewalk on two sides of the building and surrounded by paved parking on the two remaining sides. This low lying area of Ferry Village has flooded during historic storm events. Entries at or near grade are vulnerable to street flooding. Impermeable paving in the parking area does not allow storm water to penetrate into the ground and raises the temperature more than a vegetated surface would do.
