Building Better

A First Nations National Building Officers Association publication

Volume 11 | Number 1 | Special Winter Edition 2014

Plan reviews for modular homes must be mandatory

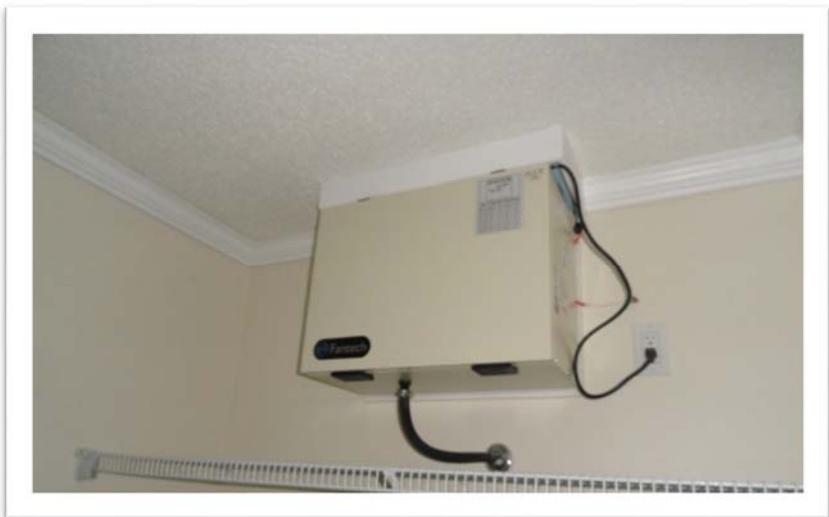
HRV installation: No access to adjusting dampers, no trap in condensate line. Undersized ventilation capacity.

6. *Access to the balancing dampers was poor.* The units were hung close to the ceiling, with no trap installed to prevent sewer gases from entering the HRV.
7. *Duct hood openings were under 450mm high.* The duct openings were on the roof. During winter months, high snow loads could block these openings.
8. *No ventilation was provided for crawlspace.* The units were designed to sit on a four-foot heated PWF foundation. Although heat runs were provided, there were no exhaust-air capabilities.

These problems required a holdback on the units. Using a modified ventilation-compliance certificate, I asked the manufacturer to provide TVC calculations and air-flow measurements (in situ). The certificates subsequently provided were unsatisfactory, and the holdback remains in place.

Because of the issues with this installation, I argued for a plans review before approval of 2012/2013 Section 95 projects. The units approved now have fresh air supplied to all the bedrooms and living areas; stale air is being removed from the bathrooms, laundry area and kitchen. The controls are simple, as is access to the units for maintenance. Exhaust ductwork is now through the floor, with little chance of condensation.

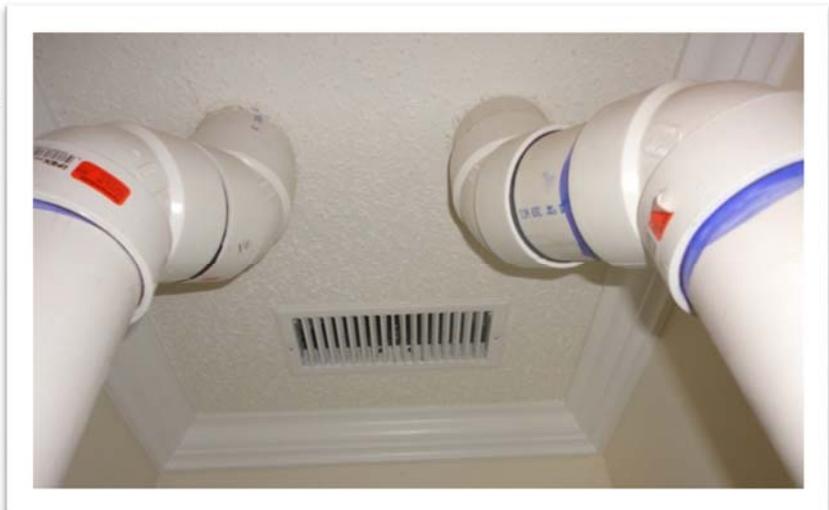
Fresh air delivery above downflow furnace. No assurance of fresh air delivery to all rooms.

2. *Unit had poor air distribution.* The installation used the down-flow furnace ductworks, however, delivery to return-air was through a ceiling opening directed down to the furnace. In addition, the dryer was installed in the same room, and when running would exhaust the fresh air coming in. The furnace fan was incapable of running at low speeds, so fresh-air distribution was only achieved when the furnace was at high speed.
