# General Liability Claim

## Fall From A Third Floor Balcony

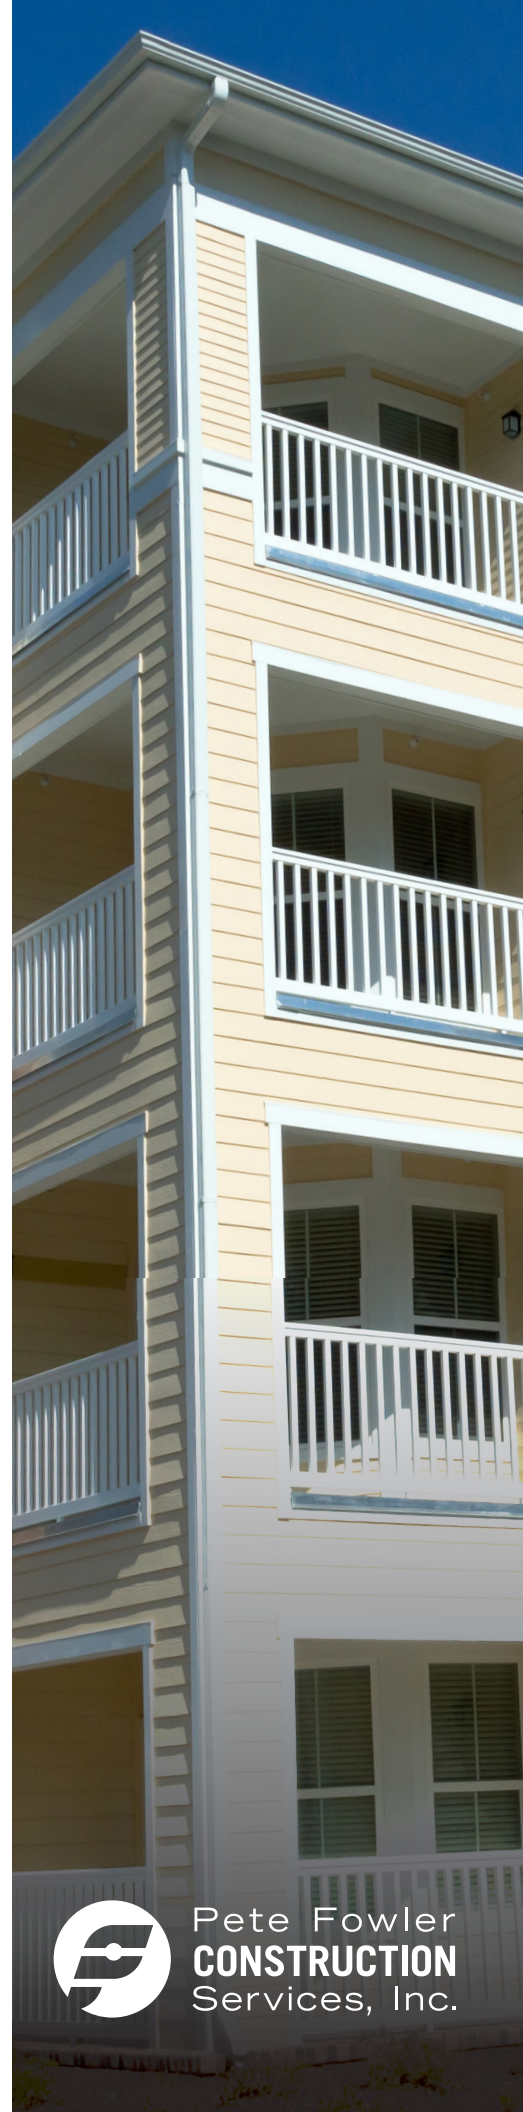
The top of the guard rail was 36 ¼-inches above the deck. The applicable building code was 1988. The project is classified Group R (residential), Division 1 (multi-family). The 1988 code Section 1711 calls for a 42-inch minimum height. Section 1711 has a list of "Exceptions: (including) 1. The top of guardrails for Group R, Division 3 and Group M, Division 1 Occupancies and interior guardrails within individual units and guest rooms of Group R, Division 1 Occupancies may be 36-inches in height." The current code exception applied only to locations "...whose top rail also serves as a handrail..." And although the language of the applicable (older) code section is ambiguous, we were able to find numerous references at the time which indicated the prevailing interpretation at the time did apply to this condition.

Therefore, although the guardrail would not meet the minimum requirements of the current code, it was obvious that the building official interpreted the 36-inch guardrail height exception to apply to this condition, and so it met the code requirements at the time of construction. In addition, there was no information to indicate an event had occurred since the time of construction that would have triggered a code upgrade requirement. Our client was able to use this information to avoid litigation altogether.
