Case Study

Leak Investigation

Solar Panel Installation

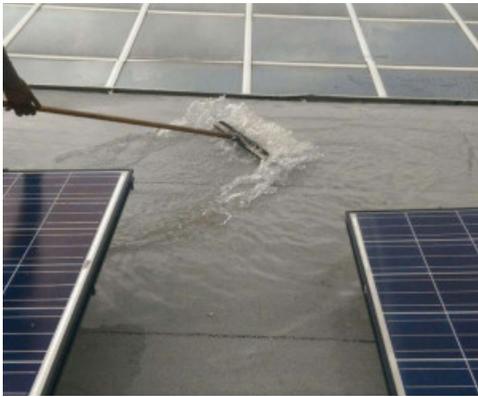
PFCS conducting water testing

PFCS was hired by the solar panel company to investigate whether or not the leaks were caused by the installation of their panels. In addition to the leak below the new panels, there were several other leaks that were not below the client's work. PFCS conducted water testing to determine if our client was liable for any of the damages. We found that the leaks below the new panels were caused by our client's subcontractors, but we proved that the leaks in the other areas of the house were unrelated.

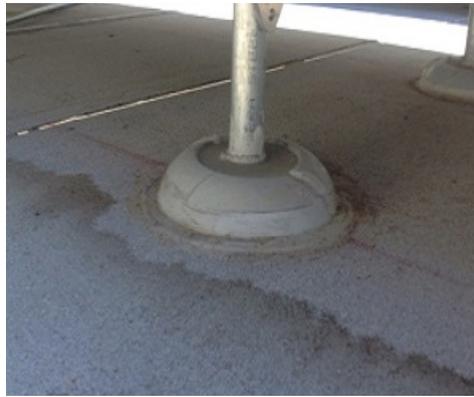
Cracking around the cold cement.

We composed and delivered a scope of work (repair) and cost estimate that totaled approximately \$25,000 to execute the repairs related to our client's work. PFCS then composed a request for proposal (RFP) and solicited bids from local contractors, which were the same price as our estimate. Because we now had real bids, the owner and our client were able to reach a sensible settlement. The result was a significant savings to our client.
