ASBESTOS MANAGEMENT PLAN

NAME OF WORKPLACE: North Fitzroy Primary School

DATE PREPARED: May 2017

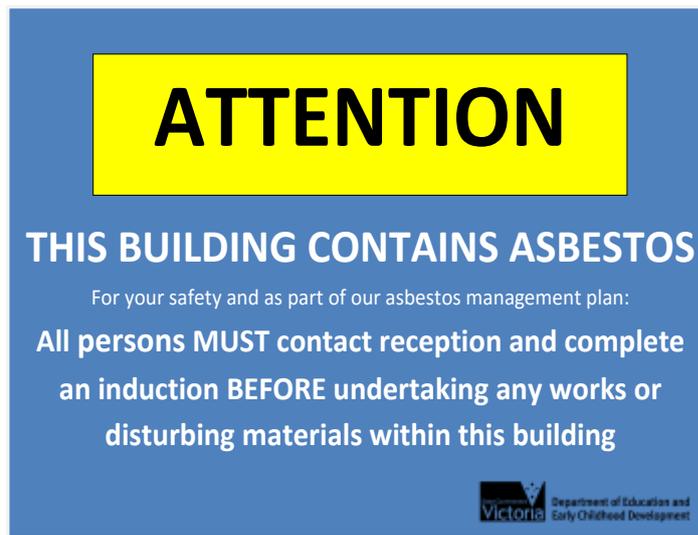
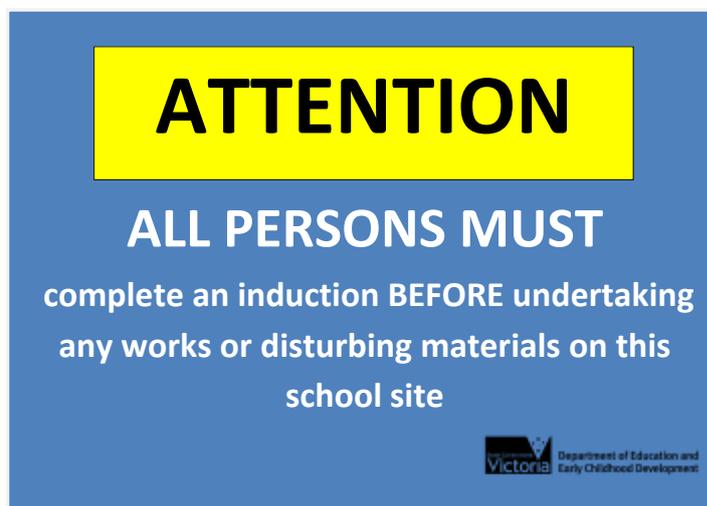
The labels will assist schools manage potential risks and ensure schools are compliant with Occupational Health and Safety legislation.

Asbestos labels will be installed as part of a DEECD Division 5 Asbestos Audit Program.
