Globe Lighting Access - London Coliseum

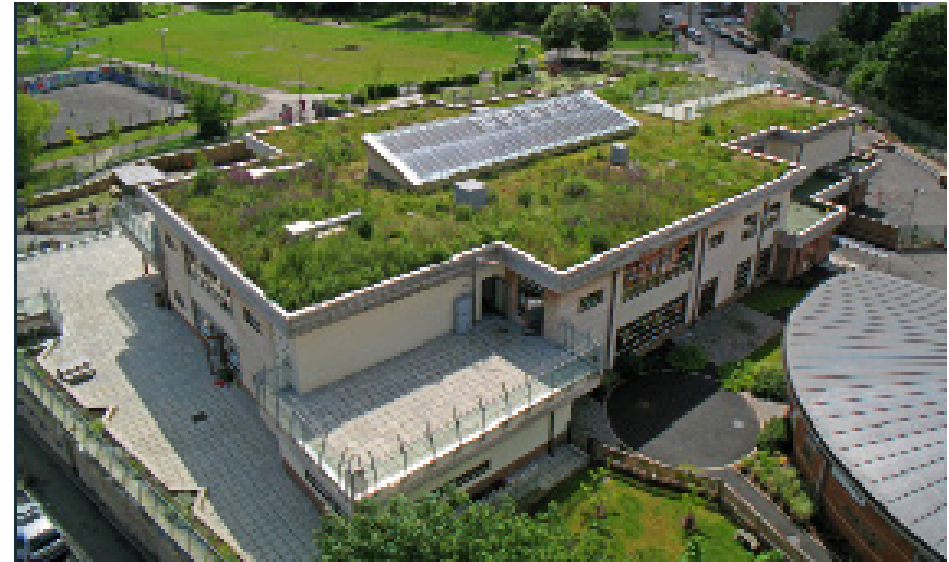
Multiple access requirements to be assessed

Consultation between the client/FM team and the design and contractor team allowed early decision making. (The early involvement of the client encouraged acceptance of the increased costs of fibre optics) Survey drawings were labelled to analyse the challenges and to communicate the best available solutions.

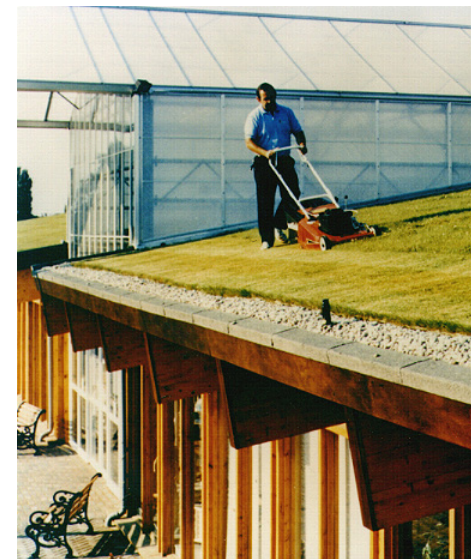
Inappropriate design & access
