SEQUENCING AND DESIGN CONSIDERATIONS FOR DEMOLITION

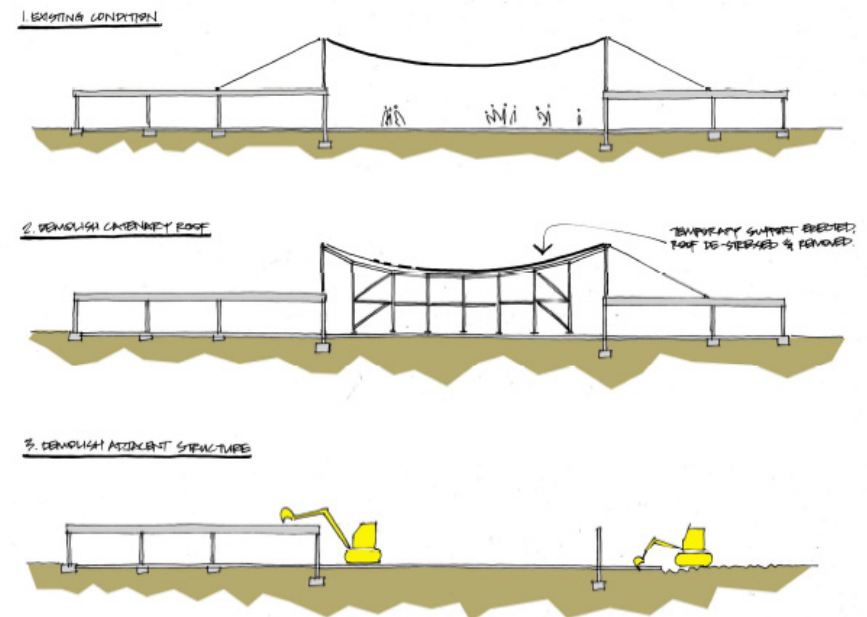
The existing structure to be demolished was a reinforced concrete framed single storey building with an exposed concrete colonnade around the perimeter. The internal walls were of brick construction. A steel framed roof extended above the reinforced concrete podium in the form of a catenary shape with post-tensioned steel ties connecting back to the adjacent concrete roof.

Early consideration was given to methods of demolition, it was envisioned that the roof would be propped from underneath, the roof covering and rock wool panels removed. The roof ties could then be de-stressed and be cut and the roof beams removed. The main concrete roof and wall could then be demolished in the usual way. The proposed method was sketched and included in the Concept Stage report.
