Reinforcing bar - Designing to reduce hazards

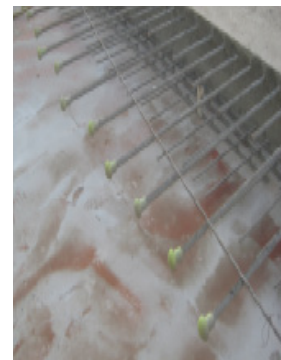
Rebar End Caps

3. Providing plastic 'mushroom' caps

- This was a less effective measure dependent on the contractor maintaining control.
- The caps were known to be prone to falling off and needed regular replacement. Their effectiveness relied upon the contractor keeping the caps up with the pace of work.

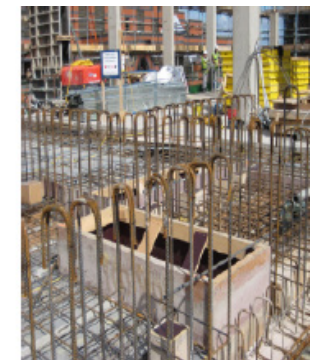
Bent 'Bob bars'

1. The use of bent 'bob bars'

- This was an effective solution in that it did not need management control or supervision on site to implement it.

- This was not always appropriate as in certain locations it had the potential to cause rebar congestion and compromise concrete quality, especially in columns.
- To be successful it needed to be adopted by the designer undertaking the rebar detailing

Effective control of a known but often overlooked hazard during the construction phase was achieved using a combination of control measures. Priority was given to those measures that most effectively dealt with the hazard. Where it was practicable, permanent protection was put in place during construction (bob bars), reducing the likelihood of cuts and impalements.
