RE: **Corrective Action Plan
Hercules LLC/Pinova Inc. - Brunswick Facility
Hazardous Waste Facility Permit No. HW-52(D&S)-2,
EPA ID No. GAD00406065520**

CORRECTIVE ACTION PLAN

HERCULES LLC/PINOVA INC. FACILITY

BRUNSWICK, GEORGIA

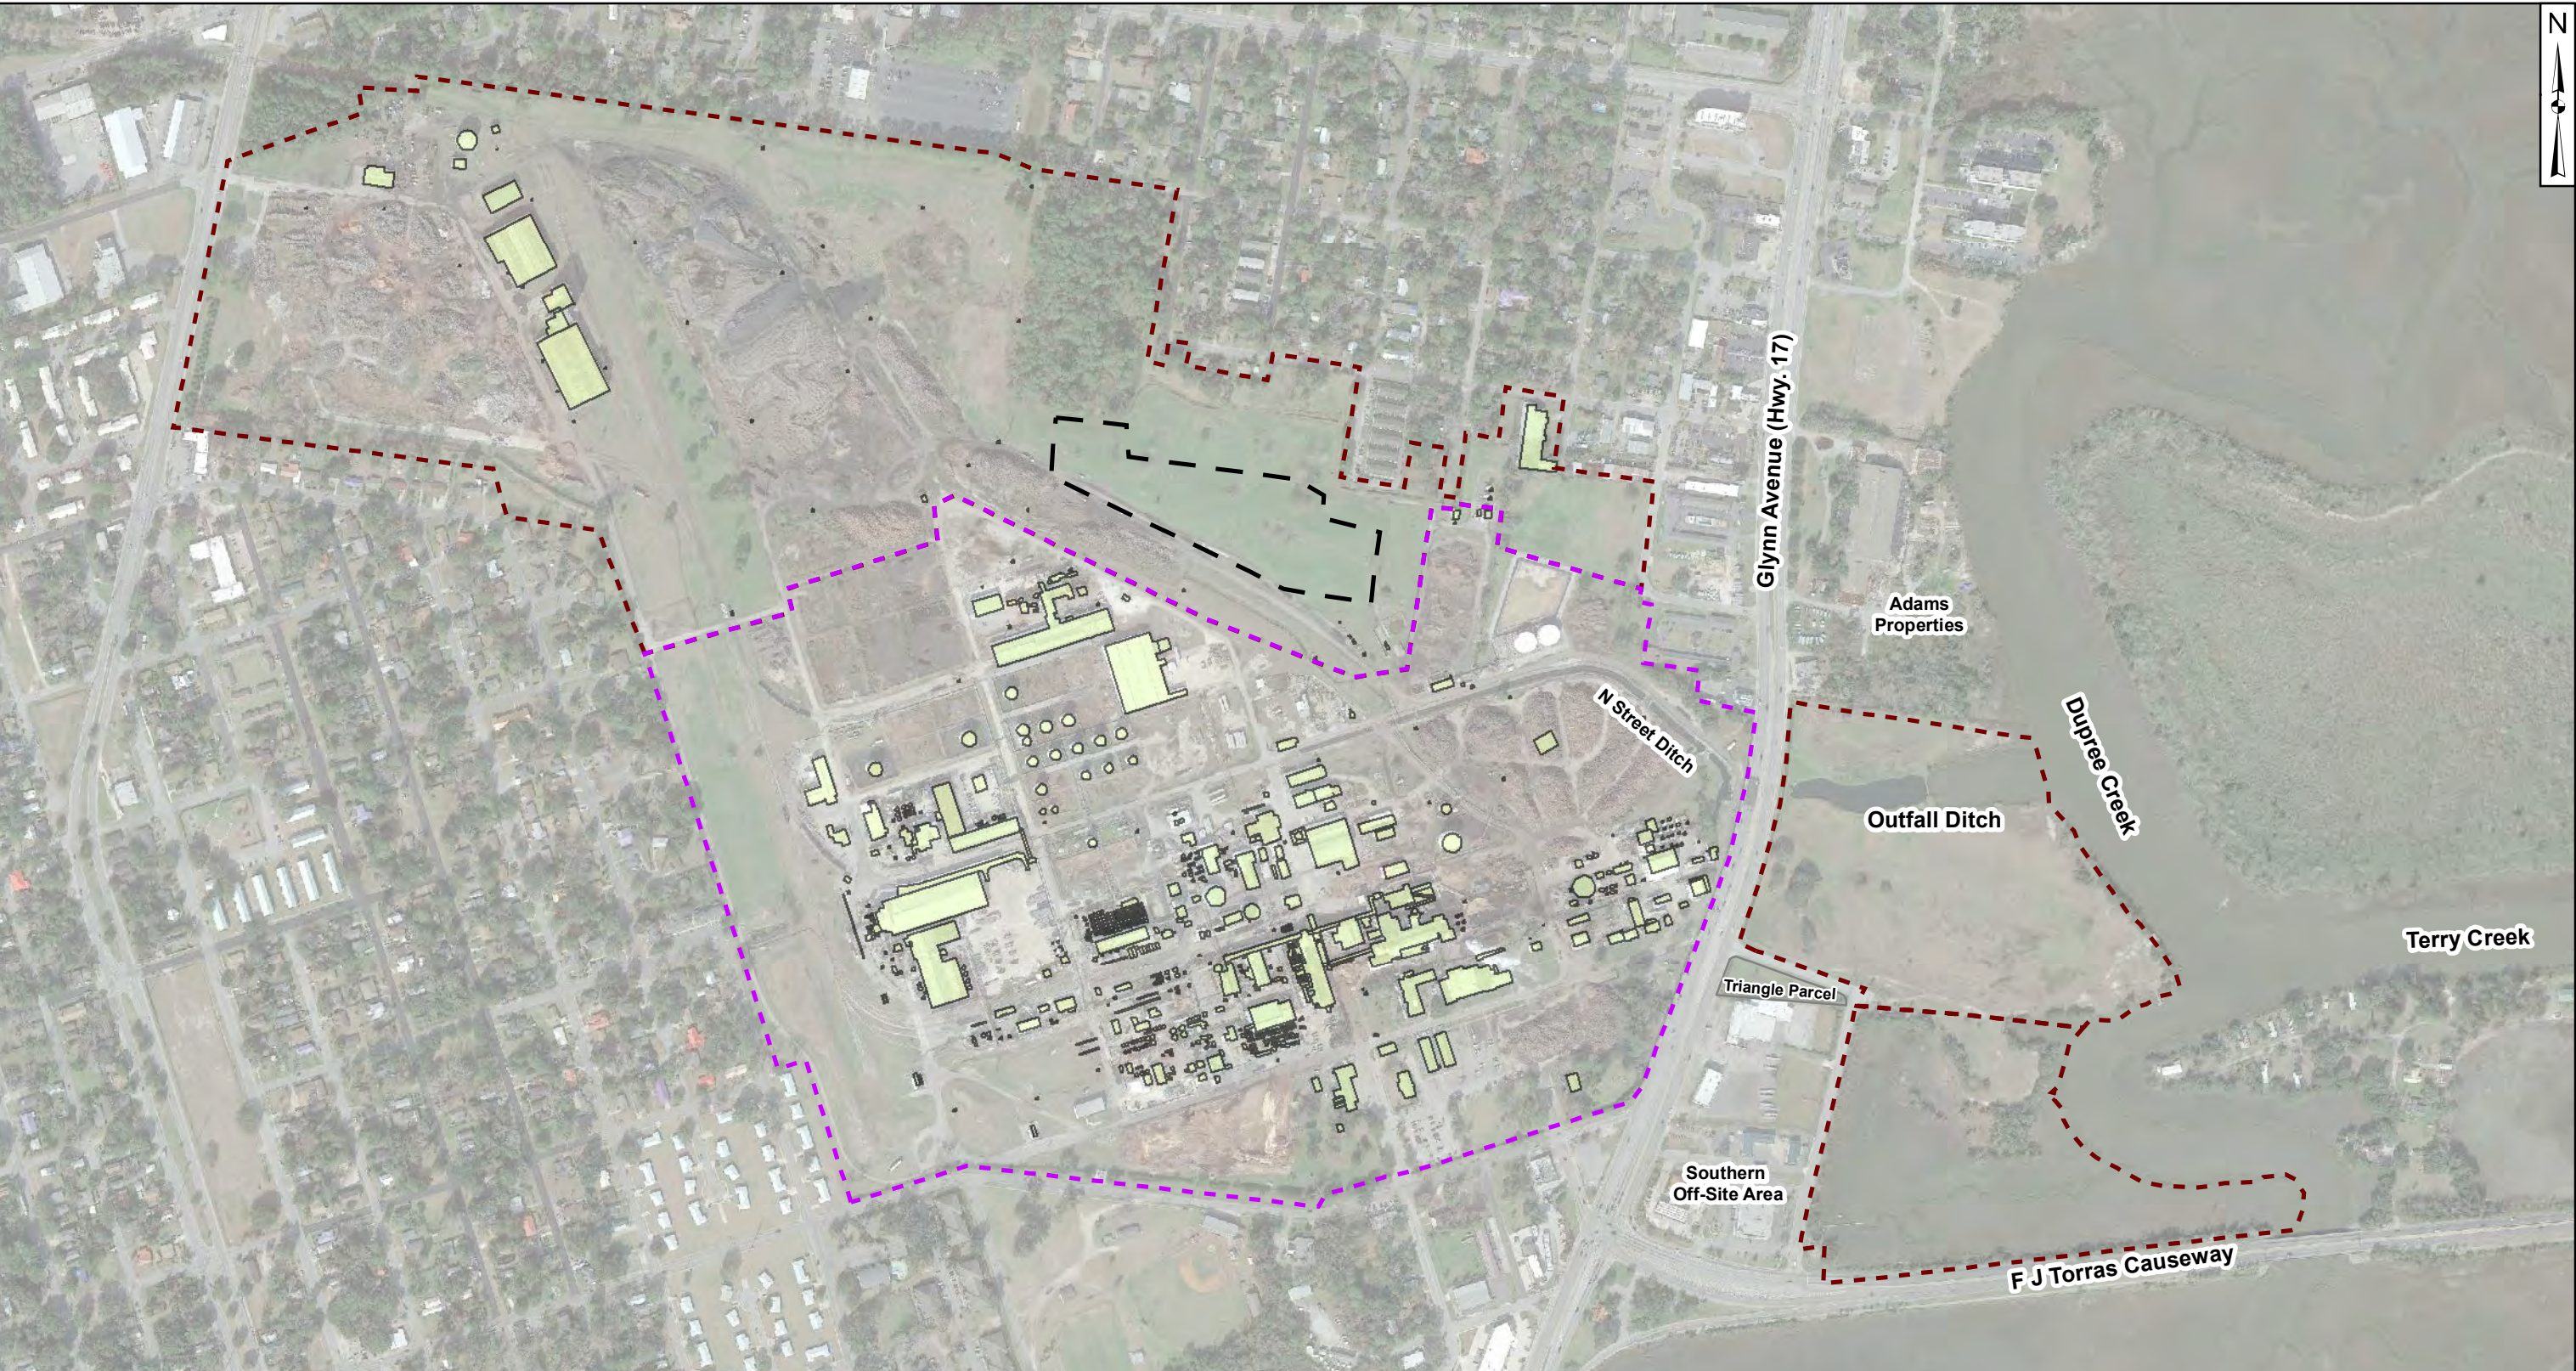
Figure
2-2

- Legend**
- Pinova property
 - Hercules property
 - Approximate location of closed surface impoundments
 - Structure

Commercial and industrial properties are located east of U.S. Highway 17 to the north and south of the easternmost portion of the Brunswick facility as shown in **Figure 2-2**. The properties immediately north of the easternmost portion of the Brunswick facility (referred to hereinafter as the “Adams Properties”) have a long history of industrial activities dating back to the early 1900s, including box and veneer manufacturing, plywood manufacturing, paint manufacturing, fuel oil distribution, and automotive repair operations.¹ The area adjacent to the southern edge of the easternmost portion of the Brunswick facility along the U.S. Highway 17 corridor is being used for commercial purposes and is referred to as the “Southern Offsite Area.” Both the Adams Properties and the Southern Offsite Area are shown on Figure 2-2.

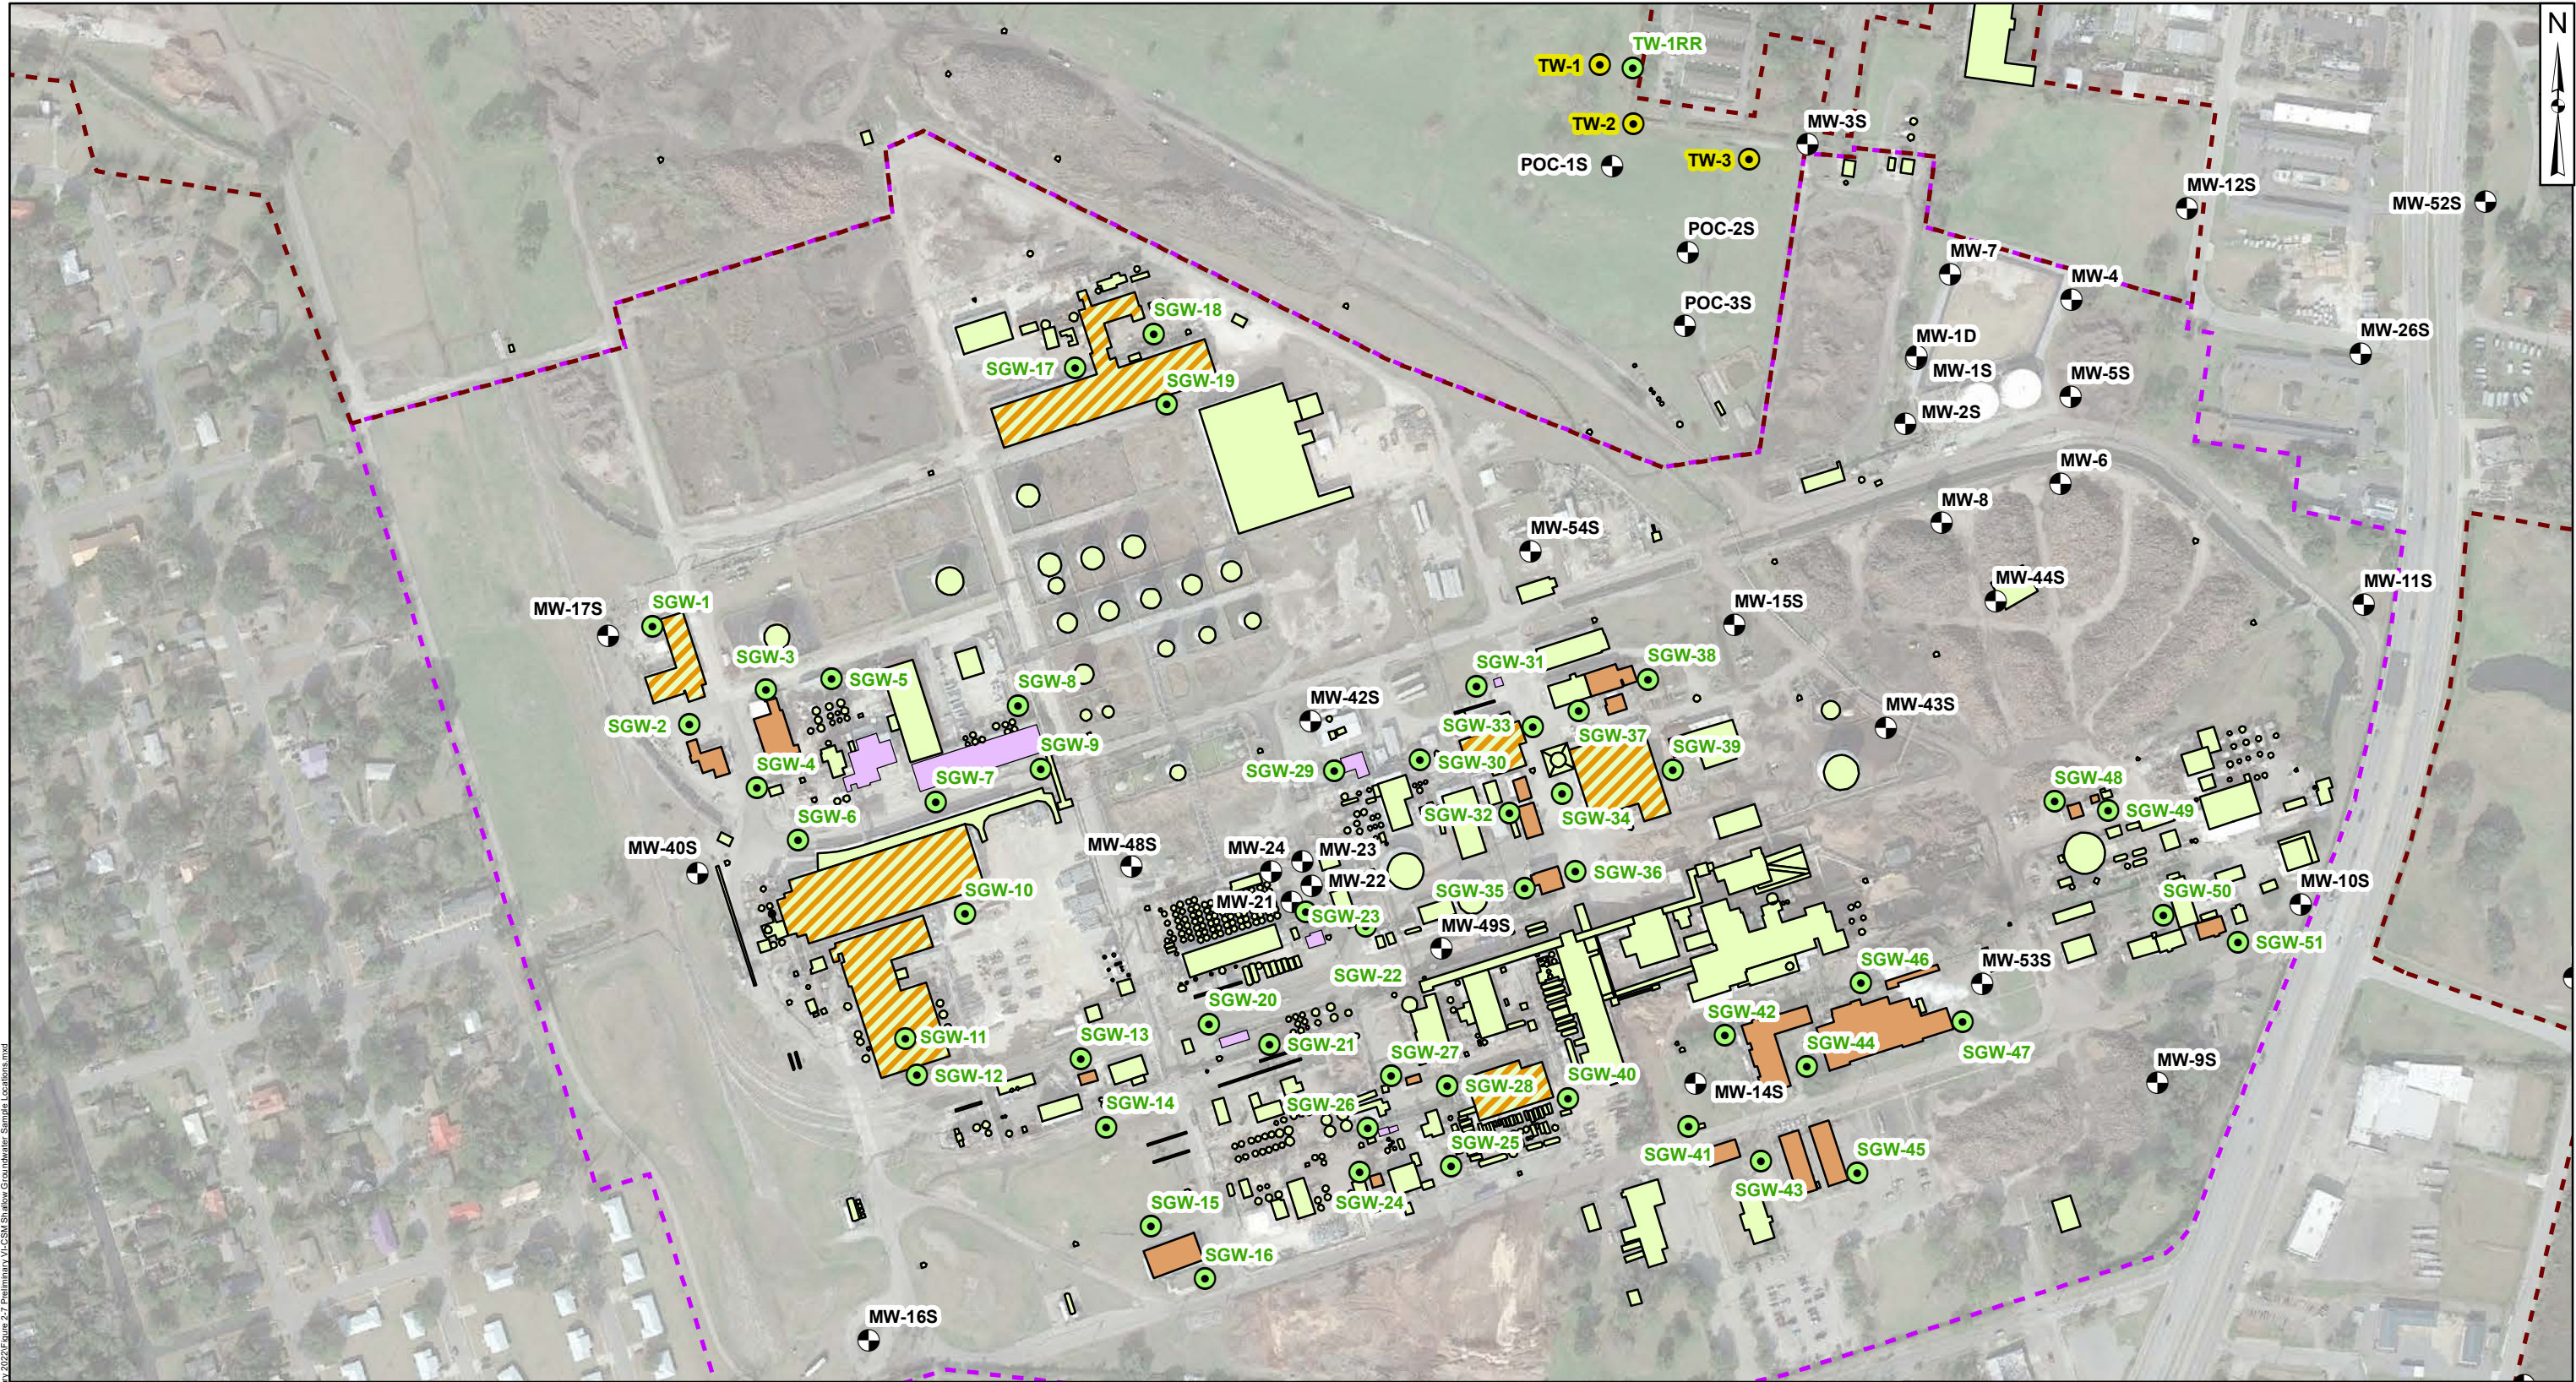
Path: N:\Hercules\Brunswick\GIS\MXD\CAP\Figures\January 2022\Figure 2-7 Preliminary VI-CSM Shallow Groundwater Sample Locations.mxd

- *Vapor Intrusion – Revised Preliminary Conceptual Site Model and Data Gap Analysis (December 2019)*: In August 2019, Hercules conducted sampling to assess shallow groundwater conditions at the Brunswick facility in areas in proximity to buildings at the Brunswick facility susceptible to vapor intrusion. These shallow groundwater sampling locations are shown on **Figure 2-7**. The

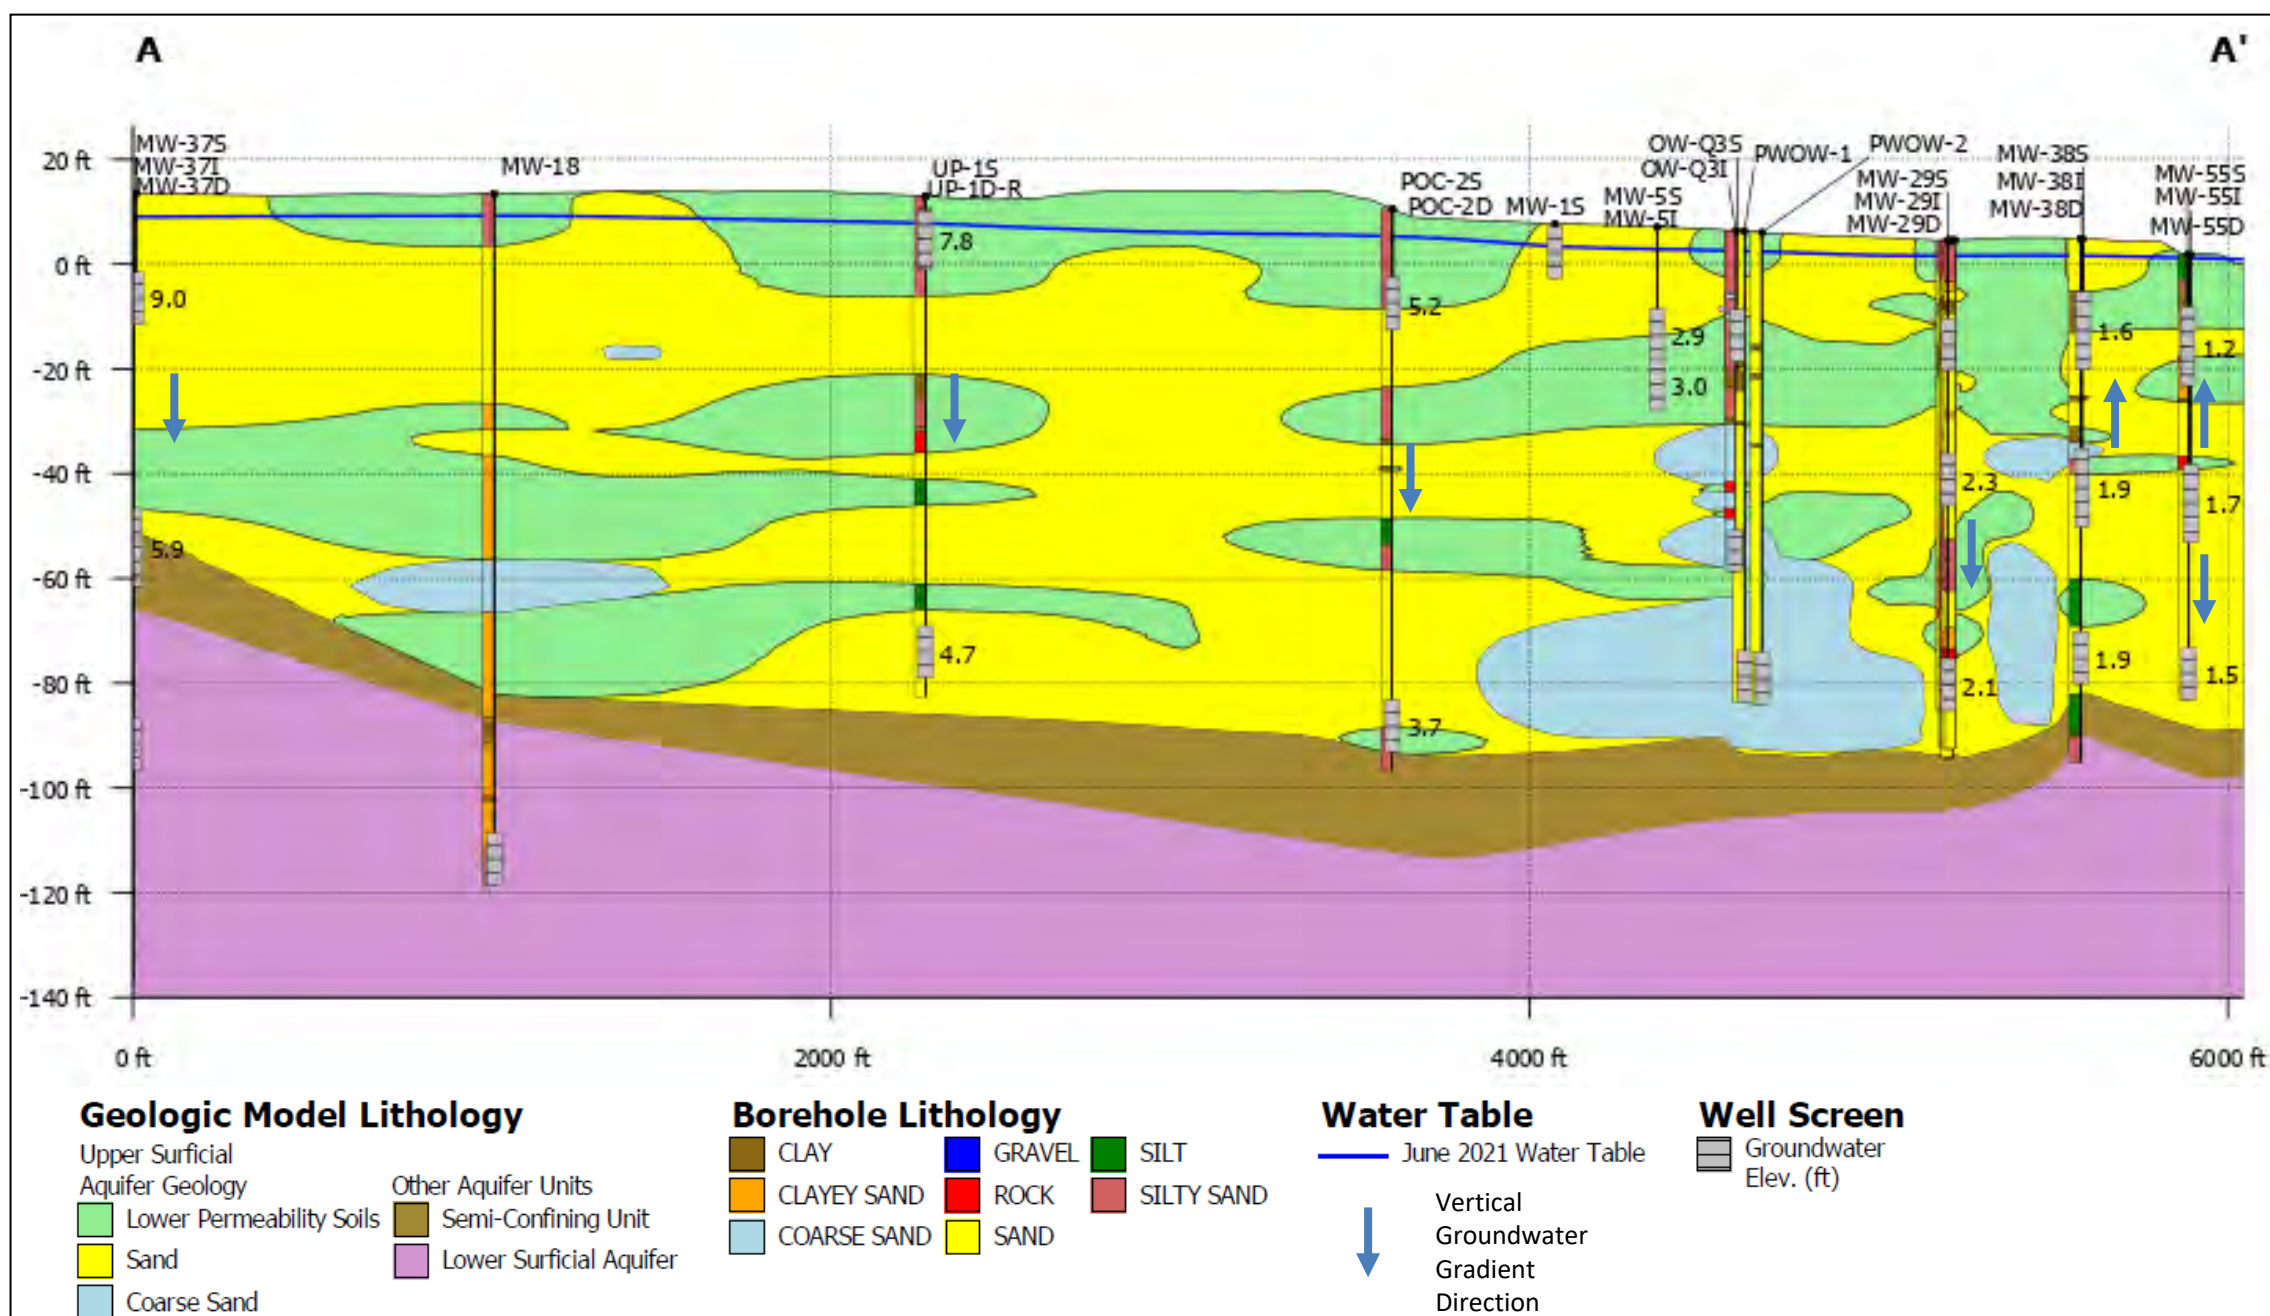
Aquifers and Confining Units Hercules/Pinova Facility Brunswick, GA		Geosyntec consultants	Figure 3-1
Kennesaw, GA	January 2022

1. Ft bgs = feet below ground surface.
2. Source: Clarke, J.S., Leeth, D.C., Taylor-Harris, D., Painter, J.A., Labowski, J.L., 2004. Summary of Hydraulic Properties of the Floridan Aquifer System in Coastal Georgia and Adjacent Parts of South Carolina and Florida: United States Geological Survey, Scientific Investigations Report 2004-5264, 54p.
3. Geologic epochs are approximate and estimated from Brunswick Pulp and Paper Co., Glynn County cross section, found on Plate 2 in *Geology and Ground-water Resources of the Coastal Area of Georgia. Bulletin 113.* (Clarke, et al., 1990).
4. In general, aquifer/confining unit (semi-confining unit) depths are generalizations and should be considered as approximate depth intervals for the Site.
5. The confining unit depth separating the upper surficial aquifer from the lower surficial aquifer is based on the boring log for monitoring well MW-52D.

For reference, aquifers and confining units are shown on **Figure 3-1**.

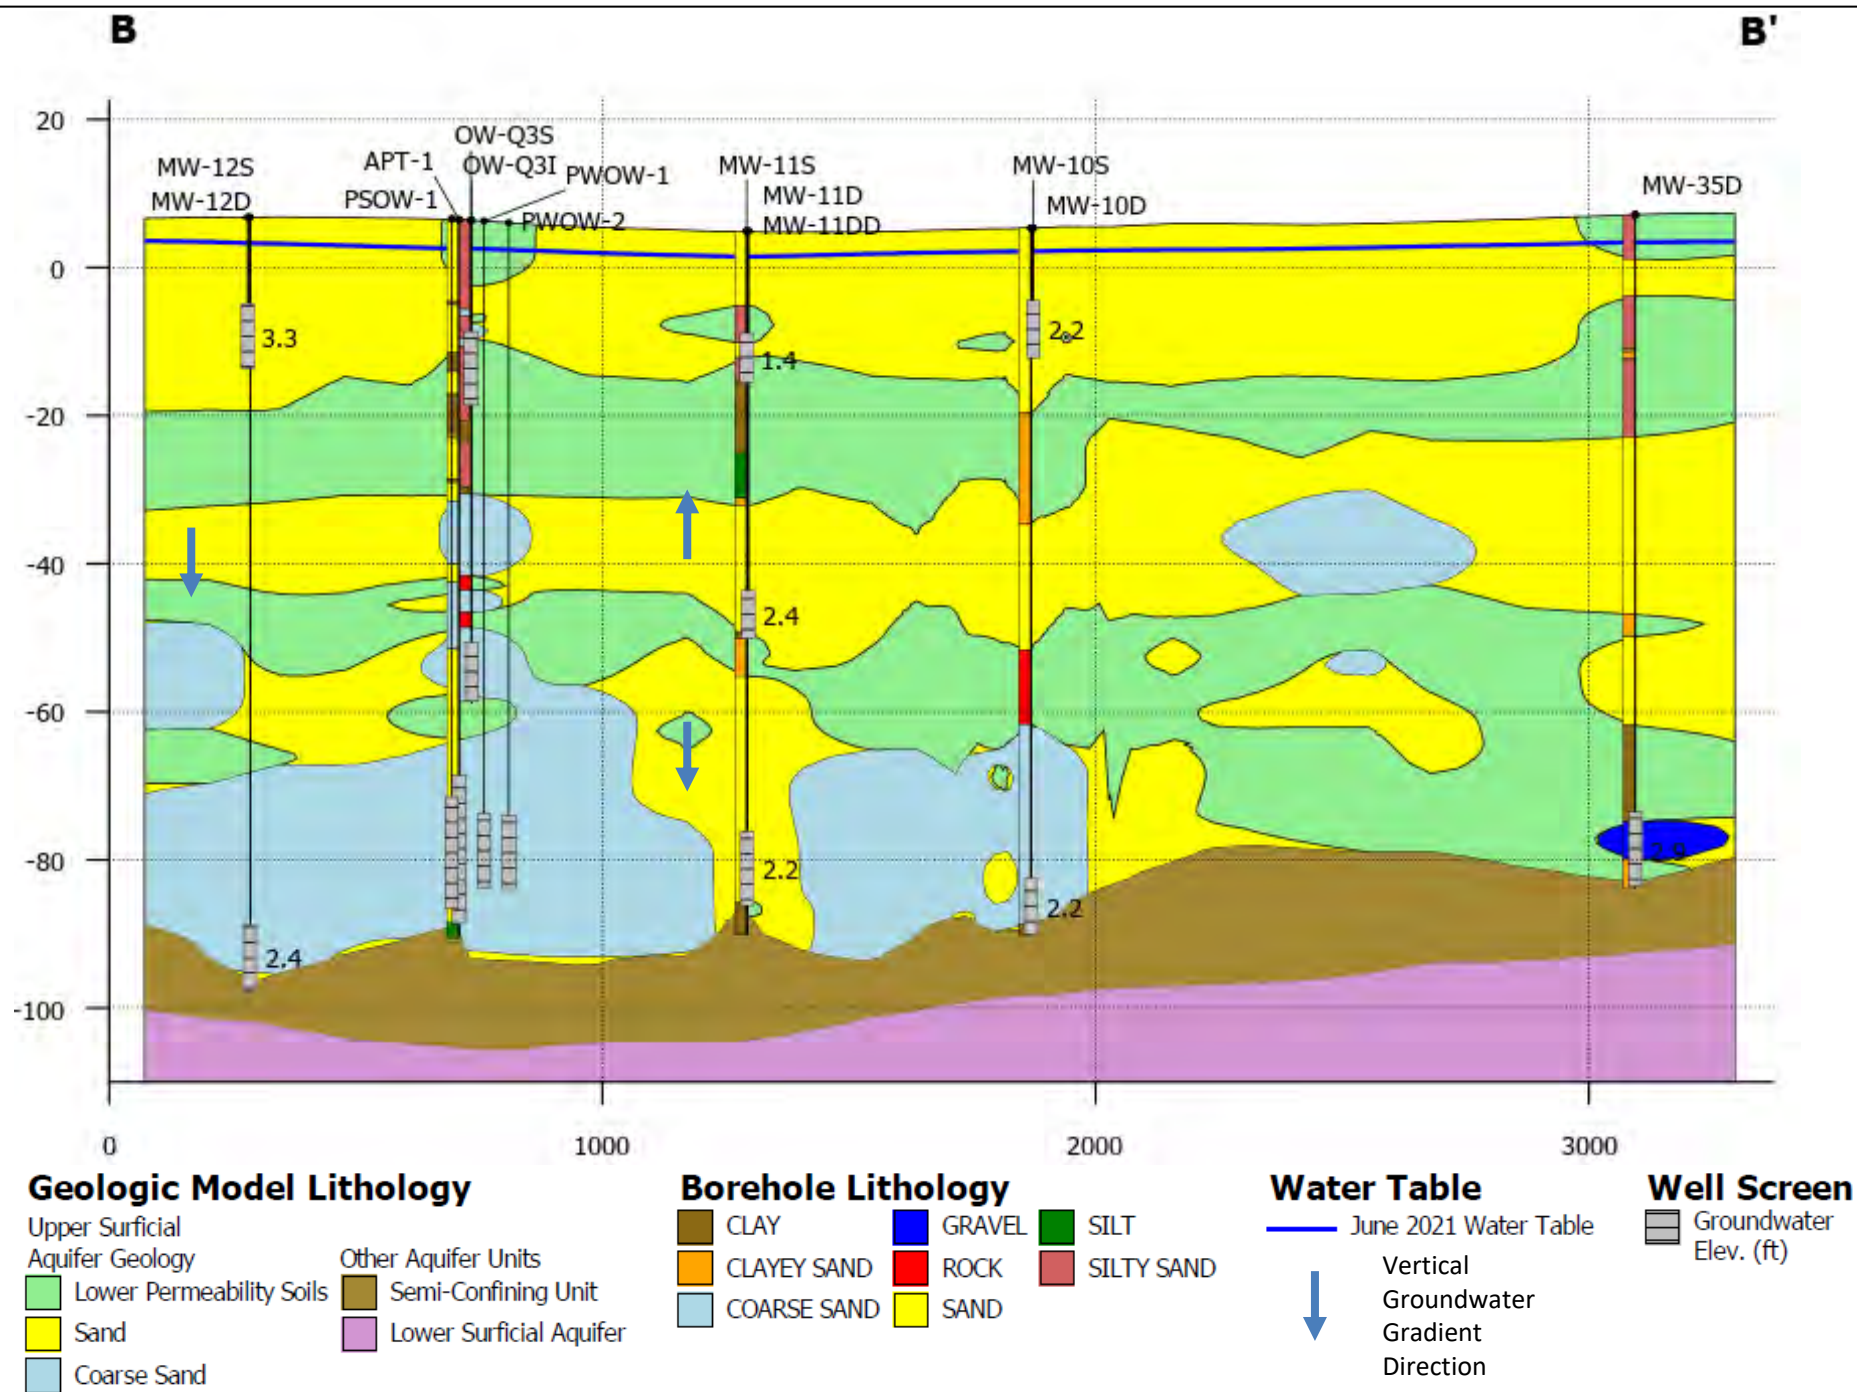
3-4

1. Lower permeability soils in the upper surficial aquifer include silty sands, clayey sands, silts, clays, and cemented sands.
2. Vertical exaggeration is 15x.

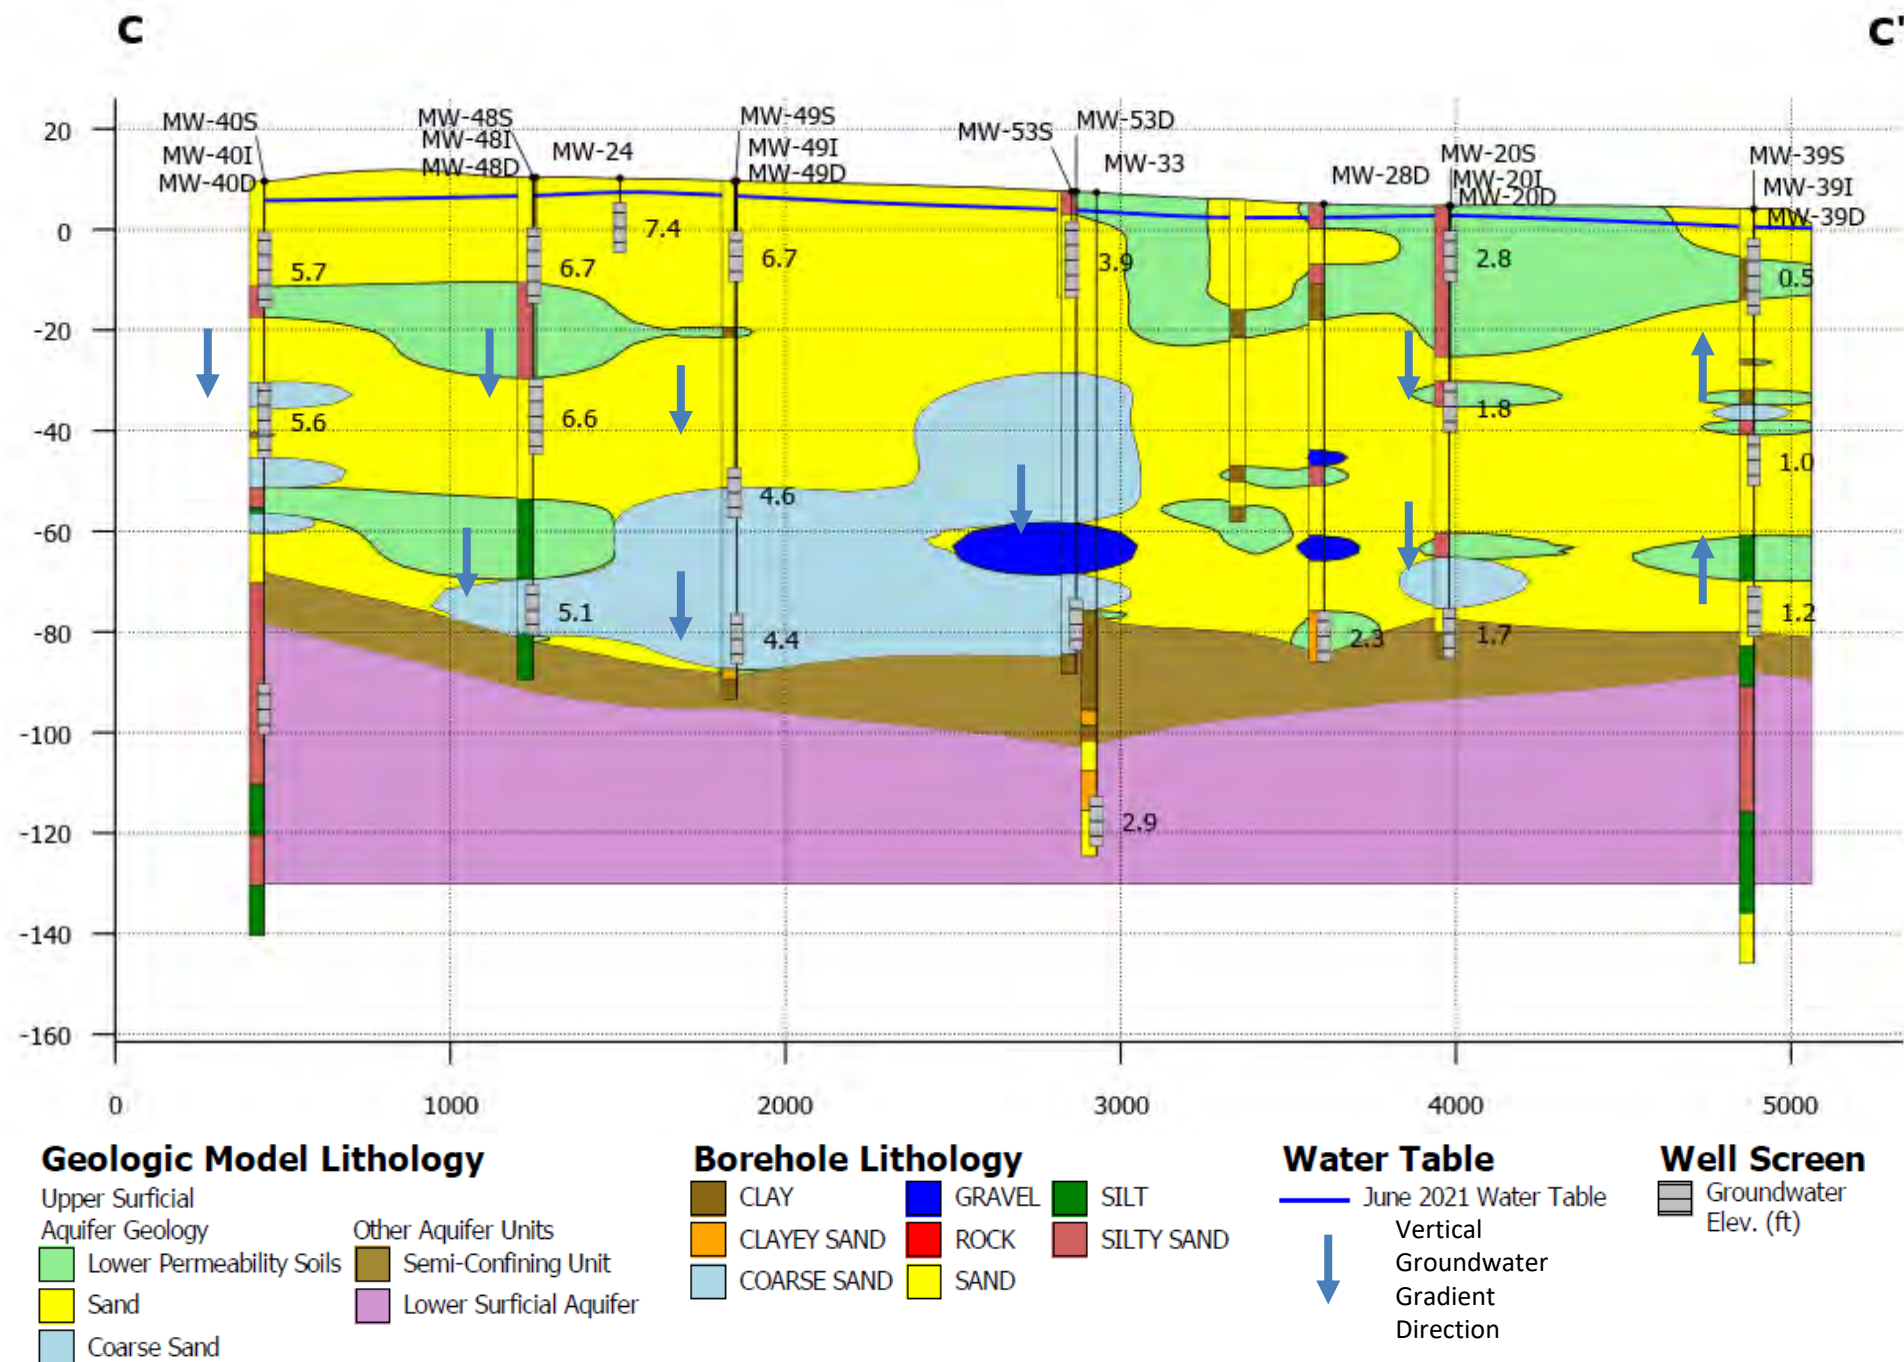
3-5

1. Lower permeability soils in the upper surficial aquifer include silty sands, clayey sands, silts, clays, and cemented sands.
2. Vertical exaggeration is 15x.

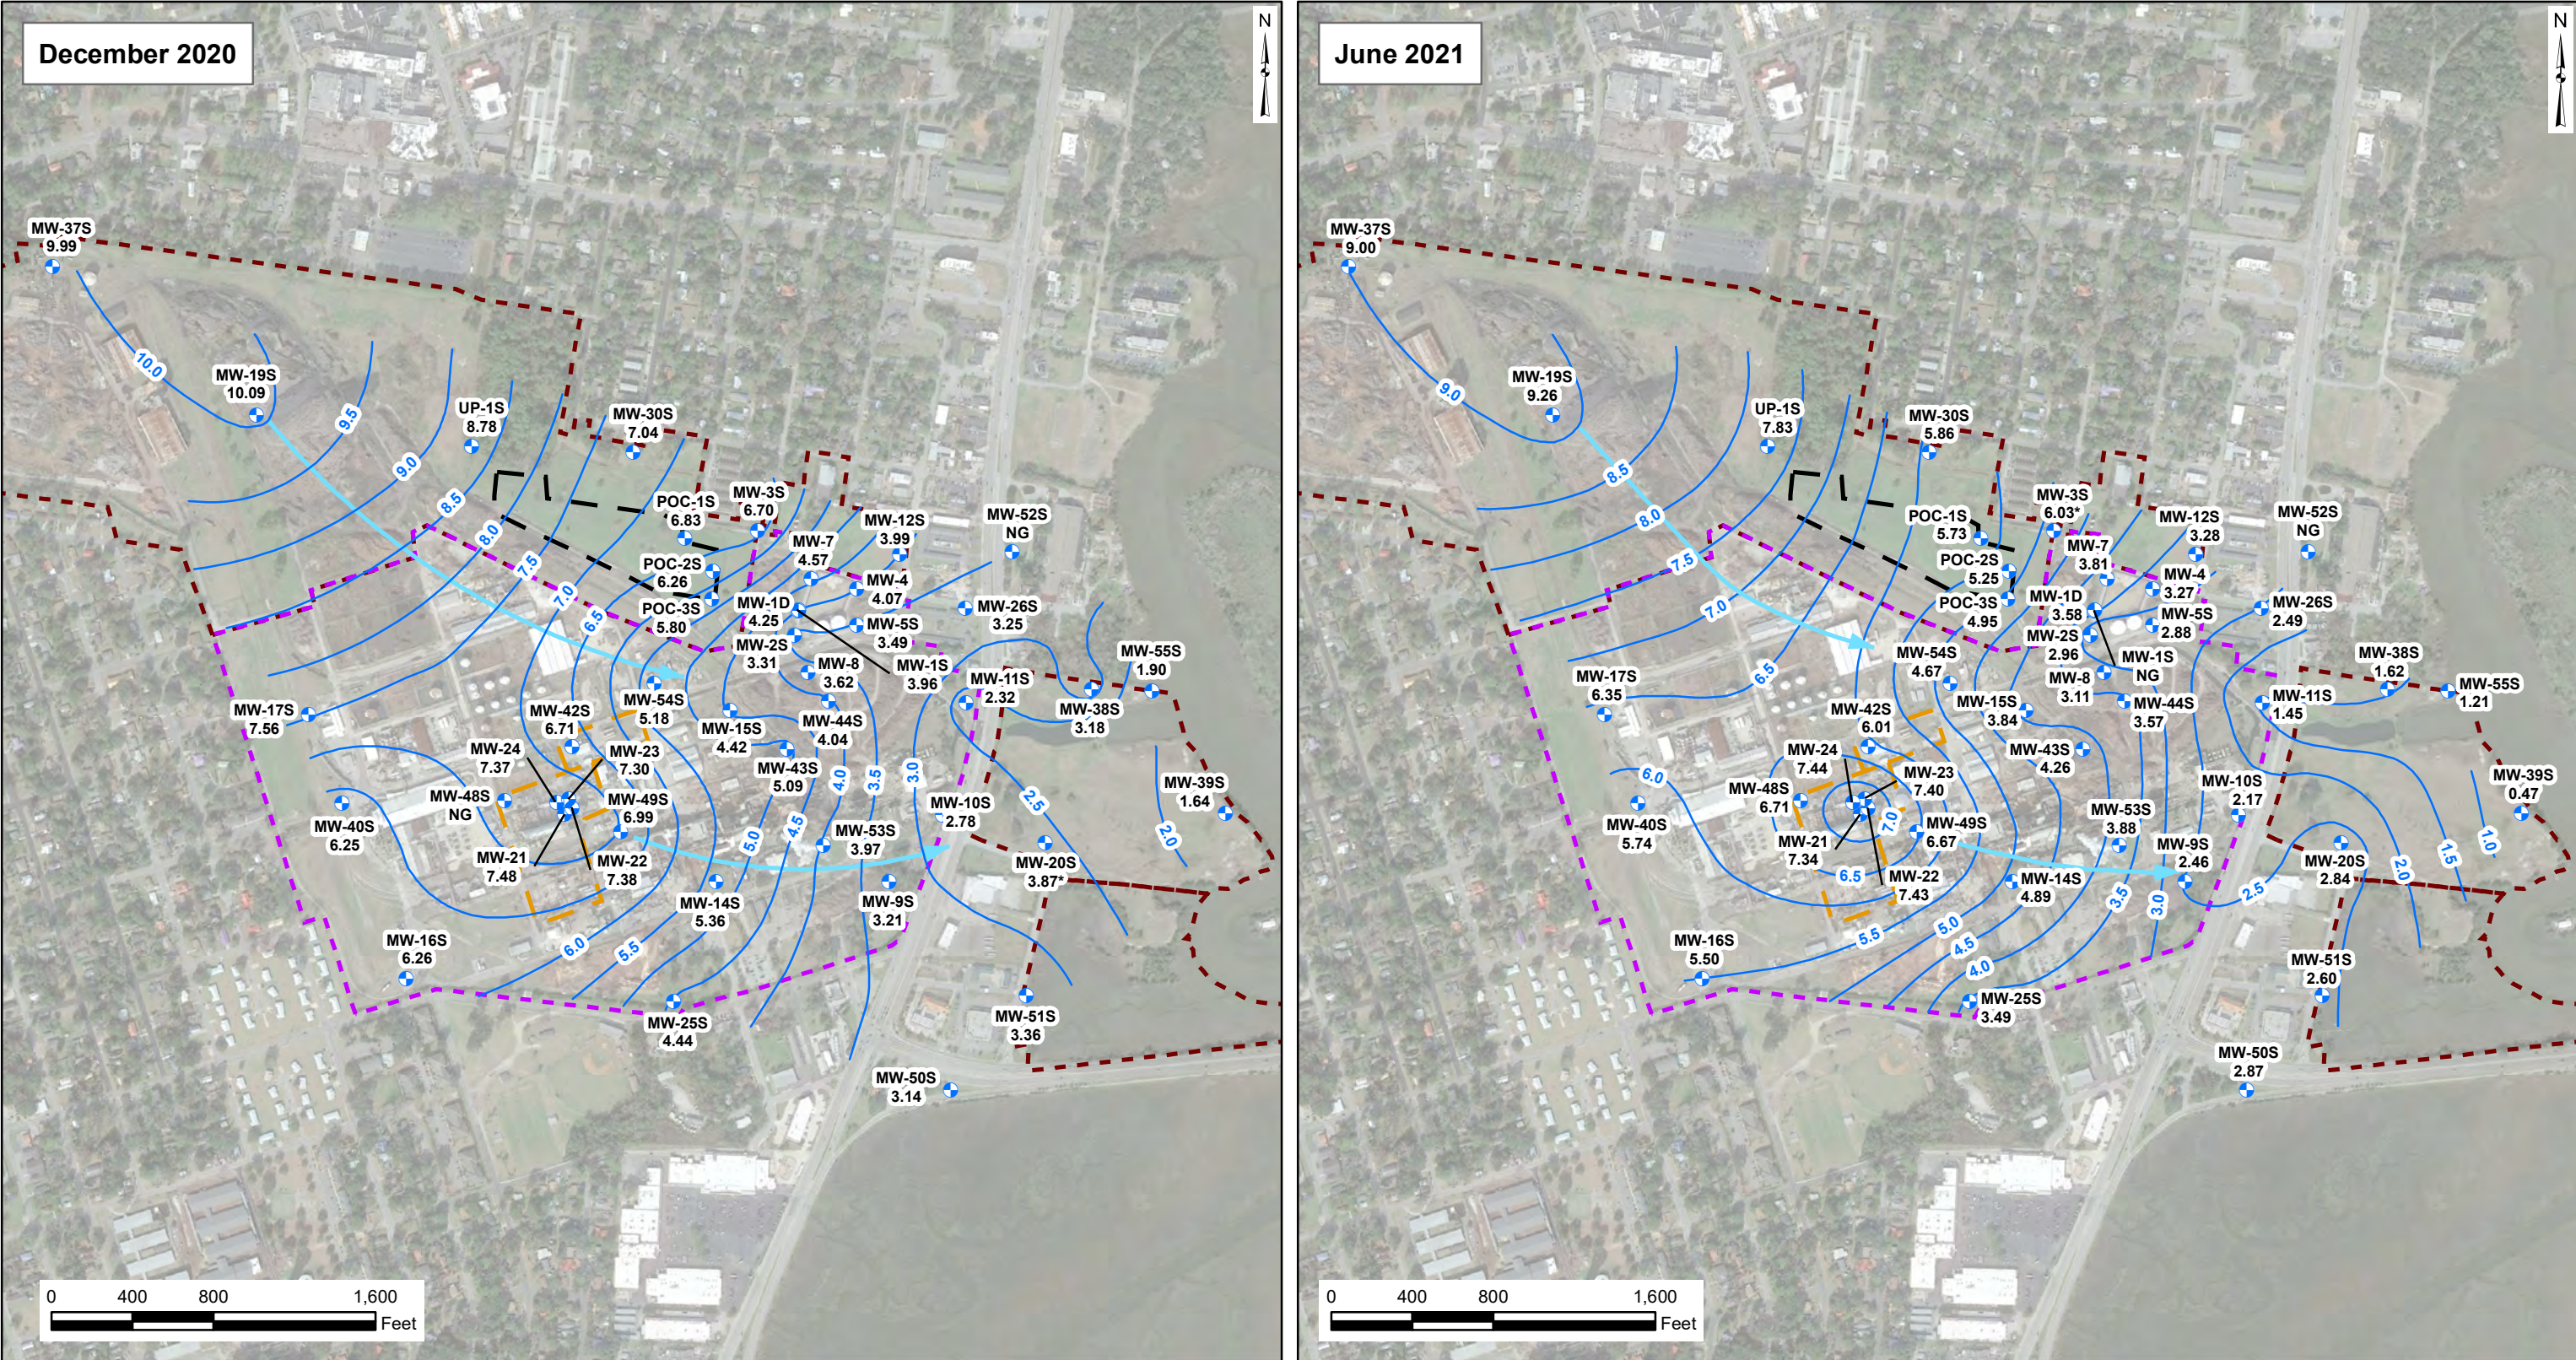
Figure
3-7

- Legend**
- Monitoring Well (Groundwater Elevation in ft MSL)
 - Groundwater Elevation Iso-Contour (ft MSL)
 - Approximate Groundwater Flow Direction
 - Approximate Location of Closed Surface Impoundments
 - Approximate Extent of Primary Potential Source
 - Pinova Property
 - Hercules Property

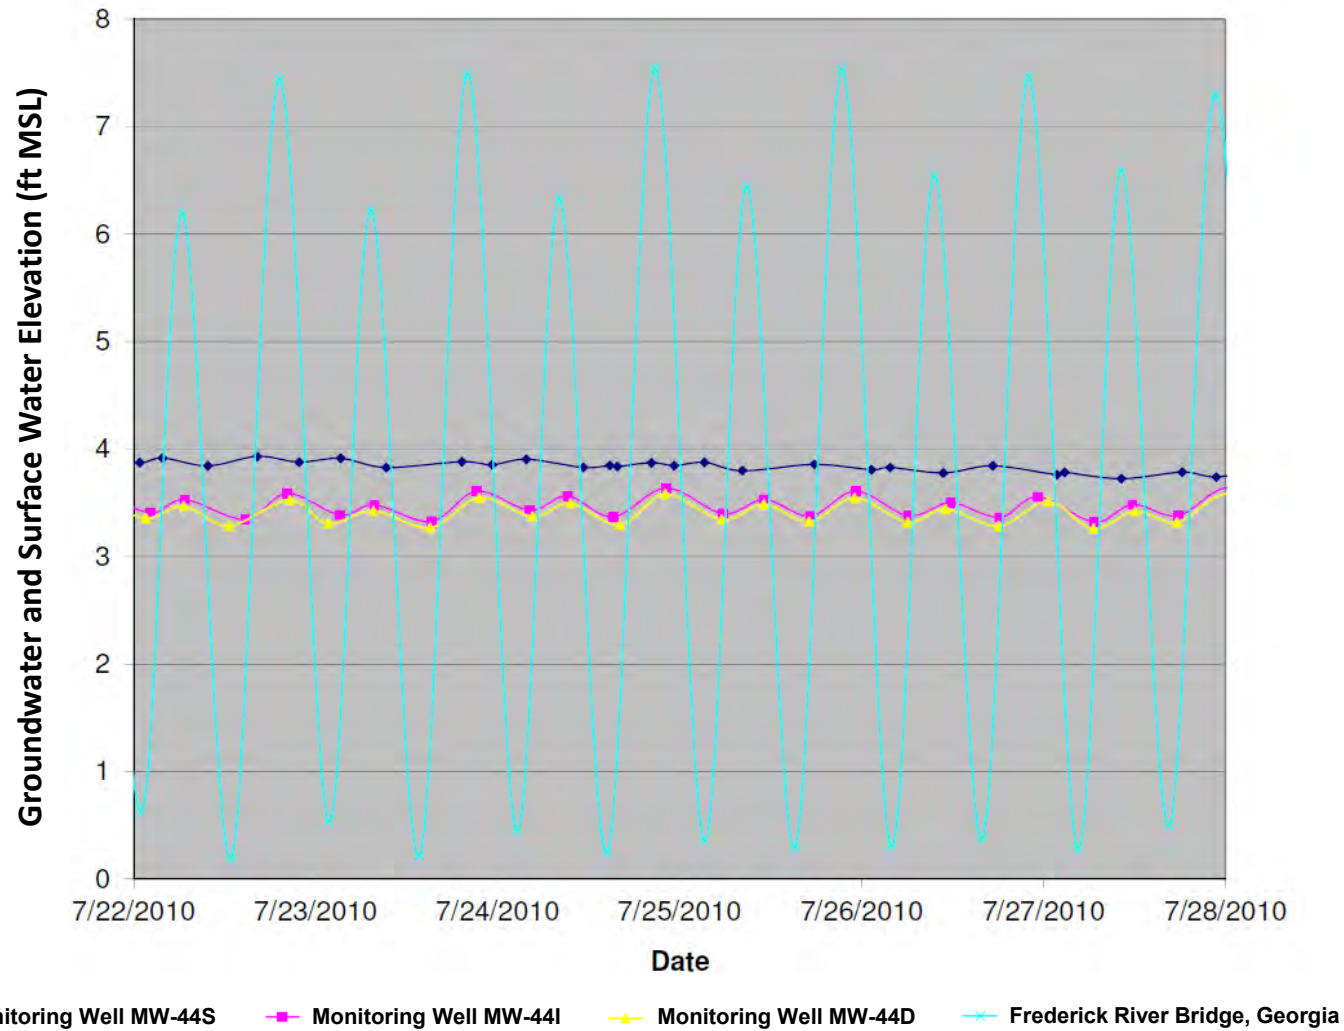
Monitoring Well MW-44 Cluster – Groundwater Elevations and Surface Water Tidal Ranges

1. ft MSL = ft above mean sea level
2. Water level measurements recorded in July 2010.
3. Figure adopted from the Brunswick Groundwater RFI Phase III Report (Antea 2015).
