RE: **Corrective Action Plan
Hercules LLC/Pinova Inc. - Brunswick Facility
Hazardous Waste Facility Permit No. HW-52(D&S)-2,
EPA ID No. GAD00406065520**

CORRECTIVE ACTION PLAN

HERCULES LLC/PINOVA INC. FACILITY

BRUNSWICK, GEORGIA

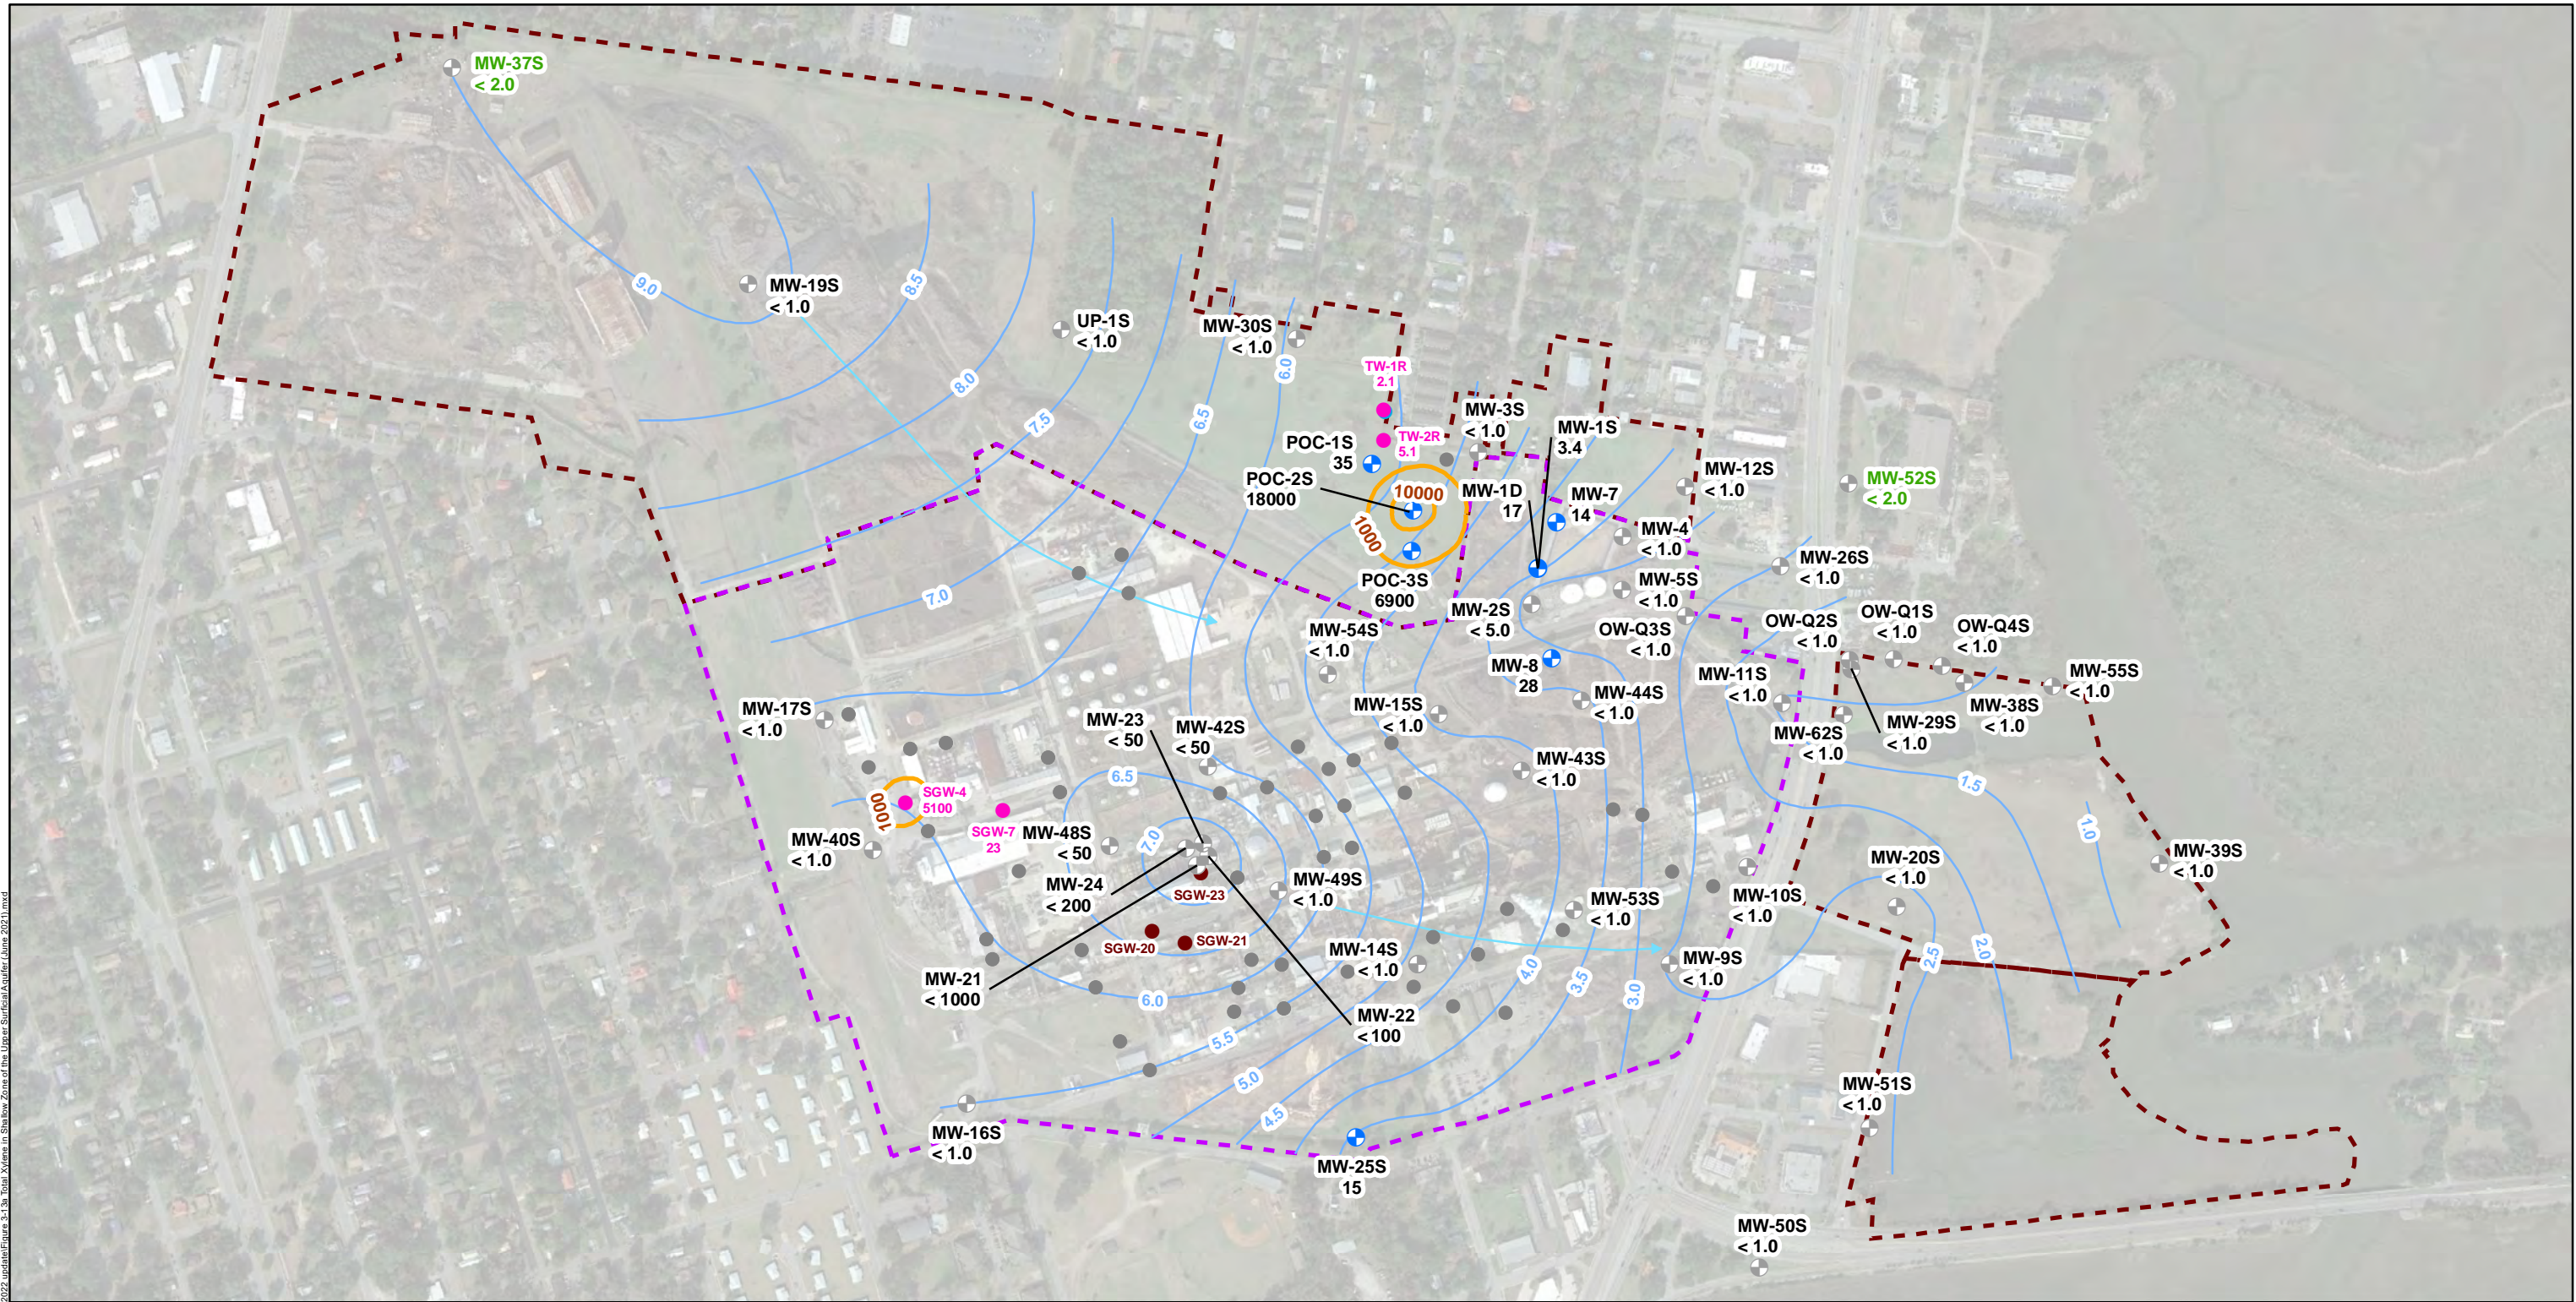
Total Xylene in Shallow Zone of the Upper Surficial Aquifer Hercules/Pinova Facility, Brunswick, Georgia	
Kennesaw, GA	August 2022
Figure 3-13a

- Total Xylene Concentration (ug/L)
- Non-Aqueous Phase Liquid (NAPL) Observed
- Not Detected Reporting Limit > MCL
- Not Detected Reporting Limit <= MCL

Groundwater conditions in shallow monitoring wells in the former surface impoundment area near the former tank farm containing what were designated as the Y-1, Y-2, and Y-3 tanks are defined by higher concentrations of xylene relative to other COPCs, including chlorobenzene and benzene. Xylenes in shallow groundwater underlying the former surface impoundment area naturally attenuate before crossing the downgradient facility boundary, as shown in **Figures 3-13a, 3-13b, and 3-13c**, whereas concentrations of benzene and chlorobenzene attenuate downgradient before comingling with the plume from the former toxaphene production plant), as shown in **Figures 3-14a, 3-14b, 3-14c, 3-15a, 3-15b, and 3-15c**. This observation is consistent with the fact that biodegradability of xylenes is generally faster than biodegradability of benzene and chlorobenzene (Field and Sierra-Alvarez, 2008; Borden et al., 1997; Howard et al., 1991).

Iso-concentration maps for the six primary COPCs in groundwater were developed for each of the three zones in the upper surficial aquifer, using the most recent groundwater monitoring result for each well location and the shallow groundwater data obtained in 2019 as part of the vapor intrusion investigation from hand auger borings. The iso-concentration maps are presented as **Figure 3-13a, 3-13b, 3-13c, 3-14a, 3-14b, 3-14c, 3-15a, 3-15b, 3-15c, 3-16a, 3-16b, 3-16c, 3-17a, 3-17b, 3-17c, 3-18a, 3-18b, and 3-18c**.

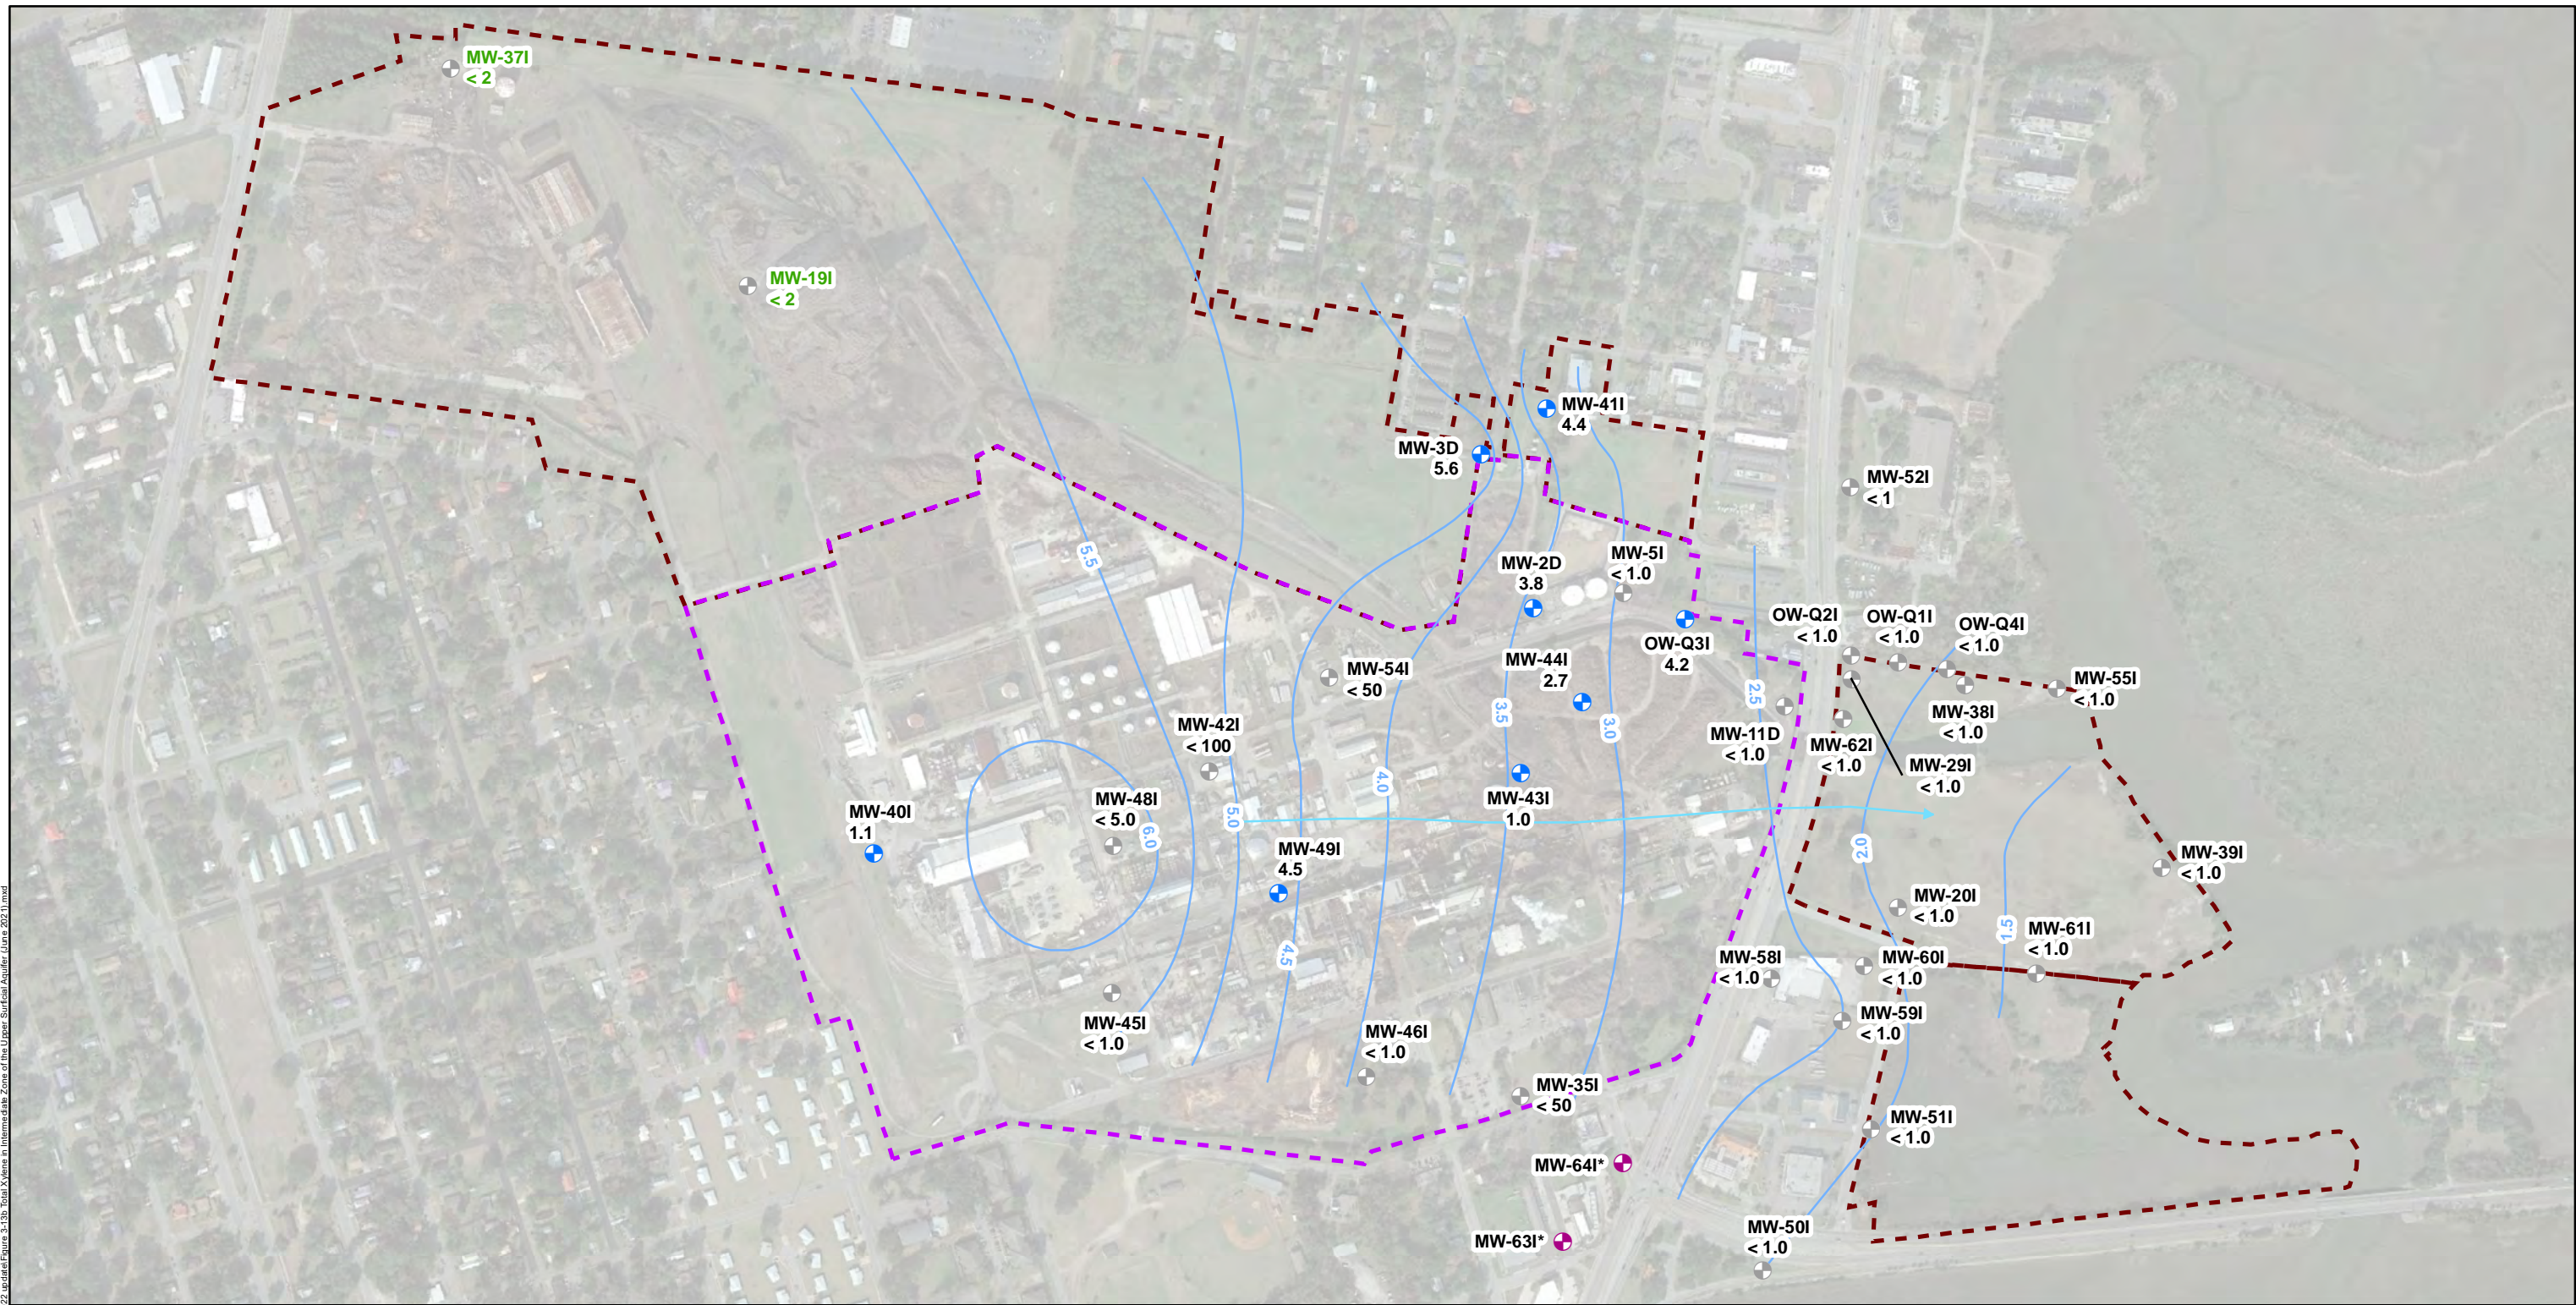
**Figure
3-13b**

Path: N:\H Hercules\Brunswick\GIS\MapDocs\Figures\August 2022 update\Figure 3-13b Total Xylene in Intermediate Zone of the Upper Surficial Aquifer (June 2021).mxd

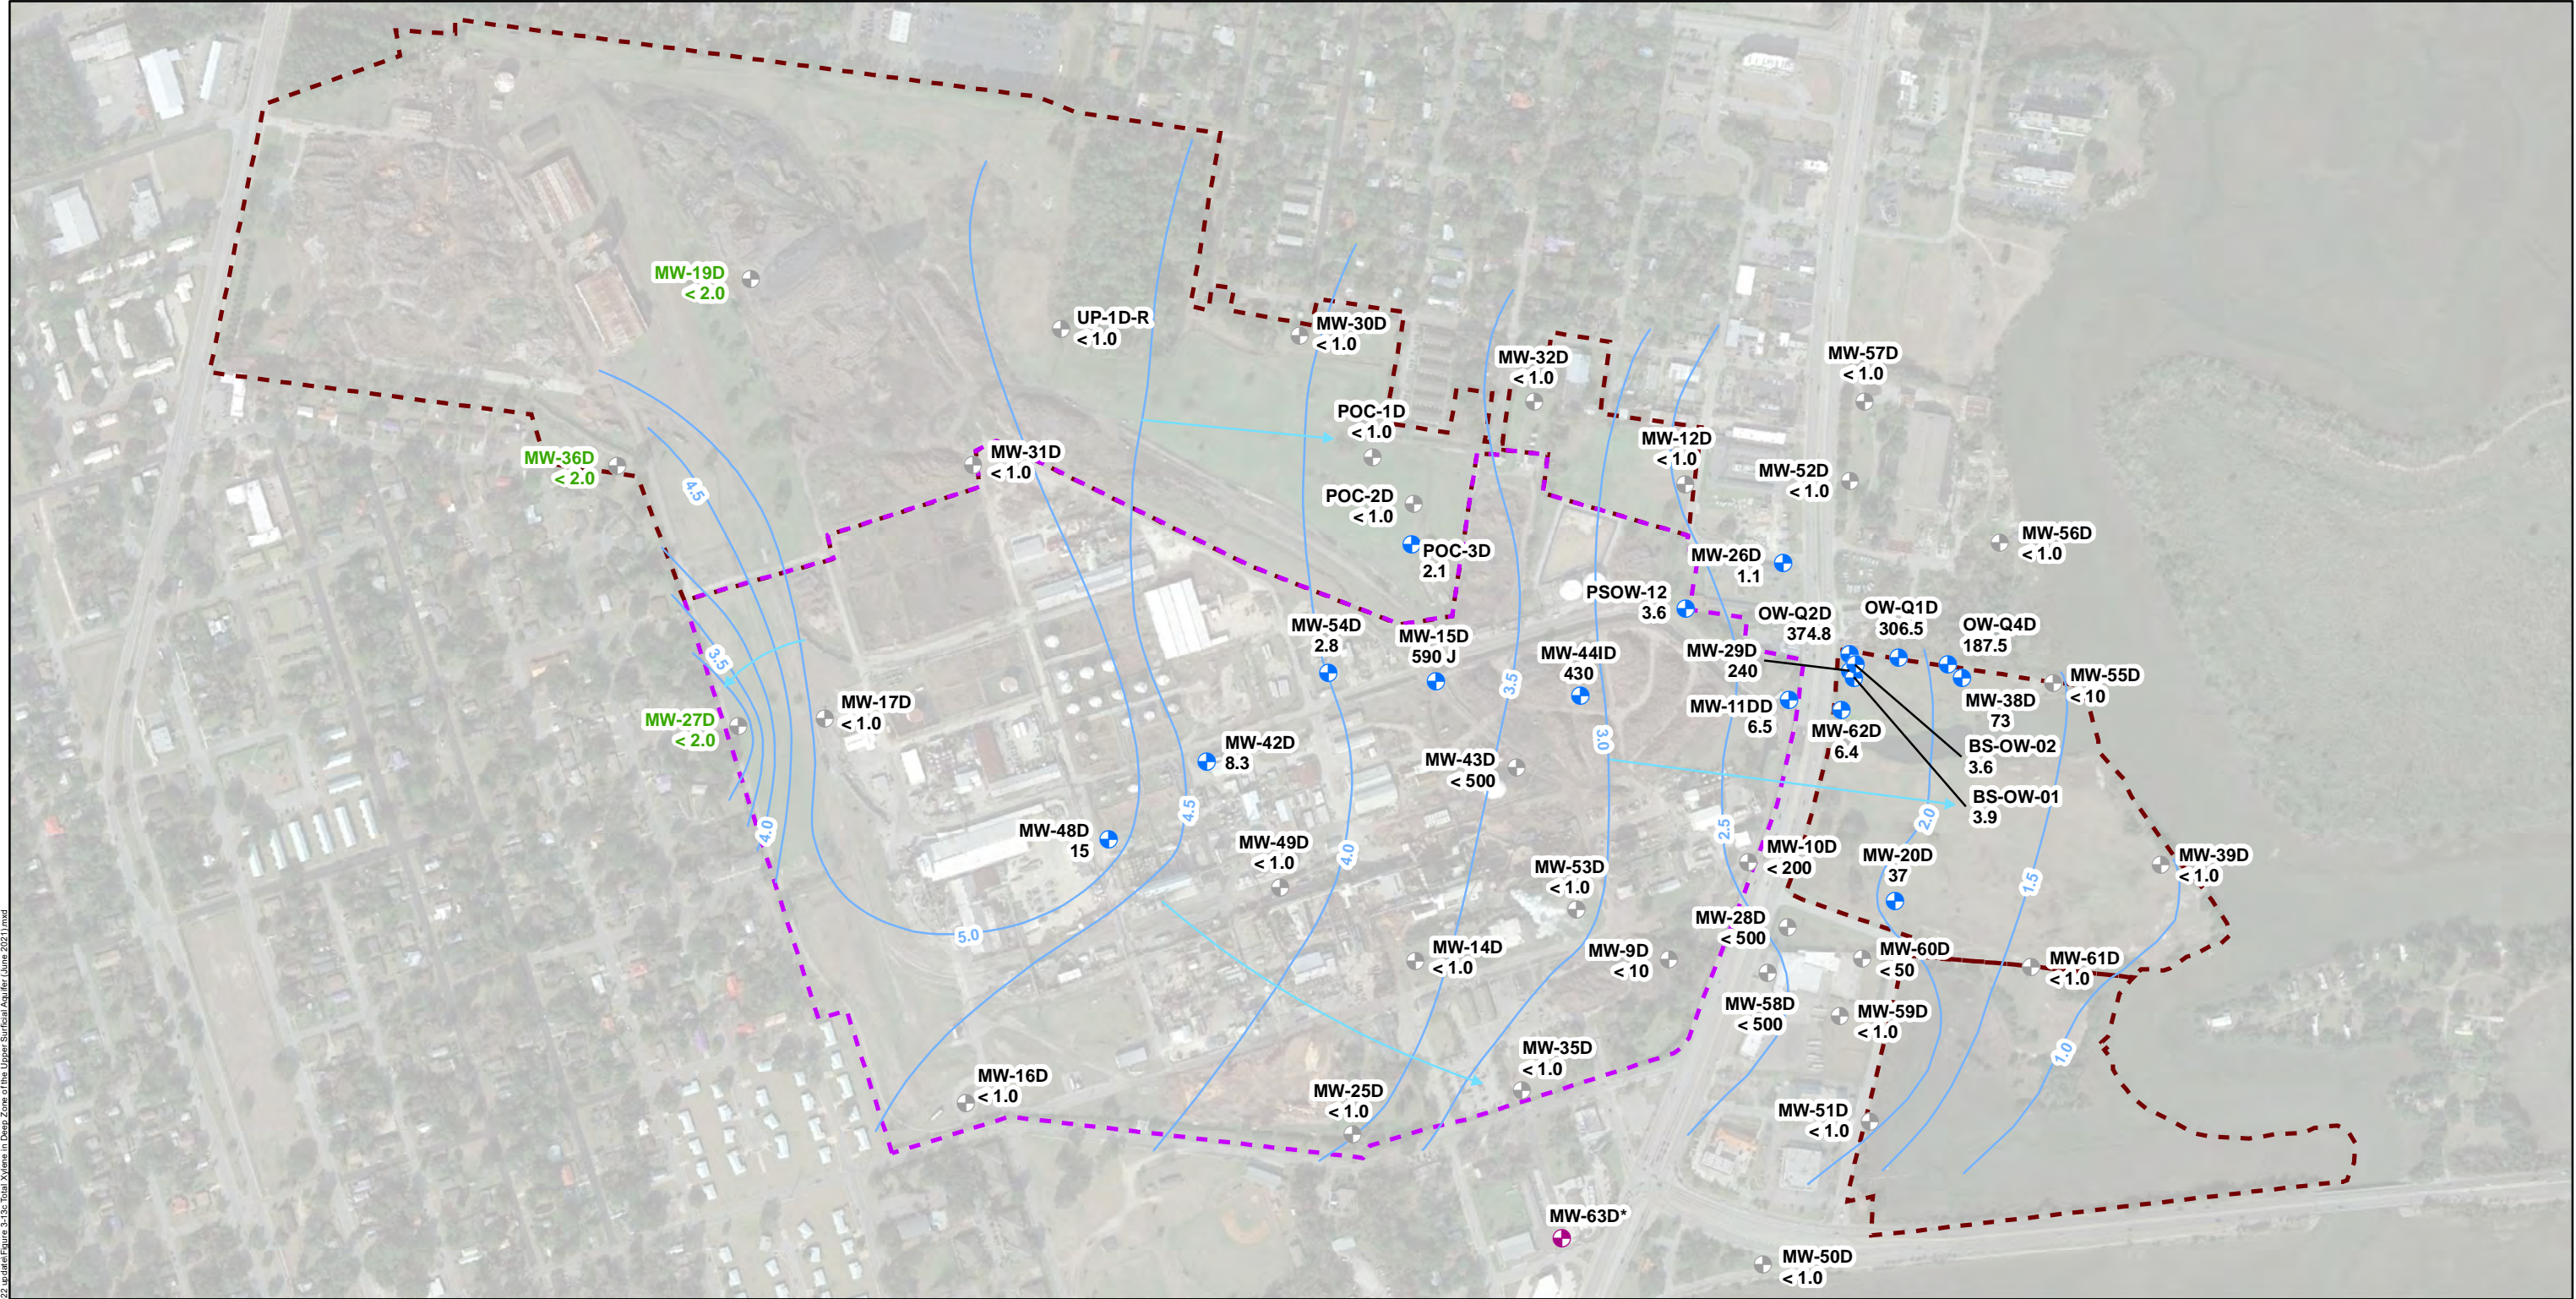
Figure 3-13c

Path: N:\H Hercules\Brunswick\GIS\MapDocs\Figures\August 2022 update\Figure 3-13c Total Xylene in Deep Zone of the Upper Surficial Aquifer (June 2021).mxd

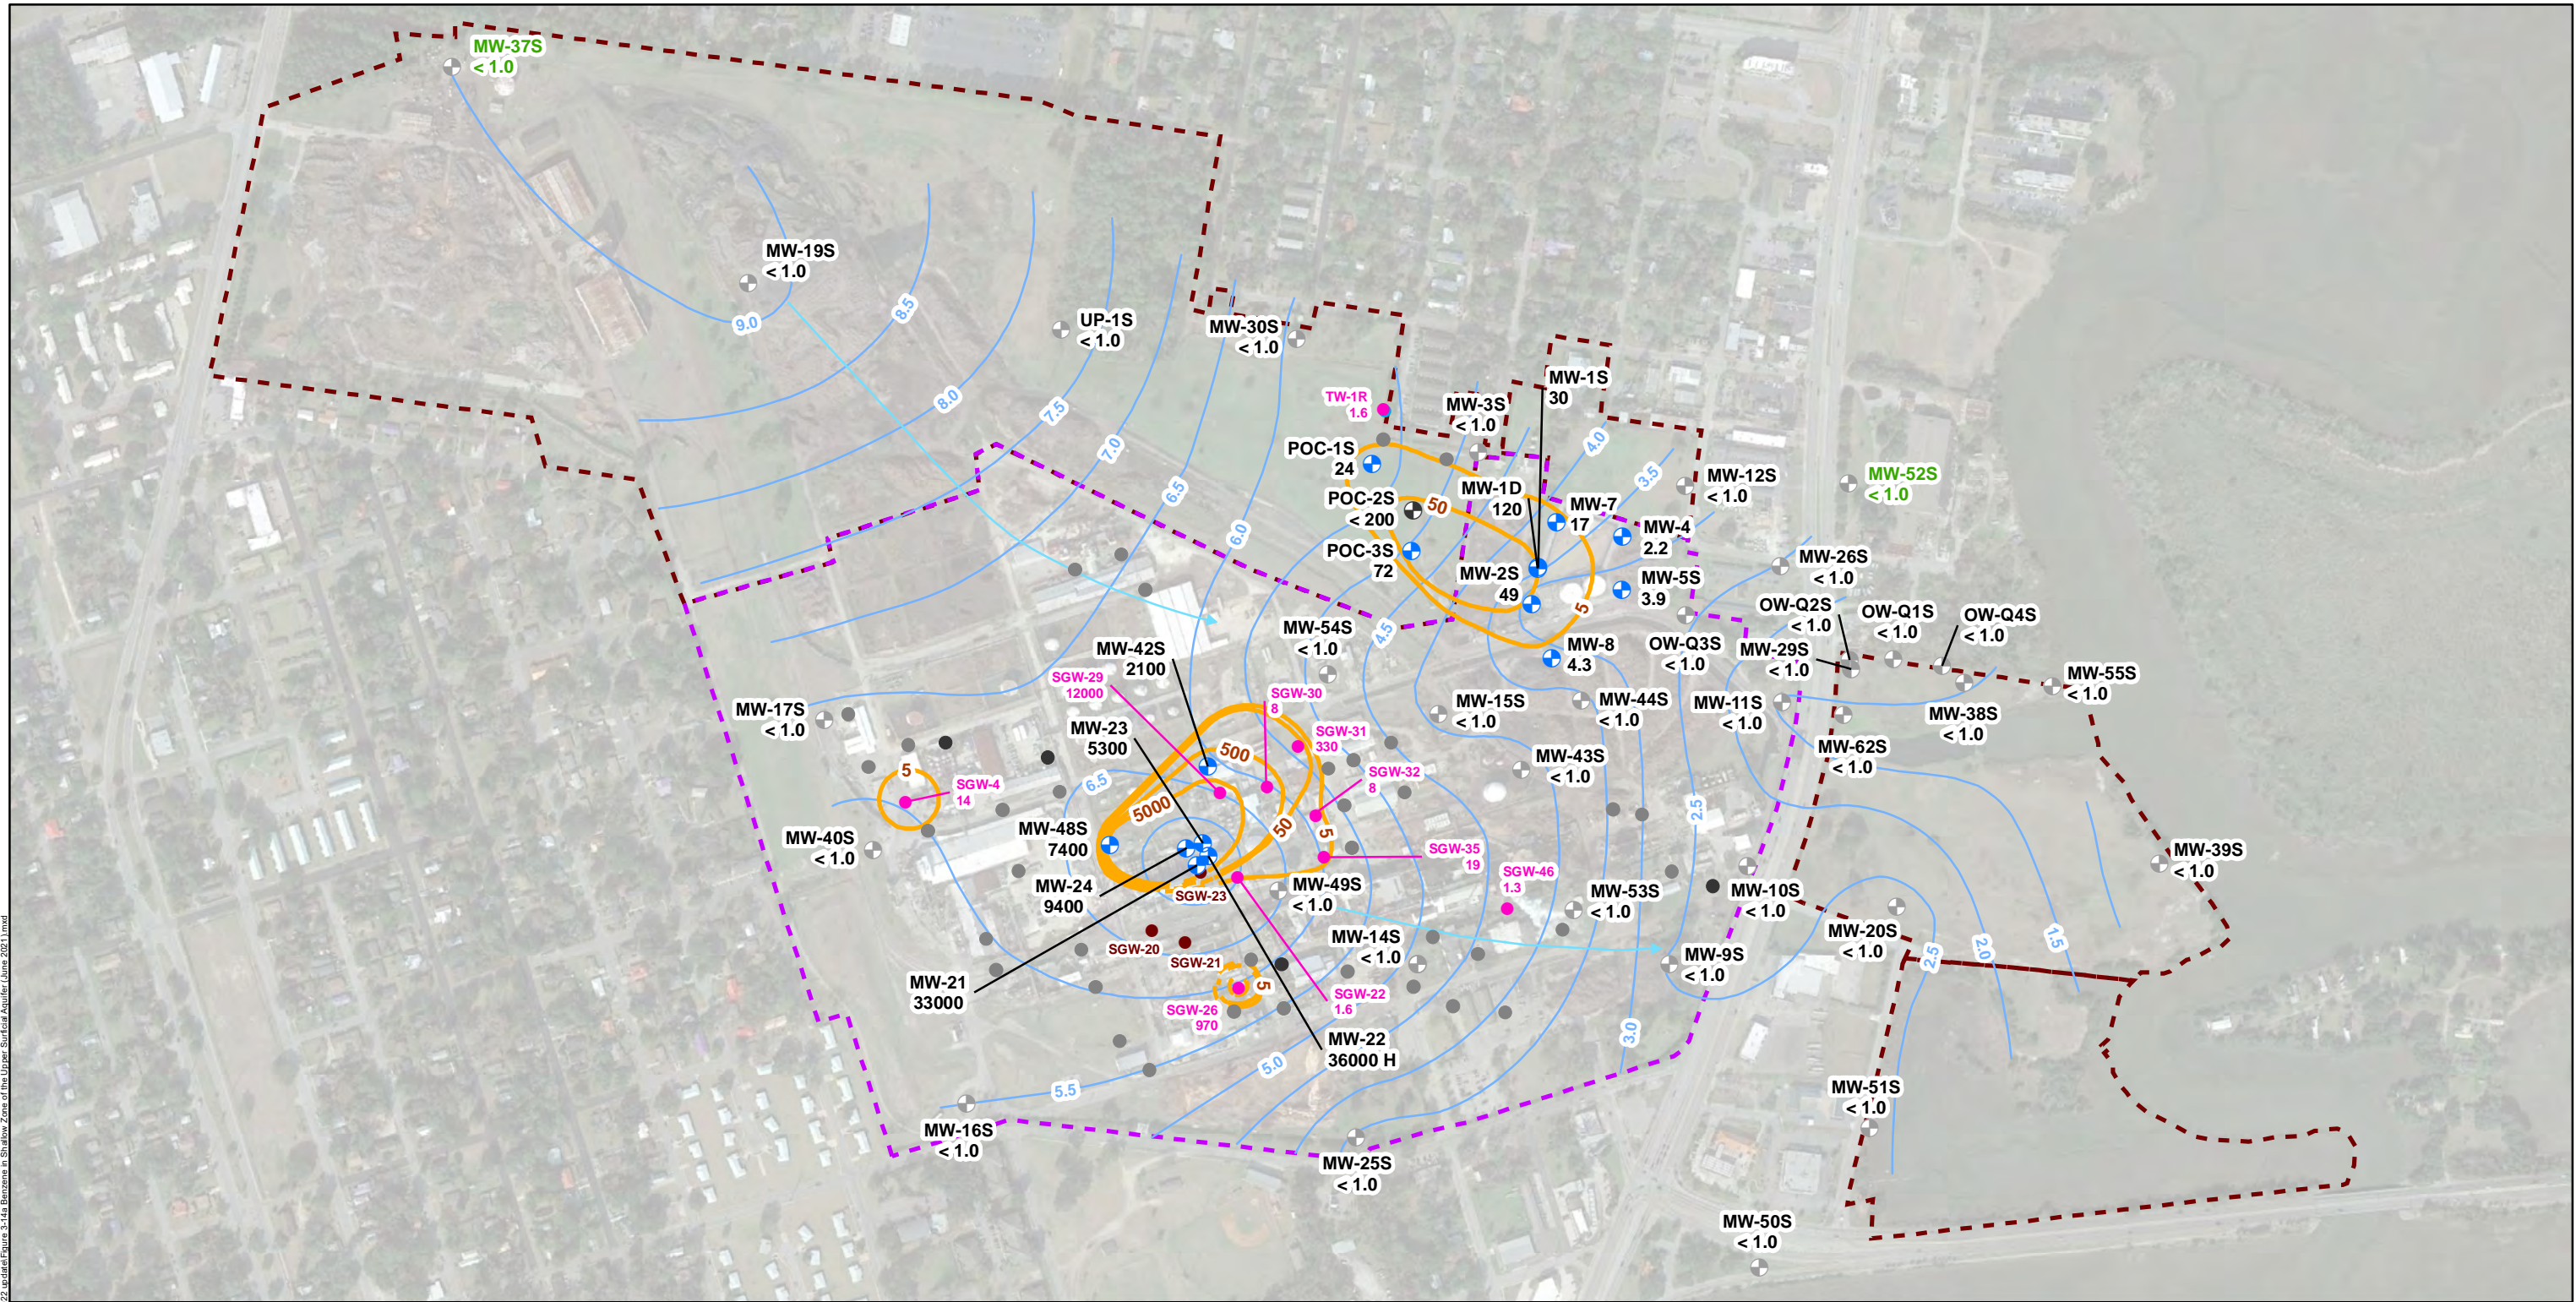
Figure
3-14a

Path: N:\H Hercules\Brunswick\GIS\MapDocs\Figures\August 2022 update\Figure 3-14a Benzene in Shallow Zone of the Upper Surficial Aquifer (June 2021).mxd

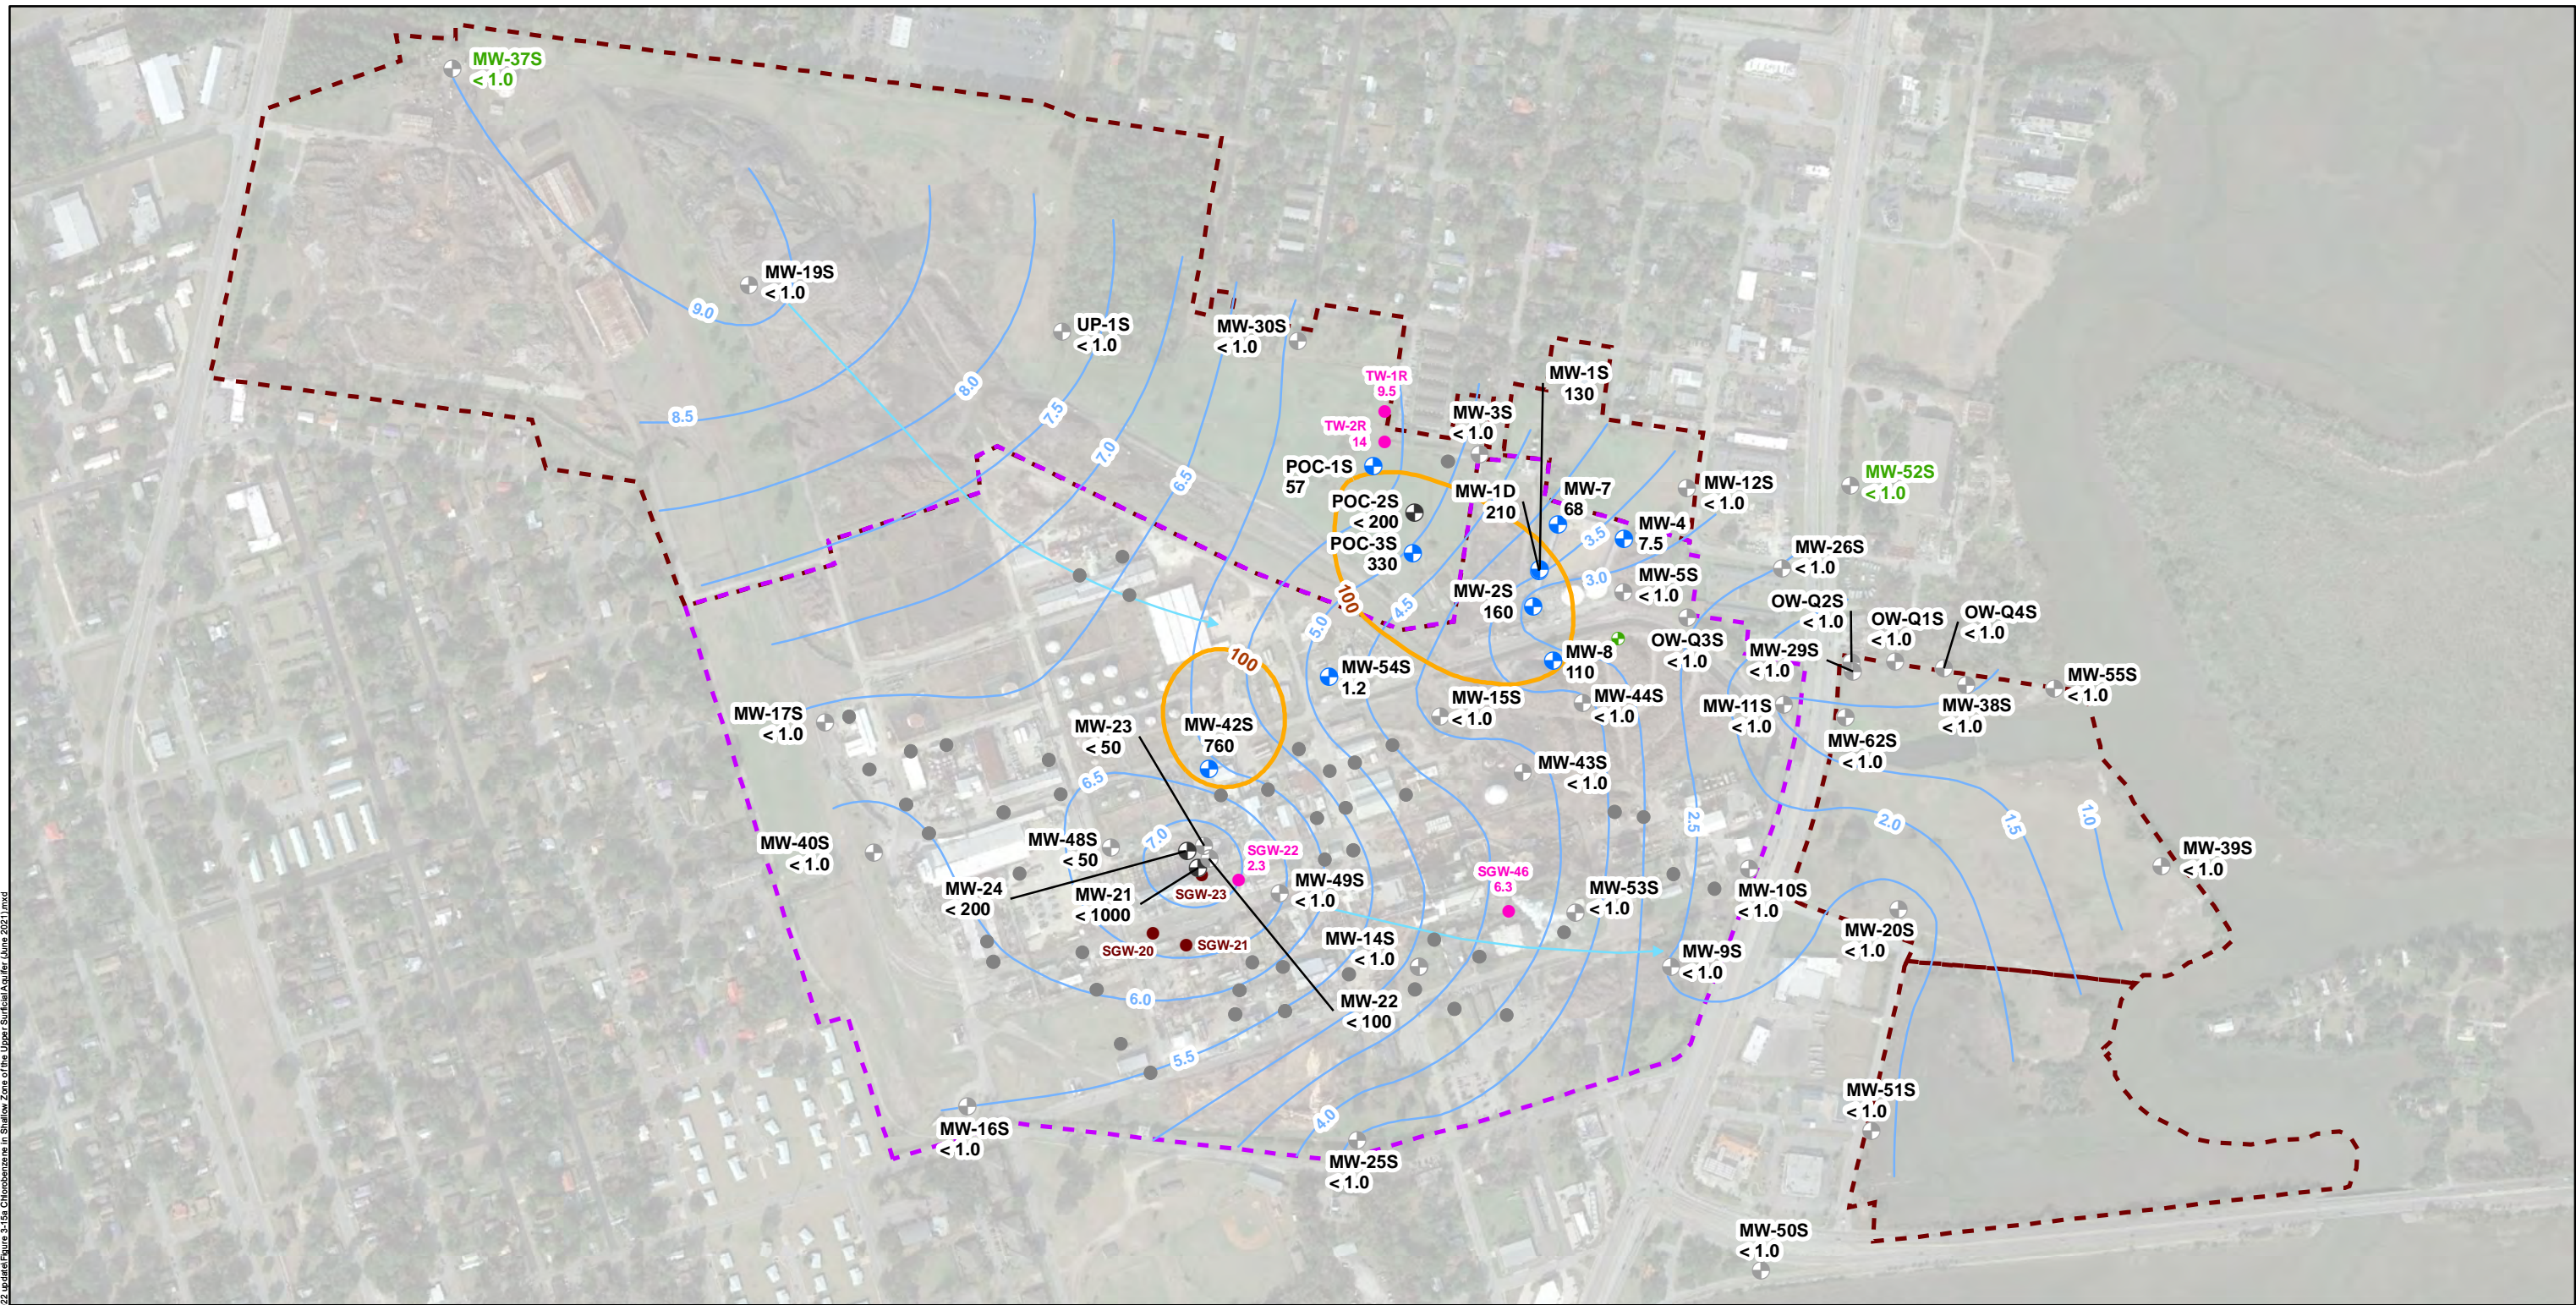
Path: N:\H Hercules\Brunswick\GIS\MapDocs\Figures\August 2022 update\Figure 3-15a Chlorobenzene in Shallow Zone of the Upper Surficial Aquifer (June 2021).mxd

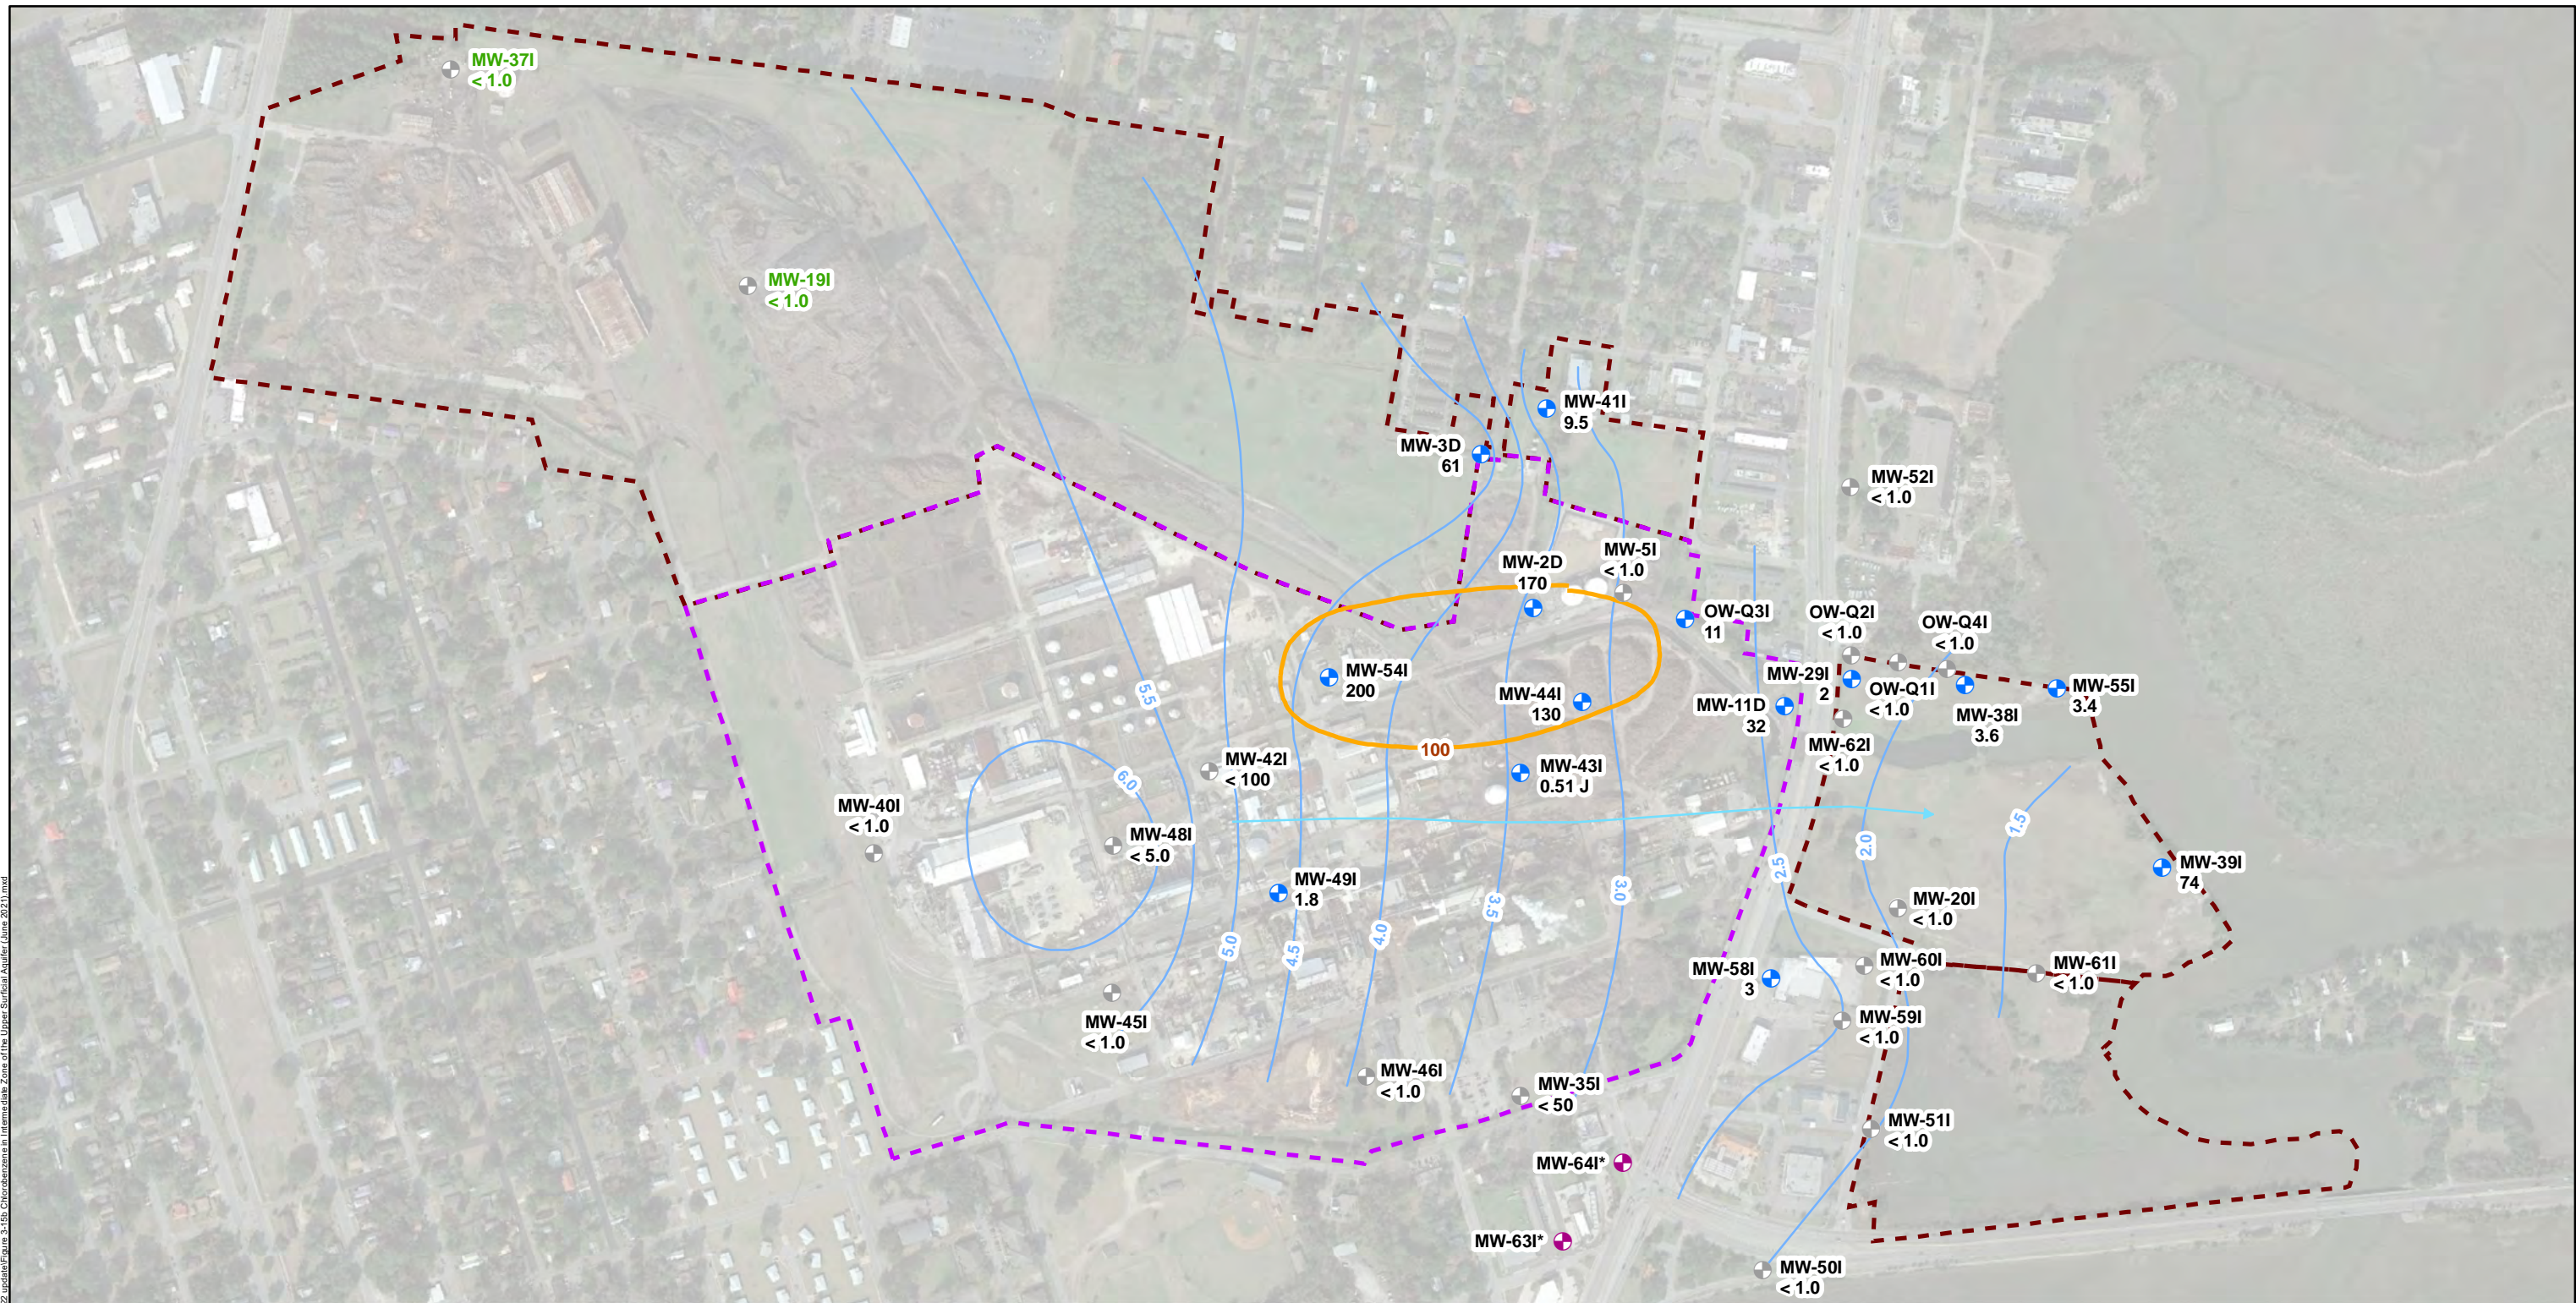
Path: N:\Hercules\Brunswick\GIS\MXD\CAP Figures\August 2022 updates\Figure 3-15b Chlorobenzene in Intermediate Zone of the Upper Surficial Aquifer (June 2021).mxd
