RE: **Corrective Action Plan
Hercules LLC/Pinova Inc. - Brunswick Facility
Hazardous Waste Facility Permit No. HW-52(D&S)-2,
EPA ID No. GAD00406065520**

CORRECTIVE ACTION PLAN

HERCULES LLC/PINOVA INC. FACILITY

BRUNSWICK, GEORGIA

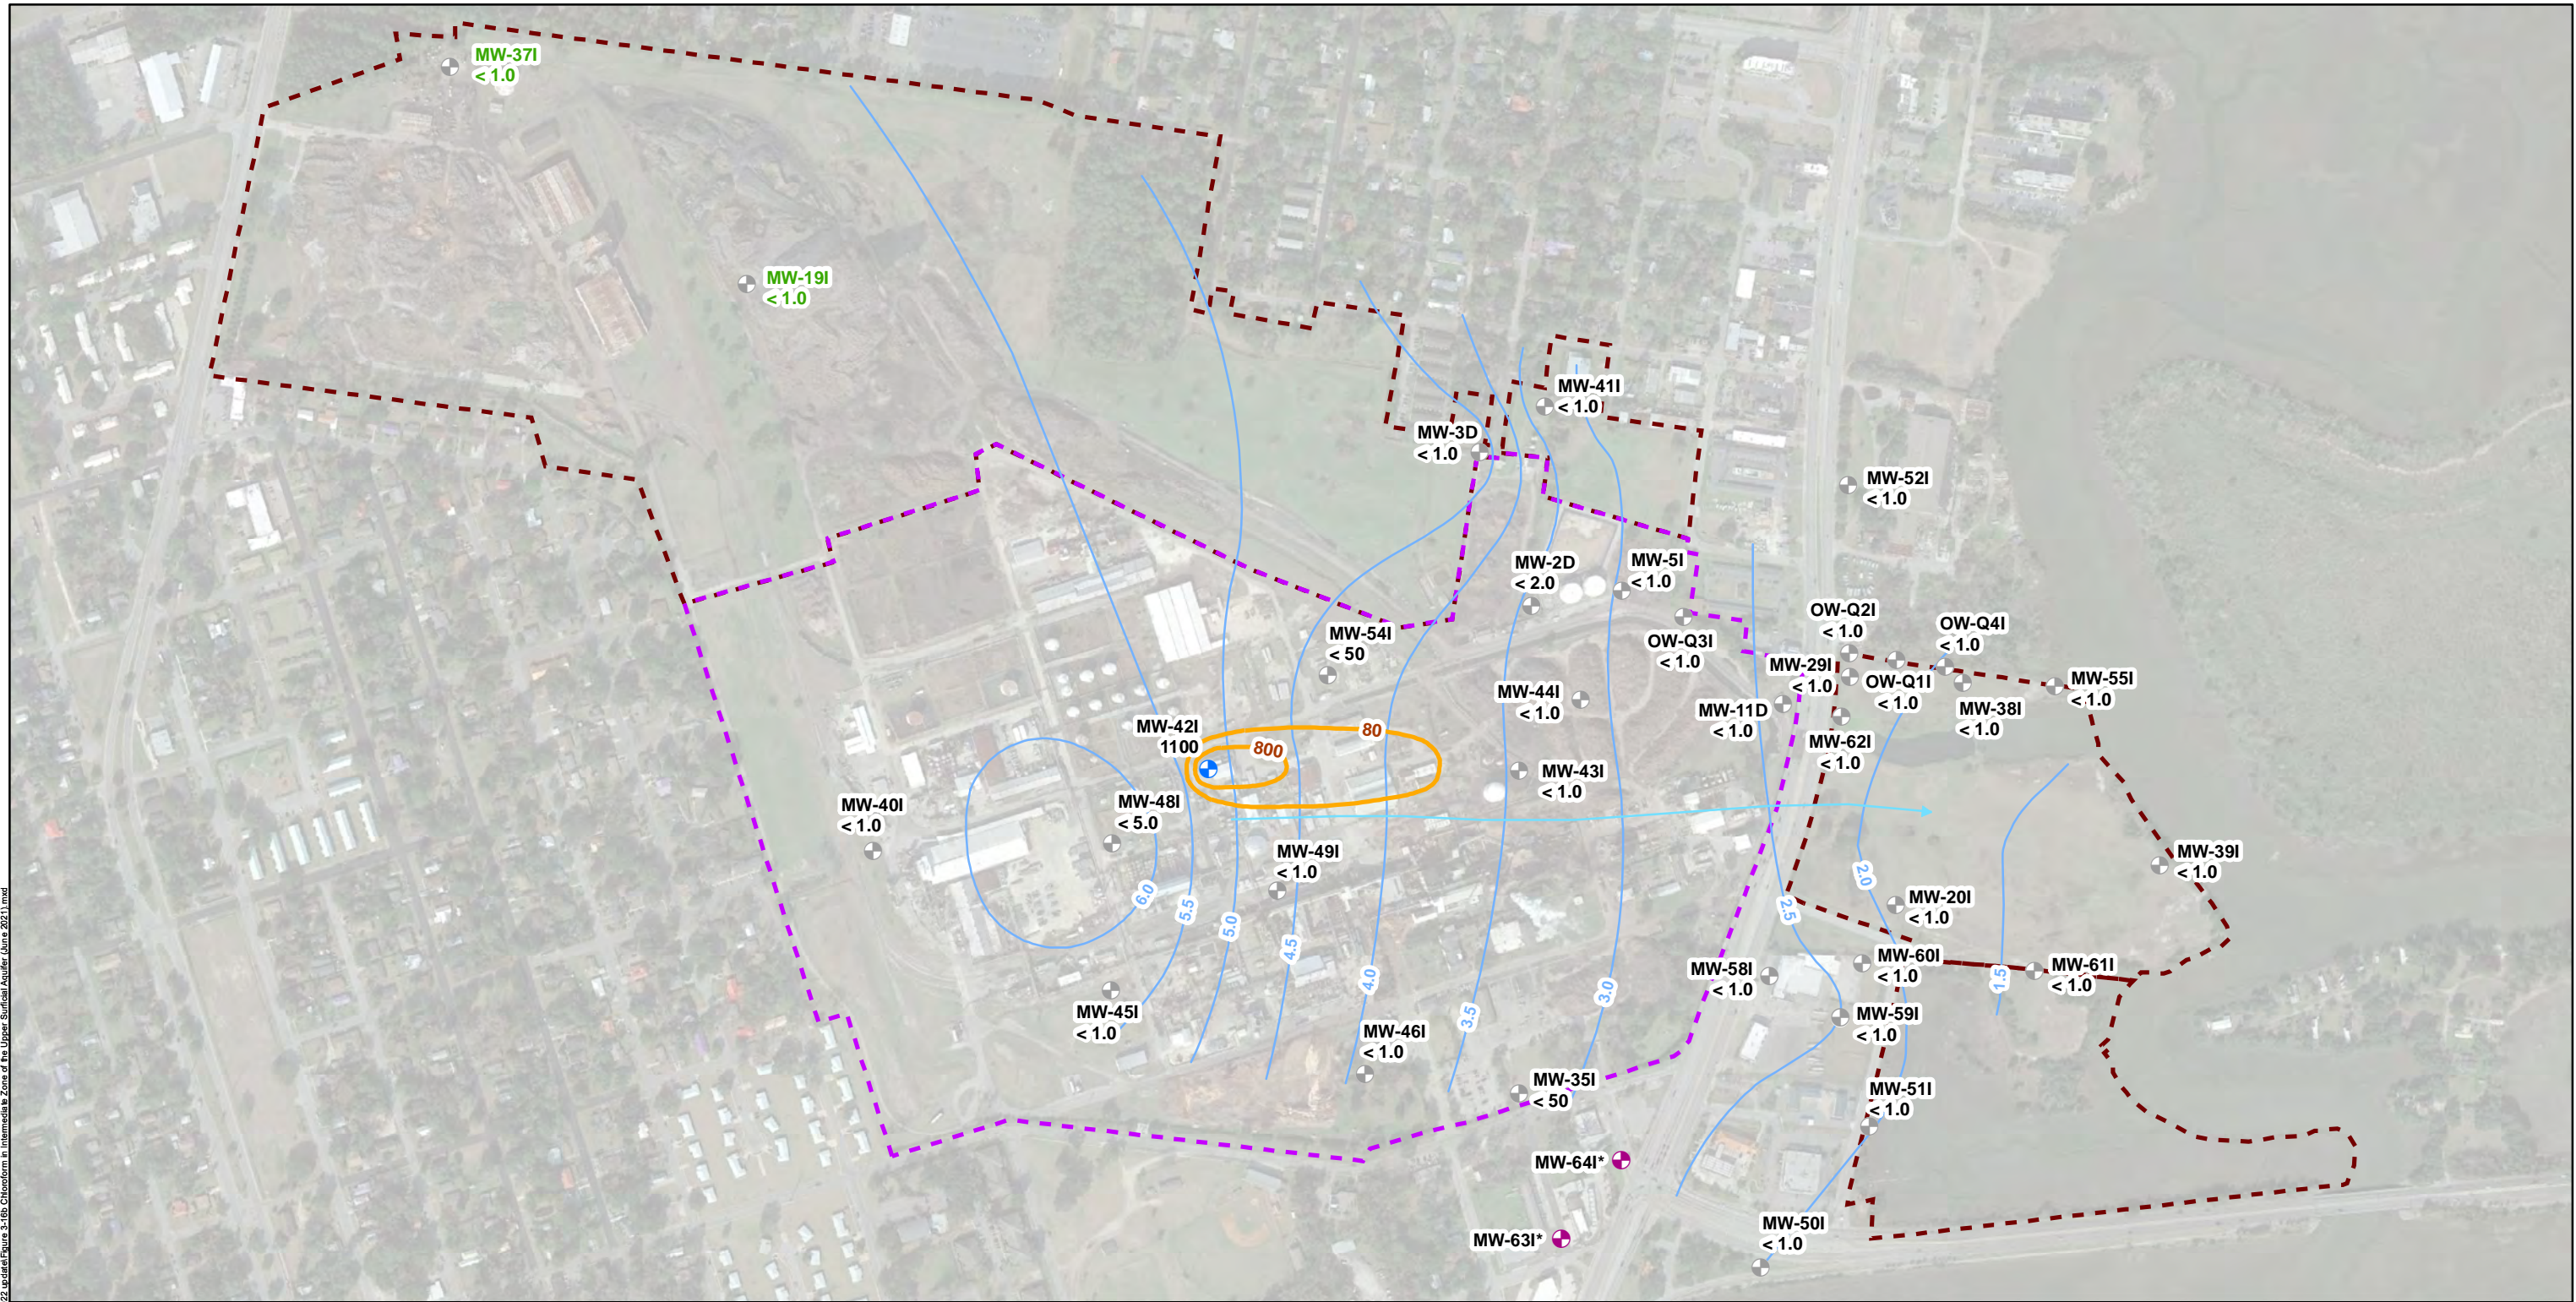
**Figure
3-16b**

- Chloroform Concentrations (ug/L)**
- Detected Concentration
 - Not Detected Reporting Limit > MCL
 - Not Detected Reporting Limit <= MCL
 - New Monitoring Well
- MW-40I** Black well label indicates sample was collected after January 2015
- MW-371I** Green well label indicates sample was collected prior to January 2015

- Chloroform Concentration Iso-Contour (ug/L) (inferred where dashed)
- Groundwater Elevation Iso-Contour (ft MSL)
- Approximate Groundwater Flow Direction
- Pinova Property
- Hercules Property

Groundwater monitoring data indicate that the vast majority of carbon tetrachloride that was released in the former toxaphene production area has degraded to chloroform, and then to methylene chloride (i.e., dichloromethane), and ultimately to carbon dioxide and organic acids. Methane is usually not a primary product of chloroform dechlorination (as demonstrated in the 2020 treatability studies discussed in Section 6.1.4 of this CAP). Chloroform, benzene, and chlorobenzene in groundwater extend east of U.S. Highway 17. Monitoring well MW-42S and temporary well point SGW-31 are located near the former toxaphene production area and groundwater samples collected from these two locations have exhibited elevated concentrations of benzene, chlorobenzene, chloroform, methylene chloride, and para-cymene in groundwater that could be a potential continuing source of COPCs to groundwater in the deep zone of the upper surficial aquifer in downgradient areas as shown on **Figures 3-14a, 3-14b, 3-14c, 3-15a, 3-15b, 3-15c, 3-16a, 3-16b, 3-16c, 3-17a, 3-17b, 3-17c, 3-18a, 3-18b, and 3-18c**. Additionally, a separately identifiable layer has been identified on the water surface at monitoring well MW-42S, but preliminary analysis indicated that this layer consisted of aqueous phase liquid rather than NAPL. This area will be further evaluated and, if appropriate, will be subject to further corrective measures as discussed in Section 6 of this CAP.

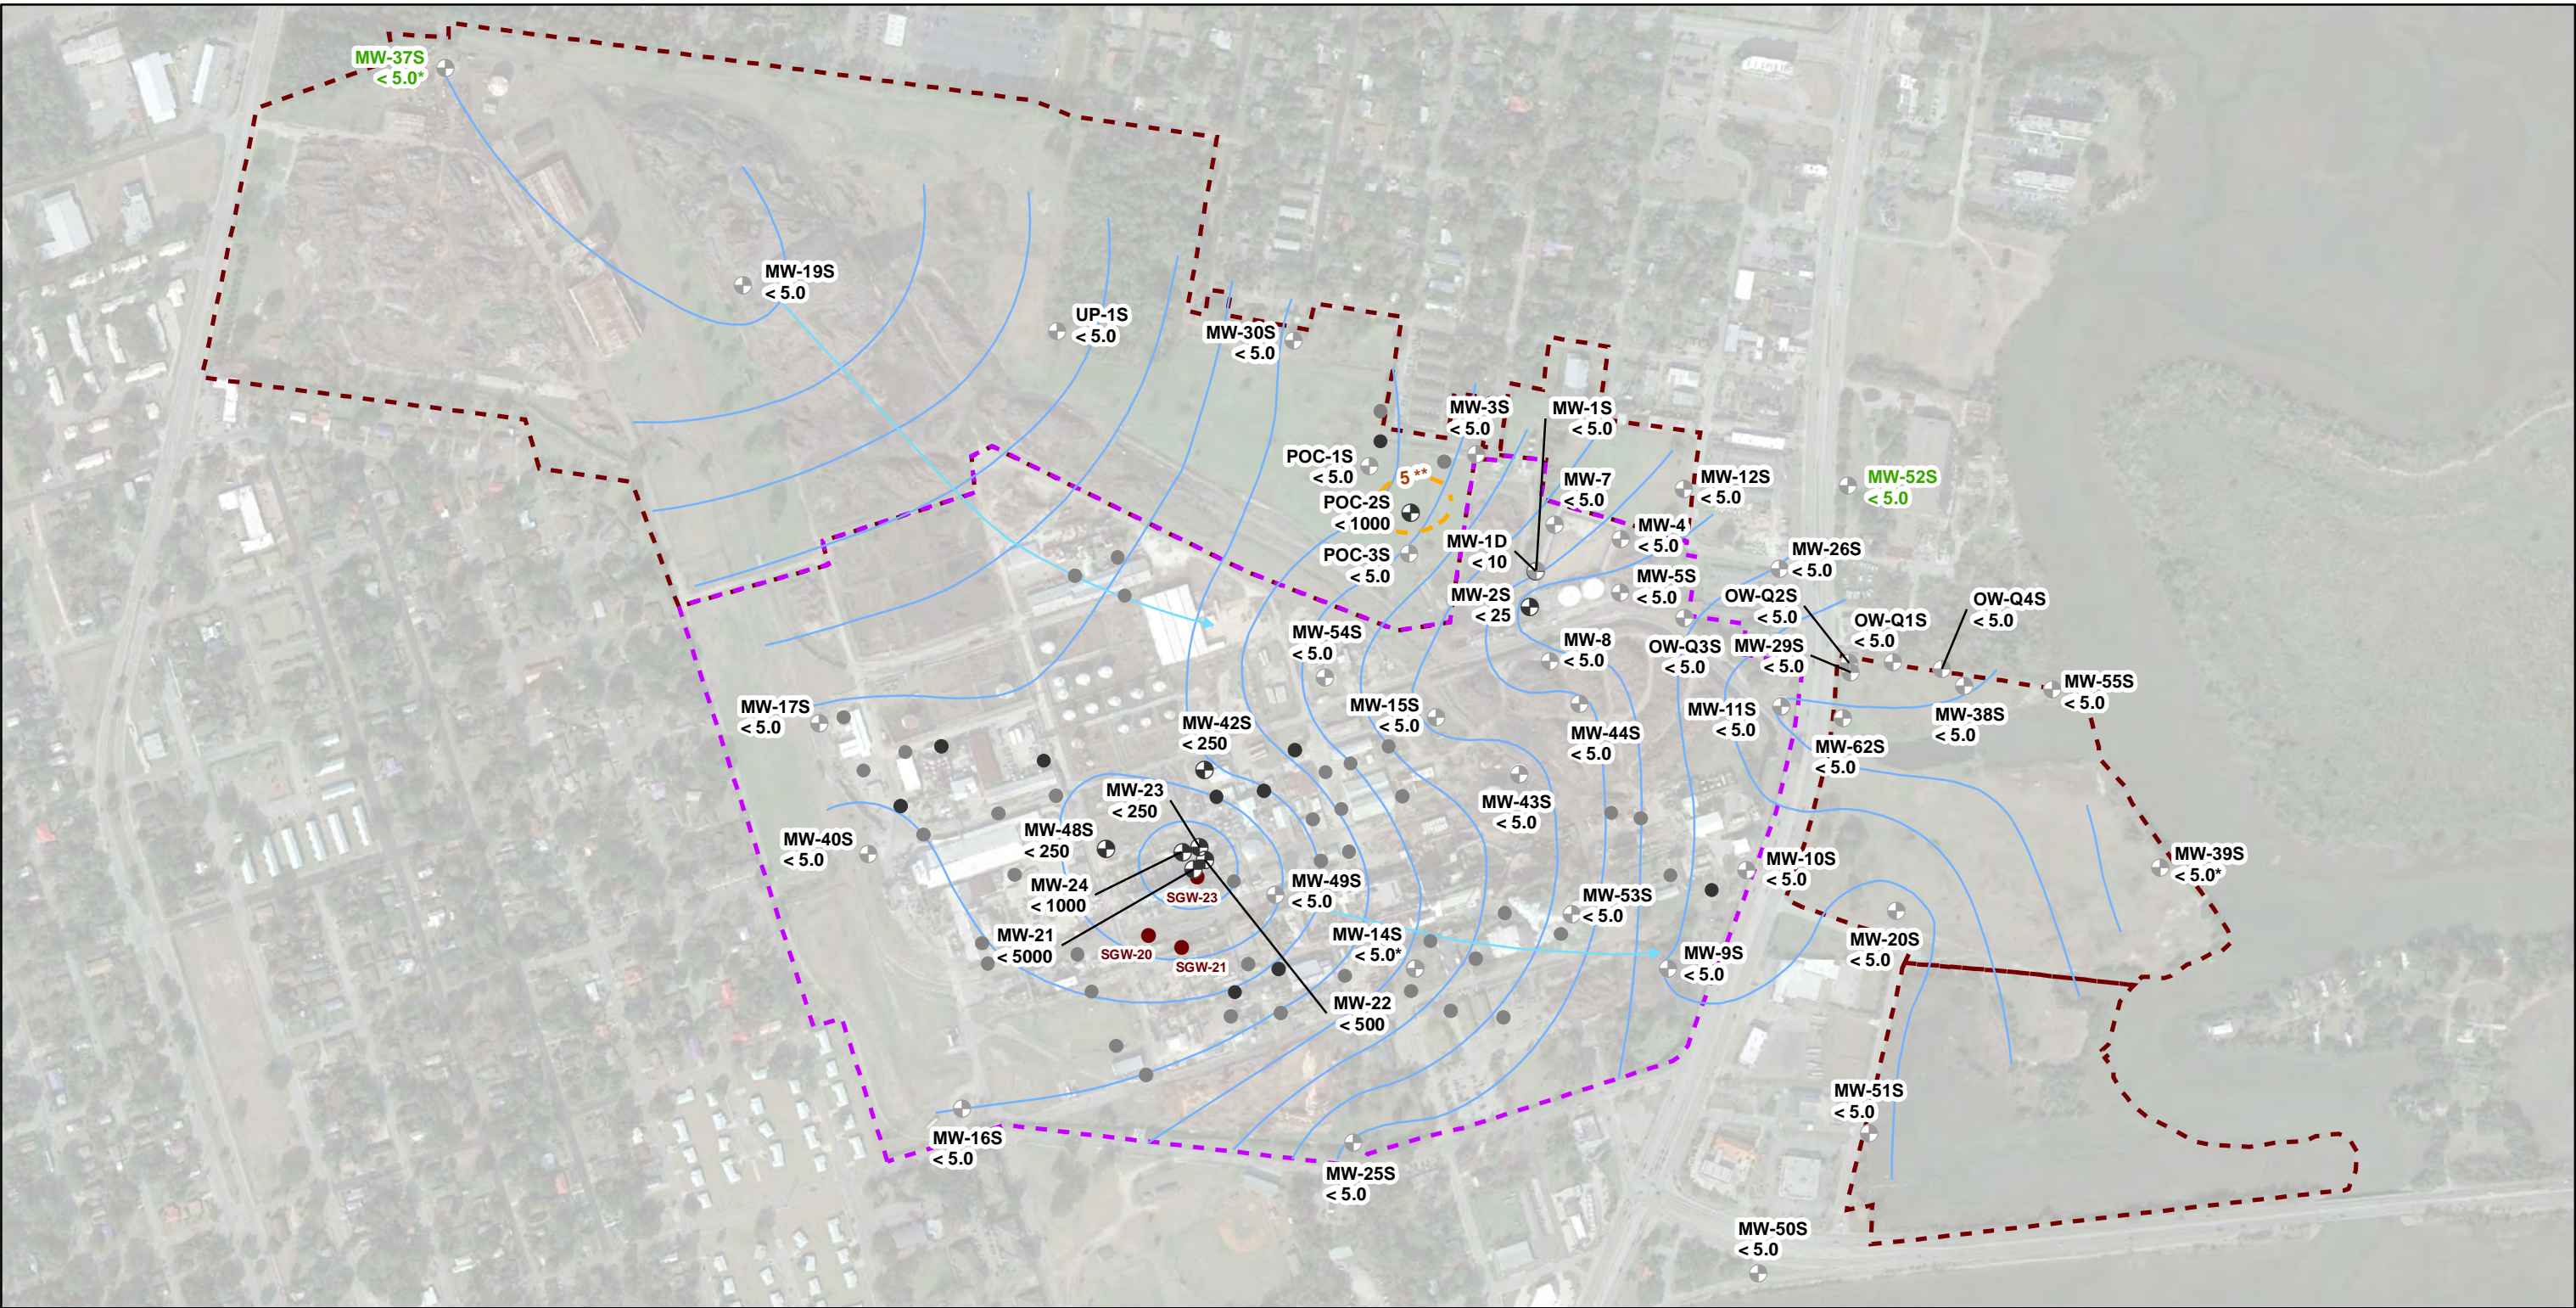
Path: N:\Hercules\Brunswick\GIS\MXD\CAP_Figures\August 2022 update\Figure 3-17a Methylene Chloride in Shallow Zone of the Upper Surficial Aquifer (June 2021).mxd

Methylene Chloride Non-Detect Concentration (ug/L) ⊕ Not Detected Reporting Limit > MCL ⊙ Not Detected Reporting Limit <= MCL MW-19S Black well label indicates sample was collected after January 2015 MW-37S Green well label indicates sample was collected prior to January 2015		August 2019 Shallow Groundwater Sample (Vapor Intrusion Investigation) ● Non-Aqueous Phase Liquid (NAPL) Observed ● Not Detected Reporting Limit > MCL ● Not Detected Reporting Limit <= MCL — Methylene Chloride Concentration Iso-Contour (ug/L) (inferred where dashed) — Groundwater Elevation Iso-Contour (ft MSL) → Approximate Groundwater Flow Direction		 		Notes: 1. Water level measurements recorded on June 7, 2021. Elevations provided in feet above mean sea level (ft MSL). 2. Most recent sampling result is shown for each monitoring well. 3. *** - Laboratory Control Sample (LCS) and/or LCS Duplicate is outside acceptance limits, high biased. 4. *** - Contour line is based on last detection of methylene chloride of 11 ug/L at monitoring well POC-2S, which was sampled in December 2019. Monitoring well POC-2S was sampled in June 2020 and methylene chloride was not detected at a detection limit of 25 ug/L. 5. The Maximum Contaminant Level (MCL) for methylene chloride is 5 ug/L. 6. Aerial photograph approximate date - January 2019. Source: Google Earth.		 		Methylene Chloride in Shallow Zone of the Upper Surficial Aquifer Hercules/Pinova Facility, Brunswick, Georgia		Figure 3-17a

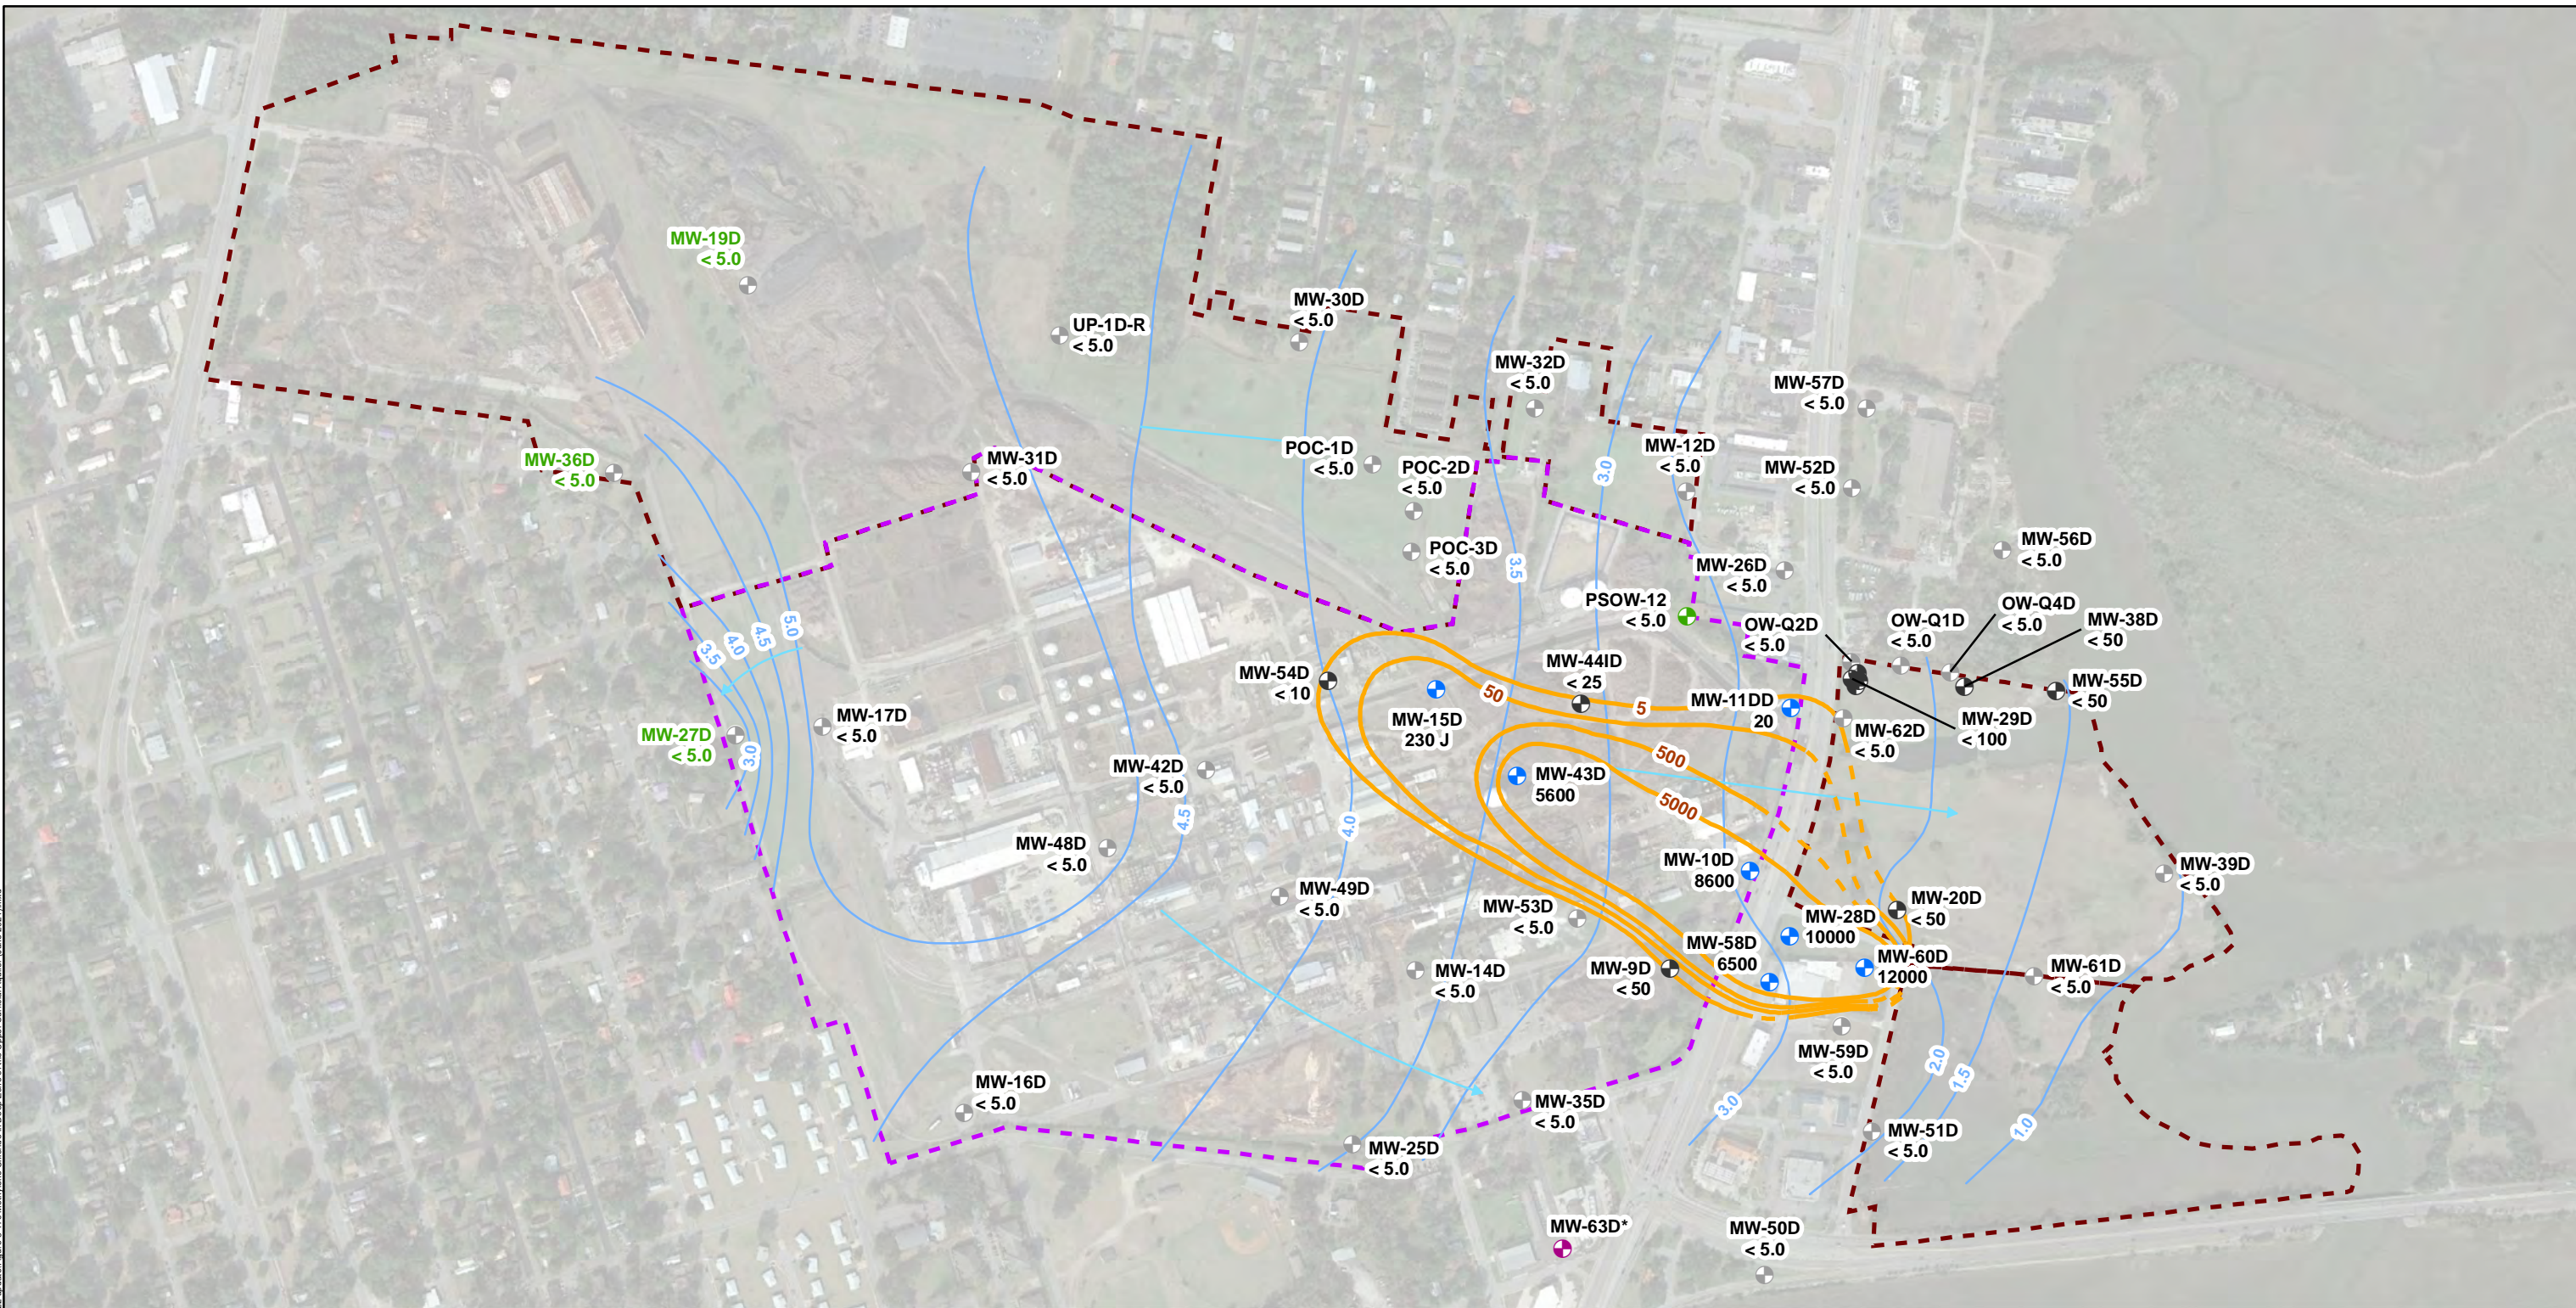
Path: N:\H Hercules\Brunswick\GIS\MapDocs\Figures\August 2022 update\Figure 3-17c Methylene Chloride in Deep Zone of the Upper Surficial Aquifer (June 2021).mxd

Methylene Chloride Concentration (ug/L) <ul style="list-style-type: none">Detected ConcentrationNot Detected Reporting Limit > MCLNot Detected Reporting Limit <= MCLNew Monitoring Well <p>MW-17D Black well label indicates sample was collected after January 2015</p> <p>MW-19D Green well label indicates sample was collected prior to January 2015</p>		Methylene Chloride Concentration <ul style="list-style-type: none">Iso-Contour (ug/L) (inferred where dashed)Groundwater Elevation Iso-Contour (ft MSL)Approximate Groundwater Flow DirectionPinova PropertyHercules Property	Notes: <ol style="list-style-type: none">Water level measurements recorded on June 7, 2021. Elevations provided in feet above mean sea level (ft MSL).Most recent sampling result is shown for each monitoring well."J" - Result is estimated.* - Monitoring well MW-63D was installed in November 2021. Results for sample collected from this monitoring well in December 2021 will be provided in the Groundwater Monitoring Report, Semi-Annual Groundwater Monitoring Event - December 2021.The Maximum Contaminant Level (MCL) for methylene chloride is 5 ug/L.Aerial photograph approximate date - January 2019. Source: Google Earth.	<div>02755501,100</div> <div>Feet</div> <div>N</div>	<div>Methylene Chloride in Deep Zone of the Upper Surficial Aquifer Hercules/Pinova Facility, Brunswick, Georgia</div> <div>Geosyntec consultants</div> <div>Kennesaw, GAAugust 2022</div>		<div>Figure 3-17c</div>

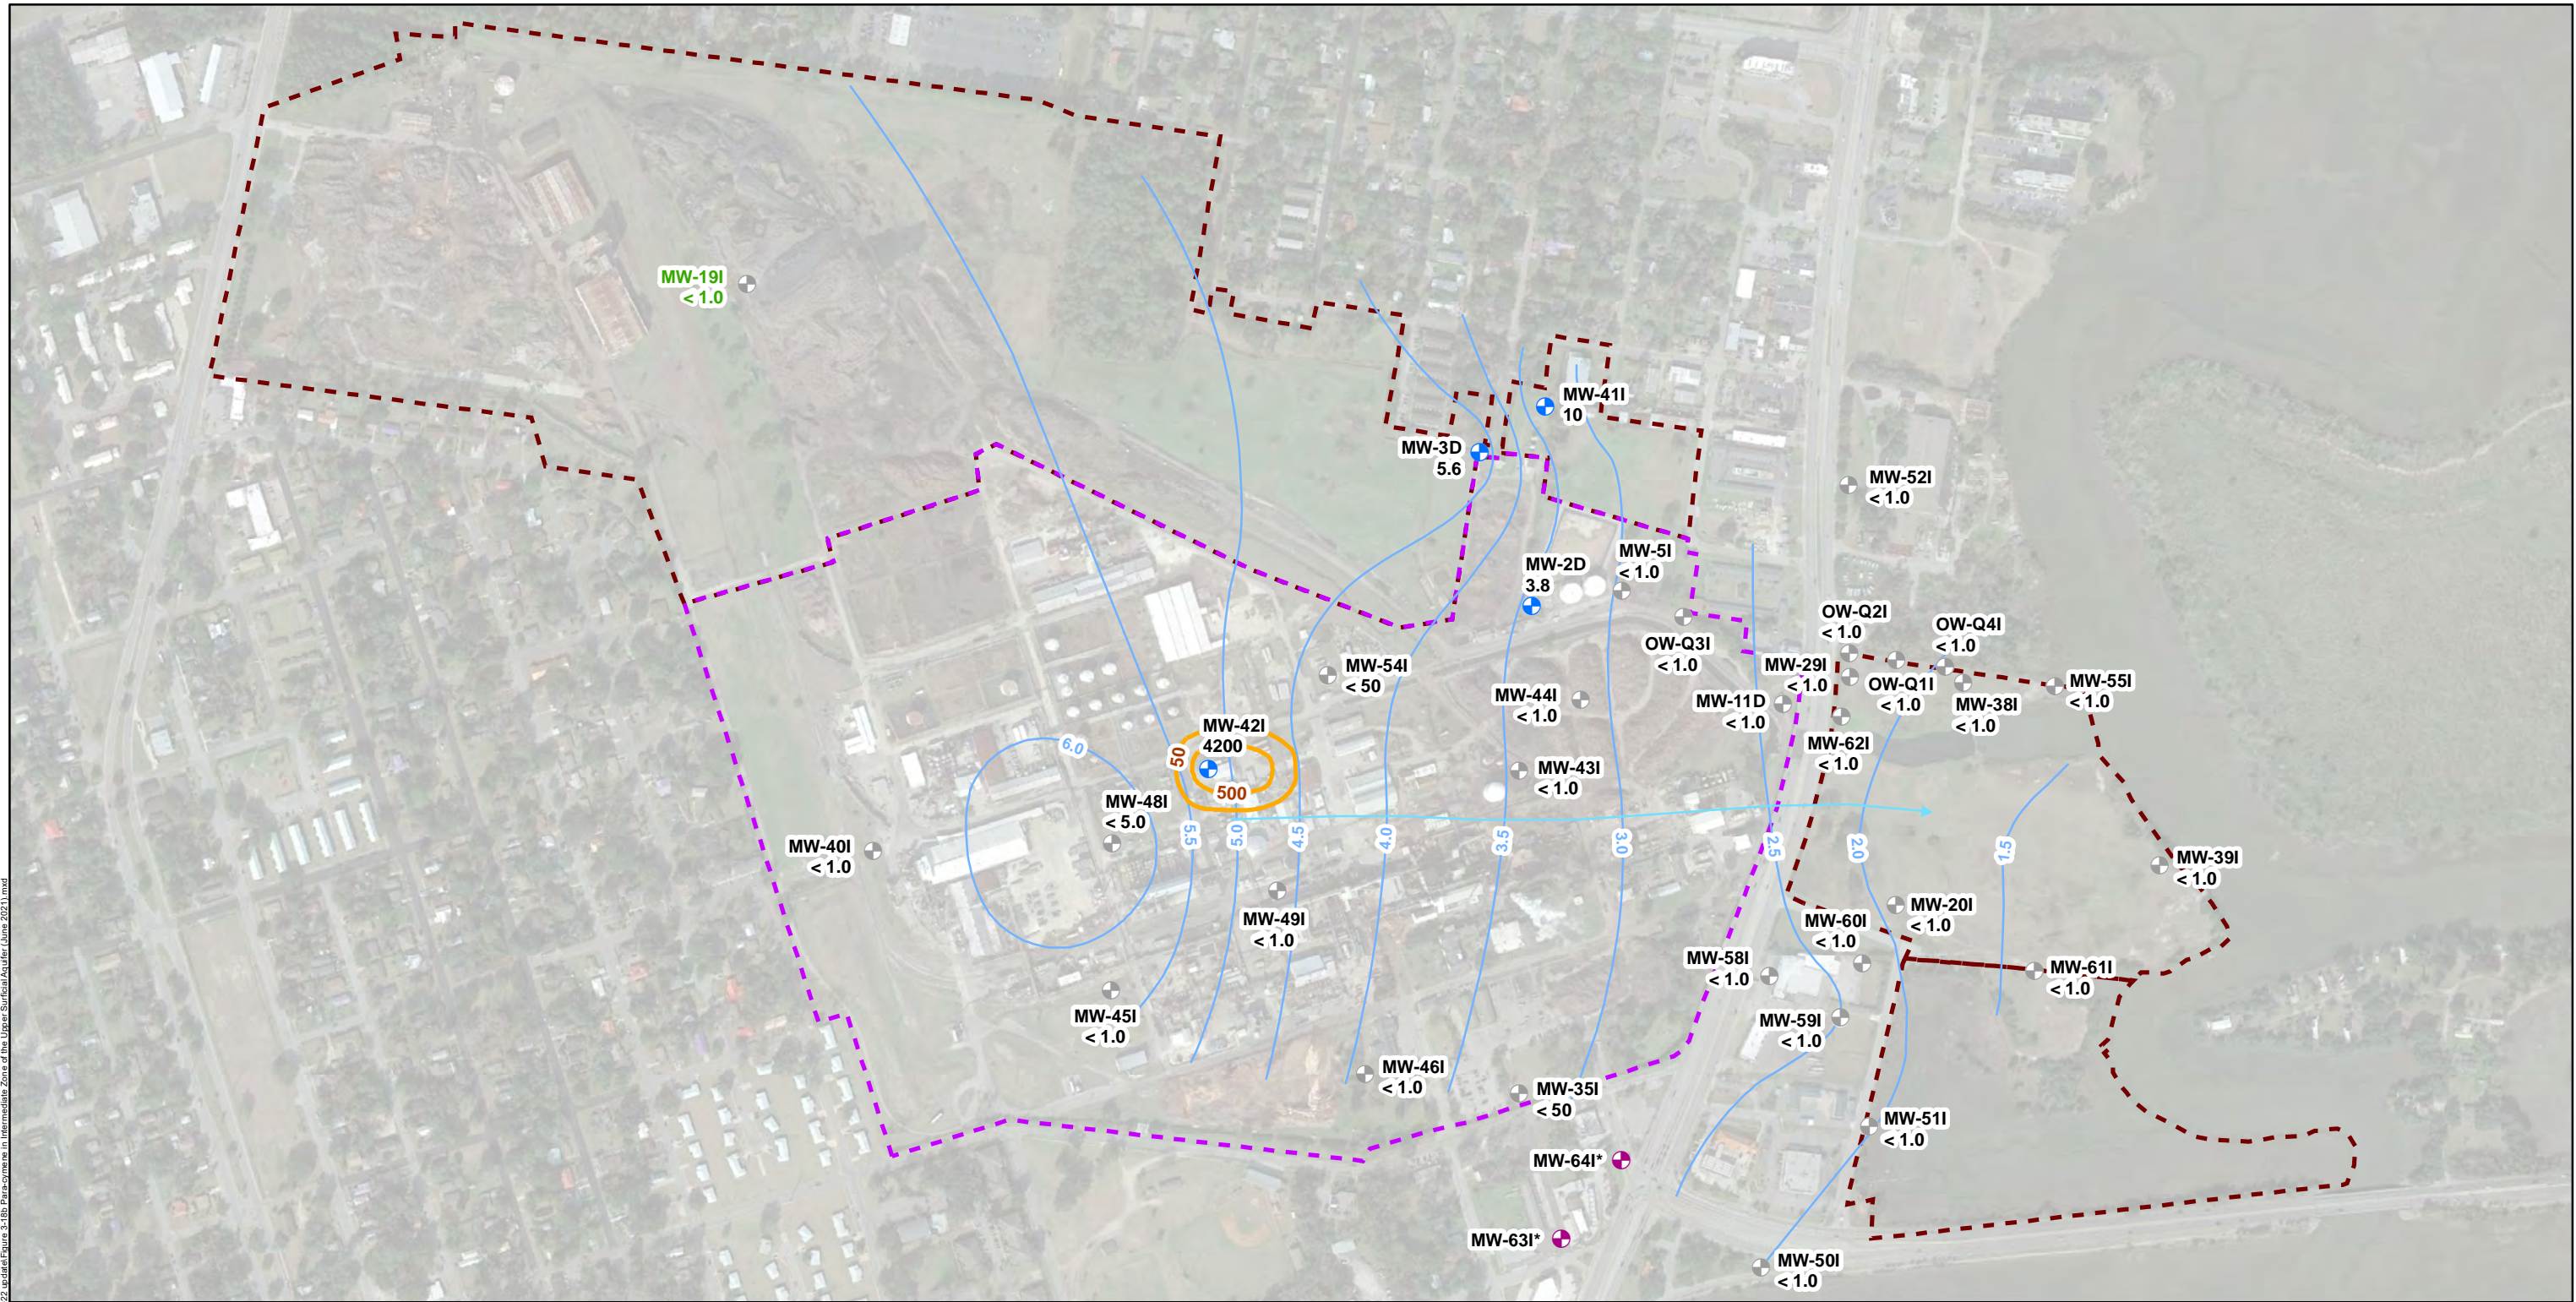
**Figure
3-18b**

Path: N:\H Hercules\Brunswick\GIS\MapDocs\Figures\August 2022 update\Figure 3-18b Para-cymene in Intermediate Zone of the Upper Surficial Aquifer (June 2021).mxd

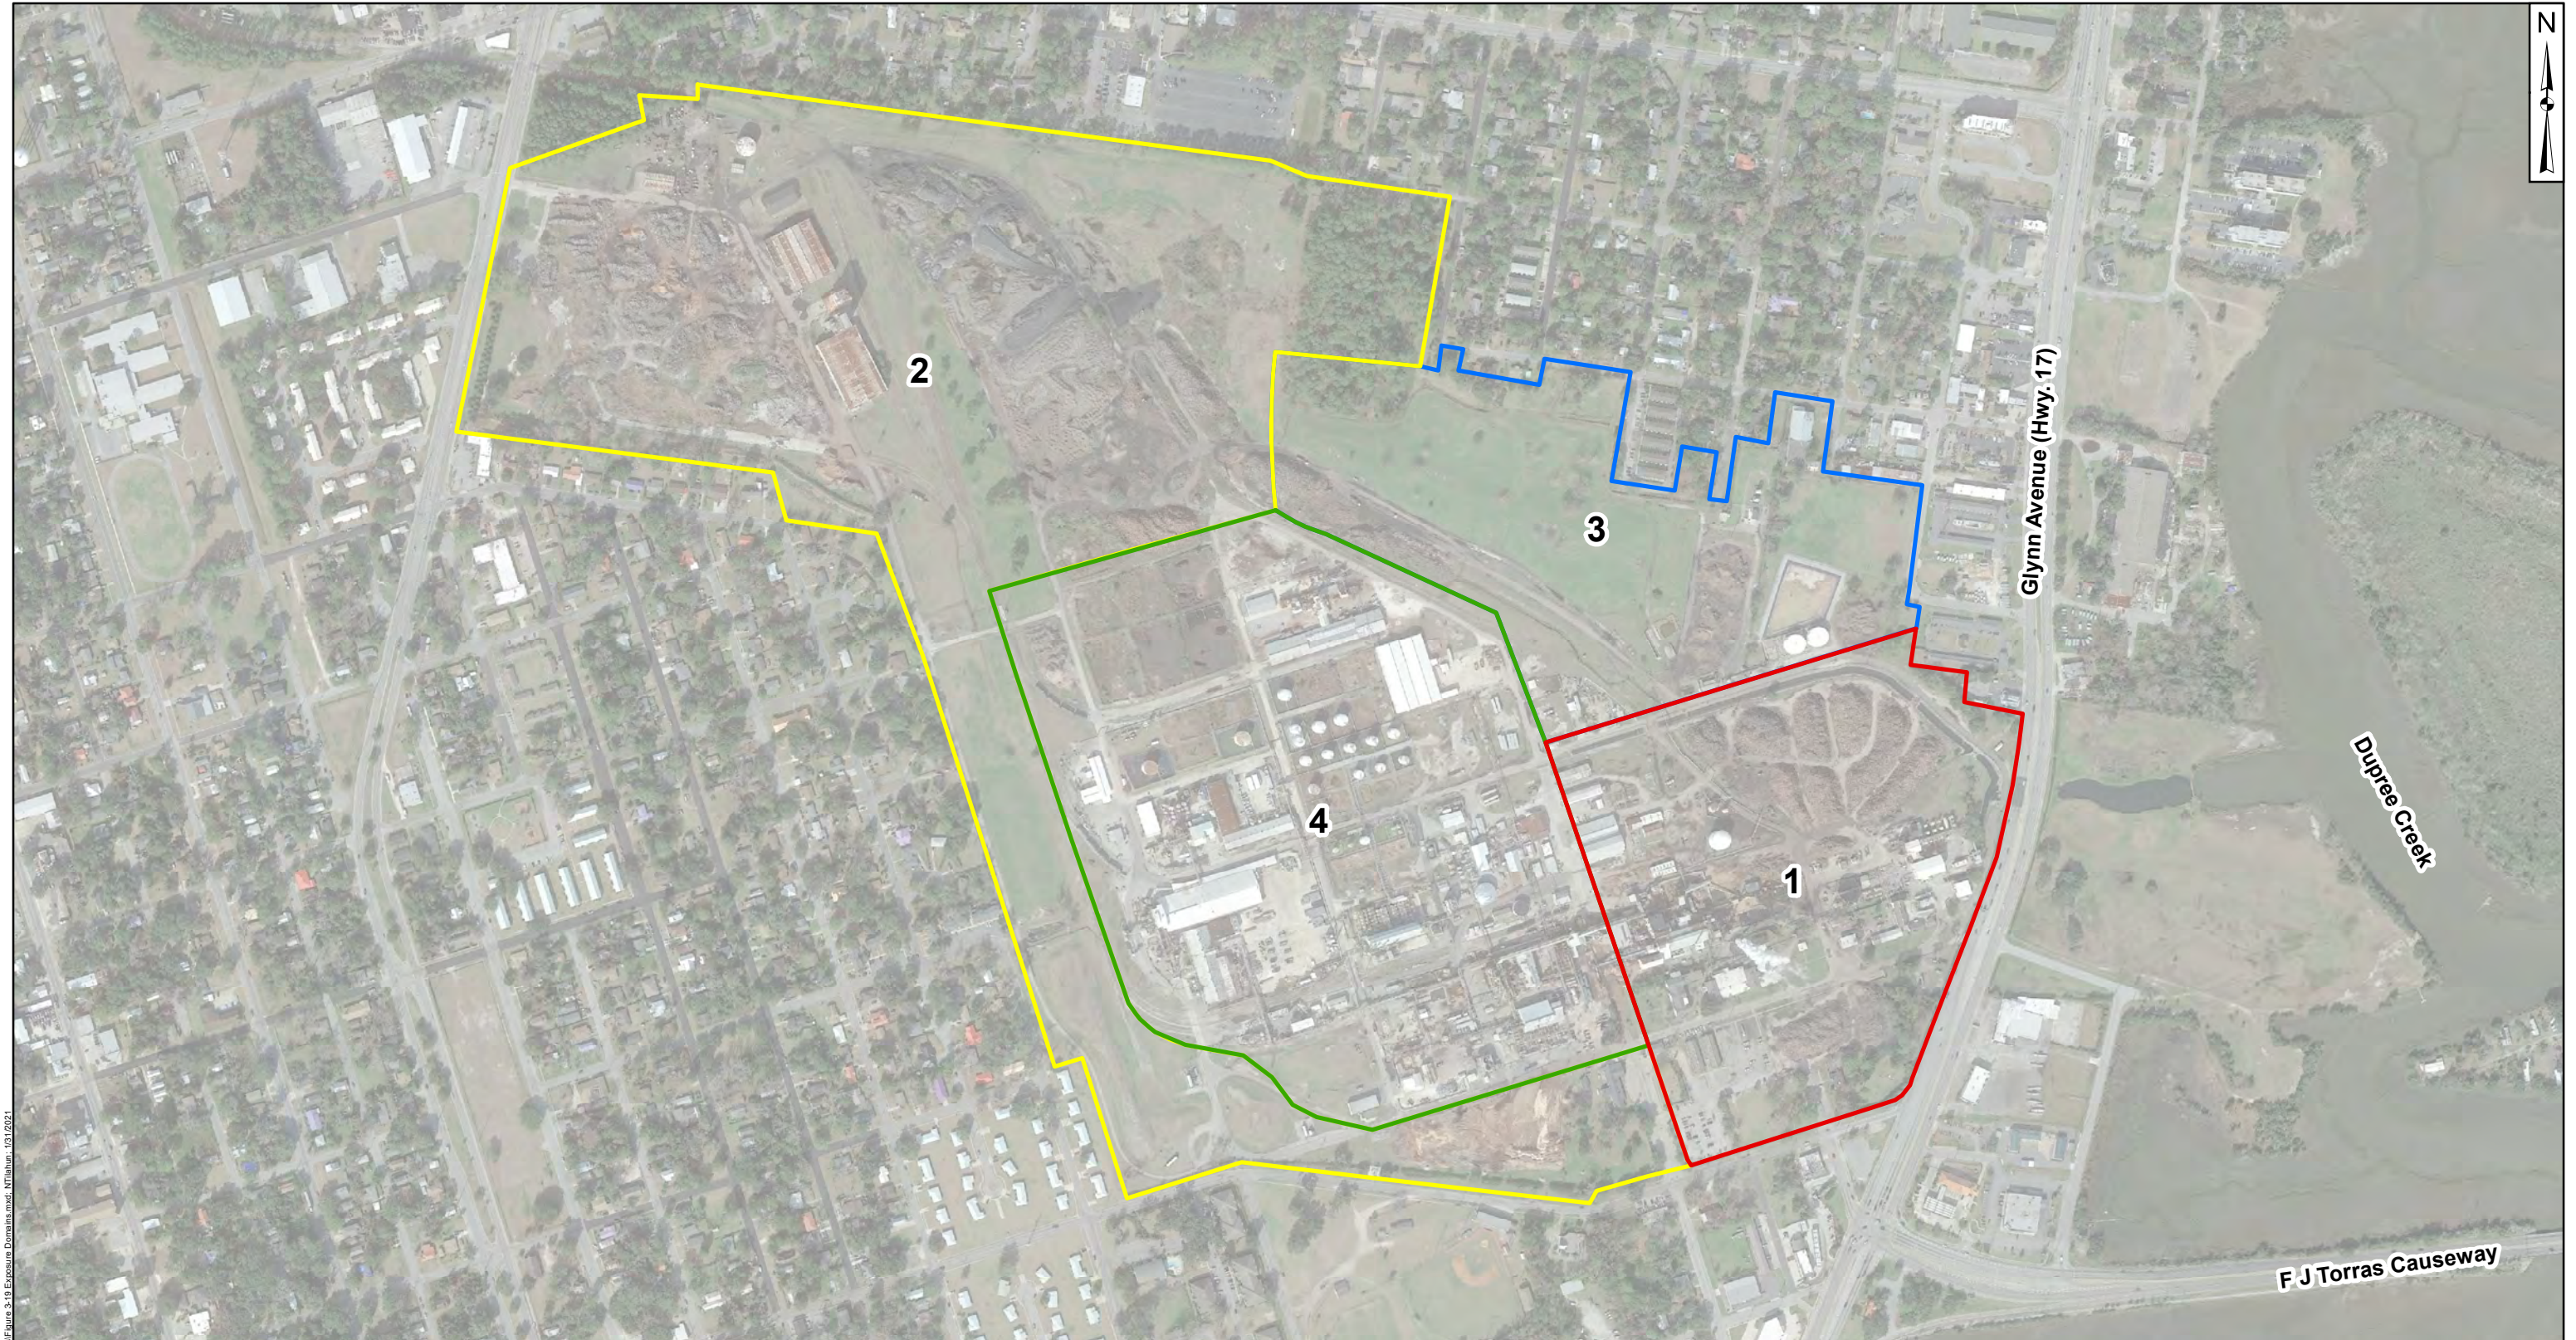
Figure
3-19

- Legend**
- Exposure Domains**
- Domain 1
 - Domain 2
 - Domain 3
 - Domain 4

As discussed in Section 2.3.2 of this CAP, Hercules completed the third phase of the RFI at the Brunswick facility using the Triad approach. The decision unit concept was introduced in 2012 during this process. Four decision units were developed and were used to help characterize soil conditions at the Brunswick facility (NewFields, 2012). The decision units were approved by EPD in the Phase III RFI Report for Soils with minor modifications and were then utilized as exposure domains as presented in the BHHRA and SLERA Report discussed in Section 2.4 of this CAP with the goal of evaluating potential risks from soils in each of the four exposure domains versus on a SWMU-by-SWMU basis. The exposure domains were based on proximity of the SWMUs to one another, and common types of activities and land uses within the Brunswick facility. The exposure domains are identified on **Figure 3-19**. The SWMUs

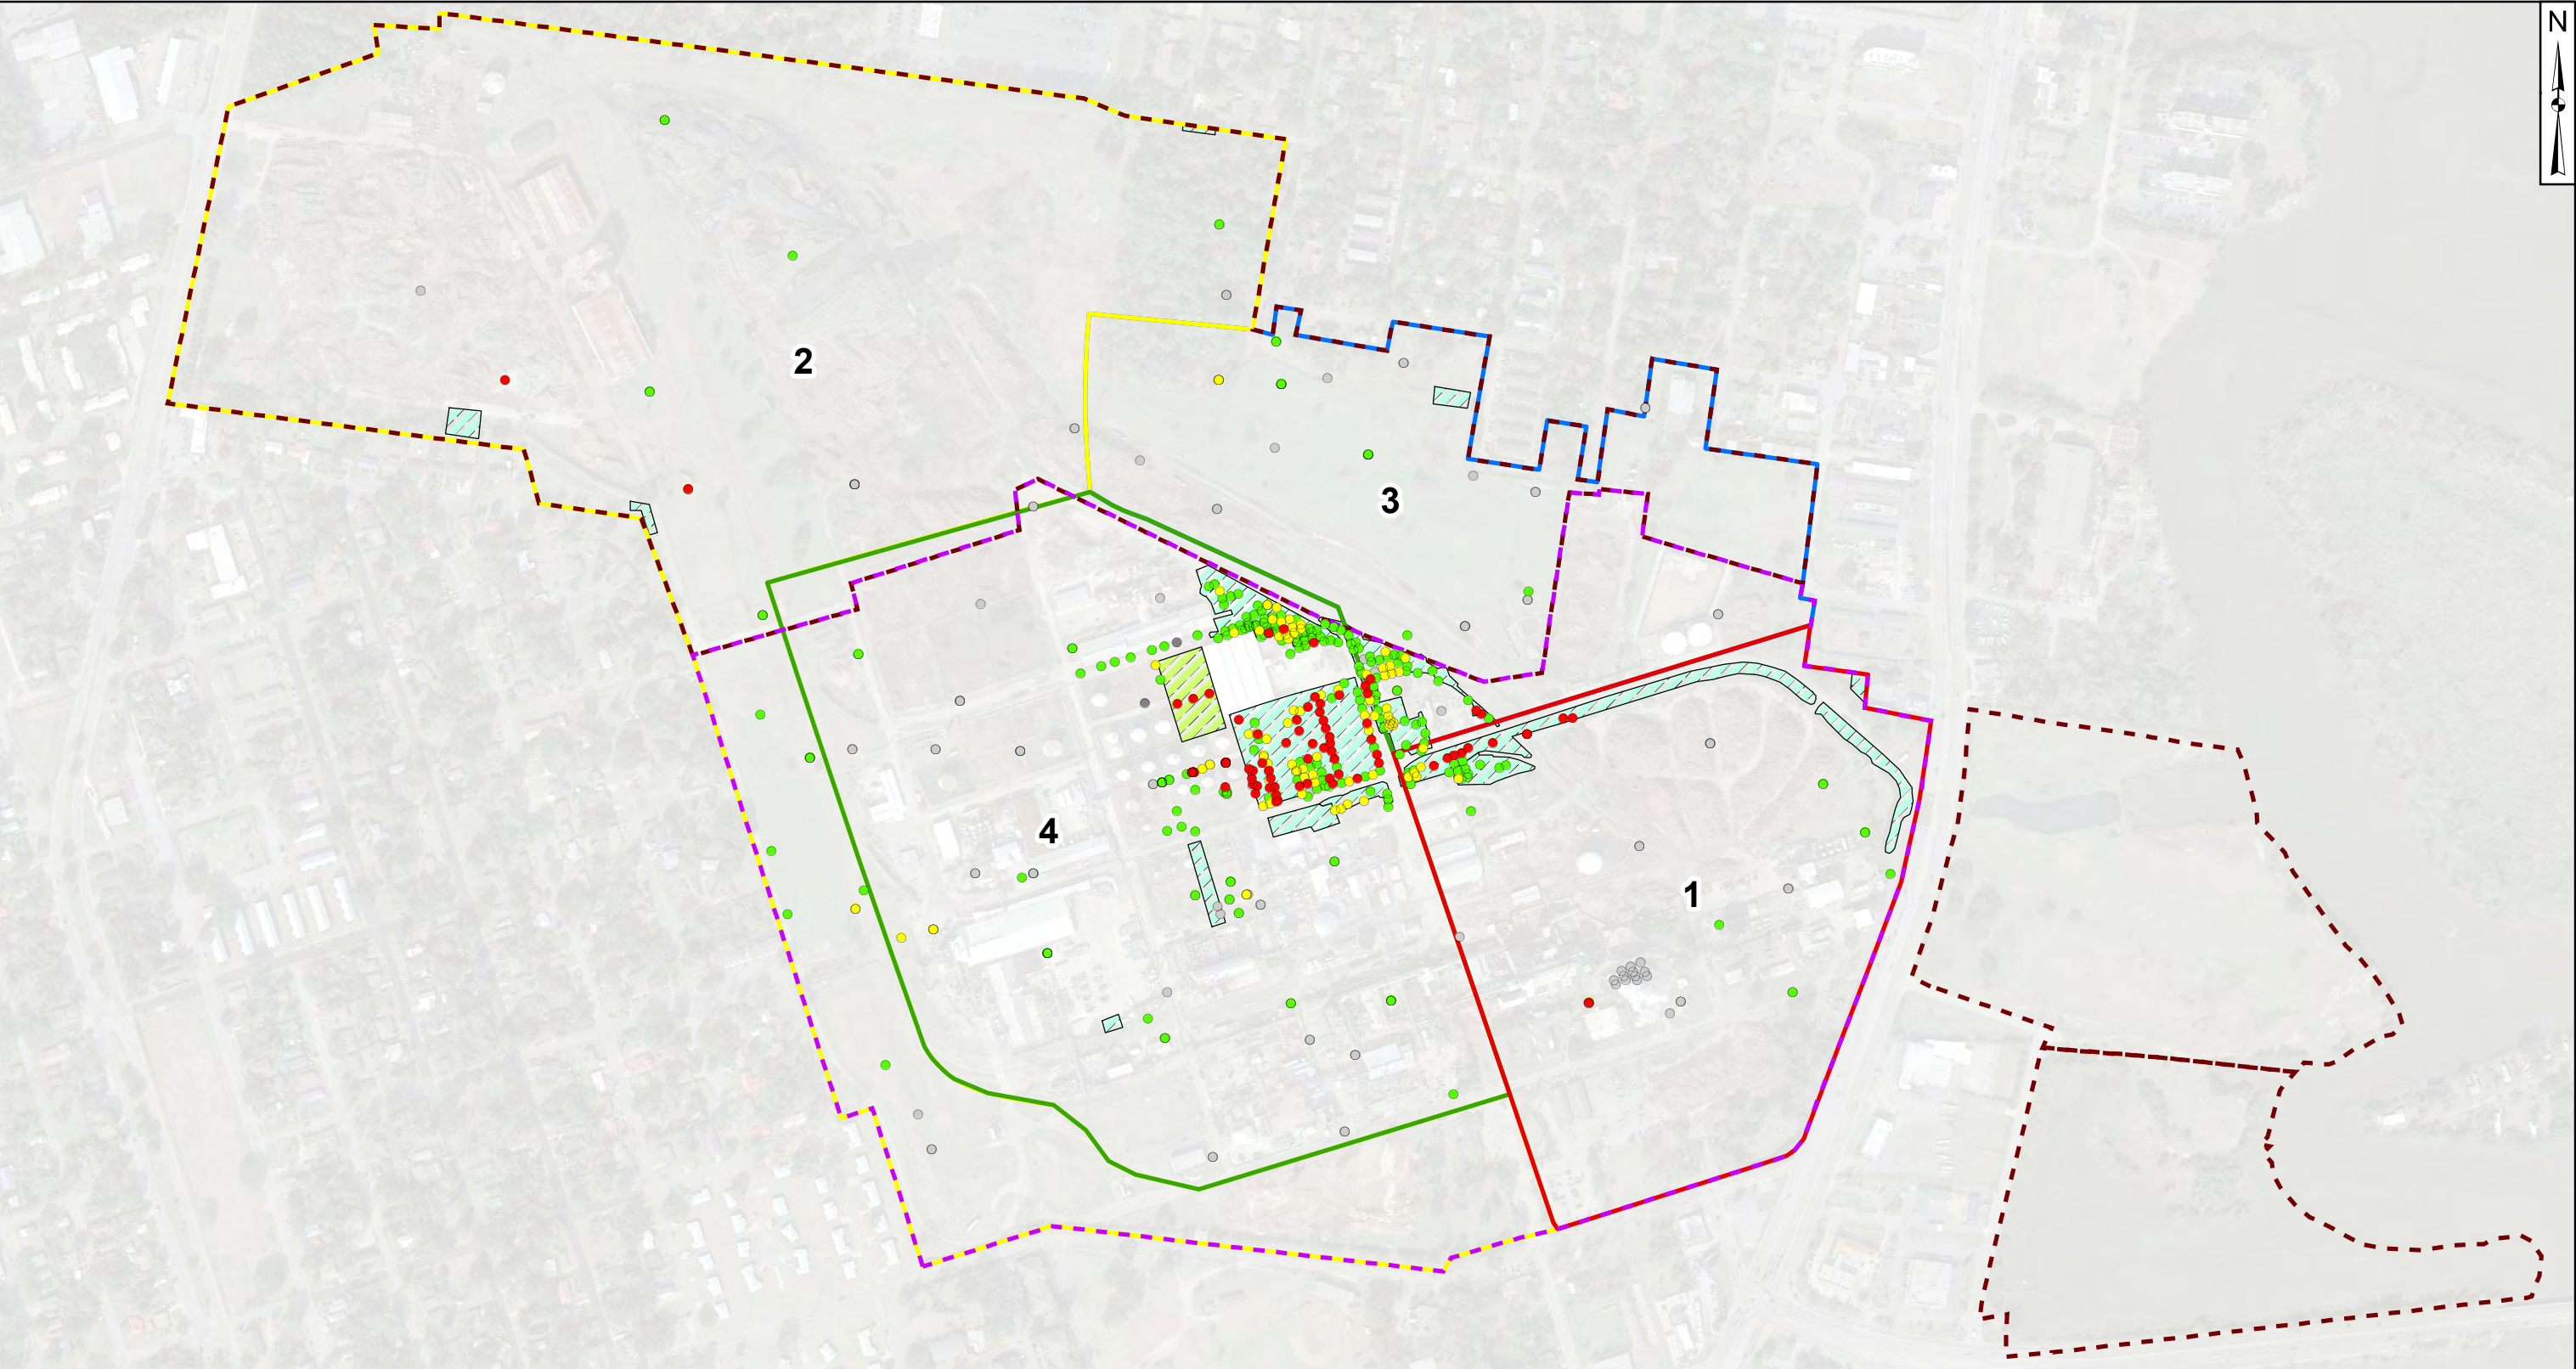
Legend <div><div><div><div></div><div>Pinova Property</div></div><div><div></div><div>Hercules Property</div></div><div><div></div><div>Excavated Areas</div></div><div><div></div><div>Solidified Soil Monolith</div></div></div><div>Exposure Domains<div><div><div></div><div>Domain 1</div></div><div><div></div><div>Domain 2</div></div><div><div></div><div>Domain 3</div></div><div><div></div><div>Domain 4</div></div></div></div></div>	Toxaphene Concentration (mg/kg) <table><tr><th>Not Detected</th><th>Detected</th></tr><tr><td><div>DL < 2.1</div><div>DL > 2.1 and < 21</div><div>DL > 21 and < 210</div></td><td><div>< 21</div><div>> 21 and < 210</div><div>> 210</div></td></tr></table>	Not Detected	Detected	<div>DL < 2.1</div> <div>DL > 2.1 and < 21</div> <div>DL > 21 and < 210</div>	<div>< 21</div> <div>> 21 and < 210</div> <div>> 210</div>	Toxaphene in Subsurface Soil Samples (>2 ft bgs) Hercules/Pinova Facility Brunswick, Georgia	
		Not Detected	Detected				
		<div>DL < 2.1</div> <div>DL > 2.1 and < 21</div> <div>DL > 21 and < 210</div>	<div>< 21</div> <div>> 21 and < 210</div> <div>> 210</div>				
<div><div><div>Geosyntec</div><div>consultants</div></div></div>		Figure 3-21					
		Kennesaw, GA	January 2022
