RE: **Corrective Action Plan
Hercules LLC/Pinova Inc. - Brunswick Facility
Hazardous Waste Facility Permit No. HW-52(D&S)-2,
EPA ID No. GAD00406065520**

CORRECTIVE ACTION PLAN

HERCULES LLC/PINOVA INC. FACILITY

BRUNSWICK, GEORGIA

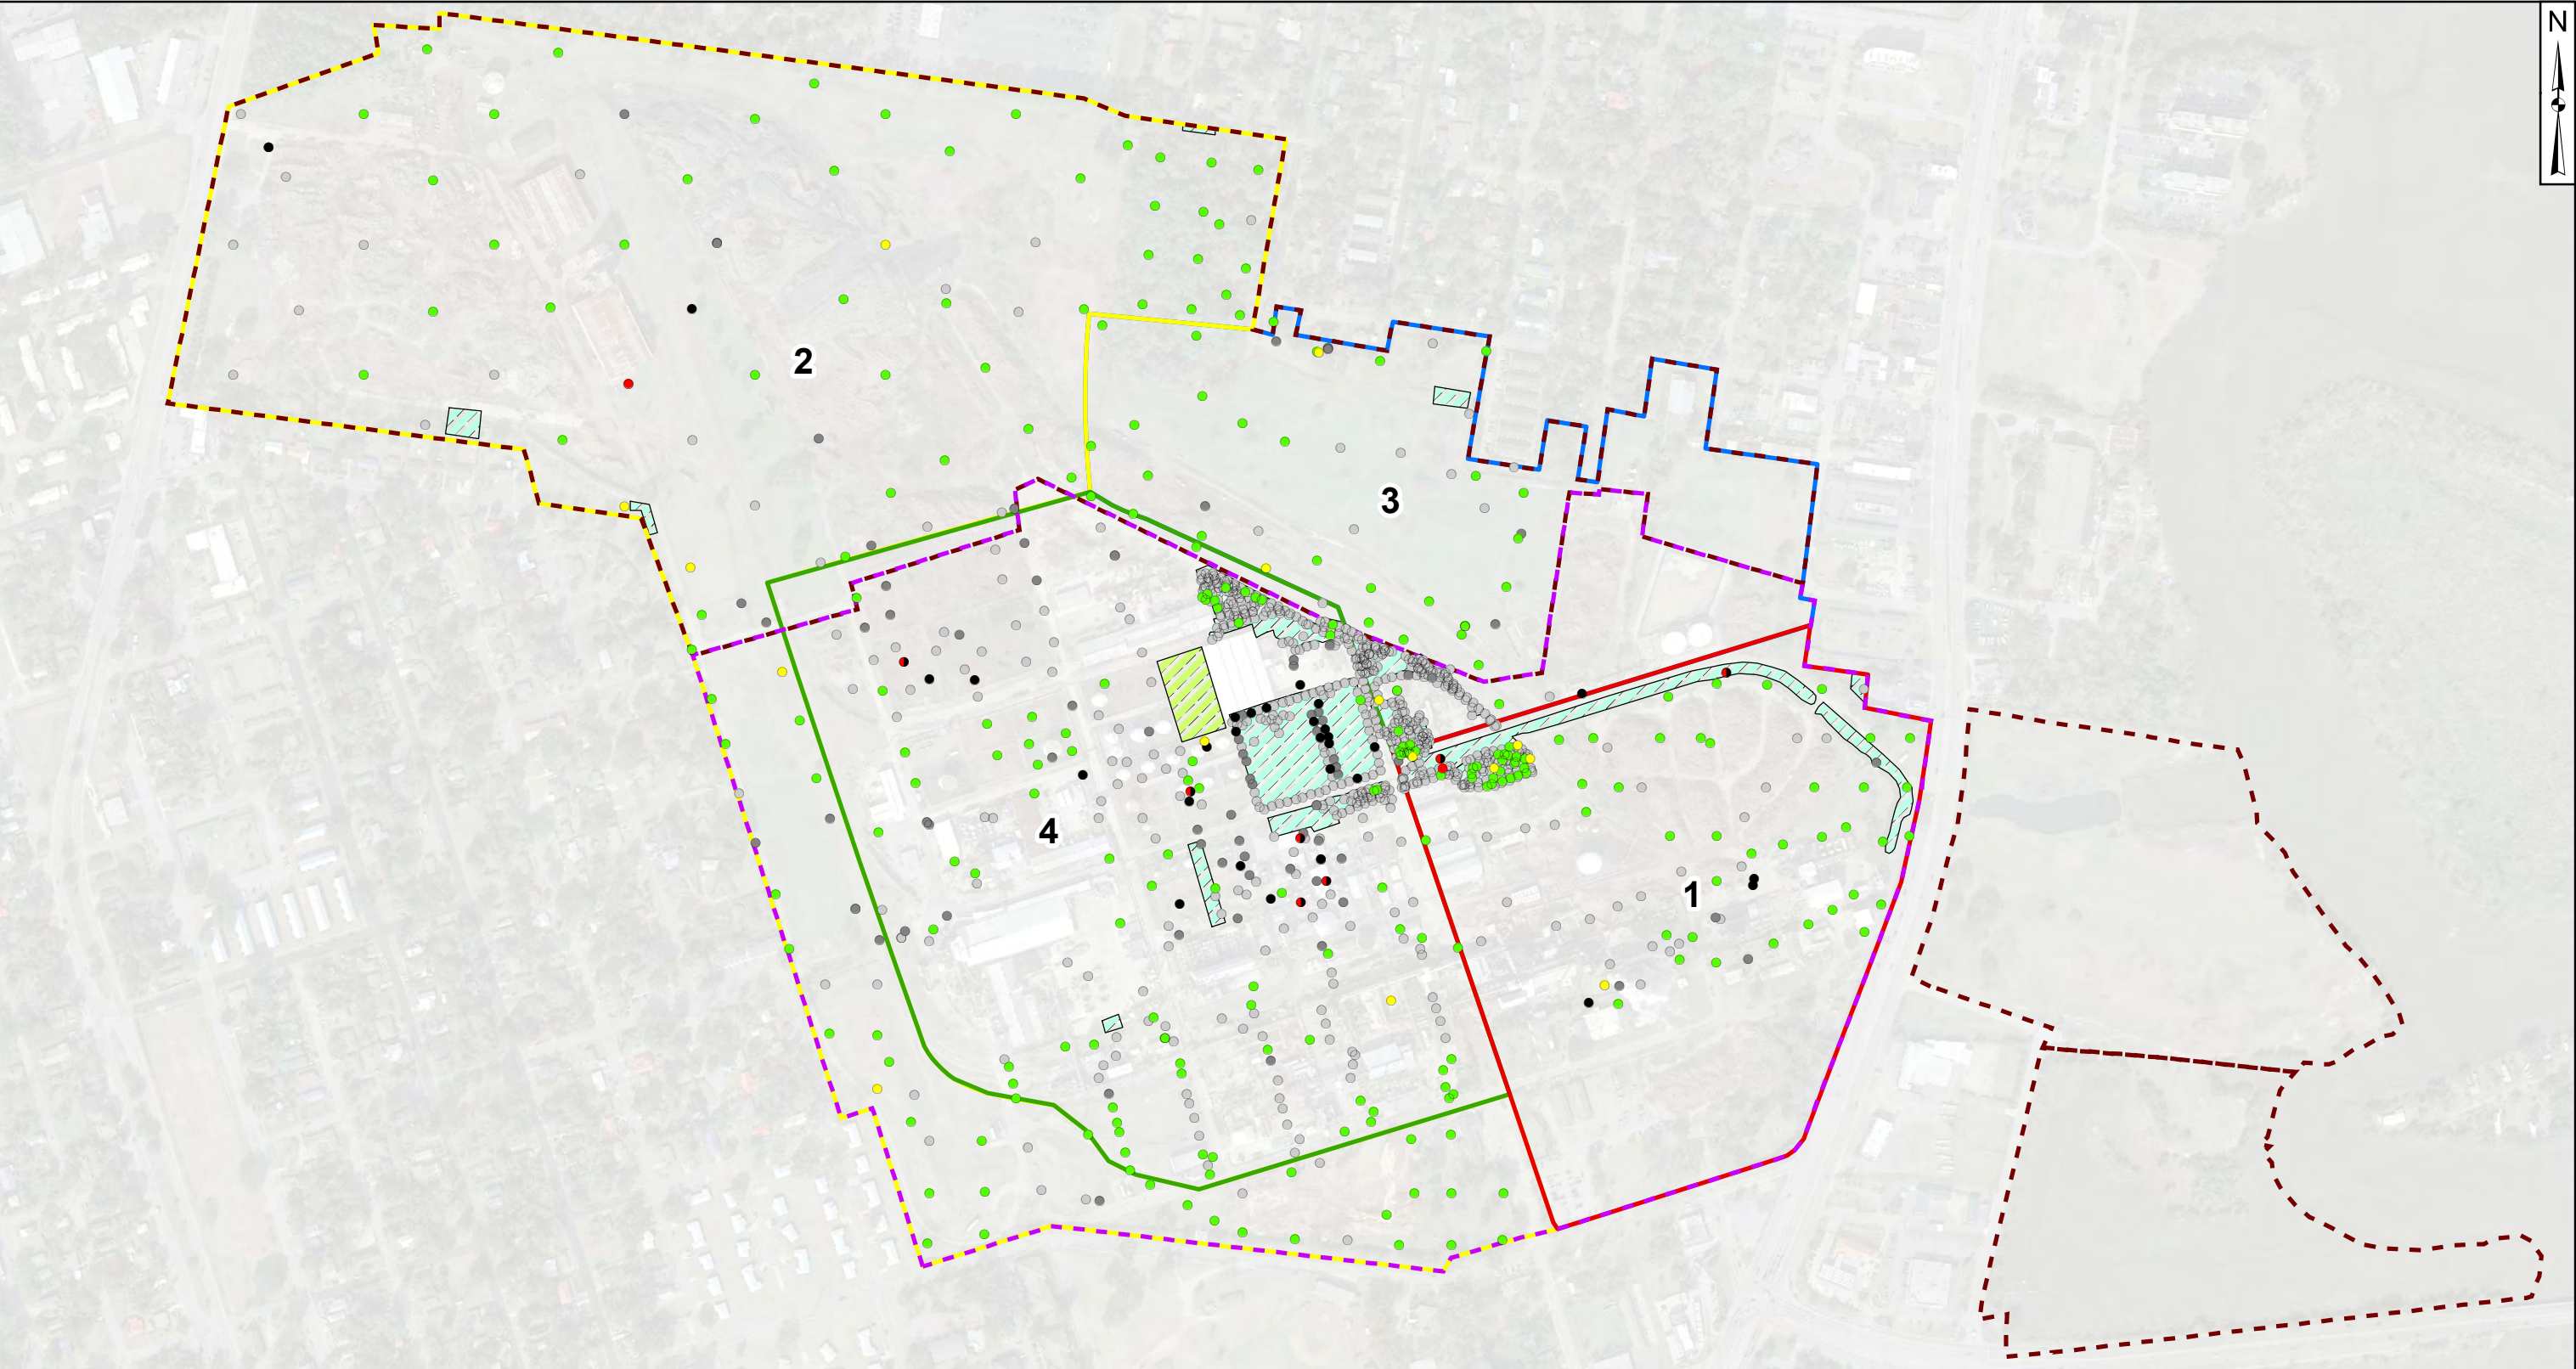
Legend		Exposure Domains		Dieldrin Concentration (mg/kg)		Dieldrin in Surface Soil Samples (0-2 ft bgs)	
<div><div></div> Pinova Property</div> <div><div></div> Hercules Property</div> <div><div></div> Excavated Areas</div> <div><div></div> Solidified Soil Monolith</div>		<div><div></div> Domain 1</div> <div><div></div> Domain 2</div> <div><div></div> Domain 3</div> <div><div></div> Domain 4</div>		<div><div>●</div> DL < 0.14</div> <div><div>●</div> DL > 0.14 and < 1.4</div> <div><div>●</div> DL > 1.4 and < 14</div> <div><div>●</div> DL > 14</div> <div><div>●</div> < 1.4</div> <div><div>●</div> > 1.4 and < 14</div> <div><div>●</div> > 14</div>		<div>Hercules/Pinova Facility Brunswick, Georgia</div> <div><div>Geosyntec</div><div>consultants</div></div> <div><div>Kennesaw, GA</div><div>January 2022</div></div>	
Notes: 1. ft bgs = feet below ground surface. 2. DL = detection limit 3. mg/kg = milligrams per kilogram 4. The concentration color coding categories are based on the Regional Screening Level (RSL) for dieldrin developed by the United States Environmental Protection Agency and indicate relative distributions of dieldrin in soils. 5. Aerial photograph approximate date - January 2019. Source: Google Earth.						Figure 3-22

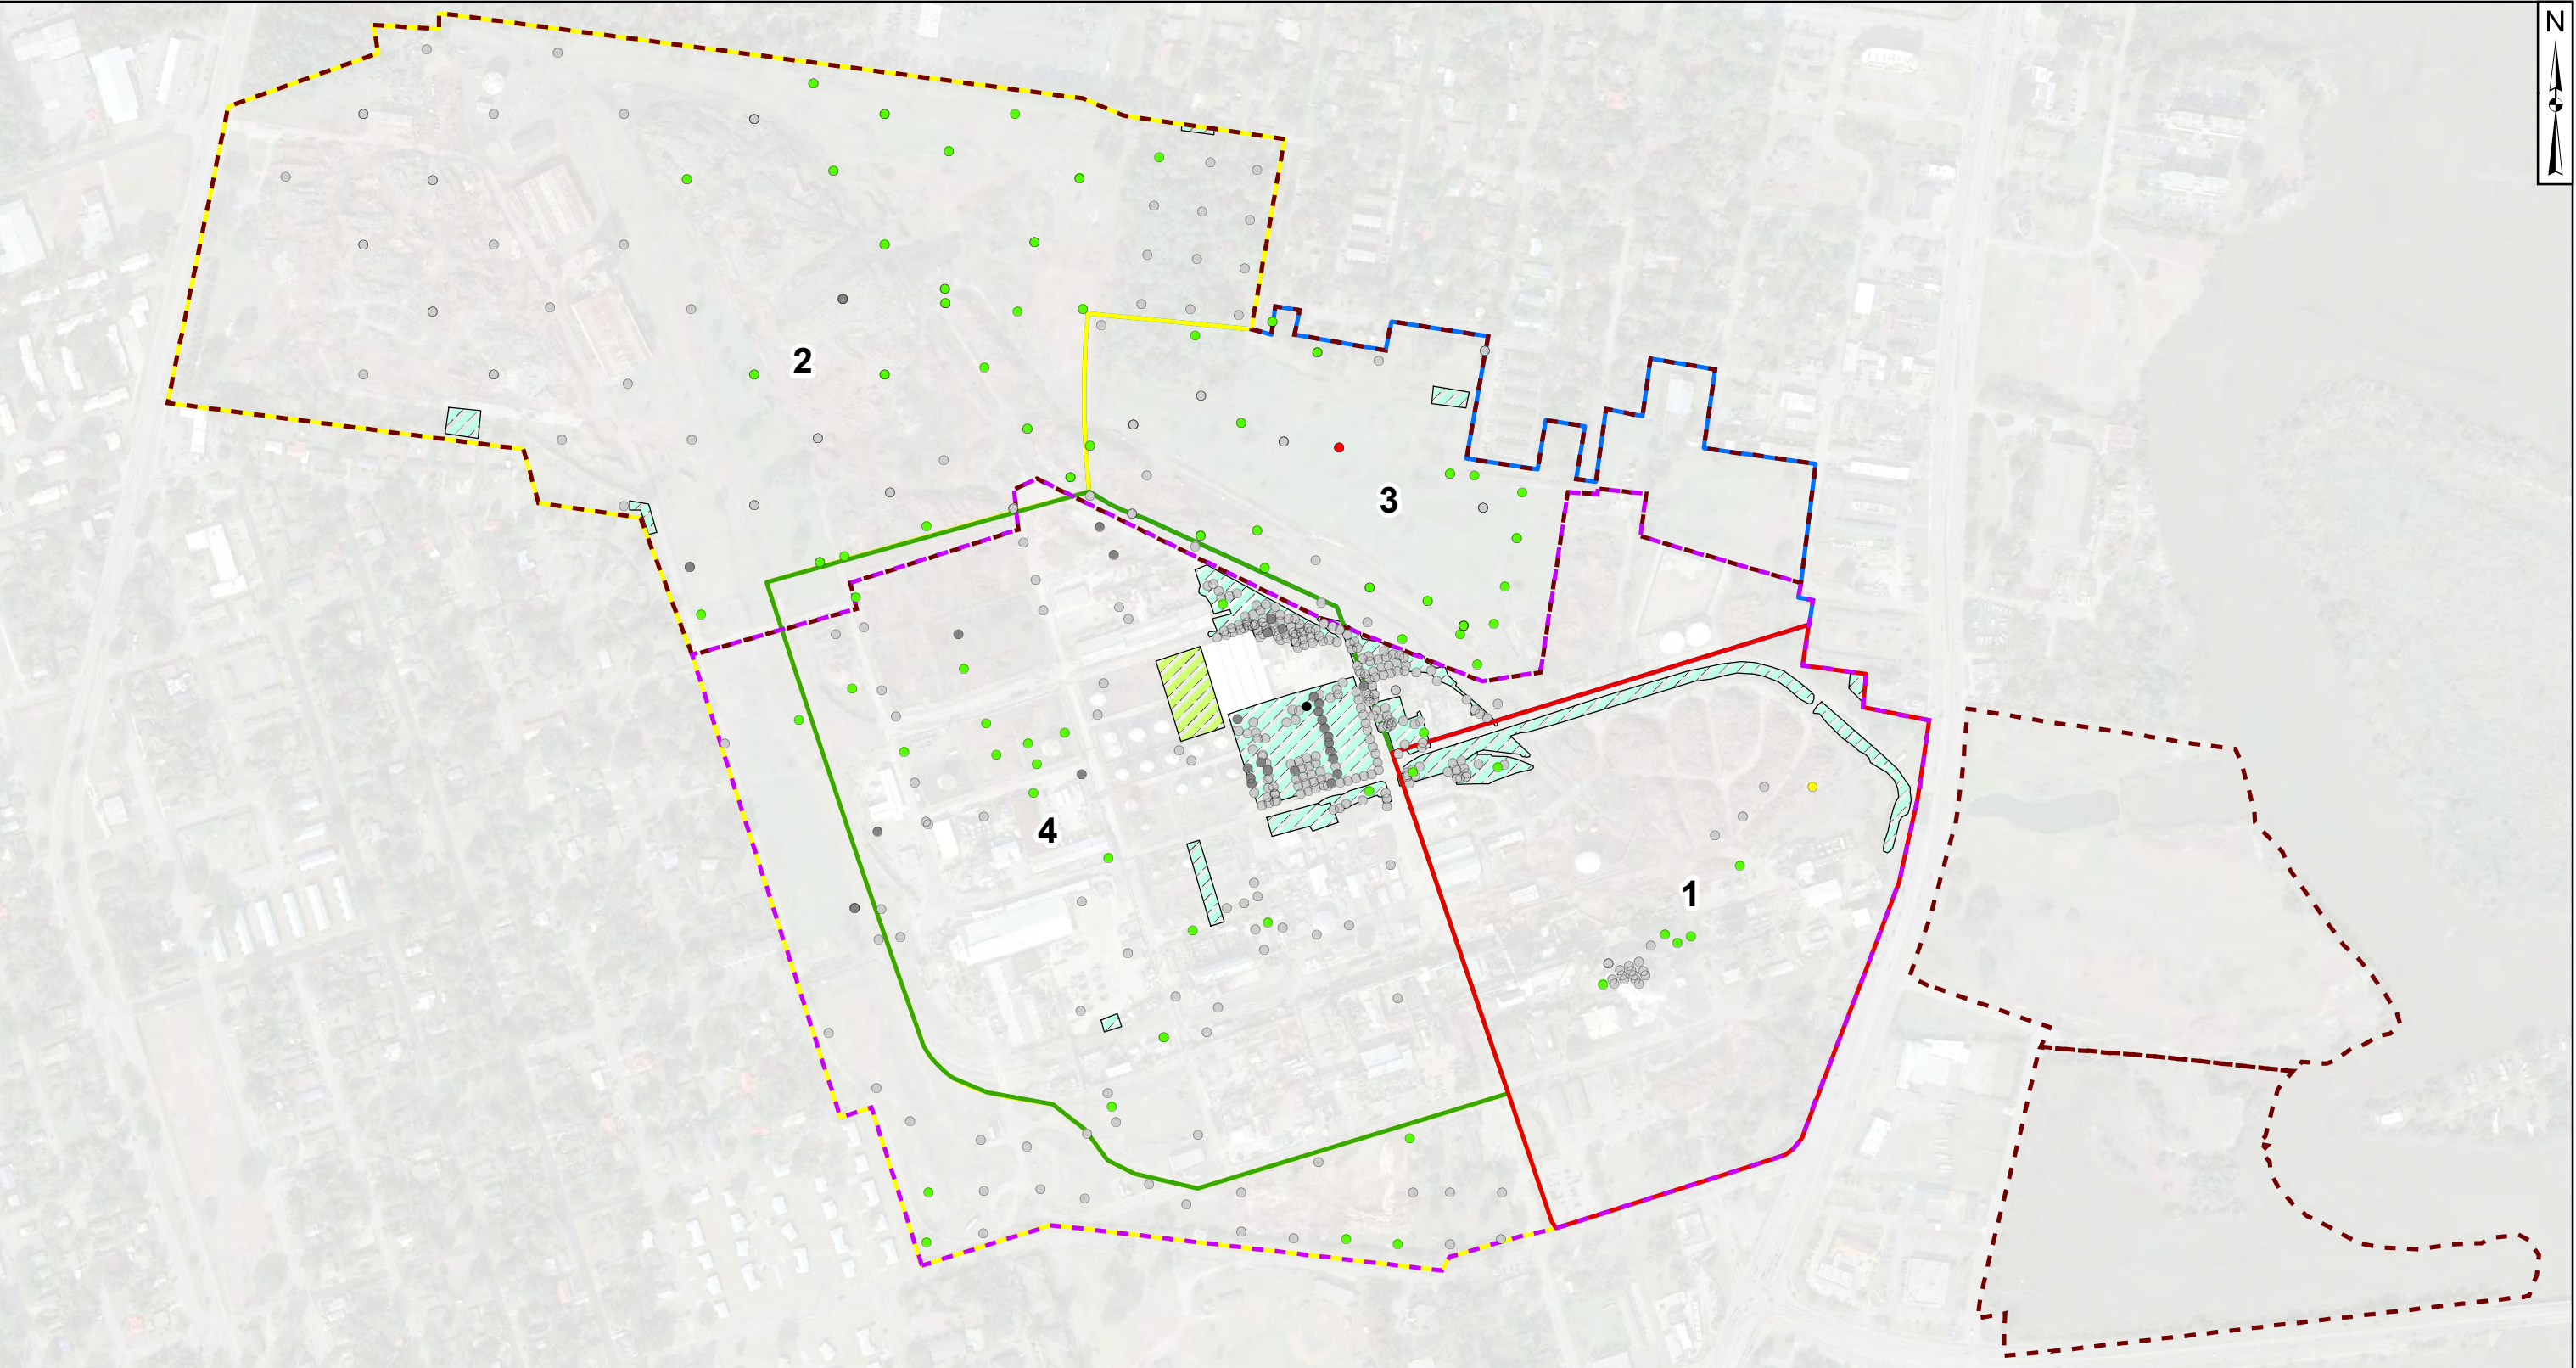
Figure
3-23

- Pinova Property
- Hercules Property
- Excavated Areas
- Solidified Soil Monolith

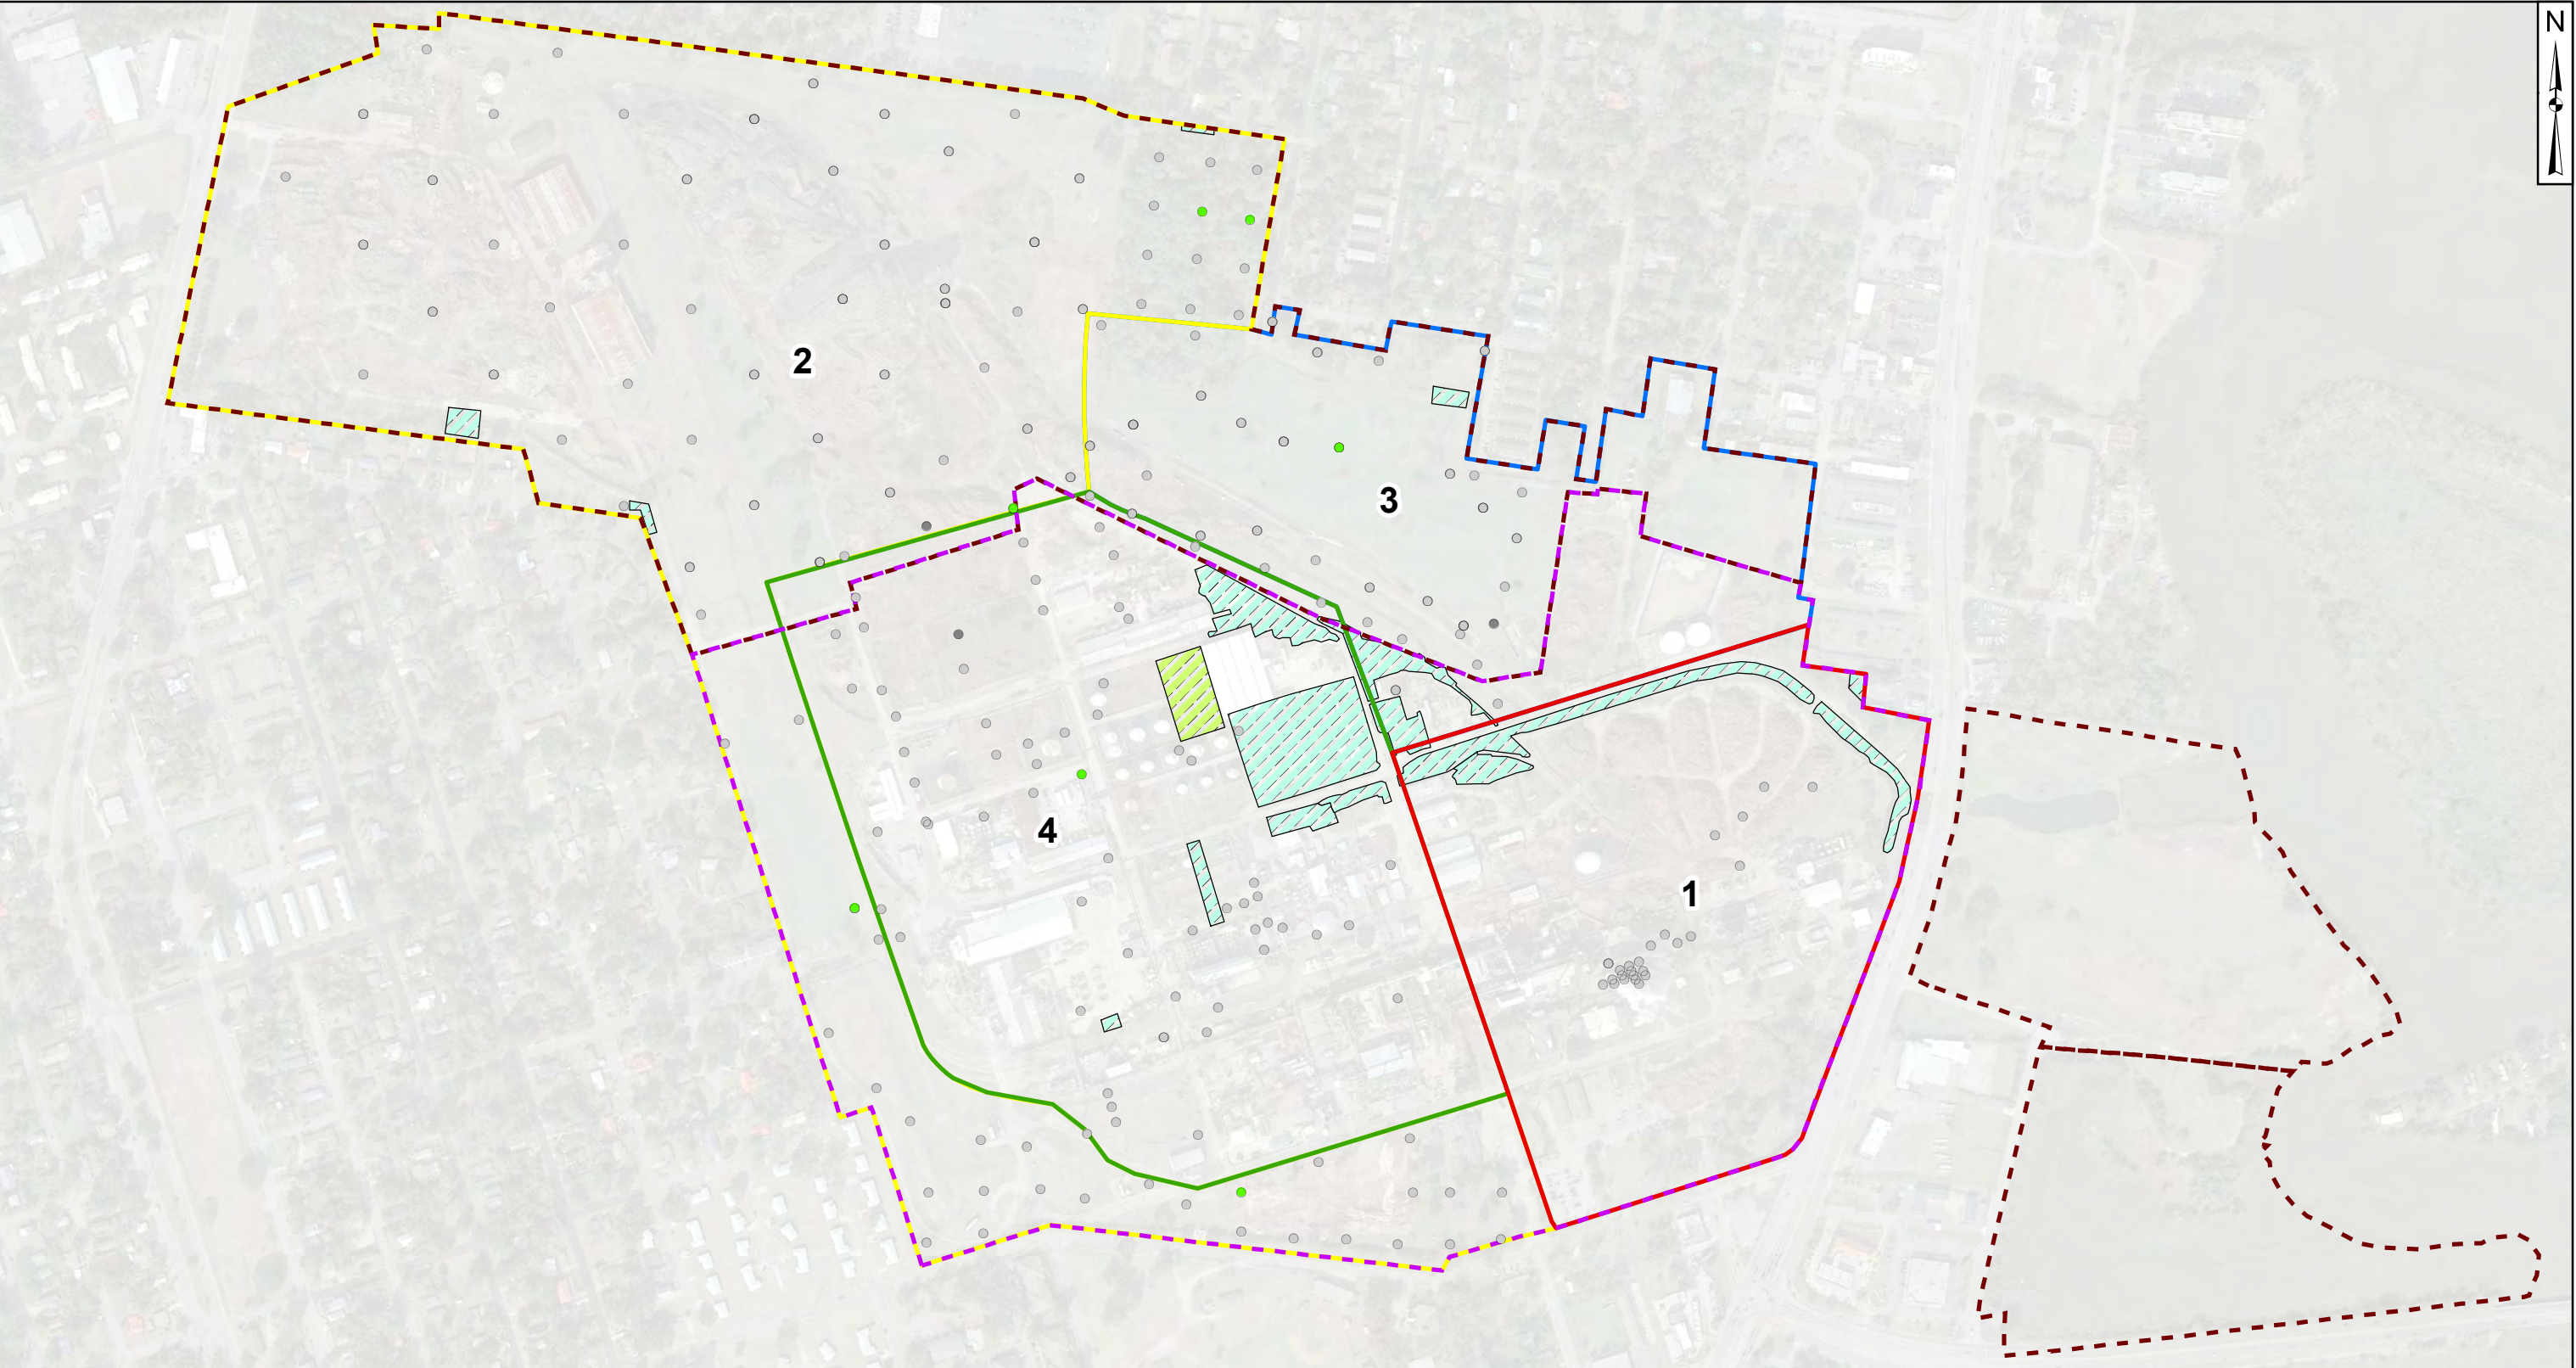
Legend <div><div><div><div></div><div>Pinova Property</div></div><div><div></div><div>Hercules Property</div></div><div><div></div><div>Excavated Areas</div></div><div><div></div><div>Solidified Soil Monolith</div></div></div><div>Exposure Domains<div><div></div><div>Domain 1</div></div><div><div></div><div>Domain 2</div></div><div><div></div><div>Domain 3</div></div><div><div></div><div>Domain 4</div></div></div></div> <td>alpha-BHC Concentration (mg/kg)<div><div>Not Detected<div><div></div><div>DL < 0.36</div></div><div><div></div><div>DL > 0.36 and < 3.6</div></div><div><div></div><div>DL > 3.6 and < 36</div></div><div><div></div><div>DL > 36</div></div></div><div>Detected<div><div></div><div>< 3.6</div></div></div></div></td> <td>Notes:<div>1. ft bgs = feet below ground surface.</div><div>2. DL = detection limit</div><div>3. mg/kg = milligrams per kilogram</div><div>4. The concentration color coding categories are based on the Regional Screening Level (RSL) for alpha-BHC developed by the United States Environmental Protection Agency and indicate relative distributions of alpha-BHC in soils.</div><div>5. Aerial photograph approximate date - January 2019. Source: Google Earth.</div></td> <td colspan="2">alpha-BHC in Subsurface Soil Samples (>2 ft bgs)<div>Hercules/Pinova Facility Brunswick, Georgia</div></td> <td rowspan="3">Figure 3-25</td>	alpha-BHC Concentration (mg/kg) <div><div>Not Detected<div><div></div><div>DL < 0.36</div></div><div><div></div><div>DL > 0.36 and < 3.6</div></div><div><div></div><div>DL > 3.6 and < 36</div></div><div><div></div><div>DL > 36</div></div></div><div>Detected<div><div></div><div>< 3.6</div></div></div></div>	Notes: <div>1. ft bgs = feet below ground surface.</div> <div>2. DL = detection limit</div> <div>3. mg/kg = milligrams per kilogram</div> <div>4. The concentration color coding categories are based on the Regional Screening Level (RSL) for alpha-BHC developed by the United States Environmental Protection Agency and indicate relative distributions of alpha-BHC in soils.</div> <div>5. Aerial photograph approximate date - January 2019. Source: Google Earth.</div>	alpha-BHC in Subsurface Soil Samples (>2 ft bgs) <div>Hercules/Pinova Facility Brunswick, Georgia</div>		Figure 3-25

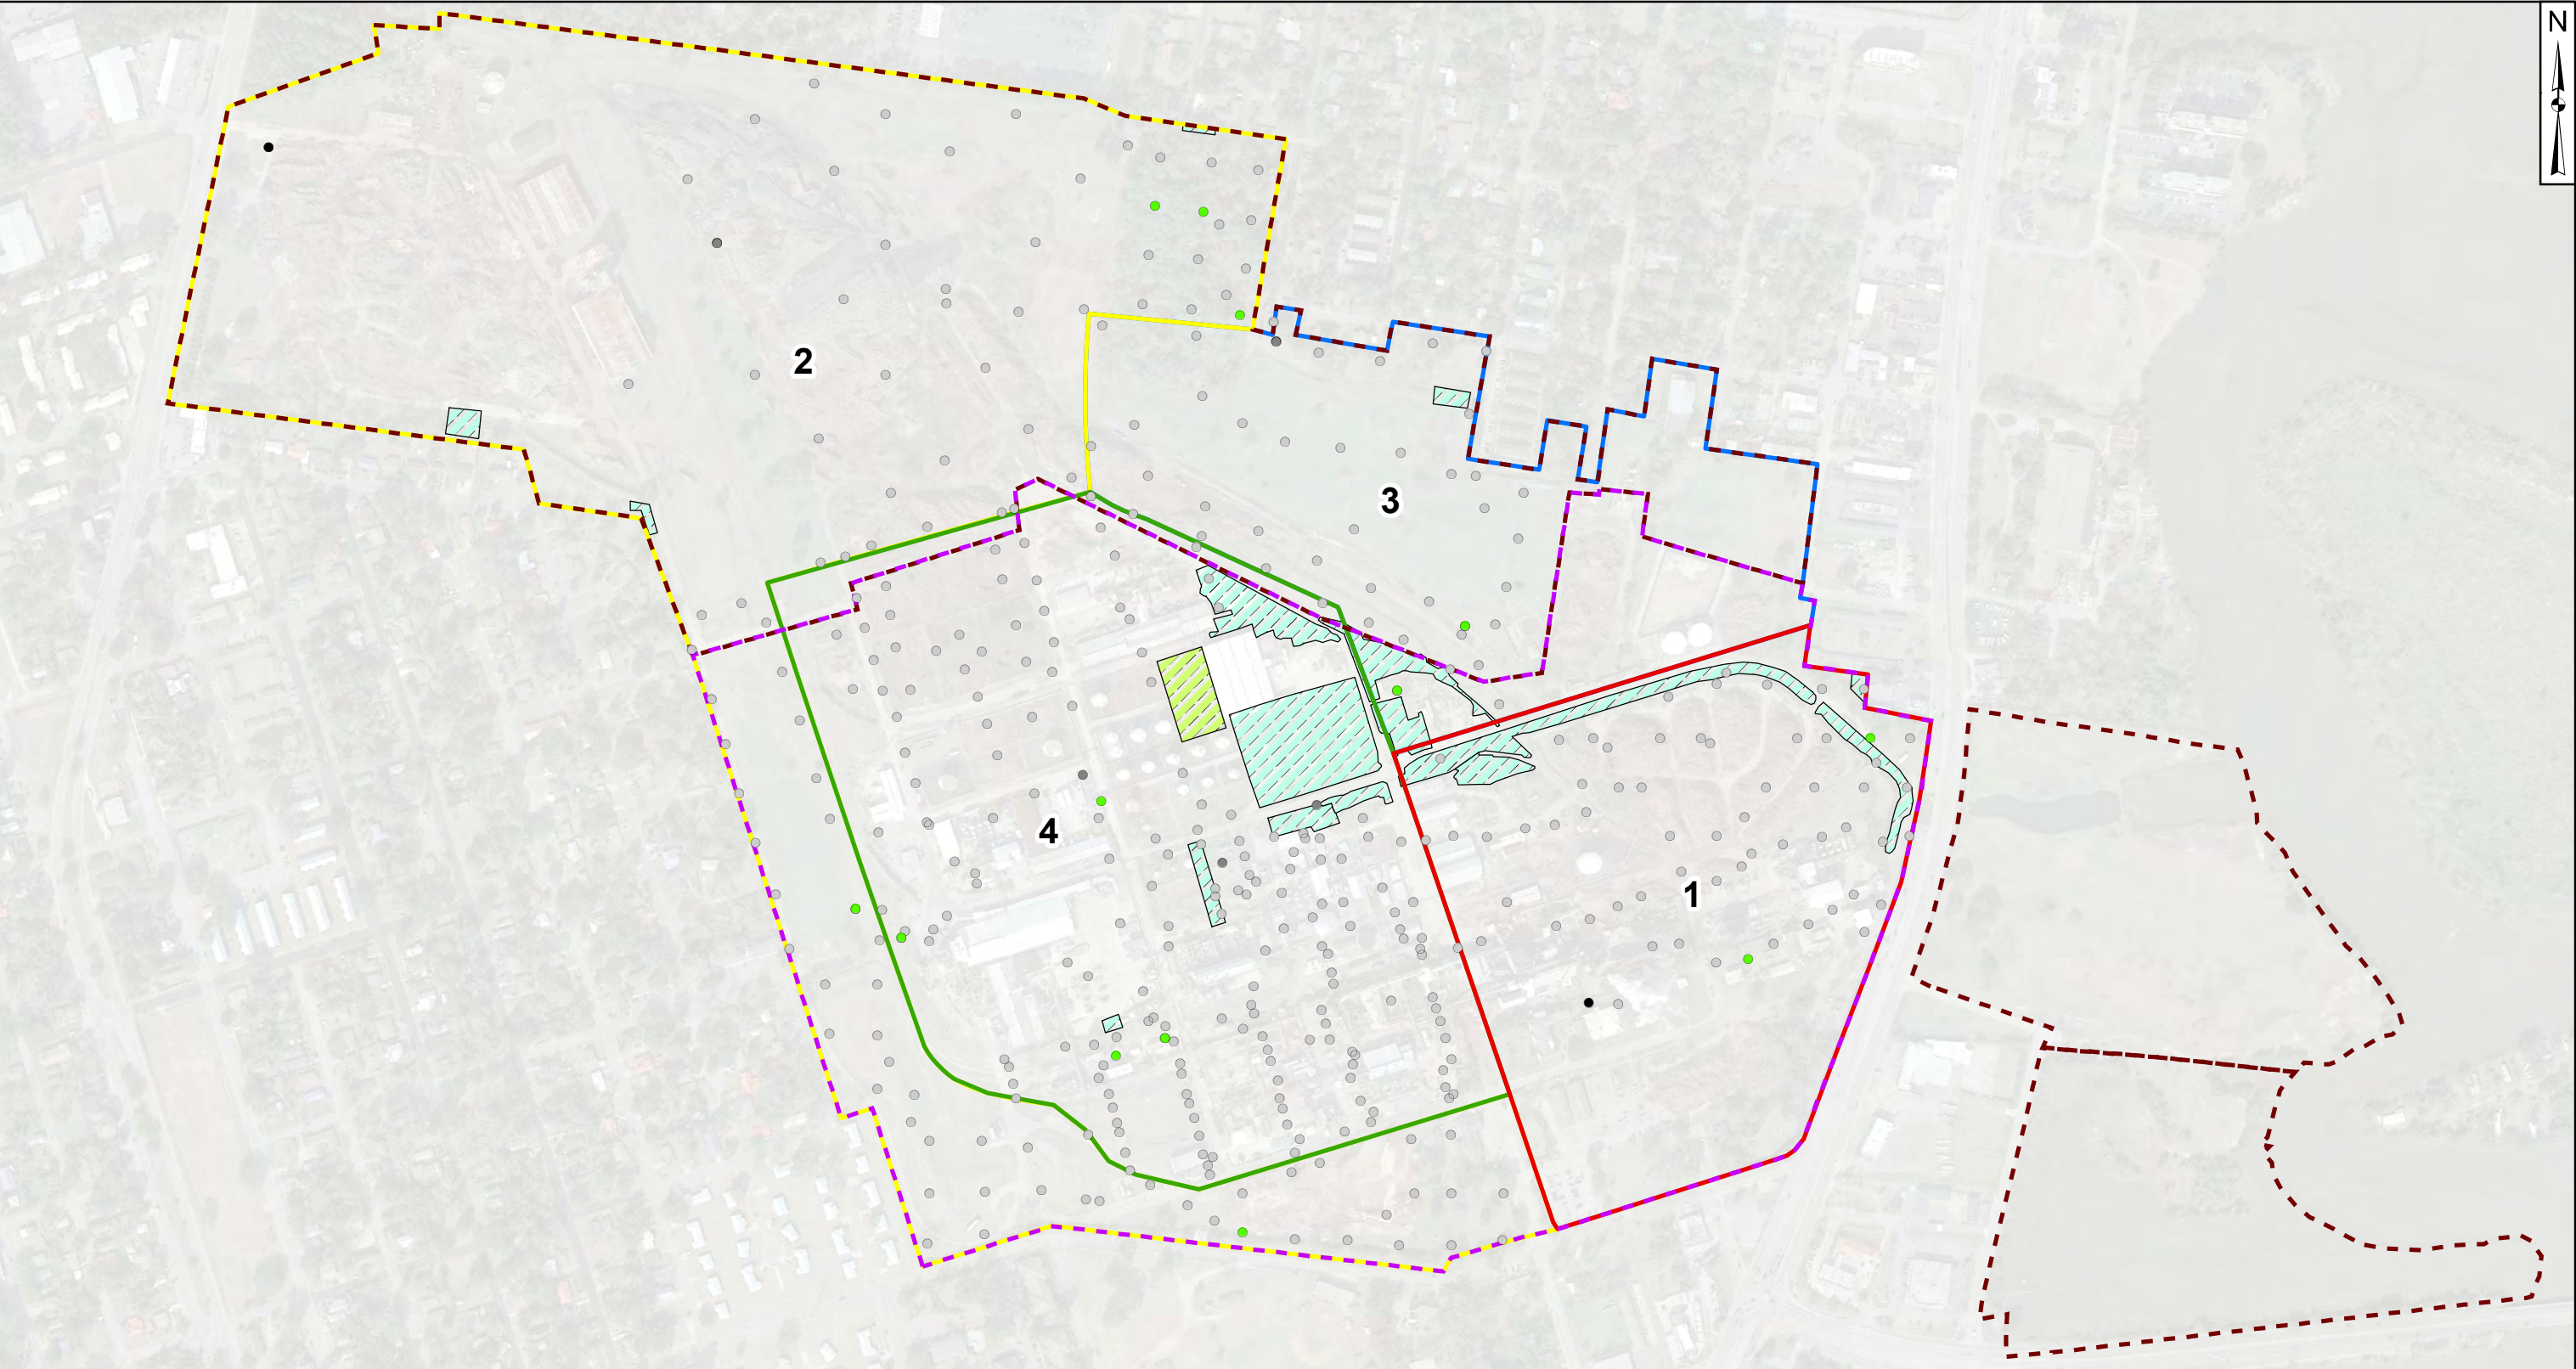
Legend <div><div><div><div></div><div>Pinova Property</div></div><div><div></div><div>Hercules Property</div></div><div><div></div><div>Excavated Areas</div></div><div><div></div><div>Solidified Soil Monolith</div></div></div><div>Exposure Domains<div><div></div><div>Domain 1</div></div><div><div></div><div>Domain 2</div></div><div><div></div><div>Domain 3</div></div><div><div></div><div>Domain 4</div></div></div></div> <td>Chlorobenzilate Concentration (mg/kg)<div><div>Not Detected<div><div>DL < 21</div><div>DL > 21 and < 210</div><div>DL > 210 and < 2,100</div></div></div><div>Detected<div><div>< 210</div></div></div></div><div>Notes:<div>1. ft bgs = feet below ground surface.</div><div>2. DL = detection limit</div><div>3. mg/kg = milligrams per kilogram</div><div>4. The concentration color coding categories are based on the Regional Screening Level (RSL) for chlorobenzilate developed by the United States Environmental Protection Agency and indicate relative distributions of chlorobenzilate in soils.</div><div>5. Aerial photograph approximate date - January 2019. Source: Google Earth.</div></div><td><div><div>02505001,000</div><div>Feet</div></div><div>Chlorobenzilate in Surface Soil Samples (0-2 ft bgs)<div>Hercules/Pinova Facility Brunswick, Georgia</div></div><div><div><div><div>Geosyntec<div>consultants</div></div></div><div><div>Kennesaw, GA</div><div>January 2022</div></div></div><div><div>Figure<div>3-26</div></div></div></div></td></td>	Chlorobenzilate Concentration (mg/kg) <div><div>Not Detected<div><div>DL < 21</div><div>DL > 21 and < 210</div><div>DL > 210 and < 2,100</div></div></div><div>Detected<div><div>< 210</div></div></div></div> <div>Notes:<div>1. ft bgs = feet below ground surface.</div><div>2. DL = detection limit</div><div>3. mg/kg = milligrams per kilogram</div><div>4. The concentration color coding categories are based on the Regional Screening Level (RSL) for chlorobenzilate developed by the United States Environmental Protection Agency and indicate relative distributions of chlorobenzilate in soils.</div><div>5. Aerial photograph approximate date - January 2019. Source: Google Earth.</div></div> <td><div><div>02505001,000</div><div>Feet</div></div><div>Chlorobenzilate in Surface Soil Samples (0-2 ft bgs)<div>Hercules/Pinova Facility Brunswick, Georgia</div></div><div><div><div><div>Geosyntec<div>consultants</div></div></div><div><div>Kennesaw, GA</div><div>January 2022</div></div></div><div><div>Figure<div>3-26</div></div></div></div></td>	<div><div>02505001,000</div><div>Feet</div></div> <div>Chlorobenzilate in Surface Soil Samples (0-2 ft bgs)<div>Hercules/Pinova Facility Brunswick, Georgia</div></div> <div><div><div><div>Geosyntec<div>consultants</div></div></div><div><div>Kennesaw, GA</div><div>January 2022</div></div></div><div><div>Figure<div>3-26</div></div></div></div>

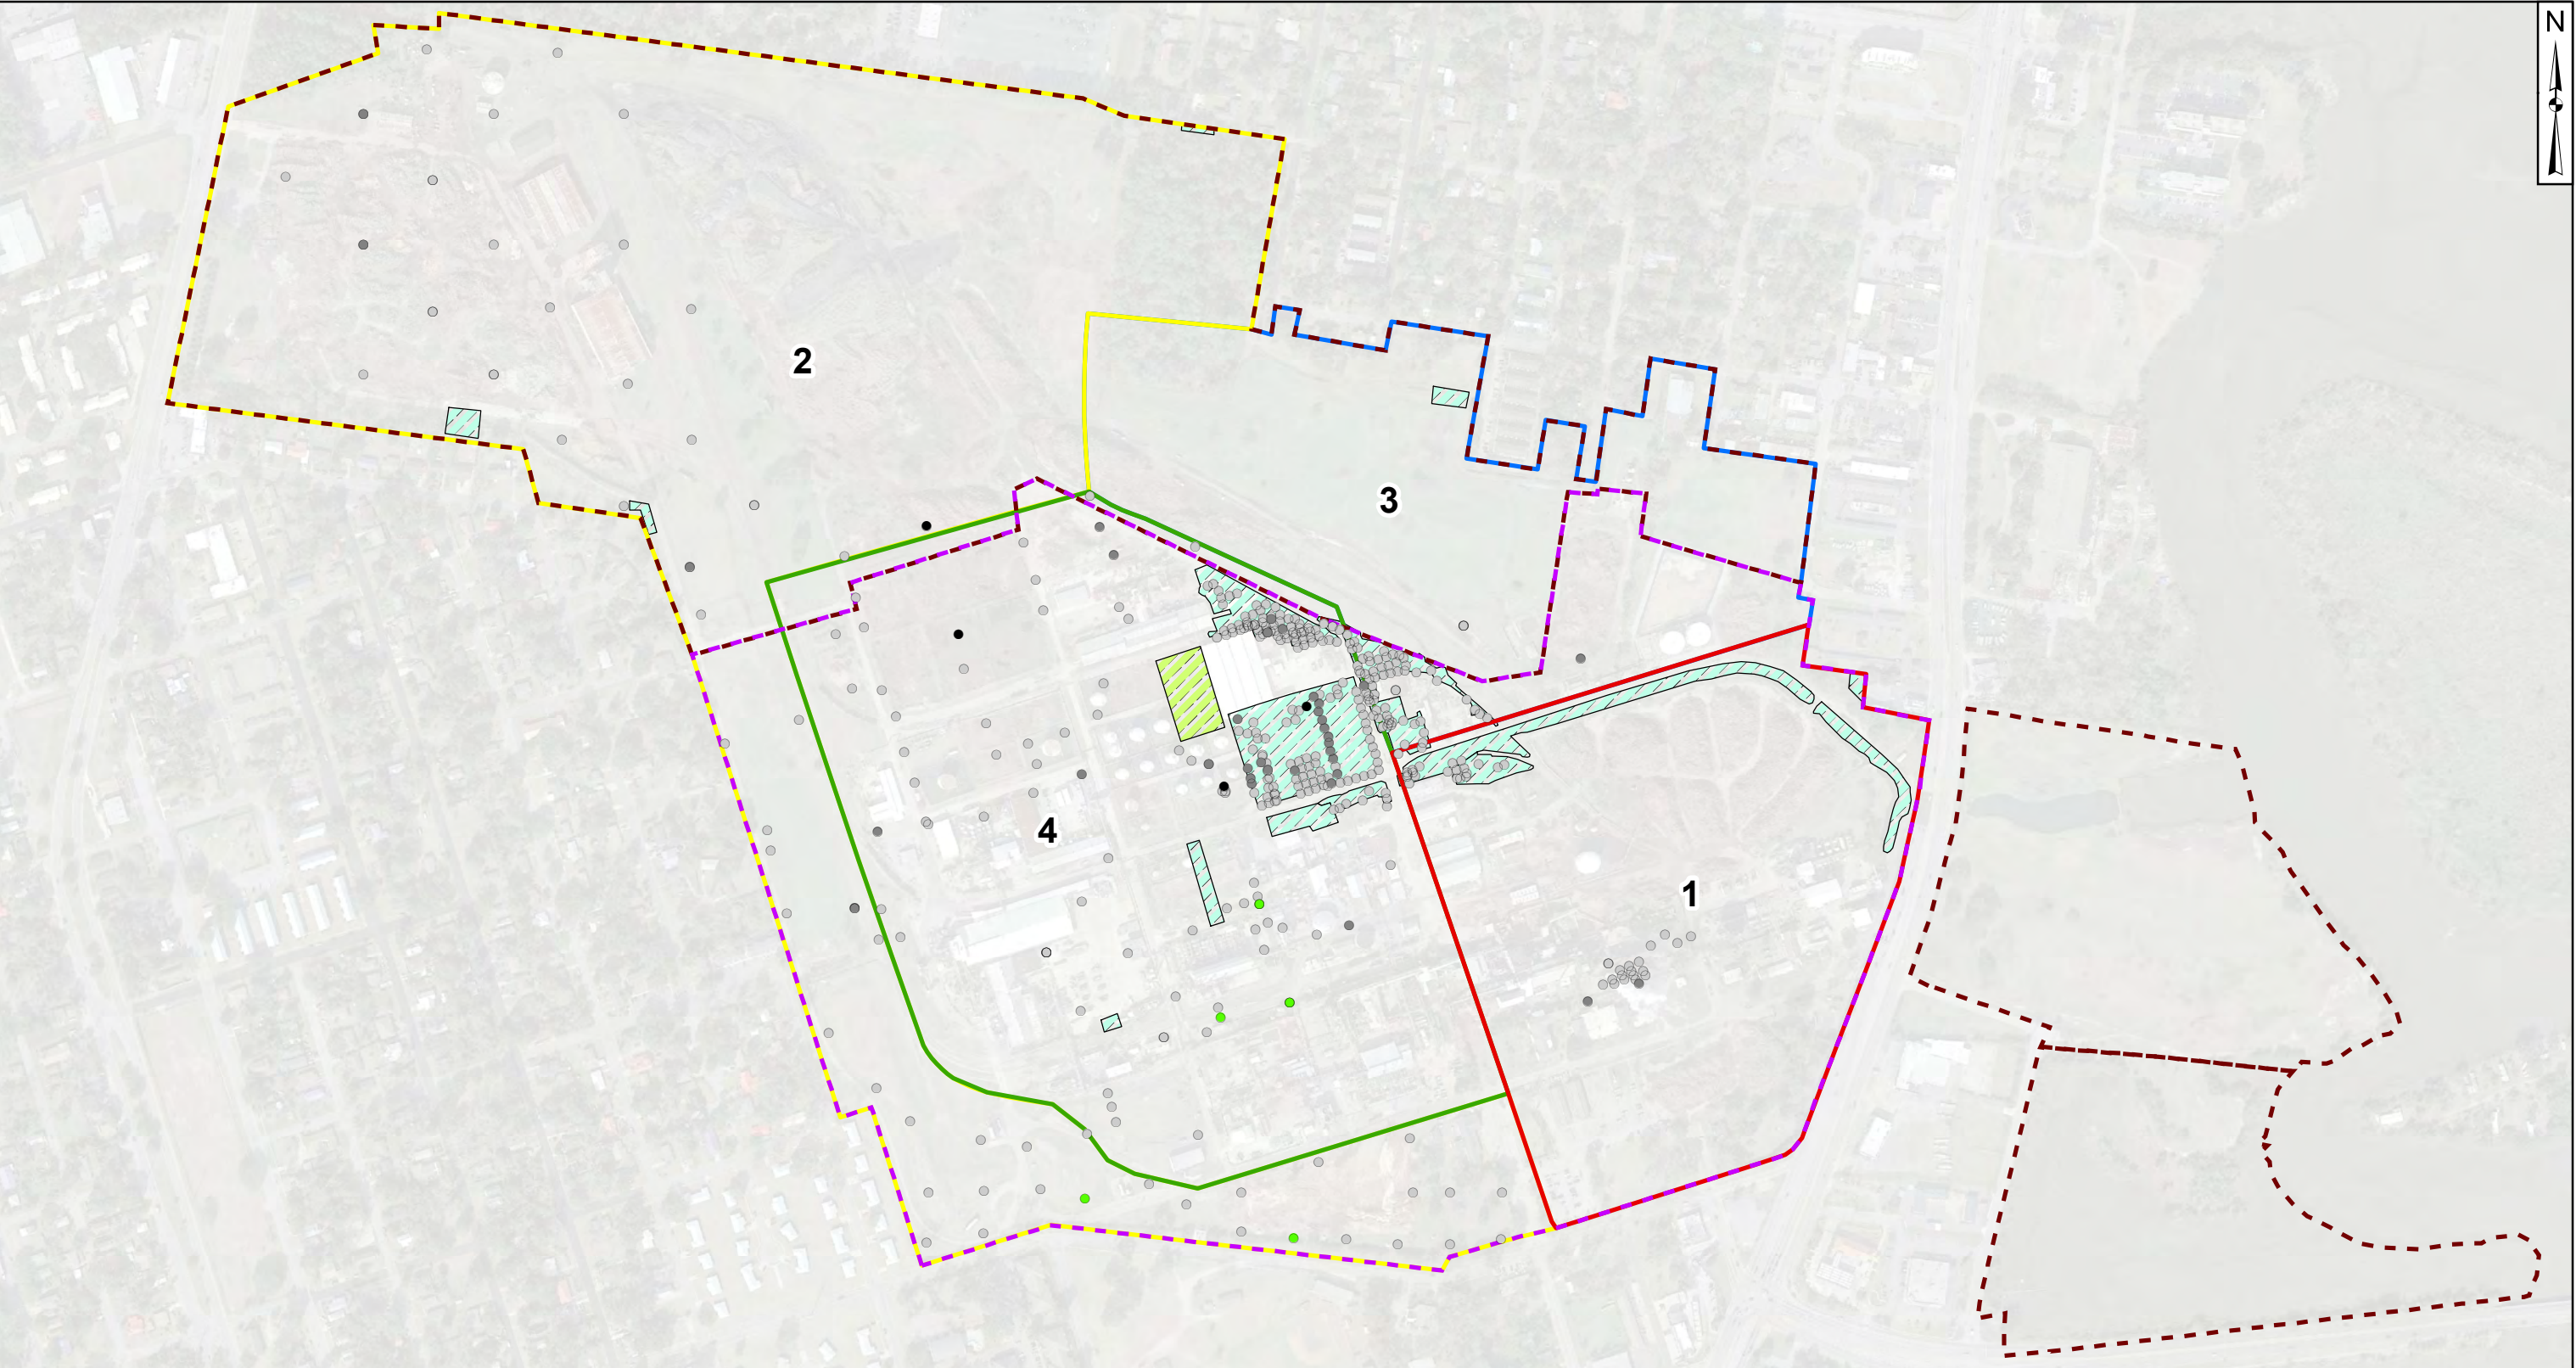
Legend <div><div><div><div></div><div>Pinova Property</div></div><div><div></div><div>Hercules Property</div></div><div><div></div><div>Excavated Areas</div></div><div><div></div><div>Solidified Soil Monolith</div></div></div><div>Exposure Domains<div><div></div><div>Domain 1</div></div><div><div></div><div>Domain 2</div></div><div><div></div><div>Domain 3</div></div><div><div></div><div>Domain 4</div></div></div></div> <td>Aroclor 1254 Concentration (mg/kg)<table><tr><th>Not Detected</th><th>Detected</th></tr><tr><td><div>DL < 0.97</div></td><td><div>< 9.7</div></td></tr><tr><td><div>DL > 0.97 and < 9.7</div></td><td><div>> 9.7 and < 97</div></td></tr><tr><td><div>DL > 9.7 and < 97</div></td><td><div>> 97</div></td></tr></table></td> <td colspan="2">Aroclor 1254 in Subsurface Soil Samples (>2 ft bgs) Hercules/Pinova Facility Brunswick, Georgia</td>	Aroclor 1254 Concentration (mg/kg) <table><tr><th>Not Detected</th><th>Detected</th></tr><tr><td><div>DL < 0.97</div></td><td><div>< 9.7</div></td></tr><tr><td><div>DL > 0.97 and < 9.7</div></td><td><div>> 9.7 and < 97</div></td></tr><tr><td><div>DL > 9.7 and < 97</div></td><td><div>> 97</div></td></tr></table>	Not Detected	Detected	<div>DL < 0.97</div>	<div>< 9.7</div>	<div>DL > 0.97 and < 9.7</div>	<div>> 9.7 and < 97</div>	<div>DL > 9.7 and < 97</div>	<div>> 97</div>	Aroclor 1254 in Subsurface Soil Samples (>2 ft bgs) Hercules/Pinova Facility Brunswick, Georgia

Not Detected	Detected									
	<div>DL < 0.97</div>	<div>< 9.7</div>									
<div>DL > 0.97 and < 9.7</div>	<div>> 9.7 and < 97</div>										
<div>DL > 9.7 and < 97</div>	<div>> 97</div>										
Notes: <div>1. ft bgs = feet below ground surface.</div> <div>2. DL = detection limit</div> <div>3. mg/kg = milligrams per kilogram</div> <div>4. The concentration color coding categories are based on the Regional Screening Level (RSL) for aroclor 1254 developed by the United States Environmental Protection Agency and indicate relative distributions of aroclor 1254 in soils.</div> <div>5. Aerial photograph approximate date - January 2019. Source: Google Earth.</div>		<div><div><div>Geosyntec</div><div>consultants</div></div></div>		Figure 3-29							
<div>02505001,000</div> <div>Feet</div>		Kennesaw, GA	January 2022
