RE: **Corrective Action Plan
Hercules LLC/Pinova Inc. - Brunswick Facility
Hazardous Waste Facility Permit No. HW-52(D&S)-2,
EPA ID No. GAD00406065520**

CORRECTIVE ACTION PLAN

HERCULES LLC/PINOVA INC. FACILITY

BRUNSWICK, GEORGIA

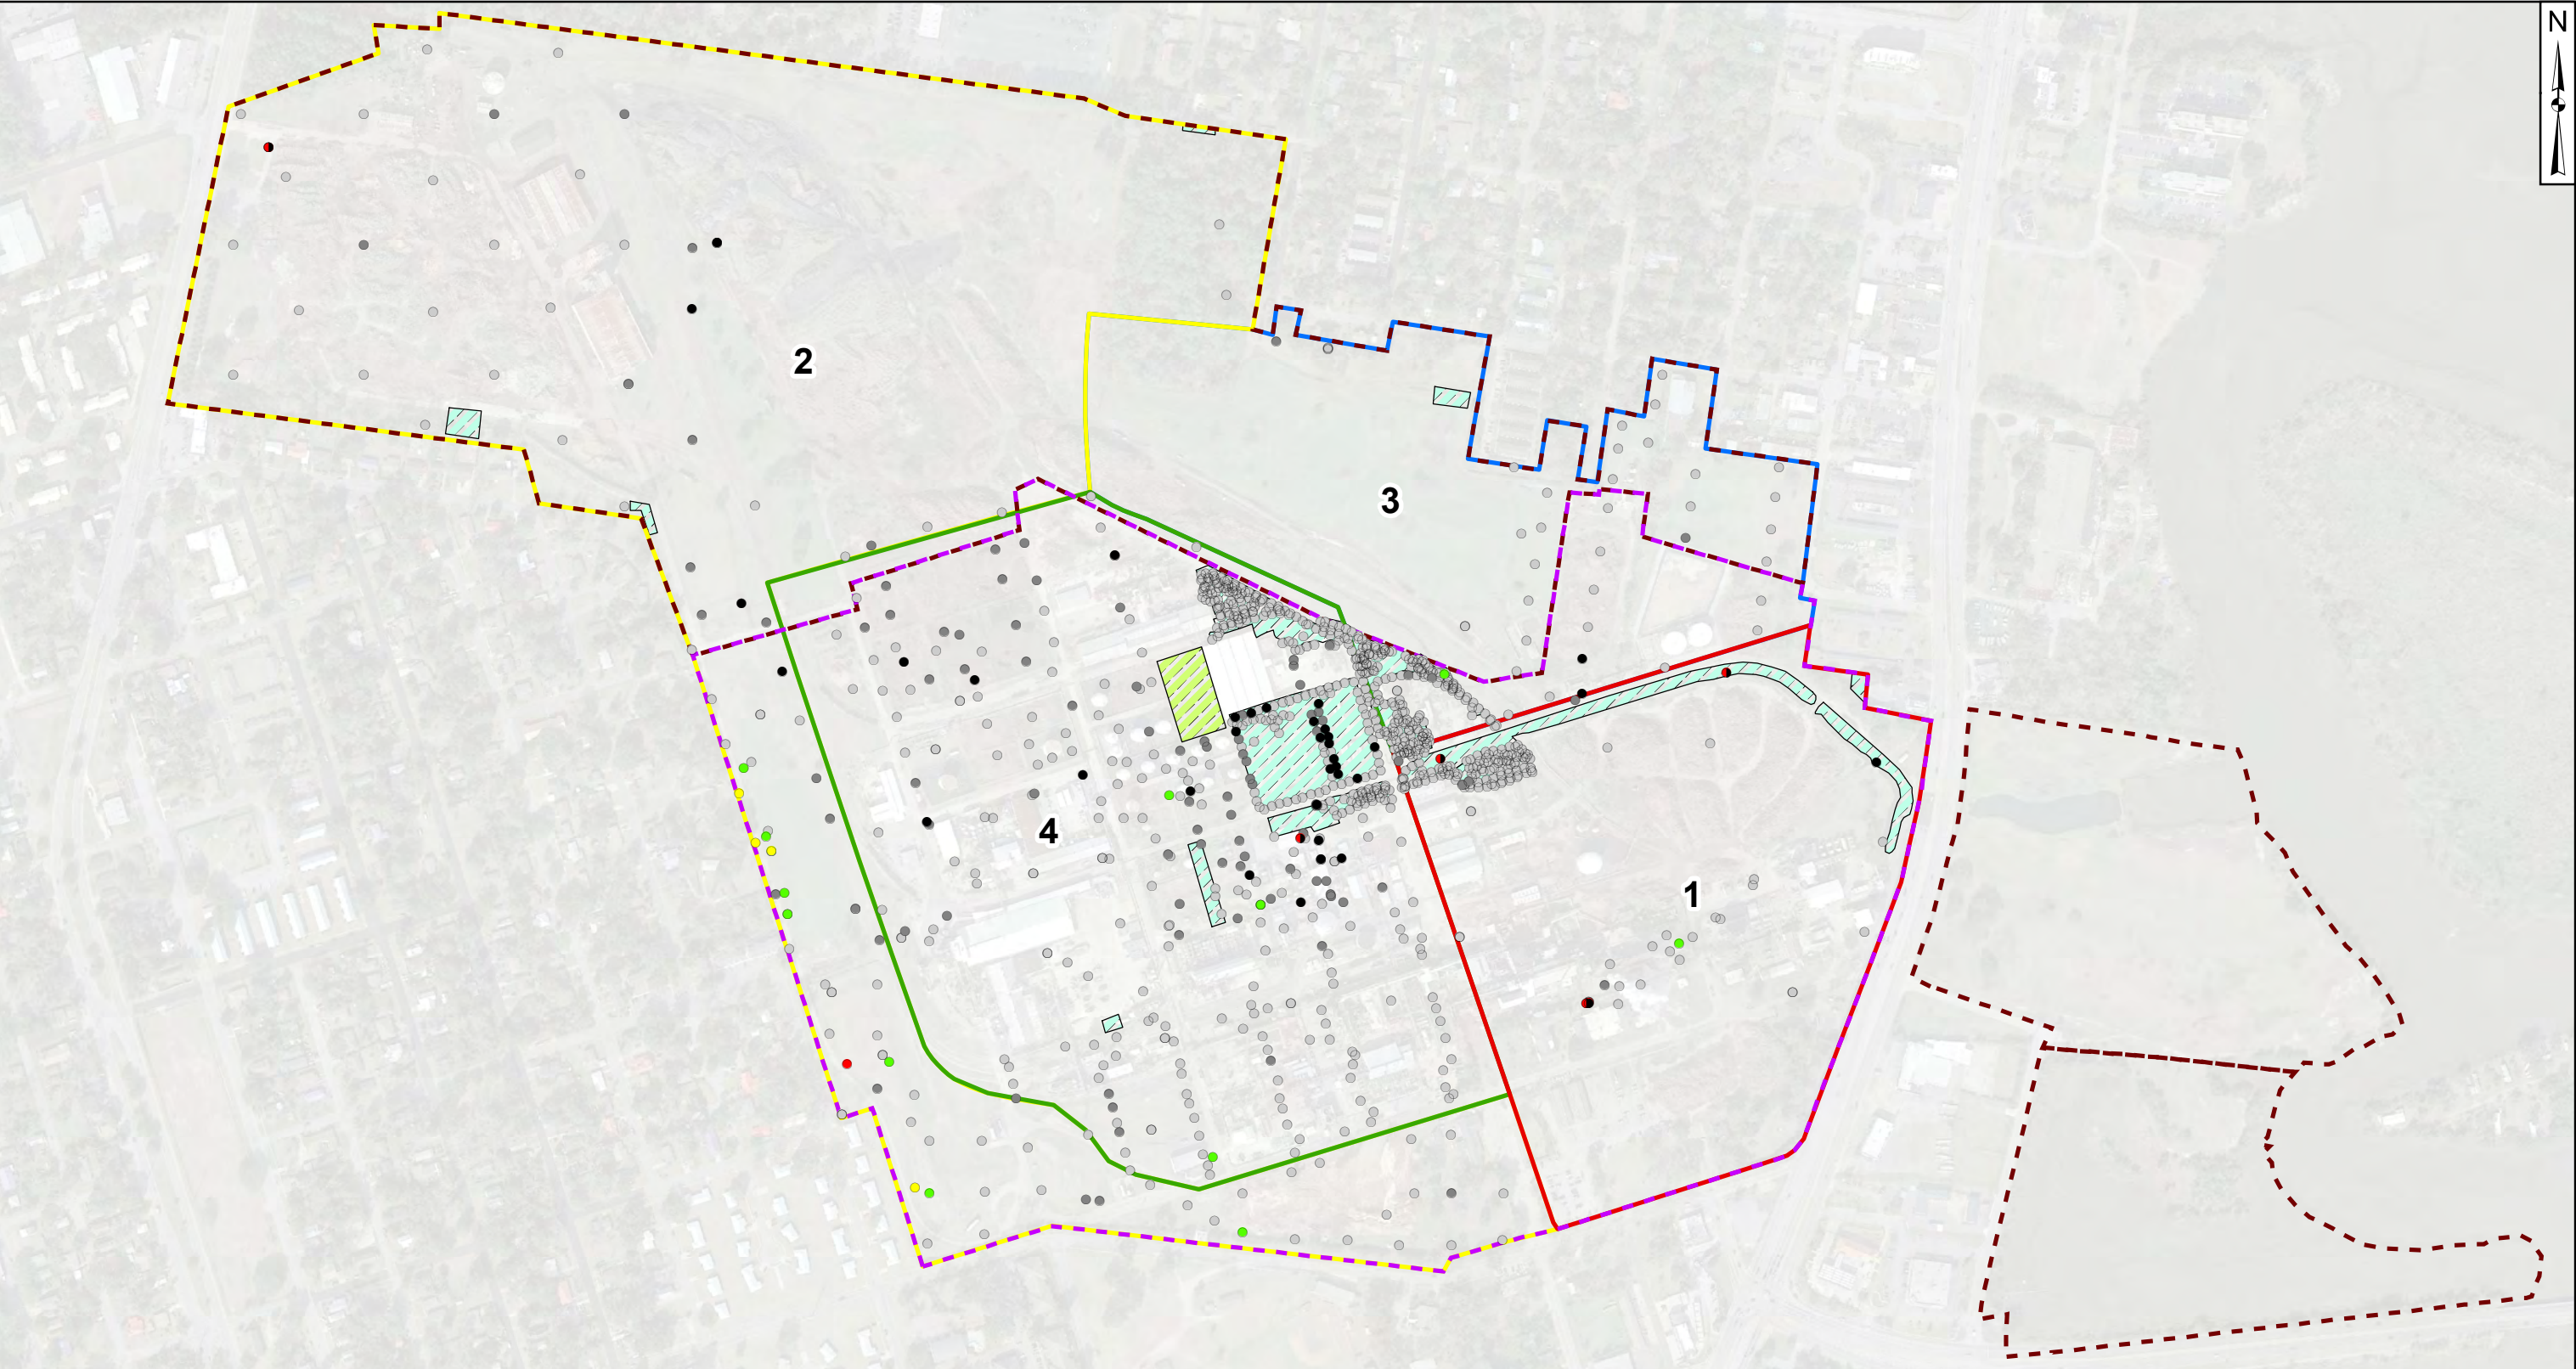
Legend <div><div><div><div></div><div>Pinova Property</div></div><div><div></div><div>Hercules Property</div></div><div><div></div><div>Excavated Areas</div></div><div><div></div><div>Solidified Soil Monolith</div></div></div><div>Exposure Domains<div><div></div><div>Domain 1</div></div><div><div></div><div>Domain 2</div></div><div><div></div><div>Domain 3</div></div><div><div></div><div>Domain 4</div></div></div></div> <td>Aroclor 1260 Concentration (mg/kg)<div><div>Not Detected<div><div></div><div>DL < 0.99</div></div><div><div></div><div>DL > 0.99 and < 9.9</div></div><div><div></div><div>DL > 9.9 and < 99</div></div><div><div></div><div>DL > 99</div></div></div><div>Detected<div><div></div><div>< 9.9</div></div><div><div></div><div>> 9.9 and < 99</div></div><div><div></div><div>> 99</div></div></div></div></td> <td>Notes:<div>1. ft bgs = feet below ground surface.</div><div>2. DL = detection limit</div><div>3. mg/kg = milligrams per kilogram</div><div>4. The concentration color coding categories are based on the Regional Screening Level (RSL) for aroclor 1260 developed by the United States Environmental Protection Agency and indicate relative distributions of aroclor 1260 in soils.</div><div>5. Aerial photograph approximate date - January 2019. Source: Google Earth.</div></td> <td colspan="2">Aroclor 1260 in Surface Soil Samples (0-2 ft bgs)<div>Hercules/Pinova Facility Brunswick, Georgia</div></td> <td rowspan="3">Figure 3-30</td>	Aroclor 1260 Concentration (mg/kg) <div><div>Not Detected<div><div></div><div>DL < 0.99</div></div><div><div></div><div>DL > 0.99 and < 9.9</div></div><div><div></div><div>DL > 9.9 and < 99</div></div><div><div></div><div>DL > 99</div></div></div><div>Detected<div><div></div><div>< 9.9</div></div><div><div></div><div>> 9.9 and < 99</div></div><div><div></div><div>> 99</div></div></div></div>	Notes: <div>1. ft bgs = feet below ground surface.</div> <div>2. DL = detection limit</div> <div>3. mg/kg = milligrams per kilogram</div> <div>4. The concentration color coding categories are based on the Regional Screening Level (RSL) for aroclor 1260 developed by the United States Environmental Protection Agency and indicate relative distributions of aroclor 1260 in soils.</div> <div>5. Aerial photograph approximate date - January 2019. Source: Google Earth.</div>	Aroclor 1260 in Surface Soil Samples (0-2 ft bgs) <div>Hercules/Pinova Facility Brunswick, Georgia</div>		Figure 3-30

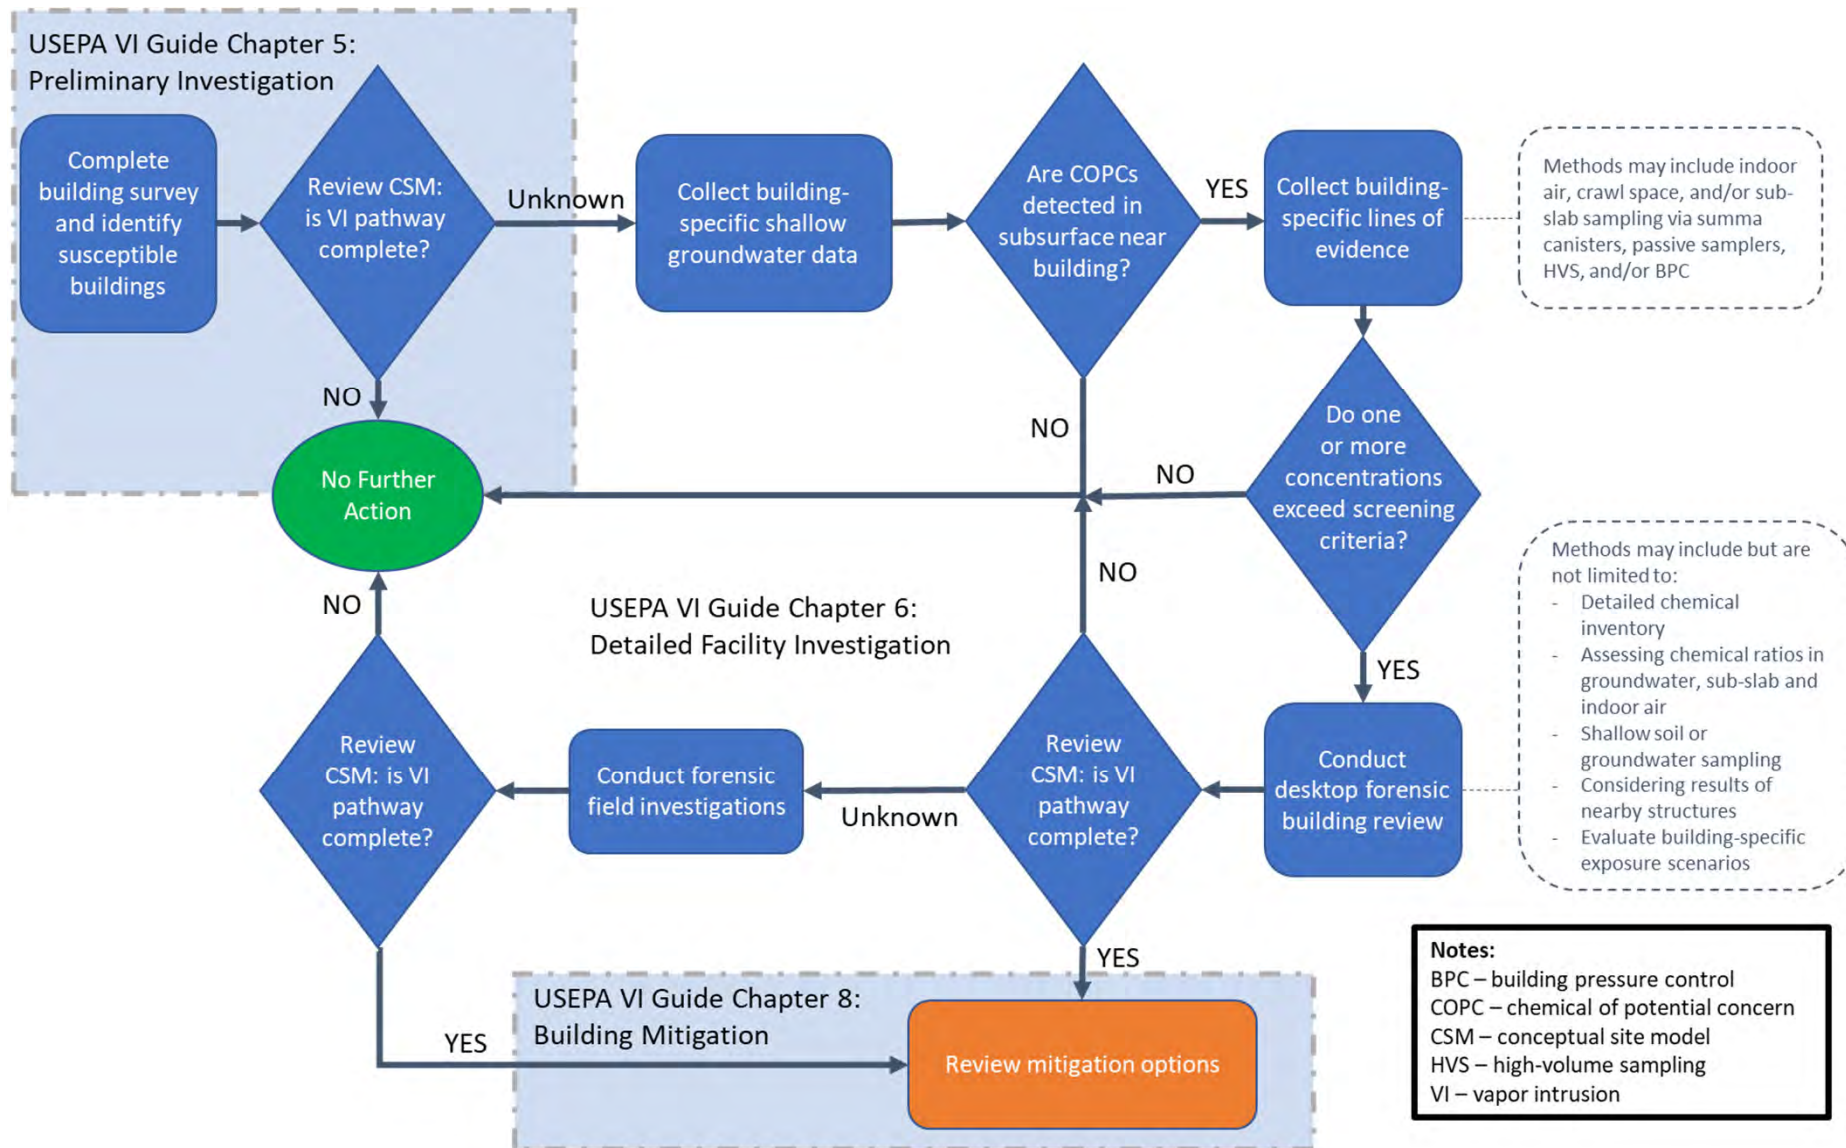
Vapor Intrusion Investigation Flow Chart

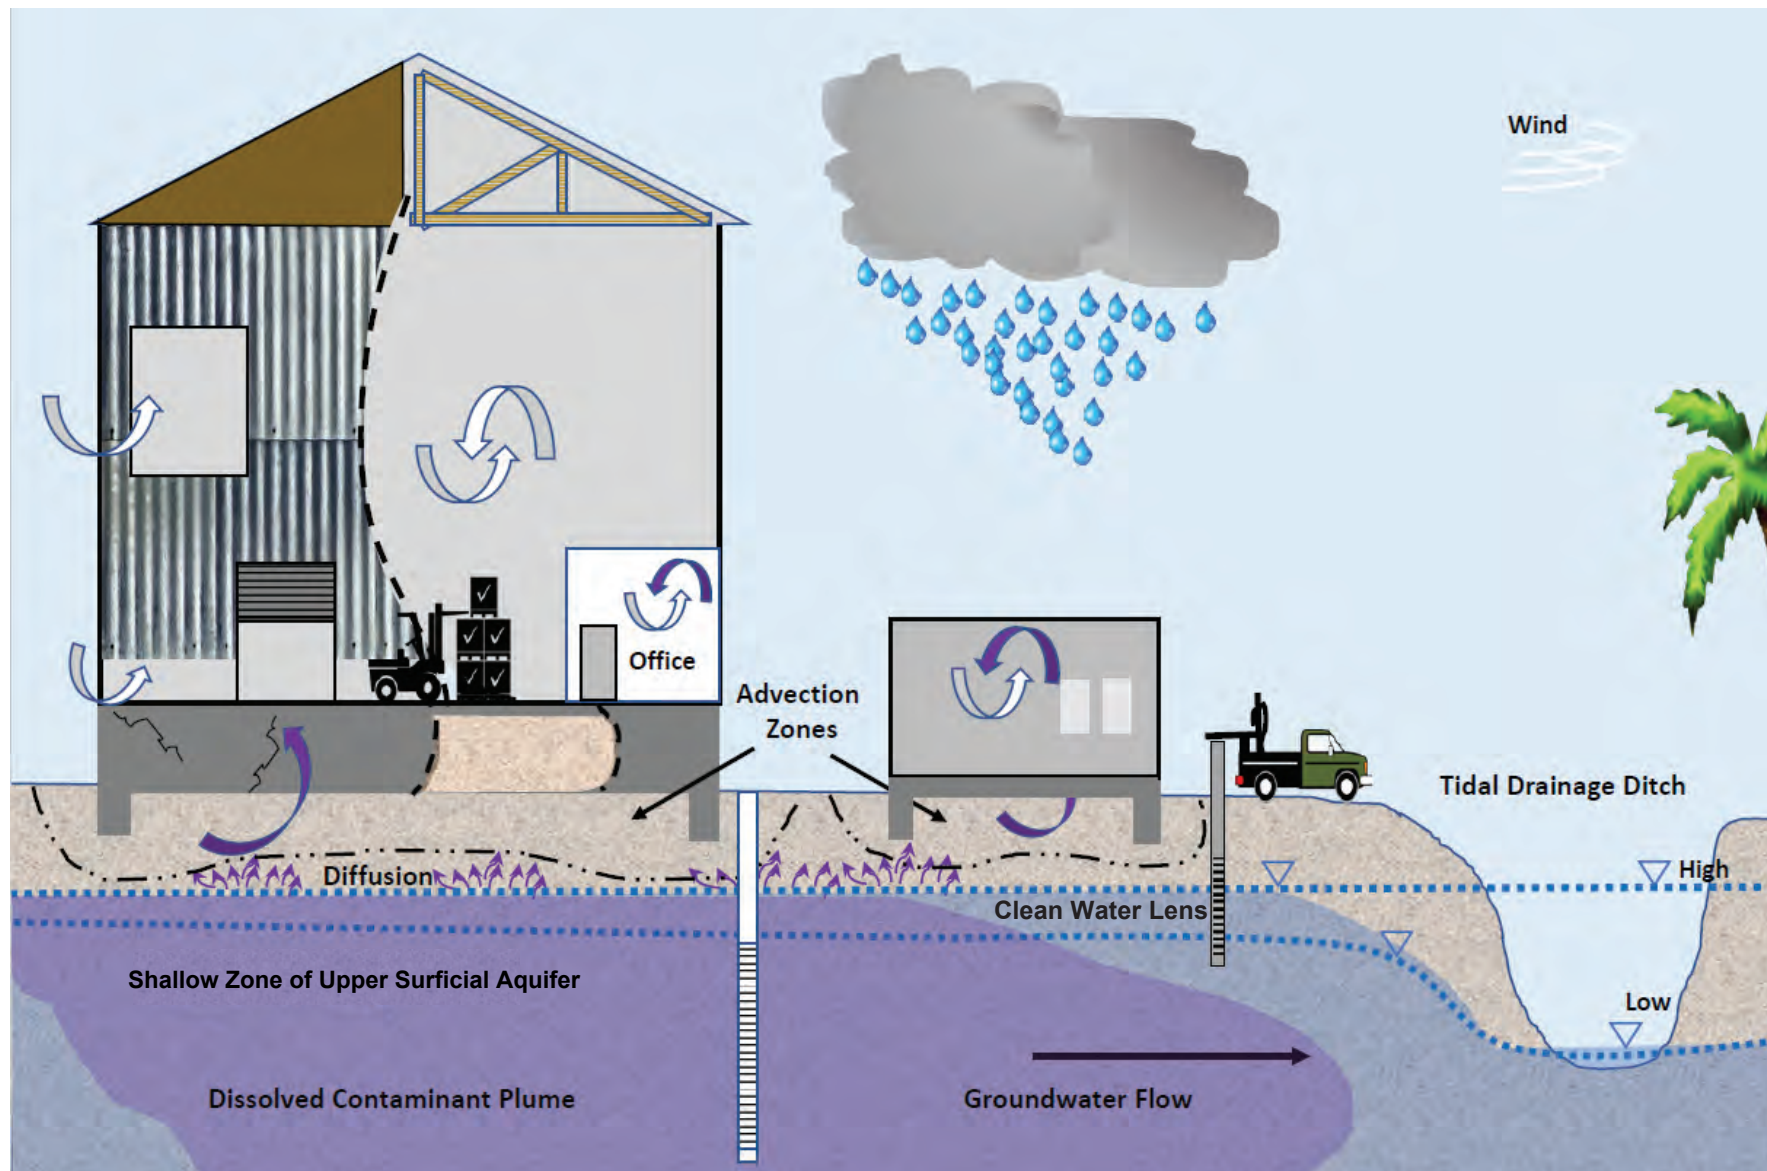
Vapor Intrusion

Conceptual Site Model

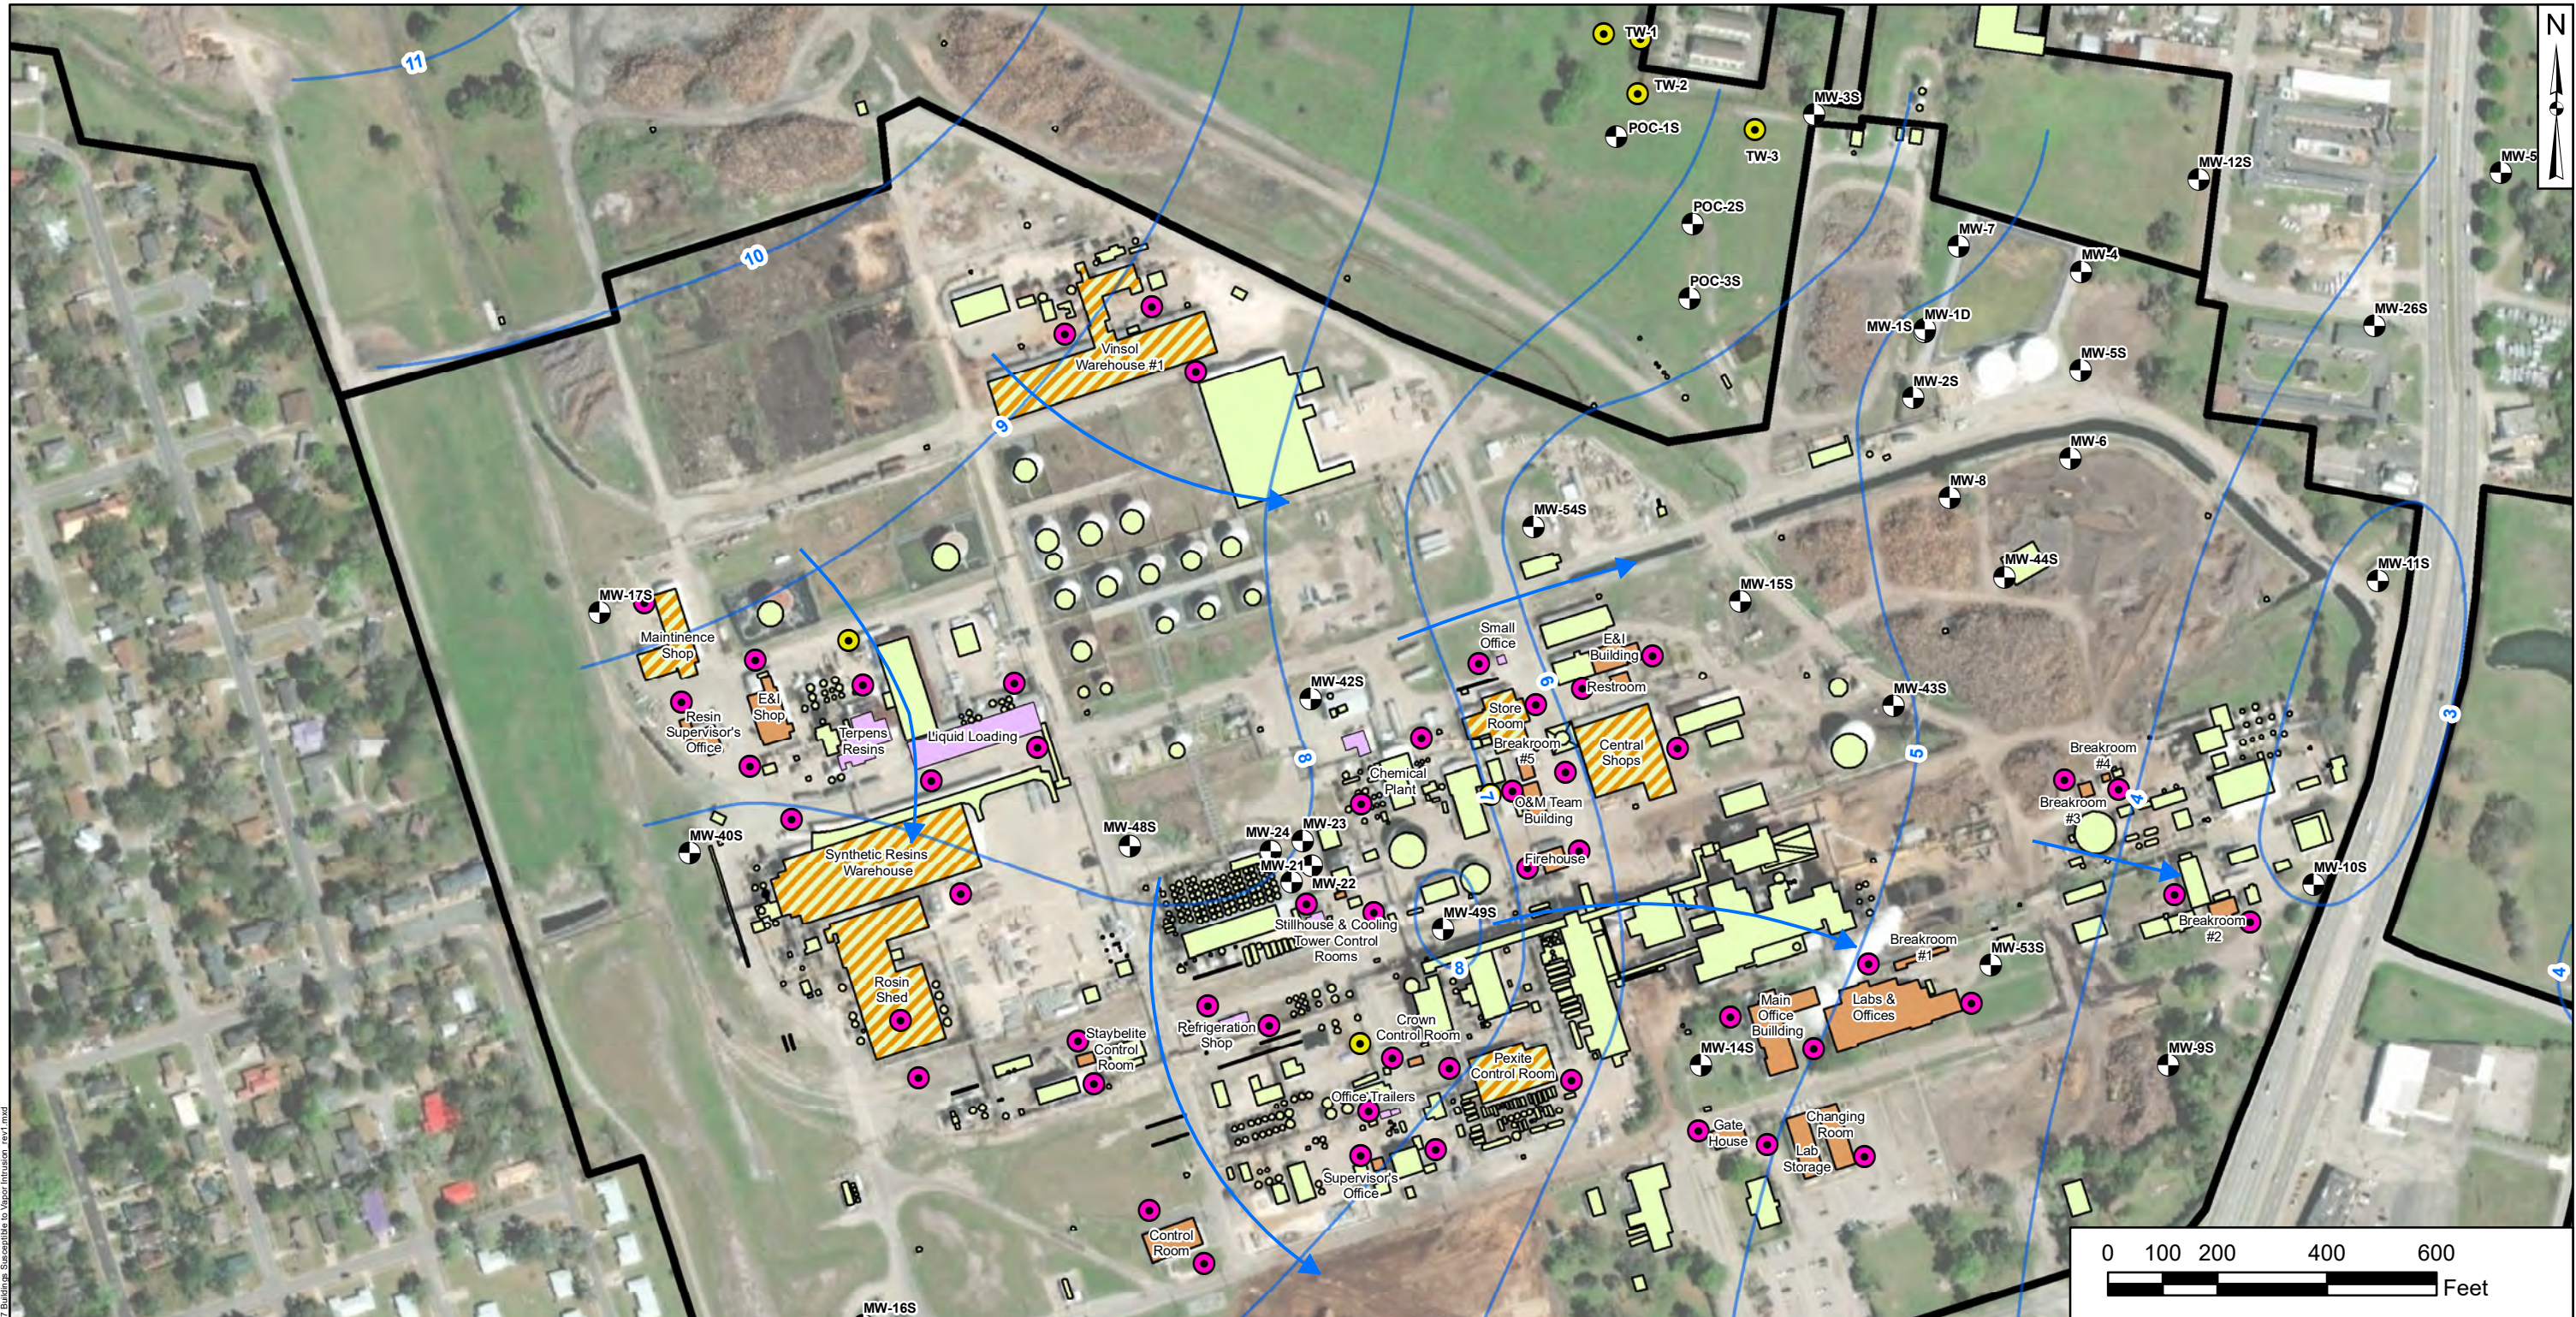
- Notes:**
1. Groundwater elevation contours are from June 2018 and are provided by Antea. June 2018 contours were used to site shallow groundwater sample locations.
 2. COPC - chemical of potential concern.
 3. CSM - conceptual site model.
 4. ND - not detected.
 5. Ft. amsl. - feet above mean sea level.
 6. ug/L - micrograms per liter
 7. VI - vapor intrusion.
 8. Existing monitoring well MW-3S were sampled for VI COPCs
 9. Temporary piezometers TW-1, TW-2 and TW-3 were sampled for COPCs.

Buildings Susceptible to Vapor Intrusion Hercules/Pinova Facility Brunswick, Georgia	
Kennesaw, GA	January 2022
Figure 3-47

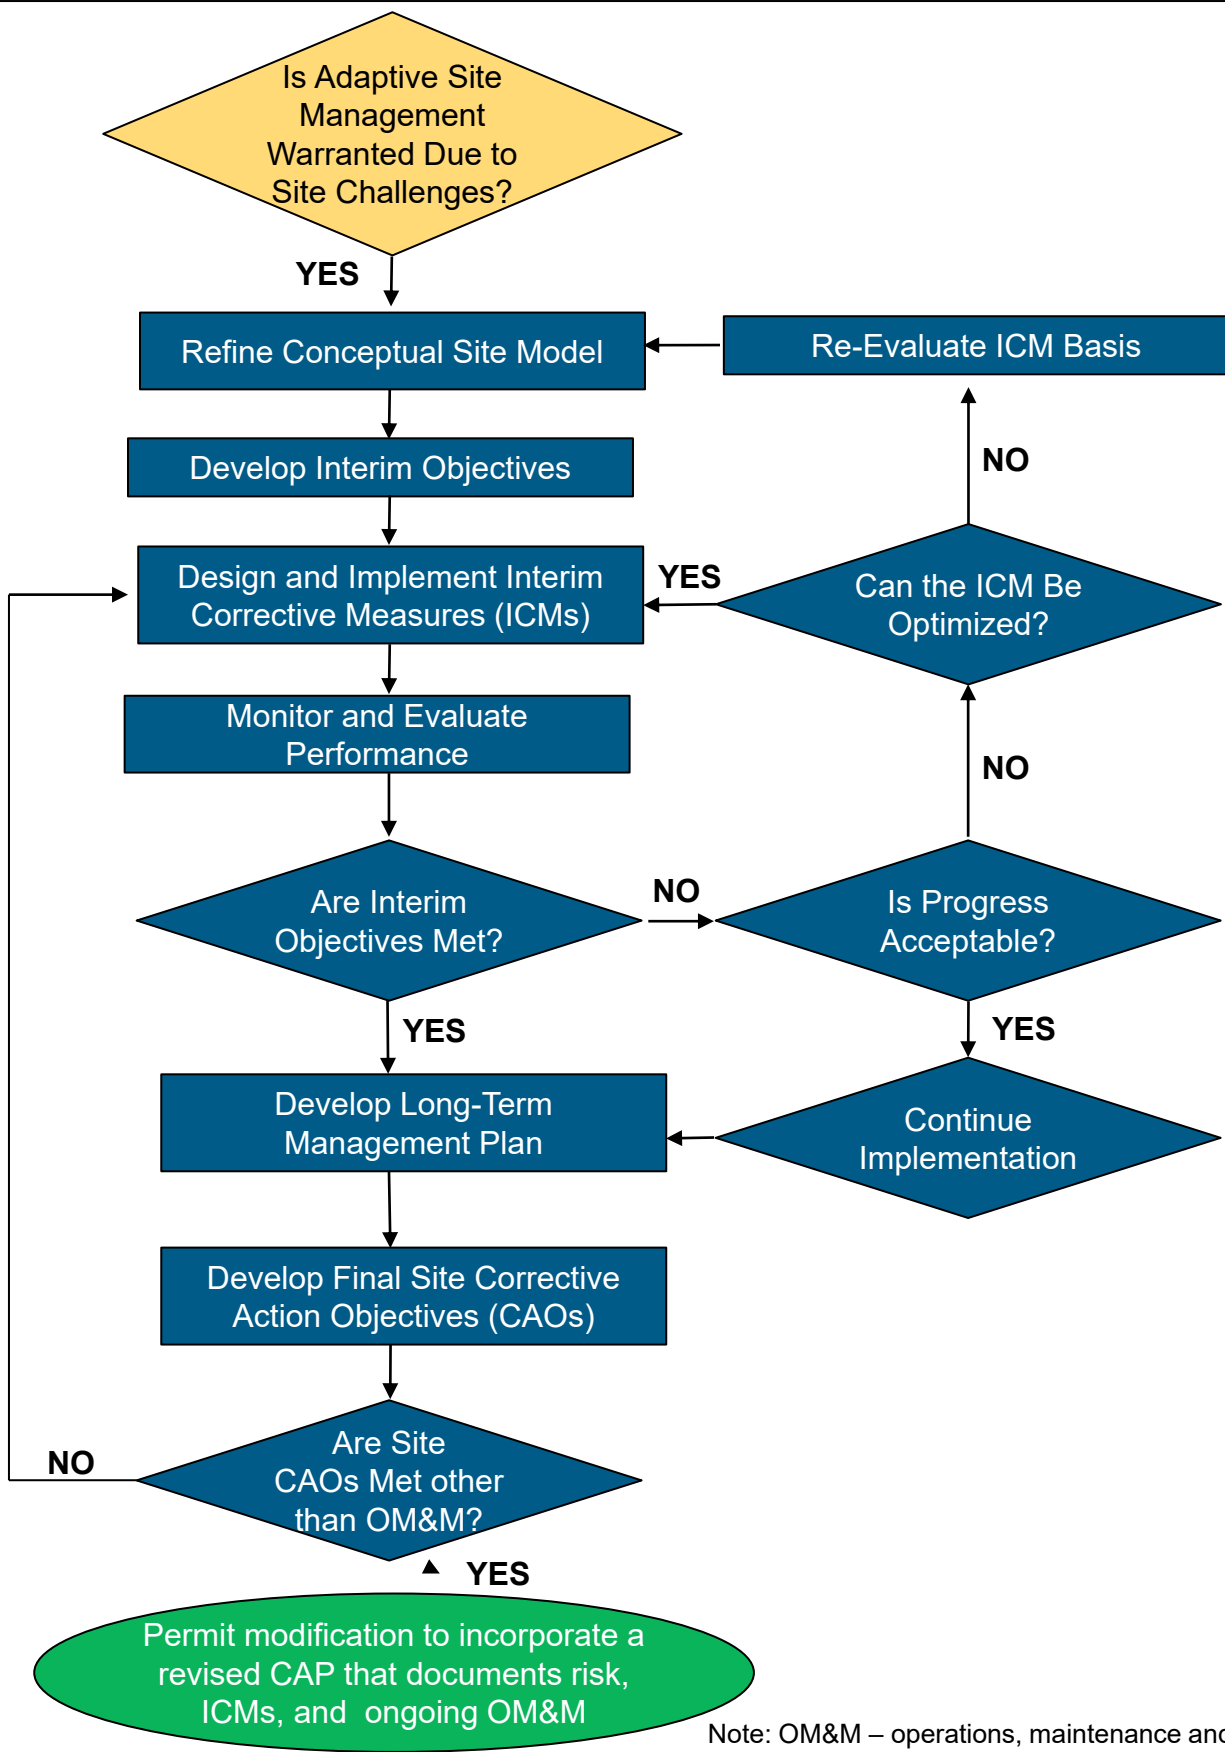
Figure
4-1

Adaptive Management Framework for Brunswick Facility Corrective Measures

A process flow chart showing this adaptive management framework for the corrective action process for the Brunswick facility is provided on **Figure 4-1**.

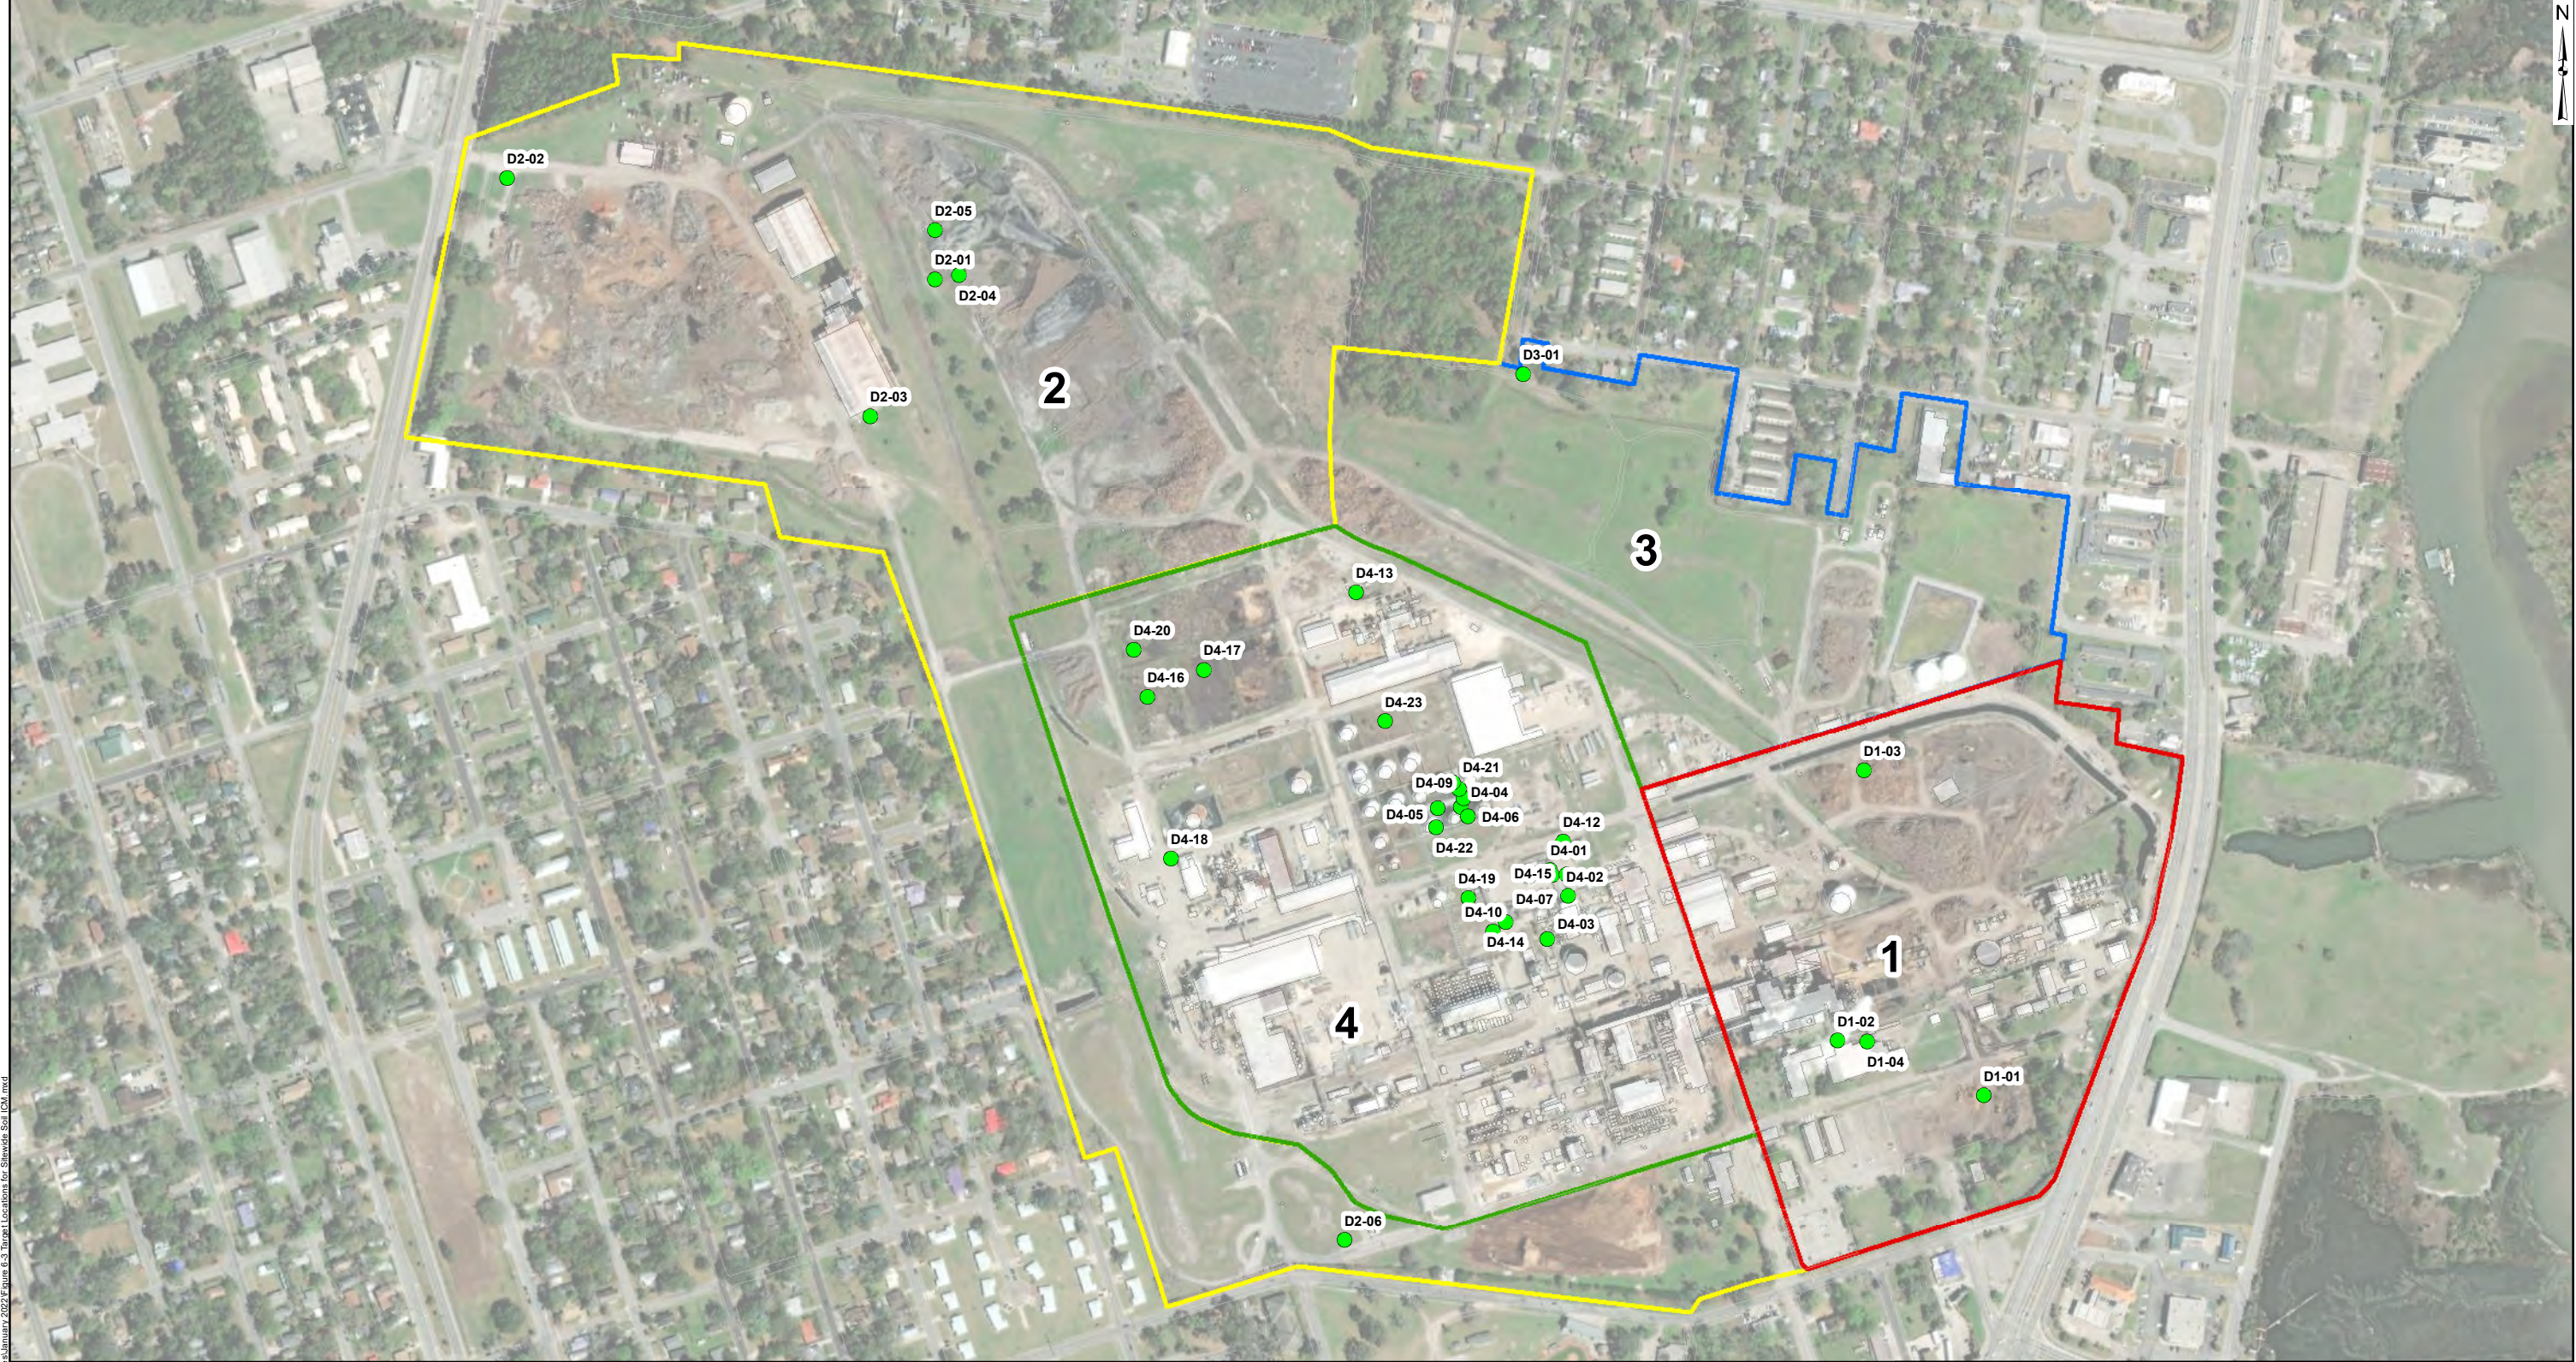
Figure
6-3

Exposure Domains ● Target Locations

Of the 34 target locations listed in **Table 6-1** and shown on **Figure 6-3**, 11 locations were determined to be inaccessible for soil excavation under current site conditions. These current conditions also generally precluded collection of soil samples at the target locations. Of the 11 target locations that were determined to be inaccessible, five are situated under lined tank containment areas, three are situated within the Vinsol containment area, two are situated under large stump piles, and one is situated under concrete paving or structures. Very soft ground conditions exist in the Vinsol containment area during certain times of the year making removal of soils in that area difficult with conventional excavation equipment. Consequently, risks from potential exposure to soils in the Vinsol containment area and other inaccessible areas will continue to be managed via the Soil Management Plan for the Brunswick facility while other locations are addressed through interim corrective measures.

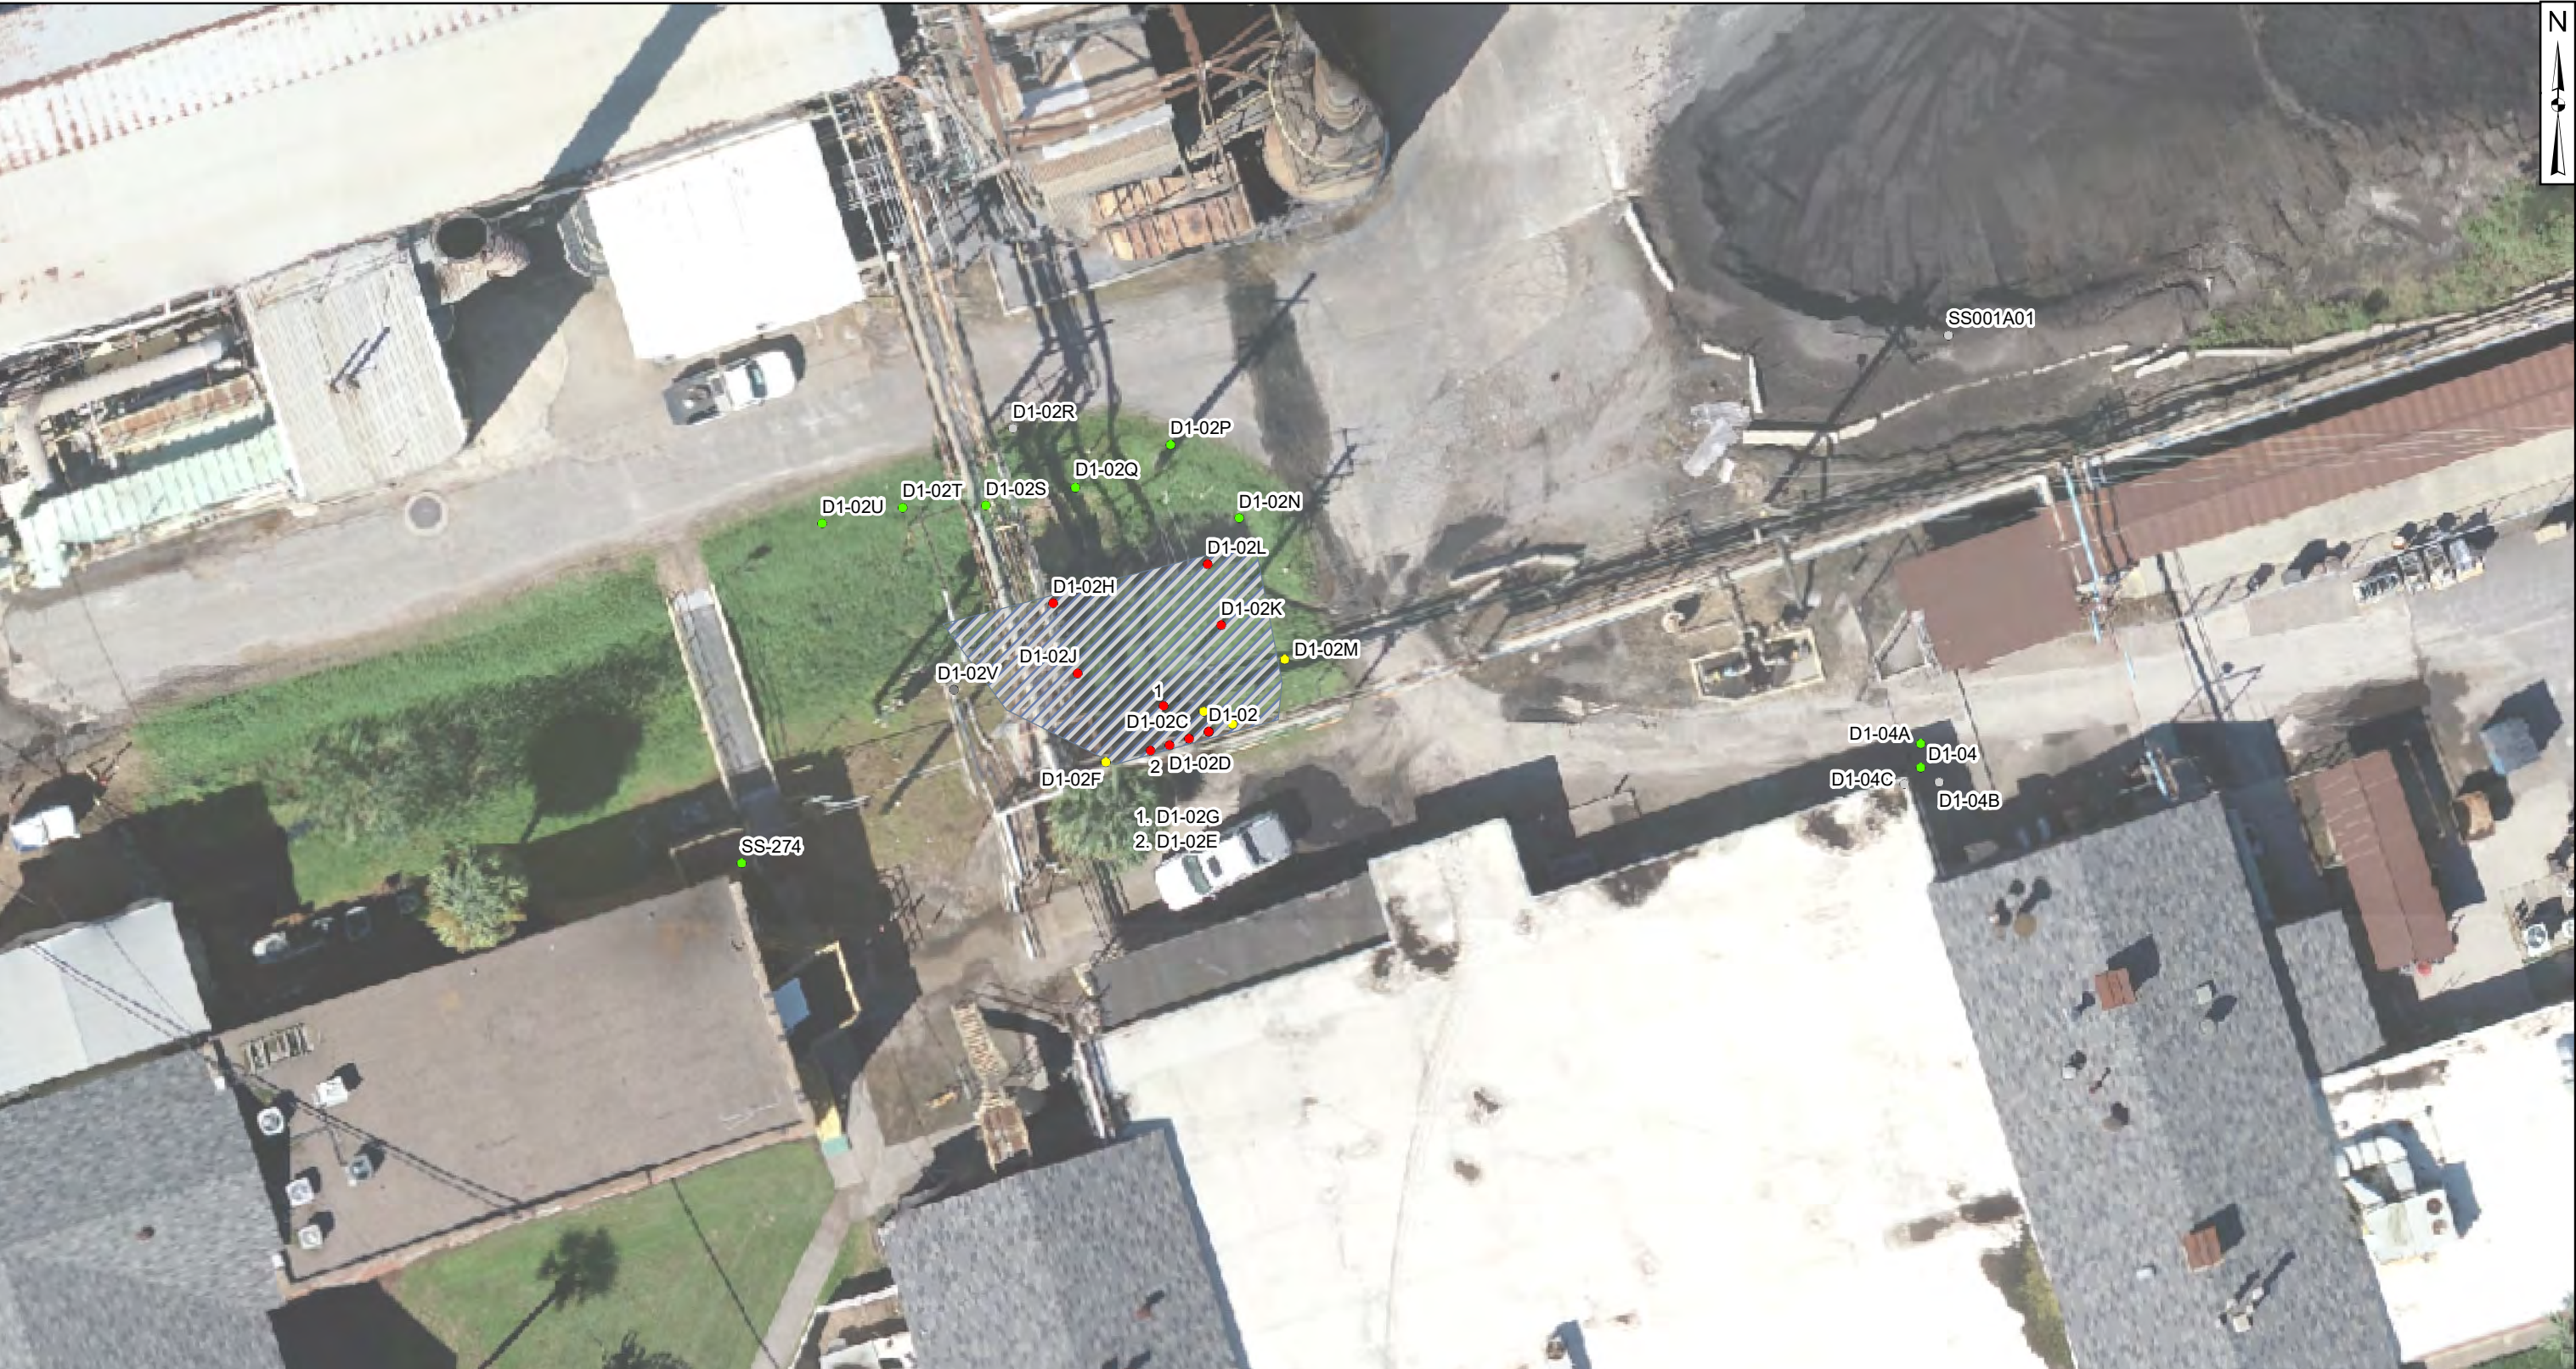
Legend <div><div></div> Proposed excavation area</div>	Toxaphene Concentration (mg/kg) <table><tr><th>Not Detected</th><th>Detected</th></tr><tr><td><div>● DL < 2.1</div><div>● DL > 2.1 and < 21</div><div>● DL > 21 and < 210</div></td><td><div>● < 21</div><div>● > 21 and < 210</div><div>● > 210</div></td></tr></table>	Not Detected	Detected	<div>● DL < 2.1</div> <div>● DL > 2.1 and < 21</div> <div>● DL > 21 and < 210</div>	<div>● < 21</div> <div>● > 21 and < 210</div> <div>● > 210</div>	<div>012.52550</div> <div>Feet</div> <div>Notes: 1. DL = detection limit 2. mg/kg = milligrams per kilogram 3. The concentration color coding categories are based on the Regional Screening Level (RSL) for toxaphene developed by the United States Environmental Protection Agency and indicate relative distributions of toxaphene in soils. The color coding does not imply excess risk. 4. Aerial photograph approximate date - December 2020.</div>	Surface Soil Delineation Sampling in Domain 1, Location D1-02 Hercules/Pinova Facility Brunswick, Georgia	
		Not Detected	Detected					
		<div>● DL < 2.1</div> <div>● DL > 2.1 and < 21</div> <div>● DL > 21 and < 210</div>	<div>● < 21</div> <div>● > 21 and < 210</div> <div>● > 210</div>					
<div>Geosyntec</div> <div>consultants</div>		Figure 6-5						
Kennesaw, GA								
January 2022
