RE: **Corrective Action Plan
Hercules LLC/Pinova Inc. - Brunswick Facility
Hazardous Waste Facility Permit No. HW-52(D&S)-2,
EPA ID No. GAD00406065520**

CORRECTIVE ACTION PLAN

HERCULES LLC/PINOVA INC. FACILITY

BRUNSWICK, GEORGIA

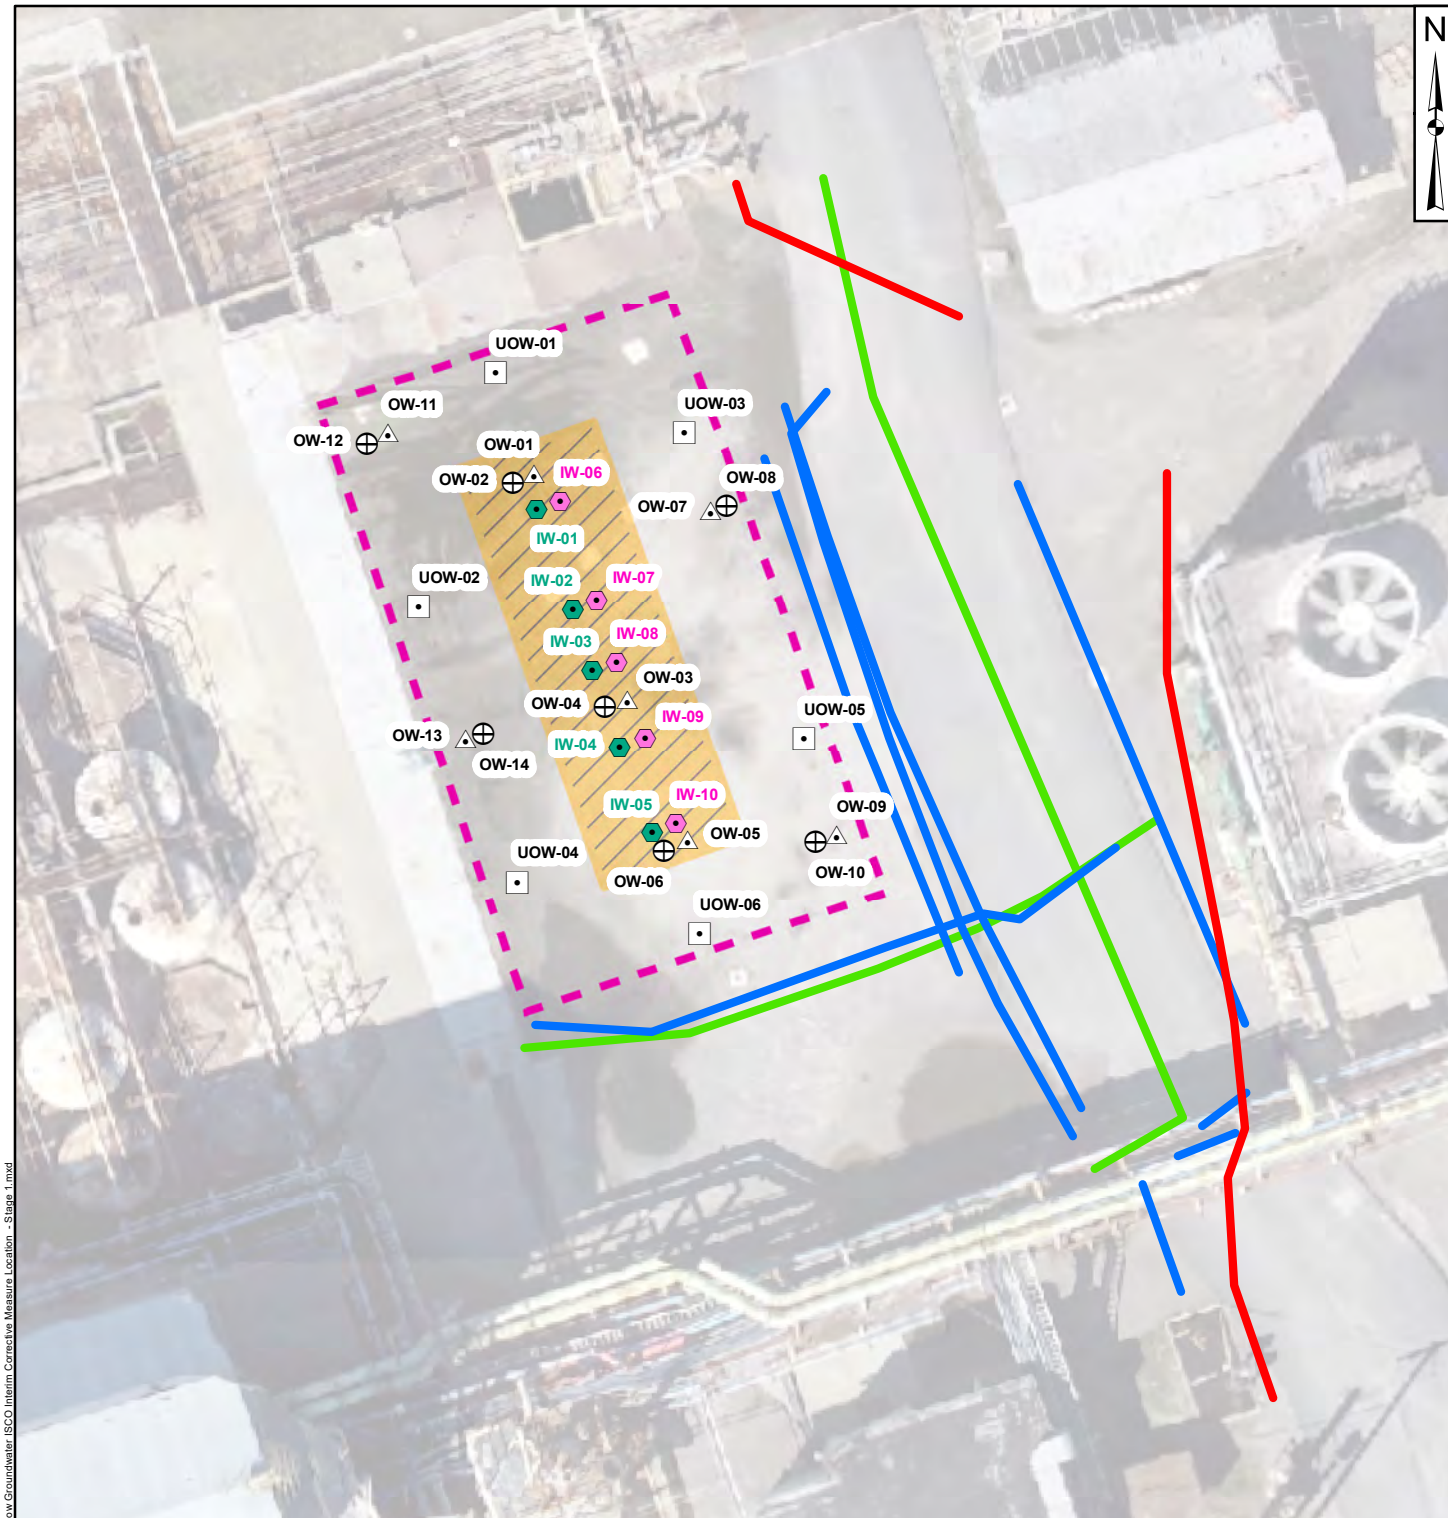
**Figure
6-11**

- Step 1 Injection Well (IW) Screened at 15-20 ft bgs
- Step 2 Injection Well (IW) Screened at 5-15 ft bgs
- ⊕ Observation Well (OW) Screened at 5-12 ft bgs
- ⚠ Observation Well (OW) Screened at 13-20 ft bgs
- Utility Observation Well (UOW) Screened at 5-10 ft bgs
- Electrical Line (Approximate Underground Location)
- Fire Suppression Line (Approximate Underground Location)
- Water Line (Approximate Underground Location)
- Treatment Area (Stage 1)
- Target Treatment

A combination of desktop, laboratory, and field evaluations were performed that led to the selection of ISCO as the remedial technology to be used for groundwater in the shallow zone of the upper surficial aquifer underlying the southern production area near the Stillhouse Control Room. Groundwater in the area shown on **Figures 6-11 and 6-12**

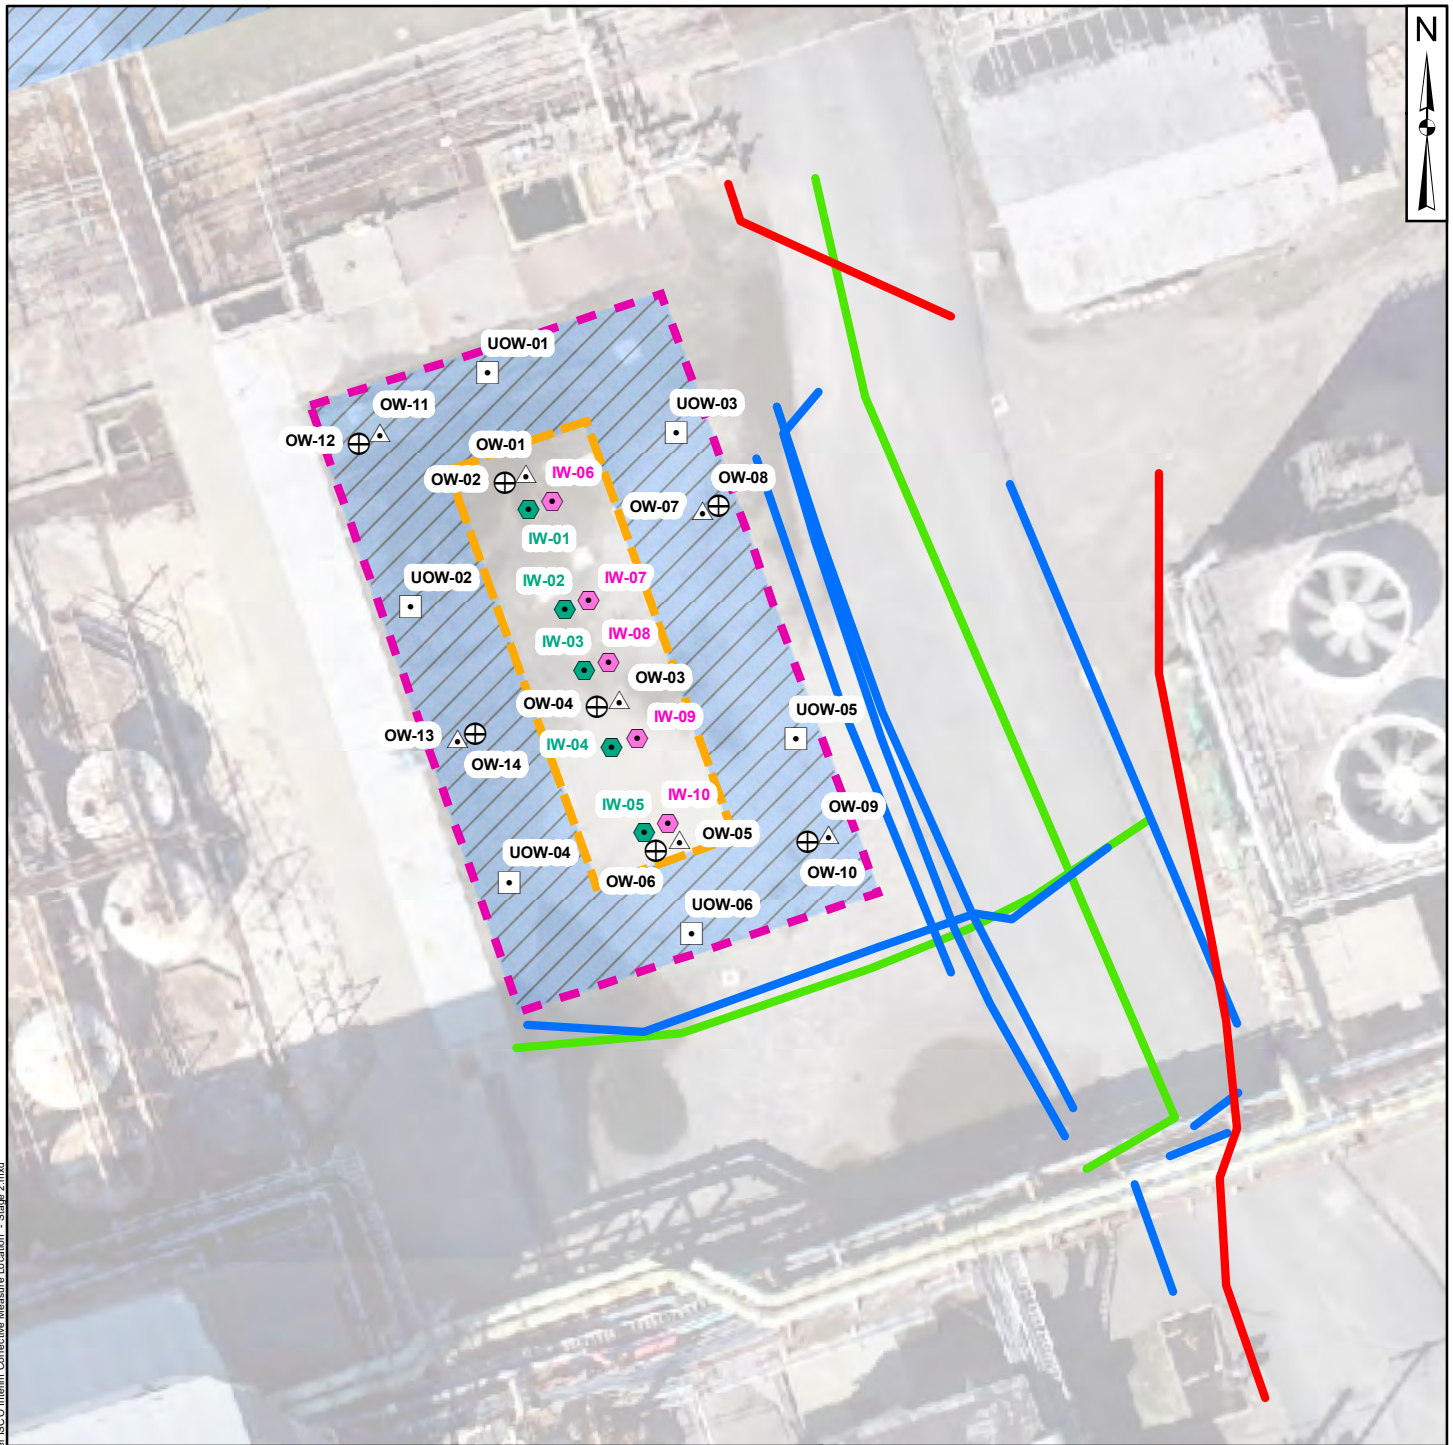
**Figure
6-12**

- Step 1 Injection Well (IW) Screened at 15-20 ft bgs
- Step 2 Injection Well (IW) Screened at 5-15 ft bgs
- ⊕ Observation Well (OW) Screened at 5-12 ft bgs
- ⊕ Observation Well (OW) Screened at 13-20 ft bgs
- Utility Observation Well (UOW) Screened at 5-10 ft bgs
- Electrical Line (Approximate Underground Location)
- Fire Suppression Line (Approximate Underground Location)
- Water Line (Approximate Underground Location)
- Treatment Area (Stage 1)
- Treatment Area (Stage 2)
- Target Treatment

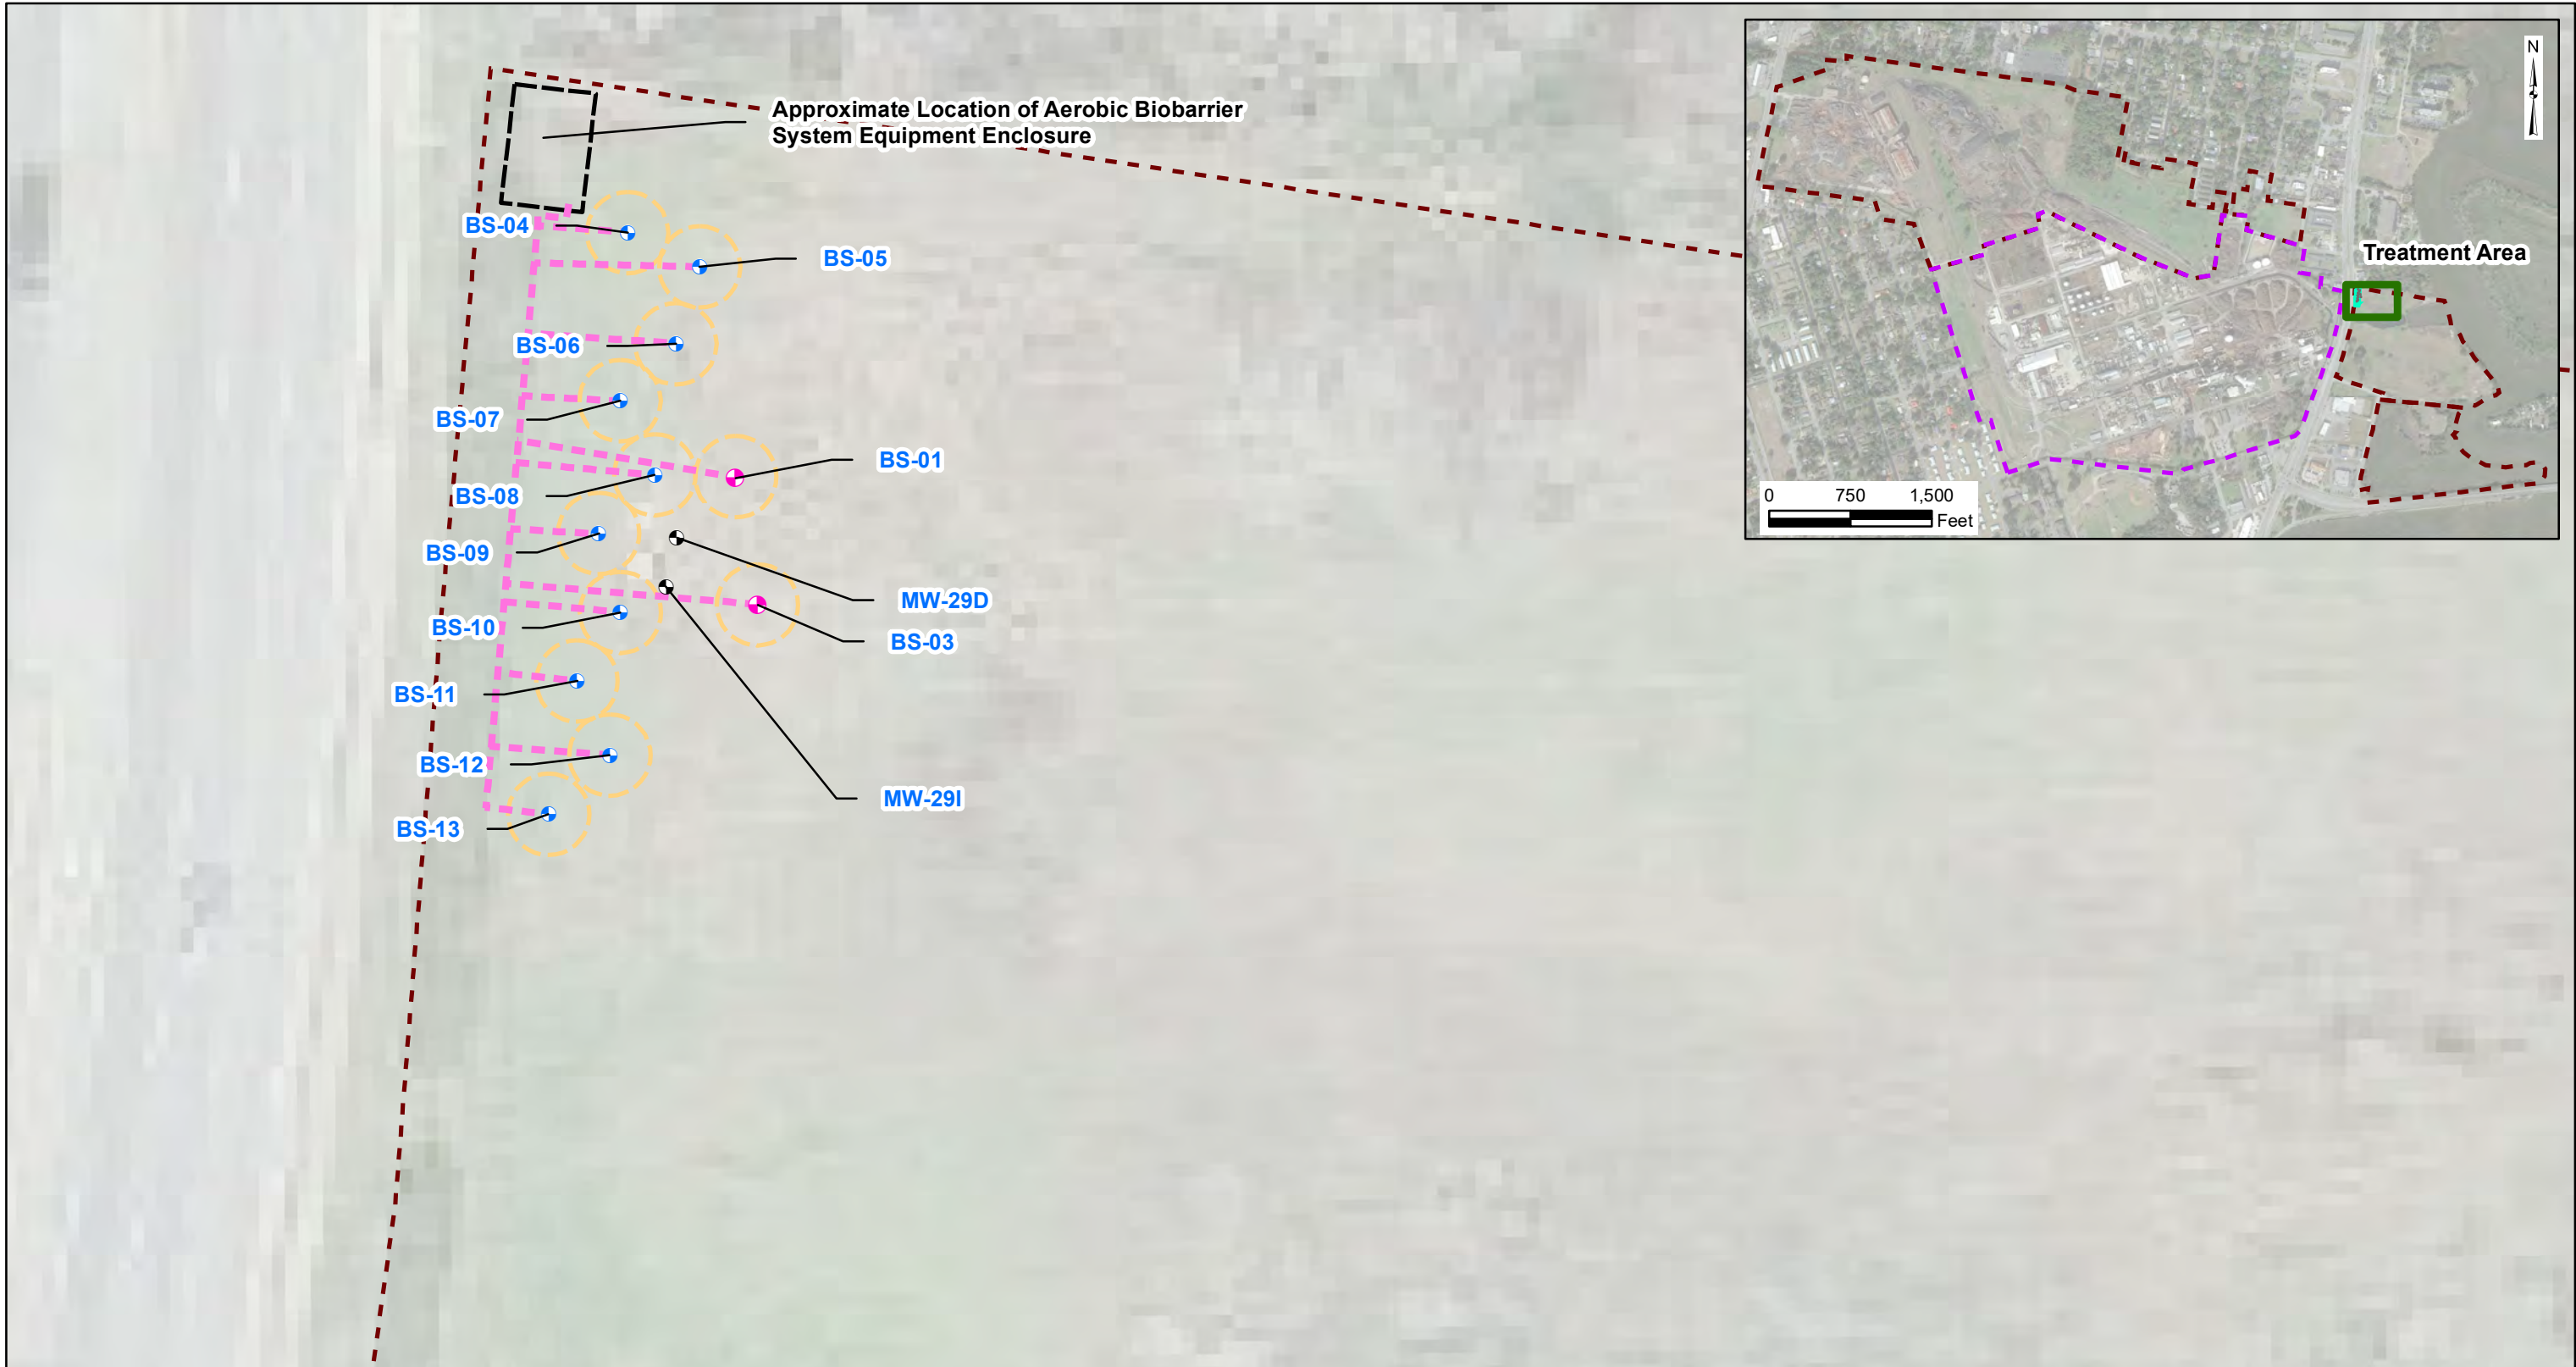
- Supplemental Biosparging Well
- Monitoring Well – Surficial Aquifer, Upper Unit
- Proposed Biosparging Well
- Approximate Location of Trench for Underground Sparging Lines
- Anticipated radius of influence of biosparging well
- Pinova Property
- Hercules Property

1. "S", "I", and "D" designate monitoring wells screened in the shallow, intermediate and deep zones of the upper surficial aquifer, respectively.
2. Proposed locations of biosparging wells are subject to change based on field conditions.
3. Aerial photograph approximate date - January 2019. Source: Google Earth.
4. Proposed location of aerobic biobarrier system equipment enclosure may be revised based on the final location of electrical service and the exact location and geometry of the aerobic biobarrier.

As described in the Aerobic Barrier ICM Work Plan, the initial segment of the aerobic biobarrier is expected to involve installation of a network of up to 12 biosparging wells (10 new wells and two existing wells), a biosparging system housed in an equipment enclosure, and a network of performance monitoring wells. A total of nine performance monitoring wells will be used to evaluate the effectiveness of the aerobic biobarrier. The performance monitoring wells are shown on **Figure 6-14b**. A baseline monitoring event and five post-startup performance monitoring events will be performed. The post-startup performance monitoring events will be performed at intervals of one month, three months, six months, nine months, and twelve months after the aerobic biobarrier is placed into operation.

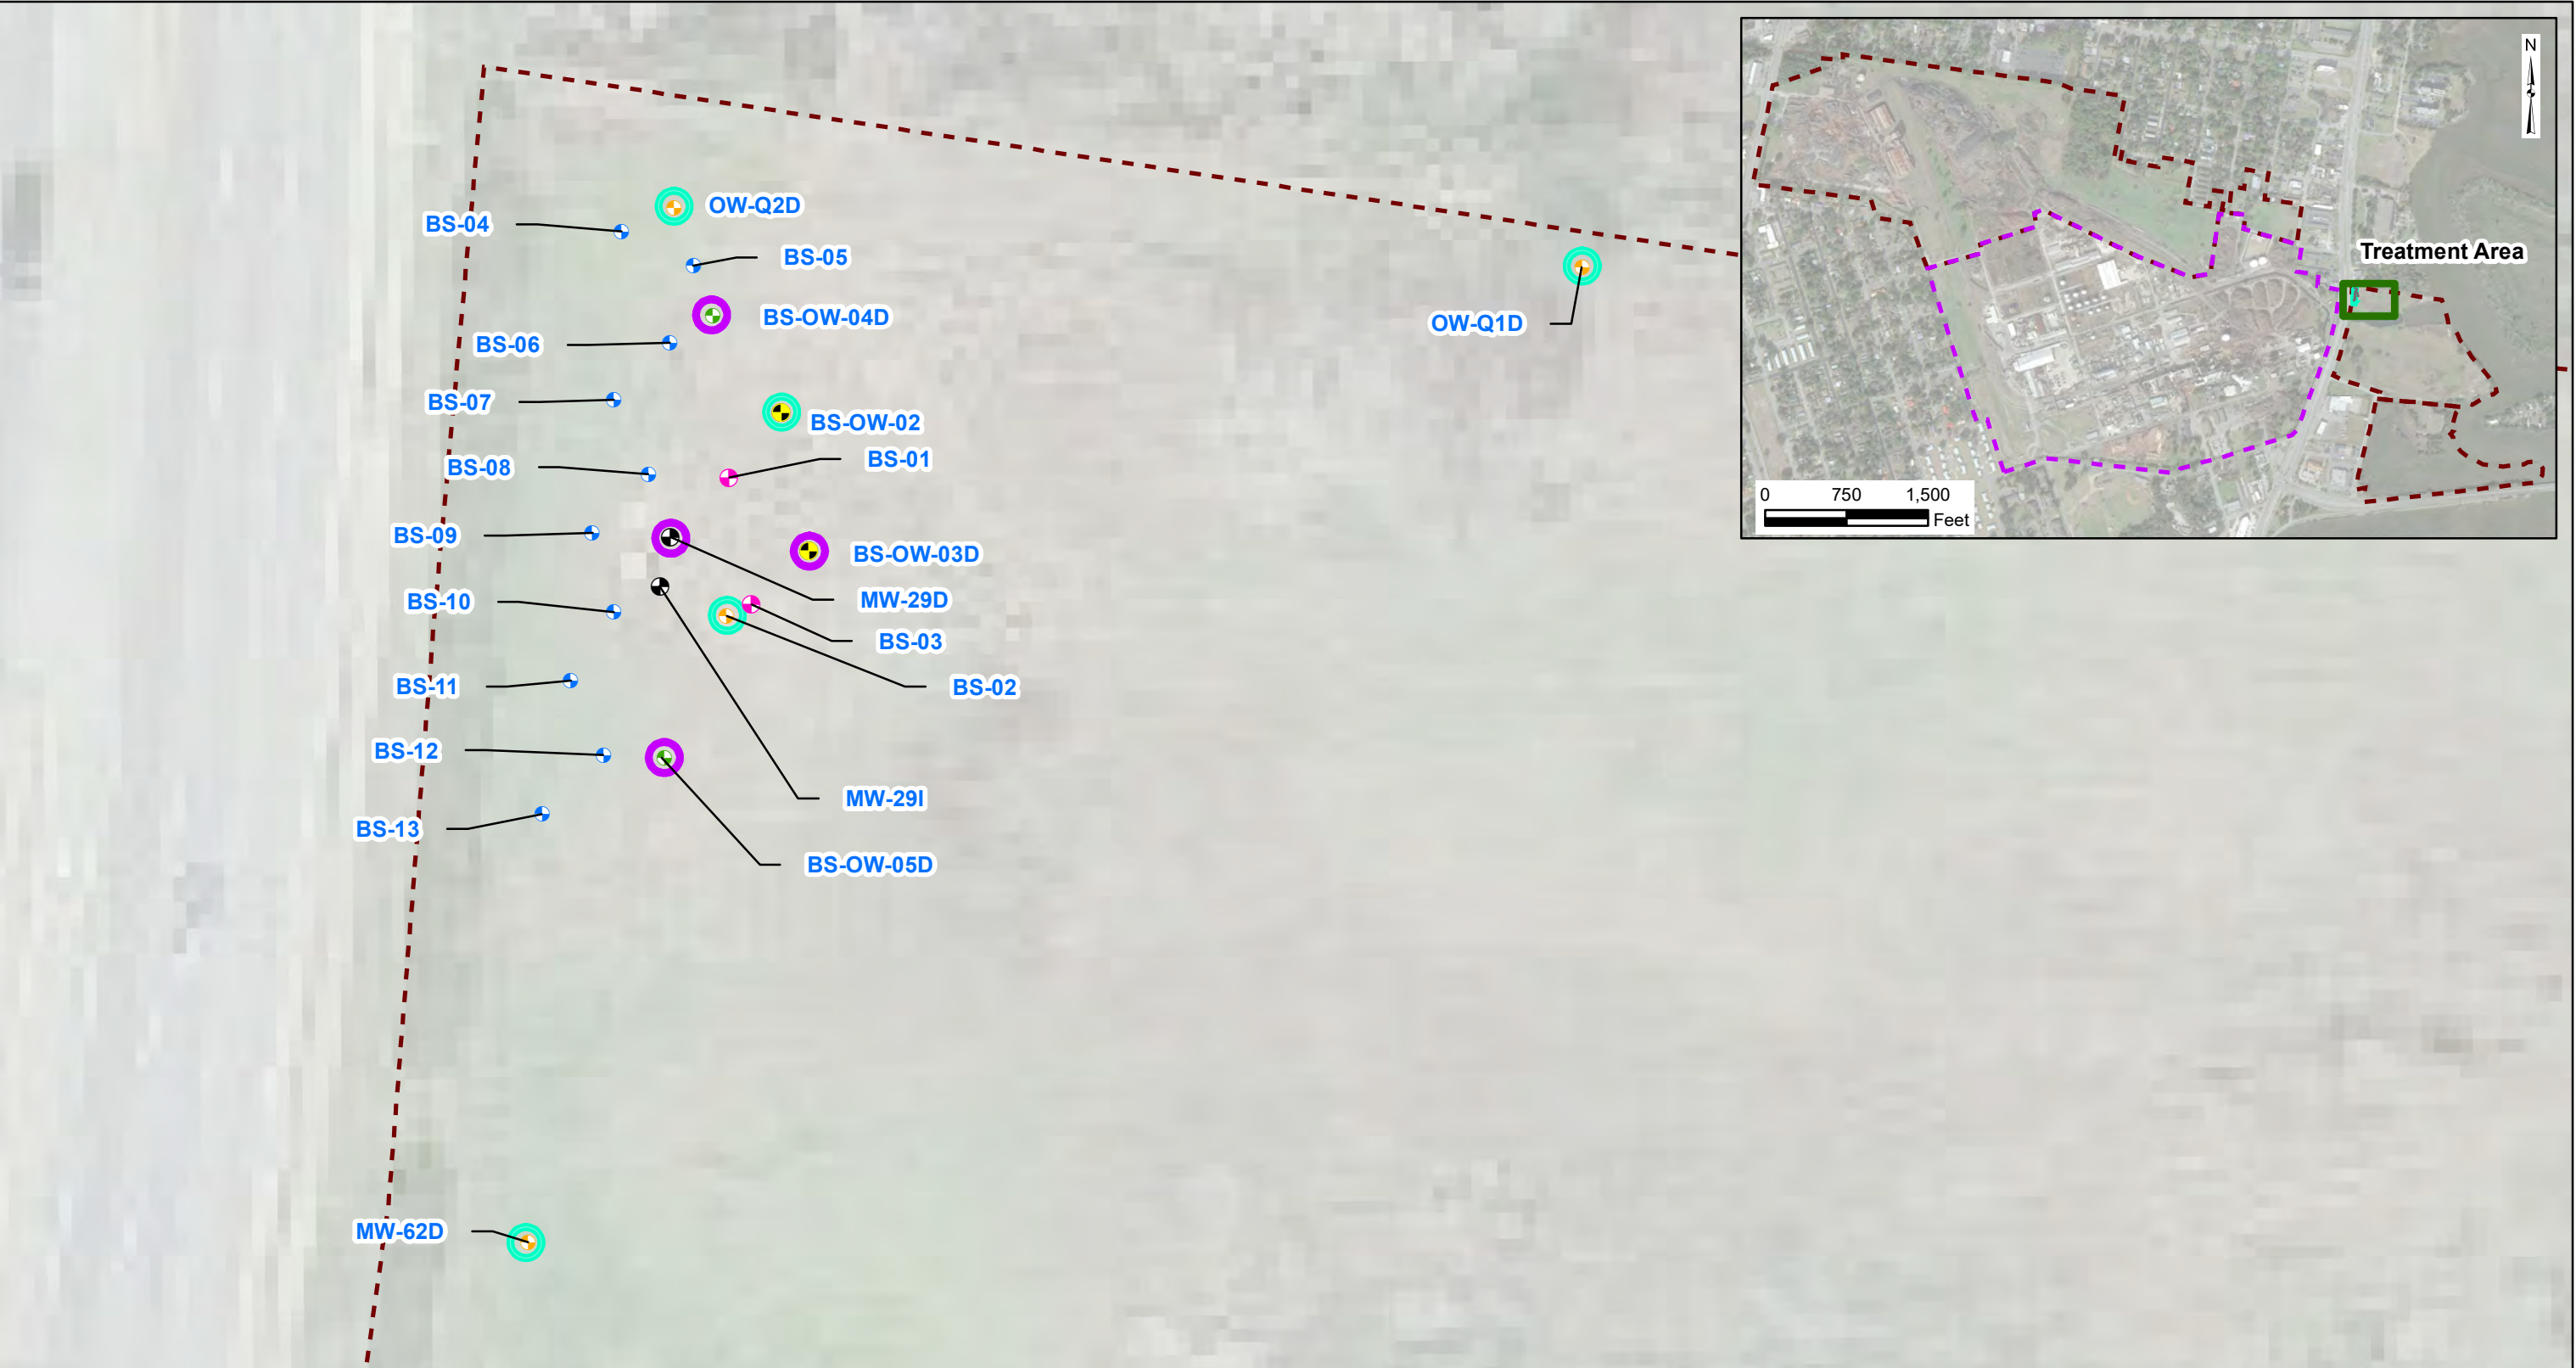
Figure 6-14b

- * - Observation well BS-OW-3I will be abandoned prior to installation of aerobic biobarrier.
- 1. "I", and "D" designate monitoring wells screened in the intermediate and deep zones of the upper surficial aquifer, respectively.
- 2. Proposed locations of biosparging performance monitoring wells are subject to change based on field conditions.
- 3. Aerial photograph approximate date - January 2019. Source: Google Earth.

Layout of Aerobic Biobarrier Performance Monitoring Wells - Deep Zone of Upper Surficial Aquifer Hercules/Pinova Facility Brunswick, Georgia	
Kennesaw, GA	January 2022

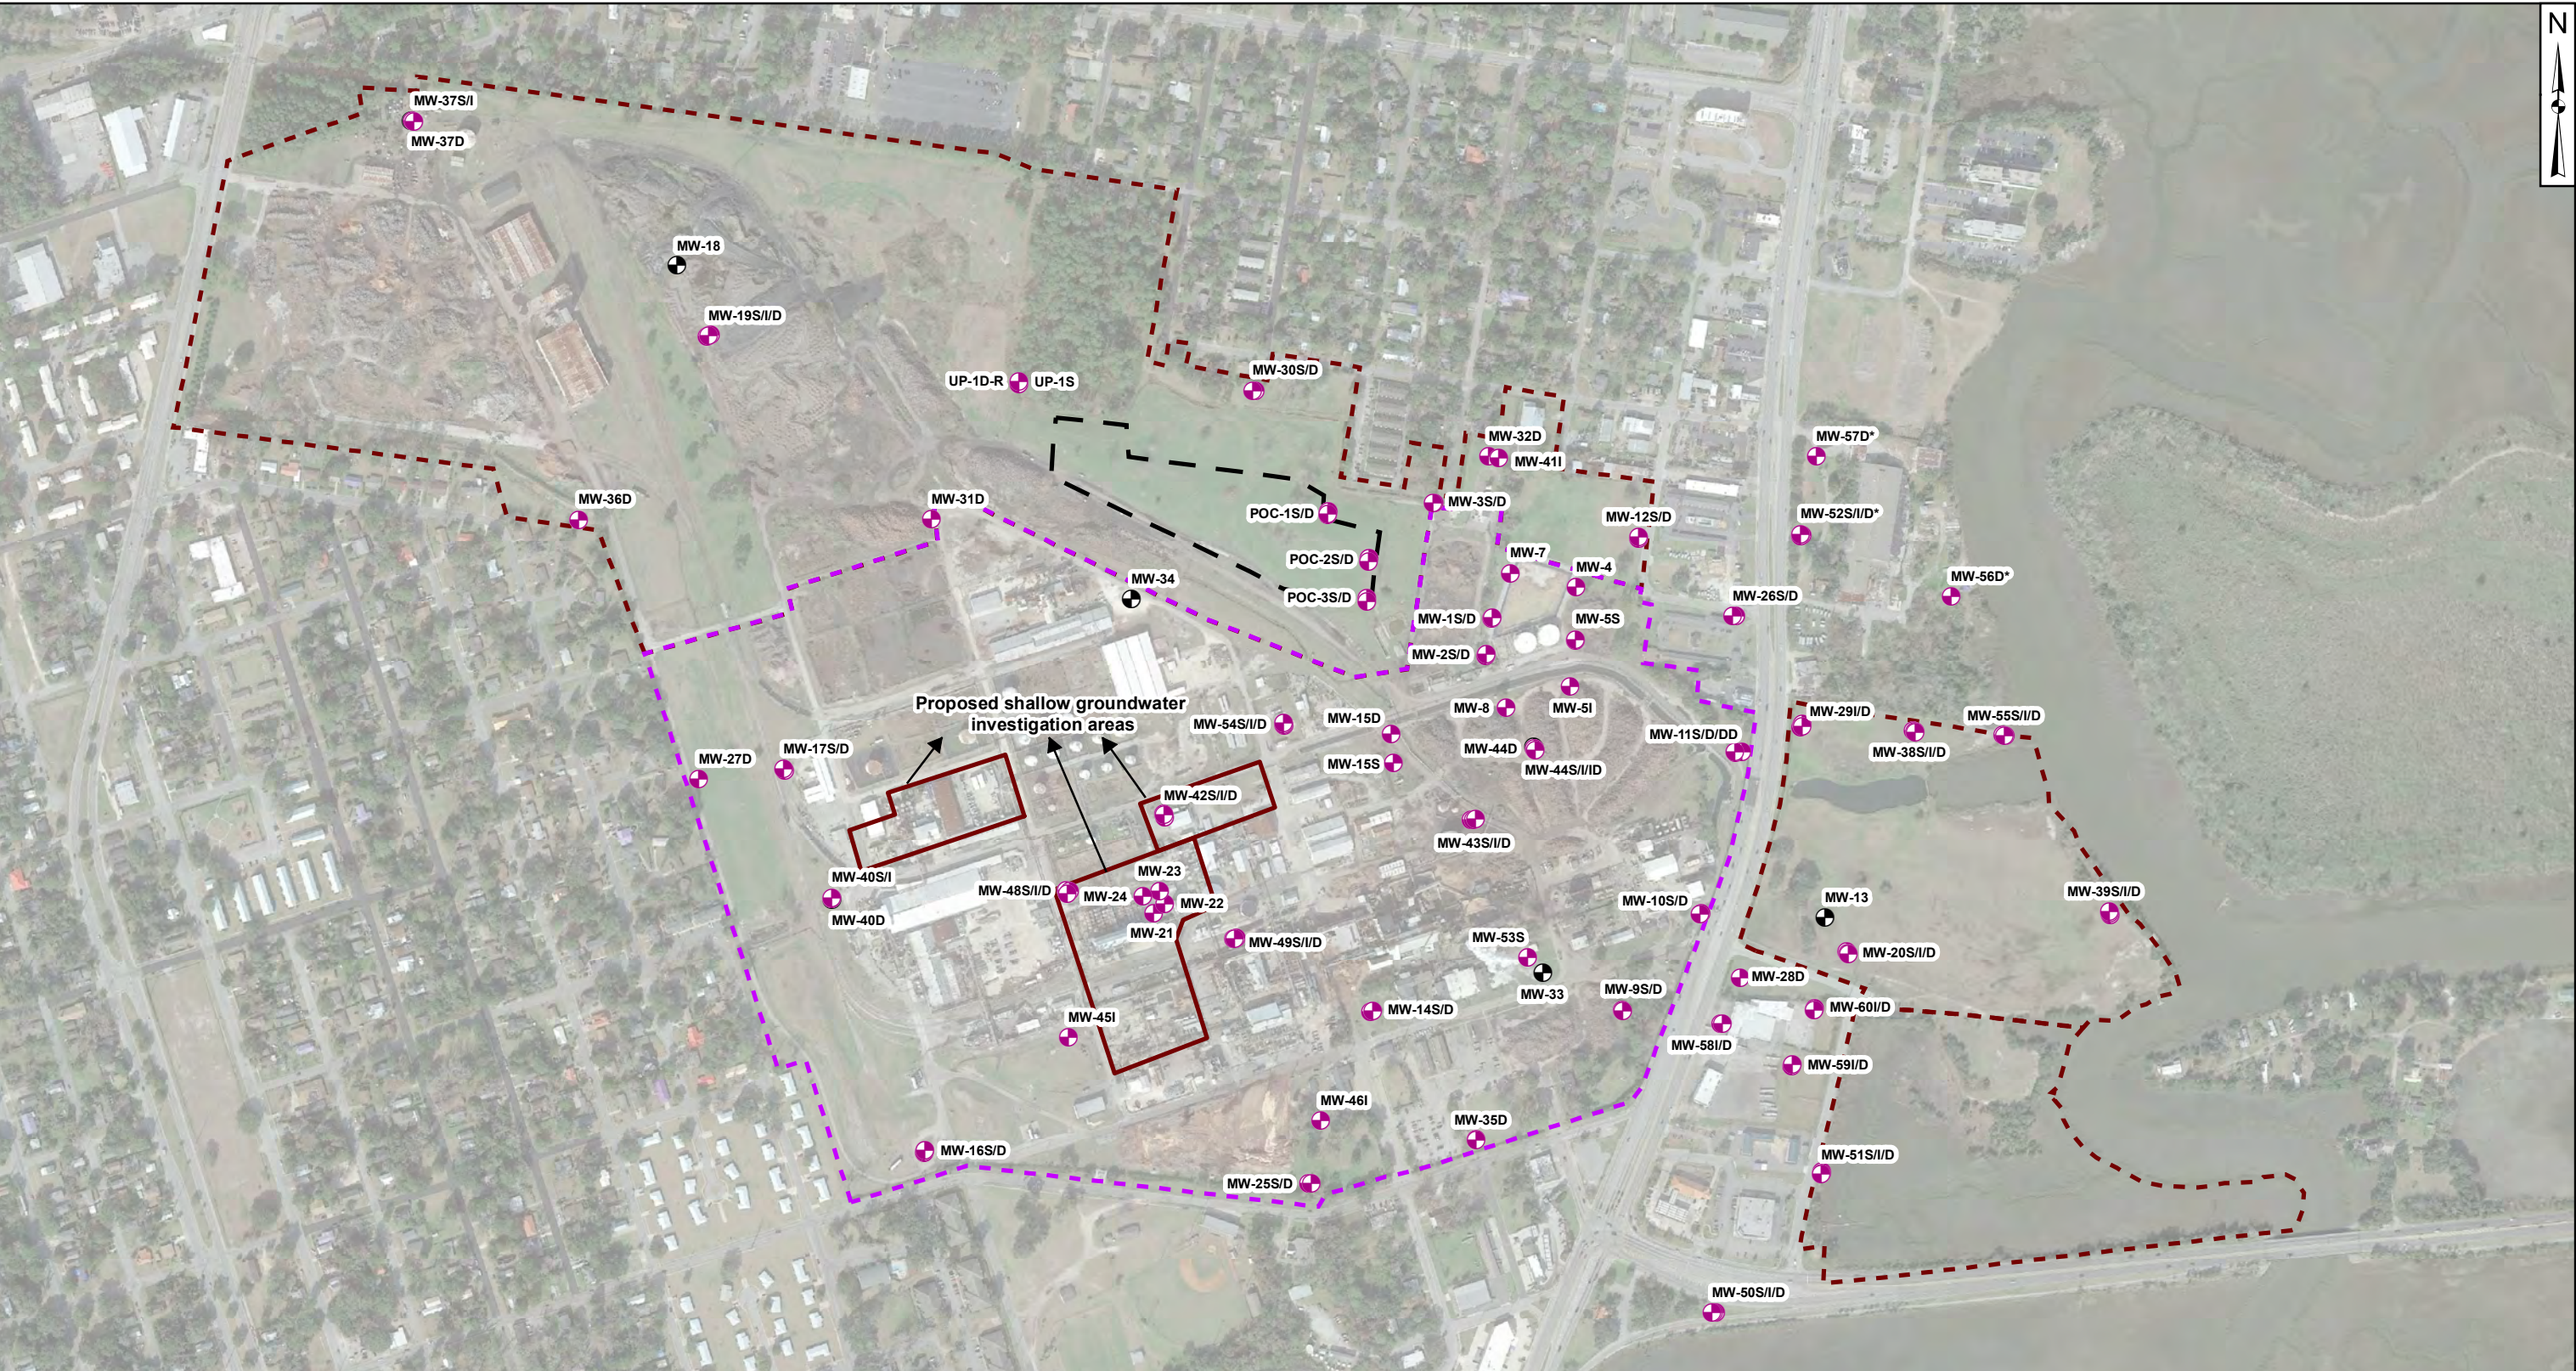
Figure
6-15

- Surficial Aquifer, Upper Unit Well
- Surficial Aquifer, Lower Unit Well
- Approximate Location of Closed Surface Impoundments
- Proposed Shallow Groundwater Investigation Areas
- Pinova Property
- Hercules Property

Characterization of shallow groundwater conditions in potential source areas will be performed initially using temporary groundwater sampling locations to inform the placement of additional monitoring wells as described below. As described elsewhere in this CAP, Hercules has already conducted extensive groundwater sampling activities to evaluate conditions in the shallow zone of the upper surficial aquifer. The characterization activities described below are intended to more intensively evaluate conditions in potential source areas and to augment the information that has already been developed regarding conditions in the shallow zone of the upper surficial aquifer. The areas targeted for investigation include the southern production area and former toxaphene production area as shown on **Figure 6-15**.

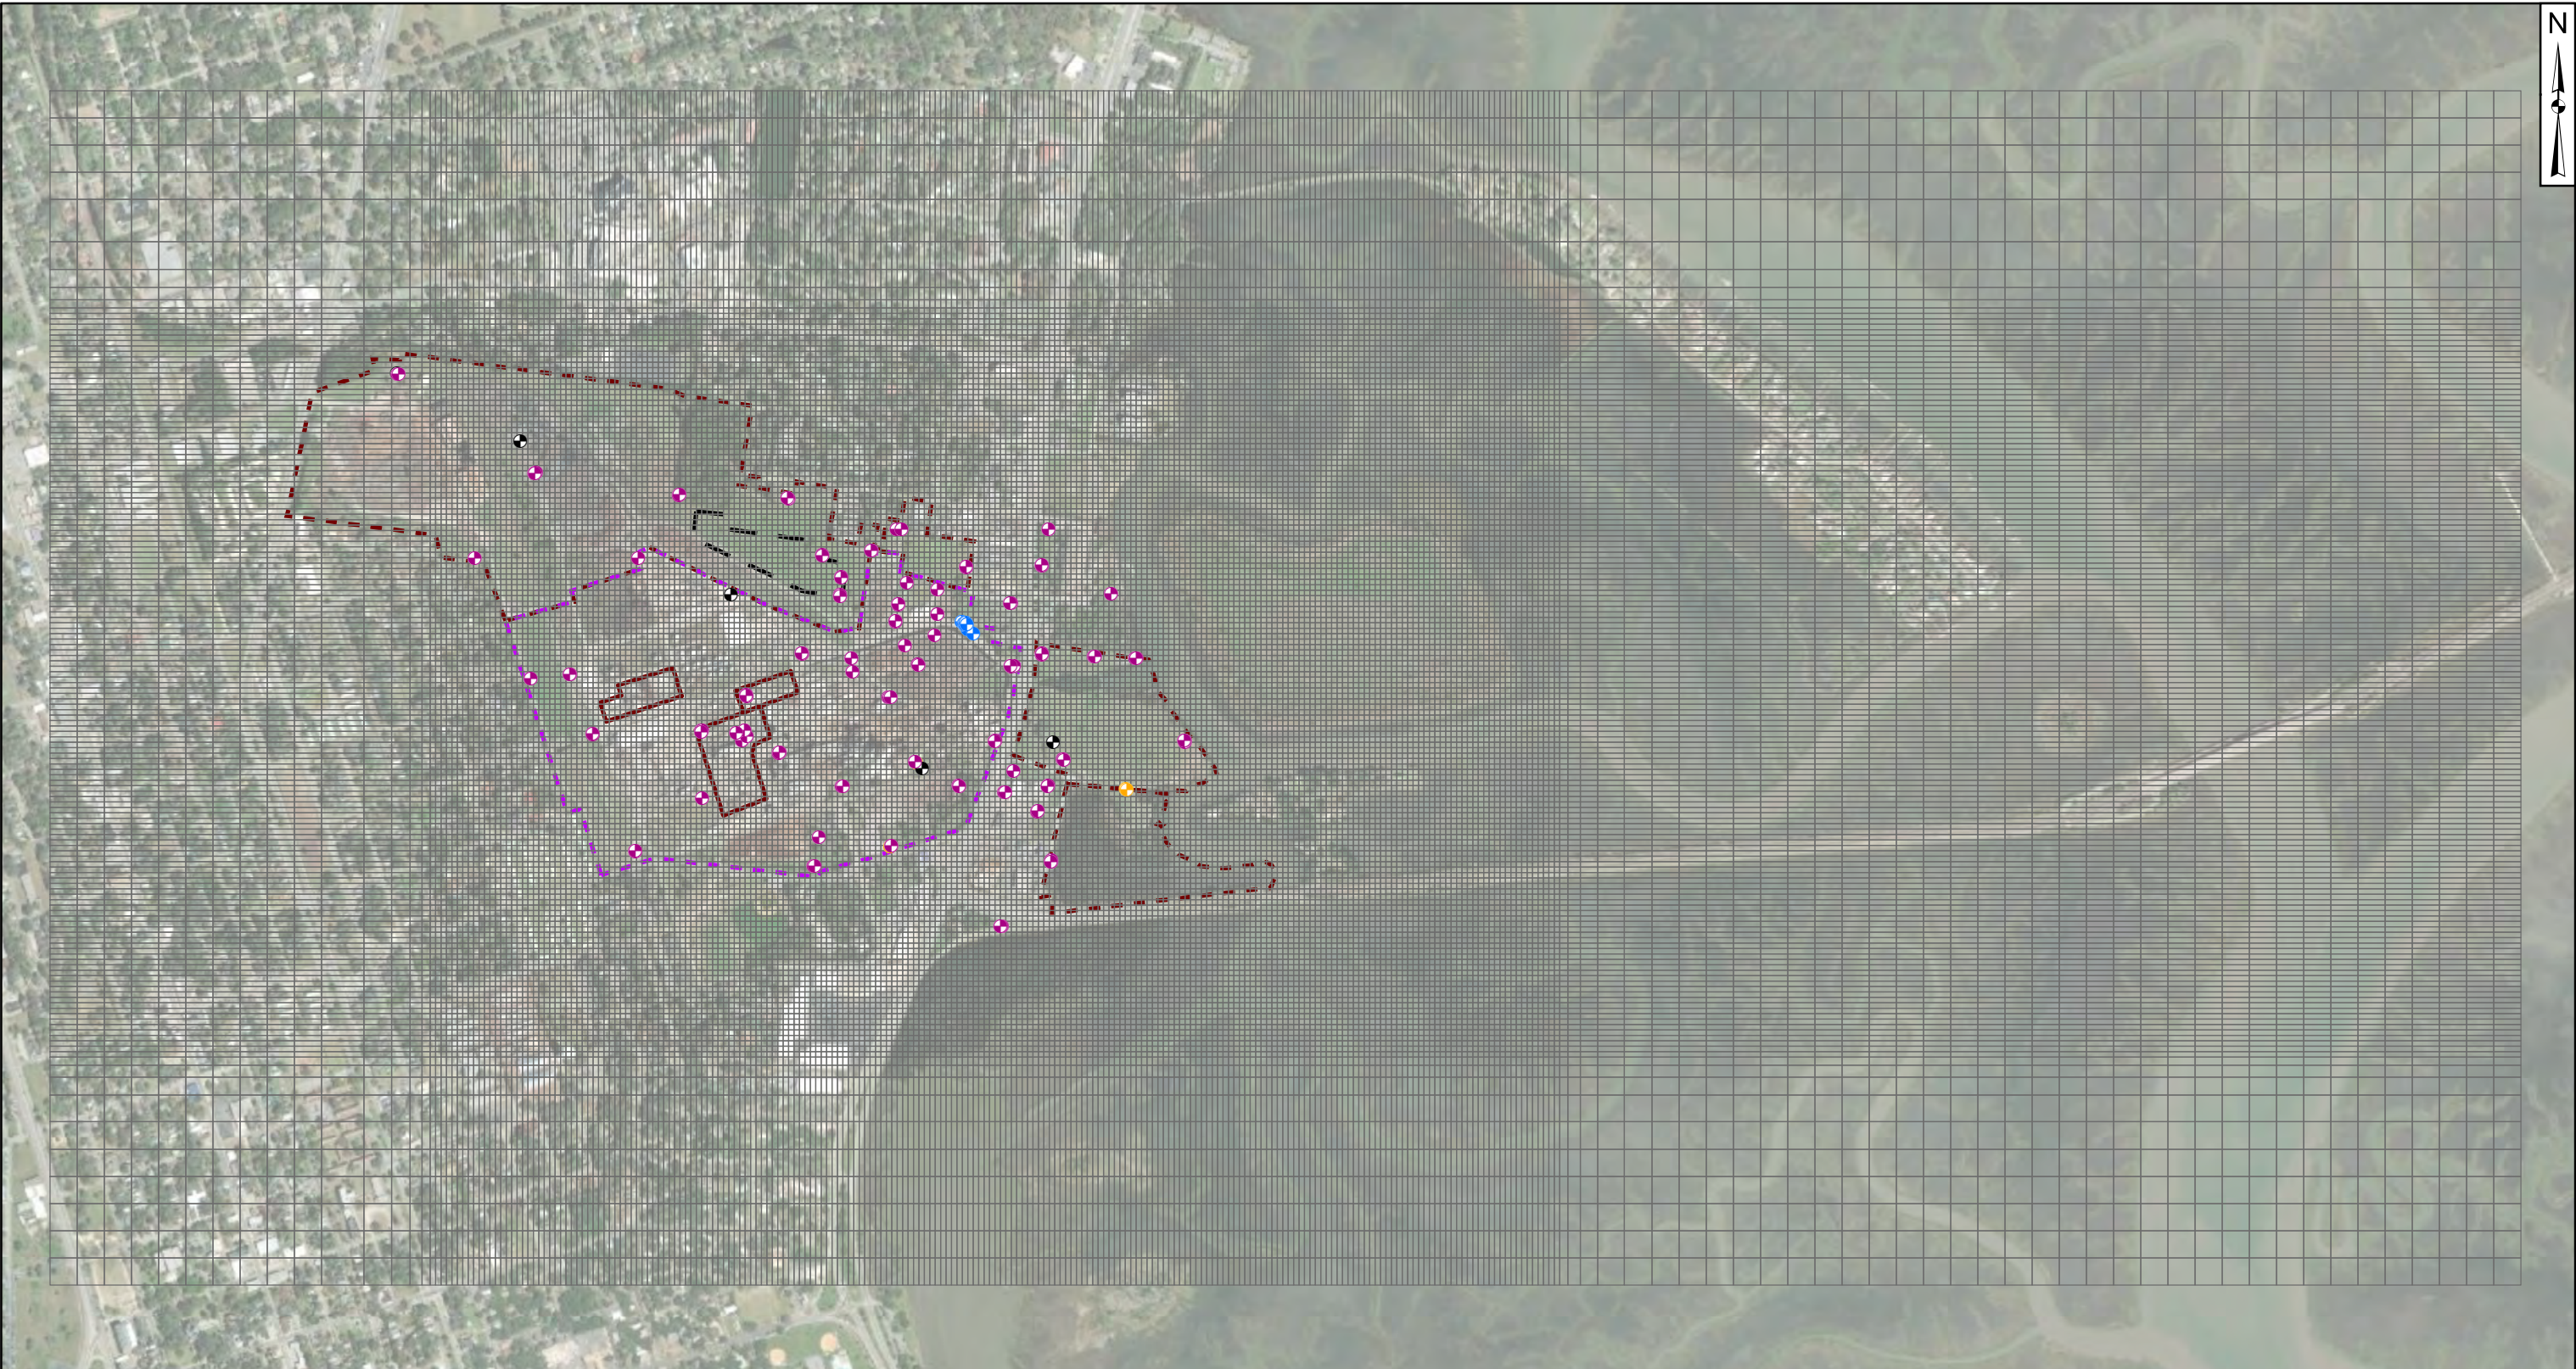
Legend <ul style="list-style-type: none">Surficial Aquifer, Upper Unit WellSurficial Aquifer, Lower Unit WellPumping Test and Plume Stop Pilot Test WellNew Monitoring Well (November 2020)Approximate Location of Closed Surface ImpoundmentsApproximate Extent of Primary Potential Source AreaPinova PropertyHercules PropertyGroundwater Flow Model Grid	0 600 1,200 2,400 Feet	Groundwater Flow Model Grid Hercules/Pinova Facility Brunswick, Georgia	
		Geosyntec consultants	
	Kennesaw, GA	January 2022	Figure 6-17

As part of further refinement of the groundwater flow model for the Brunswick facility, the model layering and hydraulic conductivity zonation will be updated to include lower permeability units (where present) which have been interpreted to separate the shallow, intermediate, and deep zones of the upper surficial aquifer. The model grid will also be refined to increase grid resolution in key areas of the Brunswick facility and to expand the model boundaries as shown on **Figure 6-17**. The groundwater flow model will then be recalibrated to reflect recent groundwater elevation measurements and sampling results for TDS (or salinity, as appropriate), under steady state conditions, in order to establish a groundwater flow field. Once the groundwater flow field has been finalized, the groundwater flow model will be updated with additional sampling results for COPCs and associated fate and transport parameters. The groundwater flow model will then be
