RE: **Corrective Action Plan
Hercules LLC/Pinova Inc. - Brunswick Facility
Hazardous Waste Facility Permit No. HW-52(D&S)-2,
EPA ID No. GAD00406065520**

CORRECTIVE ACTION PLAN

HERCULES LLC/PINOVA INC. FACILITY

BRUNSWICK, GEORGIA

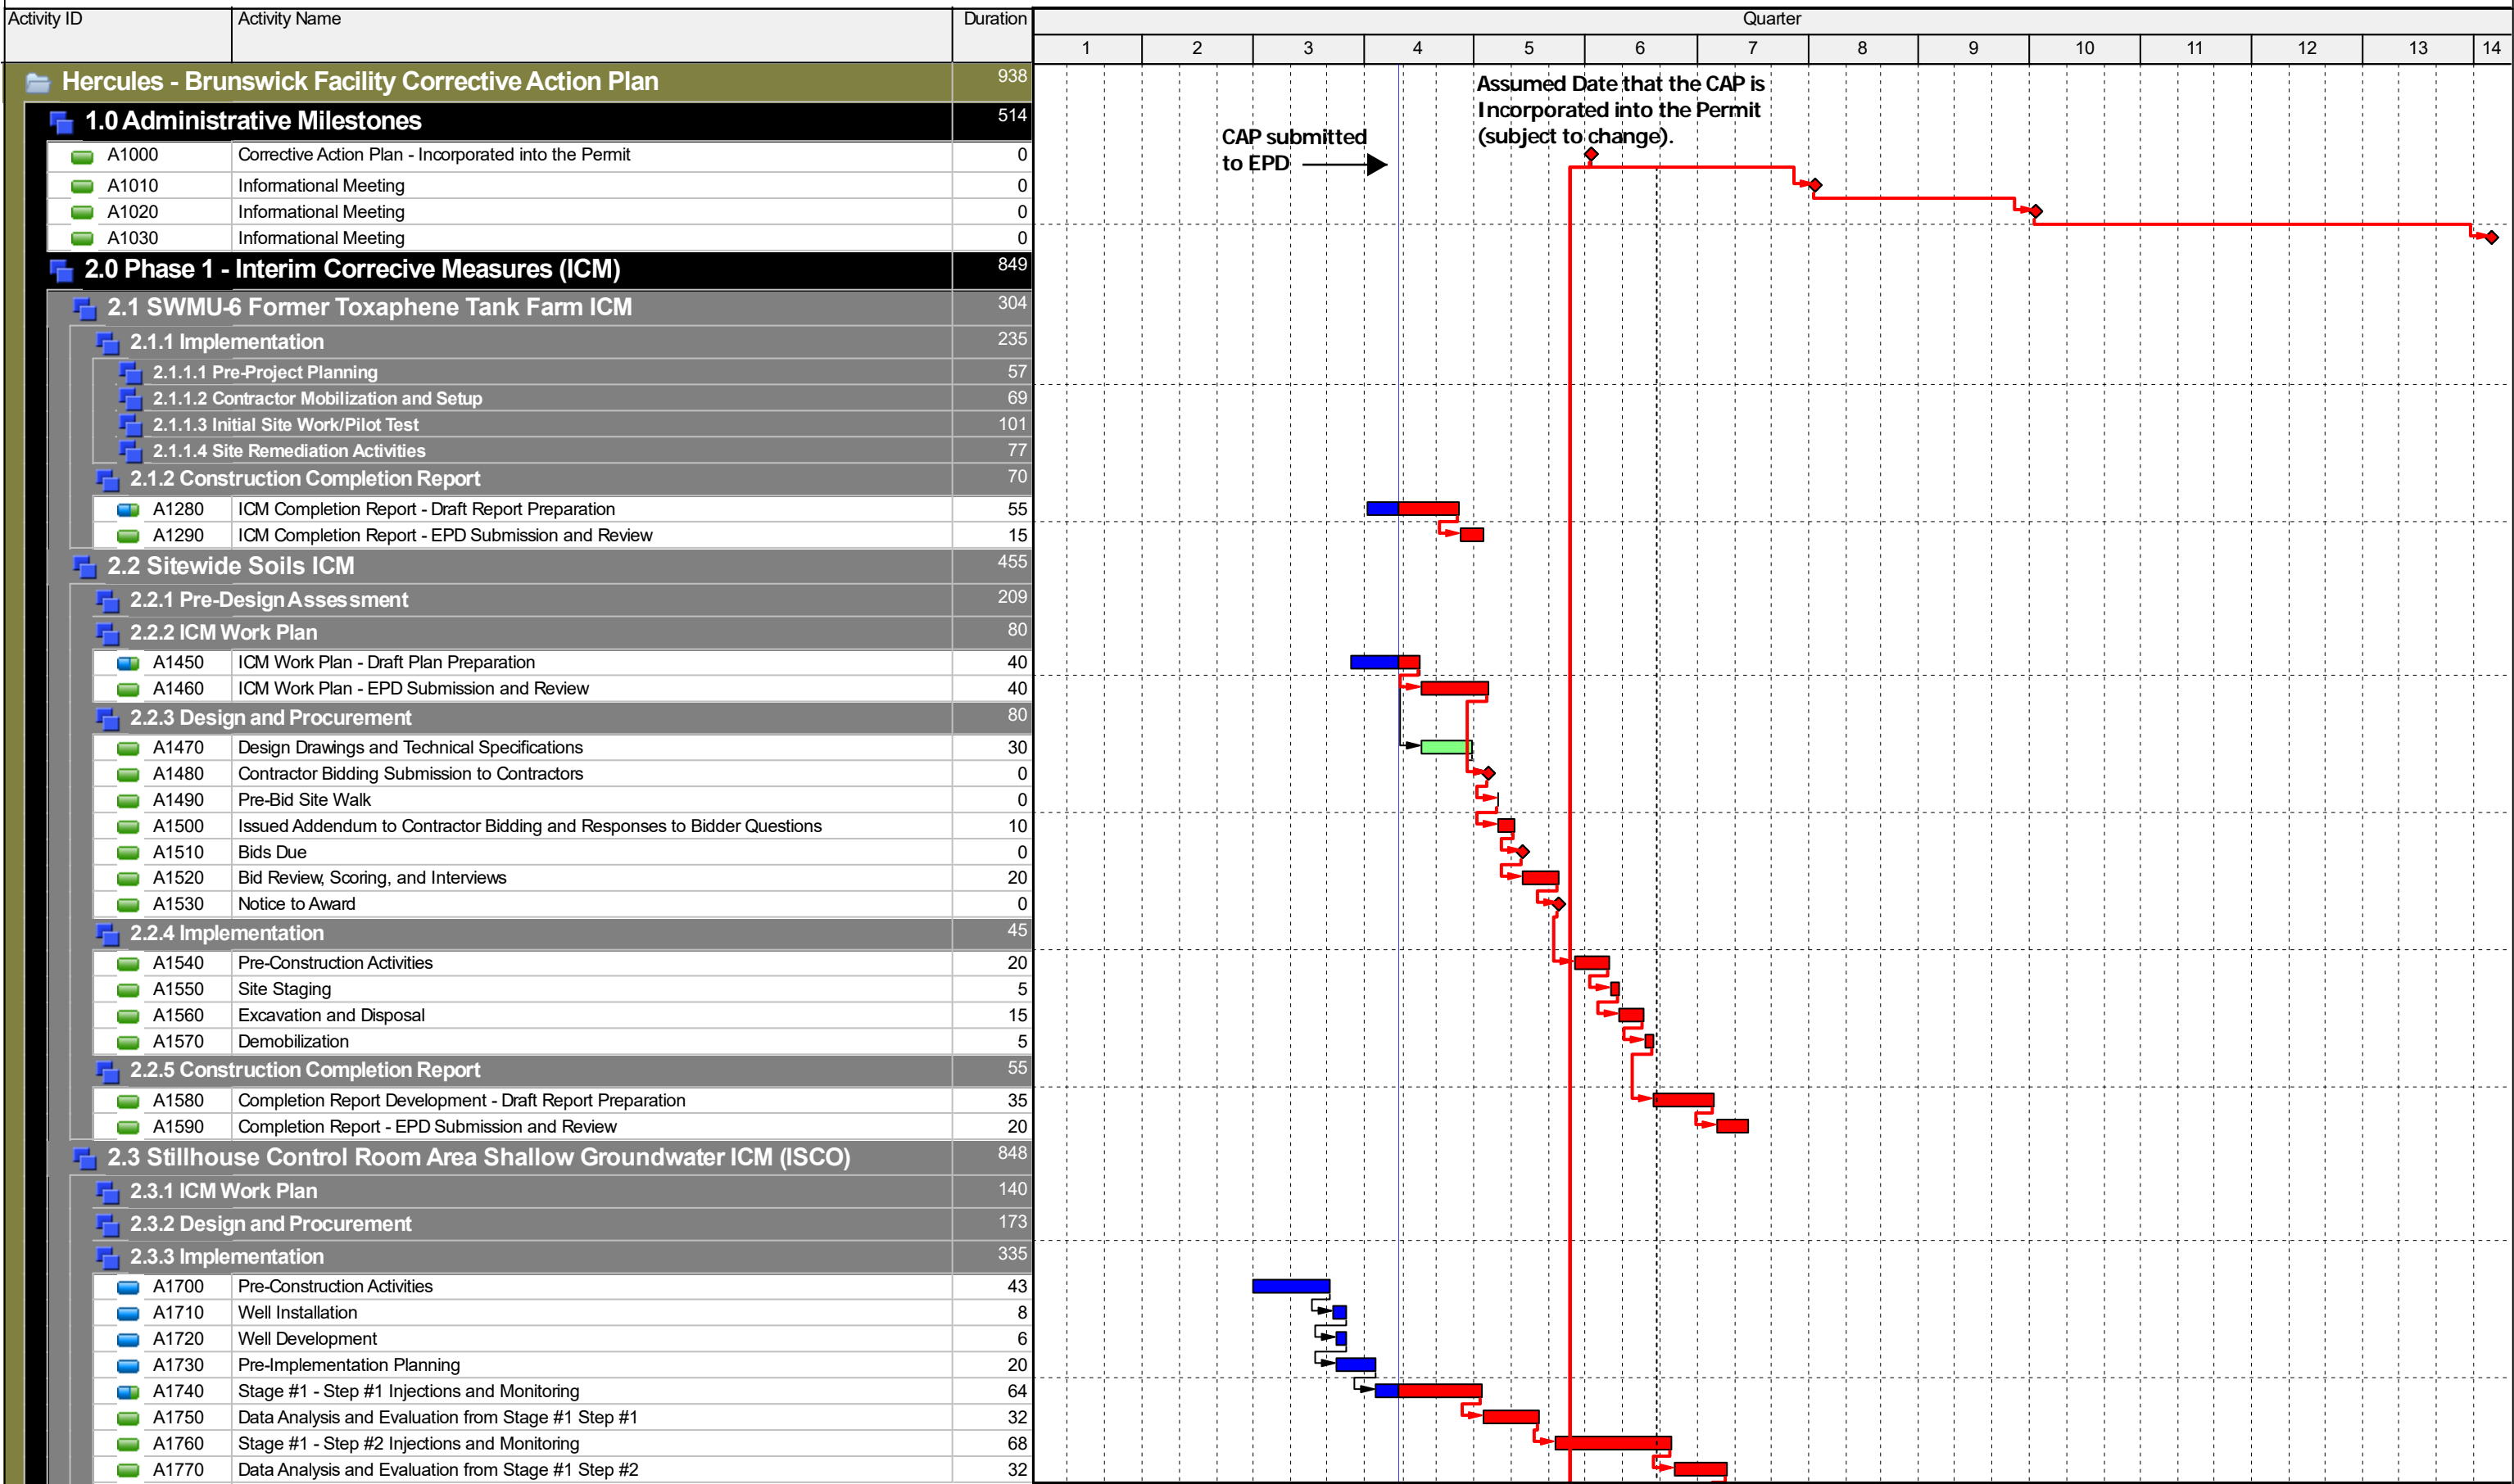
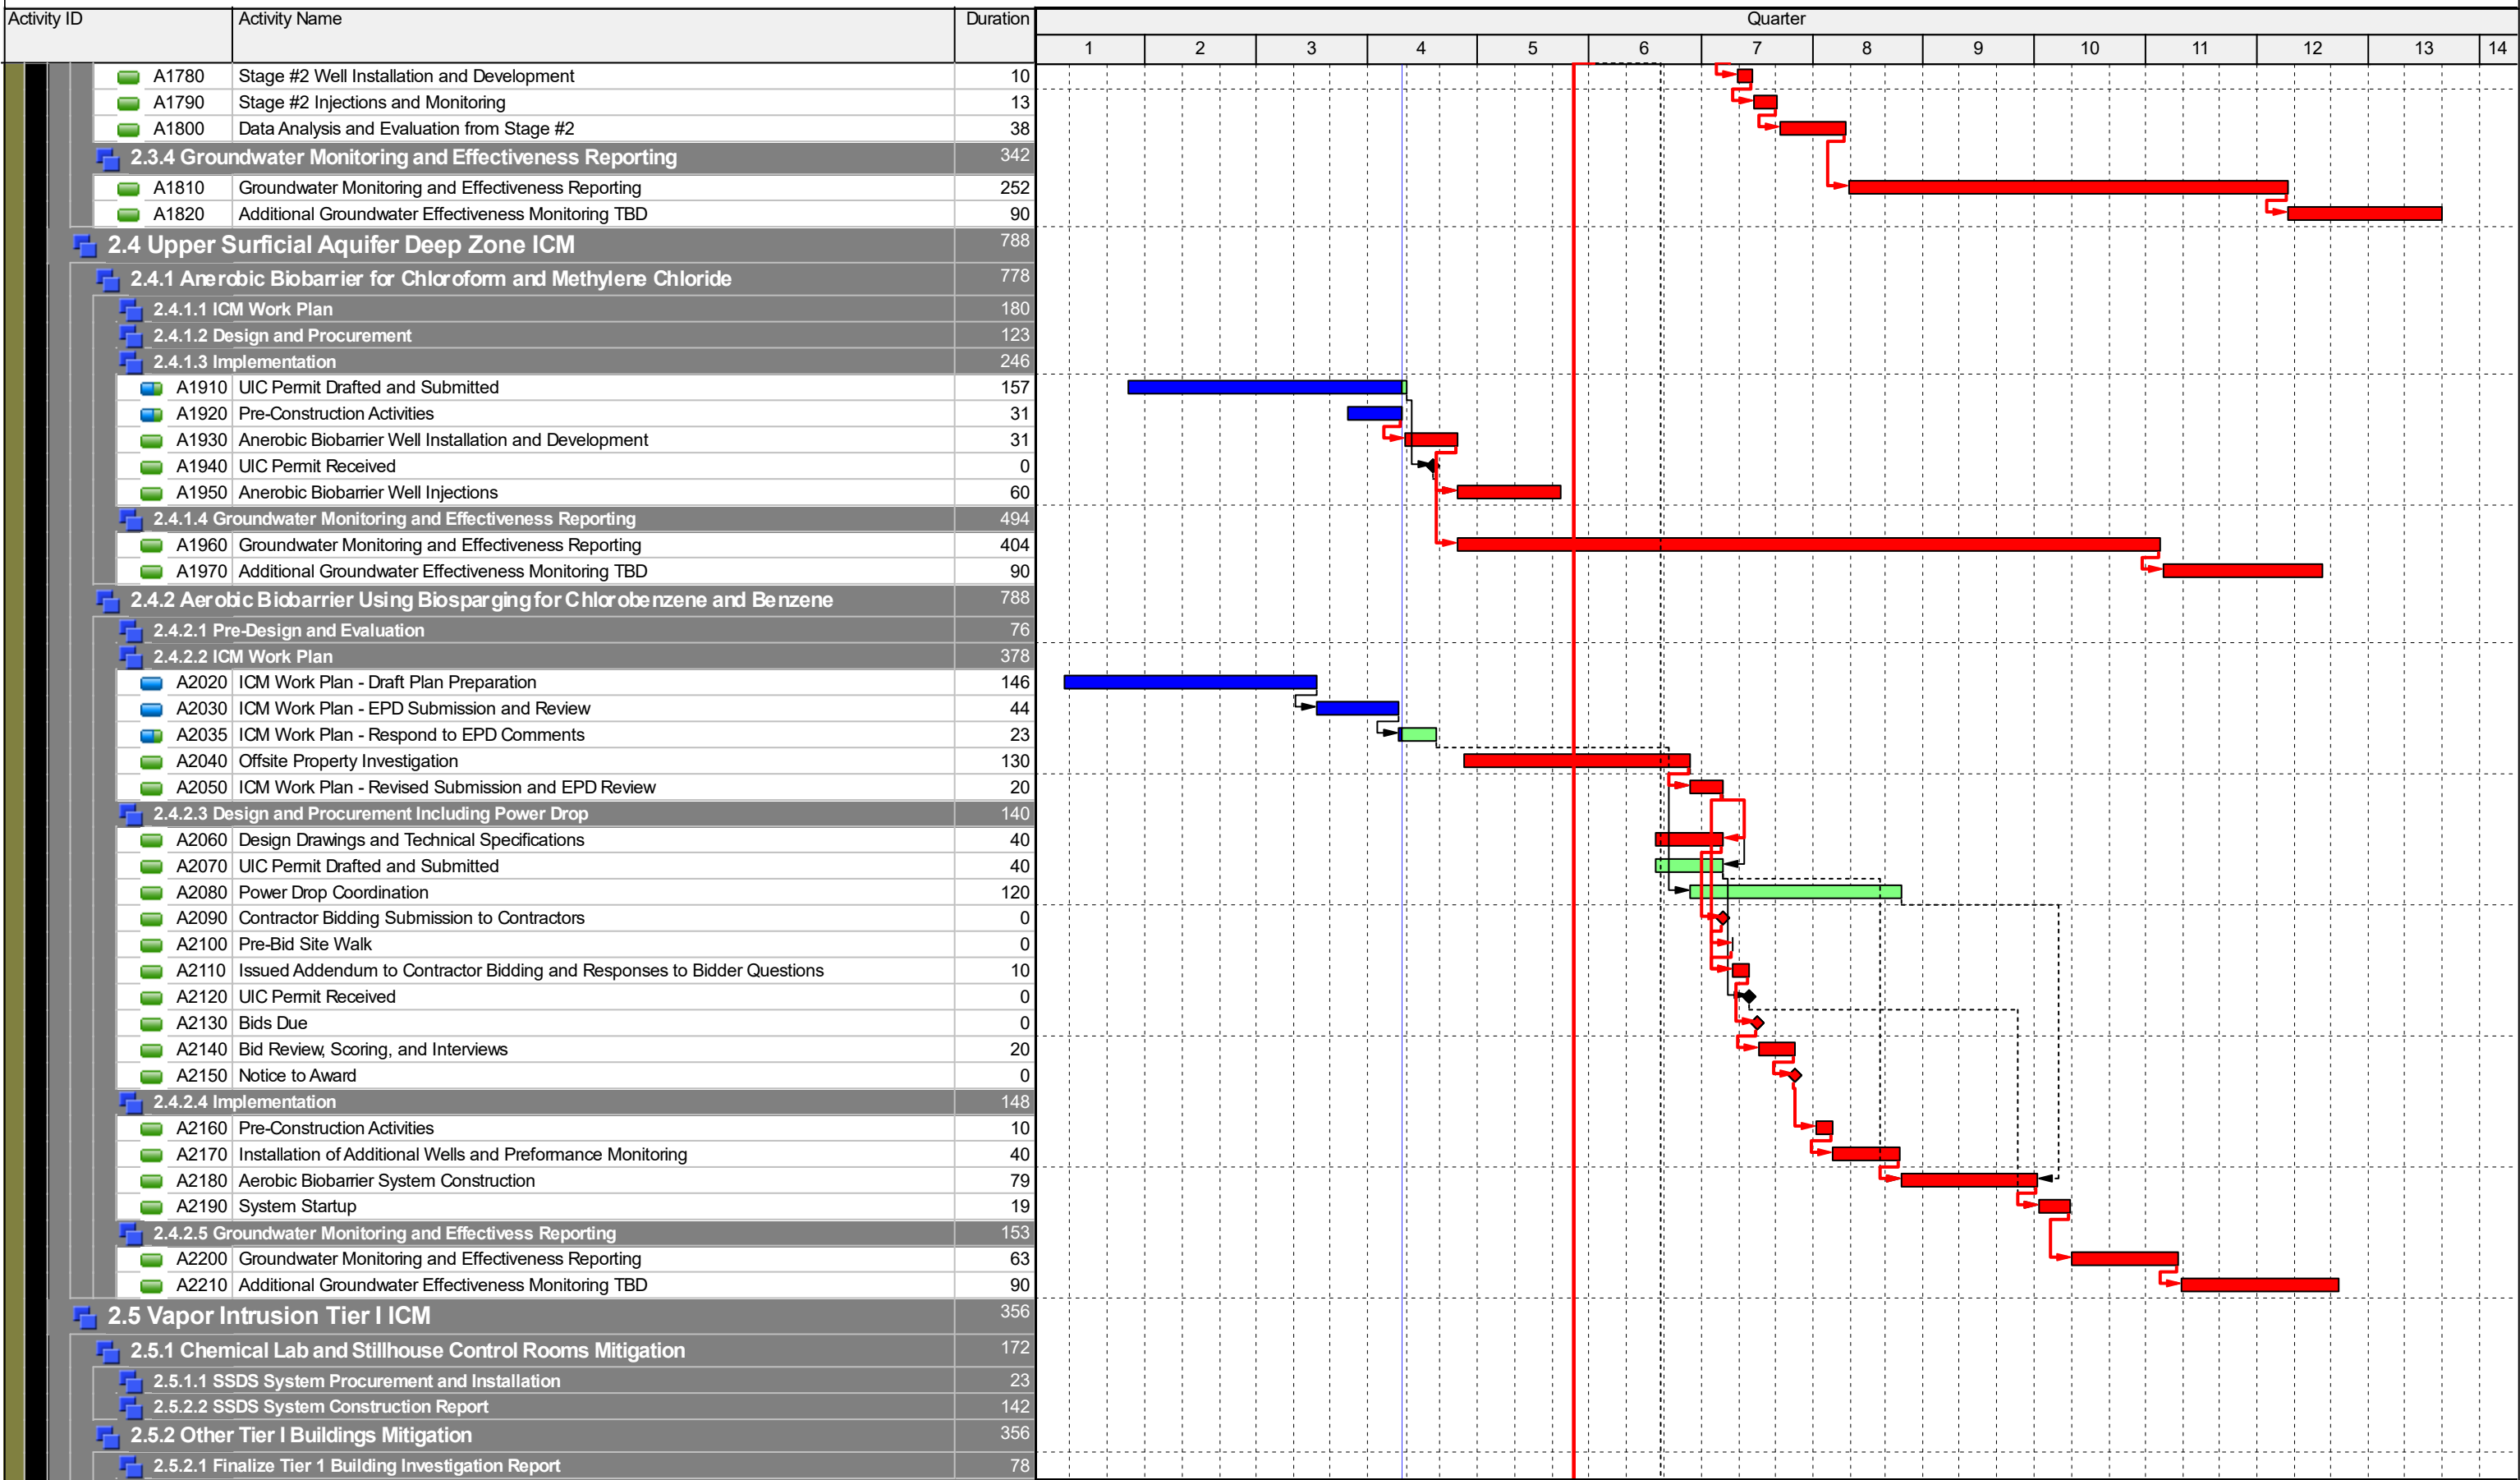
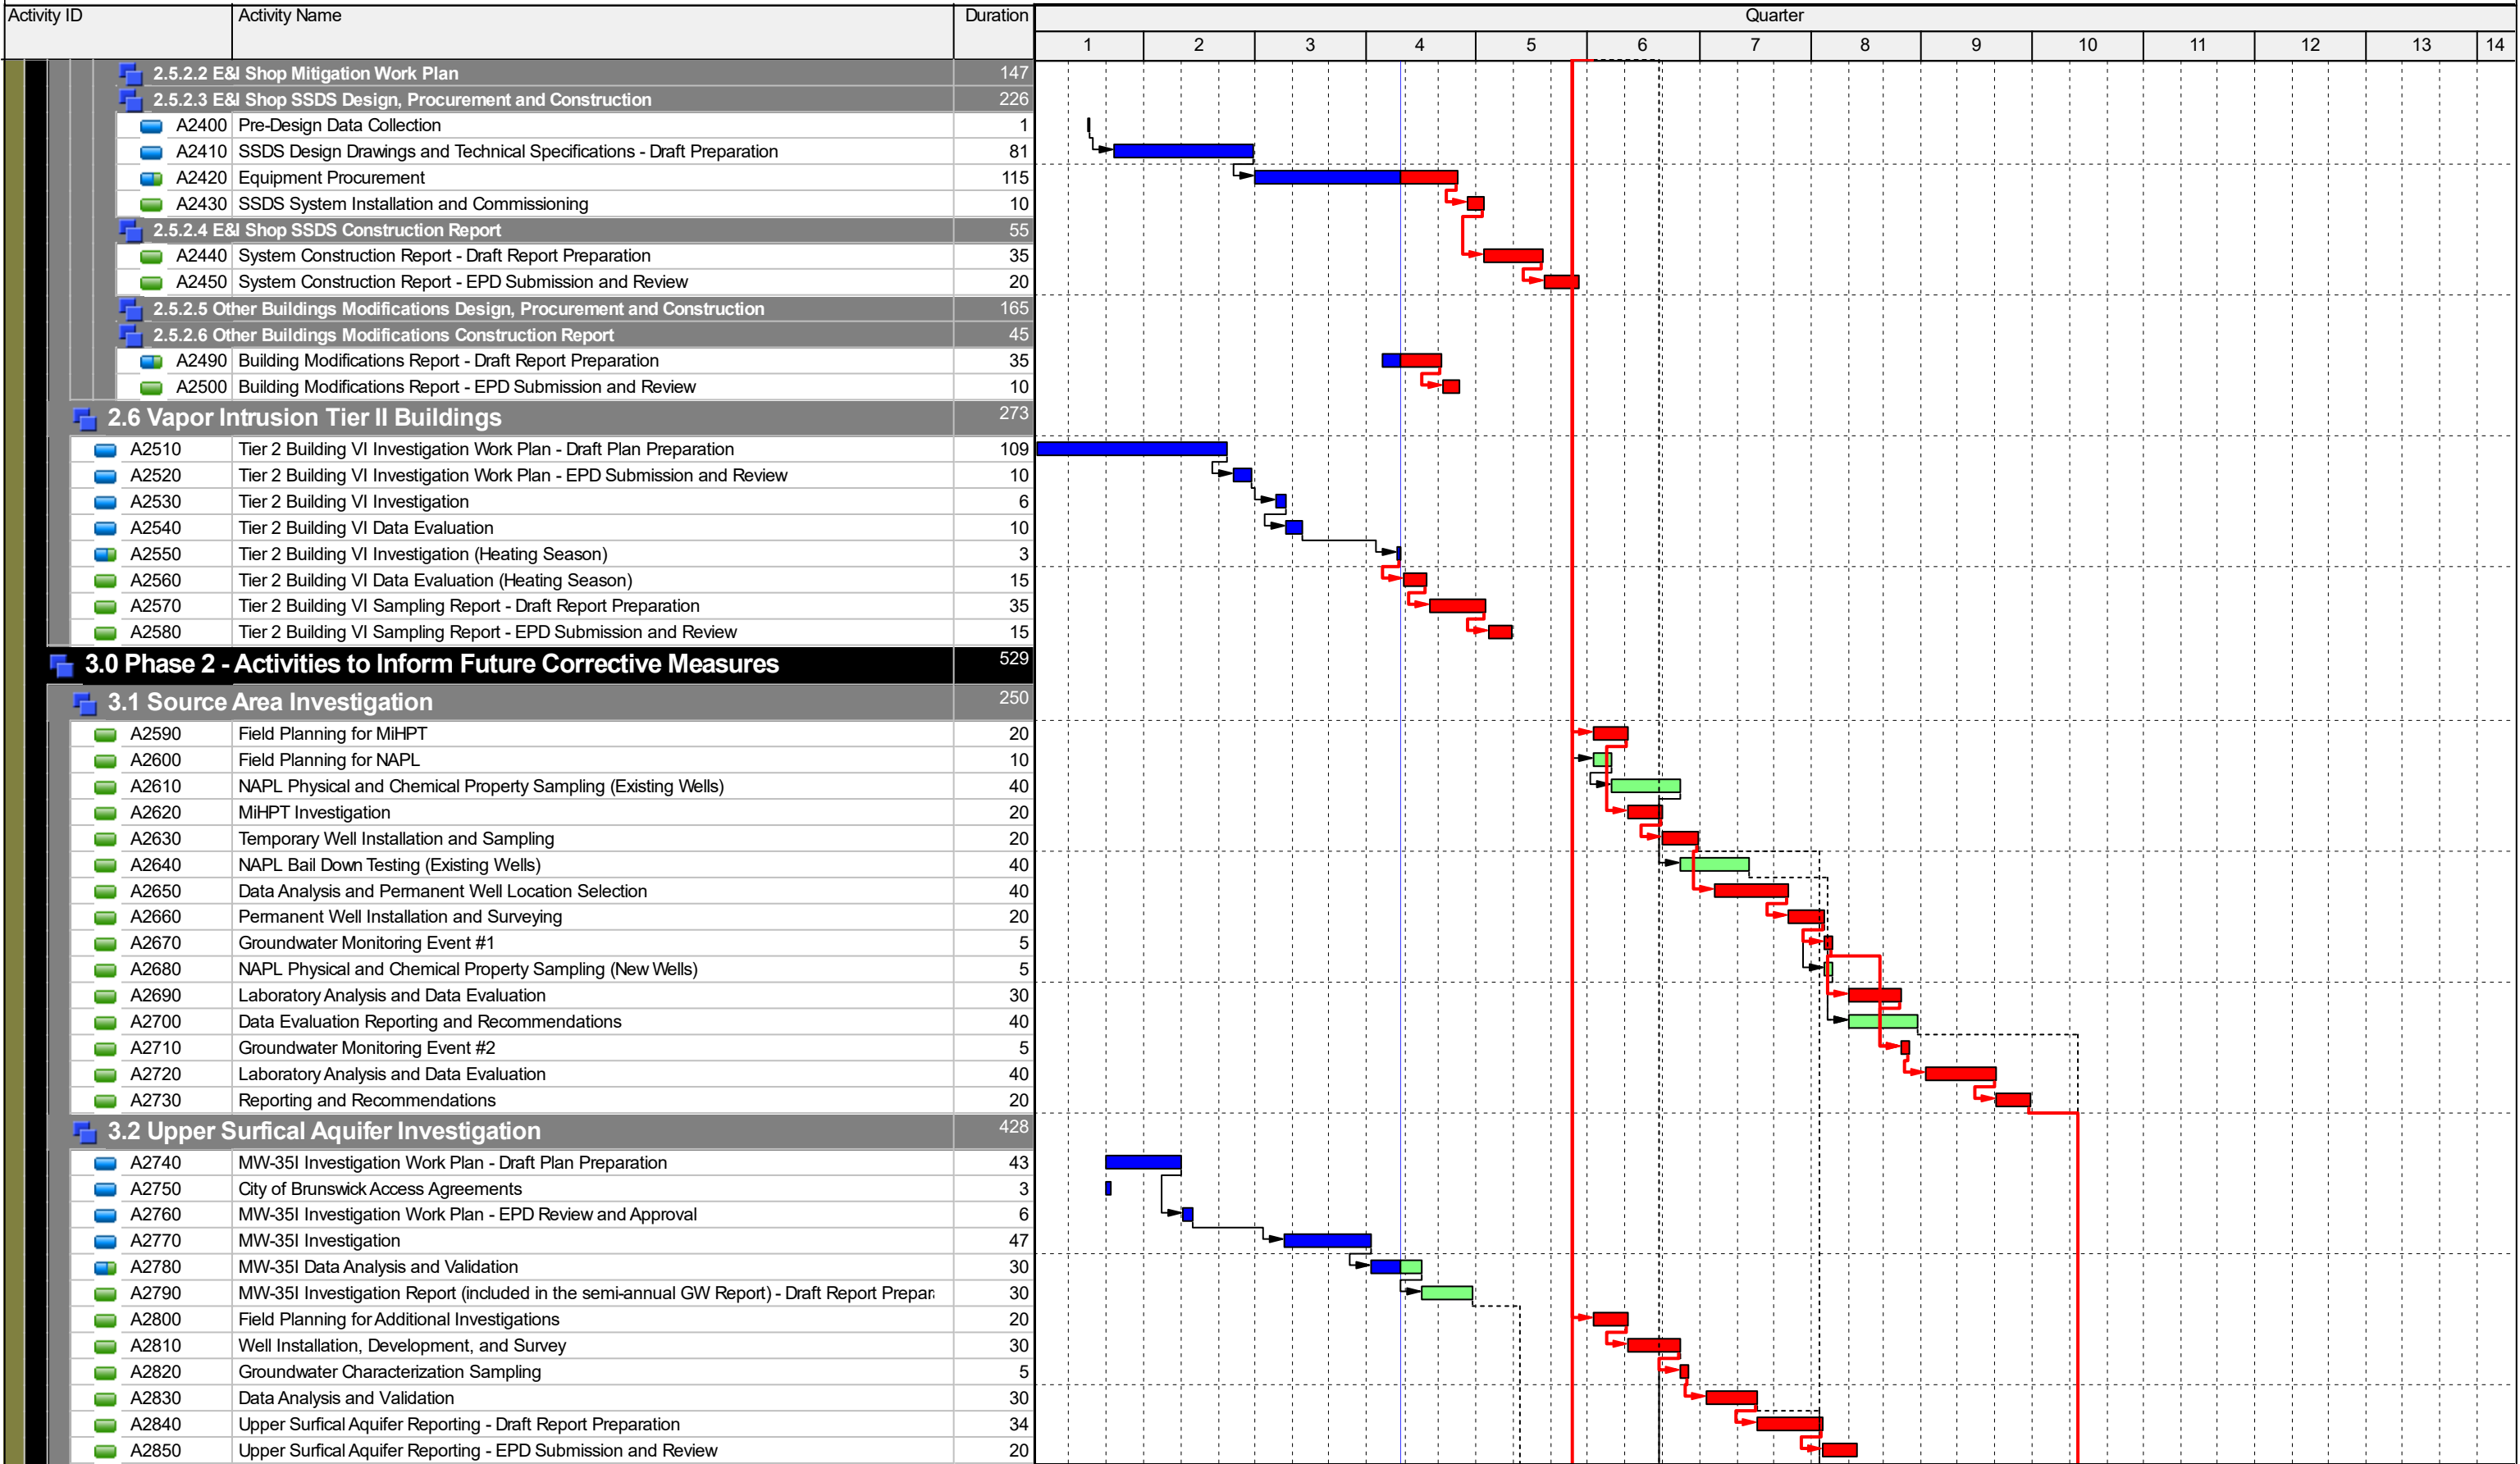
Figure 8-1 Brunswick Facility Corrective Measures Estimated Two Year Implementation Schedule

Completed Work Non-Critical Path Activity Critical Path Activity

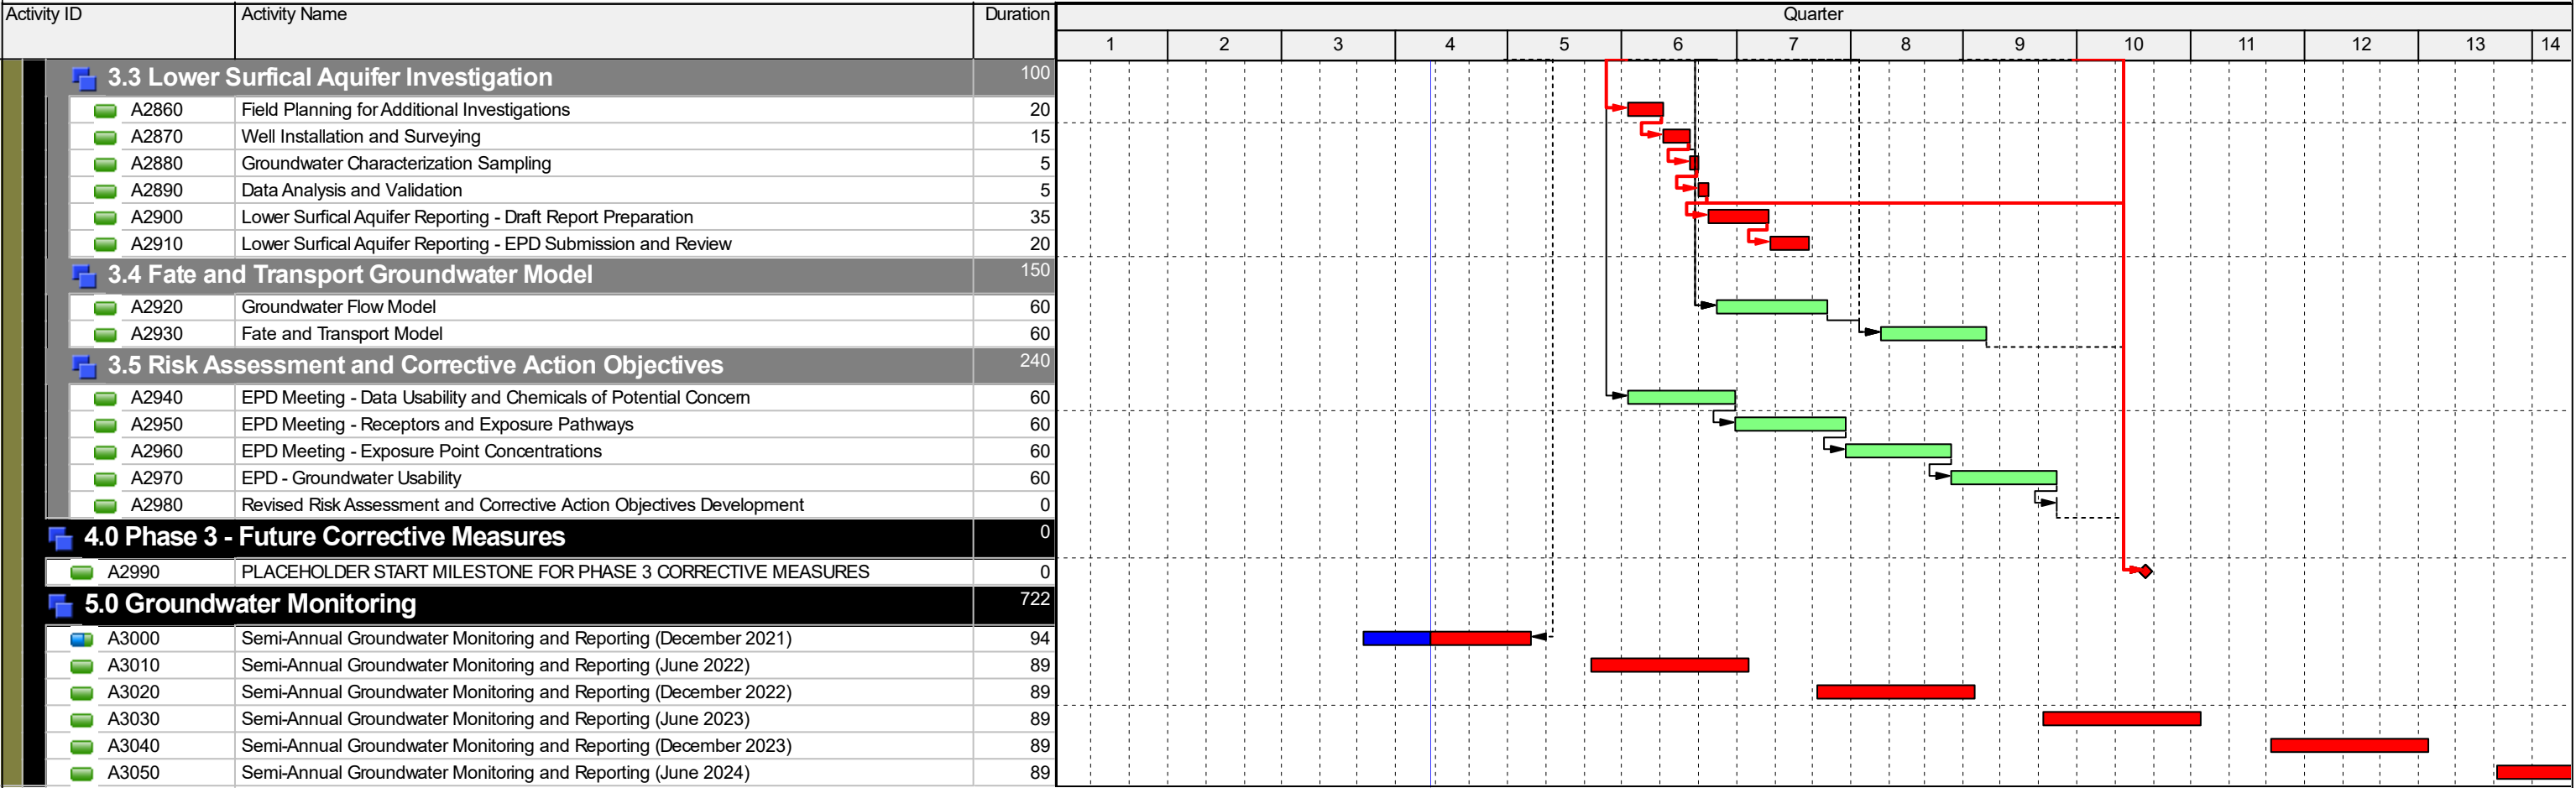
Figure 8-1 Brunswick Facility Corrective Measures Estimated Two Year Implementation Schedule

Notes:
1. Completed activities in the schedule are compressed to their work breakdown structure.
2. Duration is shown in working days, which excludes weekends and holidays.

Hercules has prepared a projected schedule of activities that are described in Sections 6.1 and 6.2 of the CAP. The estimated schedule of activities is provided in the form of a Gantt chart on **Figure 8-1**. The schedule on **Figure 8-1** is a continuation of the schedule submitted with the prior version of the CAP in February 2021 because assessment and corrective measures work has continued at the Brunswick facility and many of the activities are in “mid-stream” (i.e., in progress). For the Phase 2 and Phase 3 activities described in Sections 6.2 and 6.3 of this CAP, the schedule contemplates that those activities will culminate in preparing a revised version of this CAP in the future that will ultimately be incorporated into the hazardous waste permit for the Brunswick facility. The schedule presented on **Figure 8-1** extends for a period of two years from the submission of this CAP. The ability to project the timing of work over the course of that two-year period diminishes the further into the future that the schedule goes. Moreover, as discussed in Section 6.3 of the CAP, decisions regarding additional longer-term corrective measures are dependent on the results of future investigation activities and the effectiveness of the interim corrective measures that are in progress as discussed in Section 6.1 of the CAP.

The projected schedule of activities provided on **Figure 8-1** includes estimated durations for various tasks and steps. The estimated durations for those tasks and steps are approximated because they are dependent upon many factors including but not limited to contractor availability, inclement weather, field implementation and laboratory analytical results, local and state permitting requirements, timeframes for review of submissions by EPD, and other matters beyond the reasonable control of Hercules such as restrictions and limitations associated with the COVID-19 pandemic and disruptions to the supply chain that have been prevalent.
