Inundation and Erosion at Mirada Road

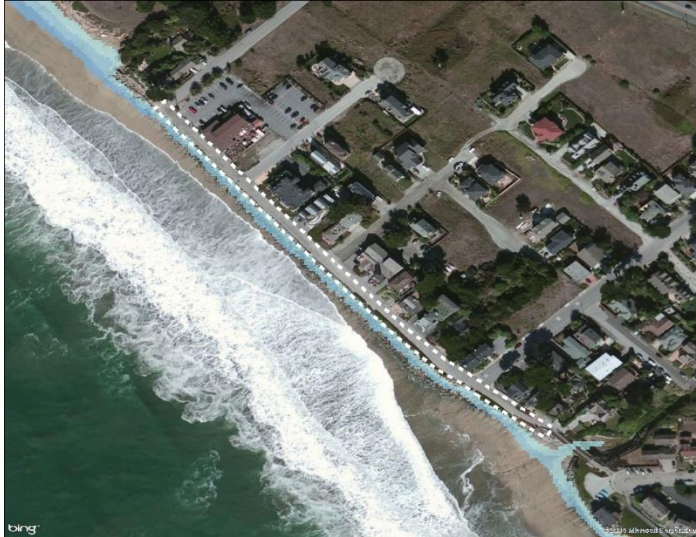
Baseline: Current conditions with 1% storm.
Inundated up to 2 feet.

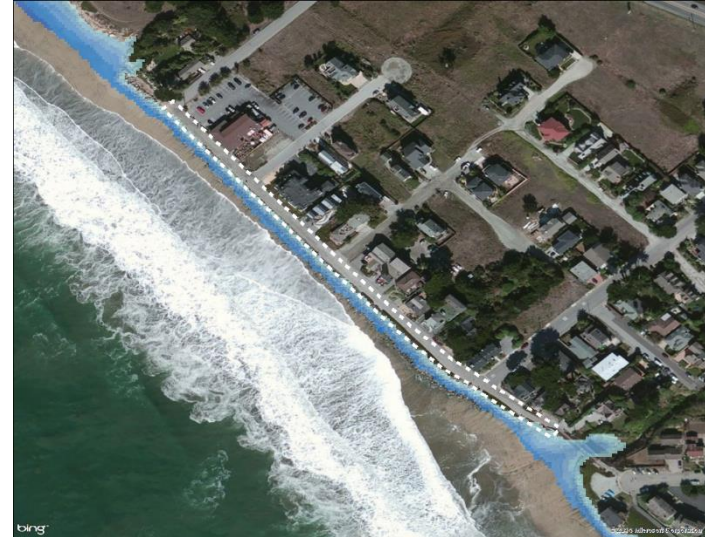
Mid-Level: 3.3 feet of sea level rise with 1% storm.
Inundated up to 3 feet.

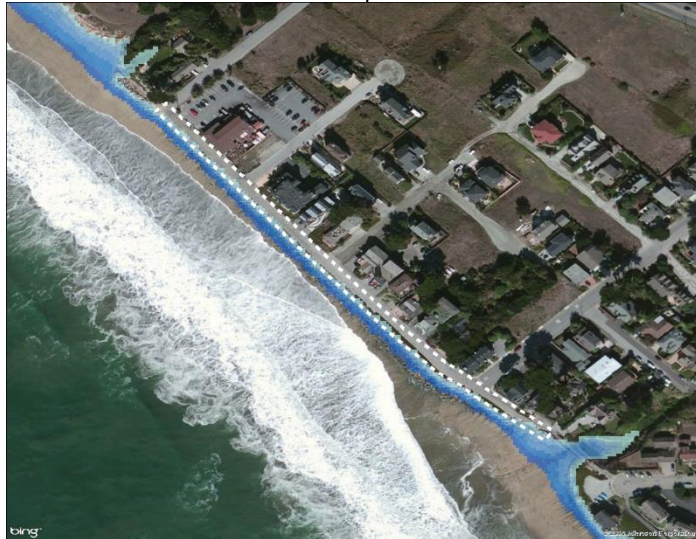
High-Level: 6.6 feet of sea level rise with 1% storm.
Inundated up to 4 feet.

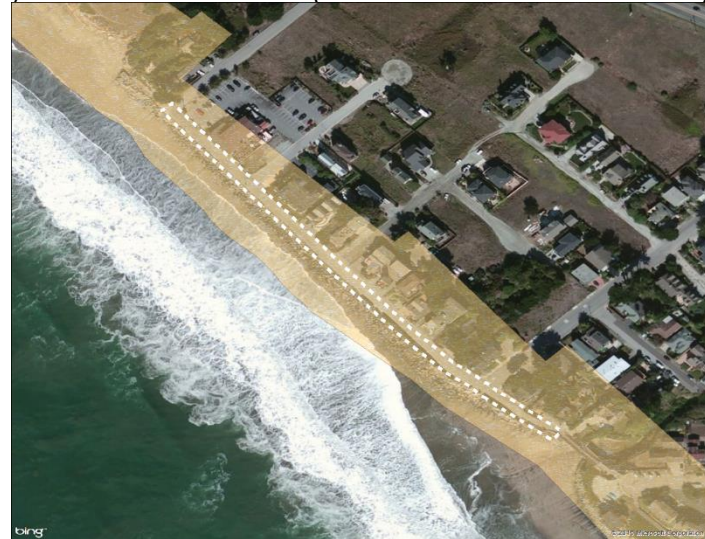
Erosion: Site is entirely in the range of erosion extents proposed by the Pacific Institute (eastern extent of erosion by 2100).
