Proposed Improvements

Gray Whale Cove Parking Lot

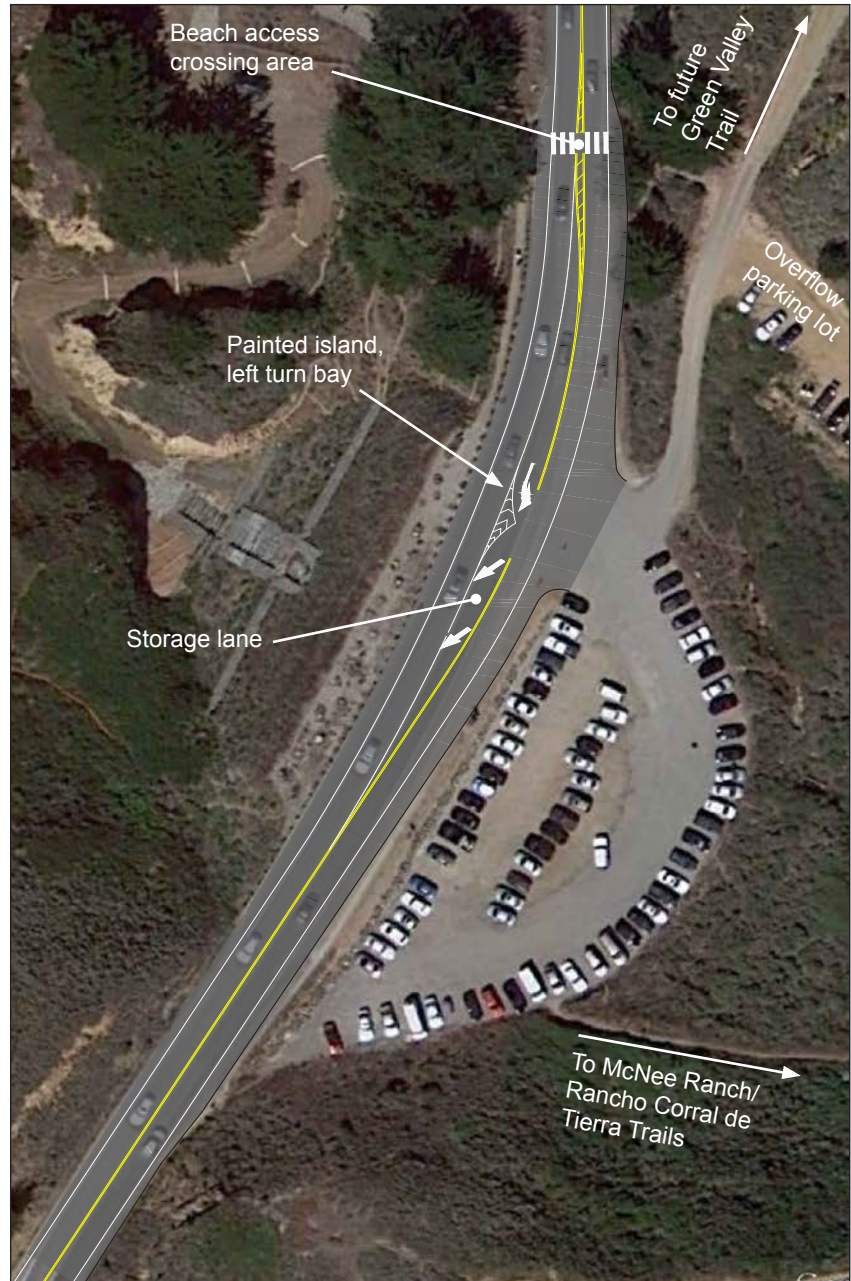
Improvements are shown above to help vehicles enter and exit the parking lot, reduce conflicts between turning vehicles and through traffic, and help pedestrians cross the highway.

- Install left turn bay with painted island to provide a storage area for left turn movements in and out of parking lot. The concept shown includes roadway horizontal alignment consistent with existing curves in this area and can be constructed with very little necessary earthwork. Without extending the widening through areas that require significantly more earthwork, standard Caltrans left turn deceleration lengths cannot be achieved. However, a retrofit with the shorter deceleration length shown here provides significant safety benefits over the existing condition with no left turn lane.

- Mark crosswalk using left turn lane taper lines as painted refuge area.
- Include pedestrian crossing warning signs at the crosswalk and in advance of the crosswalk supplemented with pedestrian activated flashing beacons at the crosswalk.

- Include signage and consider improvements to the landscaped berm between the highway and the parking lot, increasing separation and directing pedestrians to the crosswalk.

- Consider tightening the parking lot entrance and marking a crosswalk across the entrance.

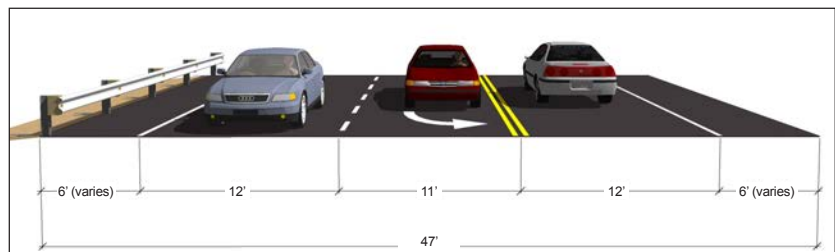
*Right.* Highway 1 facing north just past the end of the left turn lane shown in the concept above. The road is widened at this particular location to accommodate a left turn lane.
