North Half Moon Bay Shoreline Improvement Project, Pillar Point Harbor, CA Coastal Engineering Appendix

FINAL January 2015

Final Report

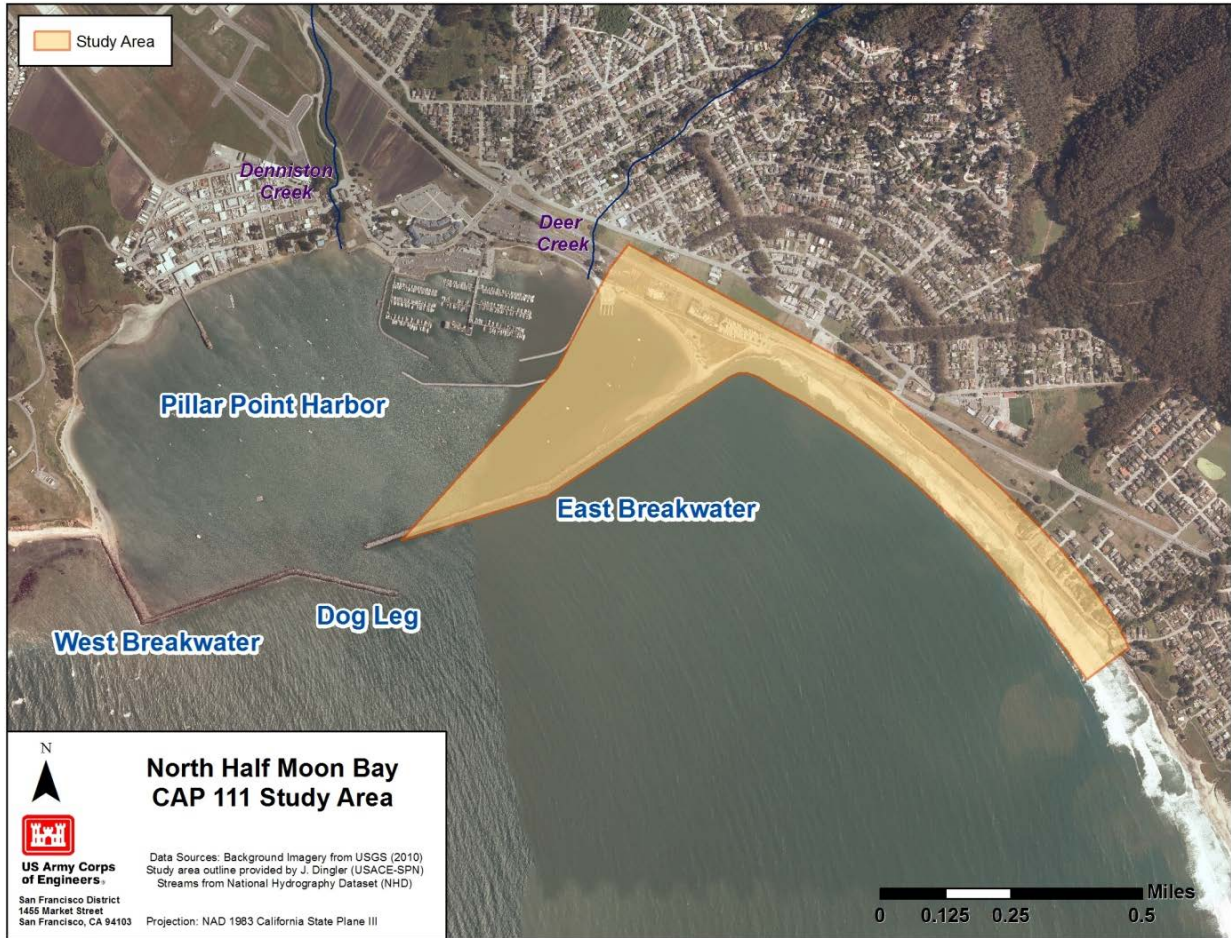
Figure 1. North Half Moon Bay study area

The study area is located adjacent and southeast of the east breakwater and extends 0.9 mi (1.4 km) along the shoreline. Construction of the east breakwater occurred between 1959 and 1961 (USACE, 1961), and rates of coastal erosion within the study area shoreline have increased since construction of the harbor (Griggs et al., 2005). It has been postulated that the construction of the east breakwater has disrupted the natural movement of sediment that supplied sand to the adjacent shoreline and further south (USACE, 1996). Thus, this study will utilize a variety of techniques to determine the extent to which the east breakwater has enhanced erosion in the study area, and evaluate potential erosion mitigation measures.

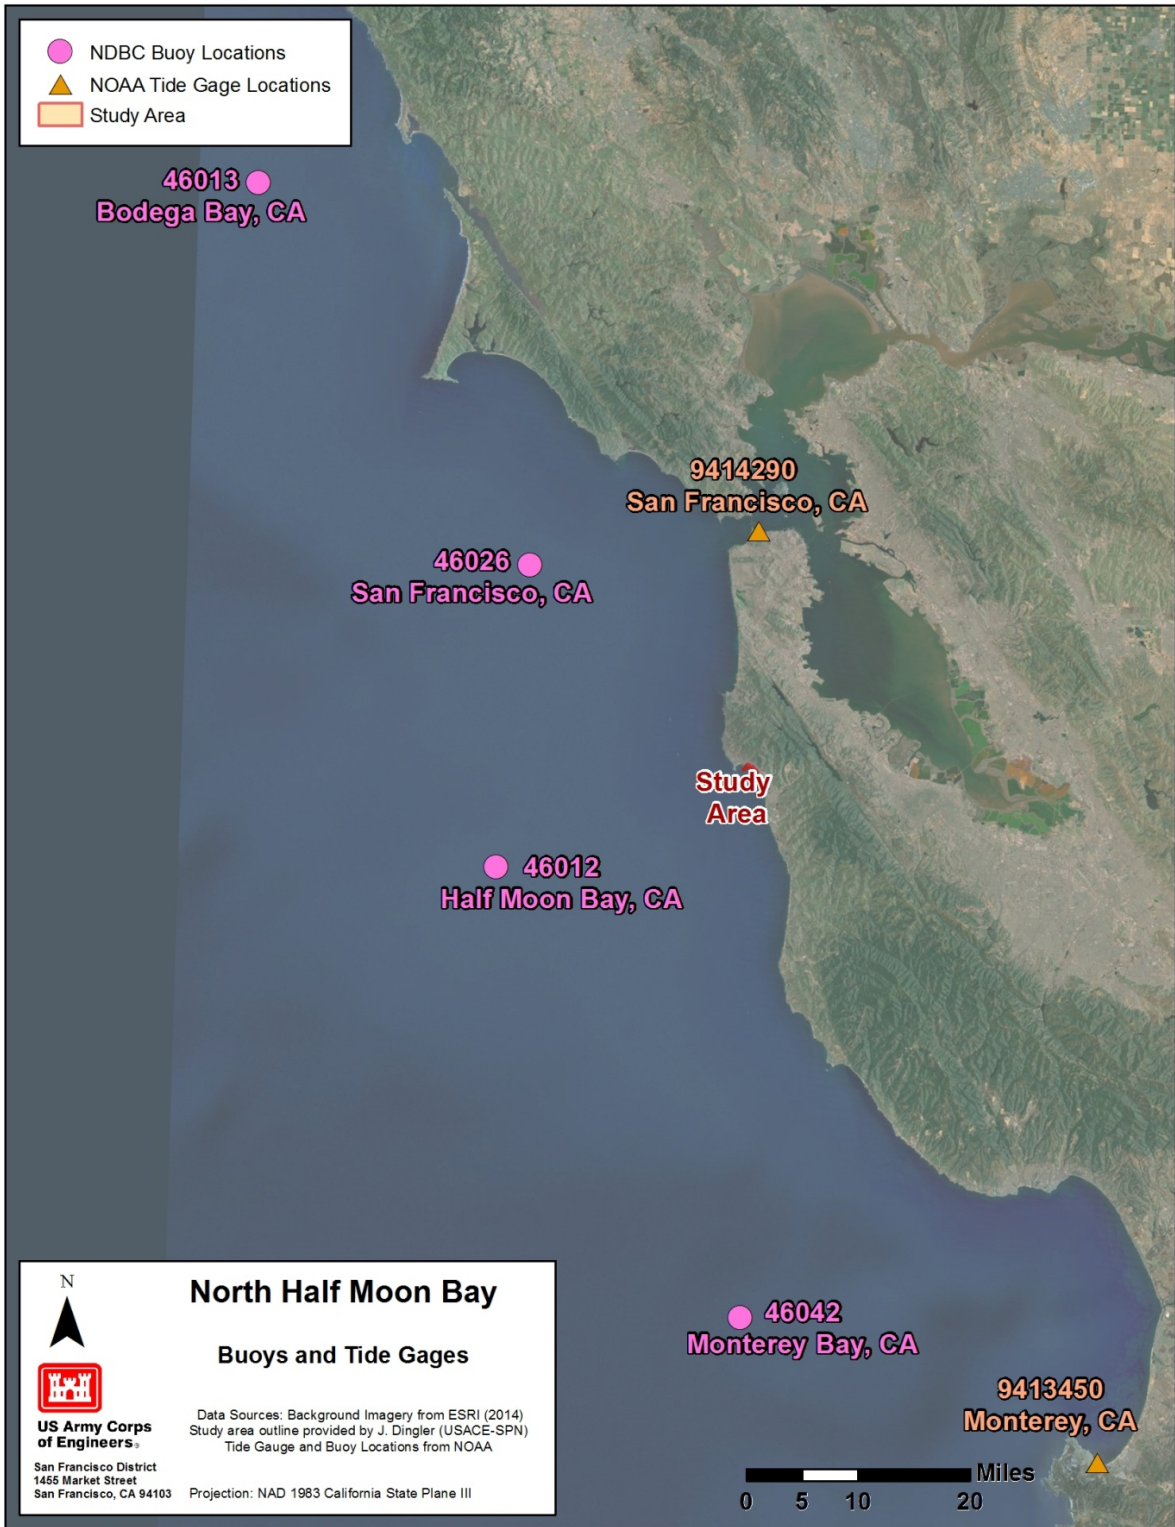
Figure 2. Select NDBC and NOAA stations in the study area region, which were used to characterize physical conditions in the study area

Physical characteristics evaluated at this site include wind, wave, water surface elevation (WSE), currents, and sediment composition. Physical characteristics data were obtained from a number of sources: nearby National Buoy Data Center (NDBC) buoys (Figure 2), National Oceanic Atmospheric Administration NOAA tide stations (Figure 2) and field measurements collected by the U.S. Geological Survey (USGS) (Figure 3). The offshore wind and wave information described herein is primarily based on the Monterey (46042) and Half Moon Bay (46012) wave buoys, with additional data from the Bodega Bay buoy (46013) utilized to further characterize physical conditions during the numerical modeling simulation period (see Section 3.3 and Table 3).

All WSE data was derived from measurements at the Monterey tide station (9413450), which is located at the southern end of Monterey Bay, approximately 60 nautical miles (111 kilometers) from the project area (Figure 2). Hourly water level data was archived from 1974 to the start of this analysis in 2011, which spans a period of 37 years. Figure 4 illustrates a representative tidal data set of predicted, verified and residual WSE from May 2 to June 2, 2011.

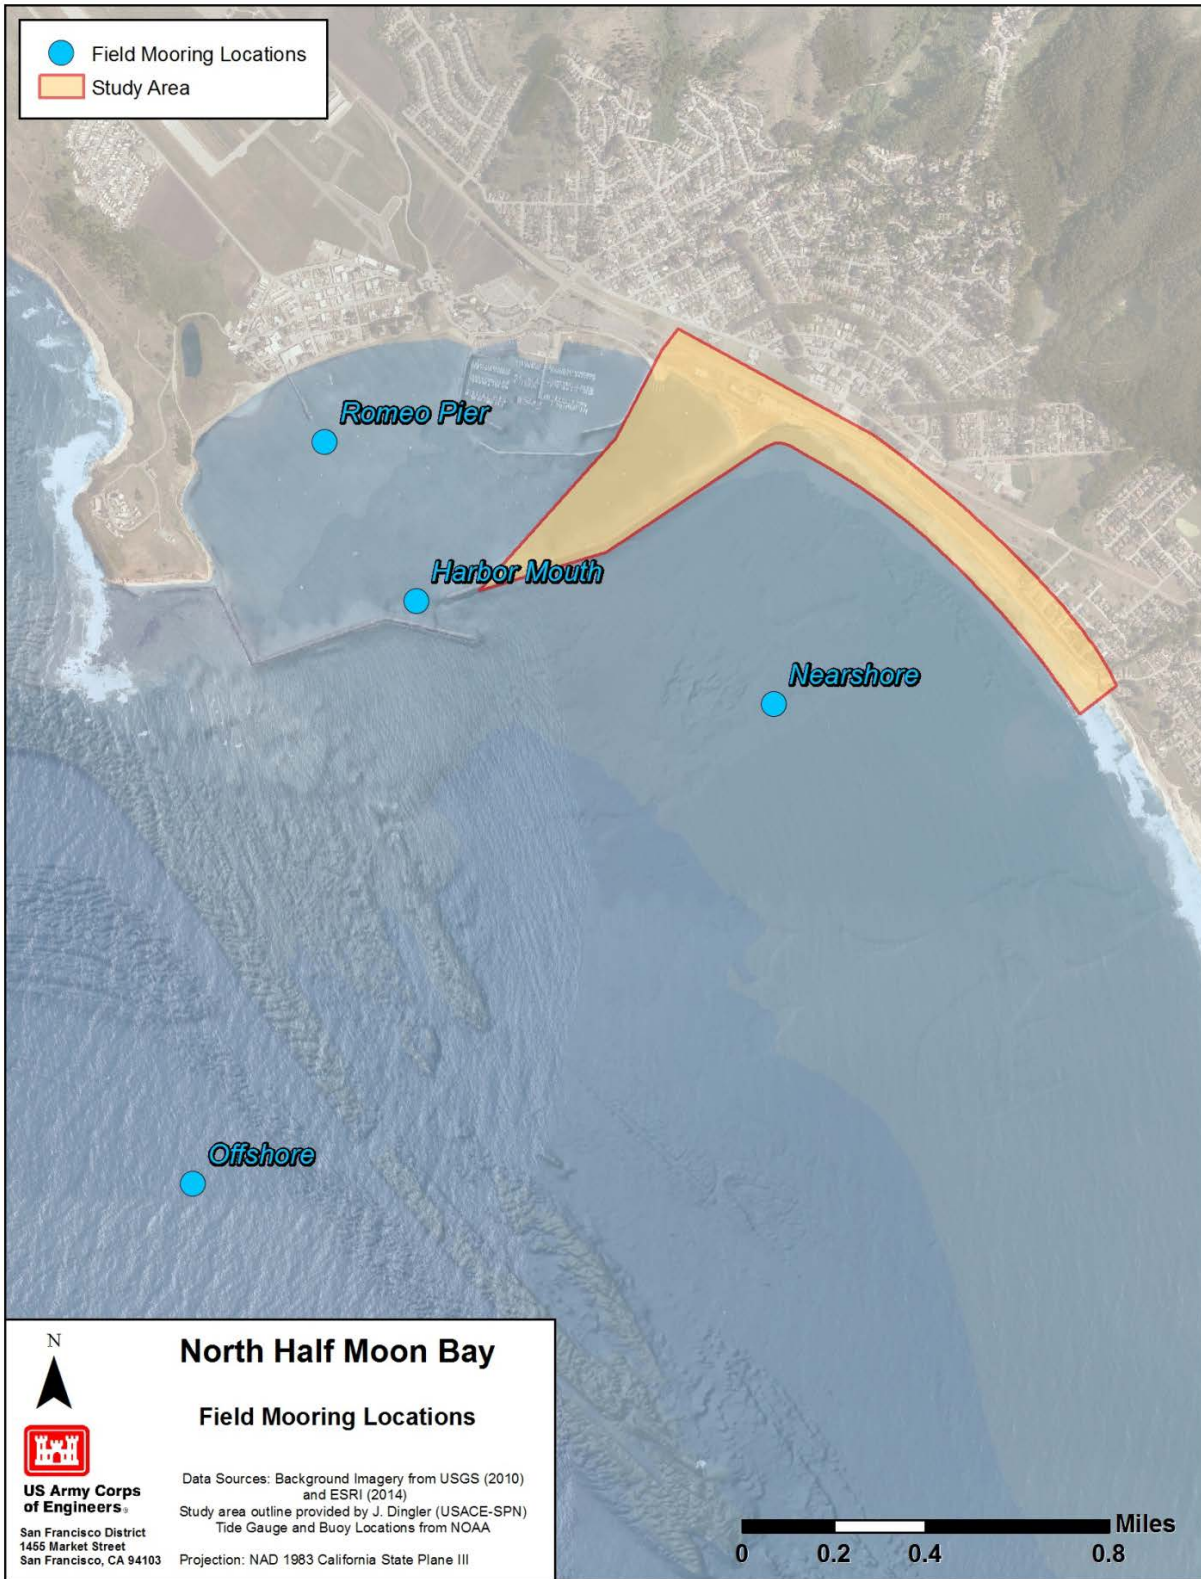
Figure 3. Field Mooring Locations at Romeo Pier, Harbor Mouth, Nearshore and Offshore

Circulation patterns in the vicinity of the study area can be a function of waves, winds, and tides. 3 moorings were deployed in the study area to describe current magnitude and direction vertically in the water column (Figure 3). However, further analysis will be necessary to decouple the current magnitude and direction in order to identify the respective contributions of waves, tides and winds. In addition, these field measurements were used to calibrate the hydrodynamic and sediment transport model used to estimate erosion rates described in Section 3.3. Finally, it should be also noted that the primary offshore current in the study area, the California Current, is too weak and far offshore to mobilize sediment in the project area (USACE, 1996).

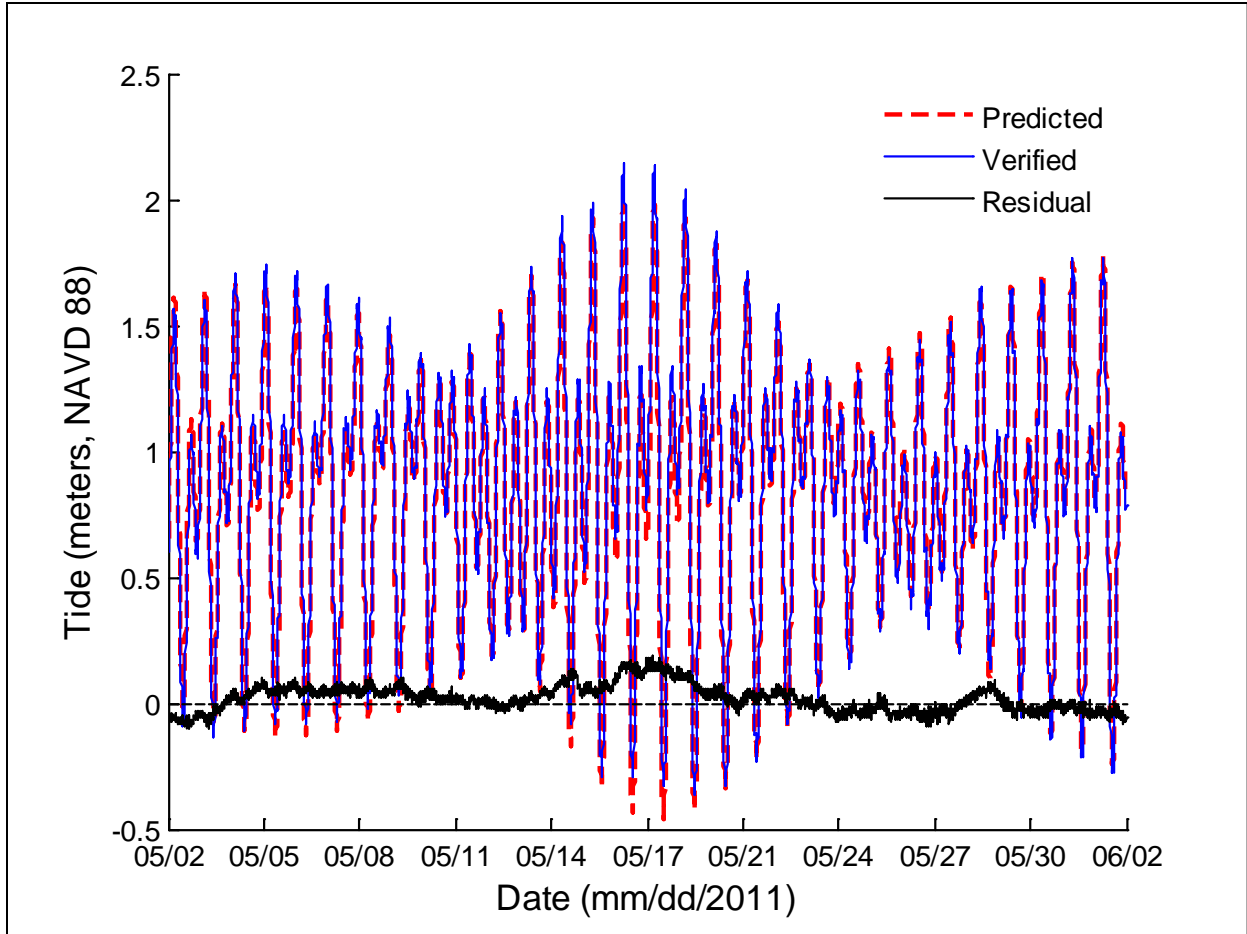
Figure 4. Time series of Monterey tide station (9413450) data from 05/02~06/02/2011 (NOAA, 2011)

Figure 4 illustrates the mixed semi-diurnal tidal signal commonly observed on the California coast, which is characterized by 2 unequal sets of daily highs and lows that vary in amplitude over time. Tidal amplitude also has a distinct seasonal signal along the California coast, with the largest tidal ranges typically occurring during spring tidal cycles in the winter months (Figure 5; Figure 6; Figure 7; Figure 8). As a result, coastal infrastructure is often more vulnerable to damage from inundation and wave attack when strong storm events (e.g., 27 January 1983) coincide with the peak of spring and other longer-term tidal cycles (Griggs and Johnson, 1983).

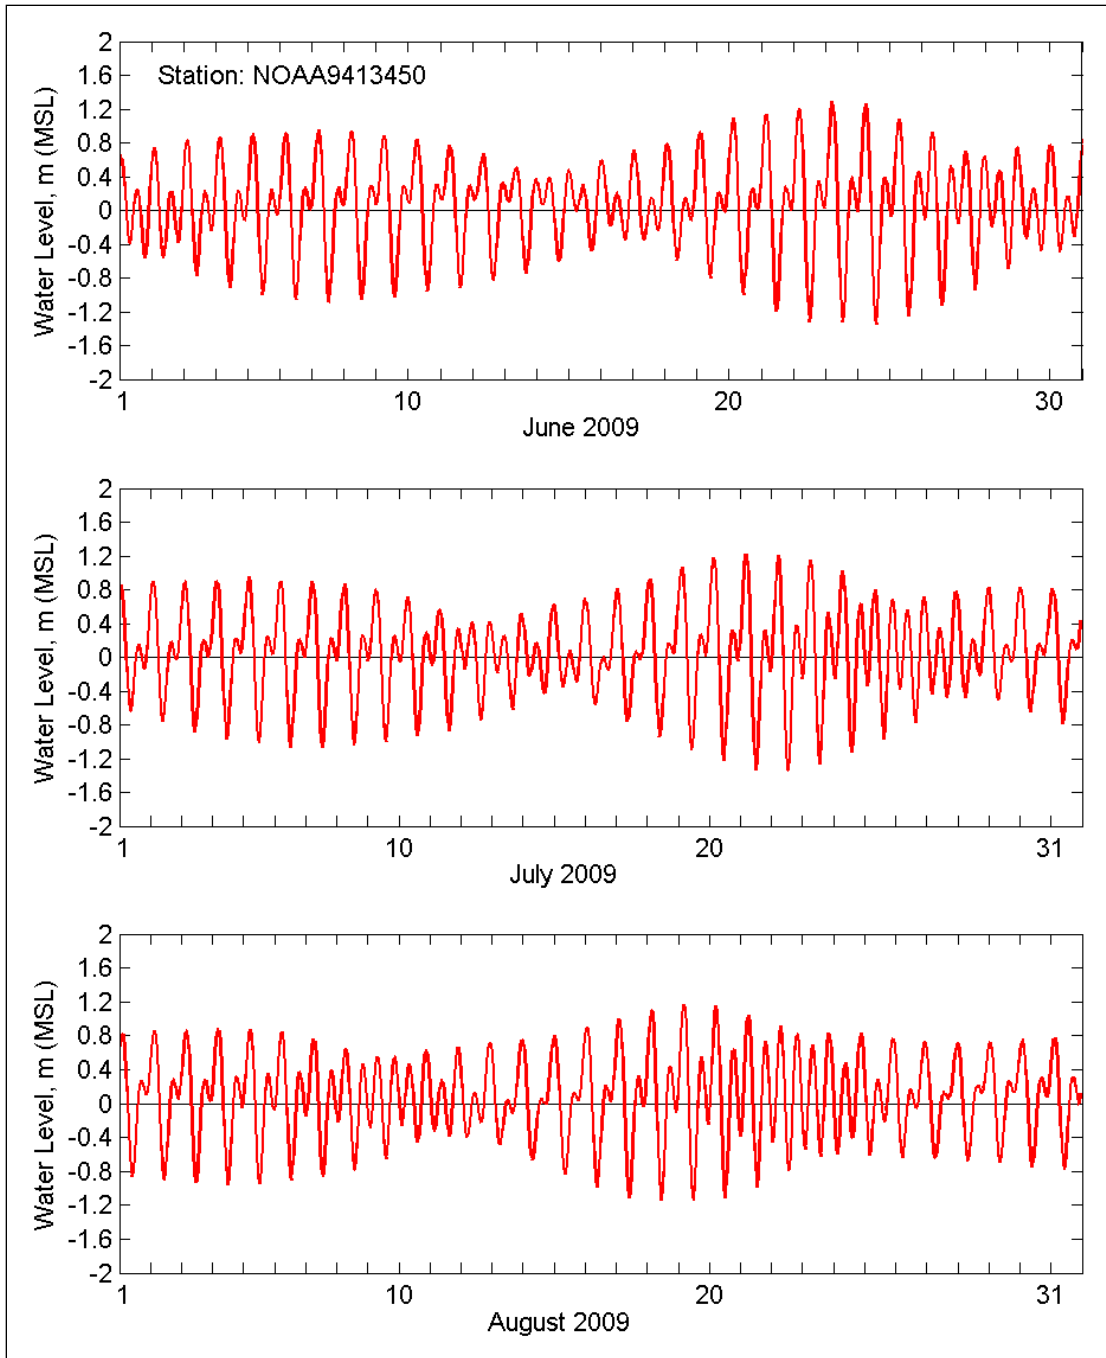
Figure 5. Water level data at NOAA Station 9413450 for June to August 2009

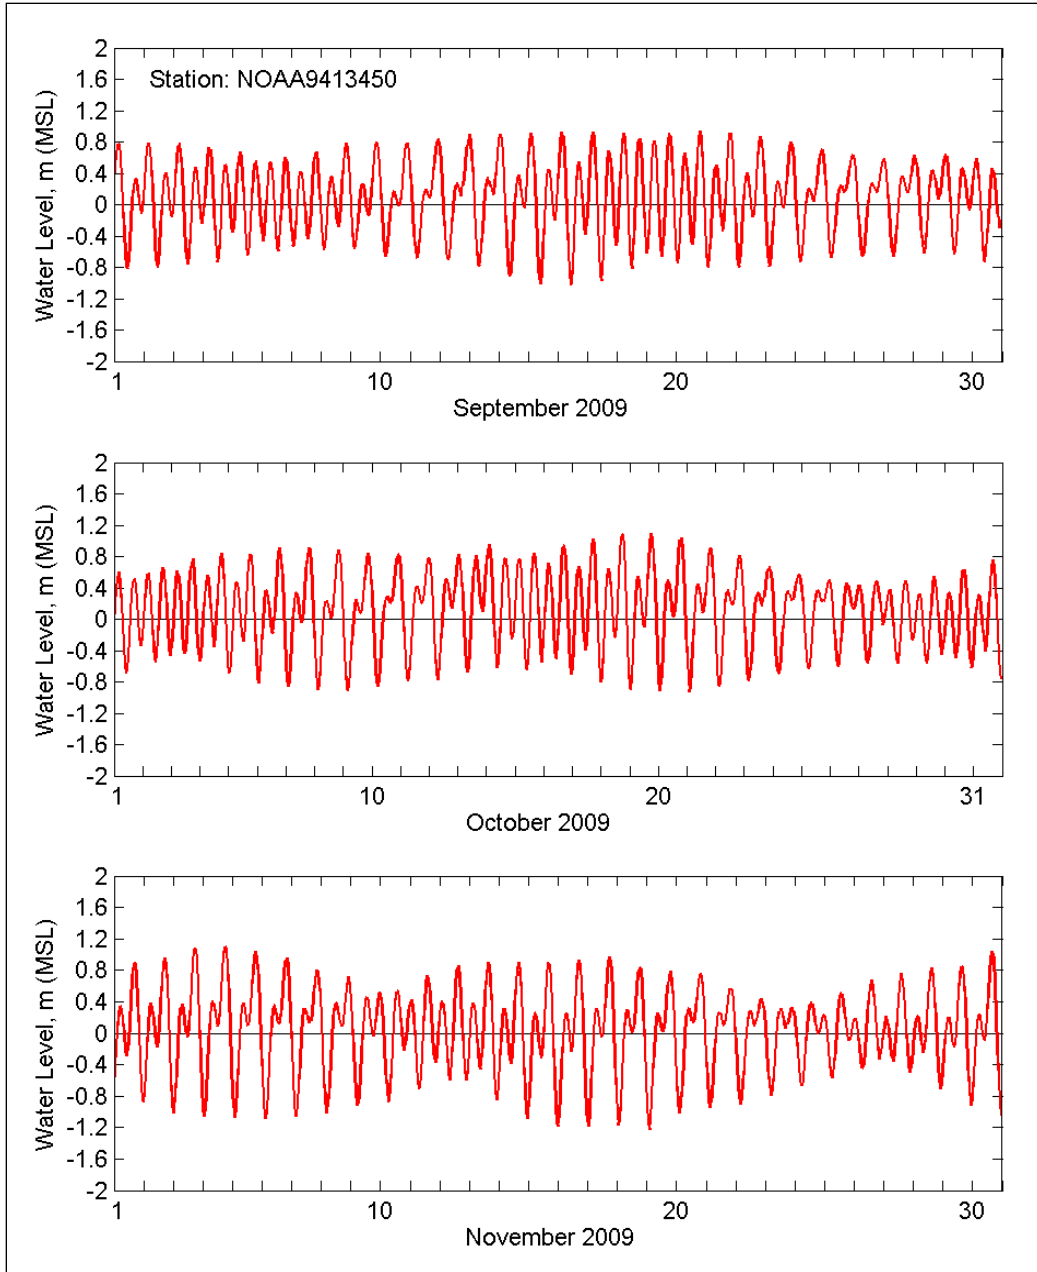
Figure 6. Water level data at NOAA Station 9413450 for September to November 2009

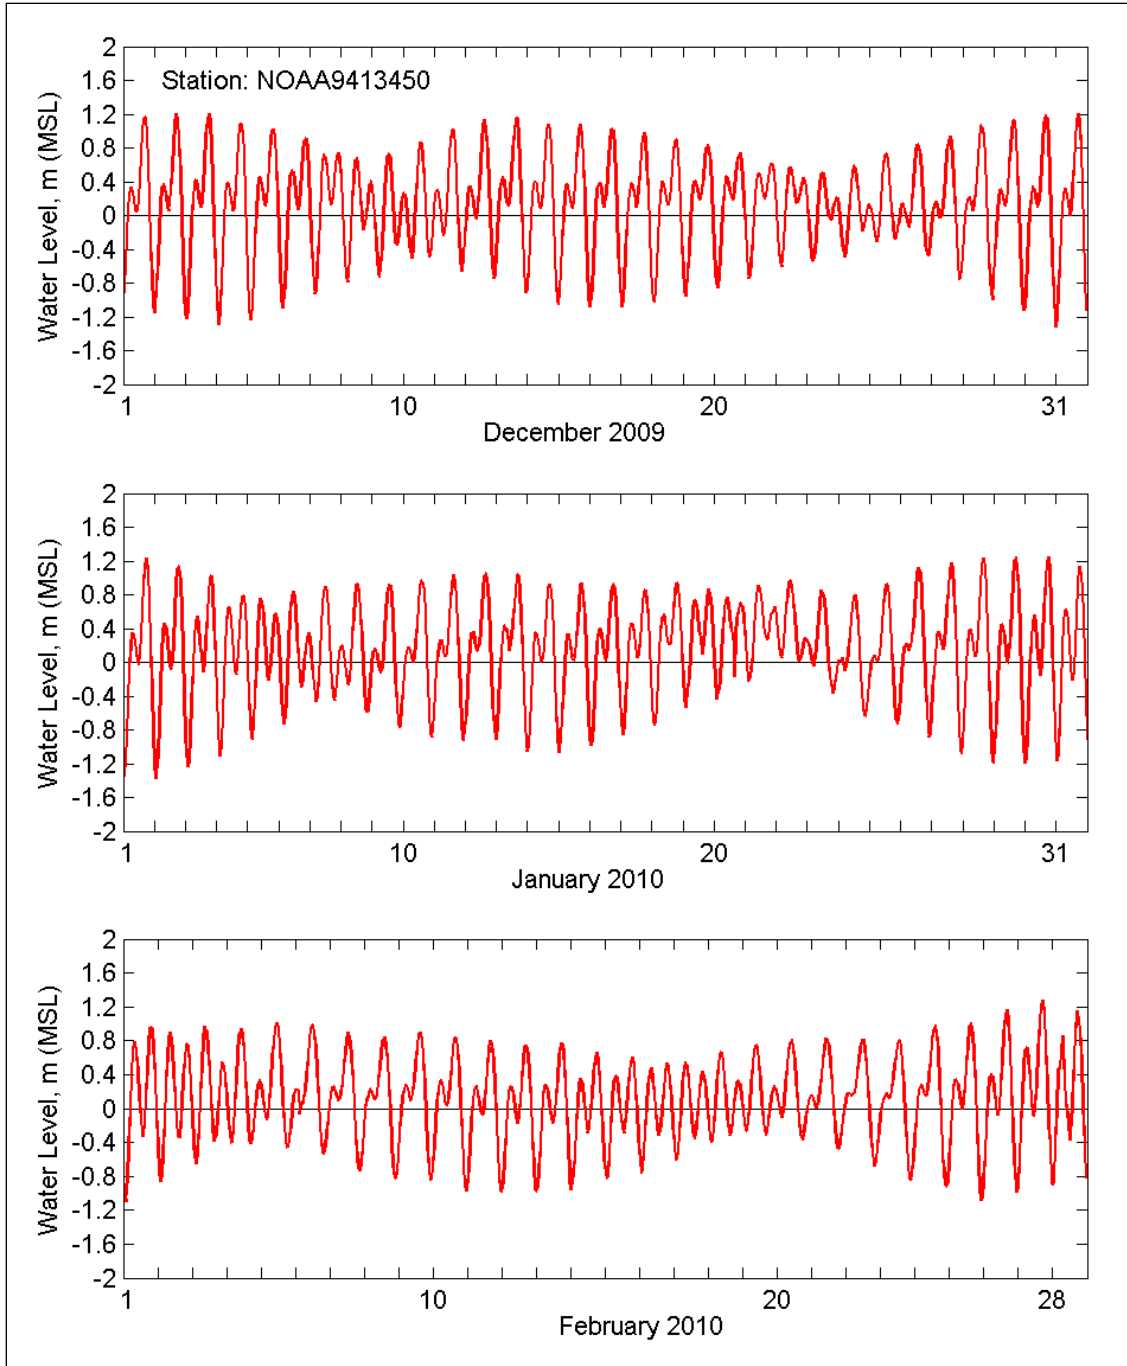
Figure 7. Water level data at NOAA Station 9413450 for December 2009 to February 2010

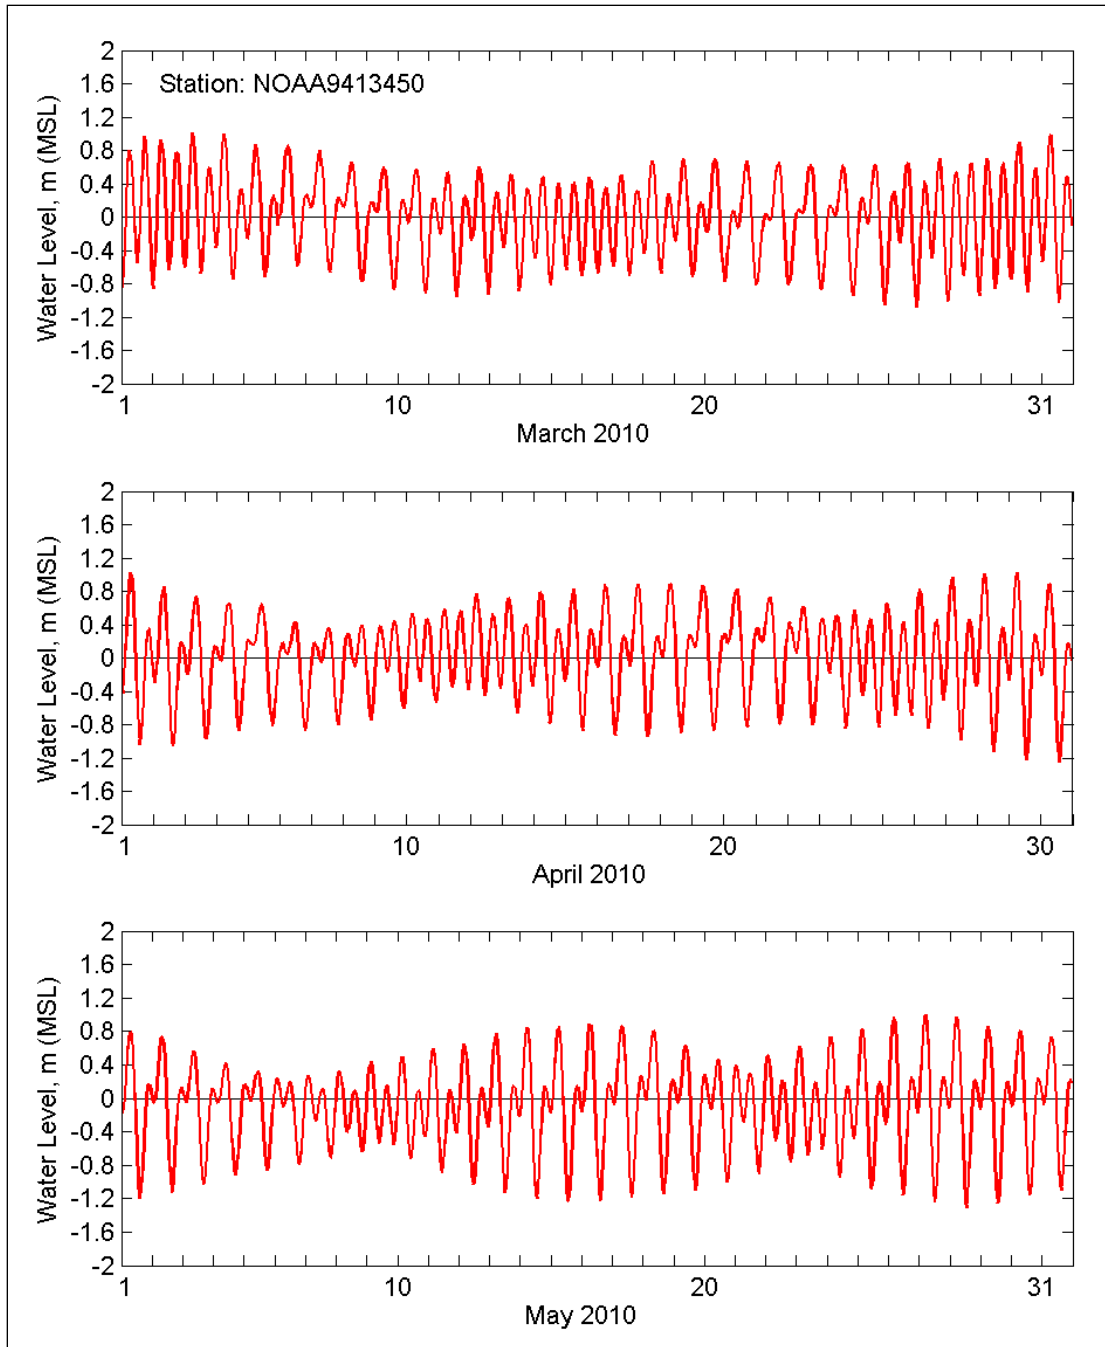
Figure 8. Water level data at NOAA Station 9413450 for March to May 2010

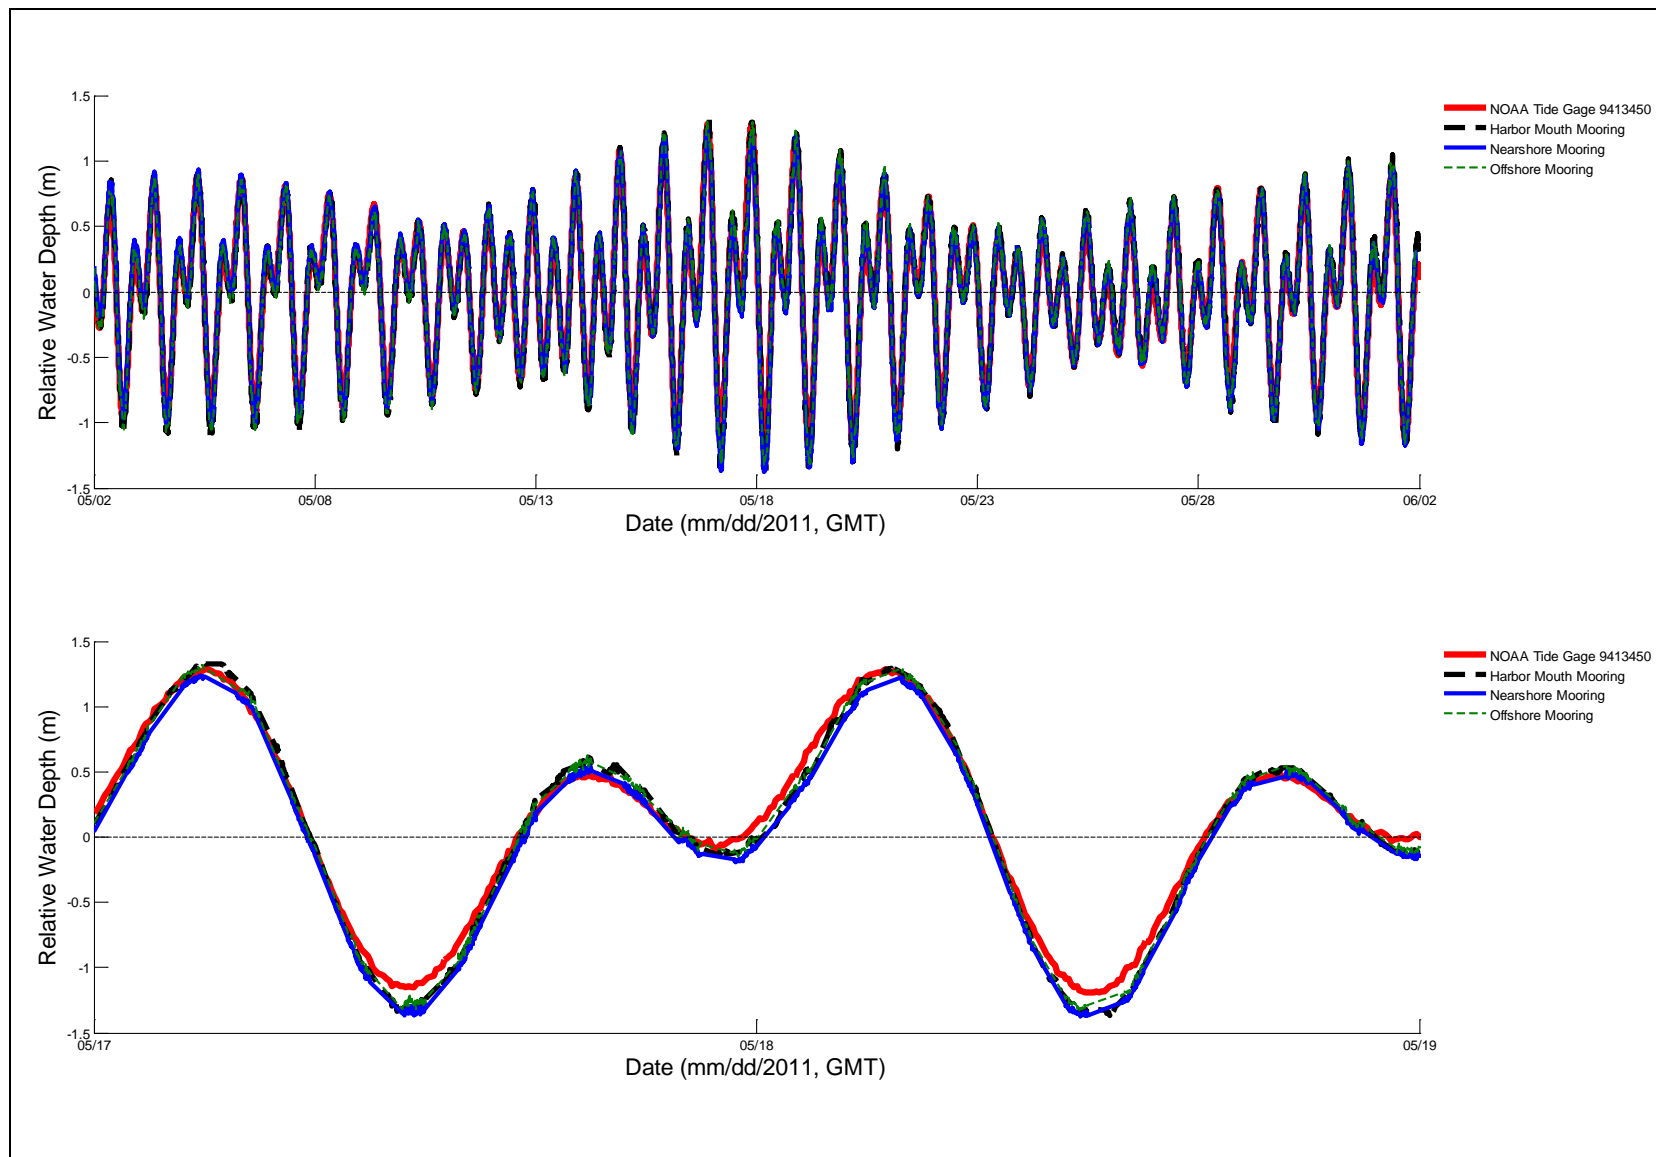
Figure 9. Comparison of measured WSEs at the NOAA tide gage, Harbor Mouth Mooring, Nearshore Mooring, and Offshore Mooring

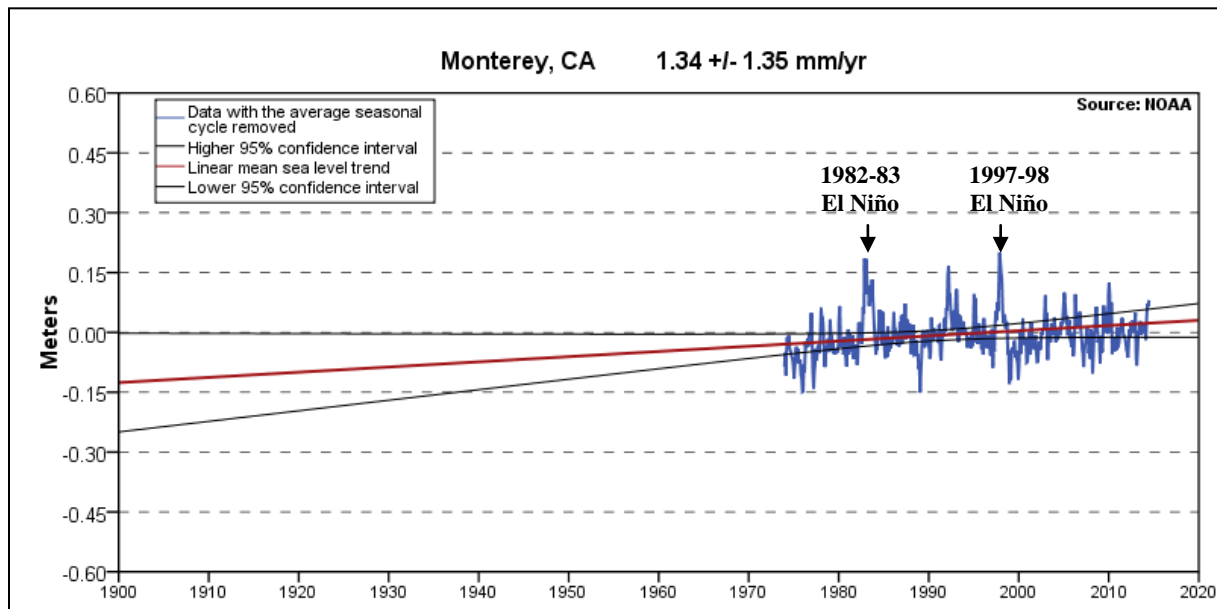
Figure 10. SLR trend at the Monterey tide station 9413450 (NOAA, 2011)

As shown in Figure 10, WSEs also fluctuate over inter-annual and longer time periods in concert with ocean-atmosphere oscillations such as the El Niño Southern Oscillation (ENSO). Strong El Niño conditions in the Pacific are associated with increased storm activity along the California coast, with storms following a more southerly track (Seymour, 1998; Storlazzi and Griggs, 2000; Griggs et al., 2005). As a result, the relatively low atmospheric pressure and strong waves associated with these events serve to elevate WSEs (National Research Council, 2012), with tidal residuals order of 0.2 m or 0.7 ft (Figure 10). El Niño conditions generally occur every 3 to 7 years, although the particularly intense and damaging El Niño events (e.g., 1982 - 1983, 1997 - 1998) tend to occur on the scale of every 10 to 20 year (Storlazzi and Griggs, 2000; Table 6). Recent research also suggests that the frequency of strong El Niño could double under current global warming projections (Santoso et al., 2013).

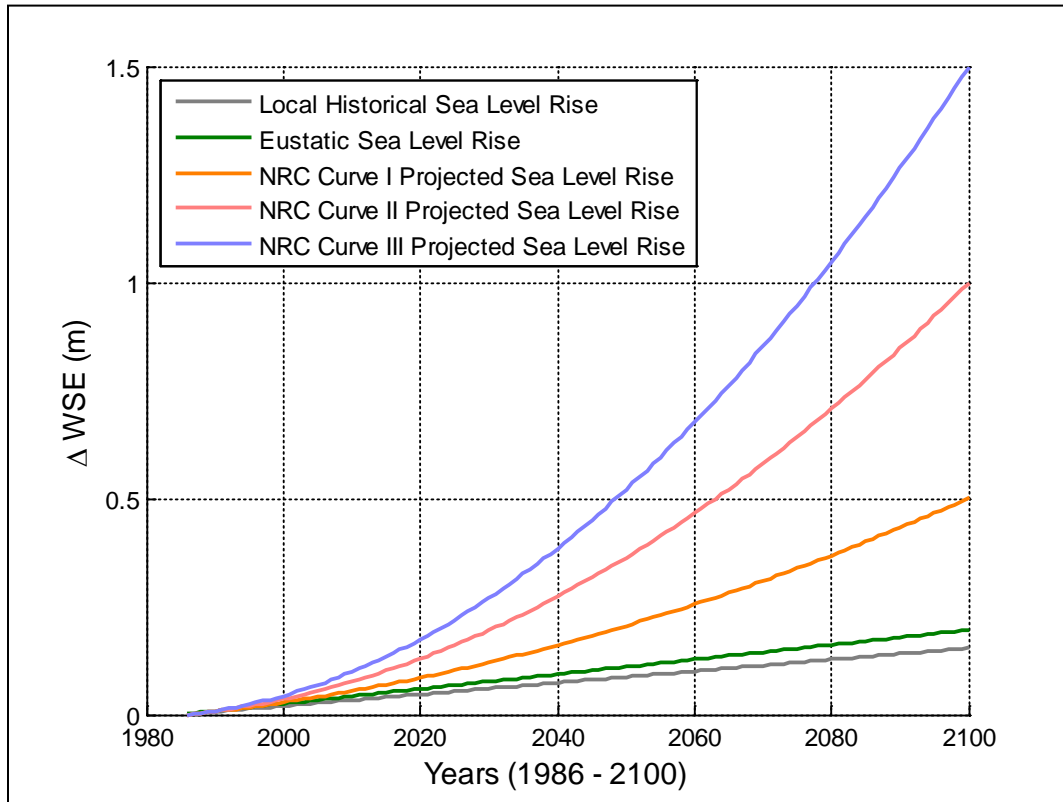
Figure 11. Local historical (USACE Low), eustatic historical, NRC Curve I (USACE Intermediate), NRC Curve II, and NRC Curve III (USACE High) sea level rise trends

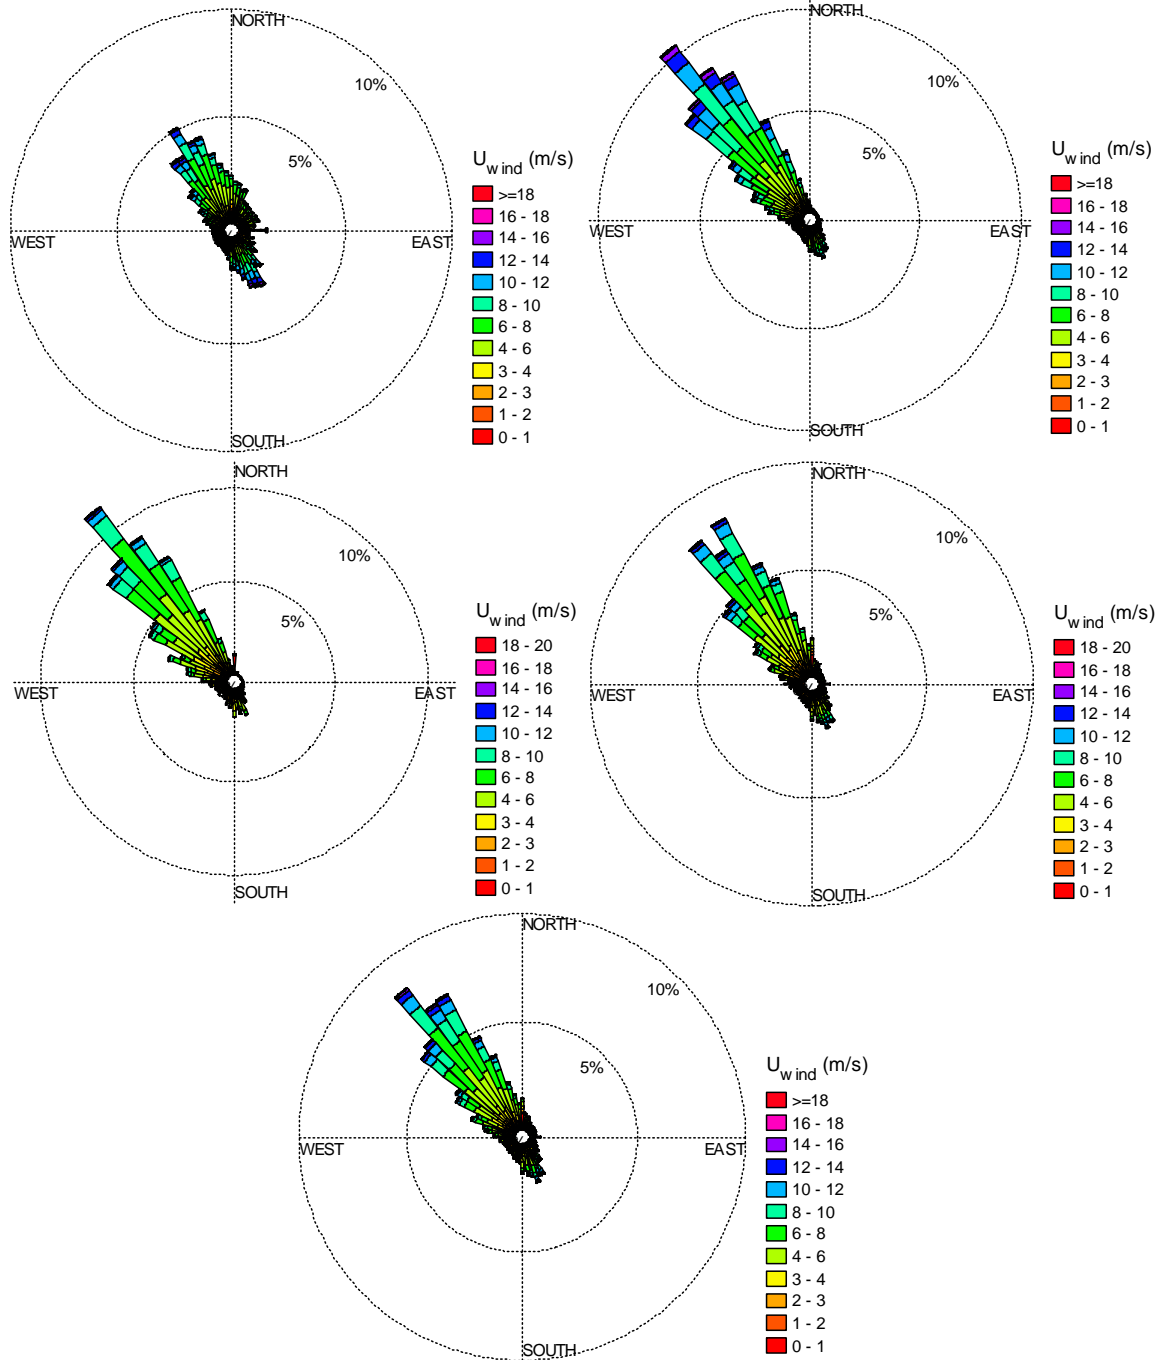
Figure 12. Wind rose of annual and seasonal directional wind speed (m/s). Winter (top-left), spring (top-right), summer (middle-left), fall (middle-right), annual (bottom).

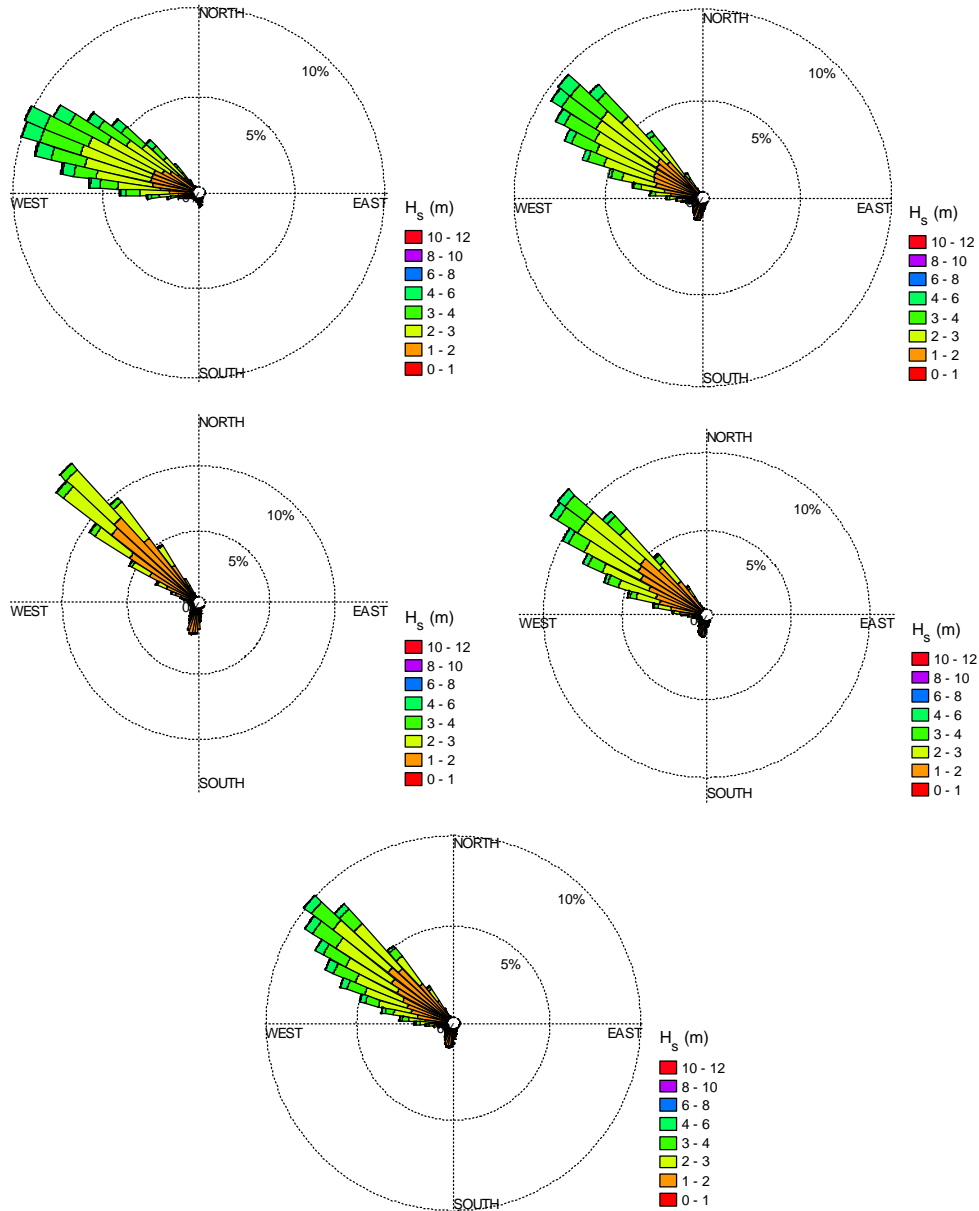
Figure 13. NDBC Buoy 46042 wave rose of annual and seasonal directional wave height. Winter (top-left), spring (top-right), summer (middle-left), fall (middle-right), annual (bottom).

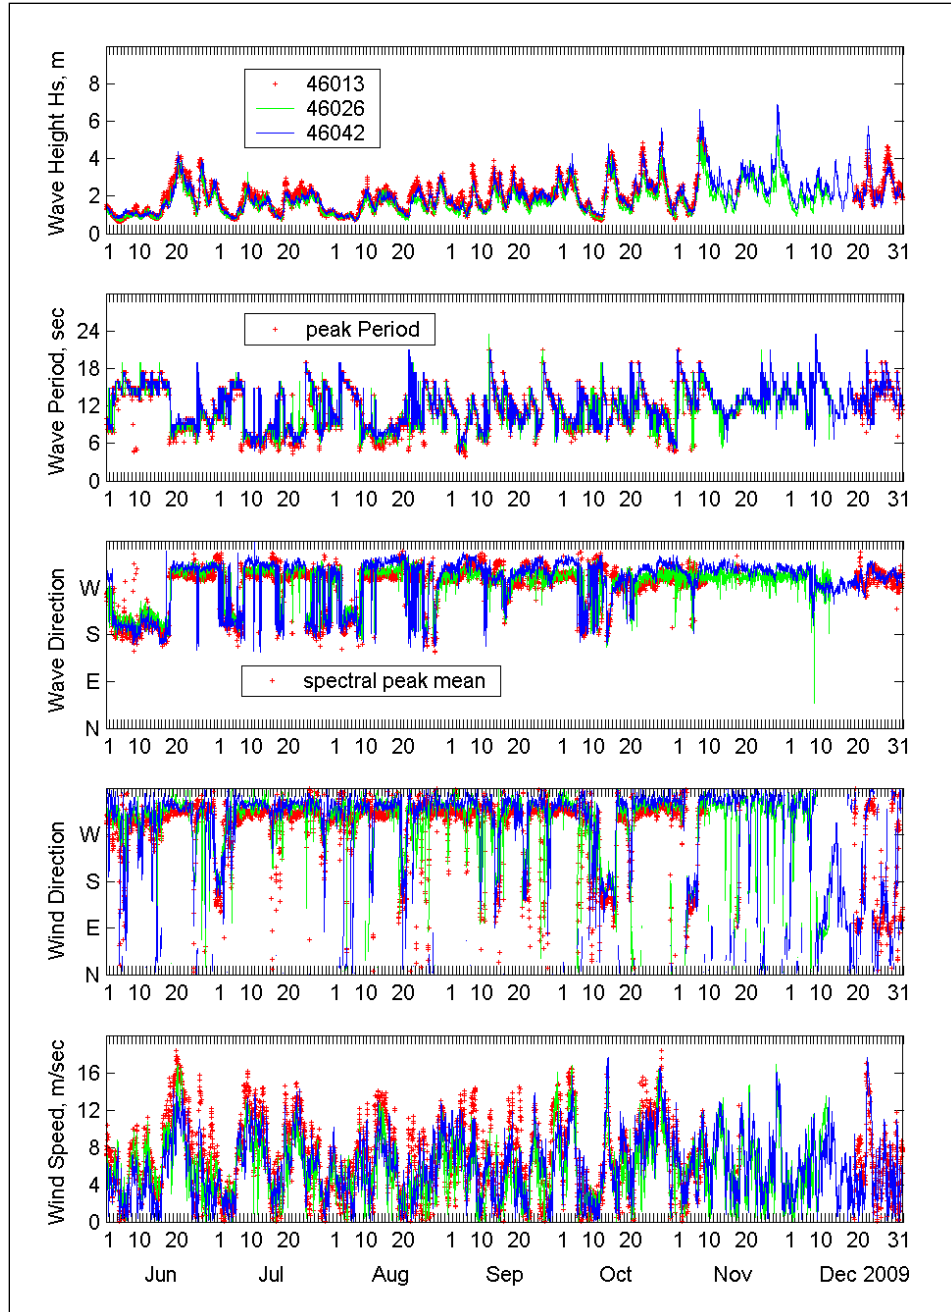
Figure 14. Wind and wave data at Buoys 46013, 46026, and 46042 for June to December 2009

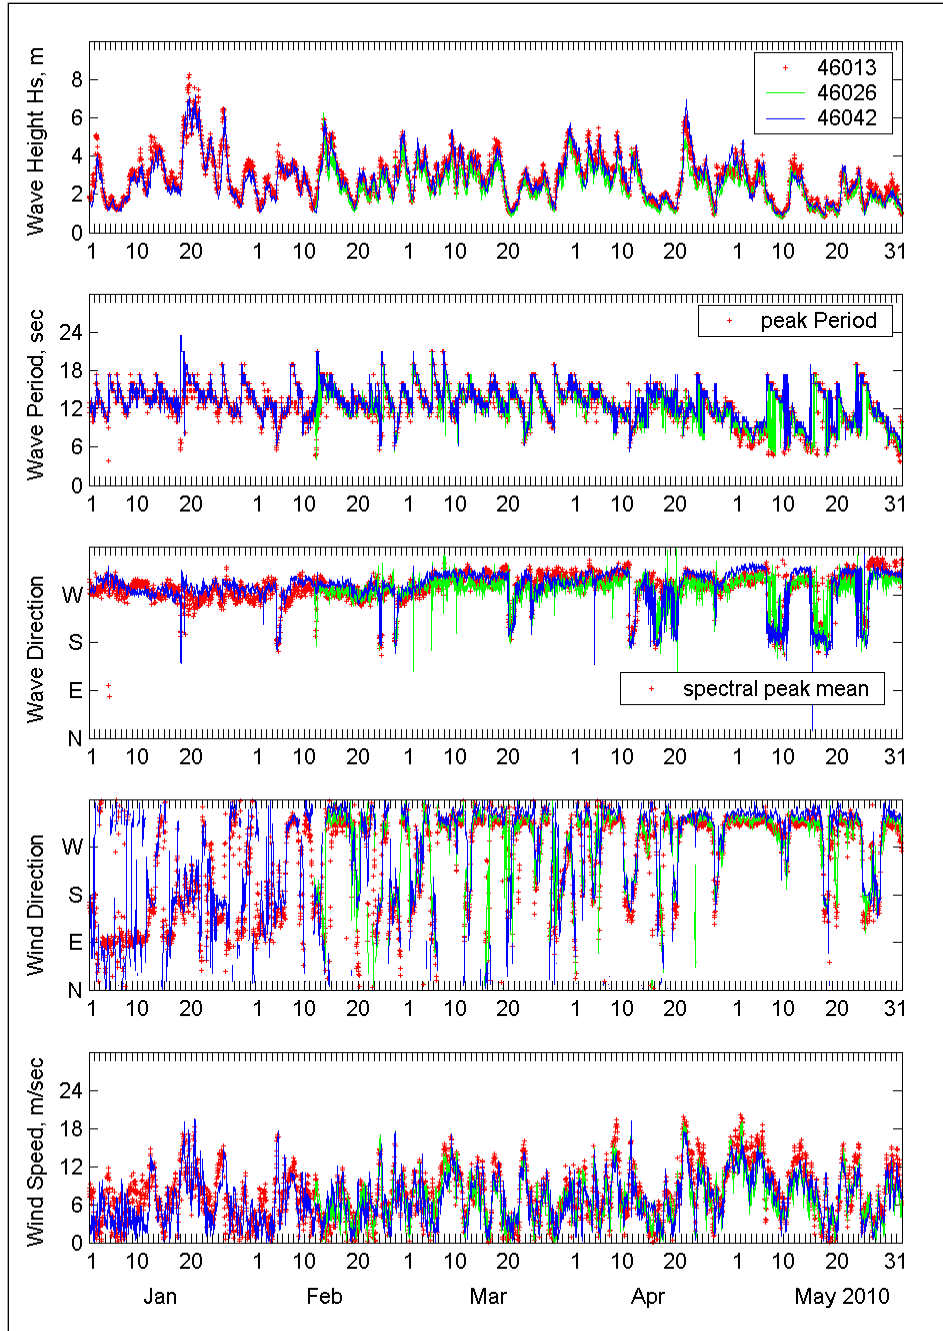
Figure 15. Wind and wave data at Buoys 46013, 46026, and 46042 for January to May 2010
