North Half Moon Bay Shoreline Improvement Project, Pillar Point Harbor, CA Coastal Engineering Appendix

FINAL January 2015

Final Report

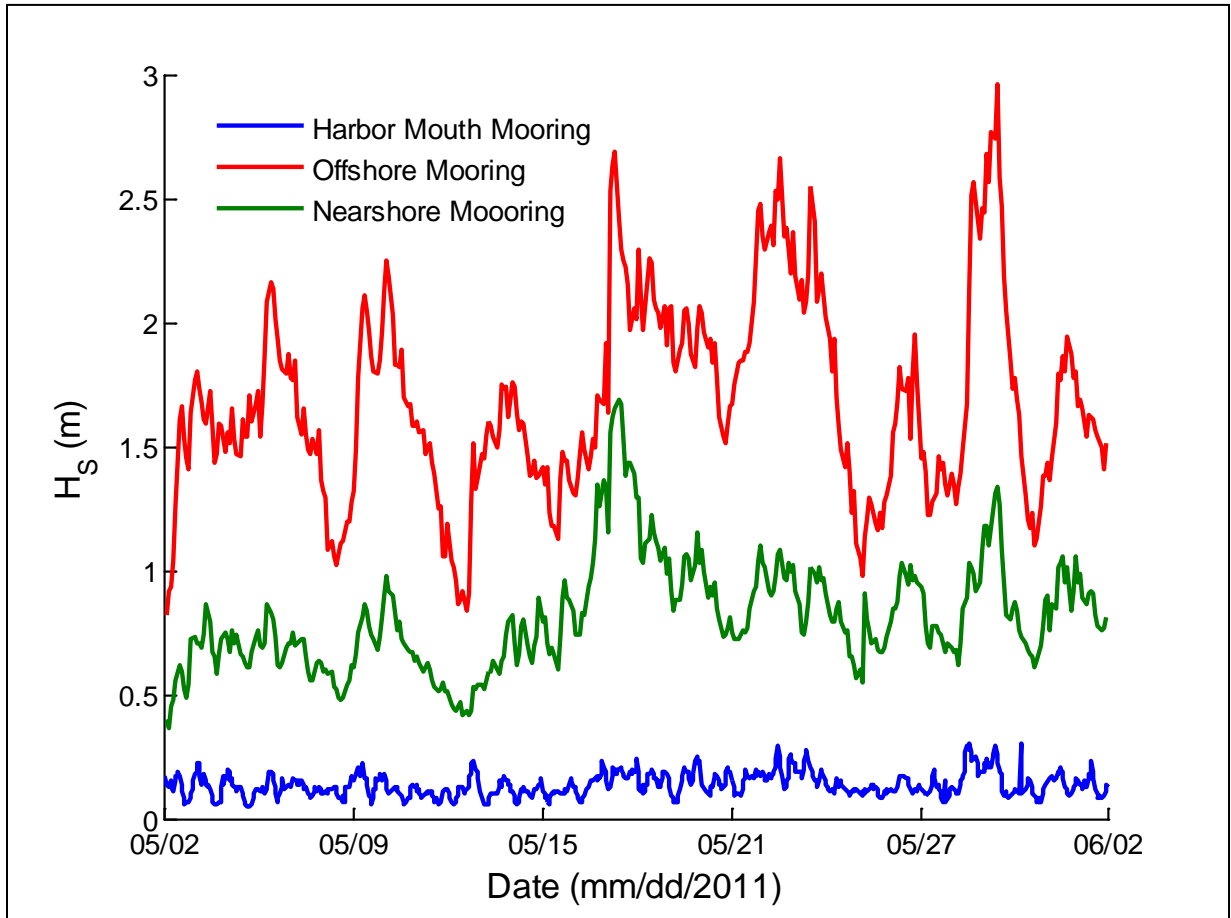
Figure 16. Nearshore wave height measured at the Harbor Mouth, west of Surfer's Beach and east of the West Breakwater

A review of the field deployment data and NOAA records indicate that several storm events occurred from May 15 to May 30 (NOAA, 2011). During these storm events, there was a notable shift in wave direction from the northwest (290 degrees) to the southwest (230 degrees) at the Offshore Mooring. This directional change is consistent with the understanding that waves typically approach from a more southerly direction during storm events. It should also be noted that this shift in wave direction was not observed at the other moorings closer to shore.

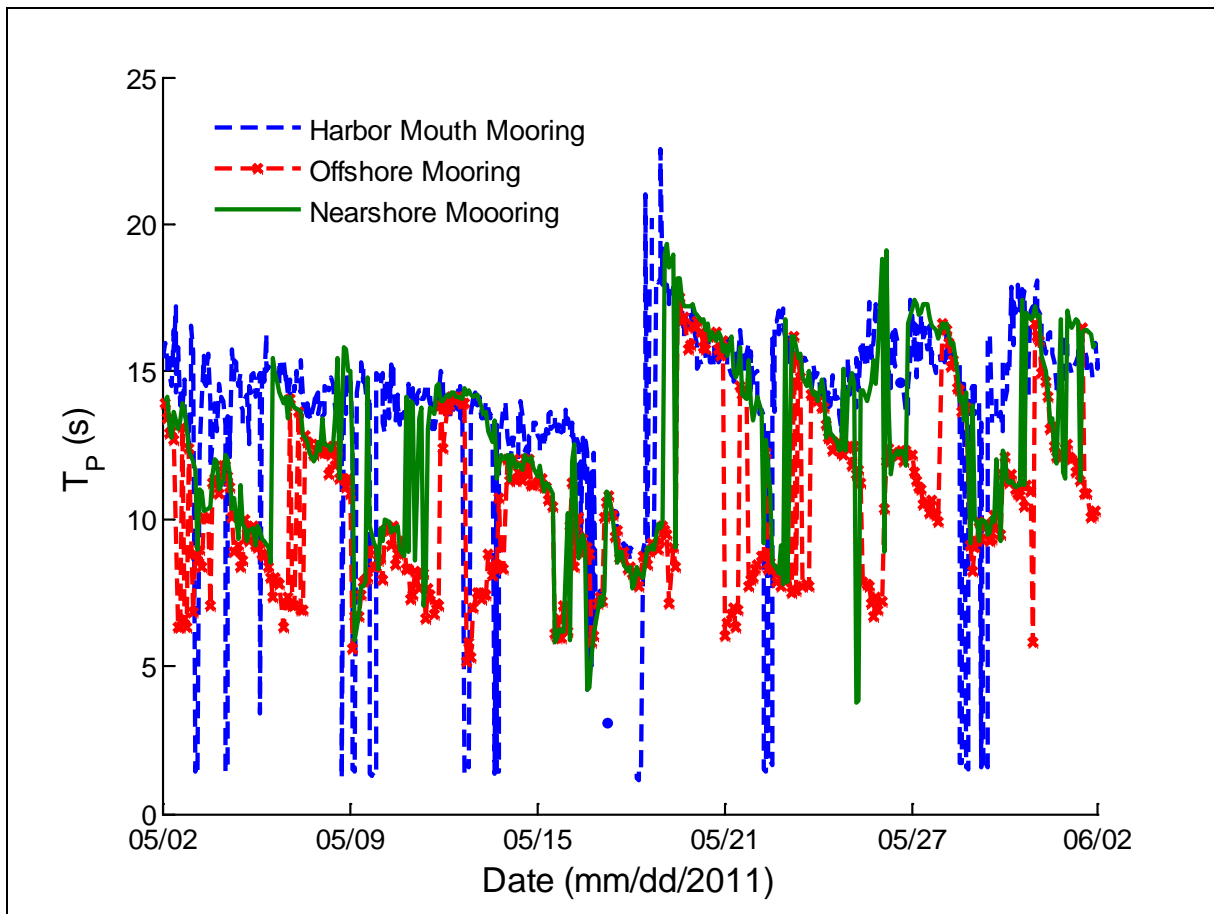
Figure 17. Nearshore peak period measured at the Harbor Mouth, west of Surfer's Beach and east of the West Breakwater

The wave period was fairly consistent between the three moorings, with a mean period of 13 seconds and a range of 1 and 23 seconds. However, there was more variability in wave period at the Harbor Mouth Mooring, possibly due to uncertainty associated with the very small wave energy measurements (Figure 17).

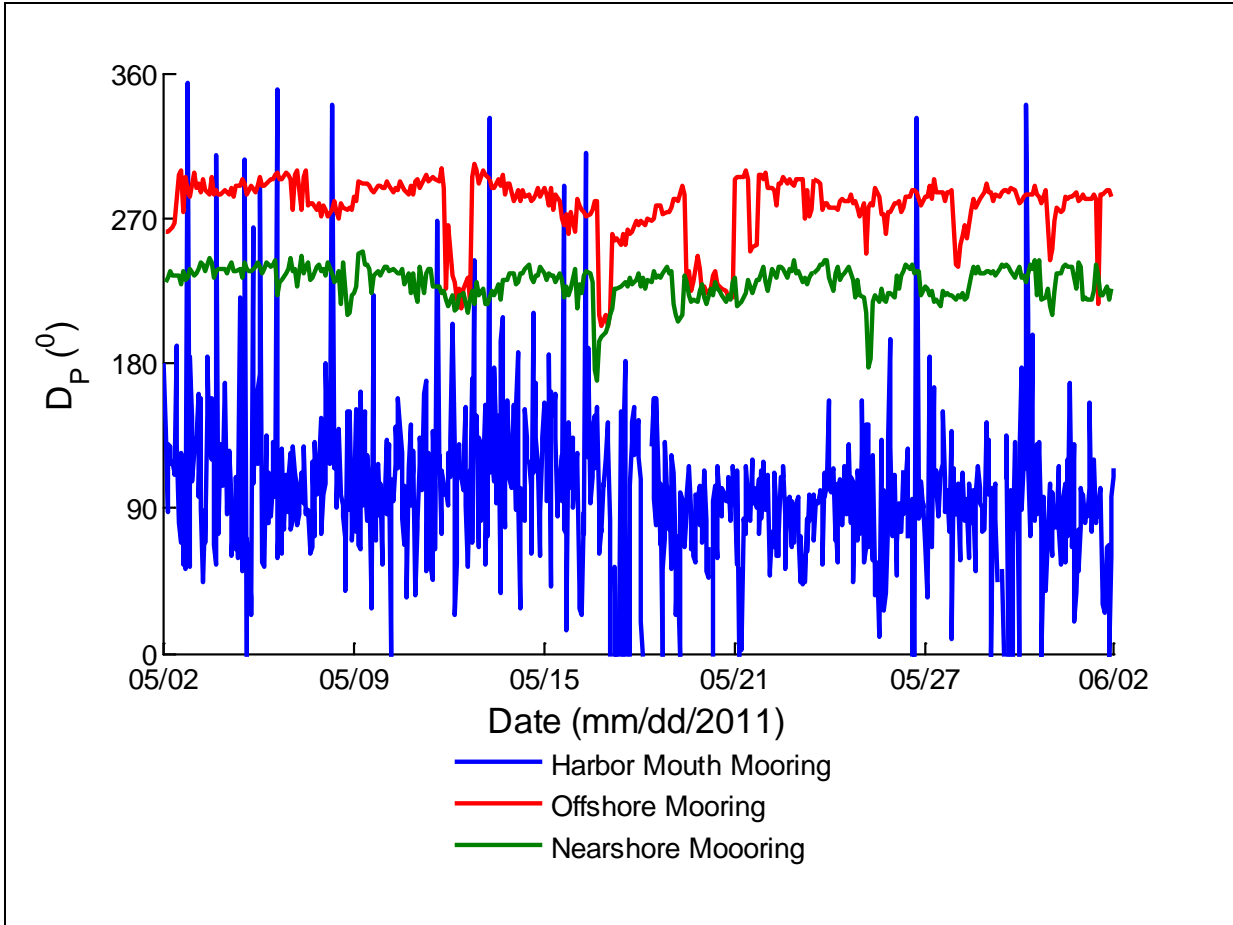
Figure 18. Nearshore wave direction measured at the Harbor Mouth, west of Surfer's Beach and east of the West Breakwater

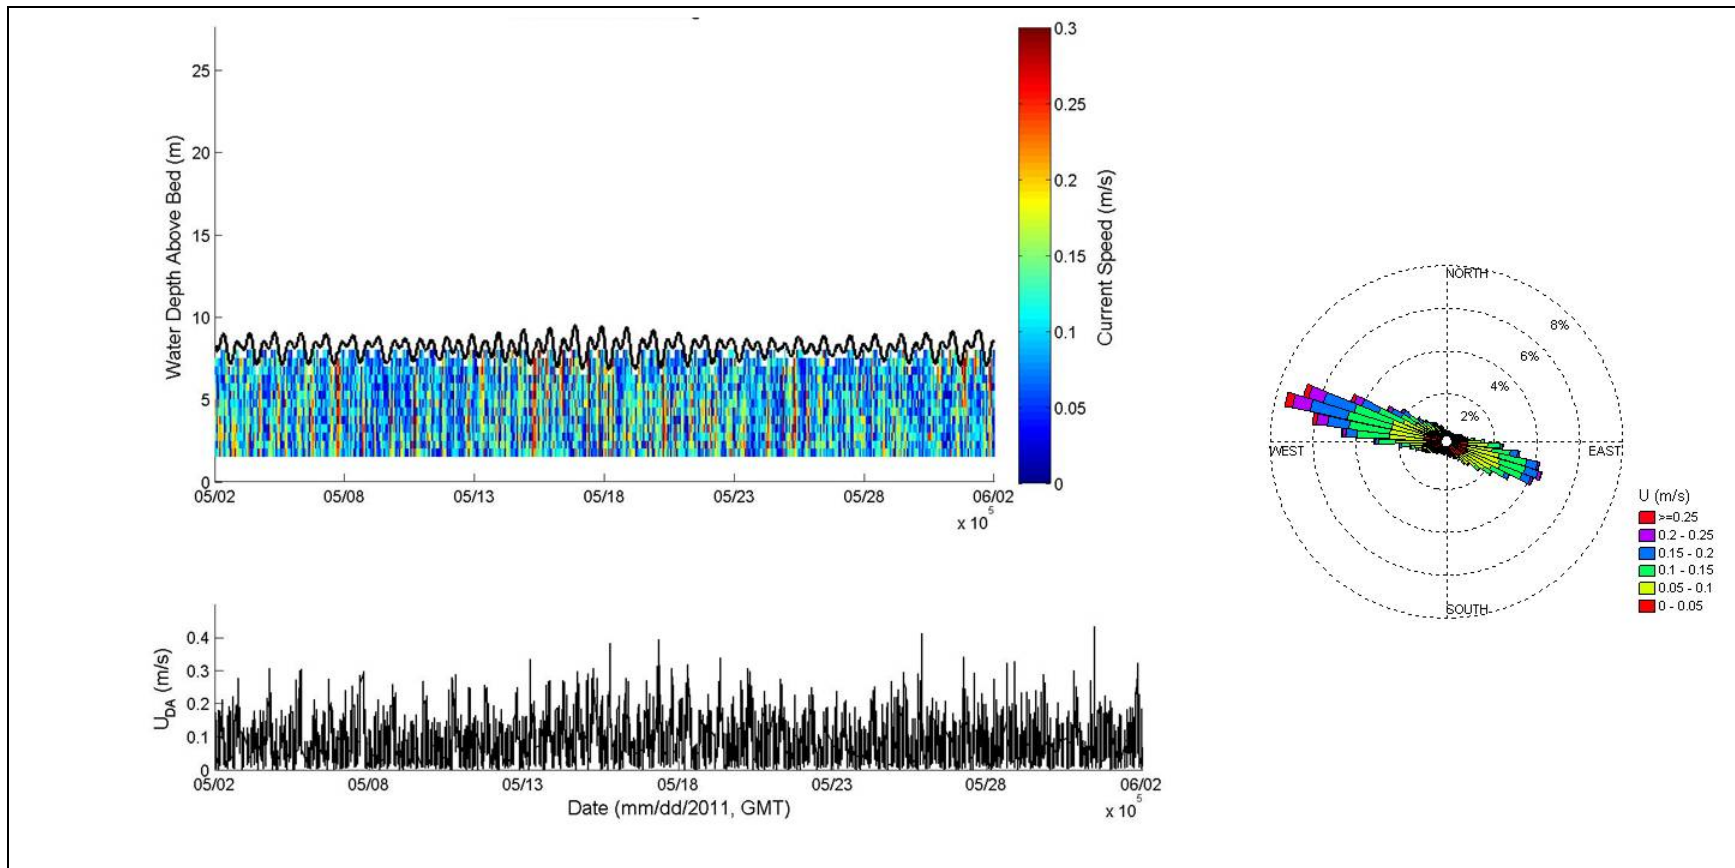
Figure 19. Vertical profile of currents at the Harbor Mouth Mooring between May 2 and June 2, 2011

Figure 19 summarizes the vertical distribution and depth averaged direction of currents at the Harbor Mouth Mooring. The blue and turquoise colors shown in the figure represent current magnitudes between 0 and 0.49 ft per second (0 and 0.15 m/s). The average current speed at the Harbor Mouth Mooring during the field deployment was 0.36 ft/s (0.11 m/s) with a maximum observed current speed of 4.6 ft/s (1.4 m/s). Tidal currents at the harbor mouth can generate large eddies within Pillar Point Harbor. 2 clockwise rotating eddies typically form in the harbor during flood tides, in the western and eastern sections of the harbor (USACE, 1996). Current direction generally aligns with the axis of the dogleg of the west breakwater and inlet to Pillar Point Harbor, as the currents oscillate to the northwest and southeast. The storm event of May 15 to May 19 was not detected in the current profile, suggesting that the Harbor Mouth Mooring may be more sheltered from storm effects than the moorings on the open coast.

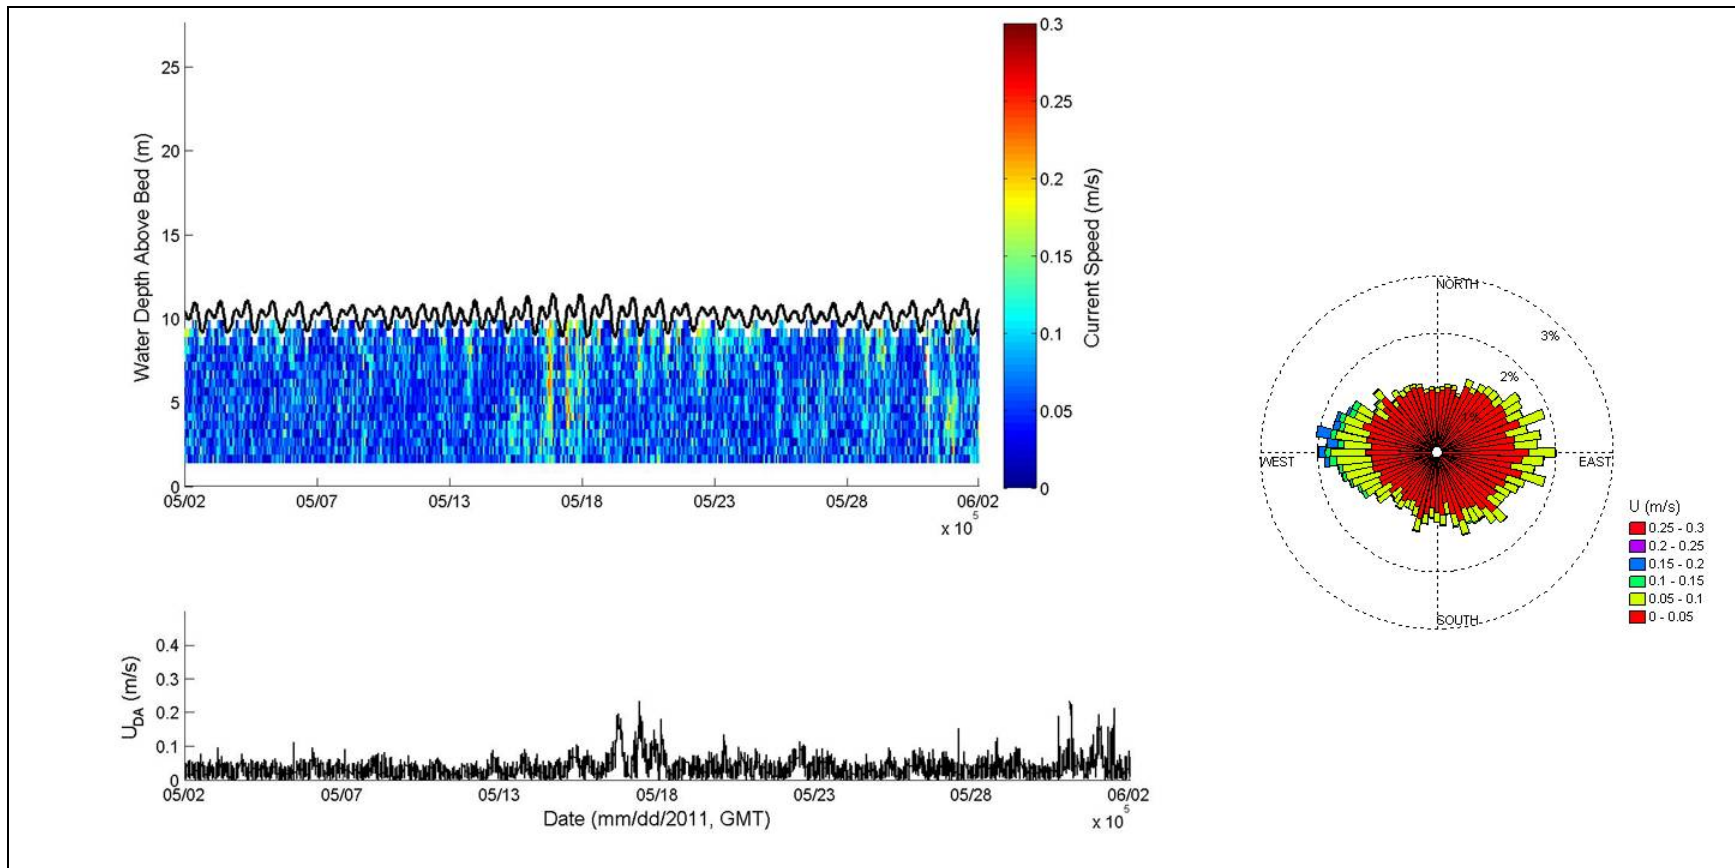
Figure 20. Vertical profile of currents at the Nearshore Mooring between May 2 and June 2, 2011

Figure 20 summarizes the vertical distribution and depth averaged direction of currents at the Nearshore Mooring. This section of the study area had the weakest current magnitudes, with an average current speed of 0.2 ft/s (0.06 m/s) and a maximum observed current speed of 0.6 ft/s (0.19 m/s). The current rose does not indicate a dominant current direction, as it appears that the currents were measured from all directions at the Nearshore Mooring. The storm event of May 15 to May 19 was observed in the vertical profile of the current measurements, and is highlighted by the bright red colors of the current profile between May 17 and 18. During this event, the measured depth averaged currents increased from approximately (0.2 ft/s) 0.06 m/s to 0.8 ft/s (0.24 m/s).

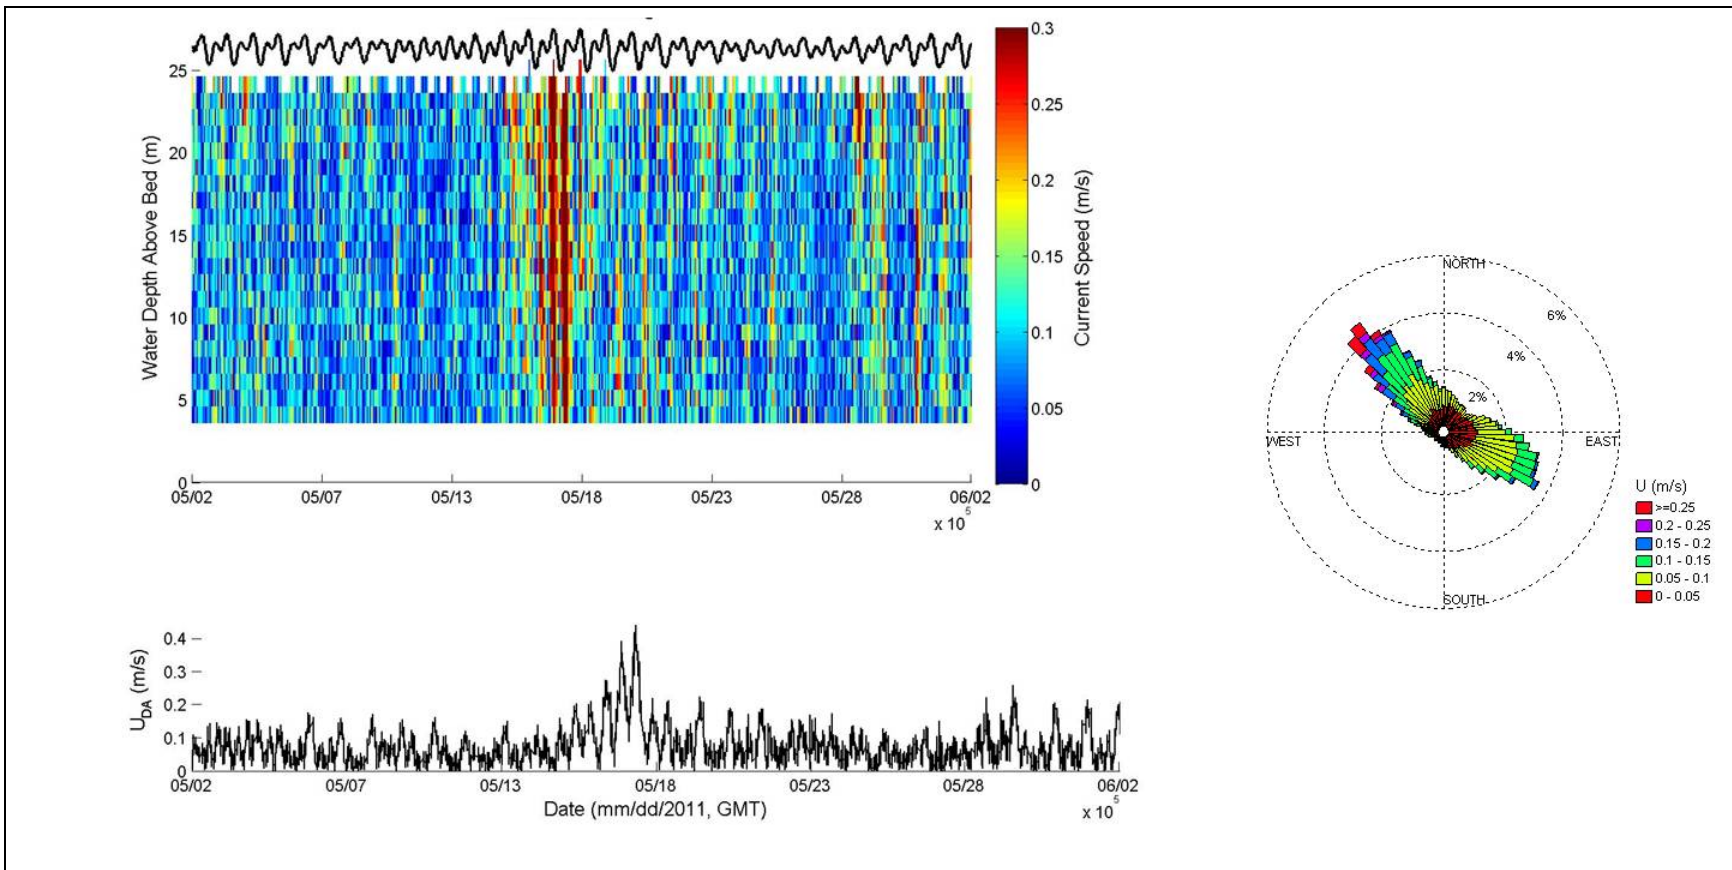
Figure 21. Vertical profile of currents at the Offshore Mooring between May 2 and June 2, 2011

Figure 21 summarizes the vertical distribution and depth averaged direction of currents at the Offshore Mooring. This section of the study area had the strongest current magnitudes, with an average current speed of 0.36 ft/s (0.11 m/s) and a maximum observed current speed of 2.0 ft/s (0.60 m/s). As in the case of the mooring at the harbor inlet, the depth averaged currents appear to be directed towards the northwest and southeast. The storm event of May 15 to May 19 was

most pronounced at this mooring, as highlighted by the dark red colors in the vertical profile. During this storm event, the measured depth averaged currents increased from approximately 0.36 ft/s (0.11 m/s) to 1.4 ft/s (0.44 m/s).

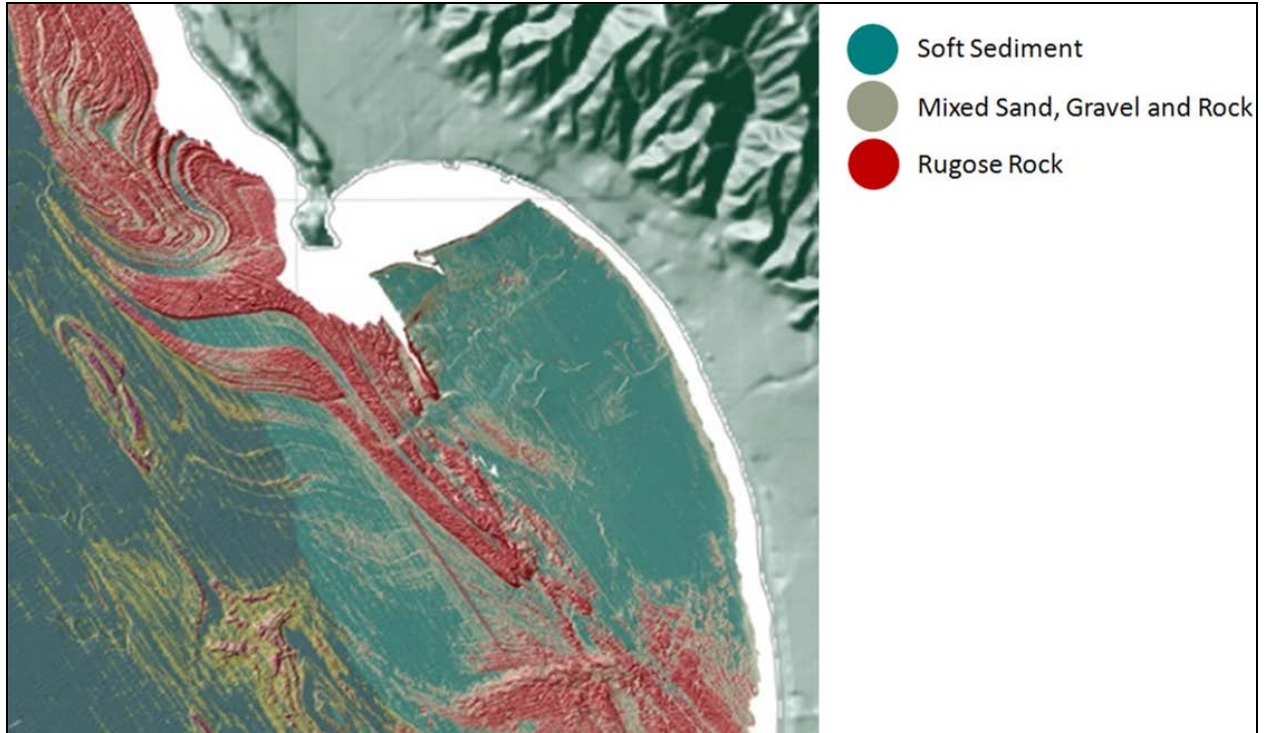
Figure 22. Seafloor sediment characteristics of the project area (USGS, 2011)

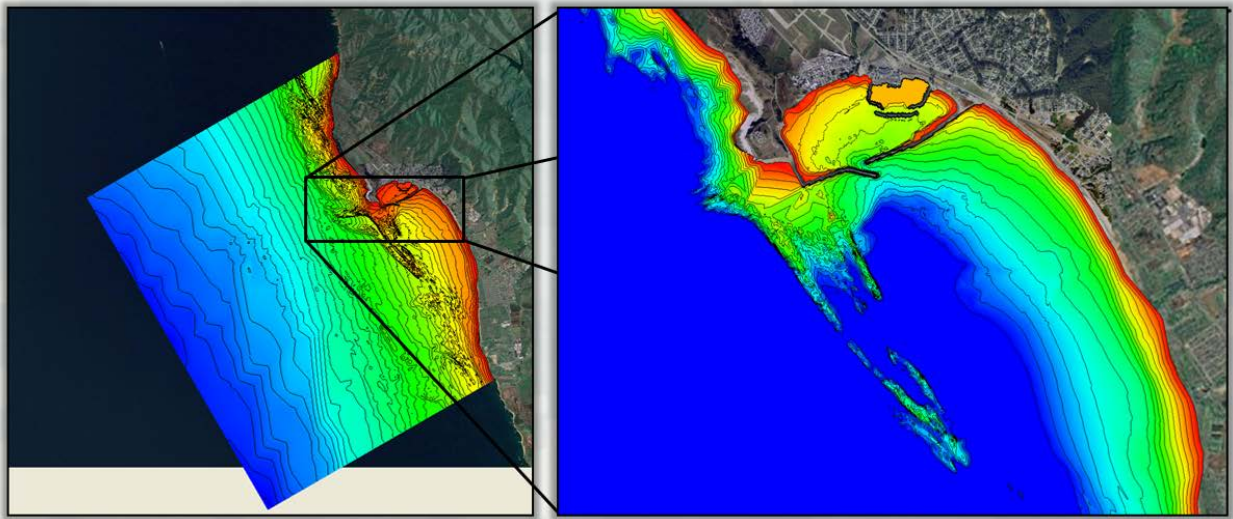
Figure 23. Composite bathymetry from all data sources

The bathymetric data used as input in the numerical modeling effort was derived from several sources, and combined into one bathymetric grid dataset (Figure 23). Much of the nearshore bathymetry in the immediate vicinity of Pillar Point Harbor was derived from a fall 2009 hydrographic survey of the harbor and surrounding areas undertaken by USACE (via a contractor) as part of the Coastal Structure Inspection Program (Towill, Inc., 2011; Figure 24). Additional nearshore bathymetry was derived from surveys undertaken by the California Sea Floor Mapping Program (California State University Monterey Bay, 2011; Figure 25). Offshore bathymetric data were obtained from the GEOPhysical Data System (GEODAS) database, which has been developed and managed by the National Geophysical Data Center (NOAA, 2011(c)).

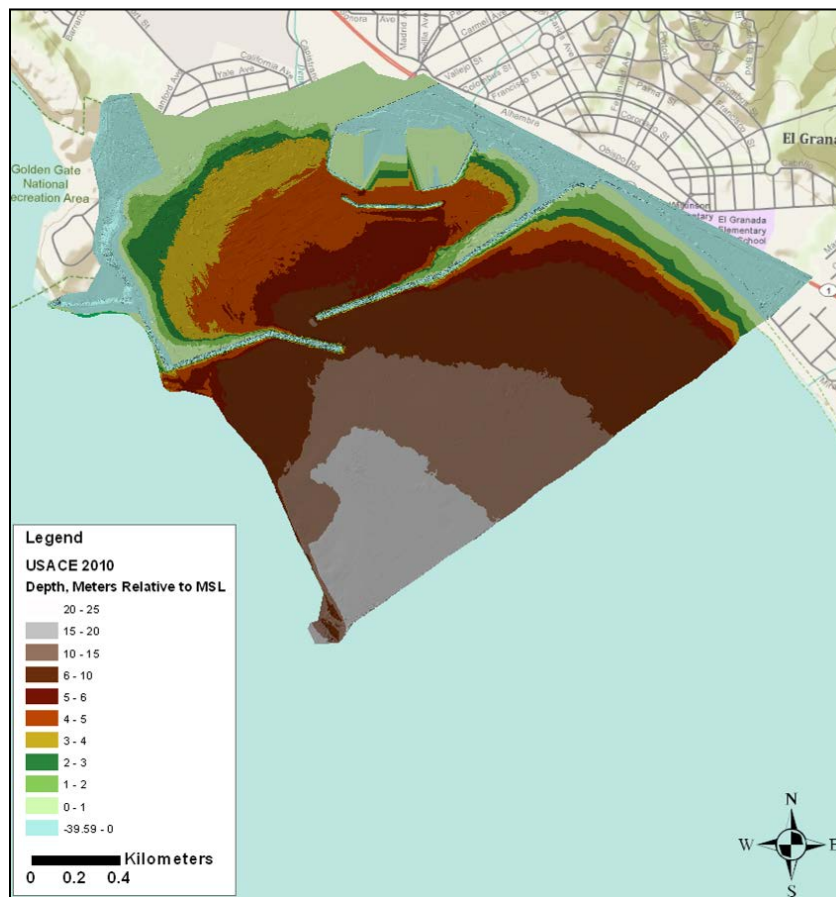
Figure 24. Bathymetry of the Pillar Point Harbor and North Half Moon Bay study area (Towill Inc., 2011)

In contrast to a number of other structures along the California coast, the breakwaters at Pillar Point Harbor were not damaged by any of these storm events. The lack of damage was likely due to variations in local bathymetry (Figure 24), with large rocky outcrops serving to dissipate a considerable amount of the wave energy approaching from the west and northwest (USACE, 1983). However, waves approaching directly from the south may bypass these rock formations resulting in more direct wave energy reaching the shoreline and breakwaters.

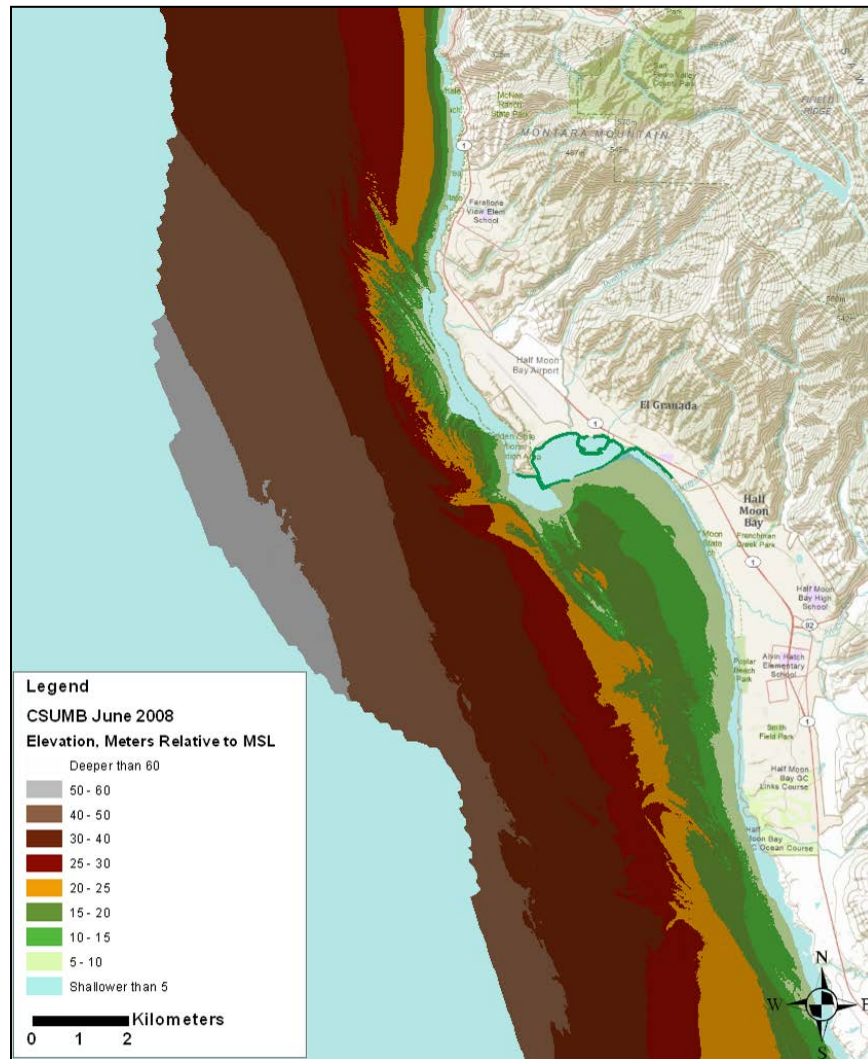
Figure 25. Bathymetry of the offshore extents of North Half Moon Bay study area (California State University Monterey Bay, 2011)

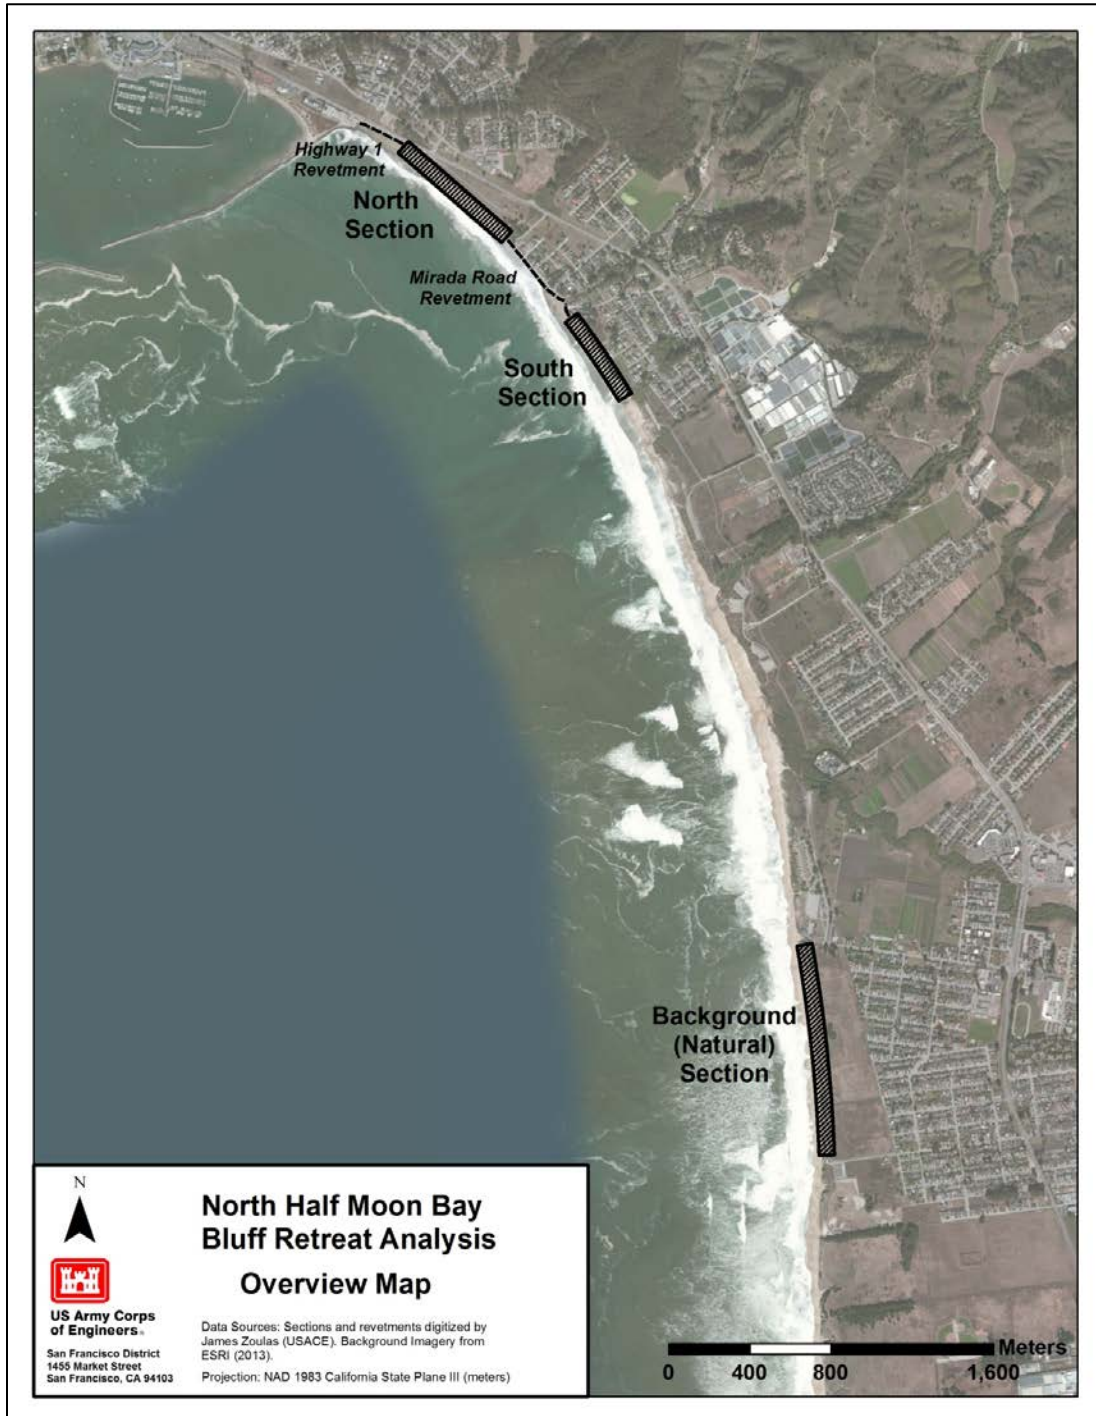
Figure 26. Map depicting the three sections of coastal bluffs addressed by the analysis

The Background section extends approximately 3,450 ft (1,050 m) south from Kelly Avenue to Poplar Street. This section is comprised of approximately 33 foot (10 m) high unprotected bluffs, and was selected to establish the “natural” background bluff retreat rate based on recommendations from USACE staff with significant geologic field experience in the study area.

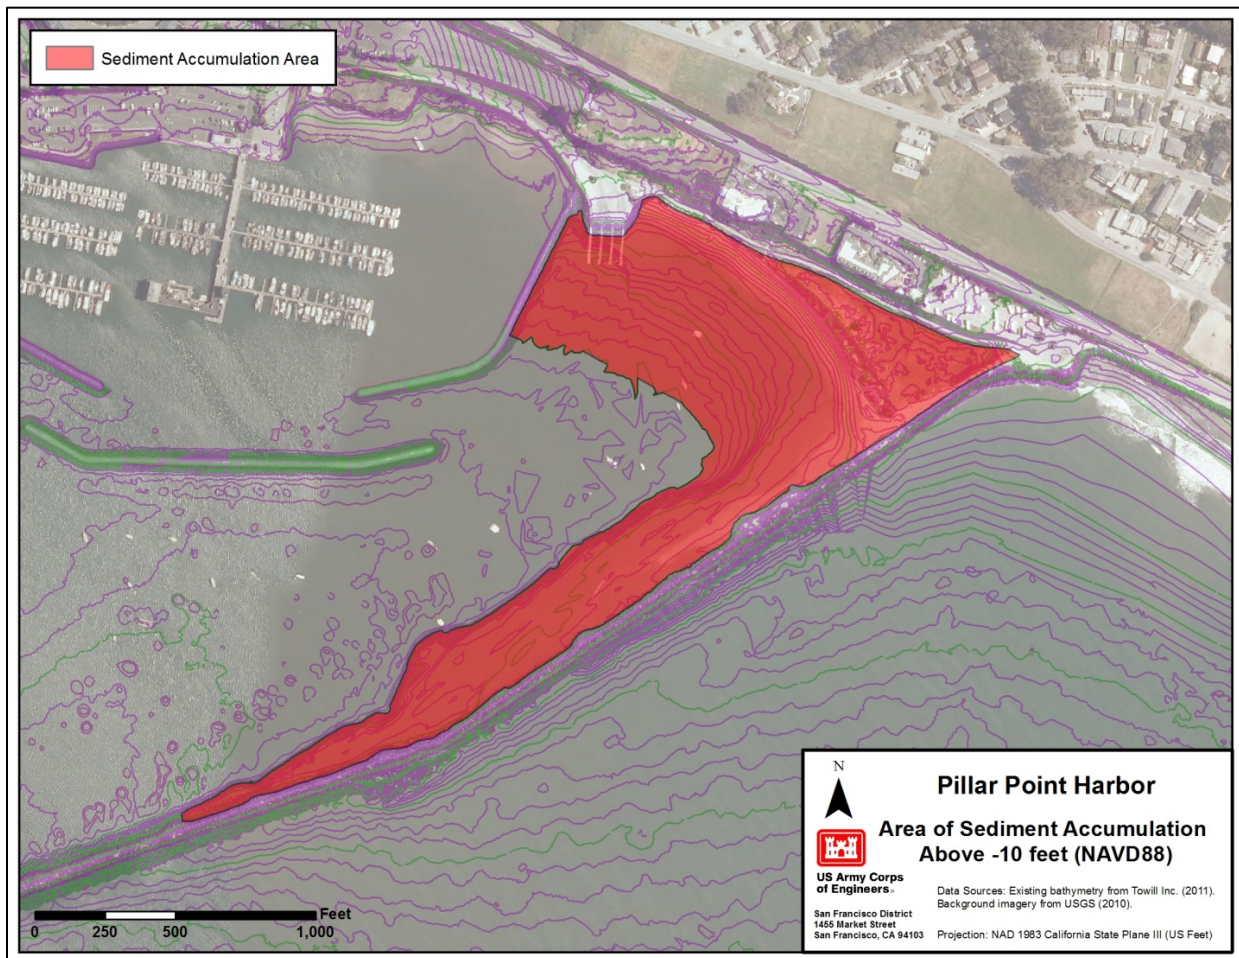
Figure 27. Area of excessive sediment accumulation and shoaling in Pillar Point Harbor

Recent hydrographic surveys and visual observations indicate that a large shoal has formed on the northwest (harbor side) of the east breakwater (Gahagan & Bryant Associates, 2007), and there has been considerable interest in removing sand from this shoal and placing it on Surfers Beach. As a result, GIS software was utilized to define potential sand removal and placement footprints and compute the quantity of sand that could be removed from this shoal down to a depth (-10 ft, NAVD 88) that approximately matched the adjacent harbor bed (Figure 27). This analysis was run for 2 sediment removal scenarios based on the total amount of sand that could be removed, and a more “realistic” sand removal strategy (see Sections 6.1 and 6.2).

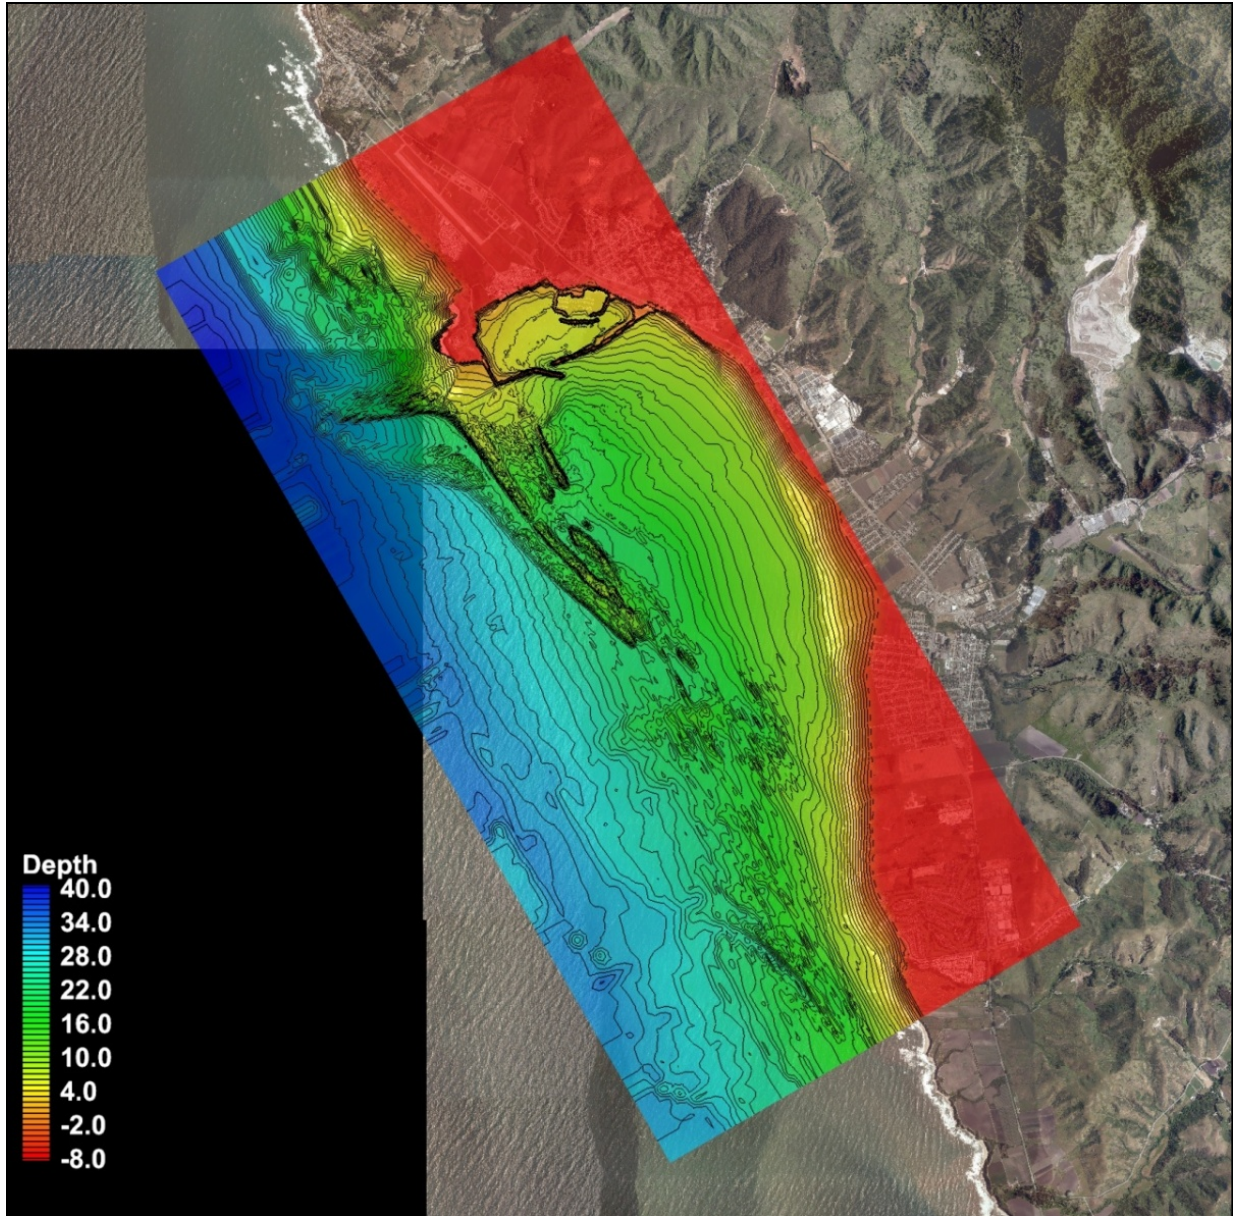
Figure 28. CMS domain and water depth (m). Note that all depths in the CMS model are referenced to Mean Sea Level (MSL) at the Monterey Tide Station (9413450).

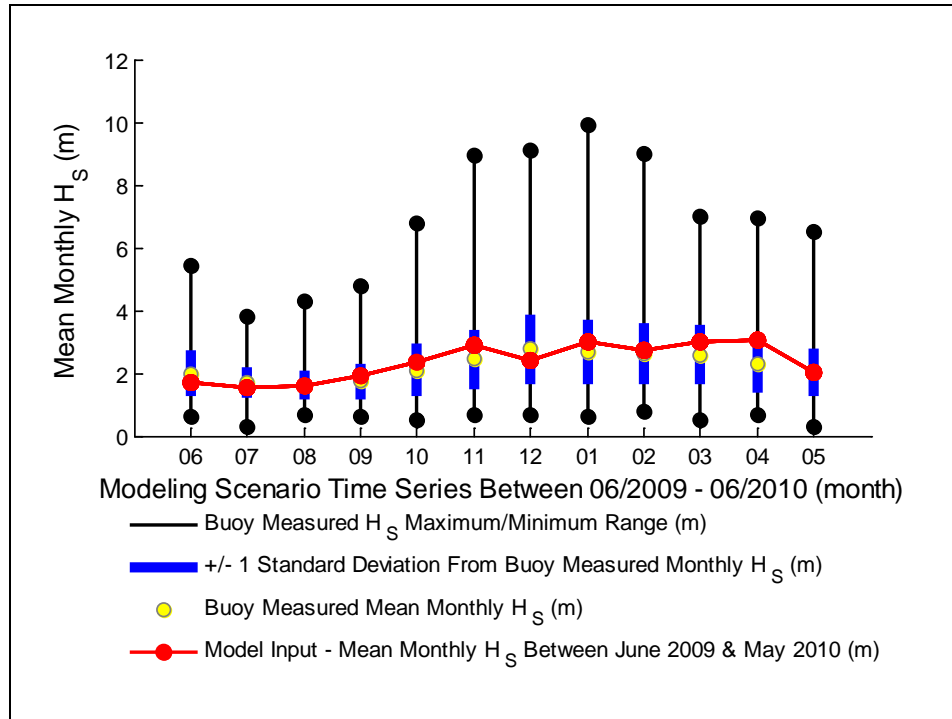
Figure 29. Mean monthly H_S from NBDC Buoy 46042

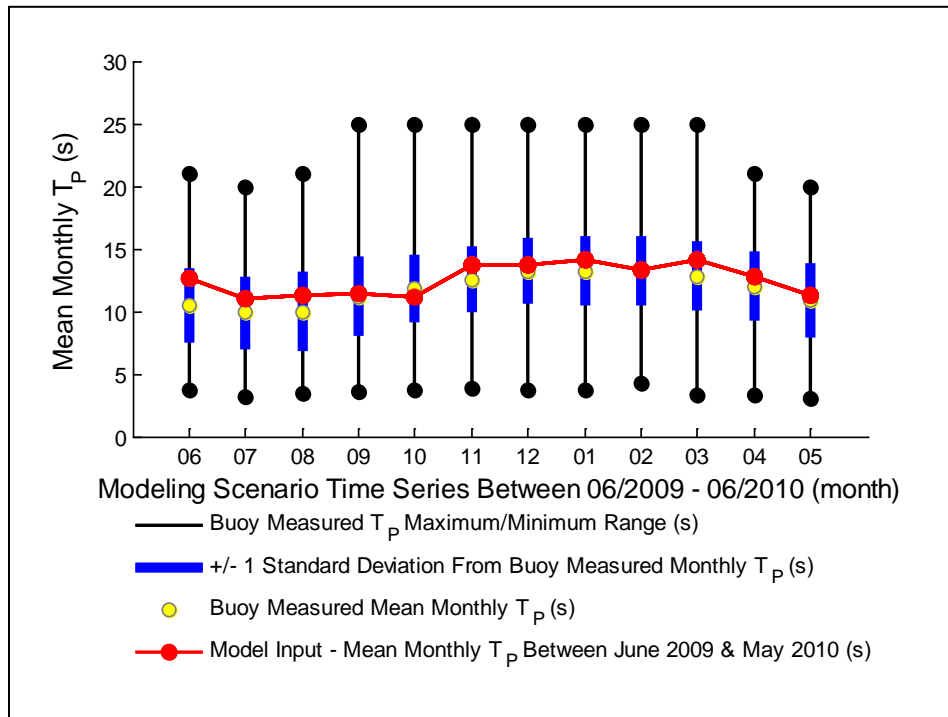
Figure 30. Mean monthly T_p from NBDC Buoy 46042

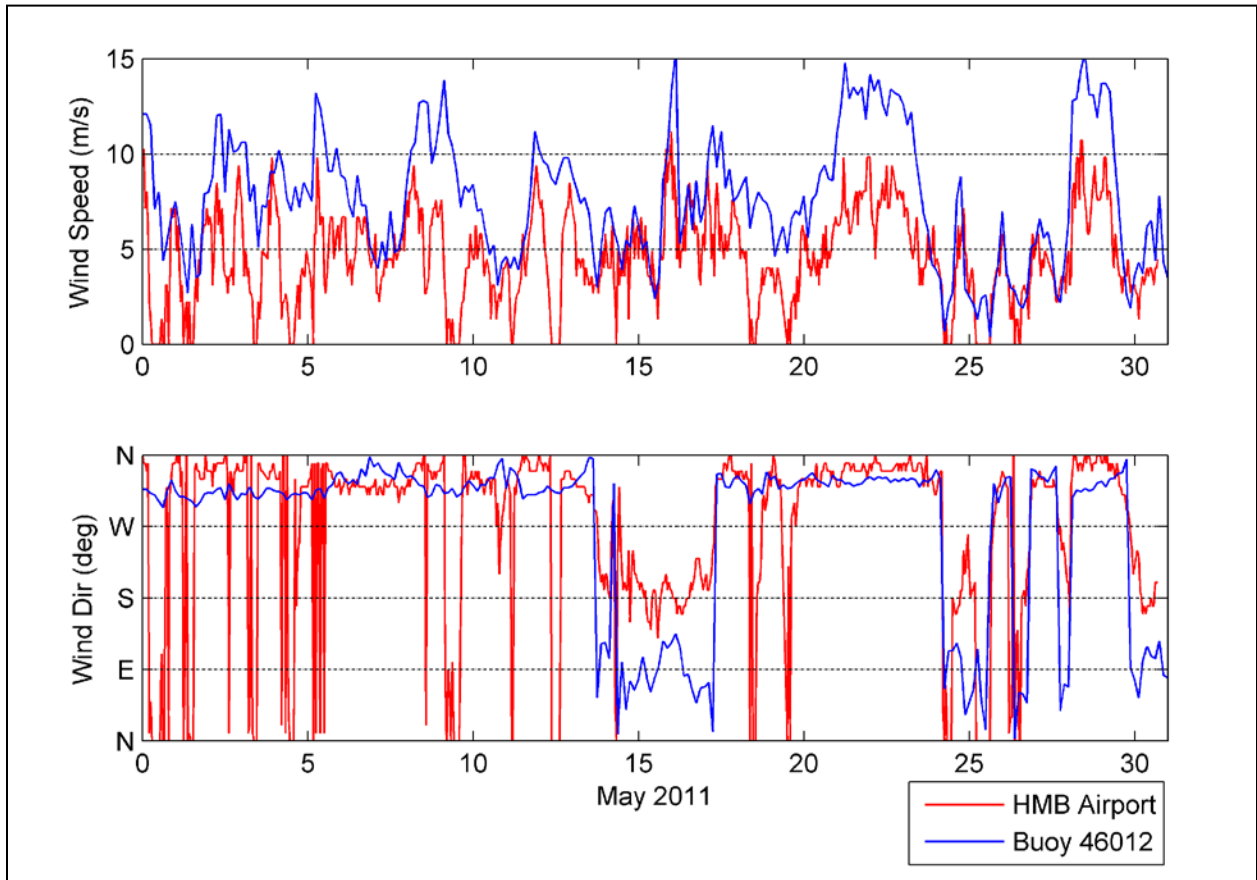
Figure 31. Offshore and coastal wind measurements

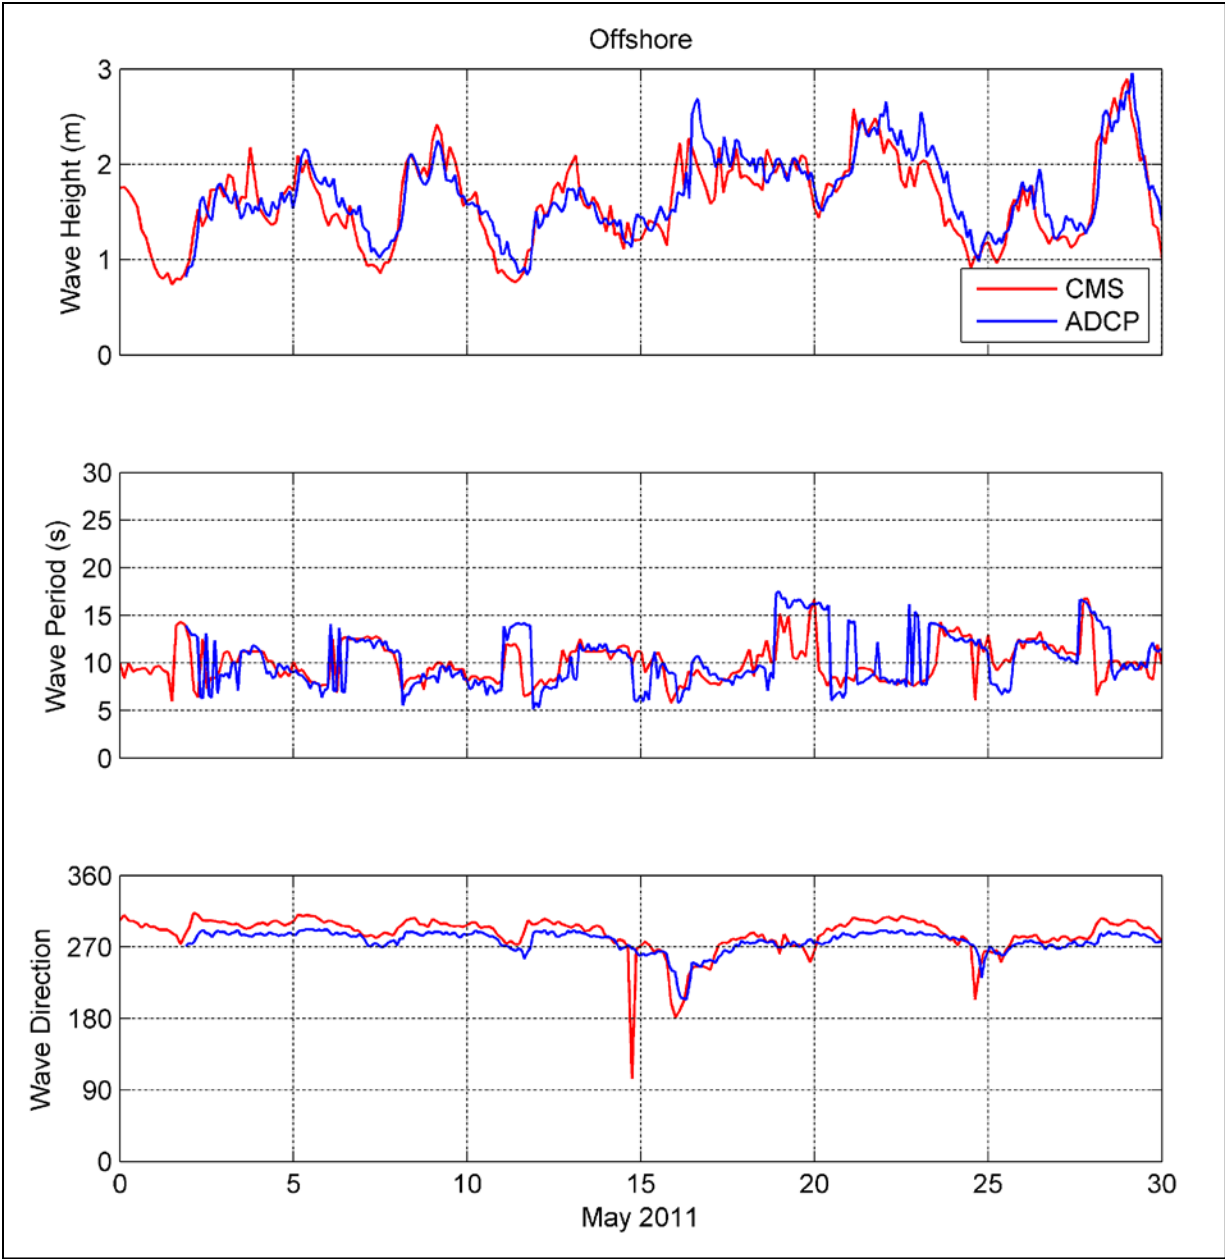
Figure 32. Wave parameter comparisons at the Offshore Mooring

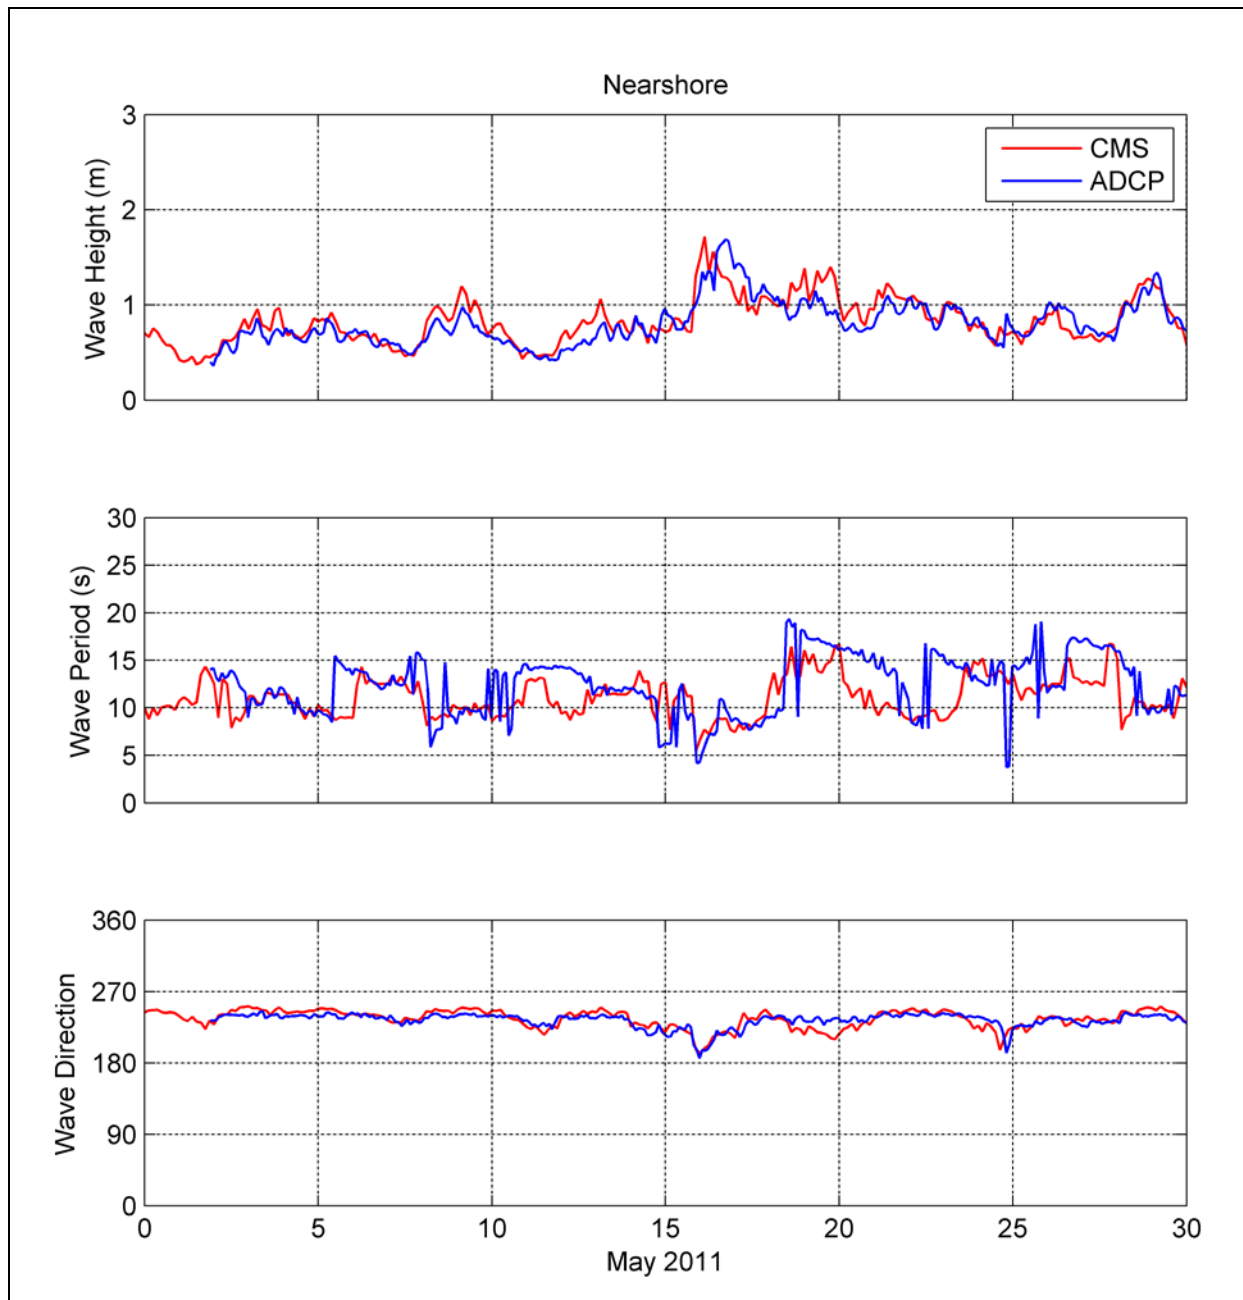
Figure 33. Wave parameter comparisons at the Nearshore Mooring
