North Half Moon Bay Shoreline Improvement Project, Pillar Point Harbor, CA Coastal Engineering Appendix

FINAL January 2015

Final Report

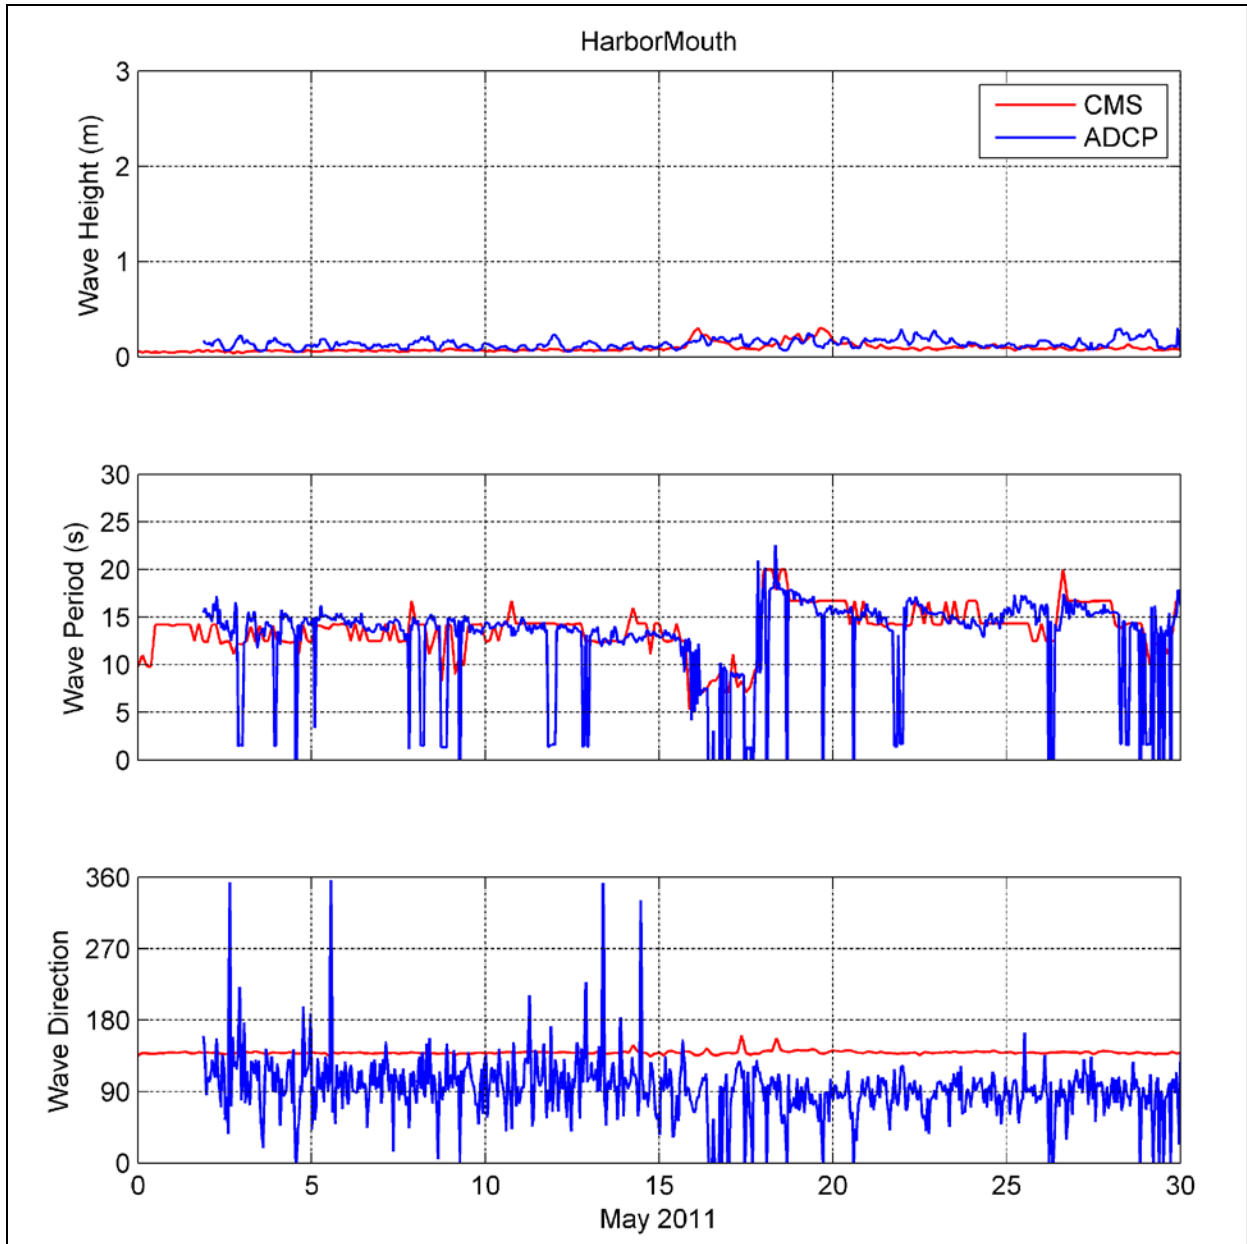
Figure 34. Wave parameter comparisons at the Harbor Mouth Mooring

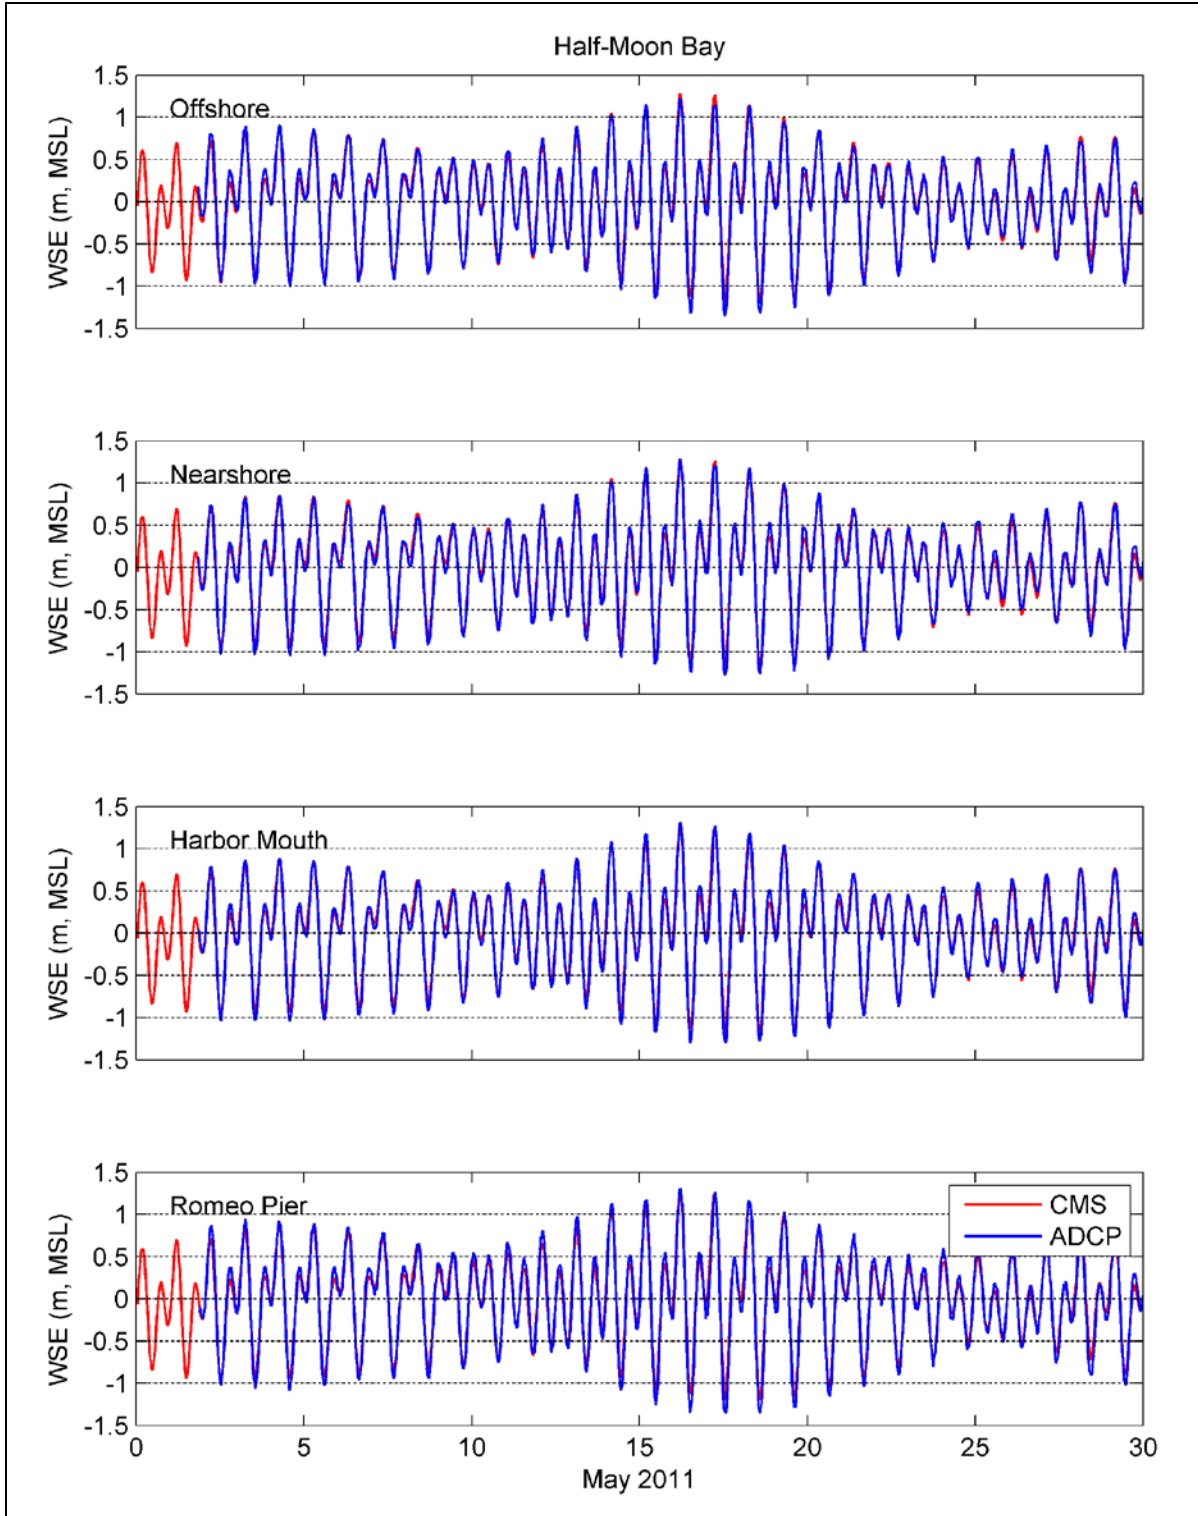
Figure 35. Water surface elevation comparisons at the instrument deployment locations

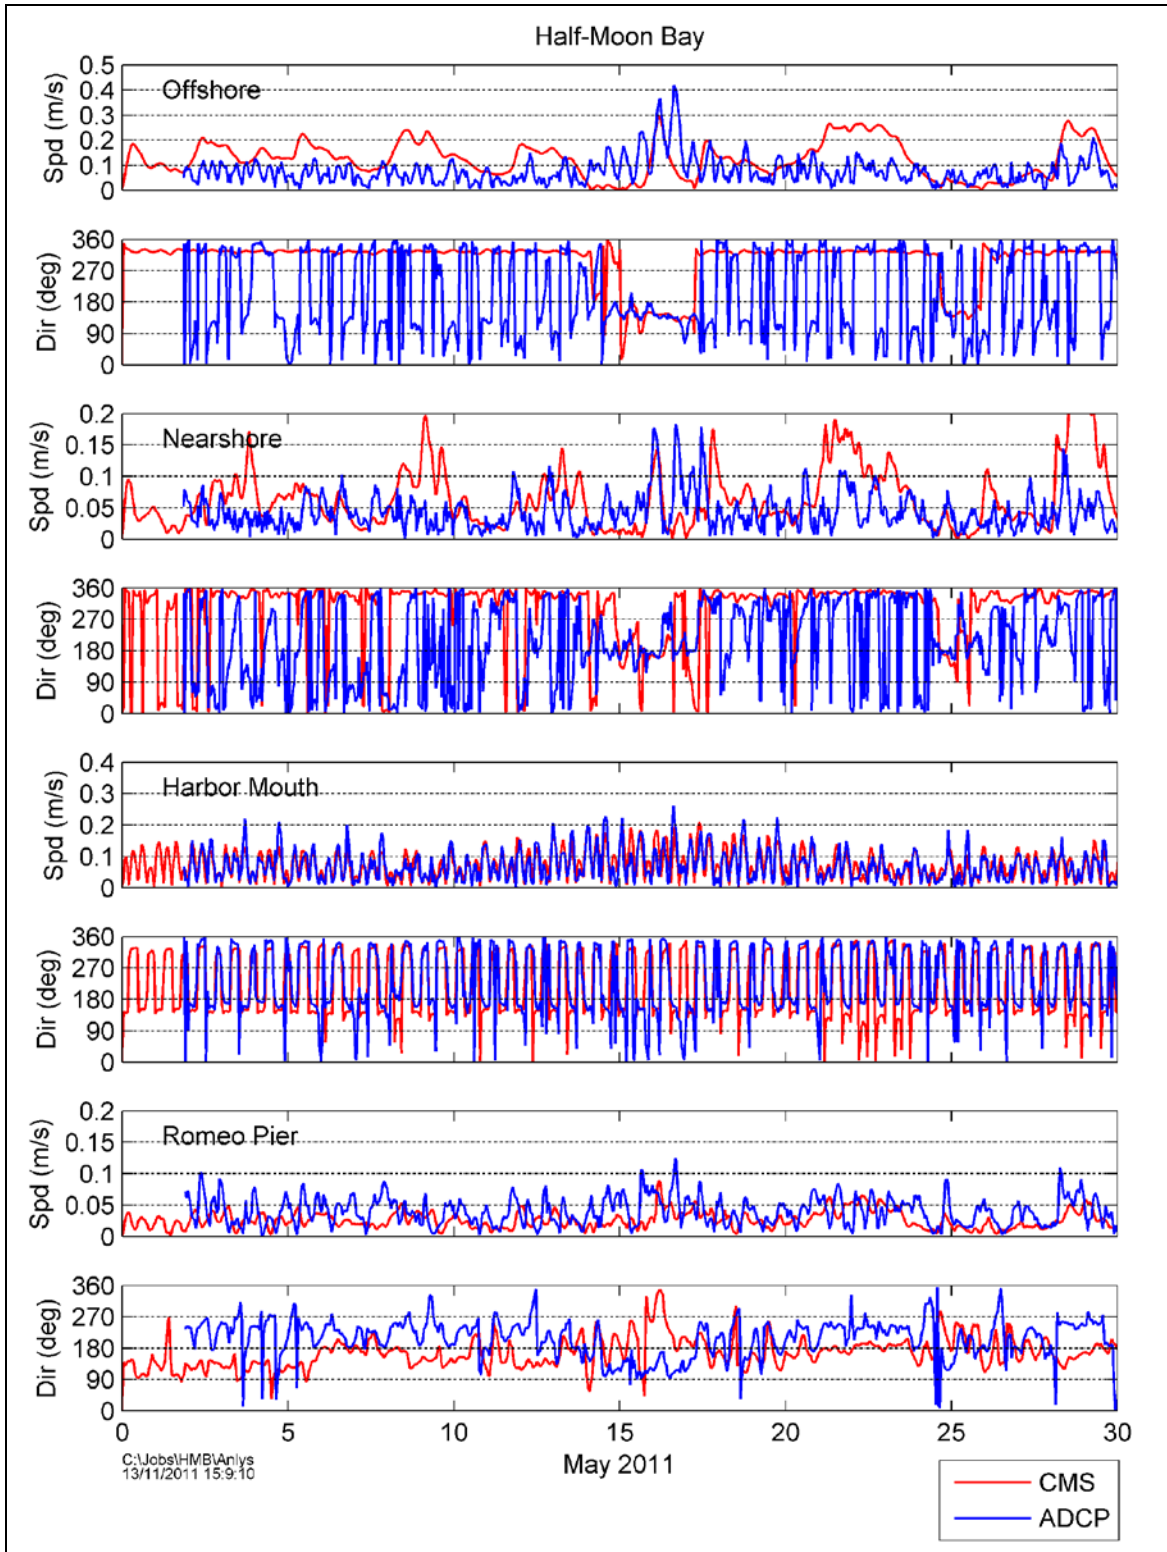
Figure 36. Current comparisons at the instrument deployment locations.

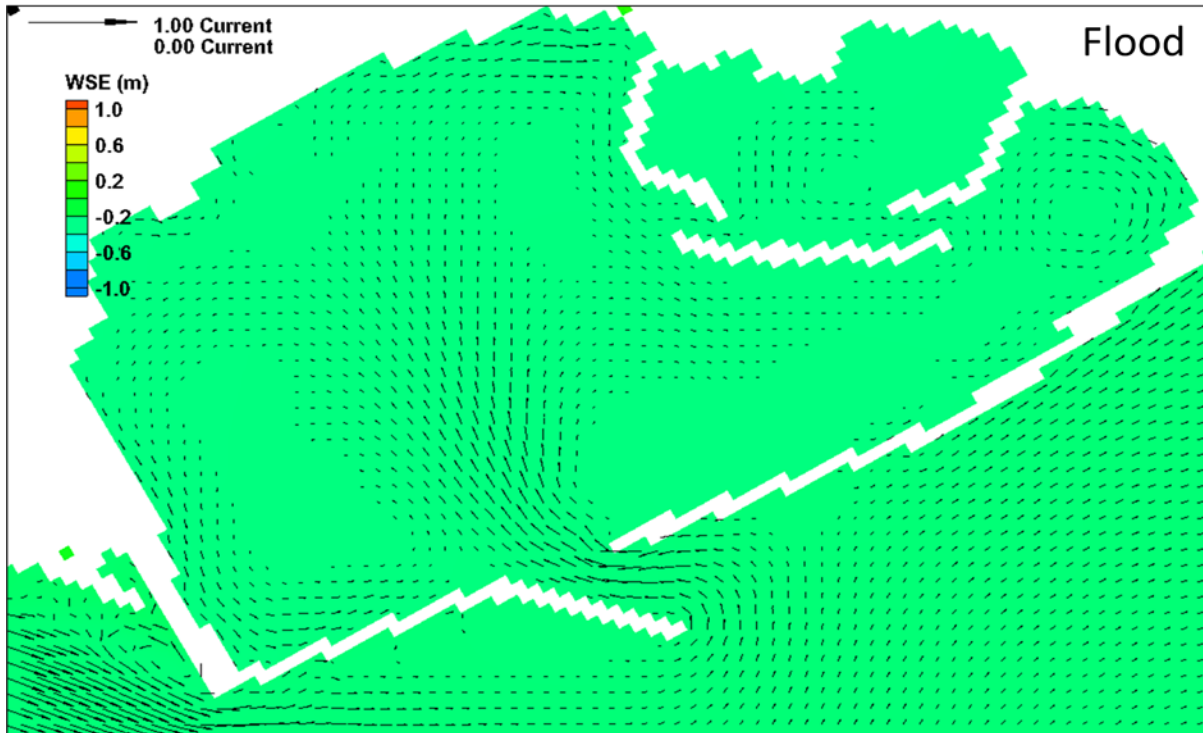
Figure 37. Circulation in Half Moon Bay during the flood tide

Figure 37 and Figure 38 depict snapshots of the depth-averaged water circulation field inside Pillar Point Harbor during the flood and ebb tide cycles, respectively. These figures demonstrate that strong tidal currents occur at the harbor entrance during the peak flood and ebb cycles, with current speeds ranging from 20 and 30 cm/sec (0.66 to 0.98 ft/sec). Within the harbor, the flood current splits into two branches as it approaches Romeo Pier. One branch flows eastward, passes the inner harbor, and turns back towards the entrance along the eastern breakwater. Another branch flows westward and turns south towards the entrance along the western breakwater. Under the ebb tide condition, the harbor water flows out along the eastern and western breakwaters, and through the middle of the harbor. The circulation pattern generated by the CMS is consistent with that found in a Pillar Point Harbor circulation study by Wuertz et al. (2011).

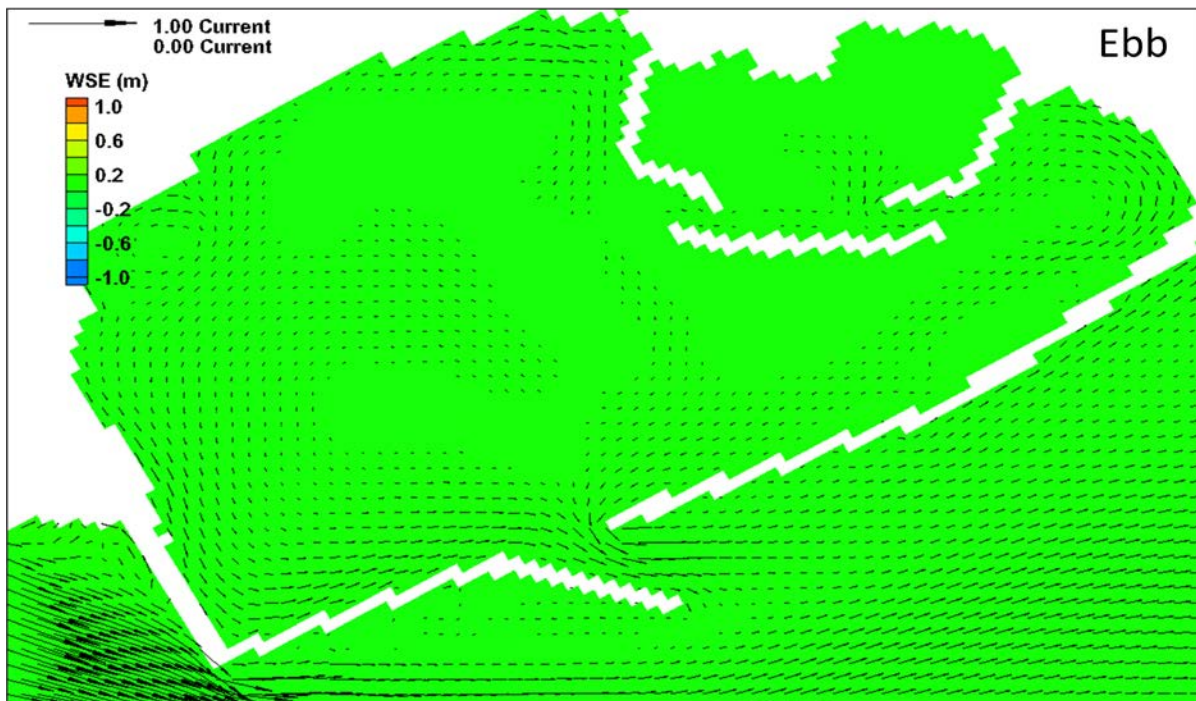
Figure 38. Circulation in Half Moon Bay during the ebb tide

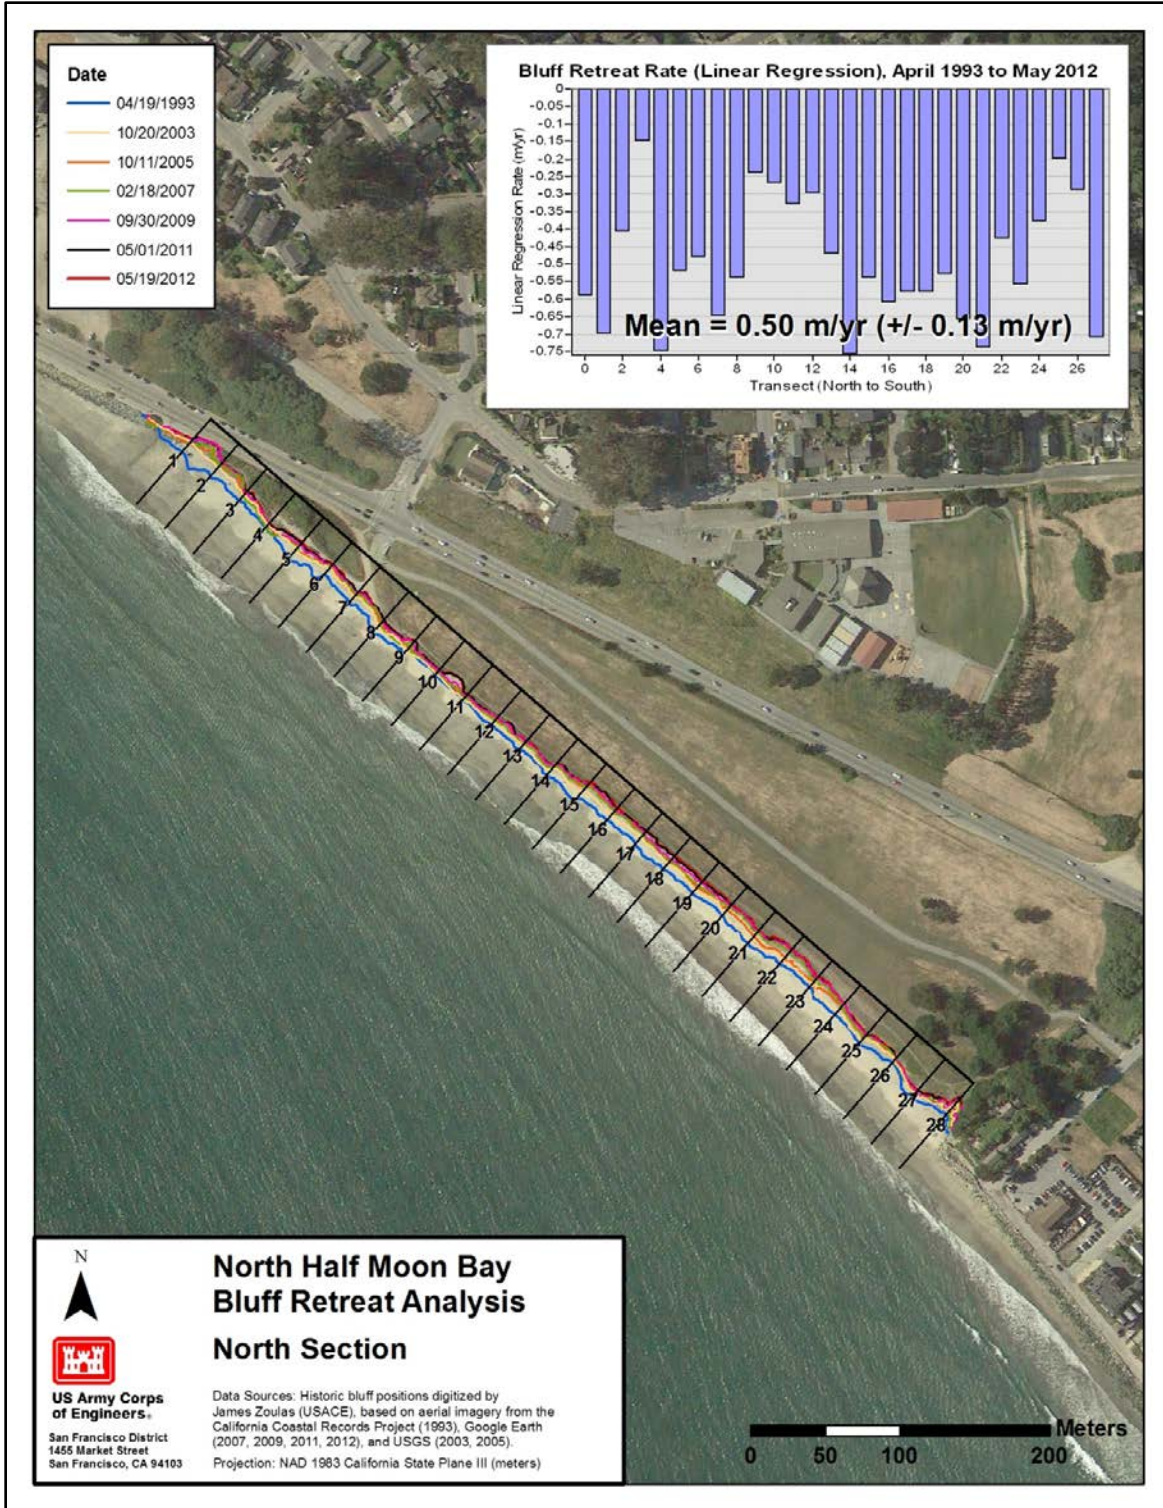
Figure 39. Bluff retreat rates along the section of shoreline between the Caltrans and Mirada Road revetments. Background imagery from Google Earth (2012)

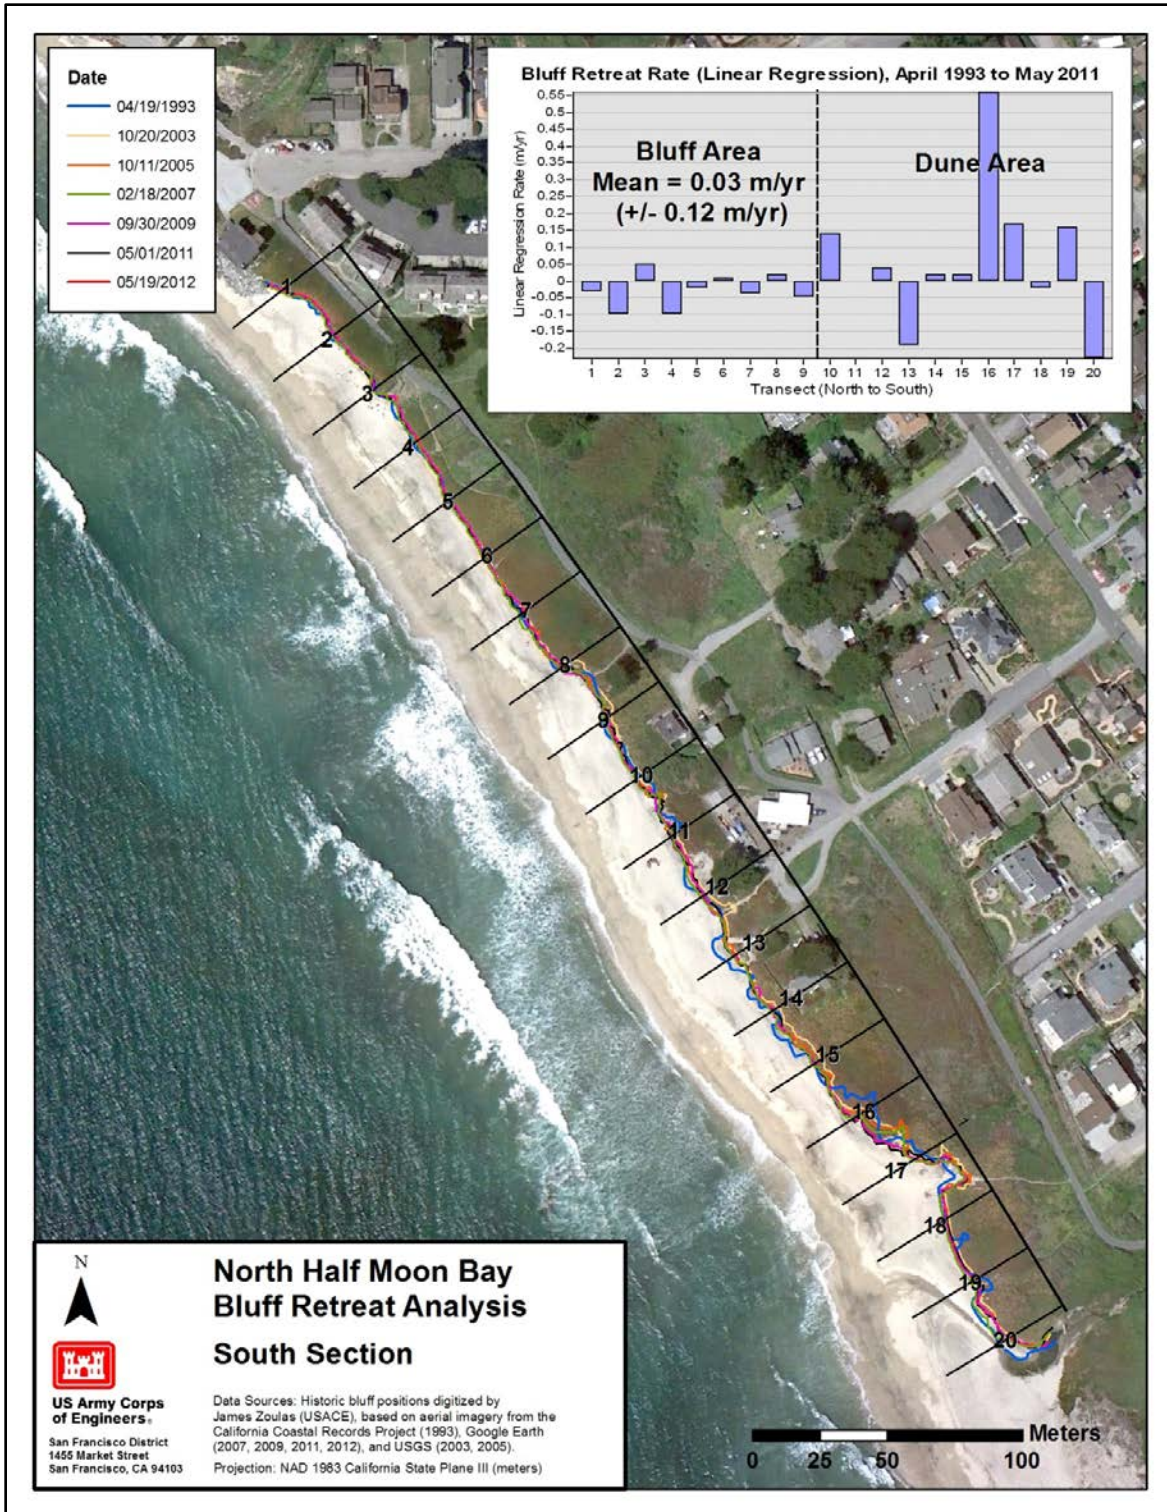
Figure 40. Bluff and dune retreat rates just south of the Mirada Road Revetment. Background imagery from Google Earth (2011)

There are several conclusions that can be drawn from the bluff erosion analysis. First, the current bluff retreat rates in three sections exhibit considerably variation (up to 1.64 ft/yr), with the bluff in the North section retreating at a significantly faster rate than the other two sections. Second, the difference between the North and Background bluff retreat rates is approximately 1.3 ft (0.4 m) per year. Thus, it can be inferred that the east breakwater is inducing up to an additional 1.3 ft/yr (0.4 m/yr) of bluff retreat in the North section. The effects of the east breakwater do not appear to extend south of the Mirada Road revetment, given the slow bluff retreat rate to the south of the revetment.

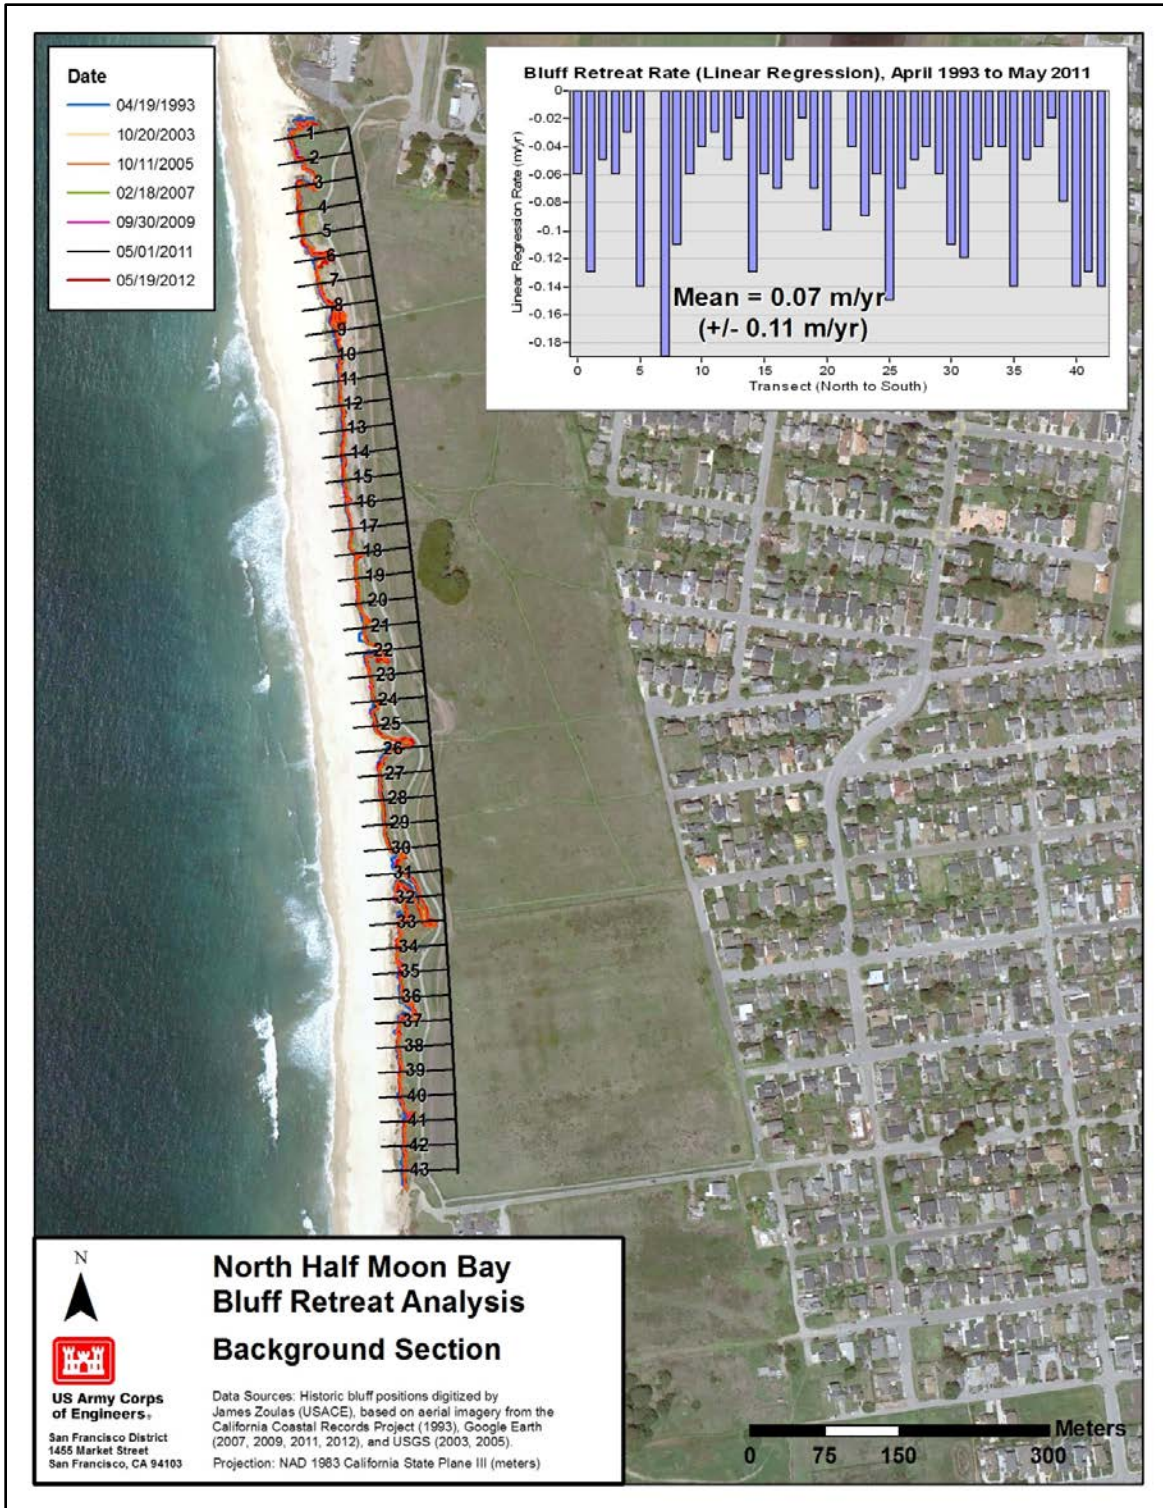
Figure 41. Bluff retreat rates along the section of shoreline used to determine the “natural” background erosion. Background imagery from Google Earth (2011)

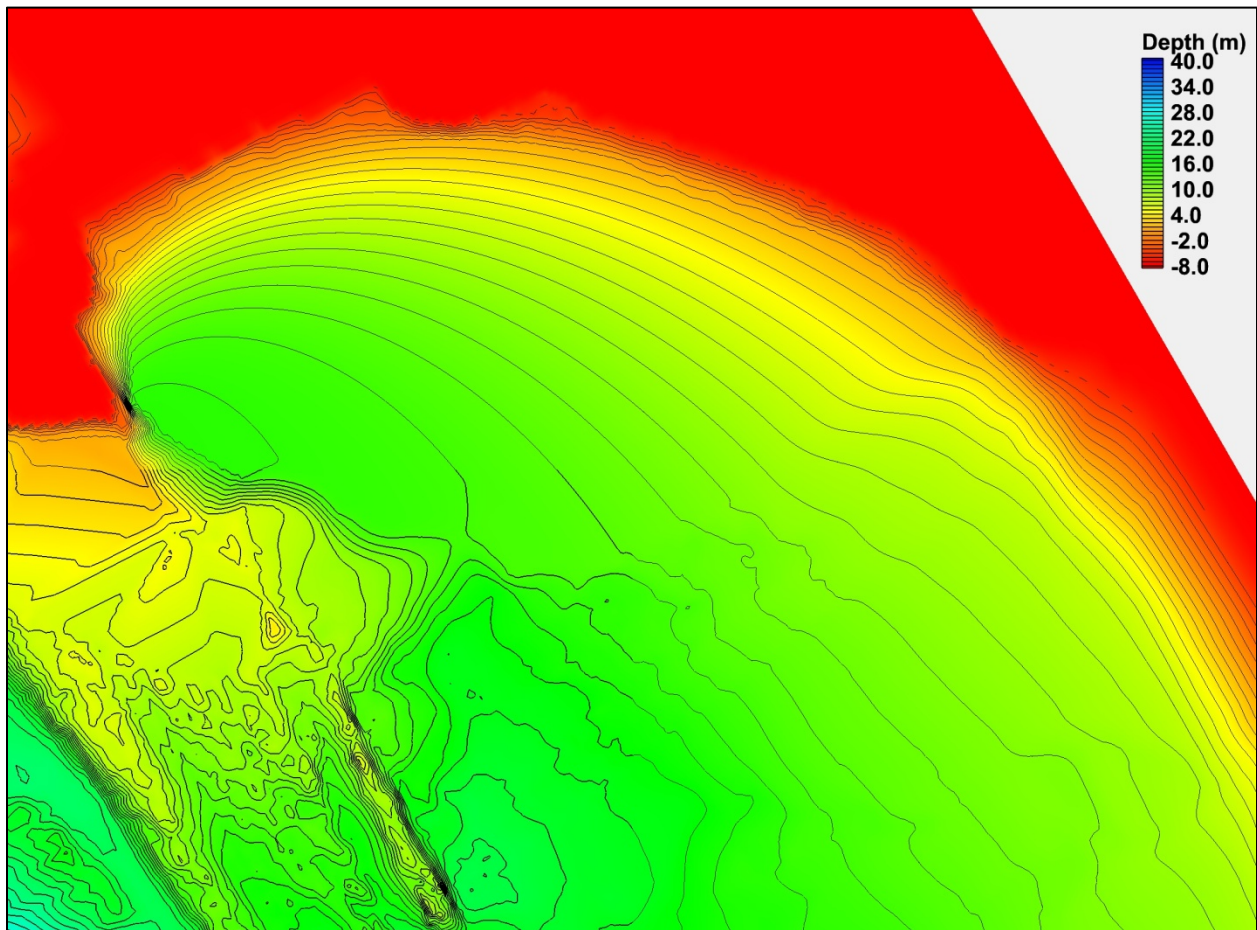
Figure 42. Bathymetric grid depicting pre-breakwater conditions

The pre-breakwater scenario was developed in order to gain a better understanding of physical conditions at the study site prior to construction of Pillar Point Harbor. The pre-harbor bathymetry was reconstructed as a logarithmic spiral beach with a concave shoreline from the up coast headland (Figure 42). This shoreline was exposed to both local seas and swell, which facilitated unimpeded longshore transport of sediment throughout the current location of the harbor. Thus, more significant changes in nearshore bathymetry are expected to occur under this scenario, given the open nature of this system when compared to the present (post-breakwater) scenario.

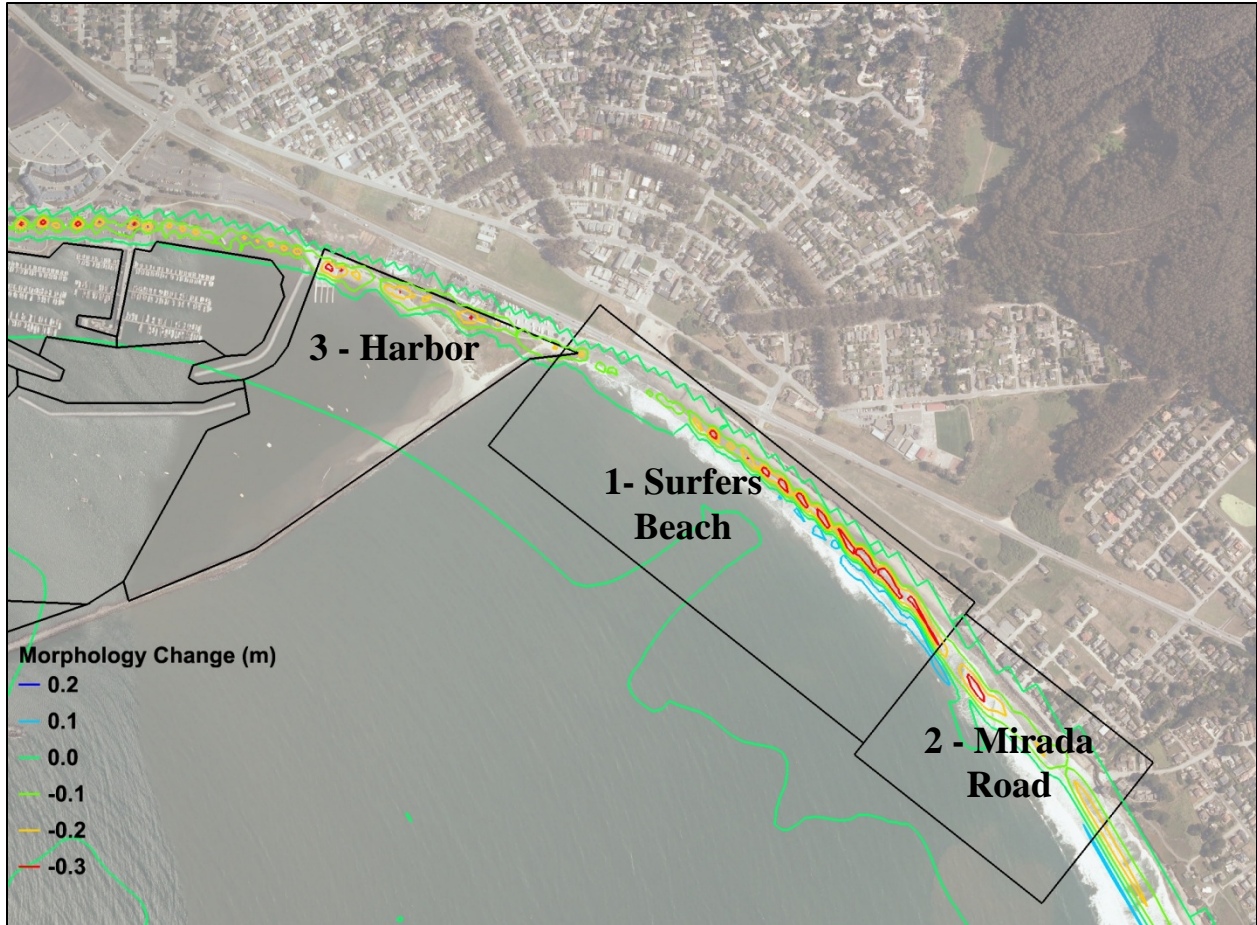
Figure 43. Erosion and accretion in vicinity of Surfer’s Beach from June 2009 to November 2009 (6 months). The boxes (1 through 3) outline the analyses areas

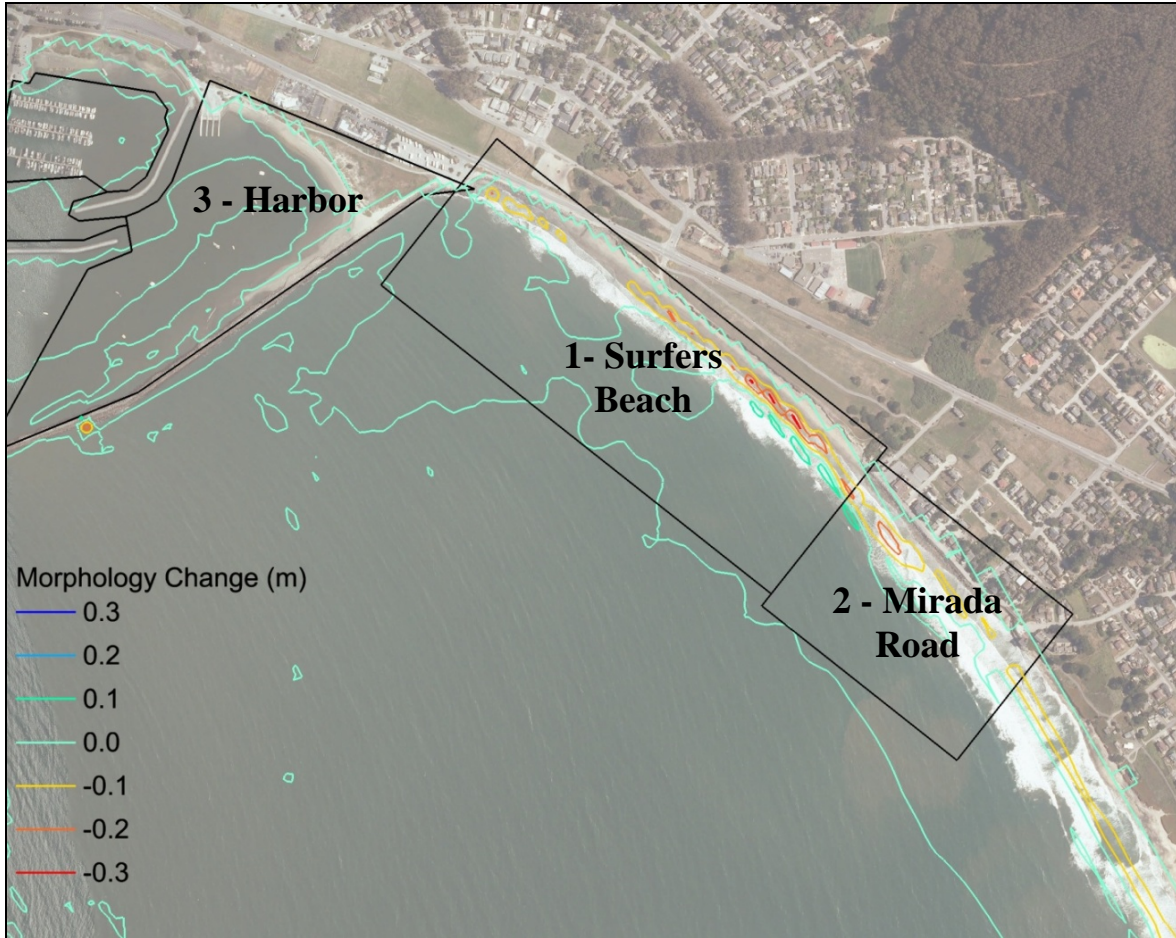
Figure 44. Calculated morphology change in the vicinity of Surfers Beach from June 2009 to November 2009 (6 months). The boxes (1 – 3) outline the analysis areas

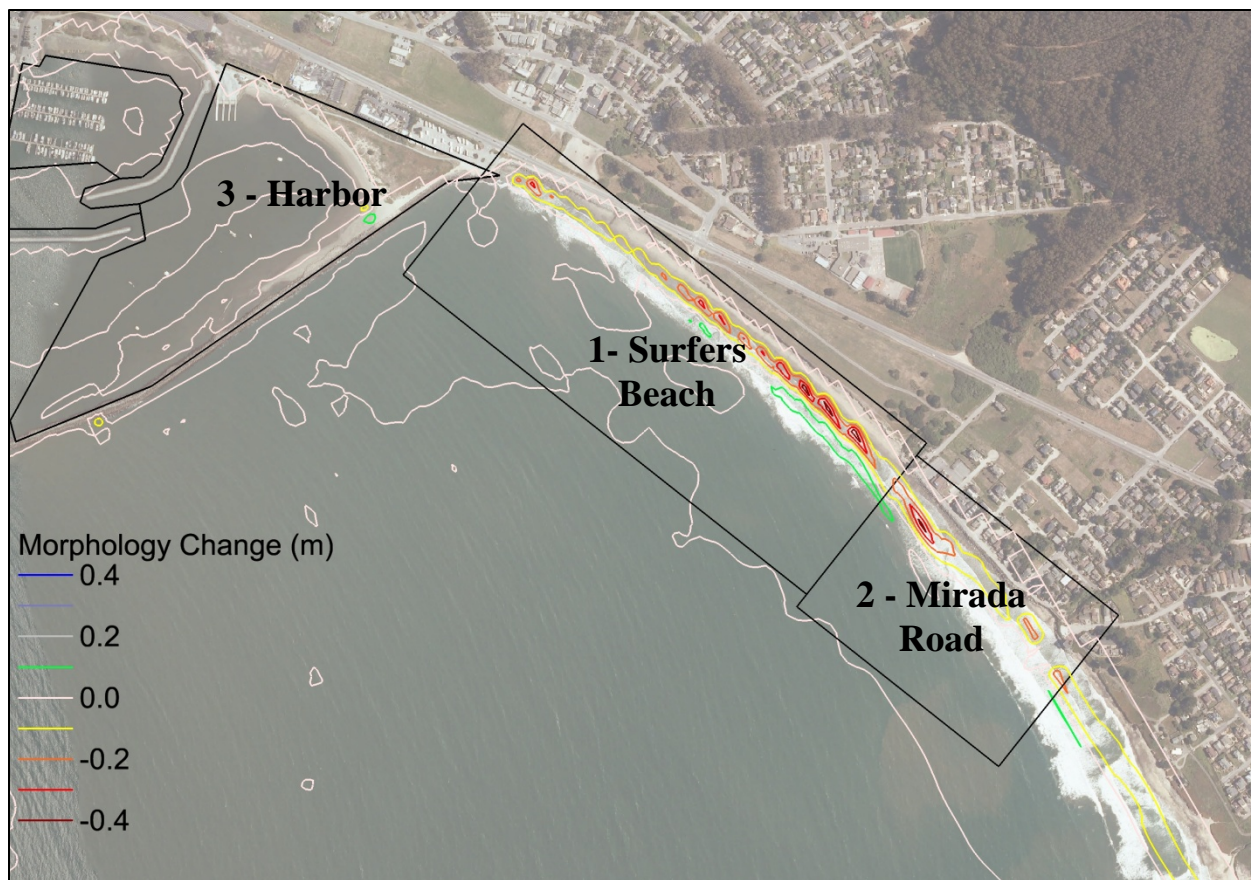
Figure 45. Calculated morphology change in the vicinity of Surfers Beach from June 2009 to November 2009 (6 months) based on a sea level rise of 0.71 ft (0.22 m) in 50 years (USACE Intermediate Rate). The boxes (1 – 3) outline the analysis areas

If sea level were to increase following the USACE Intermediate rate, the water surface would rise by 0.71 ft (0.22 m) in the study area over the course of 50 years. As a result, it is expected that rates of erosion of beach sands and adjacent bluffs would increase as the higher water levels exposed the upper beach and bluff toes to increased wave attack. This hypothesis is supported by the modeling results, which show a clear increase in erosion rates in the nearshore outside of the harbor (Figure 45; Table 22; Table 23).

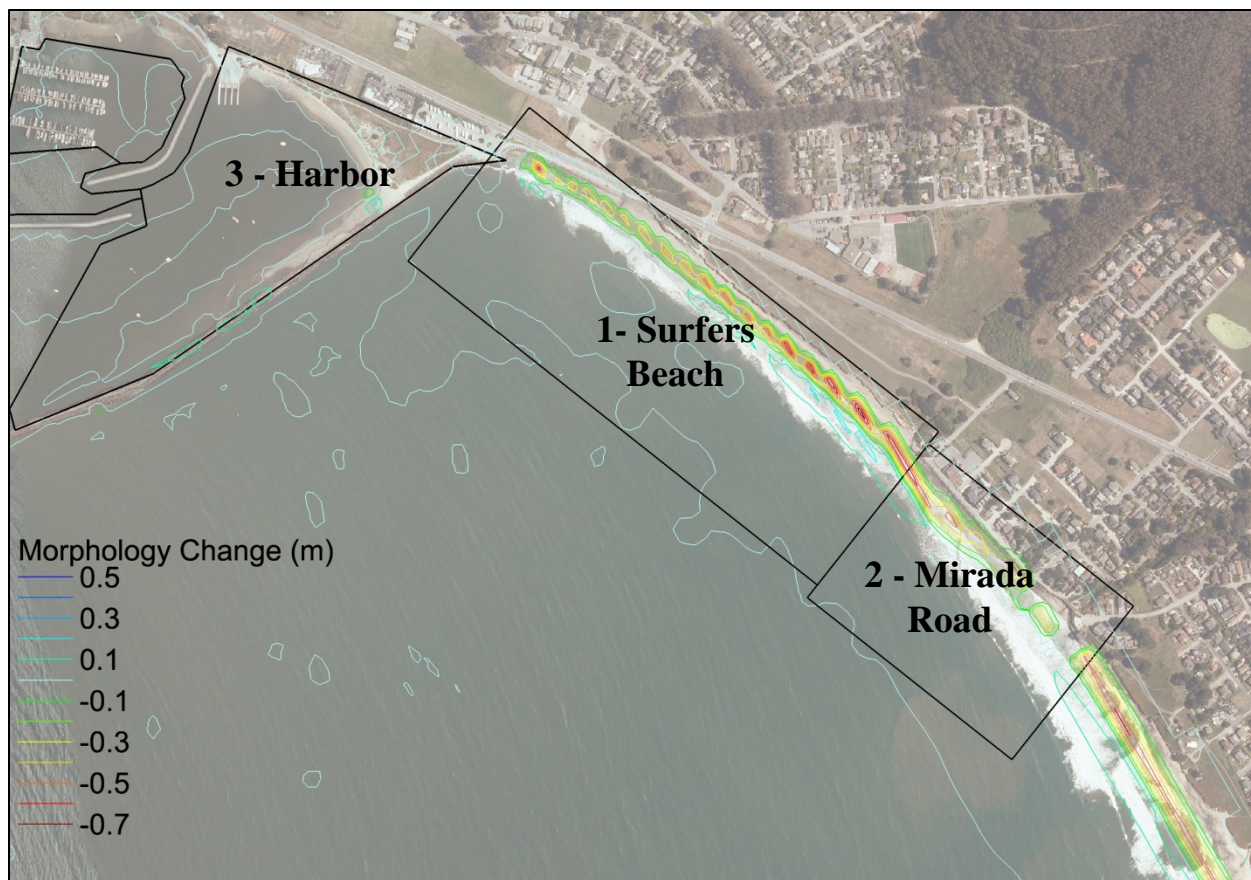
Figure 46. Calculated morphology change in the vicinity of Surfers Beach from June 2009 to November 2009 (6 months) based on a sea level rise of 2.06 ft (0.63 m) in 50 years (USACE “High” Rate). The boxes (1 – 3) outline the analysis areas

This scenario is based on the assumption that sea level will rise by 2.06 ft (0.63 m) at the end of 50 years. As anticipated, erosion rates increased in the nearshore areas outside of the harbor, with a significant increase in erosion compared to the Intermediate scenario (Figure 46, Table 25, and Table 26). There was also modest increase in accretion in the harbor, particularly in the summer and fall months (Table 27).

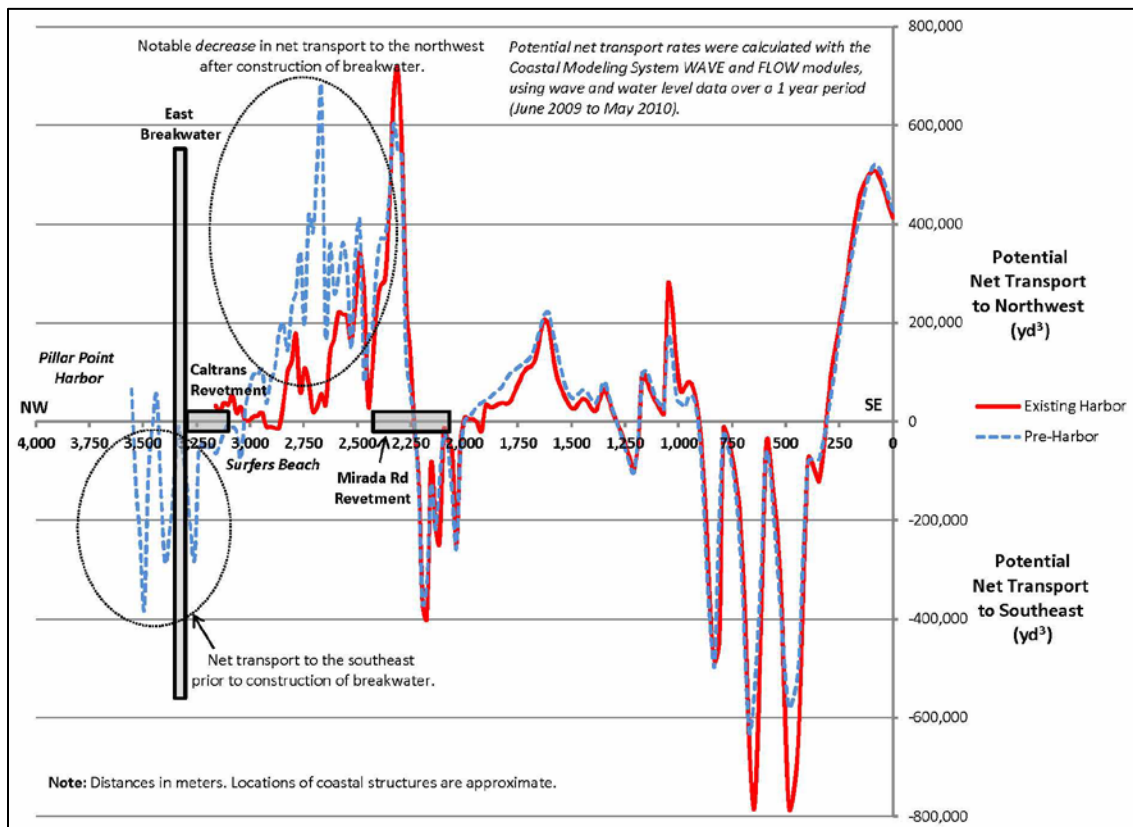
Figure 47. Potential net sediment transport based on Coastal Modeling System (CMS) simulations.

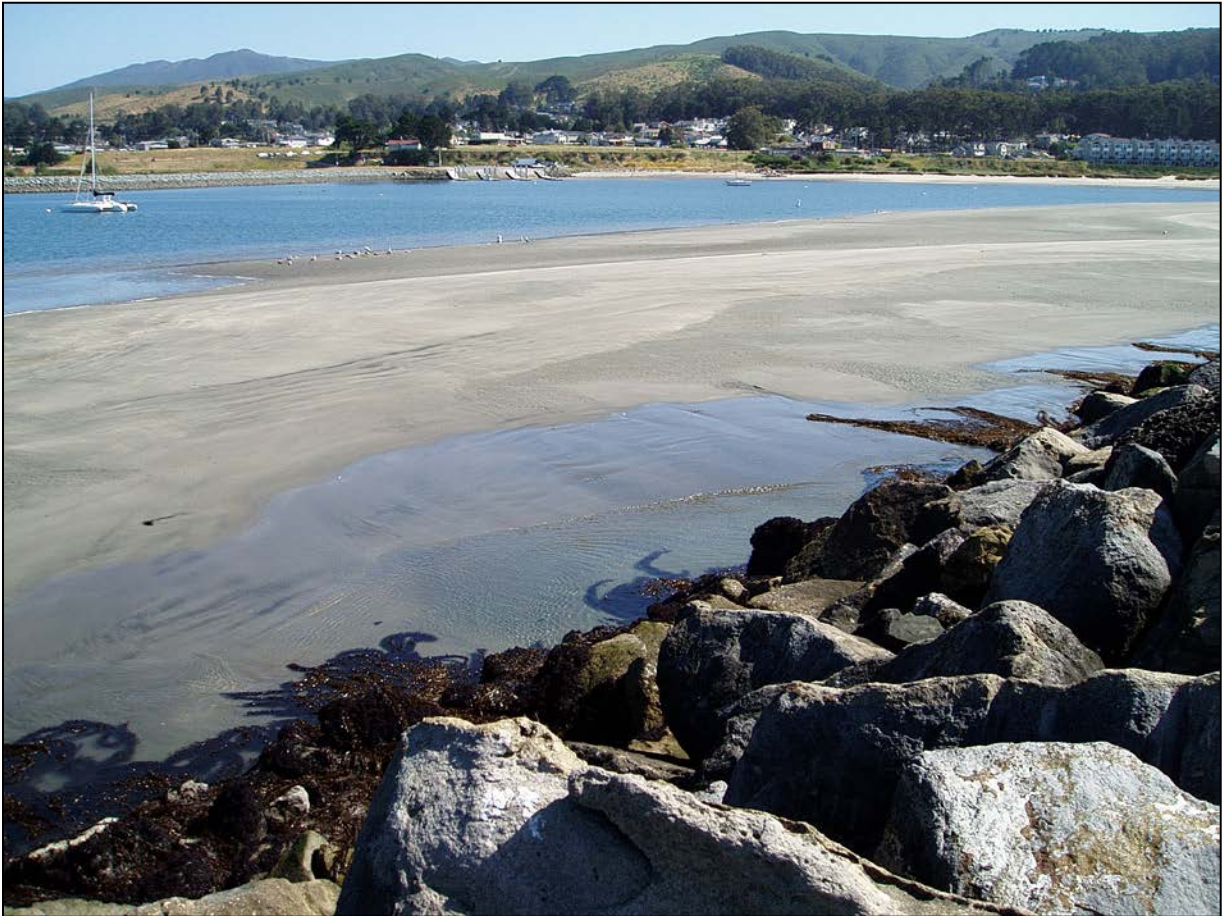
Figure 48. Photograph looking into Pillar Point Harbor showing surging of water through the east breakwater (Source: Craig Conner)

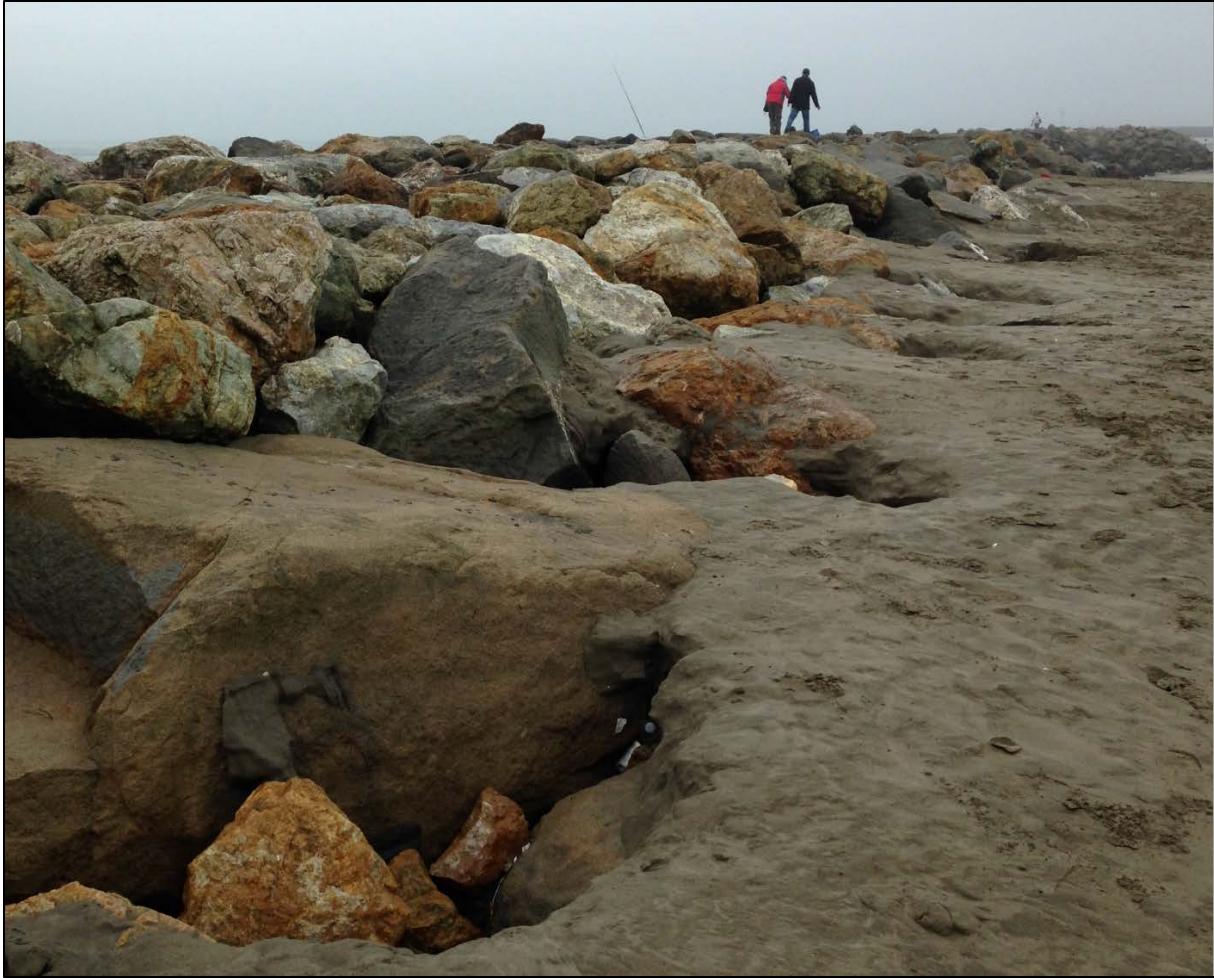
Figure 49. Photograph showing areas of scour due to surging along the harbor side of the east breakwater (Source: James Zoulas)
