North Half Moon Bay Shoreline Improvement Project, Pillar Point Harbor, CA Coastal Engineering Appendix

FINAL January 2015

Final Report

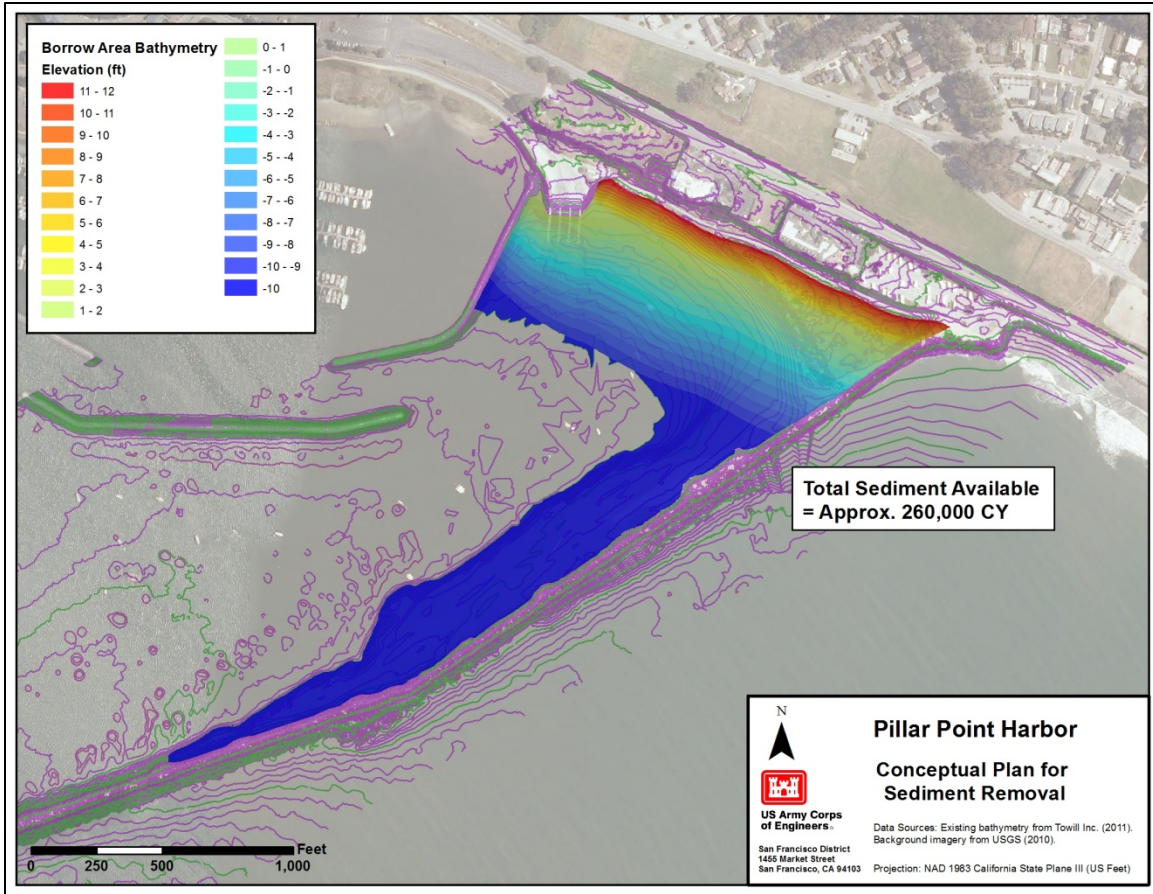
Figure 50. Conceptual plan for removing the maximum amount of available sediment from inside Pillar Point Harbor

This design measure was formulated under the assumption that virtually all of the sand that has accumulated inside of the east breakwater would be available for removal and placement on Surfer's Beach (Figure 50). Volumetric calculations performed with ArcGIS software indicated that approximately 260,000 yd³ of sand could be available if: (1) the shoal along the east breakwater were removed down to -10 ft (NAVD88), and (2) the beach extending from the boat launch ramp to the east breakwater was shifted shoreward with a slope starting 15 ft seaward of the existing pedestrian path. The cross-shore morphology of this beach would be based on existing surveyed beach profiles, in order to ensure a stable beach profile (Figure 51).

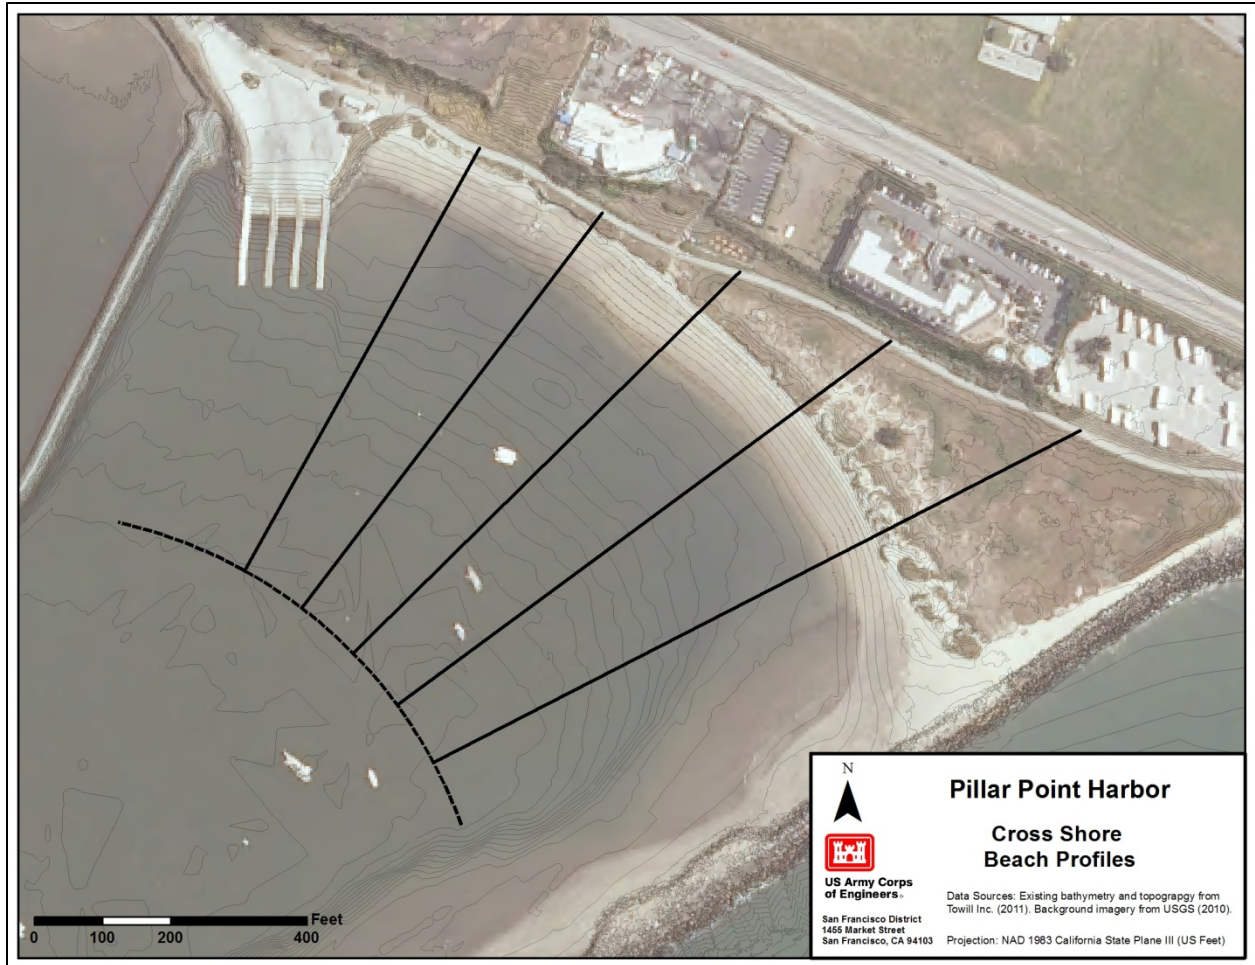
Figure 51. Locations of beach profiles utilized to determine morphology (slope) of proposed remaining beach after removal of sand

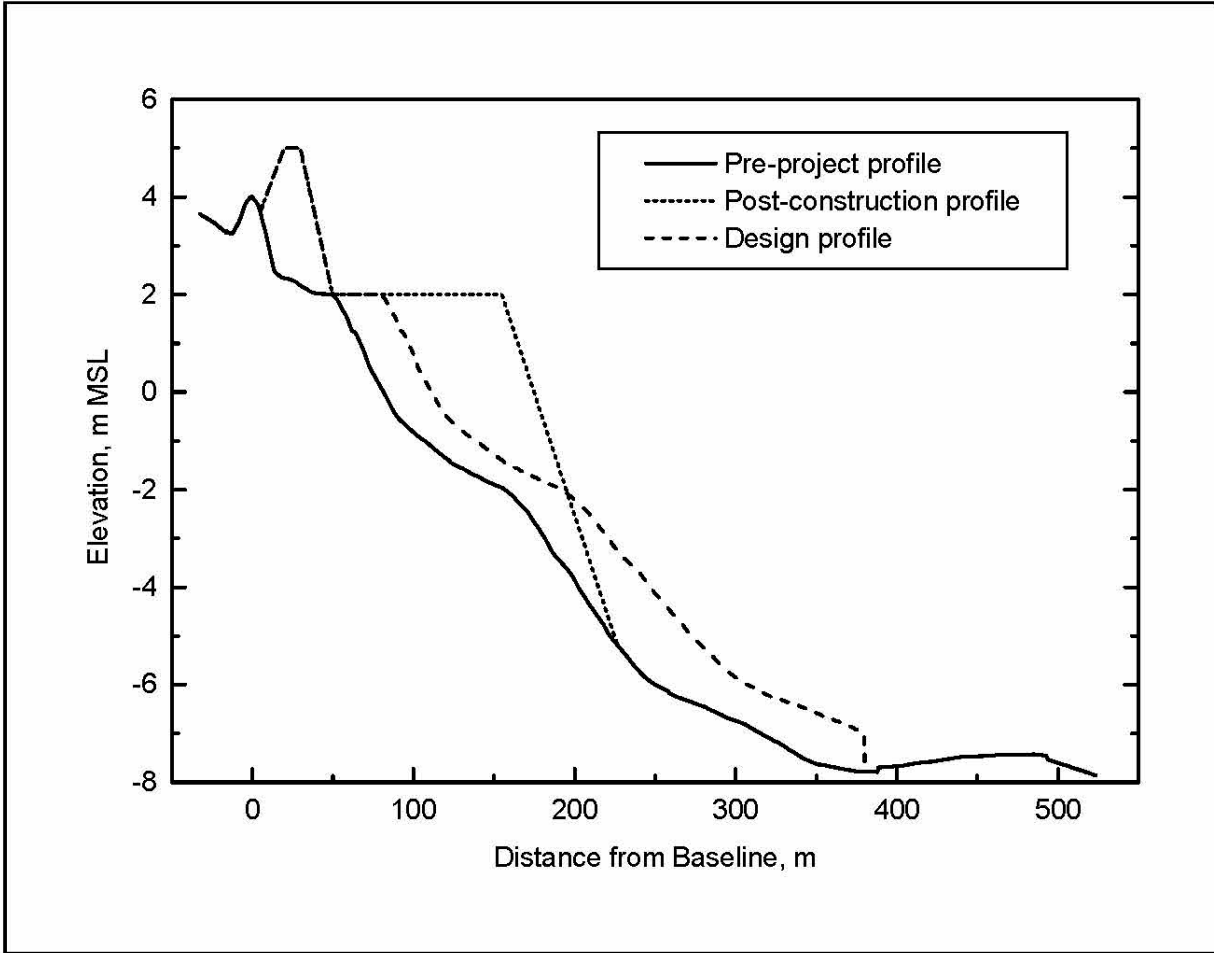
Figure 52. Schematic illustration of a typical pre-project, post-construction and design beach profiles from the CEM (USACE, 2002)

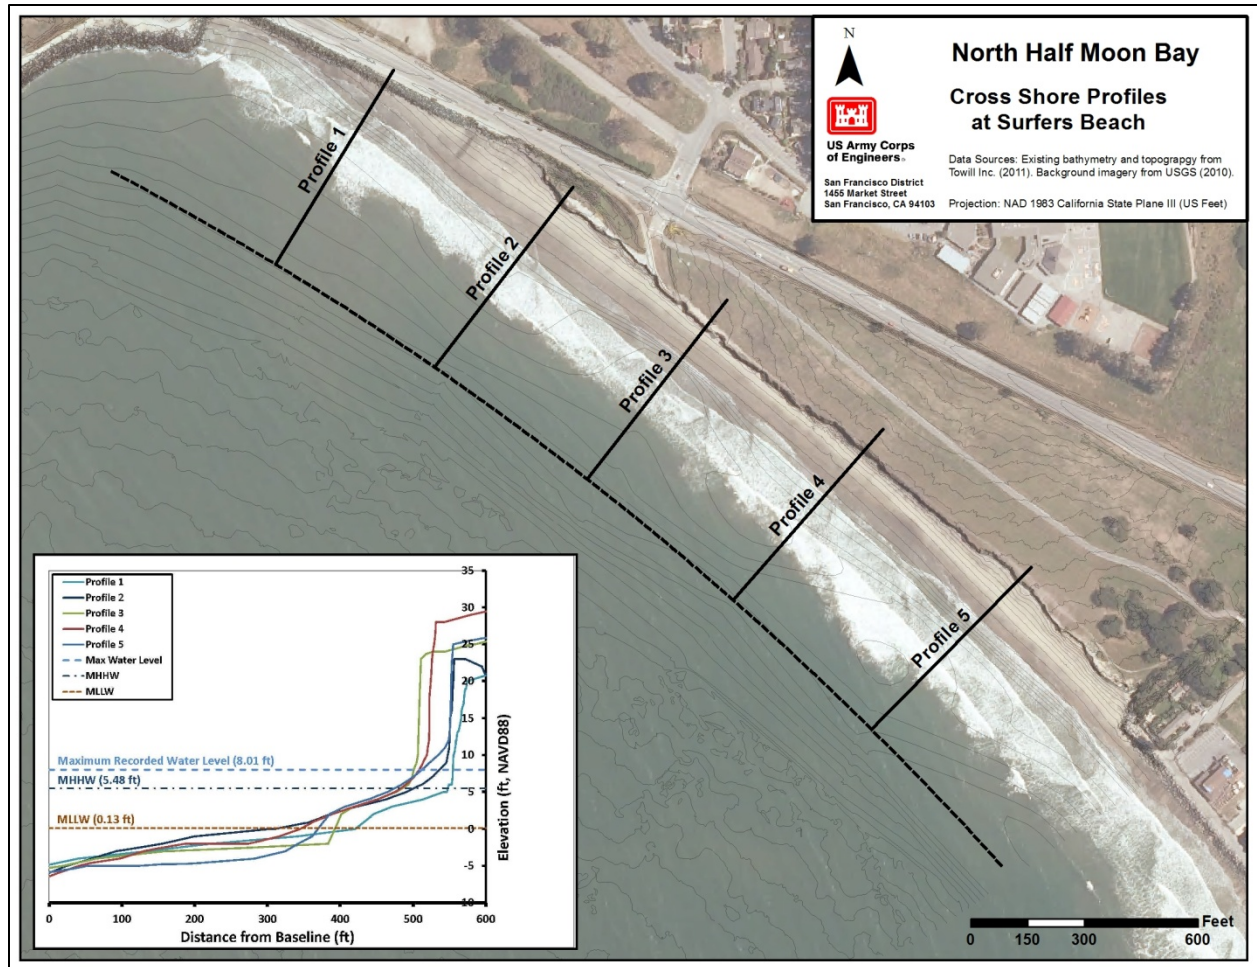
Figure 53. Existing beach profiles and water level datums utilized to formulate the maximum beach fill design measure

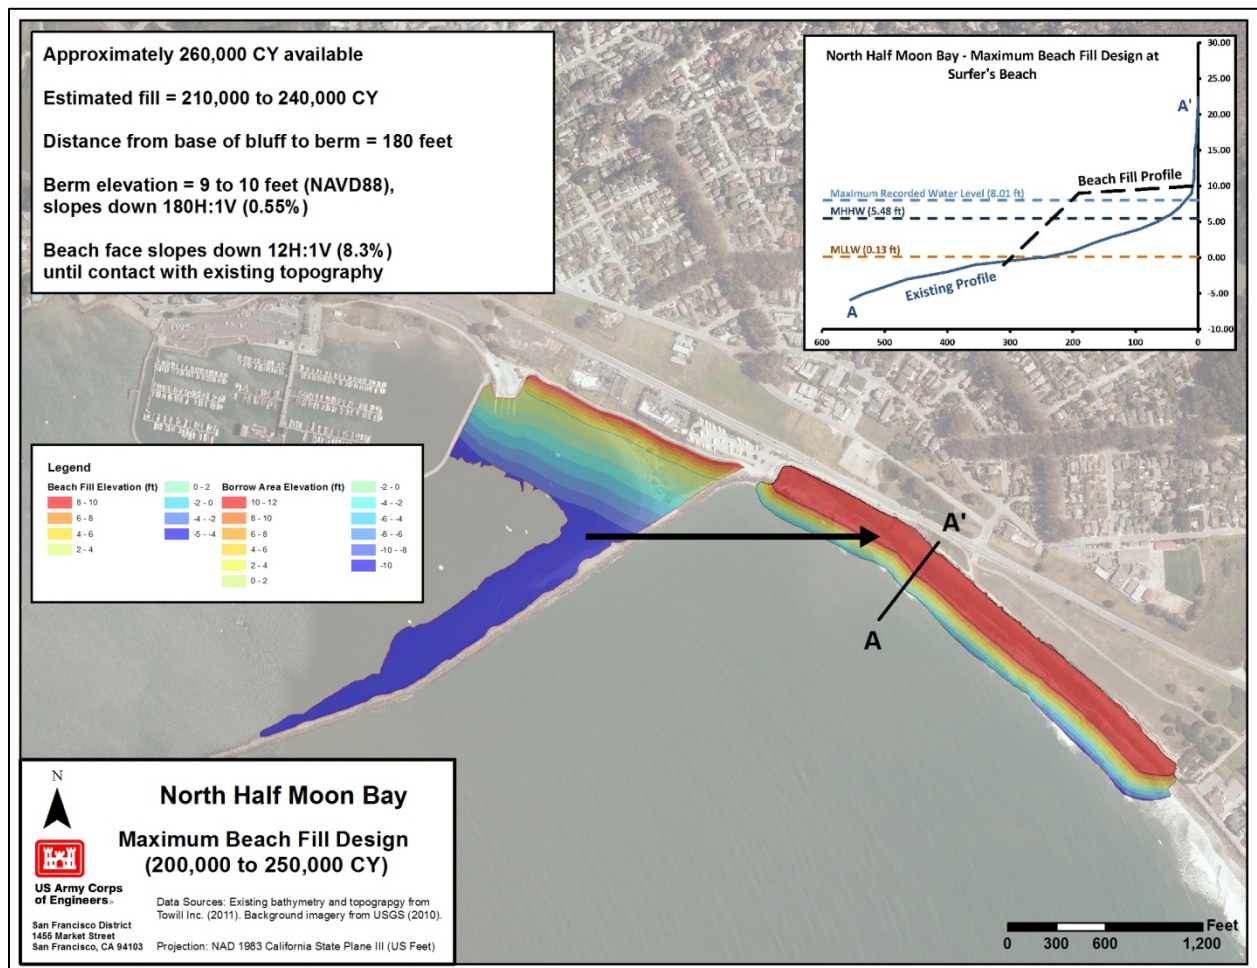
Figure 54. Schematic of maximum beach fill design scenario

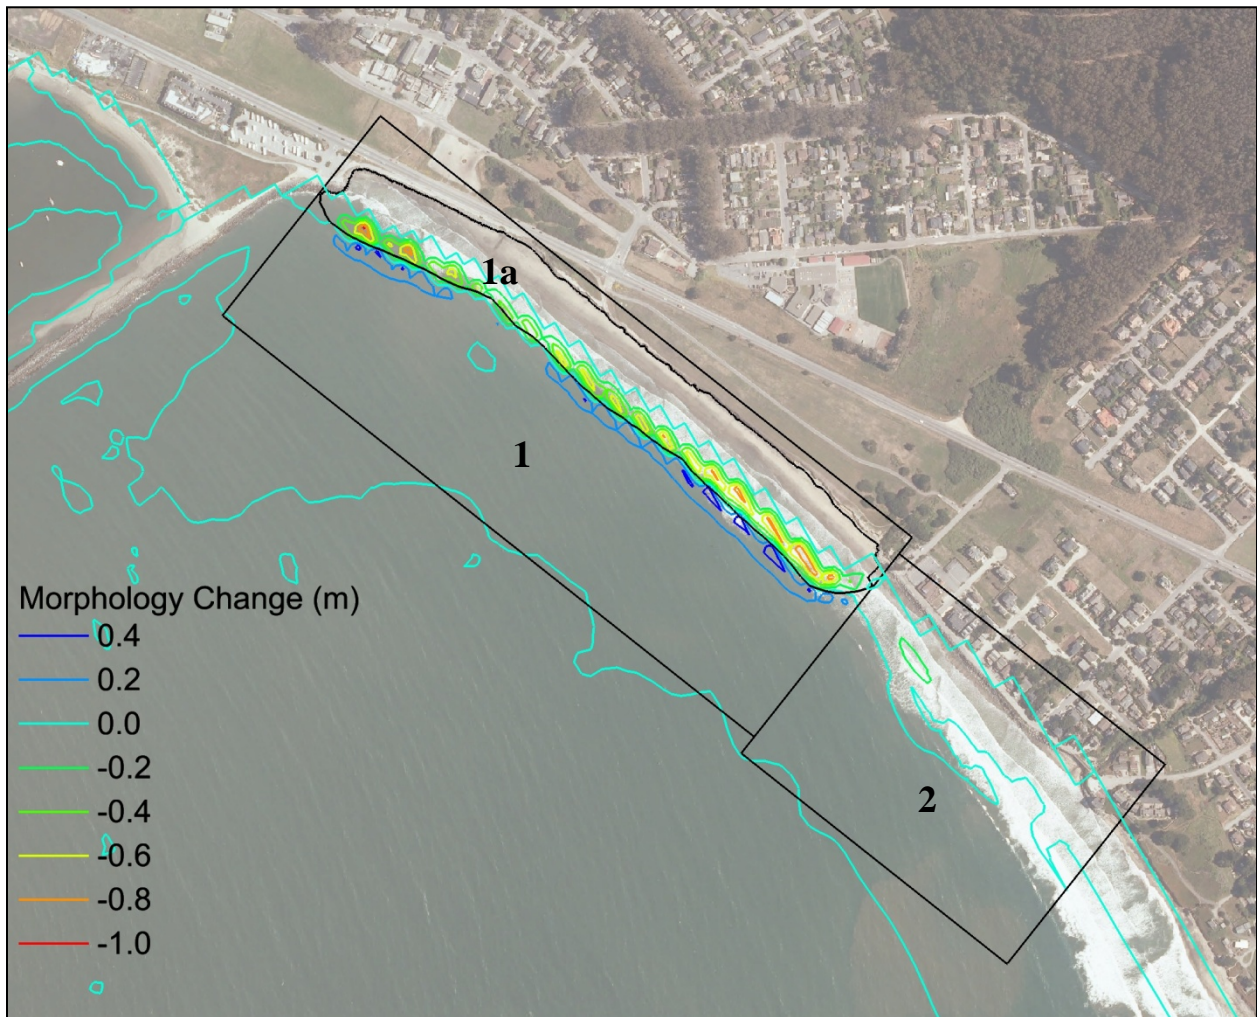
Figure 56. Erosion and accretion in vicinity of beach fill placement ($240,000 \text{ yd}^3$) from June to November 2009. The boxes outline the analyses areas

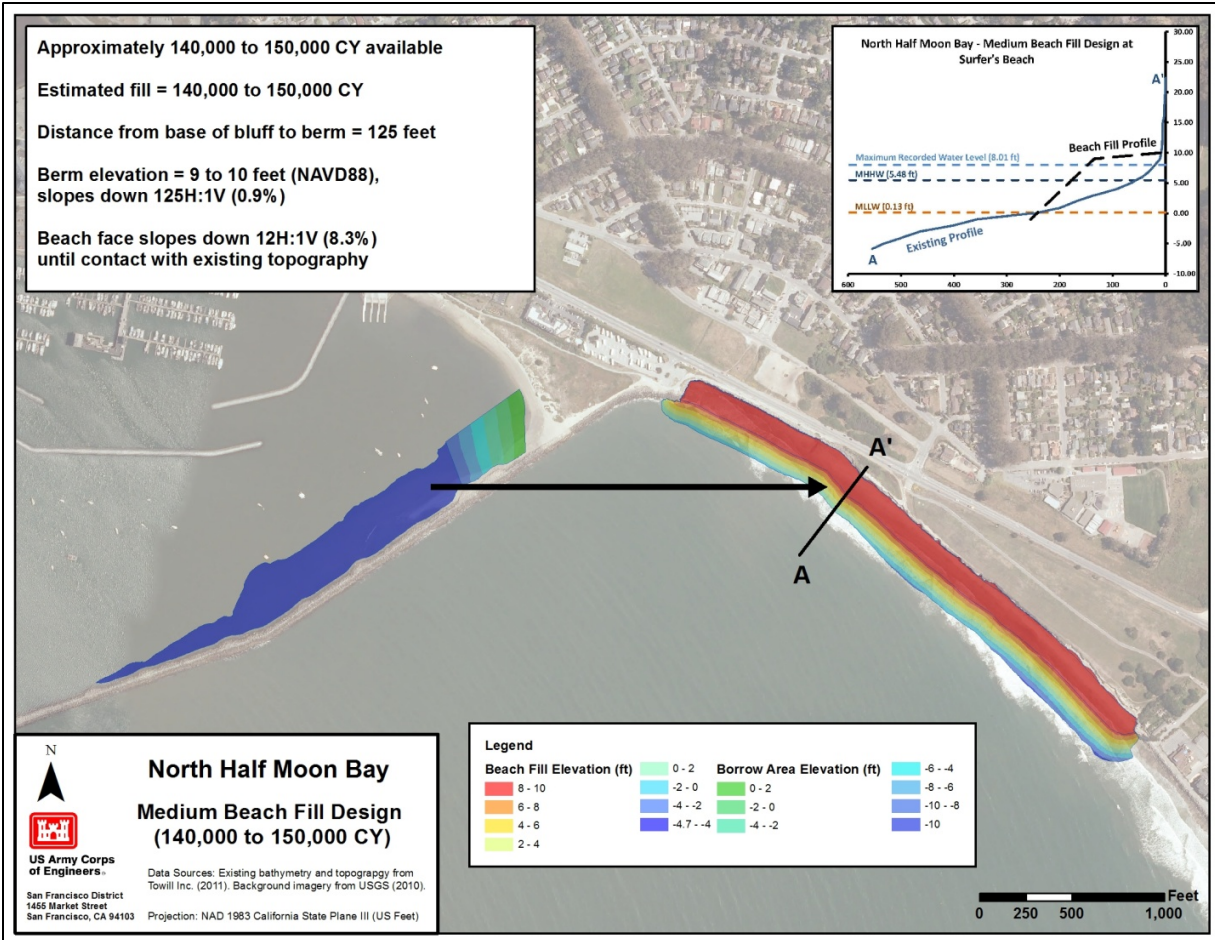
As in the case of Design Measure 1, this design measure would involve a one-time placement of sand on an approximately 3,100 foot long section of Surfer's Beach. However, this design measure was developed to represent a more modest sand removal effort from inside the harbor, due to potential environmental and recreational concerns associated with removing large sections of the vegetated sub-aerial beach. Thus, this design measure was formulated under the assumption that only the sand that had accumulated along the east breakwater can be used for placement on Surfer's Beach (Figure 57).

Volumetric computations indicated that the shoal along the east breakwater could yield approximately 140,000 to 150,000 yd³ of sand if the shoal area is dredged down to a depth (-10 ft, NAVD88) that approximately matches the surrounding bathymetry. As in the case of the maximum beach fill scenario, a target berm crest elevation of 9 ft was used, and iterative volume computations were carried out to determine the maximum berm width that could be constructed with 140,000 to 150,000 yd³ of sand. As a result, the medium beach fill design will include a 125 ft wide beach berm, with a beach face that will slope down at 12H:1V, until it contacts the existing nearshore bathymetry.

Figure 57. GIS schematic of medium beach fill design scenario including a borrow area along the east breakwater

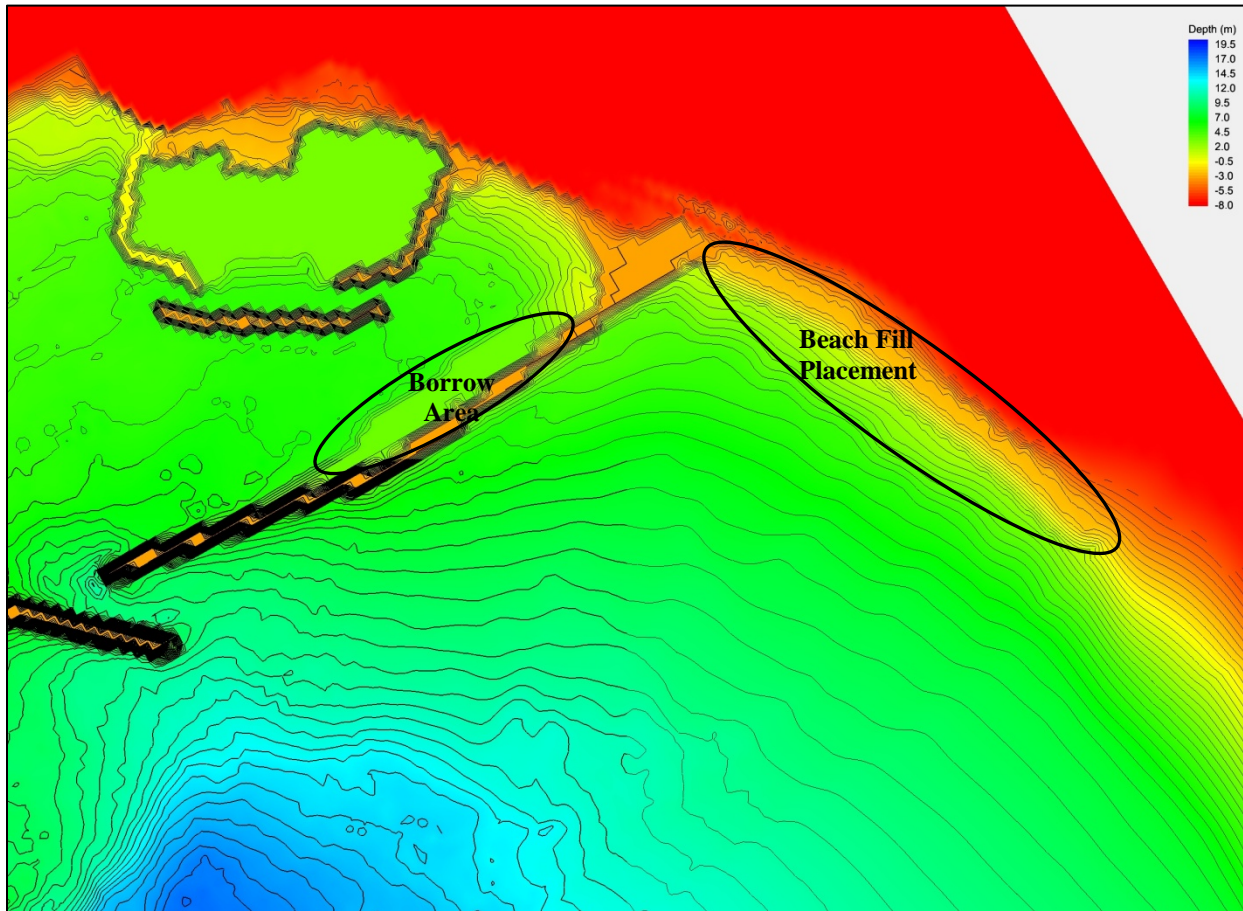
As in the case of Design Measure 1, the performance of the medium beach fill scenario was simulated over the course of 1 year with the CMS modeling suite. However, this modeling simulation also included changes to the proposed borrow area, in order to evaluate if and at what rate sand might accumulate in the newly dredged shoal area (Figure 58).

It should be noted that SMS (Data Calculator tool) indicated that this beach fill design would require 147,000 yd³. This is quite close to value (144,000 yd³) calculated in GIS. However, the volume calculations for the borrow area were quite different in GIS (144,000 yd³) and SMS (89,000 yd³). This difference is likely due to the relatively coarse representation of the shoal and adjacent features (e.g., east breakwater) in SMS. In any case, this model run simulated the impact of removing the shoal down to -10 ft or -3.048 m (NAVD88), as the GIS computations (which utilized higher resolution bathymetry) indicated that dredging to this depth will yield 144,000 yd³.

Figure 58. Depth grid used to simulate medium beach fill design (140,000 to 150,000 yd³) scenario. Note that this scenario includes a borrow area from the shoal adjacent to the east breakwater

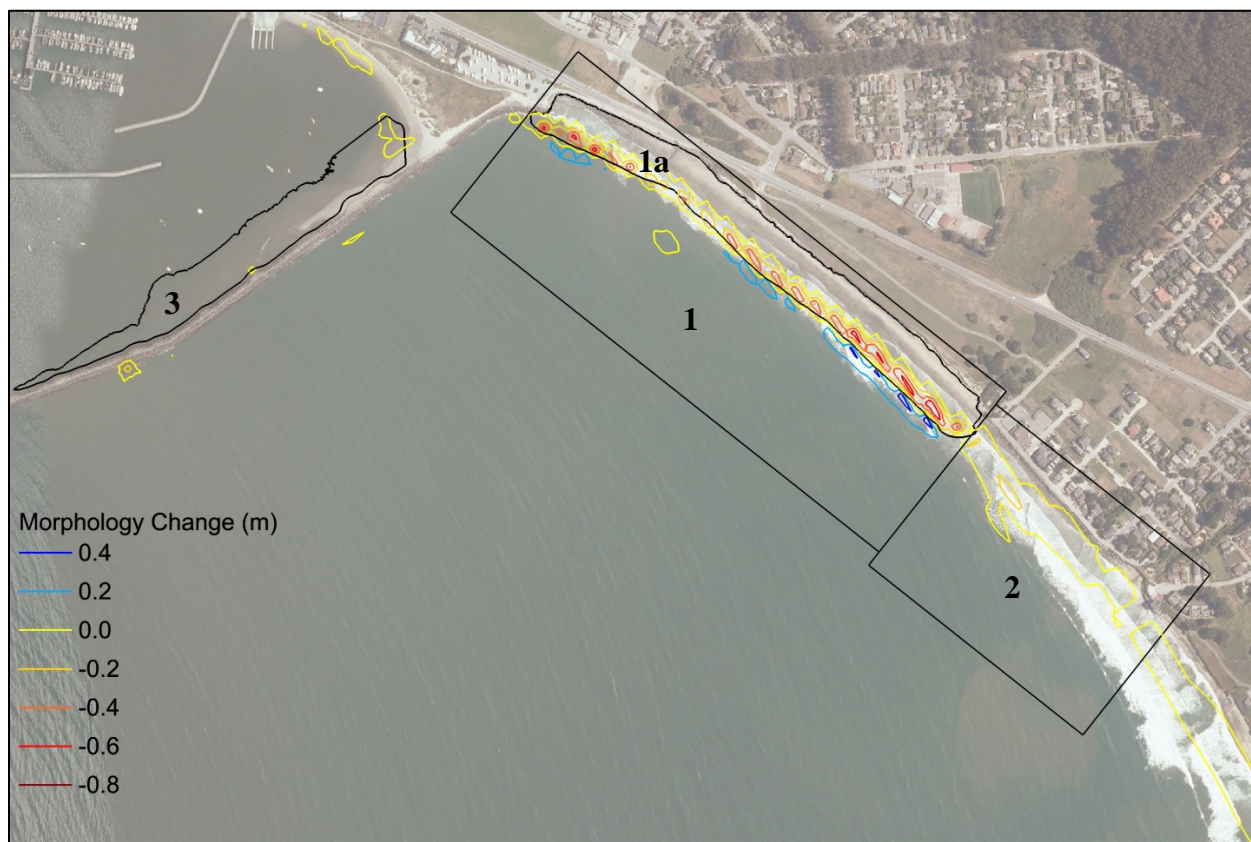
The results from the medium beach fill design modeling effort were fairly similar to the results from Design Measure 1 (Figure 59, Table 31, Table 32, Table 33, Table 34). As in the case of the Design Measure 1 simulation, there was net erosion in the vicinity of the fill placement area (box 2) and in front of the Mirada Road revetment (box 3). The net erosion quantity in the fill placement area (box 2) was slightly smaller (+900 yd³) than in the Design Measure 1 simulation, and there was slightly more net erosion (-500 yd³) near the Mirada Road revetment (box 3).

hydrodynamic conditions, so the expected lifespan of the visible placement is likely longer than 6 years. In addition, the total residence time of the placed sand in the project area could be on the order of 30 to 40 years, given the net erosion rate of 4,000 yd³/yr in the vicinity of the beach fill placement (box 2).

In terms of the borrow area (box 4), there was little change with only modest erosion of approximately 300 yd³. This result suggests that sand will not necessarily immediately accumulate in the borrow area under the hydrodynamic conditions simulated by this model run. However, the period of time simulated by this model run did not include extreme wave conditions (often associated with El Niño events), which are thought to be responsible for transporting sand through and over the east breakwater into the shoaling area (USACE, 1996).

Figure 59. Erosion and accretion in vicinity of beach fill placement (140,000 to 150,000 yd³) and borrow areas from June 2009 to November 2009 (6 months). Boxes outline the analyses areas

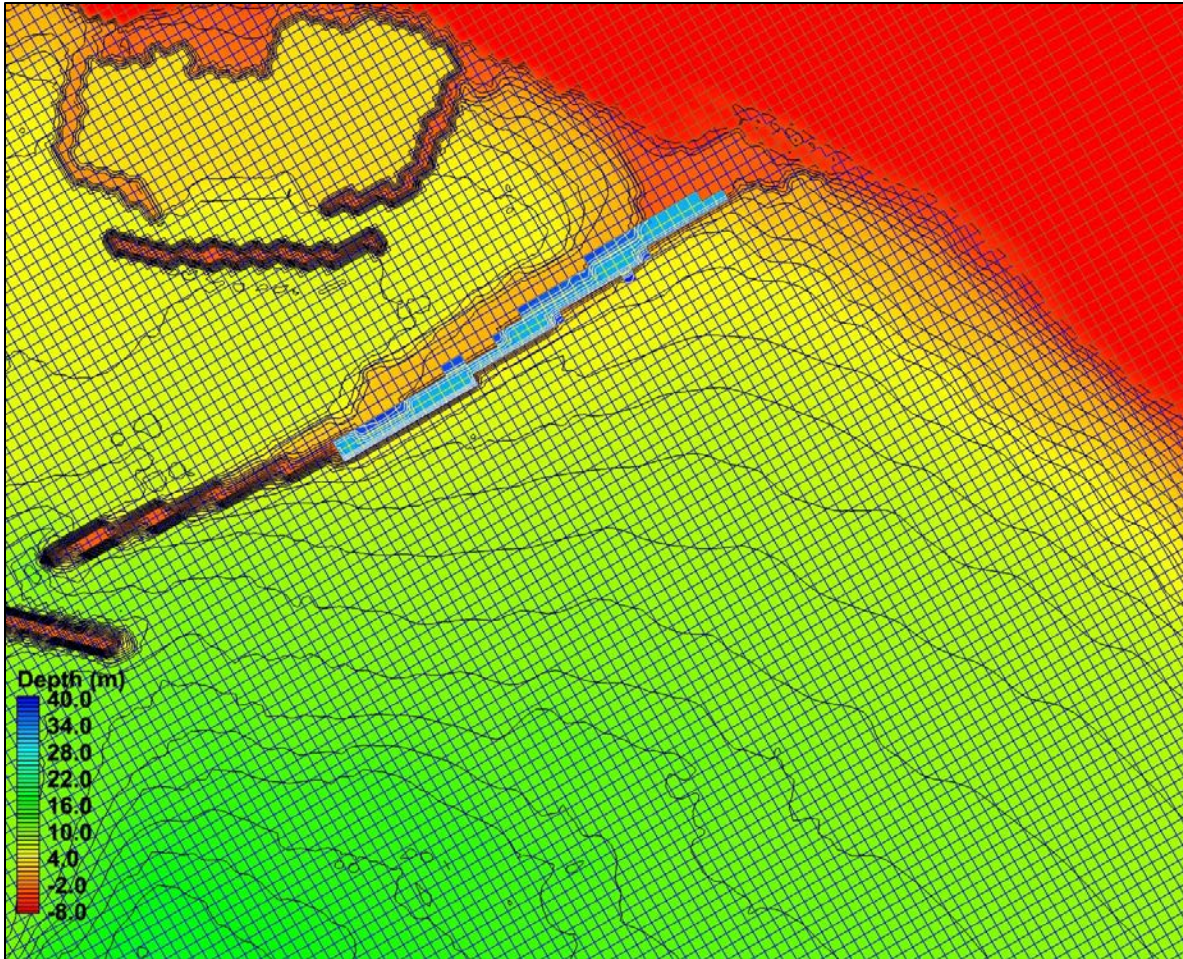
As in the case of Design Measures 1 and 2, the performance of sealing a section of the east breakwater was simulated over the course of 1 year with the CMS modeling suite. It should be noted that the original CMS-Wave and Flow files specified the breakwater cells as part of a “permeable” structure, based on an analysis of site conditions depicted by aerial imagery (Lin, personal communication, 2013). Thus, the CMS-Wave and Flow bathymetry grids and associated files were then altered to make a section of the breakwater “impermeable” to sediment transport.

Figure 60. Modified grid with "impermeable" cells highlighted in blue

The proposed modification would involve sealing a larger 2,500 ft section of the east breakwater, under the assumption that surging poses a potential problem from near the root of the breakwater (station 10+00) to the bend at approximately station 35+00 (Figure 60). Cost estimates from the 1978 repair of the east breakwater indicated that placing approximately 600 yd³ of concrete to seal holes along a 1,600 foot section would cost \$346,000 (2014 dollars) not including include mobilization/demobilization (USACE, 1978). Given the uncertainty regarding the quantity of concrete needed to seal the breakwater, it is assumed that the cost will likely be in the range of \$400,000 to \$600,000.

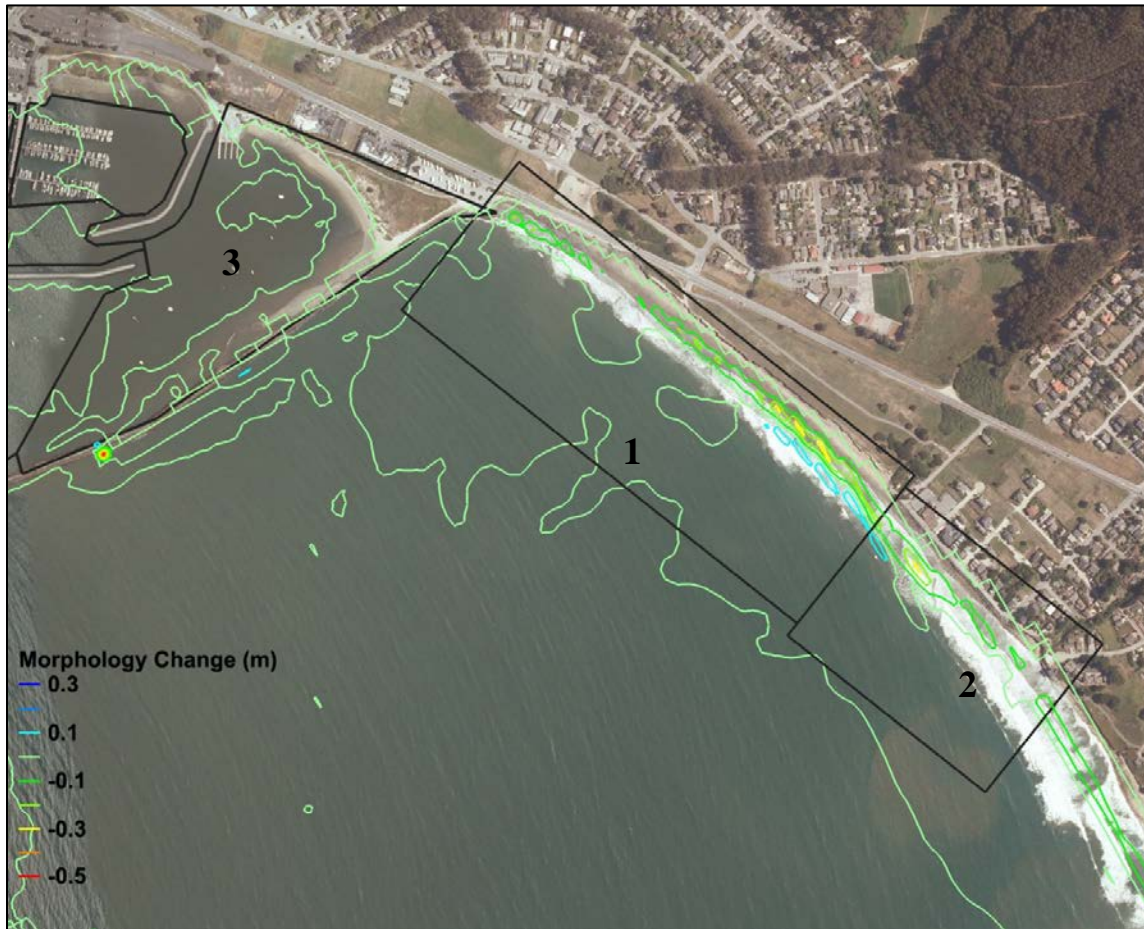
Figure 61. Erosion and accretion from June 2009 to November 2009 (6 months). The boxes outline the analyses areas

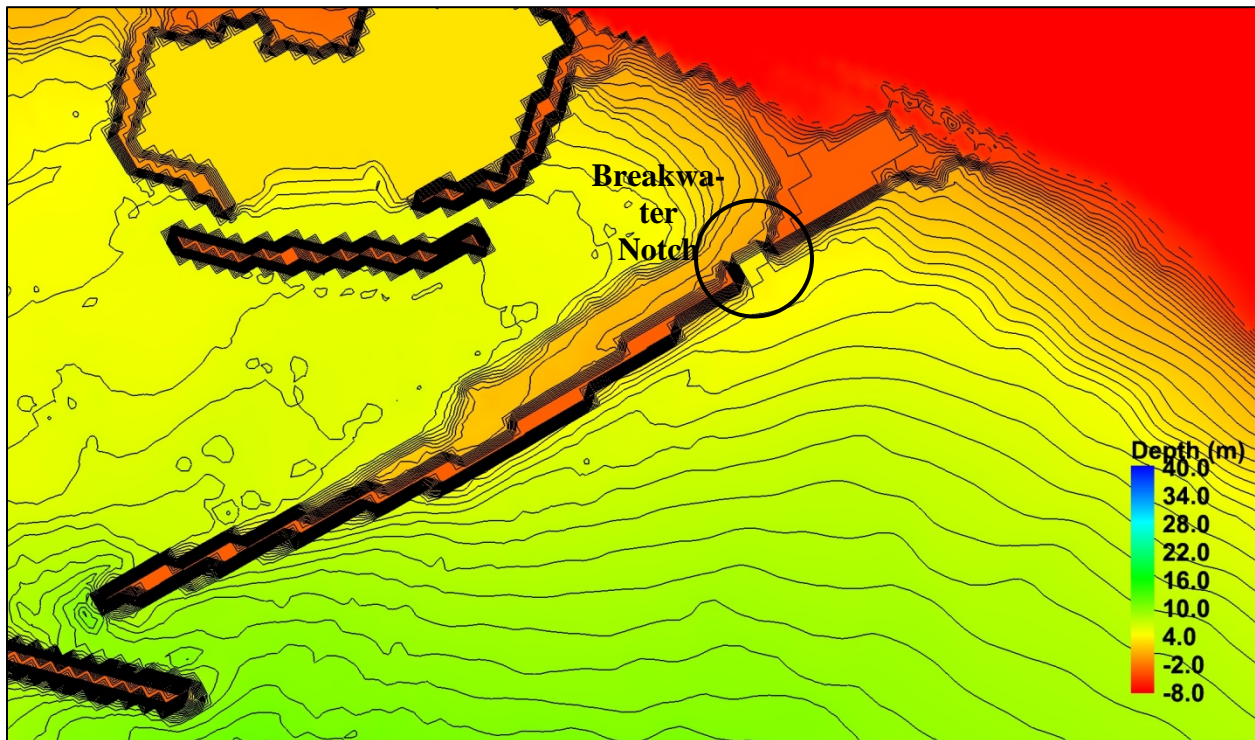
This design measure would involve removing a short (~200 foot long) section of the east breakwater from approximately station 18+00 to 20+00 (Figure 62). This opening in the east breakwater would then allow currents (longshore and tidal) to move sand from the harbor to just offshore of Surfers Beach, where the sand would presumably provide some degree of protection to the beach and bluff toe. This design measure was previously briefly evaluated in the USACE Initial Appraisal (USACE, 2009), and comments during the public meeting on 8 Nov 2013 indicated that there is some local stakeholder support for this measure.

Figure 62. Bathymetric grid depicting the ~ 200 foot notch in the east breakwater

Cost estimates from the east breakwater Repair Design Documentation Report indicate that removing 170 linear ft of the breakwater would cost \$230,000 with an additional \$39,000 for mobilization/demobilization (USACE, 2006). This would translate into a cost of approximately \$1,600 per linear foot of section removed, which could range from \$240,000 to \$320,000 if 150 ft and 200 ft are removed, respectively. Thus, this measure would be significantly less expensive than the beach fill design measures.

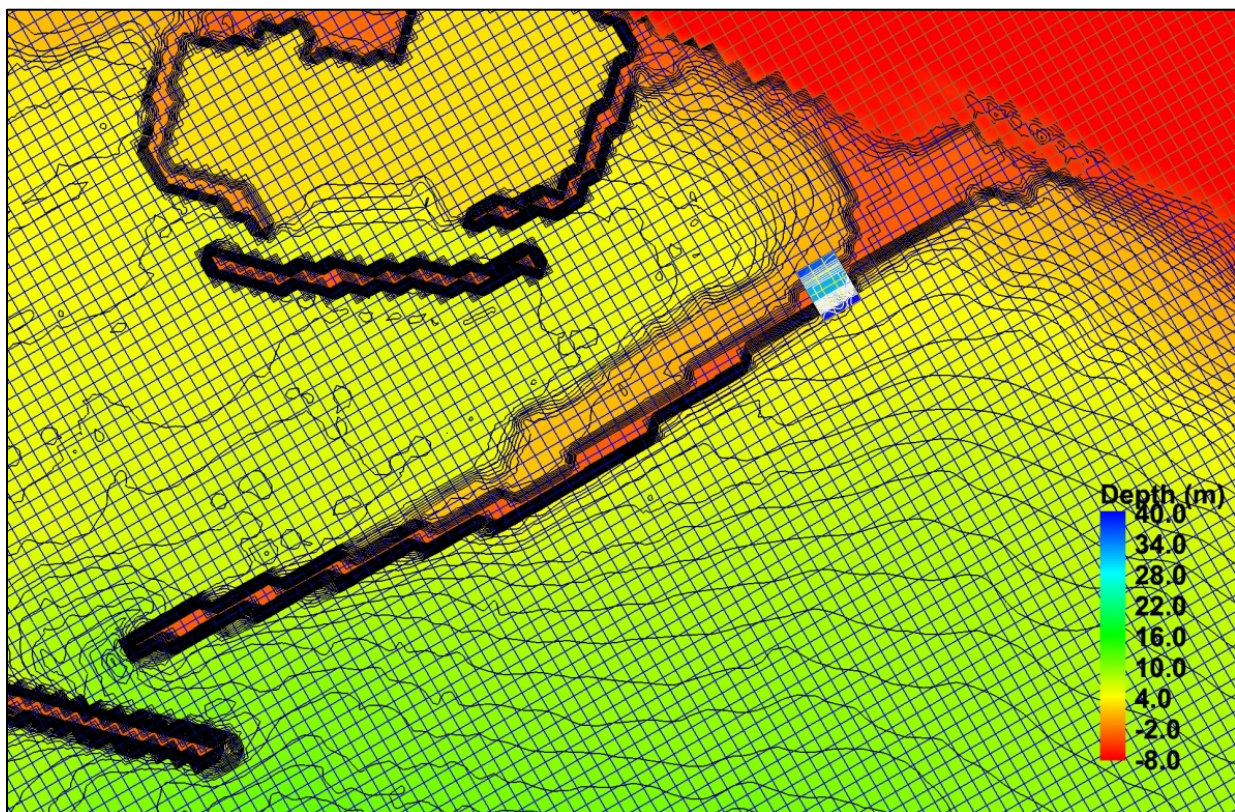
As in the case of Design Measures 1 through 3, the performance of a 200 foot long notch in the east breakwater was simulated over the course of 1 year with the CMS modeling suite. This was accomplished by altering the bathymetric Wave and Flow grids to include a notch with a depth that matched the bathymetry on the ocean side of the breakwater (Figure 63). In addition, the relevant lines were removed from the associated advanced cards and structure files.

Figure 63. Bathymetric cells that were altered to depict a breakwater notch (cells highlighted in blue)

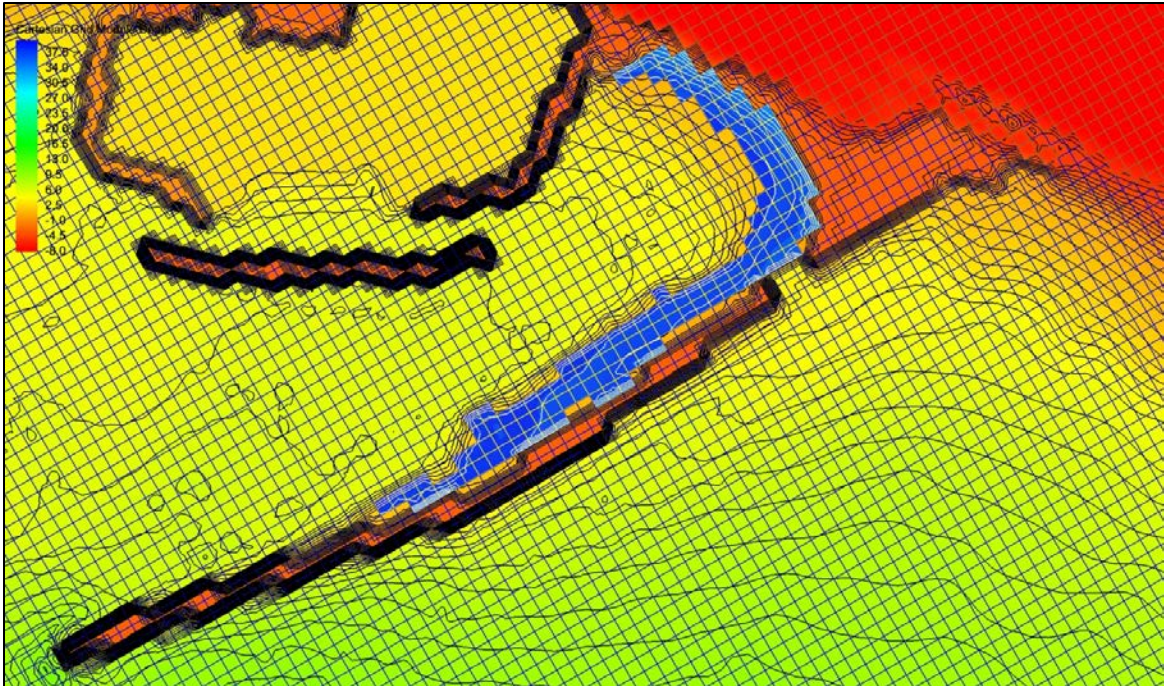
The cells depicting the shoal along the inside of the east breakwater were specified as “limited erodible” with a limit of 10 ft (~3 m) in order to allow for up to 10 ft of erosion of the sand (Figure 64). This limit was based on the assumption that the sand in this area was at least 10 ft deep per hydrographic surveys (Towill Inc., 2011), and would be subject to erosion under the certain hydrodynamic conditions (e.g., high current velocities). In addition, the cells depicting the bottom of the newly created notch were specified as “limited erodible cells” with a limit of 2 ft (Figure 65), in order to ensure that the model would not be overly aggressive in depicting scour (Lin, personal communication, 2013).

Figure 64. Cells specified as “limited erodible cells” with a limit of 3 m, as it was assumed that sand in these areas was at least 3 m (10 ft) deep

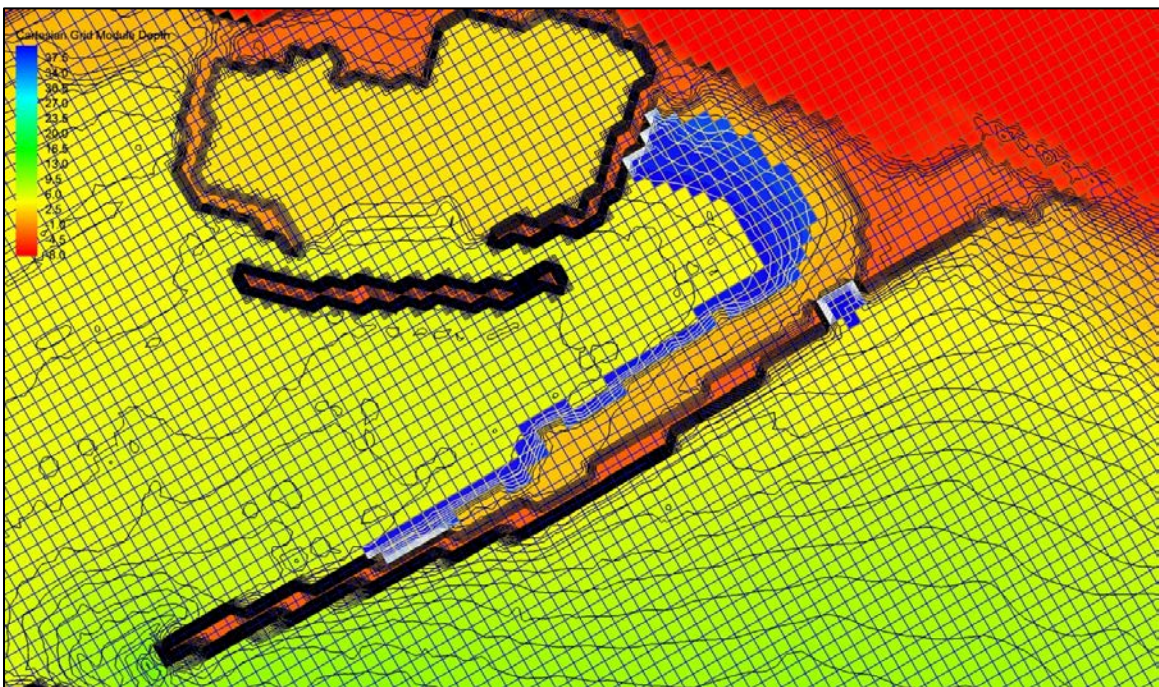
Figure 65. Cells specified as “limited erodible cells” with a limit of 0.6 m, as it was assumed that sand in these areas was at least 0.6 m (2 ft) deep

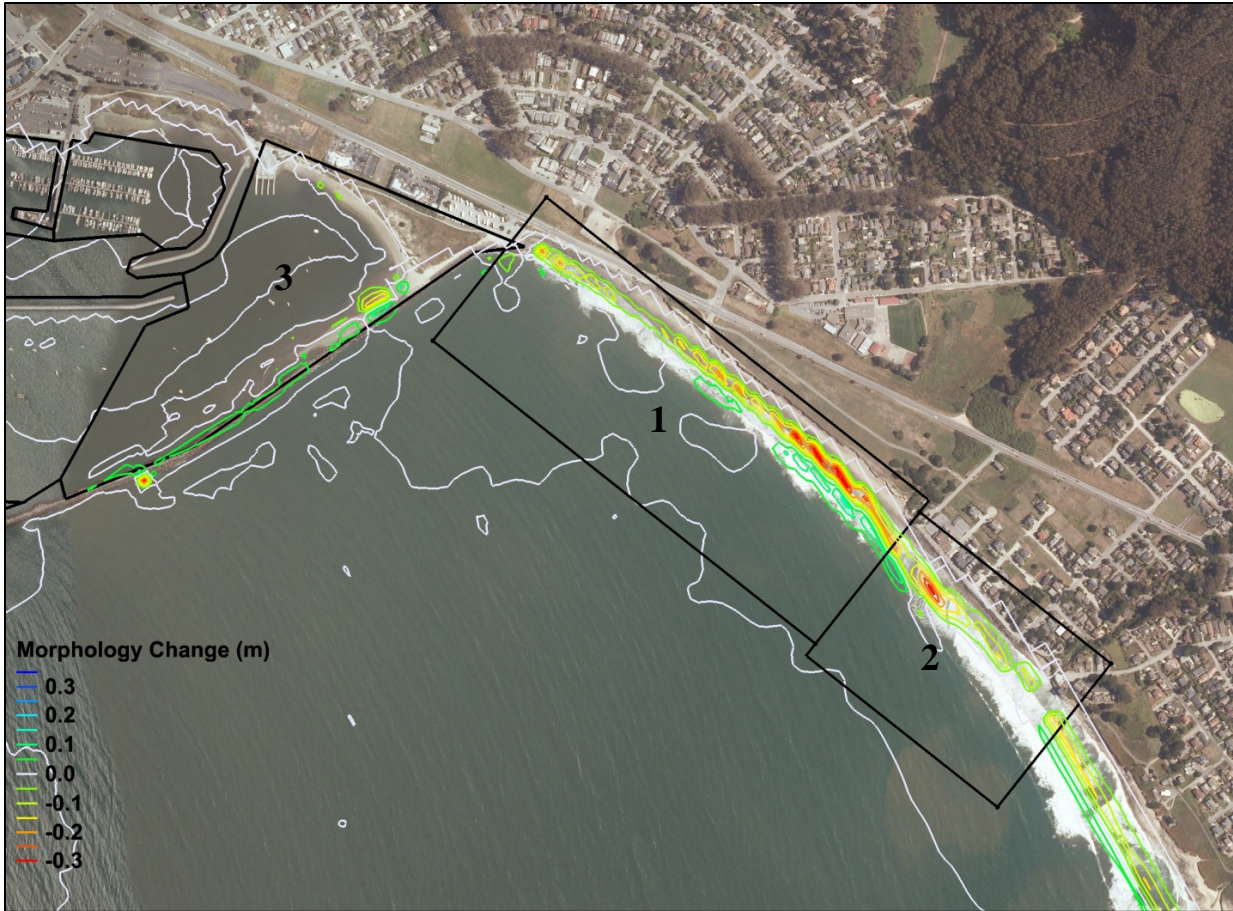
Figure 66. Morphology change associated with a breakwater notch from June to November 2009

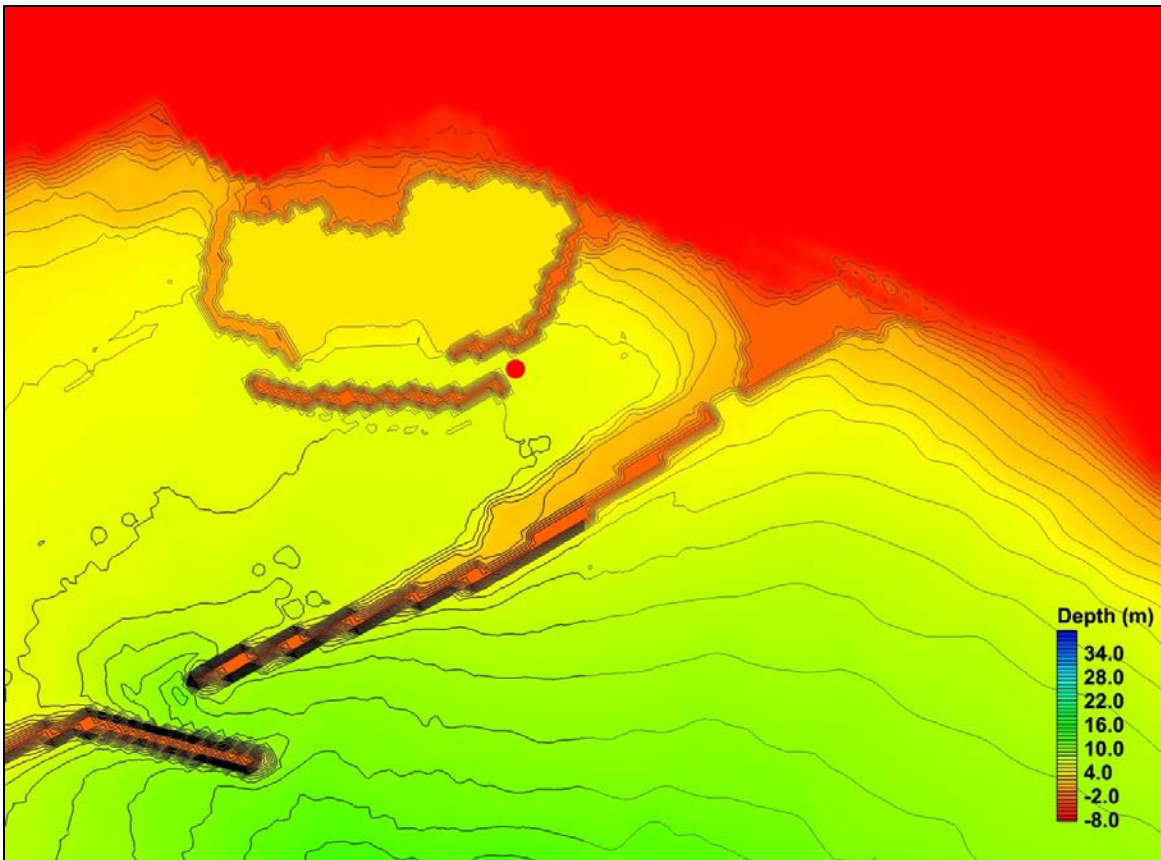
Figure 67. Location of time series of wave heights derived from the baseline condition and breakwater notch model runs

In addition, the opening of a notch could alter hydrodynamic conditions inside the harbor in such a way to potentially create navigation hazards. For example, a cursory analysis of model outputs indicates that wave heights could slightly increase adjacent to the inner breakwaters in the event of construction of the notch (Figure 67 and Figure 68). As a result, there will need to be detailed analysis of potential hydrodynamic impacts associated with this design measure, which could add to the overall design cost. Thus, these factors provide sufficient justification for not further pursuing this design measure, given the need for immediate erosion mitigation benefits.

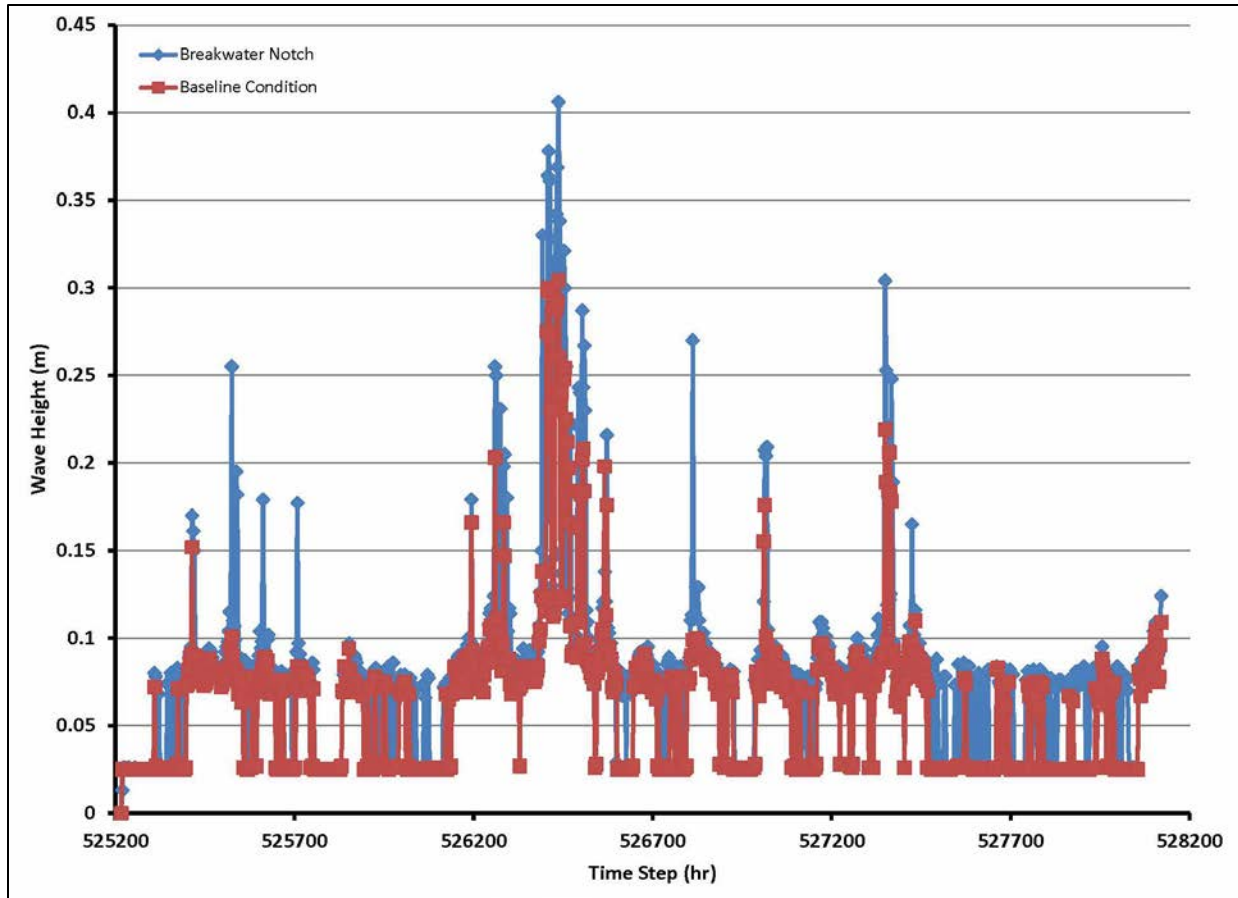
Figure 68. Wave heights near the inner breakwaters for the breakwater notch design measure and baseline condition from Dec 2009 to March 2010
