North Half Moon Bay Shoreline Improvement Project, Pillar Point Harbor, CA Coastal Engineering Appendix

FINAL January 2015

Final Report

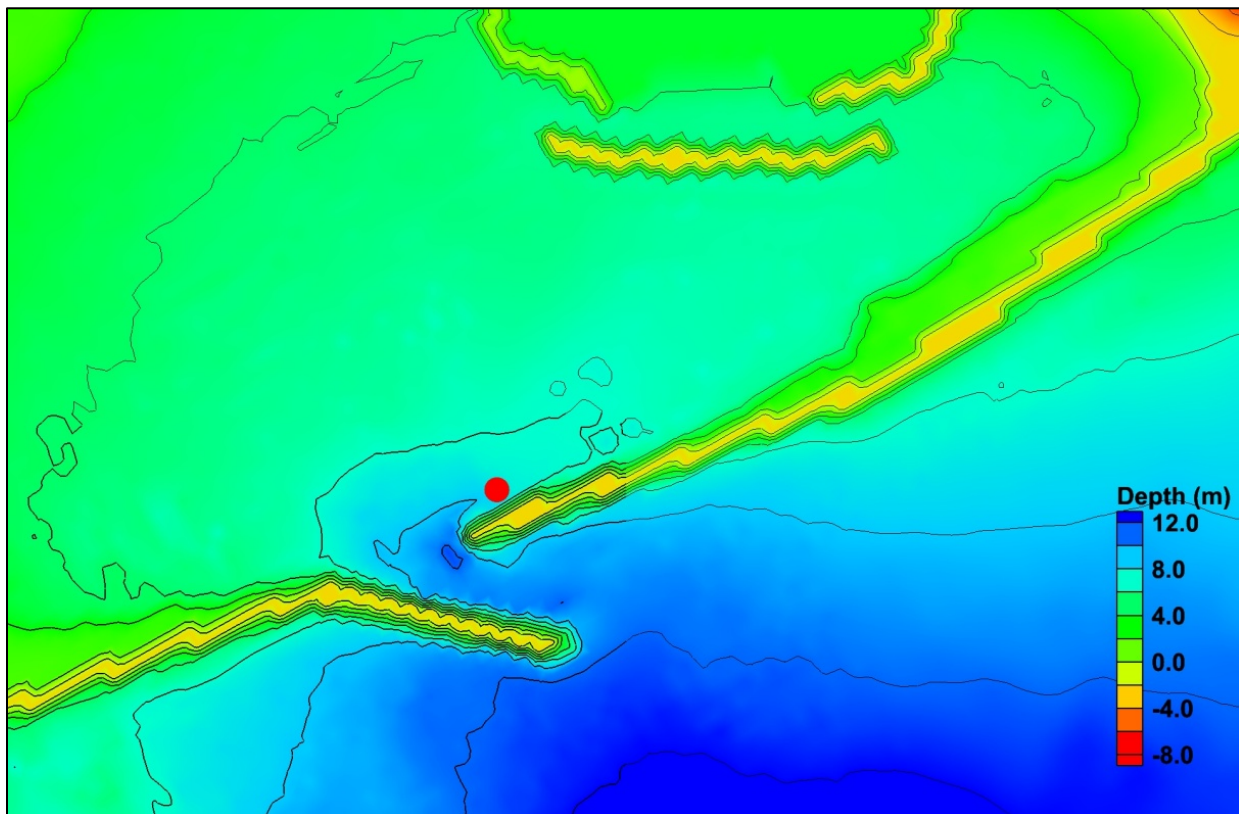
the harbor. An analysis of modeled current direction and magnitude suggest that sand placed along the harbor side of the east breakwater near the entrance would likely be transported out of the harbor (Figure 69 and Figure 70). This hypothesis is supported by a recent harbor circulation study, which utilized dye distribution and identified a zone of scour just inside of the head of the east breakwater (Wuertz et al., 2011).

Figure 69. Location of modeled current magnitude and direction data used to evaluate Design Measure 5

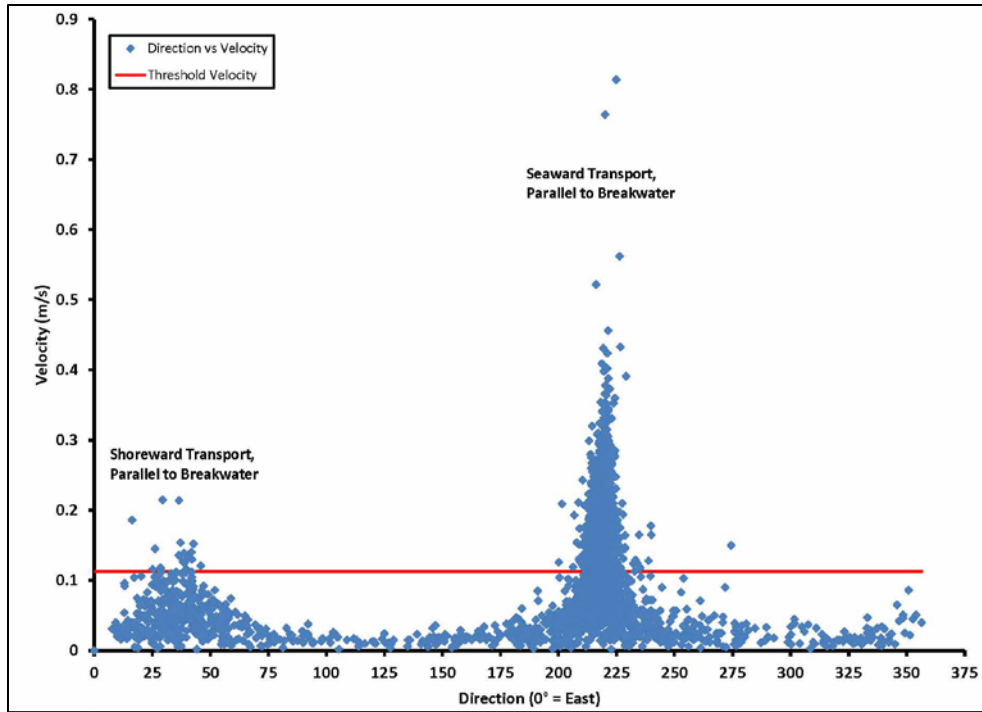
Figure 70. Modeled current magnitude and direction data (see Figure 3 for location)

In order for sand to be transported, local currents must exceed a given threshold velocity. Calculations performed as part of the 1996 USACE shoaling analysis indicated that the threshold velocity for sand within the harbor (assuming a d_{50} of 0.1 mm) is approximately 0.37 ft/s or 0.11 m/s (USACE, 1996). Current measurements from the harbor mouth indicate that this threshold is frequently exceeded under "typical" hydrodynamic conditions, although the strongest measured currents were associated with flood tides at this particular location (Figure 3 and Figure 19). This suggests that placement of sand directly in the harbor mouth would likely result in the sand being circulated back into the harbor by the strong flood tide currents. Thus, further analysis is required to determine if there are other suitable locations for sand placement, particularly along the east breakwater.

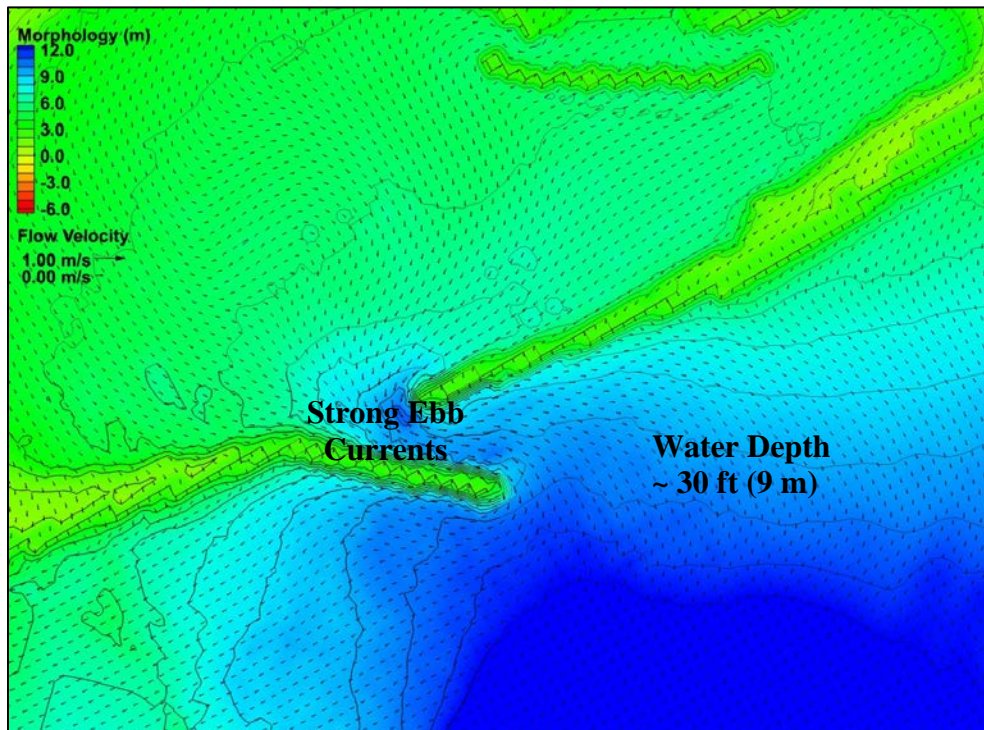
However, it appears that most of this sand would be transported to the relatively deep (~30 ft) water directly offshore of the entrance (Figure 71). If the sand were to settle on the seafloor at this depth, it is unlikely that the relatively small waves associated with beach building would be able to mobilize and transport this sand onshore. Thus, this cursory examination of modeled currents suggests that placement of sand along the east breakwater will not necessarily provide shoreline erosion mitigation benefits for Surfers Beach.

Figure 71. Modeled flow field associated with the typical ebb tide conditions

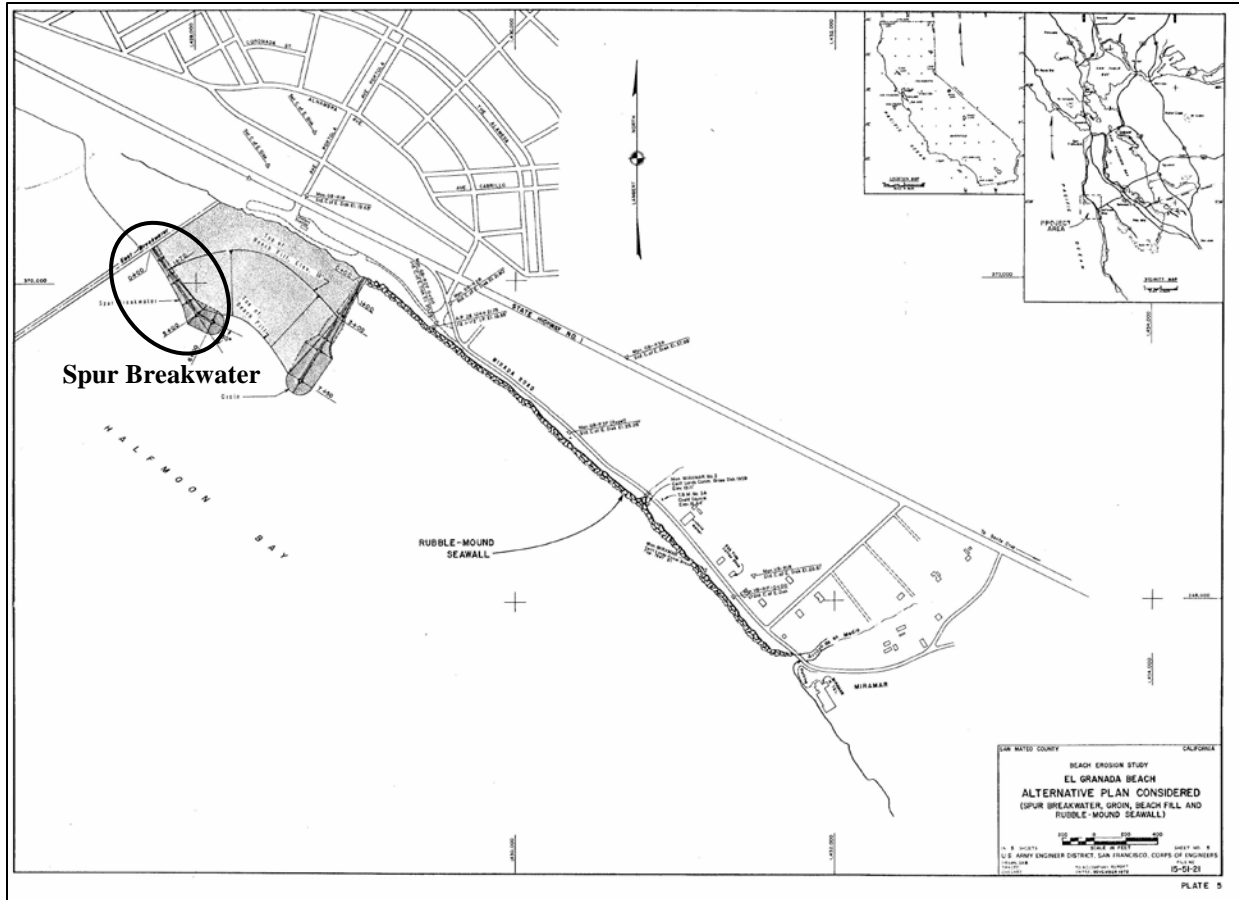
This design measure was a key component of several of the alternate plans considered by the previous USACE Beach Erosion Control Report (USACE, 1971). The 1971 report evaluated the efficacy of a 600 foot long rubble-mound spur breakwater, in conjunction with other measures such as groins, a seawall, and beach fill (Figure 72). This evaluation involved the formulation of design criteria, cost estimates and an economic analysis. The report did not evaluate the spur breakwater as a stand-alone measure, and assumed that it would be charged with 230,000 yd³ of beach fill.

Figure 72. Schematic from the El Granada Beach Erosion Control Report showing the proposed spur breakwater and other design measures (USACE, 1971)

The proposed spur breakwater would have been constructed with a crest elevation sloping down from 10 ft (MLLW) at the east breakwater to 7 ft (MLLW) at the head. The crest would be 15 ft wide with side slopes ranging from 1.75:1 to 3:1, and a layer of 8 to 10 ft of A1 armor stone (4 to 6 tons) over B2 and C underlayer stone (Figure 73). The total first cost of the spur breakwater was estimated to be \$3.2 million if the proposed 230,000 yd³ of beach fill is not included in the estimate.

The 1971 report also included a summary (Appendix D) of findings from an investigation of several deflector-arm breakwater configurations with a 1:100-scale hydraulic (physical) model. The investigation found that the presence of a 500 foot long deflector-arm breakwater “causes formation of desired eddy effect behind this structure and also diverts the attack of the littoral currents down beach about 1,000 ft from the junction of the east breakwater and shore.” It should be noted that the physical modeling appendix did not provide an estimate of how much sand would be retained by a spur breakwater structure.

In the end, the report concluded that the alternatives which included the spur breakwater would be too expensive, given the high total first cost associated with the beach fill component. Thus, the report recommended the construction of a 4,600 foot long rubblemound seawall (revetment). Cost continues to be a concern, as a more recent cost estimate (USACE, 2006) for the repair of a 170 foot long section of the east breakwater suggests that breakwater construction could cost up to \$4,200 per linear foot (USACE, 2006). This would translate into a construction cost of approximately \$2.5 million for a 600 foot long spur breakwater, and this cost would not include beach fill in the newly protected area.

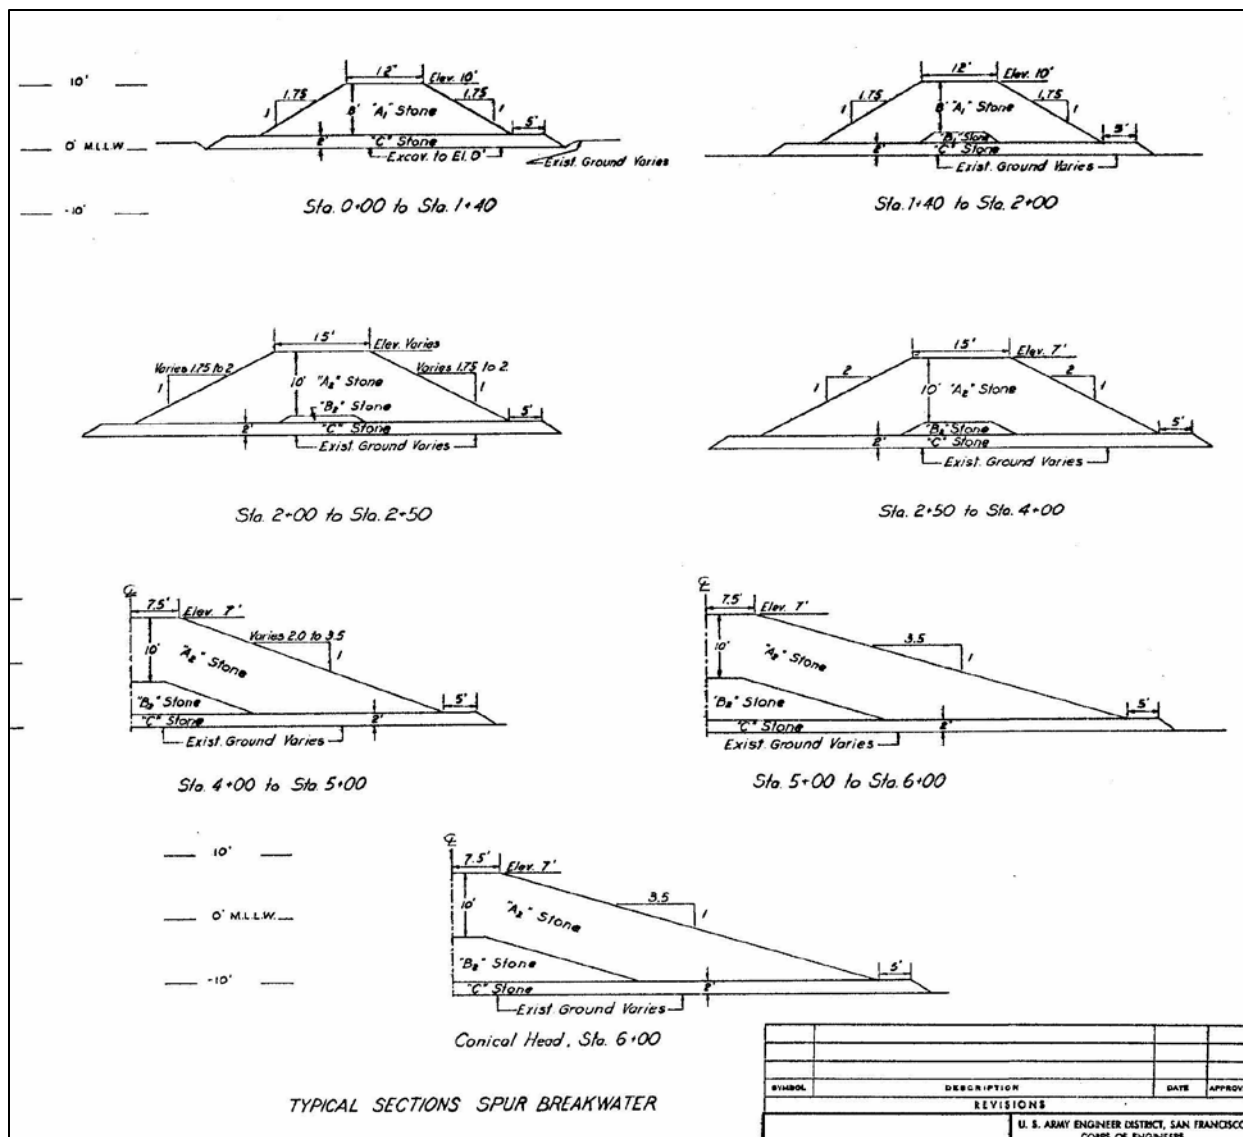
Figure 73. Sample cross-section of proposed spur breakwater, from the El Granada Beach Erosion Control Report (USACE, 1971)

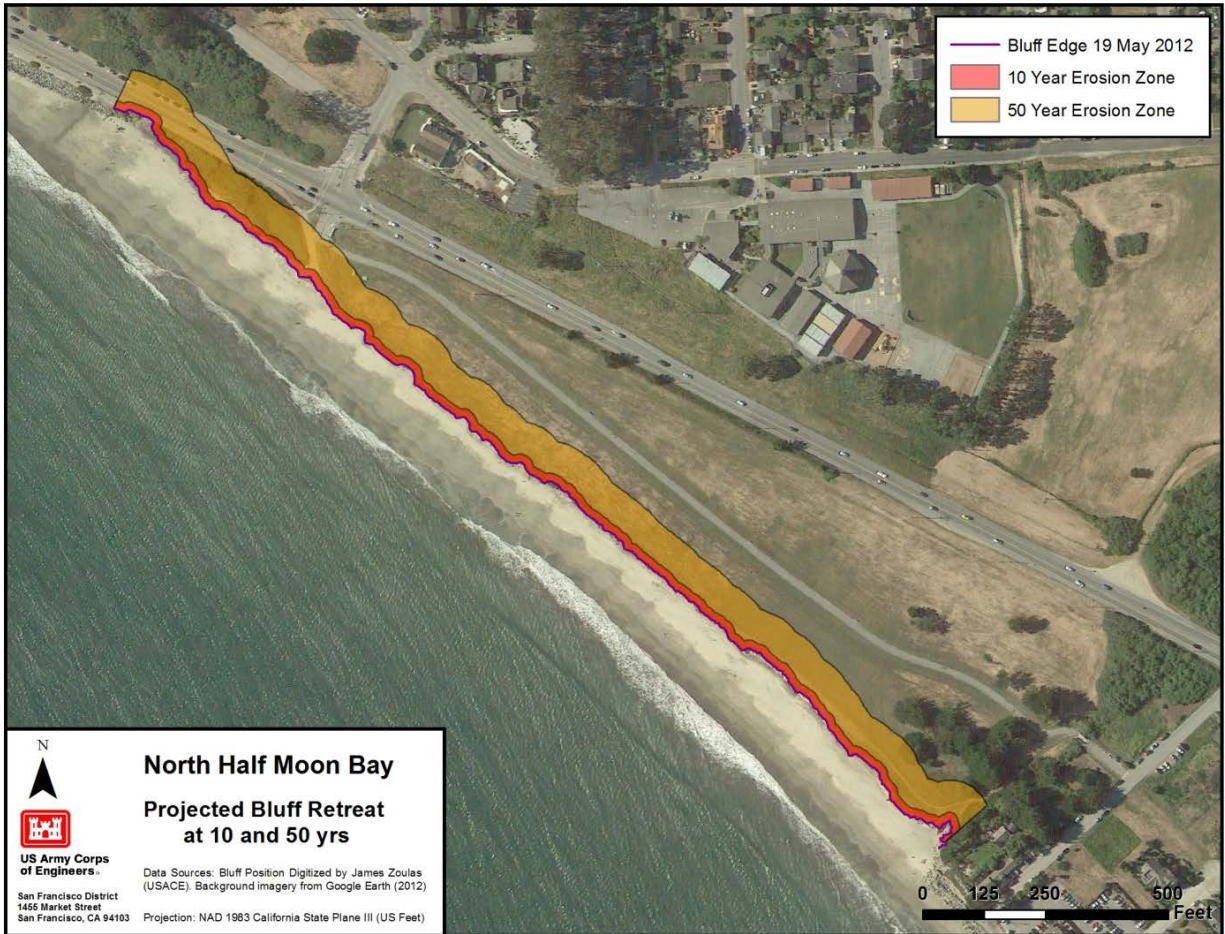
Figure 74: Extent of projected bluff retreat at 10 and 50 years, based on the estimated retreat rate of 1.64 ft (0.50 m) per year

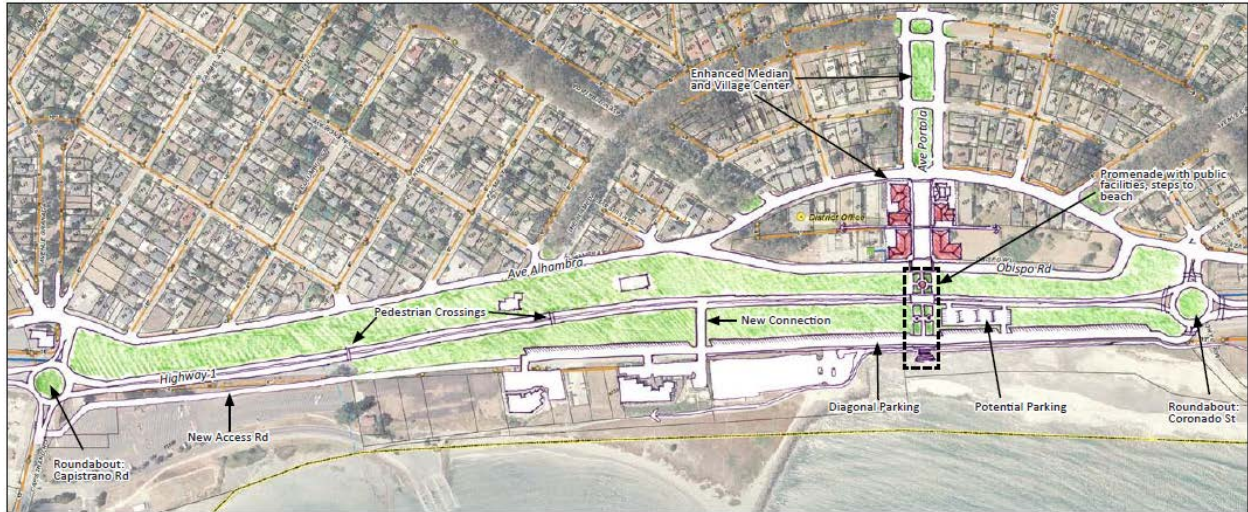
However, it is unlikely that only a small section of highway would be relocated, as moving even a small section would require realignment of a much longer section of roadway. For example, the Highway 1 Safety and Mobility Improvement Study (Local Government Commission et al., 2010) proposed several Highway 1 realignment alternatives, all of which would involve realigning an approximately 4,400 foot long section of highway (Figure 75). This study only proposed conceptual level plans and did not include detailed cost estimates. However, a study of a comparable situation, the Great Highway at Ocean Beach in San Francisco, indicates that

Figure 75. One of three conceptual plans for realigning Highway 1 from Capistrano Road to Coronado Street (from Local Government Commission et al., 2010)

relocating a coastal highway could cost \$3,700 per linear foot (Moffatt & Nichol, 2007). Thus, relocating 4,400 ft of highway could cost over \$16 million, not including the additional costs associated with obtaining the necessary real estate and right-of way.
