Midcoast Community Council

Date: April 10, 2024

Re: McNee Ranch State Park/Montara Mountain North Peak Access Road Maintenance

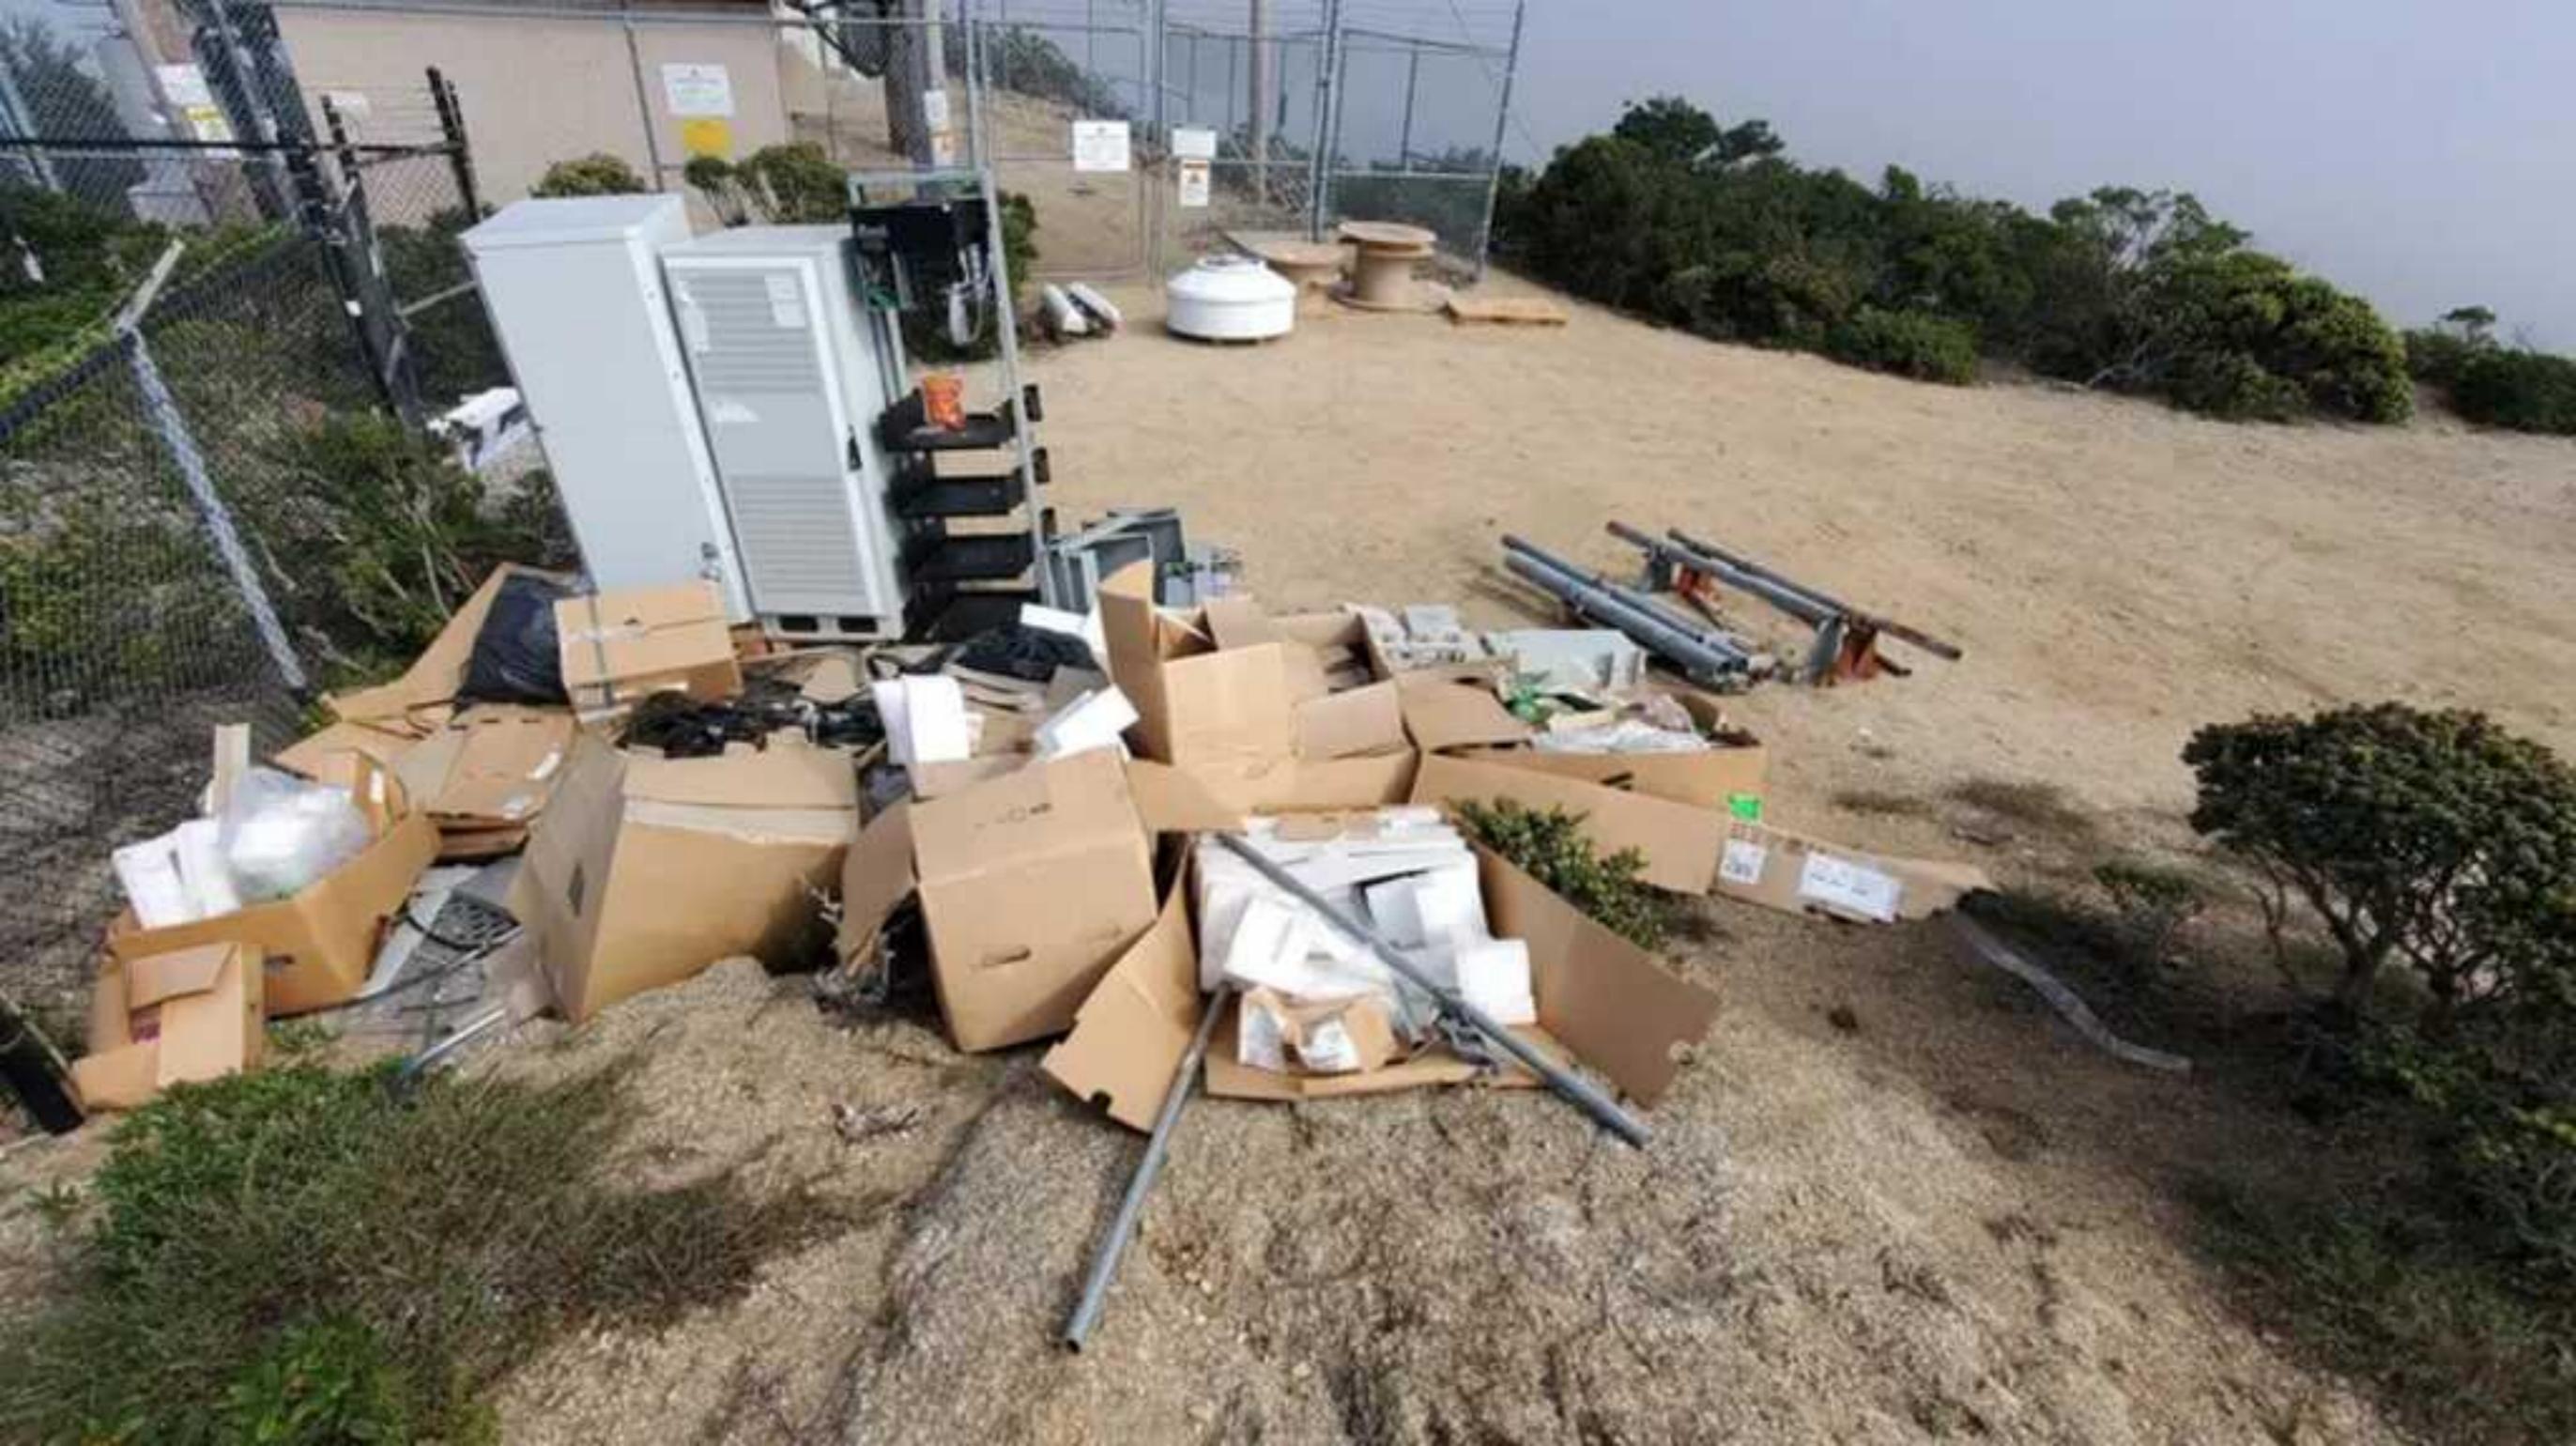
Garbage left behind by a company working on their equipment on Montara Mountain in September 2023. It was reported and photographed by more than one Park visitor. Some debris, including plastics and polystyrene foam, was scattered by wind onto adjacent public land.

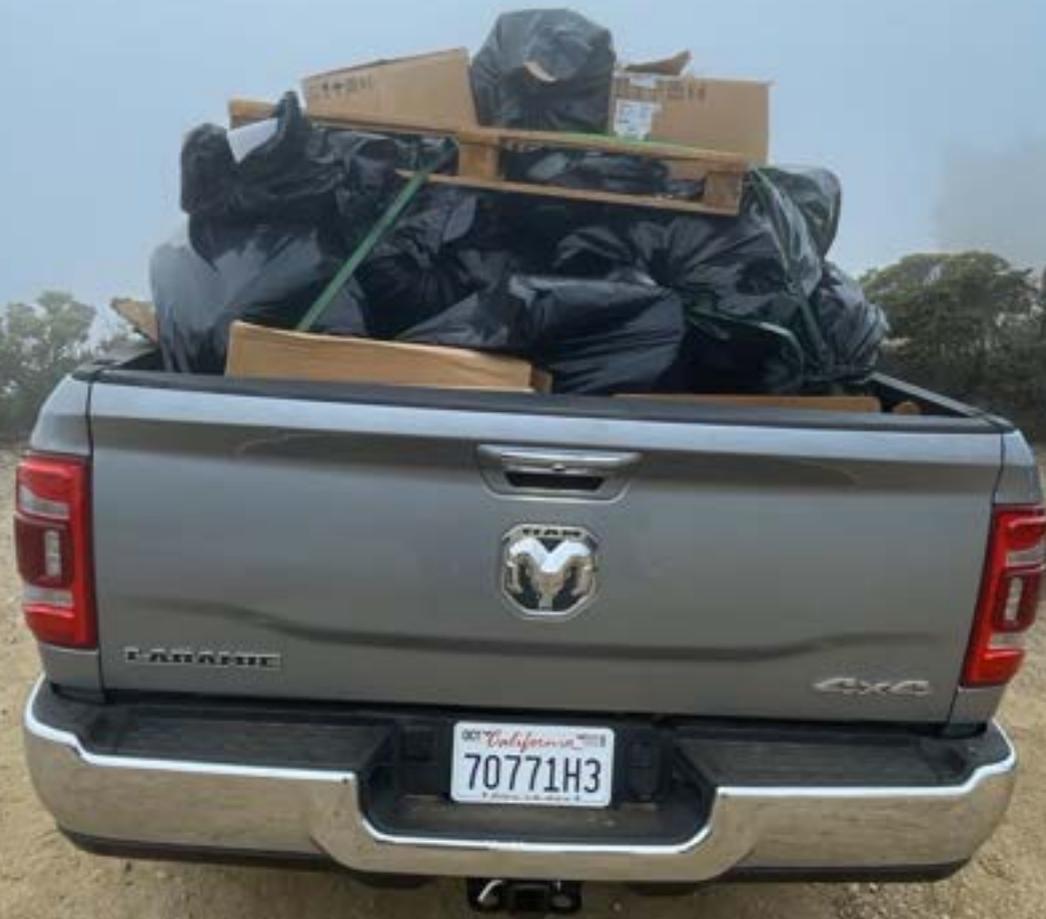
Sep 20, 2023 at 17:27:36
San Pedro Mountain Road
Half Moon Bay CA 94019
United States

Amount of garbage removed after Code Enforcement Department
action. (Photo courtesy of San Mateo County)

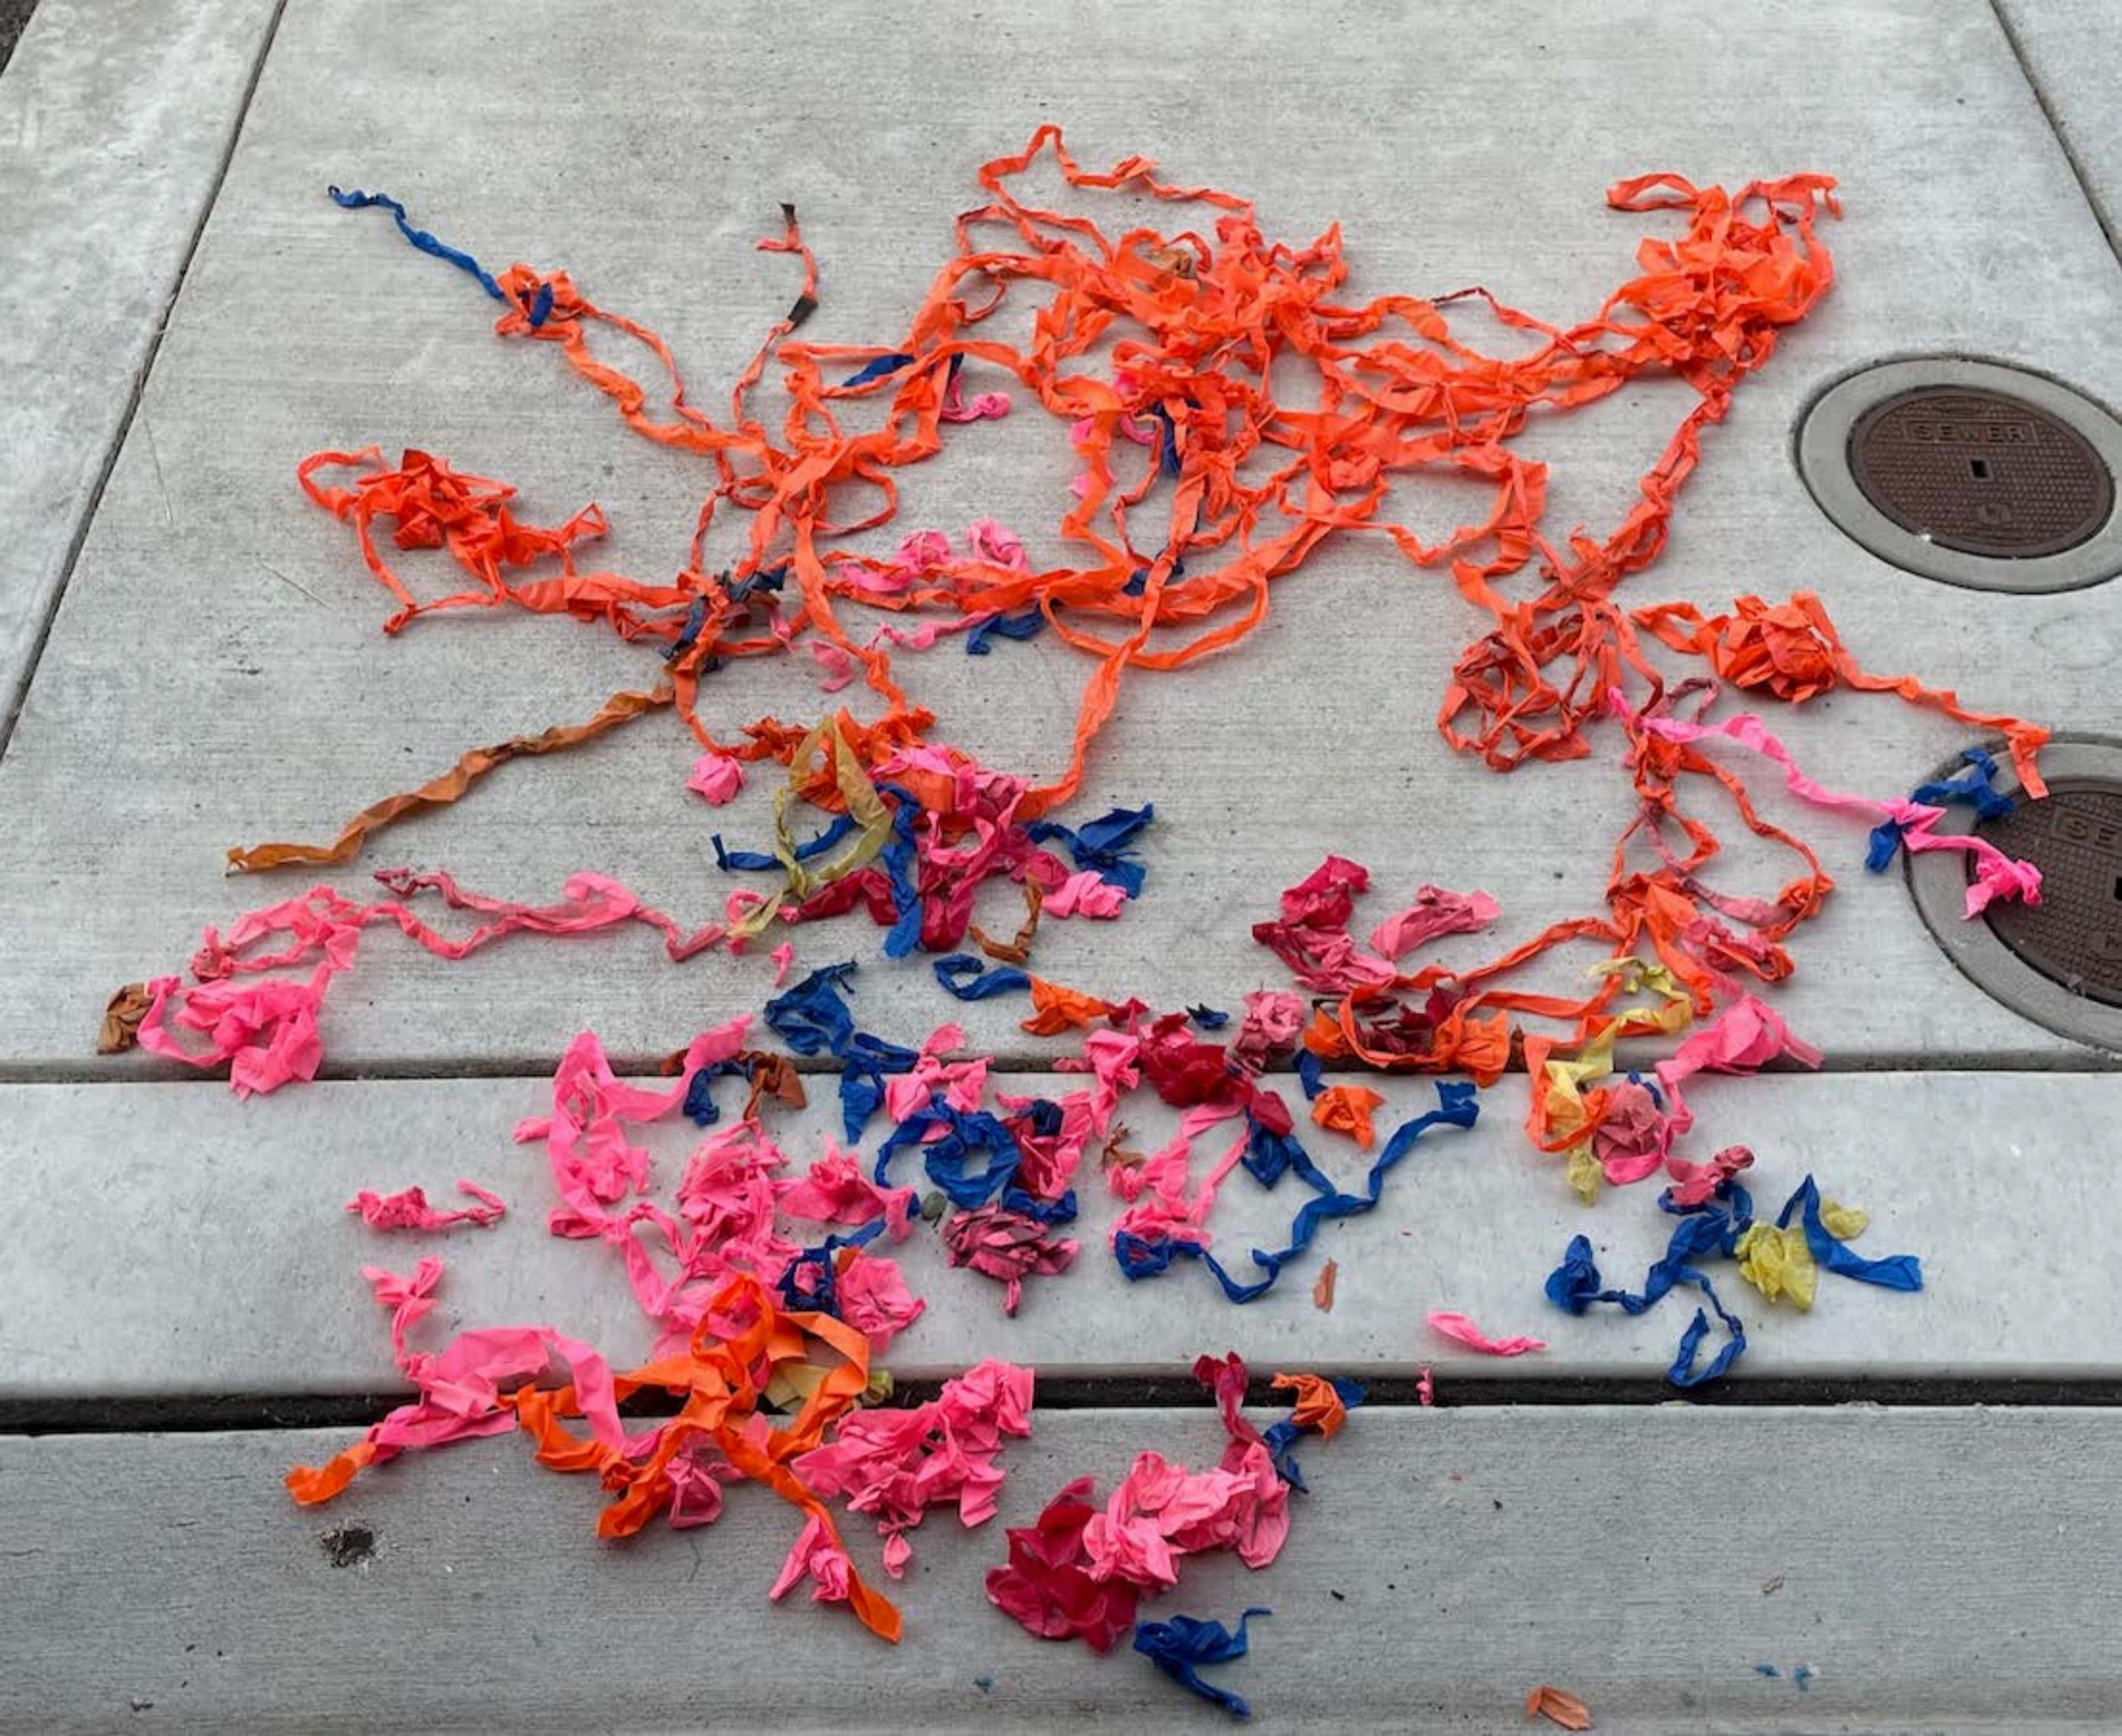
Plastic markers left behind weeks after the work was completed.
These were cleaned up by a local recreational visitor to the Park.

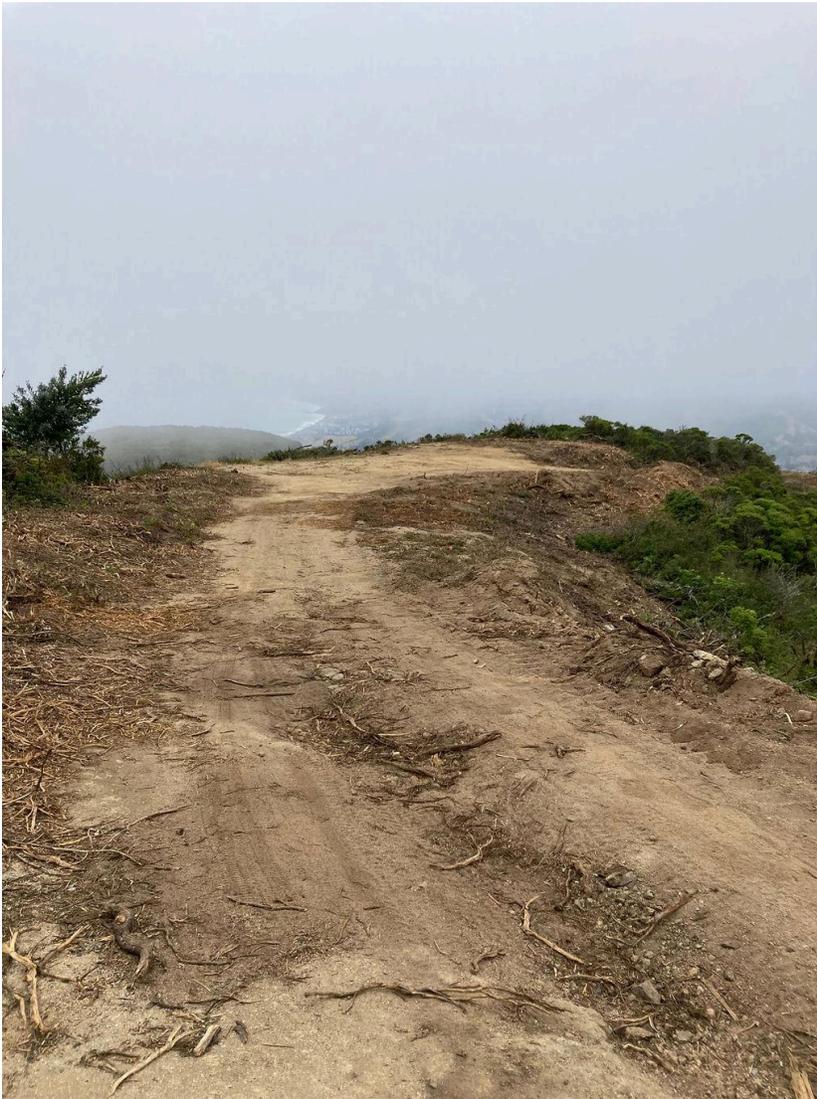
The result of the recent road maintenance project was excessive shoulder clearing that damaged slope edges and removed large amounts of vegetation beyond the road perimeter in some areas. McNee Ranch State Park is an area of unique and sensitive habitats, including several species of concern, and there is potential for significant impact to ecosystems and wildlife. We understand from more than one plant biologist that although many plant species are

expected to recover, the recovery process could take years. The shoulder clearing also left areas ripe for the spread of invasive species that tend to invade in areas of soil disturbance. Because this was intended as a temporary fix and not a long-term solution, grading in some areas created the potential for increased erosion and poor drainage during future storm events. In fact, there are areas where the short-term mitigation strategies used during this recent maintenance effort have already failed during this season's storms.

Excessive clearing of vegetation and slope damage.
(Photo courtesy of Gregg Dieguez)

In light of the unfortunate way this project was handled and the concerns expressed by the public, the MCC requests that the County work with CA State Parks in the near term, to create a plan to restore areas of excessive clearing and address areas where short-term stormwater runoff mitigation strategies failed and where continuing drainage issues exist. The plan should include a long-term strategy to mitigate any invasive plants that may have spread or been introduced by this work. We also recommend a follow up assessment of impact from the recent road maintenance and creation of a regular maintenance plan for the road that focuses on care of the park as a primary goal. This road maintenance plan should take into account all previous maintenance efforts, identify lessons learned, include documented best practices and provide an educational component that ensures those who implement road maintenance work are properly trained and managed. Development of the maintenance plan should afford an opportunity for public comment and for local citizen involvement. Further, we ask the County to pay for all the work outlined above to rectify the issues to which it has in large part contributed.
