Midcoast Community Council

Date: April 10, 2024

Re: McNee Ranch State Park/Montara Mountain North Peak Access Road Maintenance

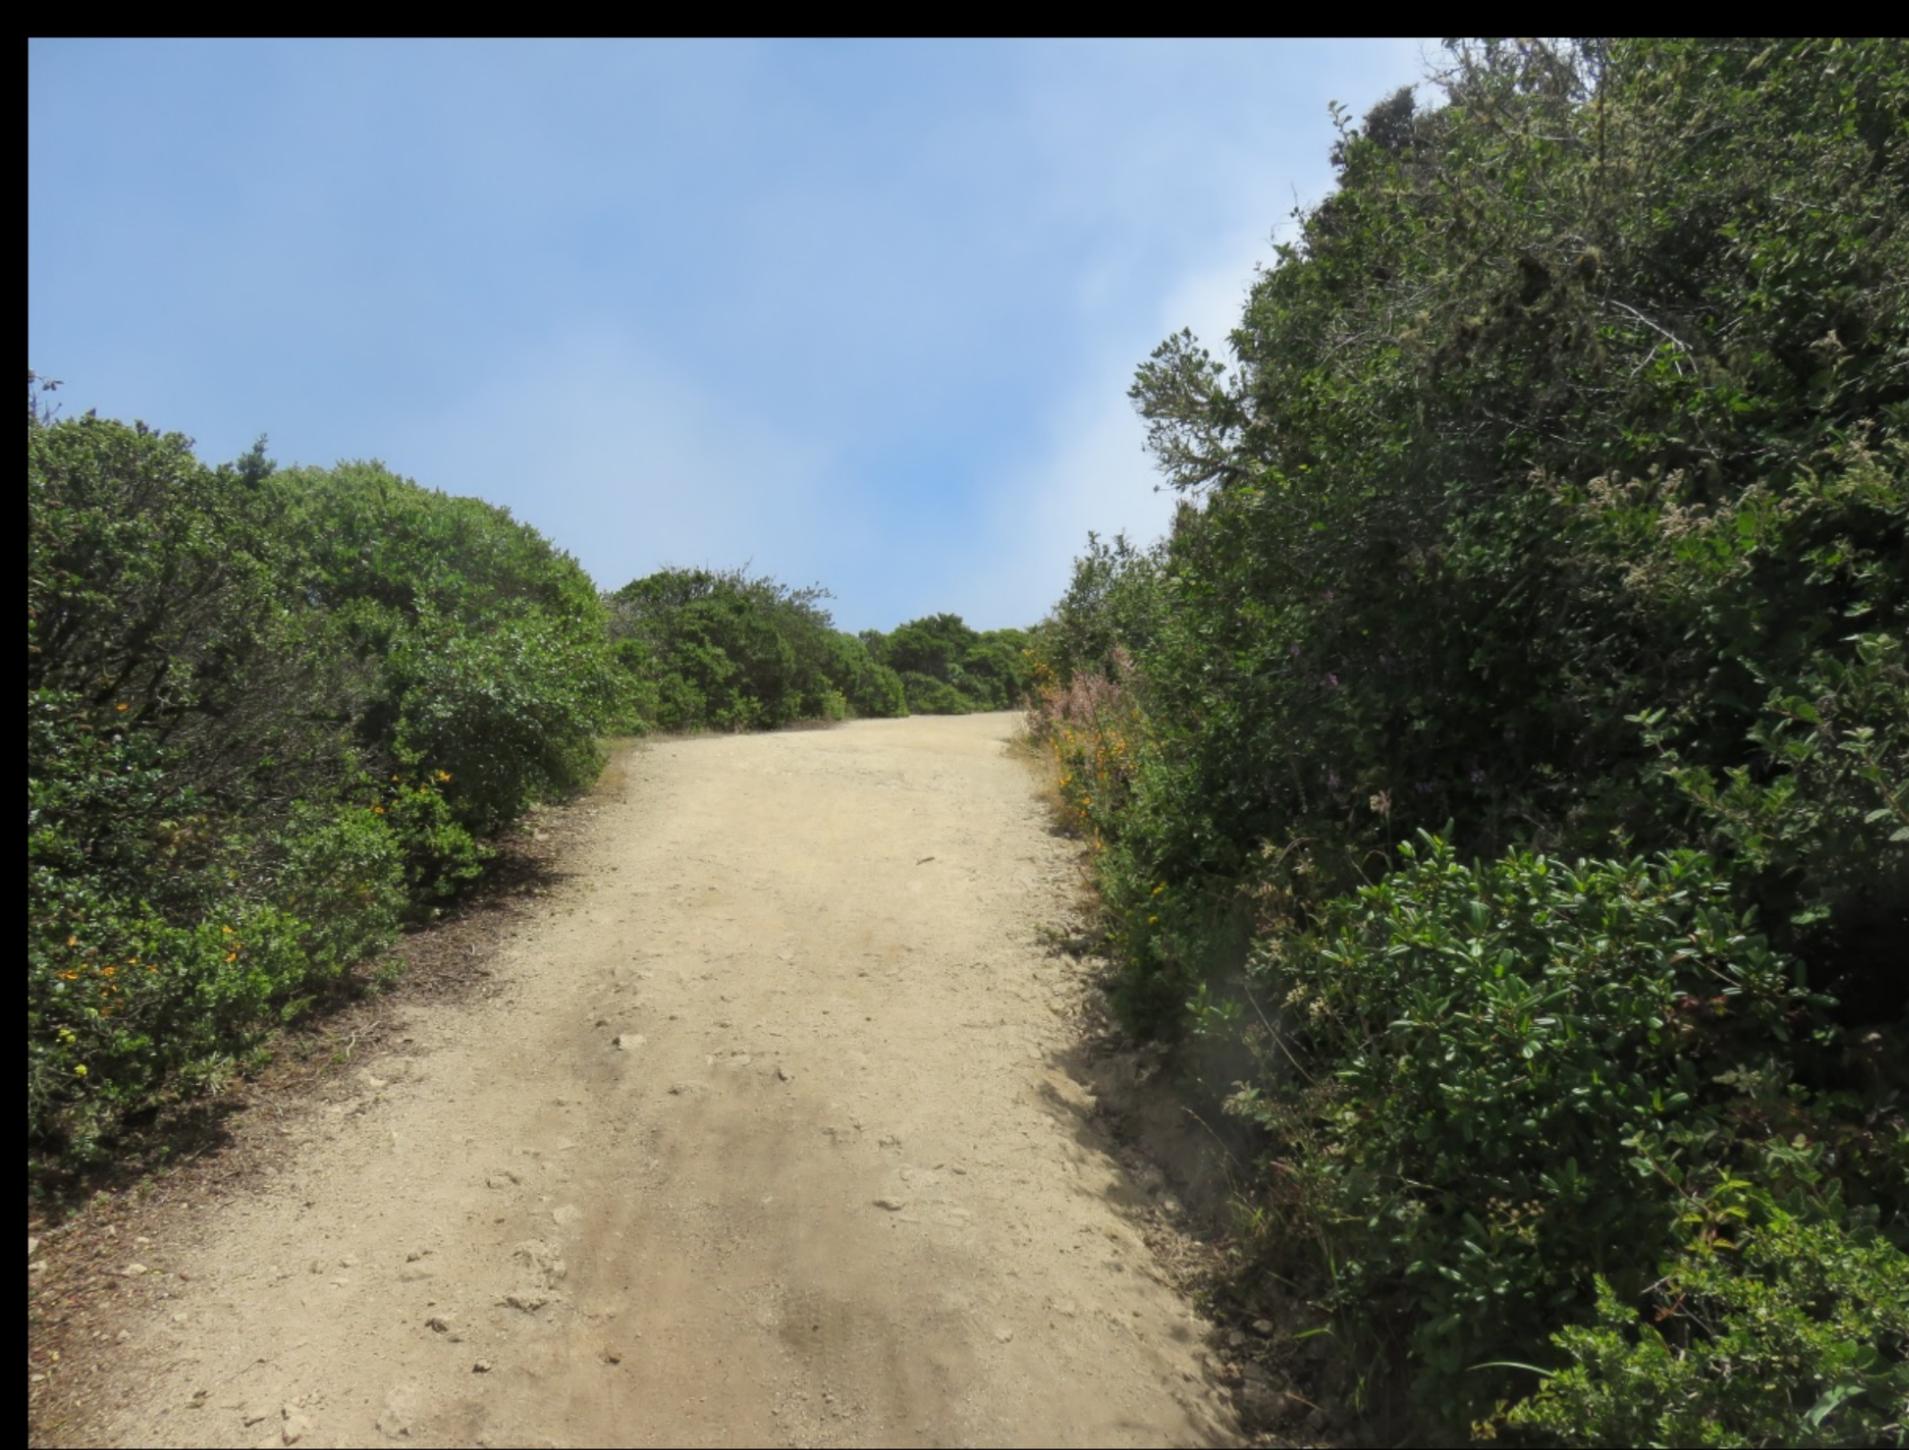
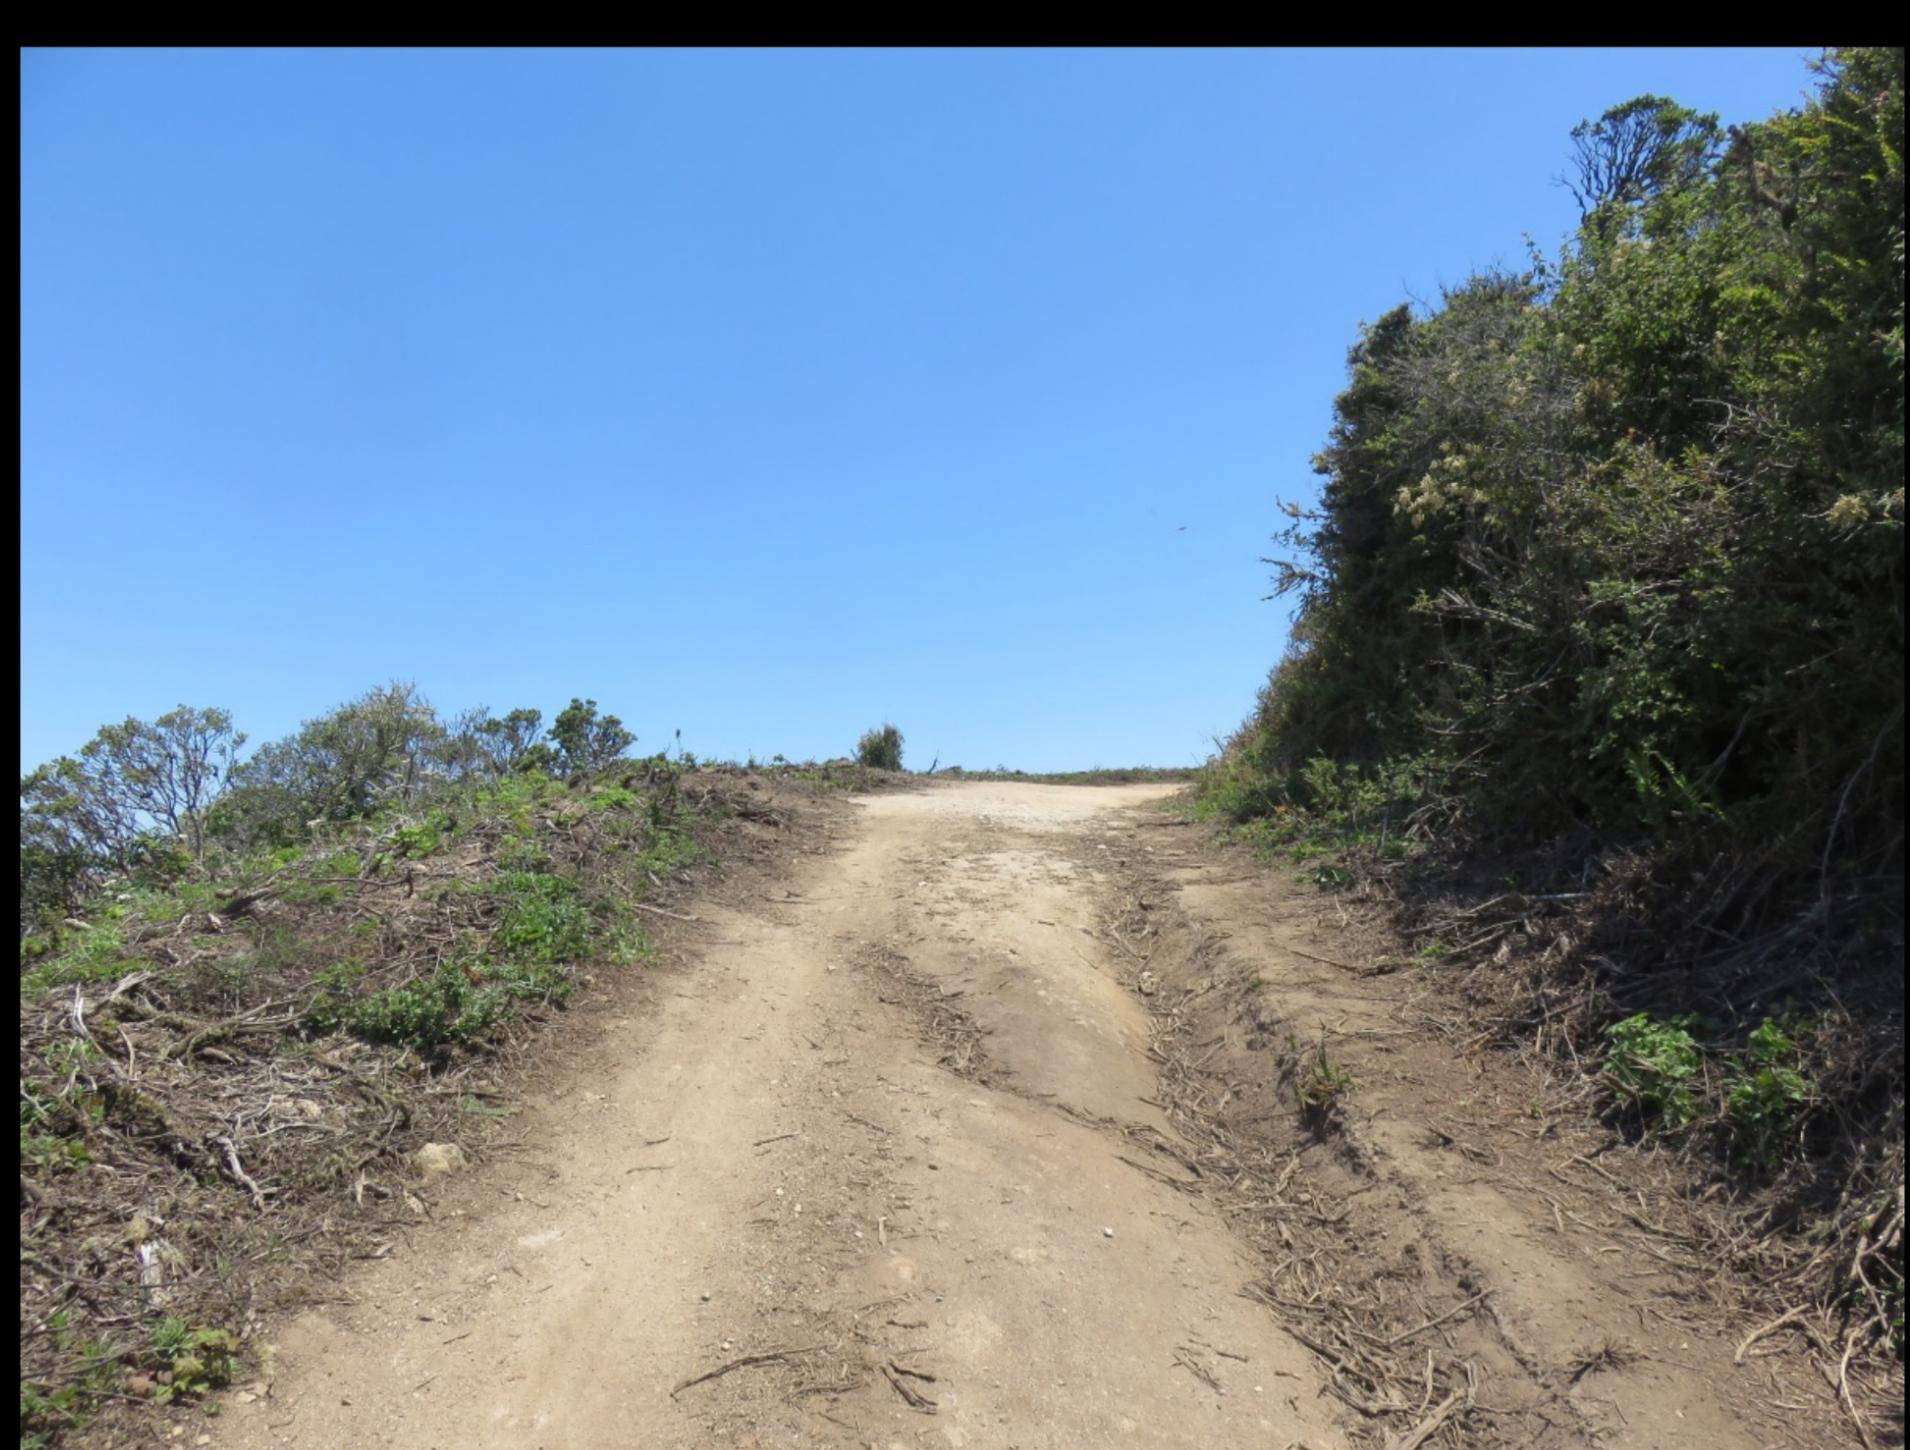
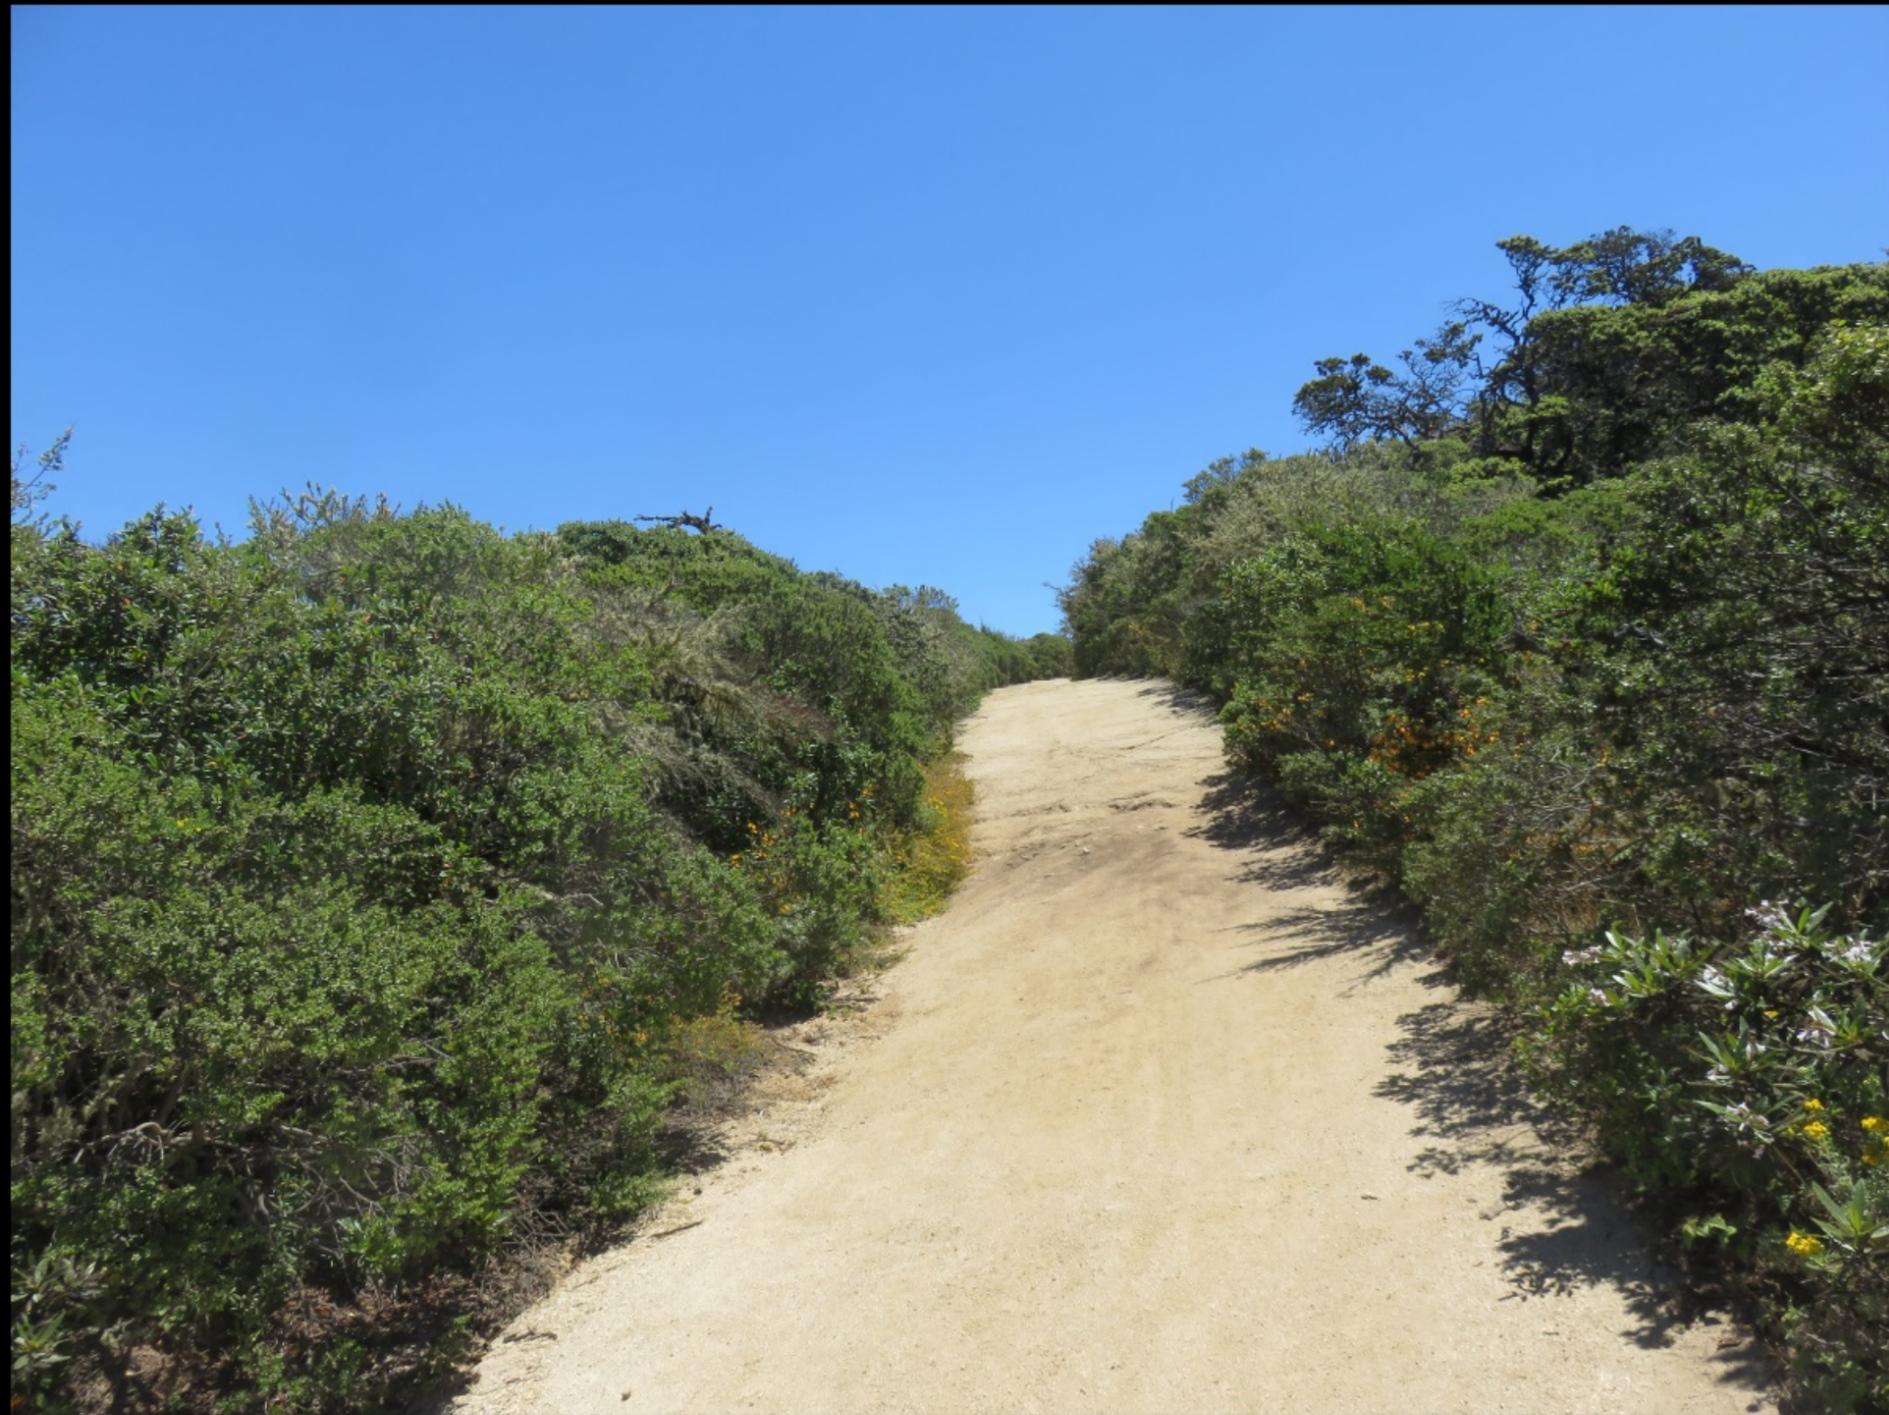
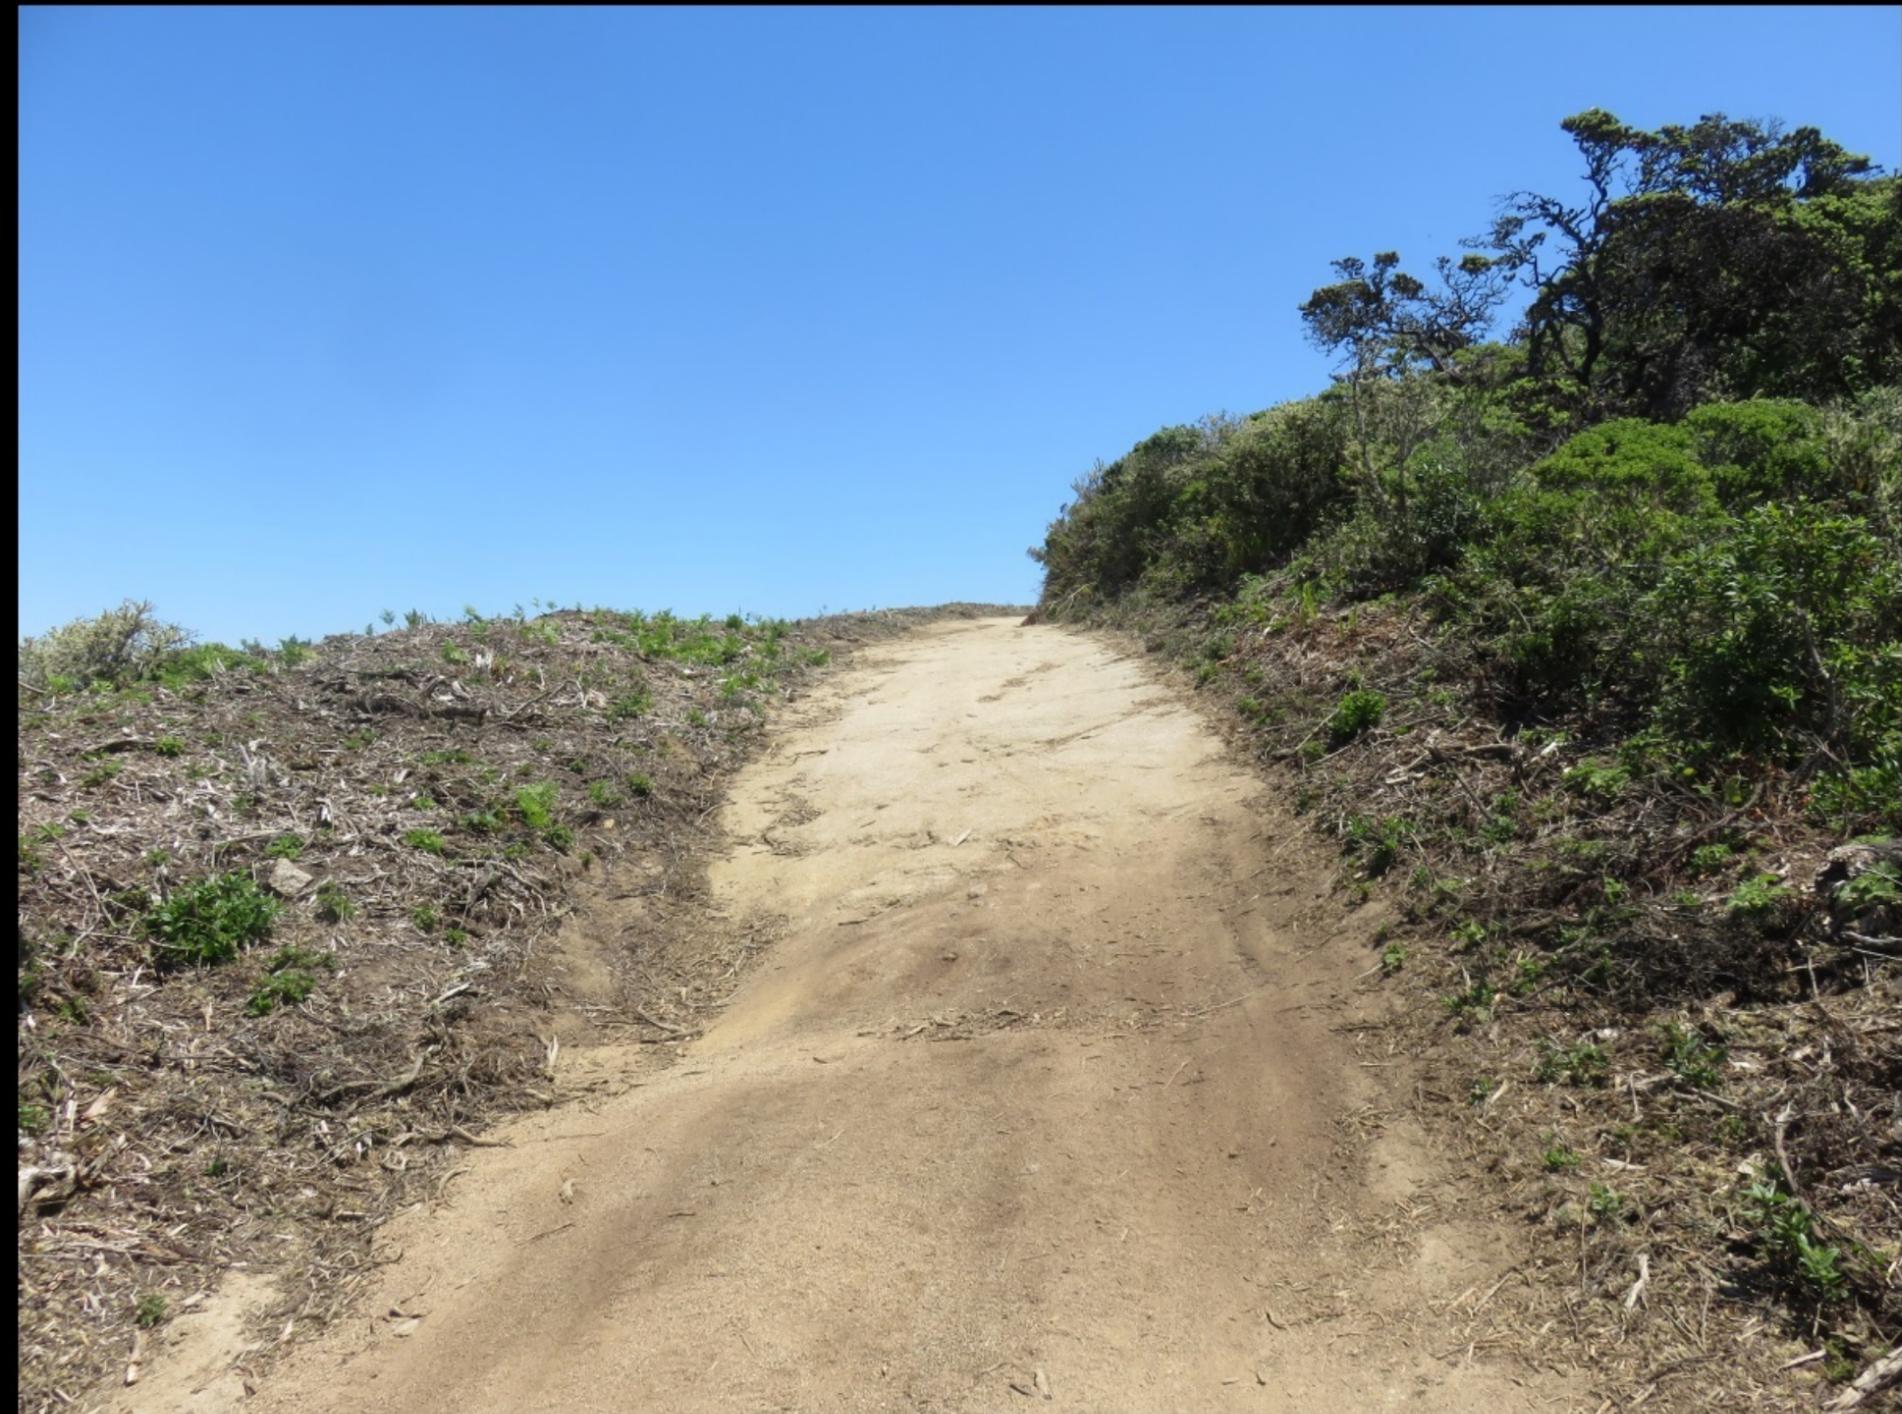
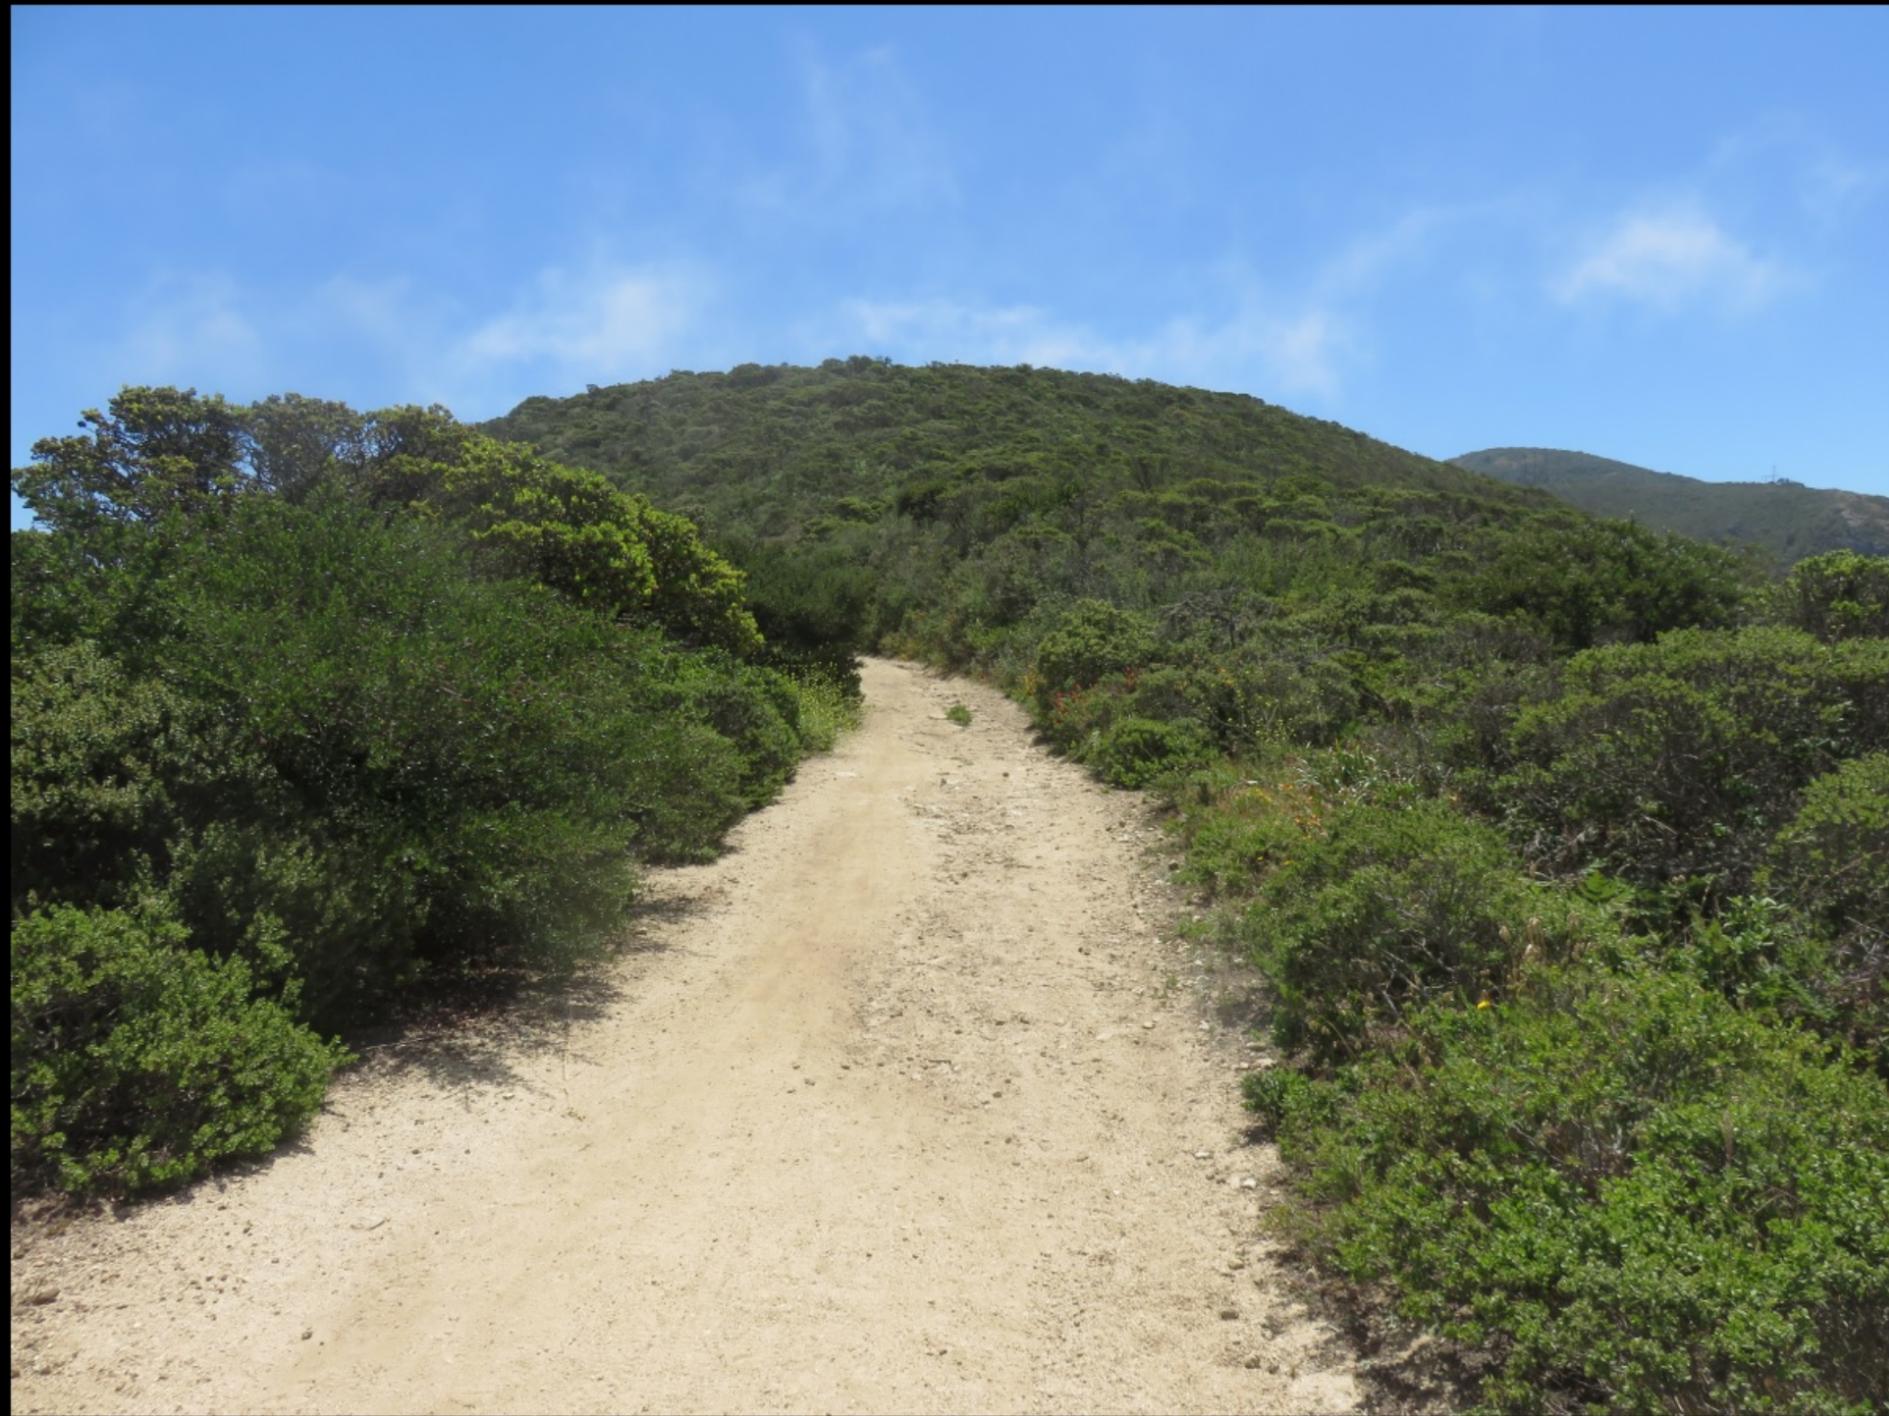
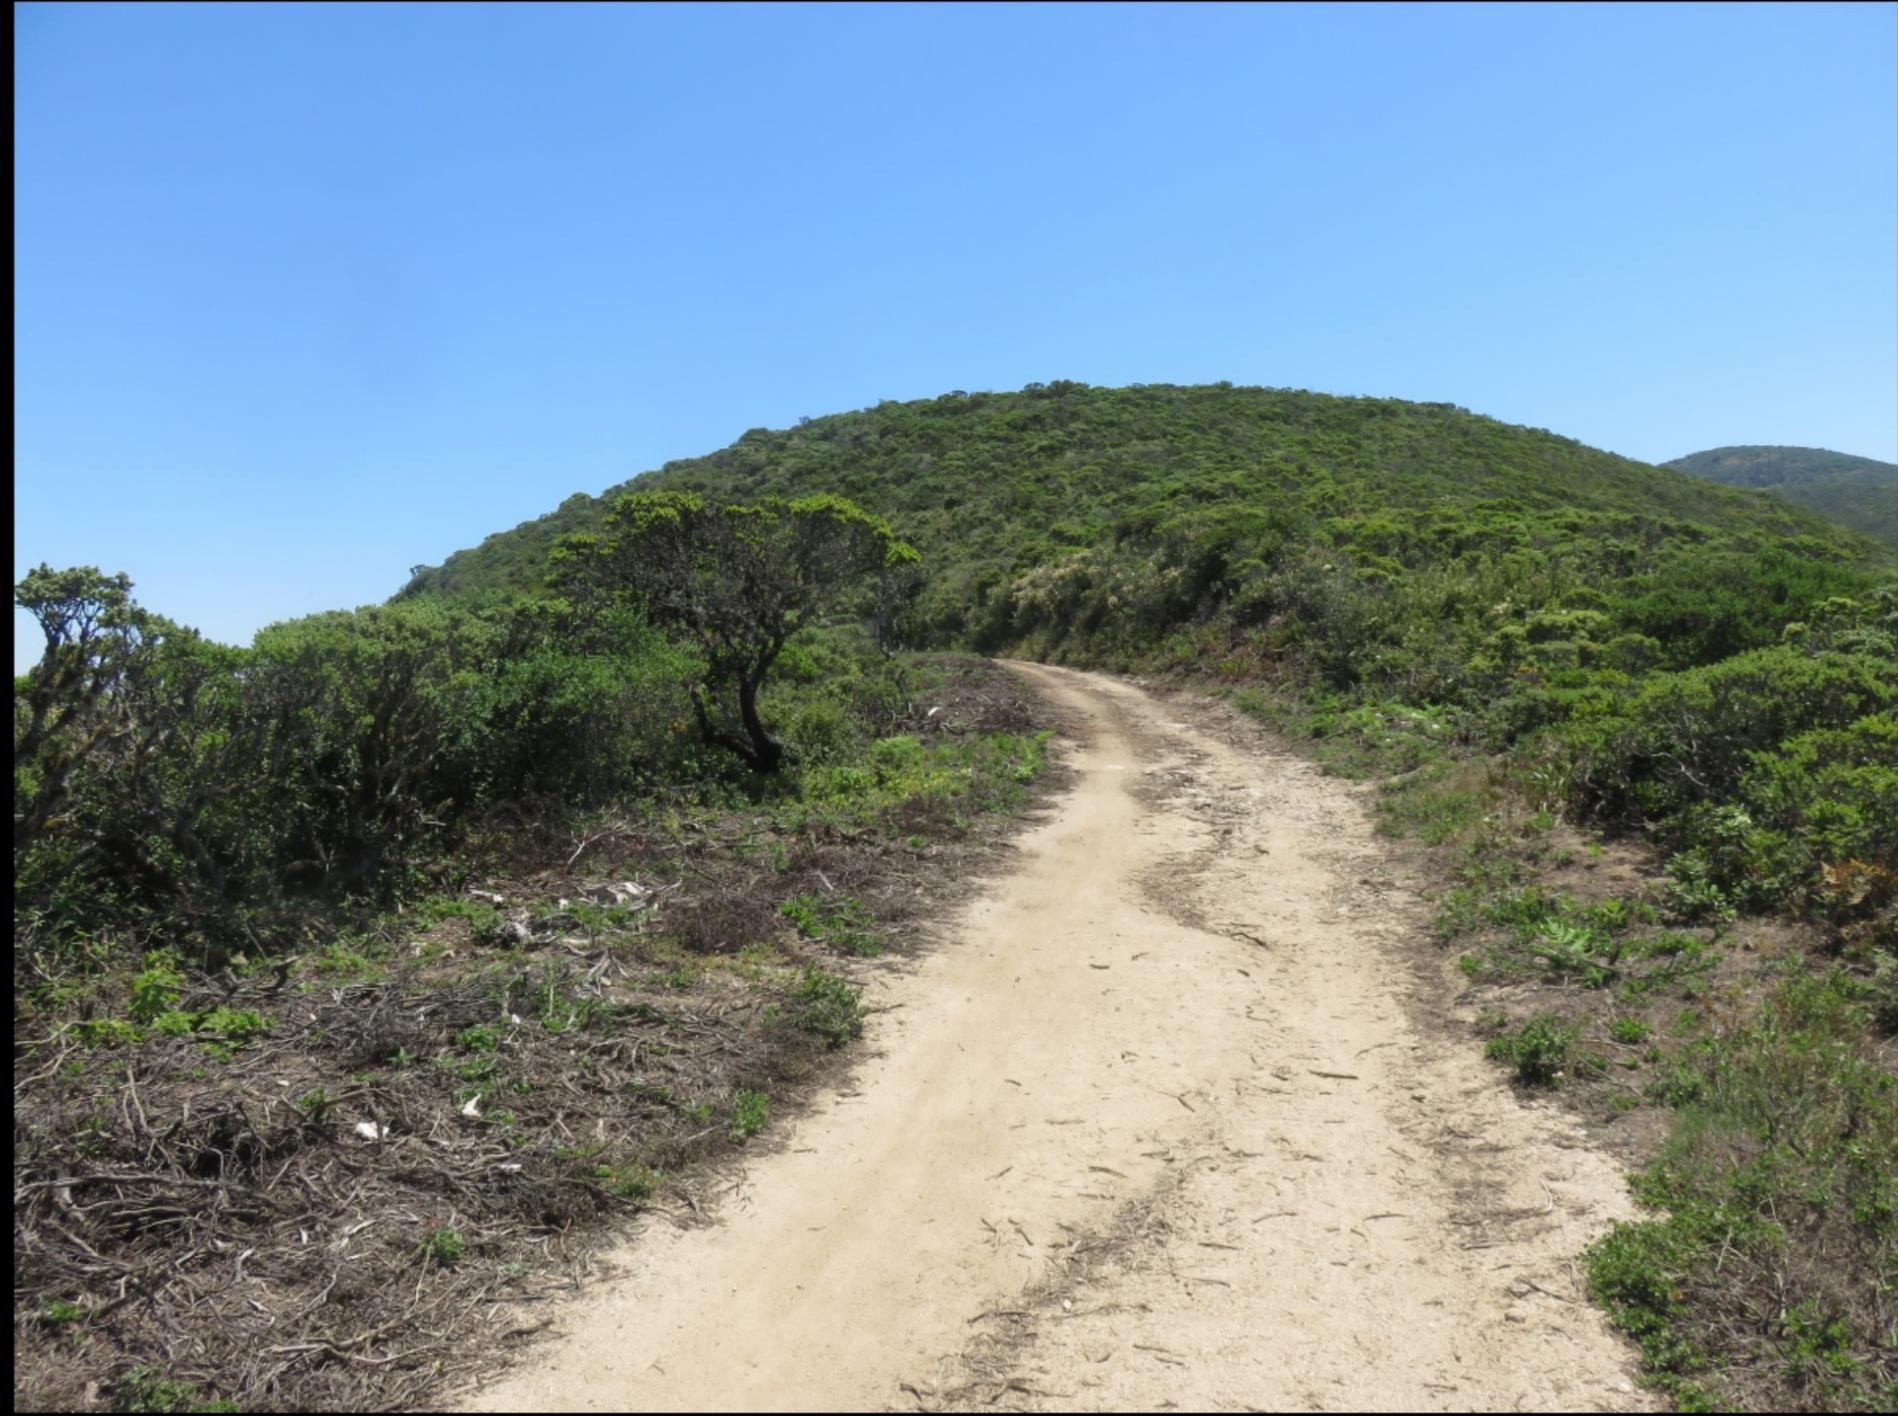
Photos taken after the road maintenance compared with photos of the same spot taken previously.
