2023 LOWER DESCHUTES RIVER WATER QUALITY REPORT

Deschutes River Alliance
May, 2024

Purpose:

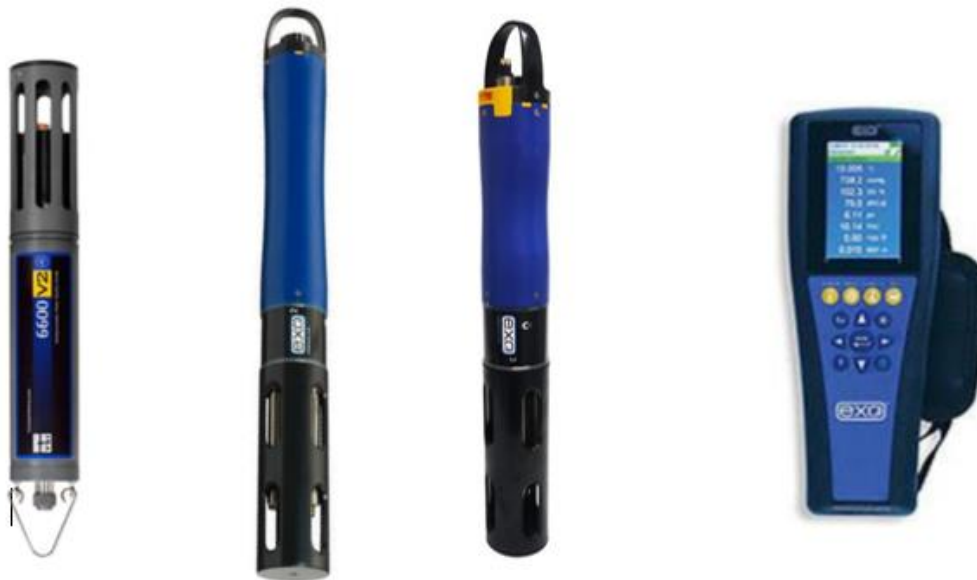
Figure 2. YSI 6600 V2 multiparameter data sonde (left), YSI EXO2 multiparameter data sonde (second to the left), YSI EXO3 multiparameter sonde (second to right), and YSI 650 MDS Handheld (right). Source: YSI

Before deployment, all the YSI data sondes were tested and calibrated to lab standards and programmed to record hourly readings of the following water quality parameters: temperature, DO, pH, conductivity, and turbidity. Each sensor was cleaned by an automatic central wiper to eliminate inaccurate results caused by biofouling.

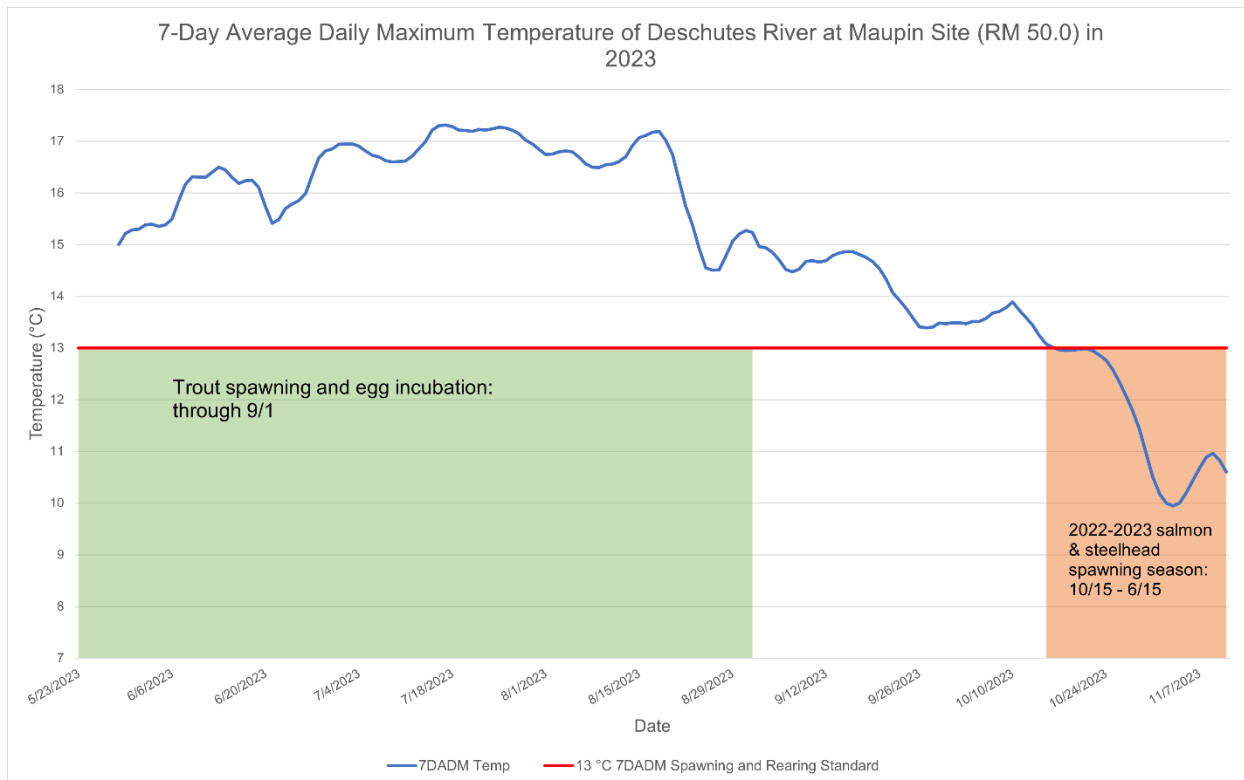
Figure 7. 2023 7-DADM water temperature at River Mile 50.0 of the lower Deschutes River with the maximum temperature standard during spawning and rearing times (October 15 – May 15) for salmon and steelhead shaded in orange and shown with red line (13°C). The green highlighted area shows the resident trout spawning/incubation period continuing until at least the end of August (Zimmerman & Reeves 2000).

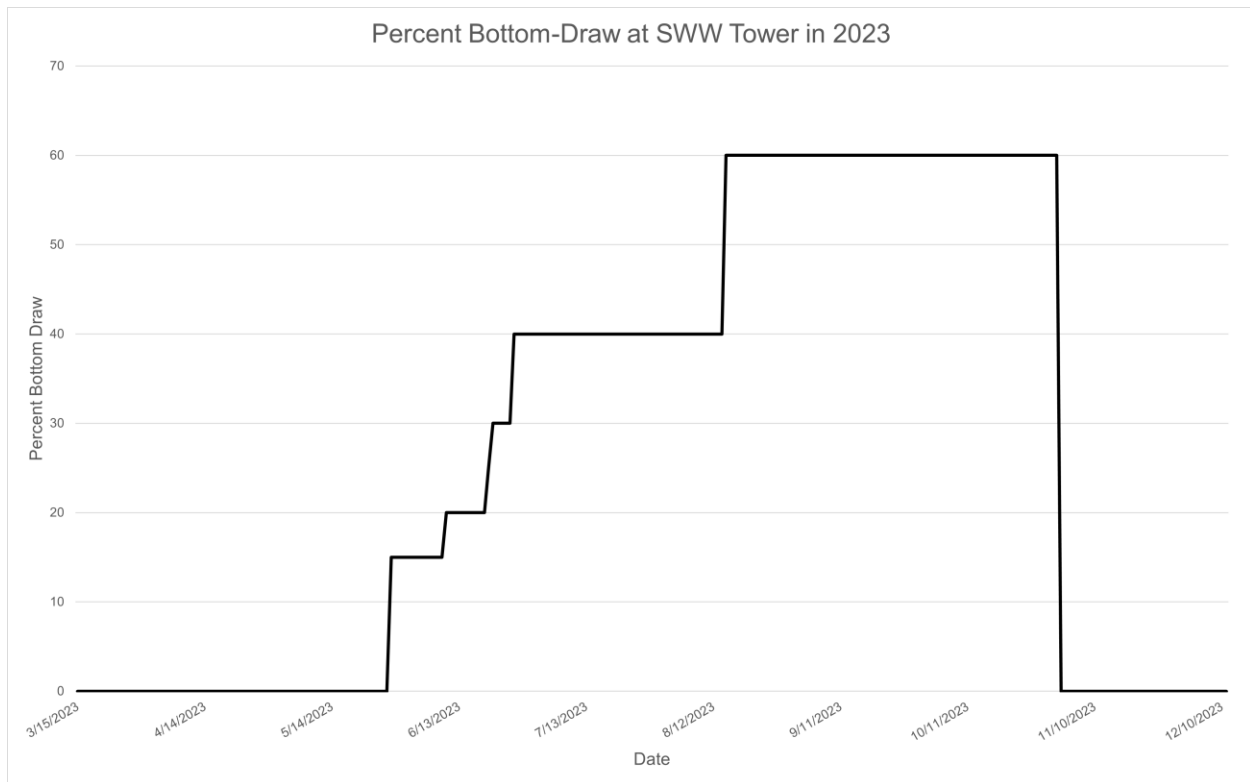
Figure 17. Percent (%) bottom-draw at the Selective Water Withdrawal Tower in 2023. Maximum bottom draw is ~ 60-65%. Data source: adapted from PGE data report to ODEQ 2023.

Like recent years, the only bottom water releases of cold water from the SWW Tower occurred during summer months (Figure 16). Bottom draw began on May 28 with 15% bottom water being released. Bottom draw increased slowly until August 15 when operations switched to maximum bottom draw (60%). Maximum bottom draw remained in place until November 1 when operations shifted back to 100% surface draw.

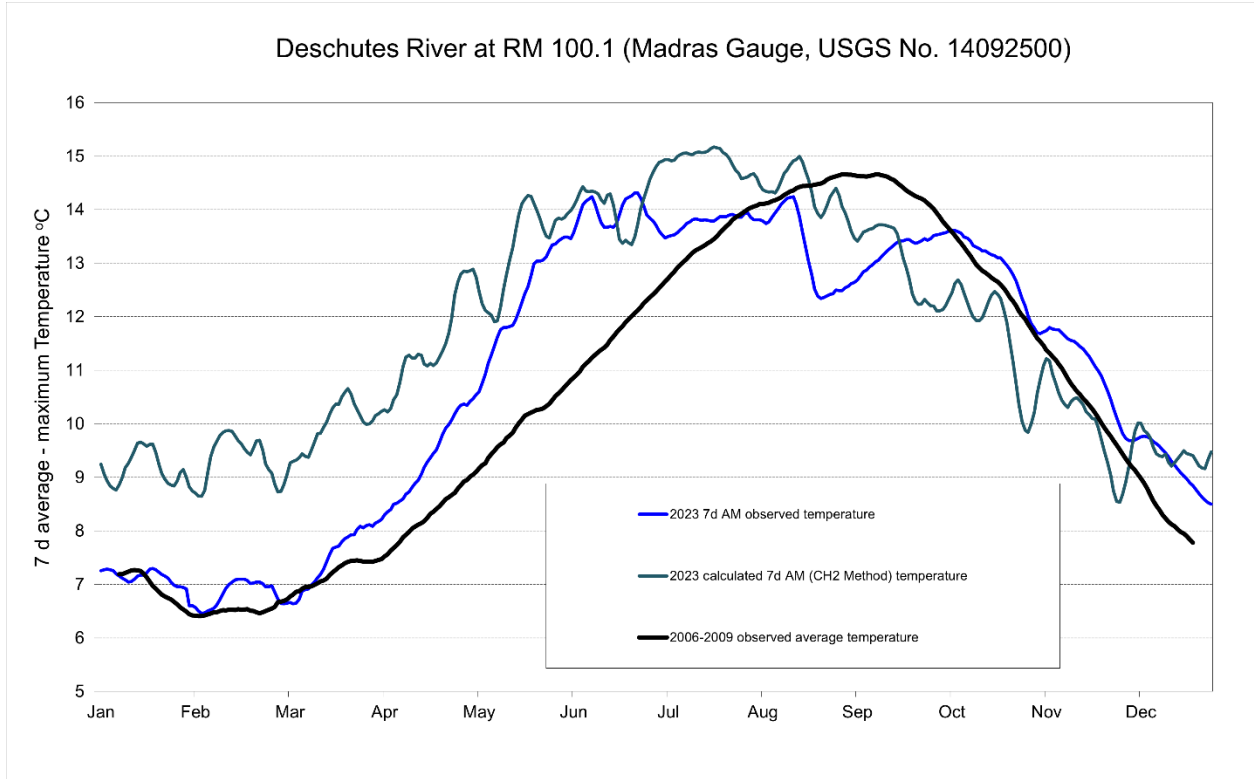
Figure 18. Licensees modeled and observed 7DADM water temperatures at the Reregulating Dam tailrace. Graphic depicts the intentional shift in water temperatures of the lower Deschutes River as a result of SWW Tower operations. Source: retrieved from PGE data reporting to ODEQ in 2023.
