SEISMIC RETROFIT  
OF UNREINFORCED  
MASONRY HERITAGE  
CHURCHES IN THE  
PHILIPPINES

JANUARY 13 – 14, 2016

# Global Seismic Responses of Unreinforced Heritage Masonry Construction

prof. eng. Claudio Modena

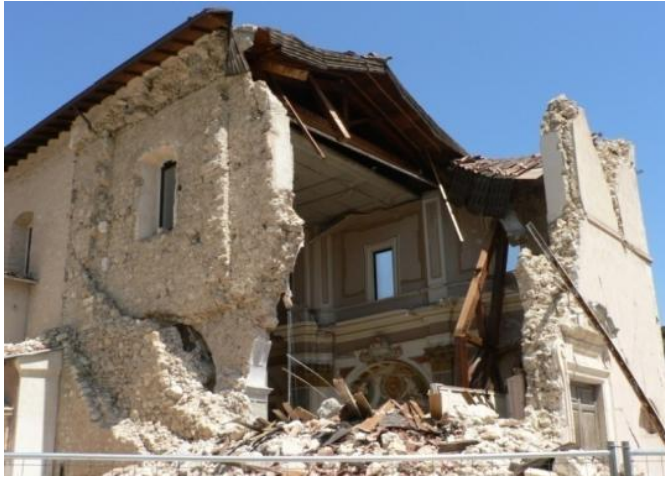
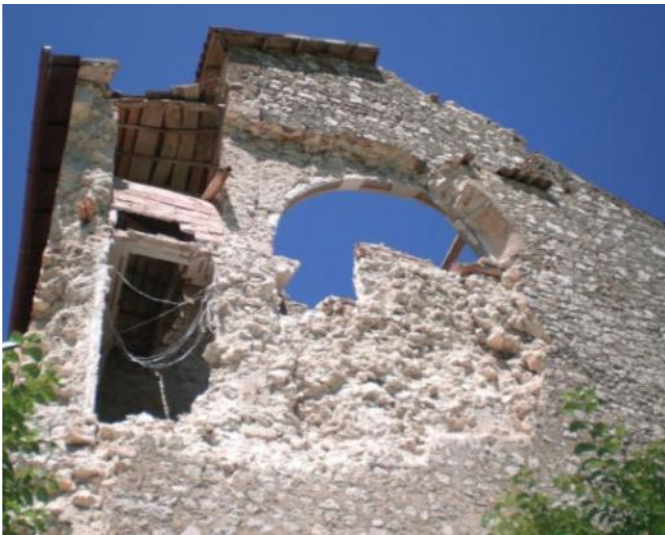
San Michele, Villa Sant' Angelo

# THE PROBLEM OF MASONRY QUALITY

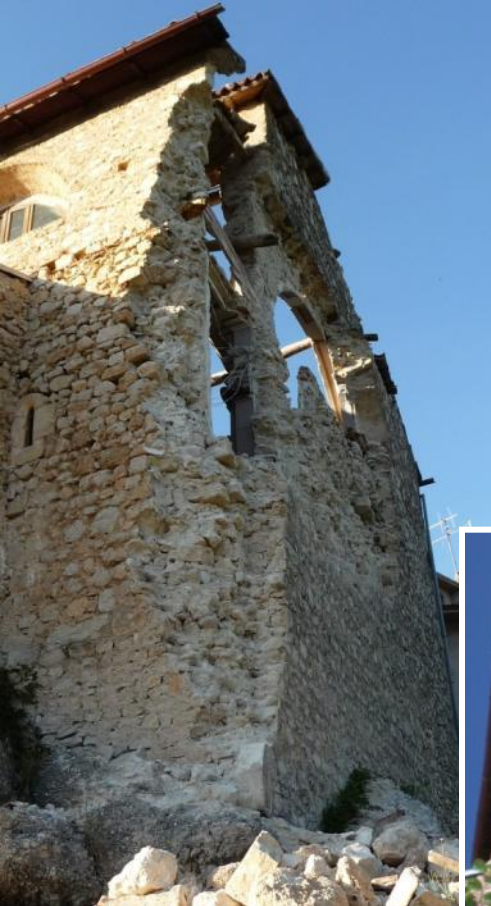
**SAN GIOVANNI, SAN  
DEMERIO NEI VESTINI**

## THE PROBLEM OF MASONRY QUALITY

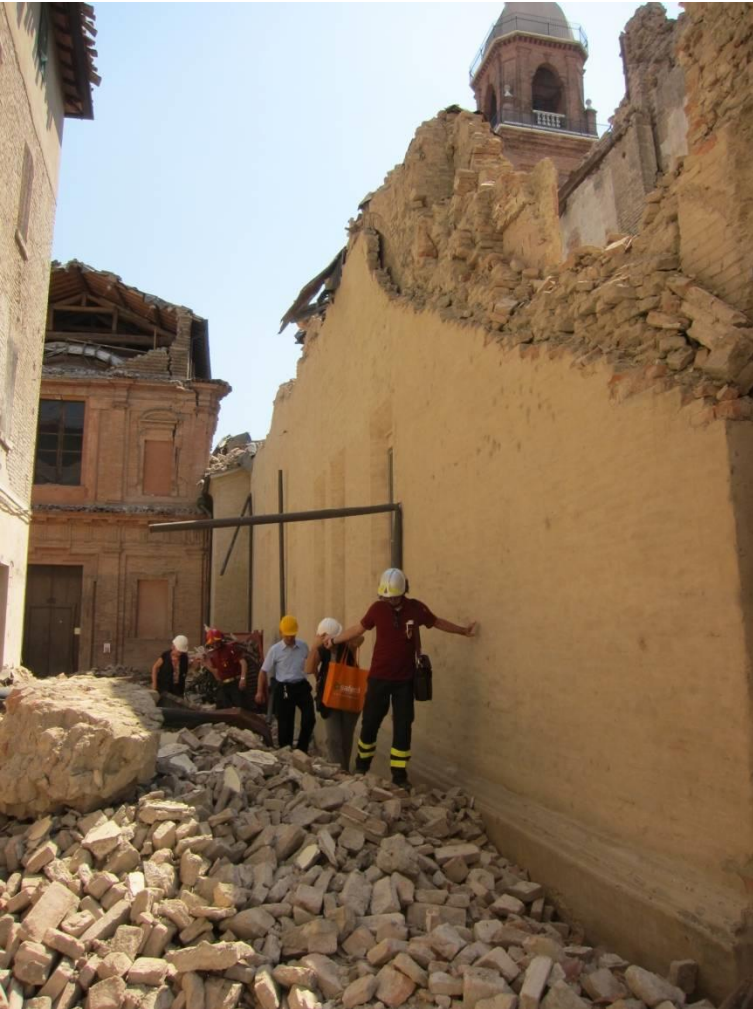
Collegiata Santa Maria Maggiore, Mirandola

## THE PROBLEM OF MASONRY QUALITY

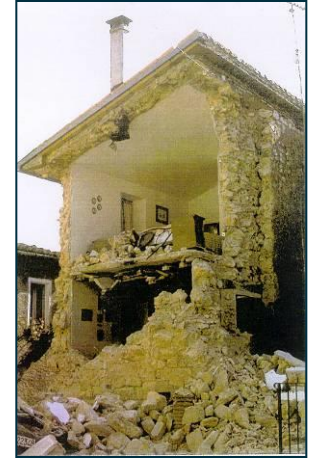
- **Structural causes:**

Scarce connection between orthogonal walls

Absence of ties and tie beams

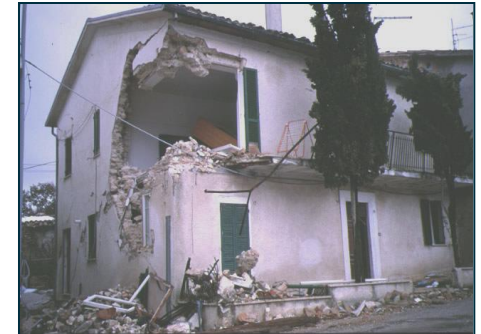
- **Damage:**

Collapse of the corner

- **Structural causes:**

Scarce connection between orthogonal walls and between floors and walls

Presence of openings close by the corner

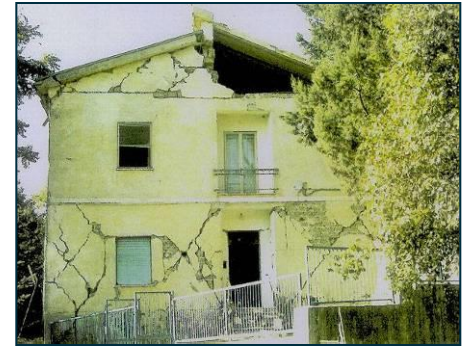
Scarce connection between roof and orthogonal walls

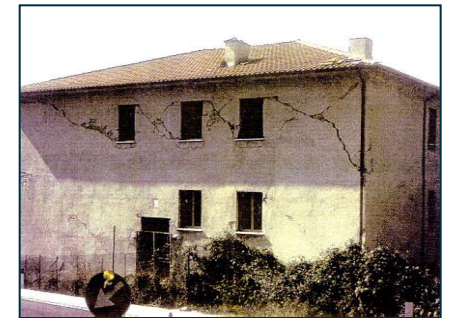
### Shear cracking in the masonry piers

Crossed (in the central masonry piers) or inclined diagonal cracks in the squat masonry piers

Shear cracking of the wall under in-plane actions

Presence of many openings

Scarce quality of the masonry or presence of discontinuities

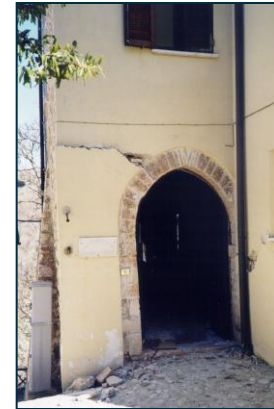
### In plane overturning of the masonry piers

Horizontal cracks (tensioned corner) localized mainly at the base of the building

Eventual crushing of the compressed toe, due to attainment of maximum compressive strength

Excessive slenderness of the masonry piers due to the presence of many openings or large openings

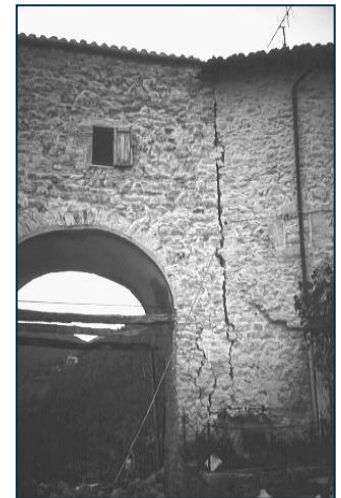
### Buildings interaction: detachment of adjacent buildings

Vertical cracking at the joint between adjacent buildings

Scarce connection between the buildings

Different stiffness of connecting structural bodies

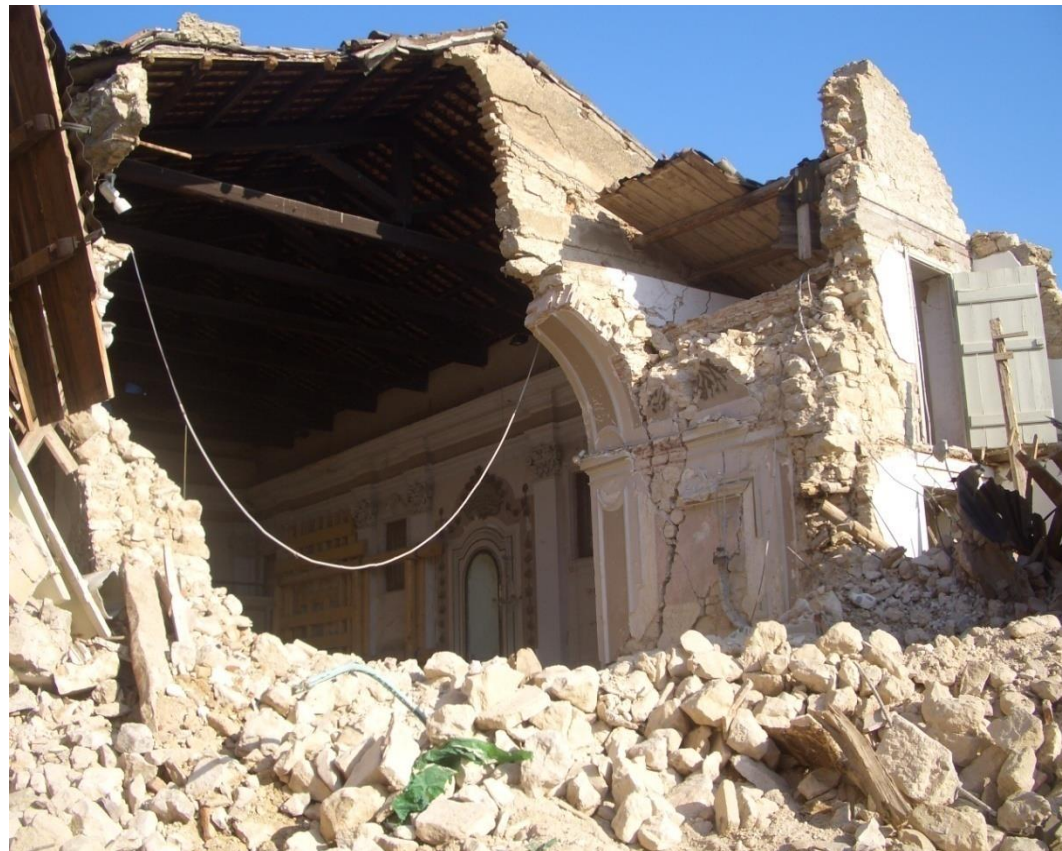
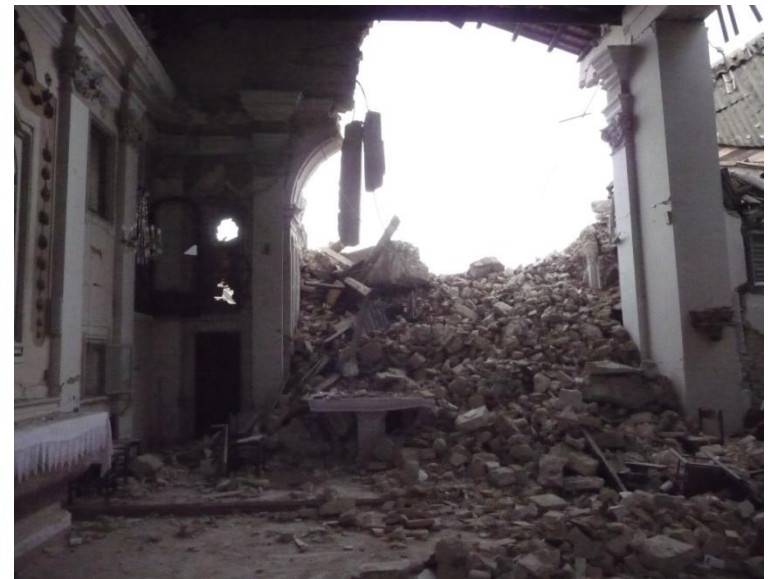
### St. Pietro Apostolo – Onna, L'Aquila

The German government immediately signaled desire to help the local community, it **especially** financed the rebuilding of the church, dedicated to St. Pietro Apostolo, also severely damaged by the seismic action.

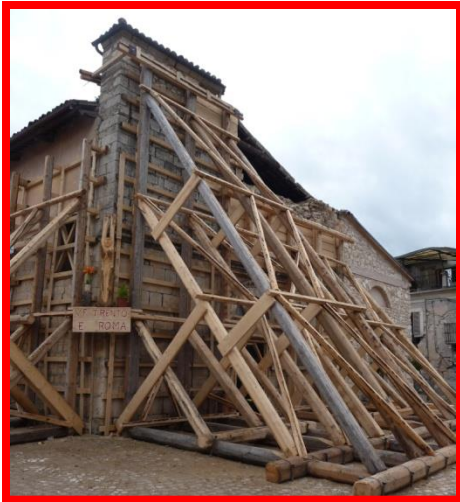
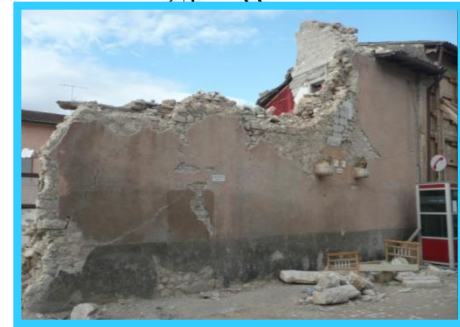
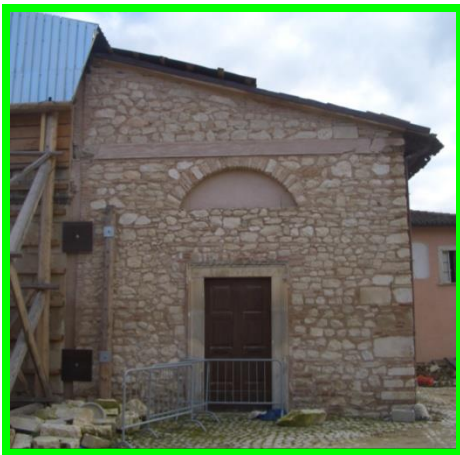
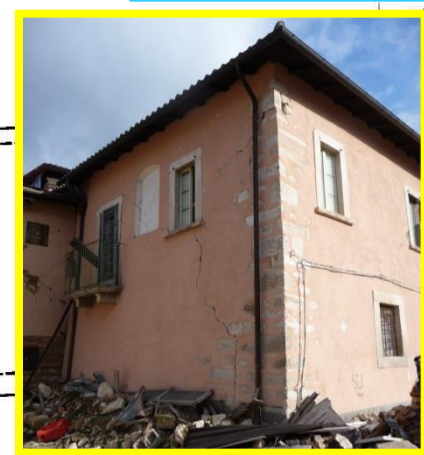
The church is included in an **AGGREGATE**, that include some buildings with different history and structural typology.

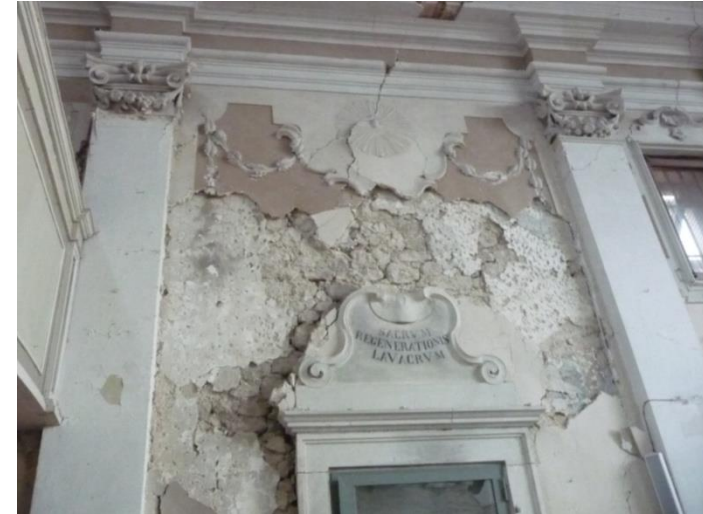
LEFT LONGITUDINAL WALL – PRESENCE OF OPENINGS AND NICHES

The longitudinal walls show the damages due to their in plane behaviour. The presence of several niches and openings worsen the wall property.

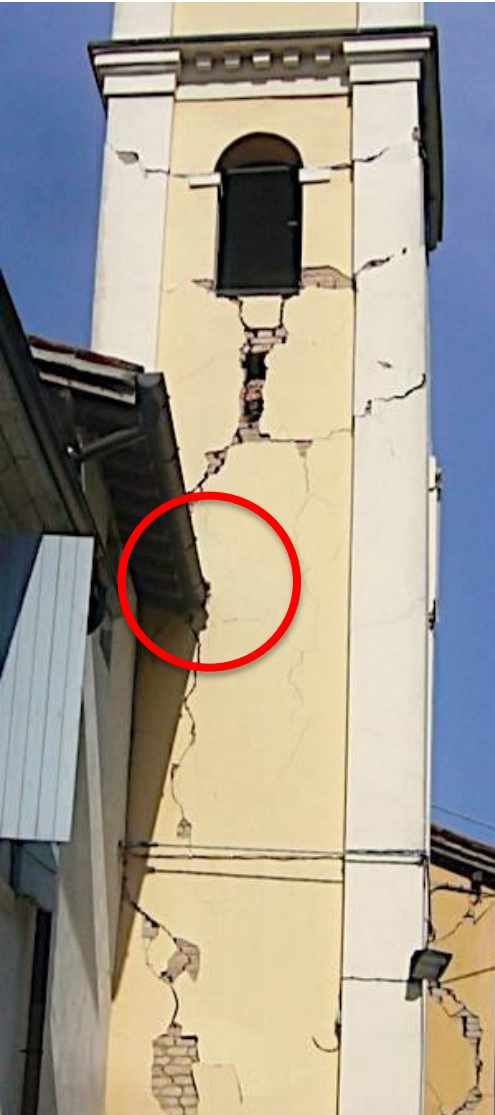
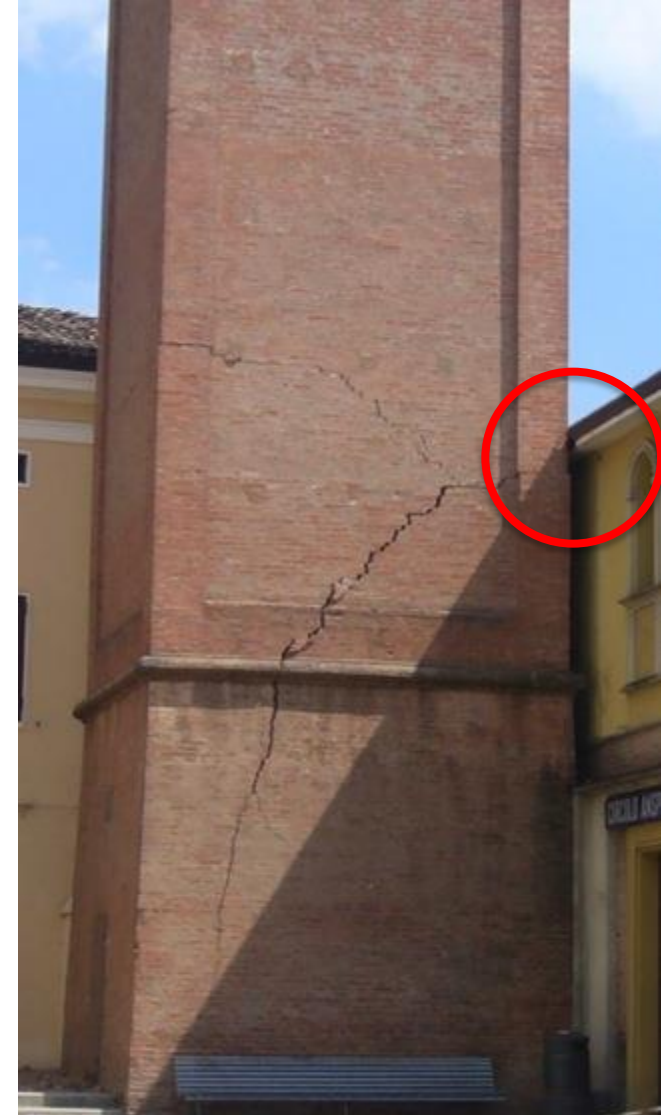
## Bell towers connected to other buildings

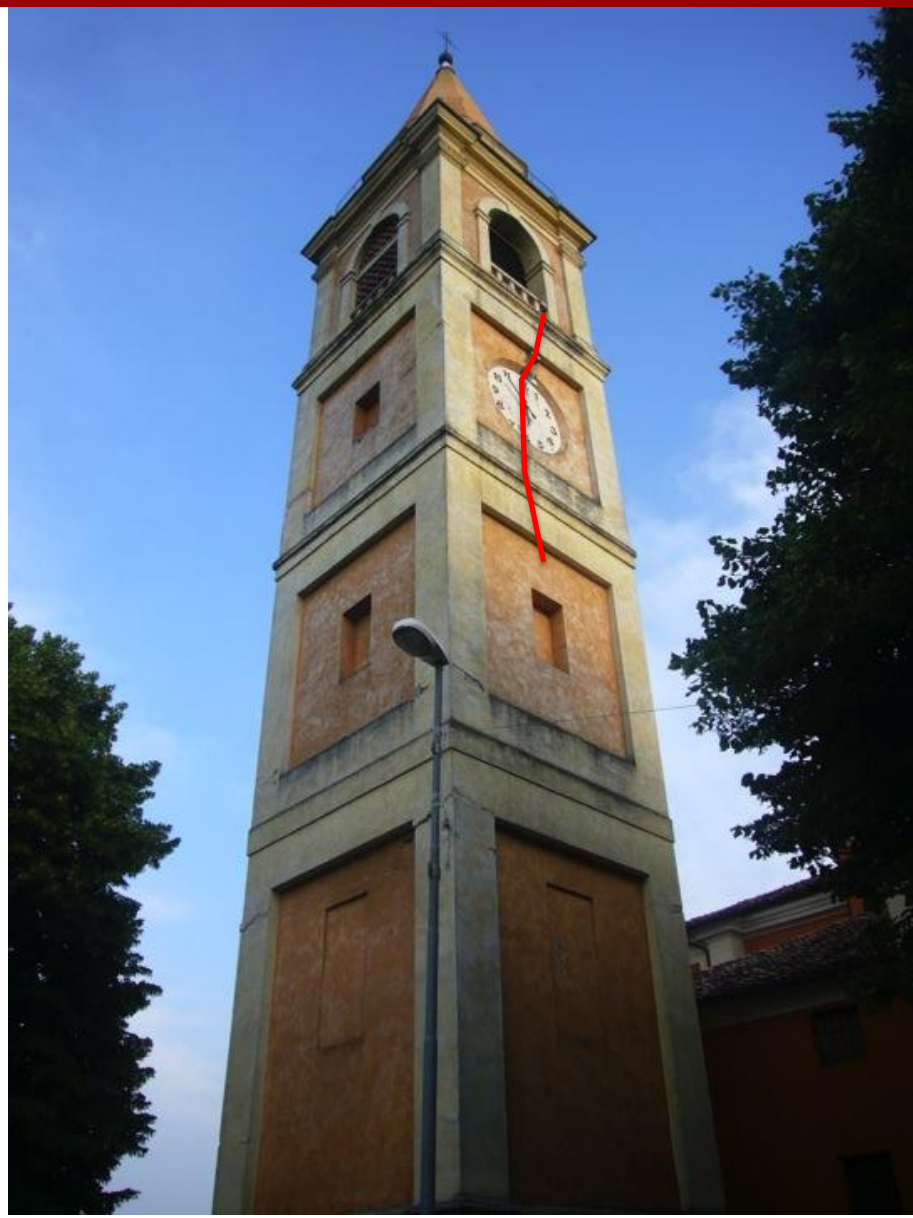
San Pietro - Fossa

# Isolated bell towers

vertical cracks

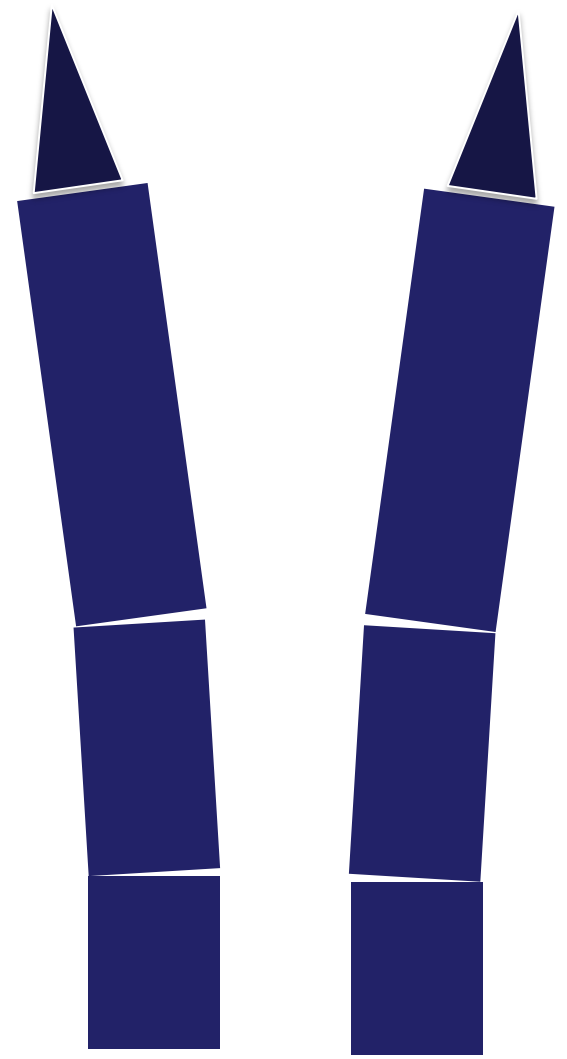
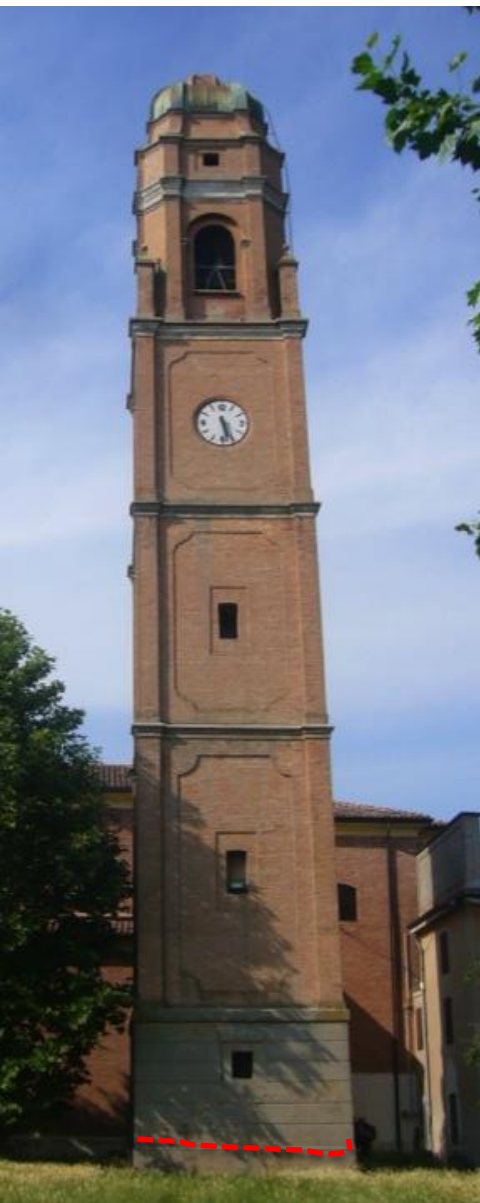
Isolated bell  
towers

horizontal  
cracks

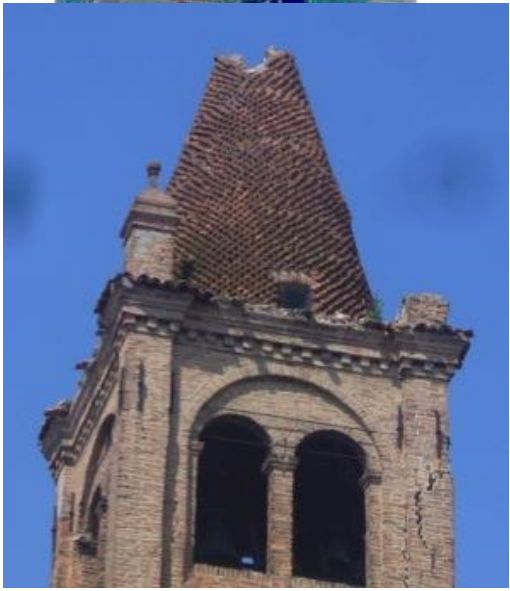
Spires

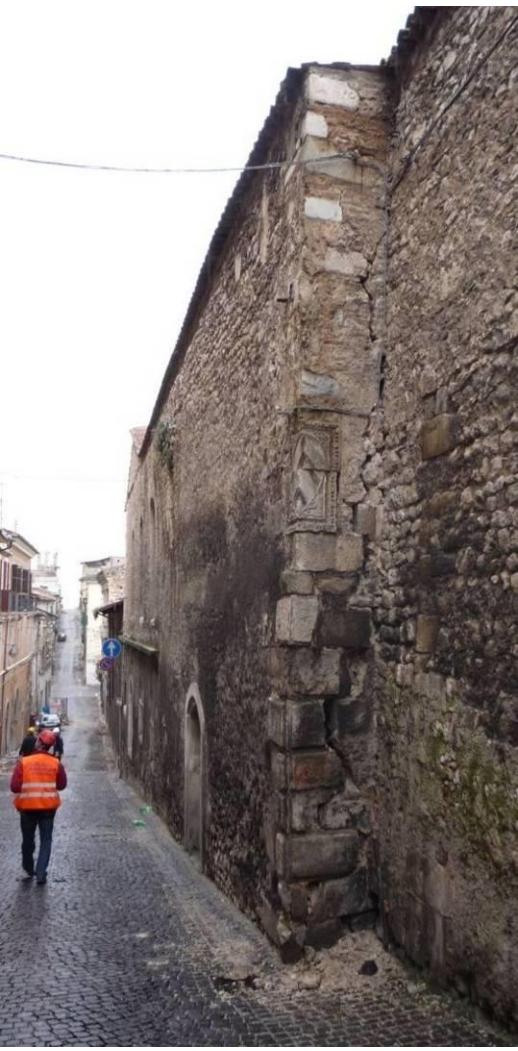
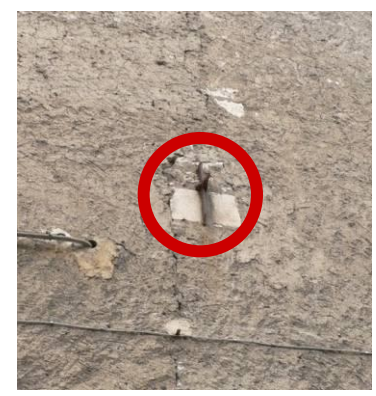
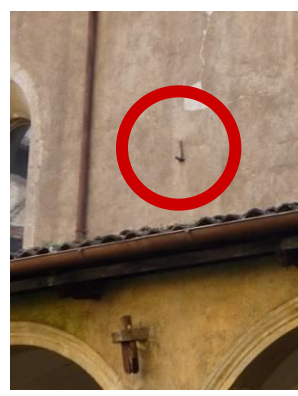
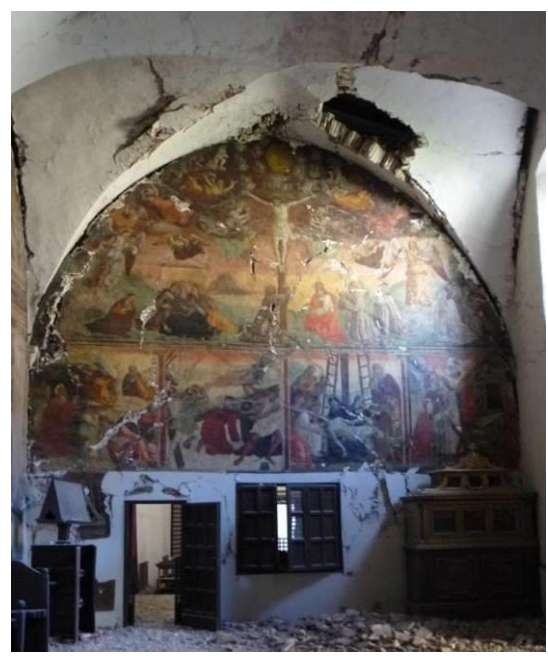
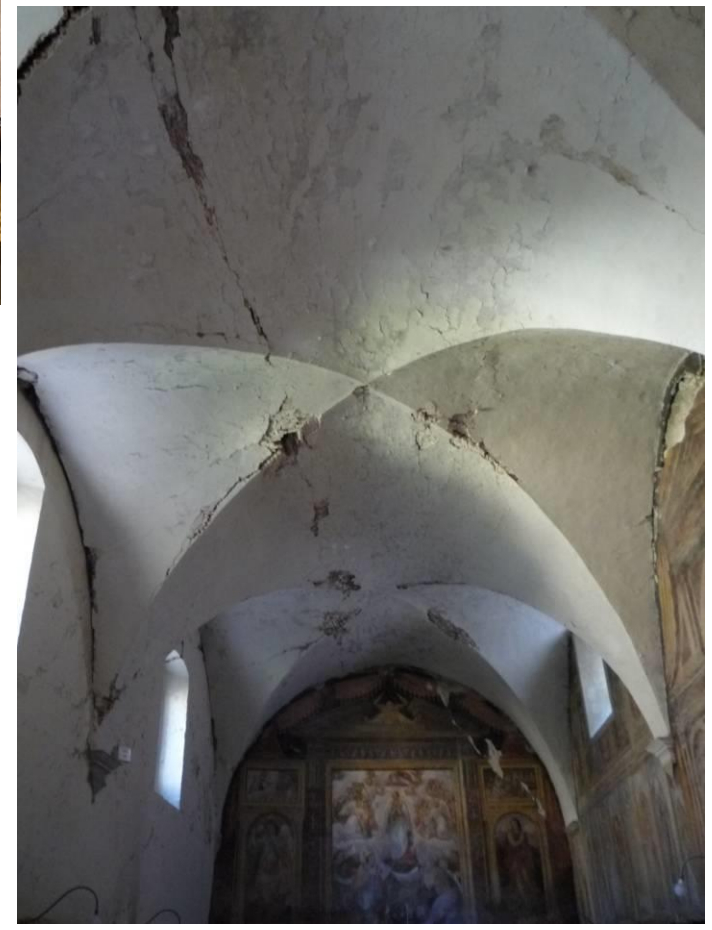
**BEATA ANTONIA, L'AQUILA**

# DAMAGE DUE TO PAST INTERVENTIONS: ABSENCE OF TIES

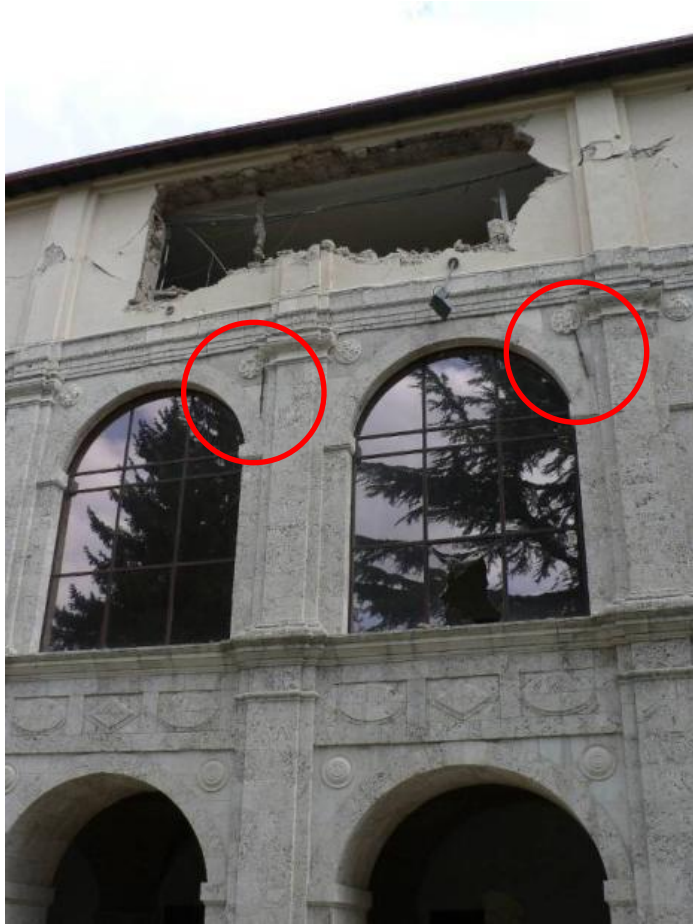
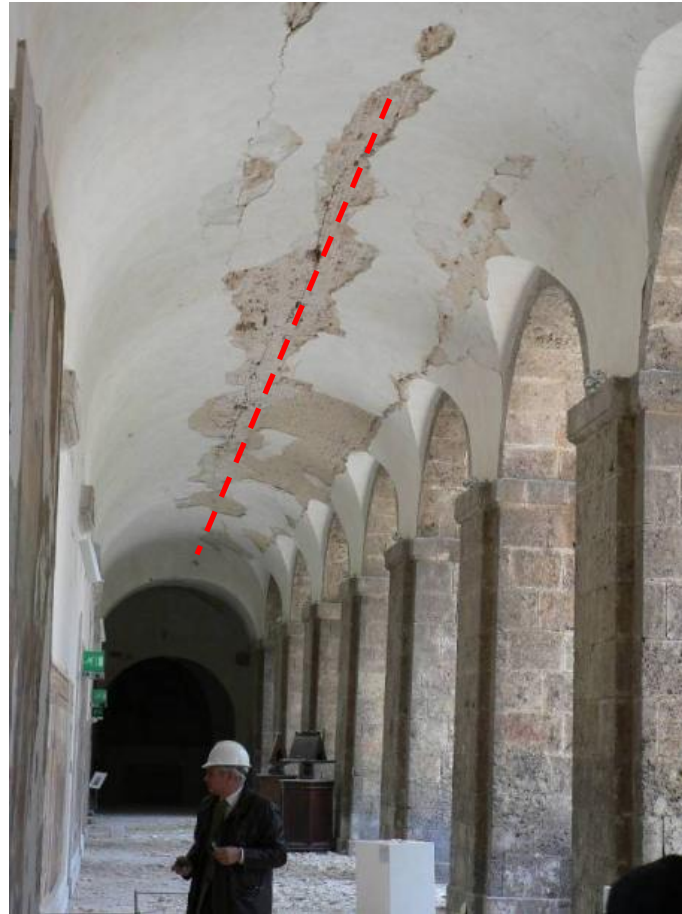
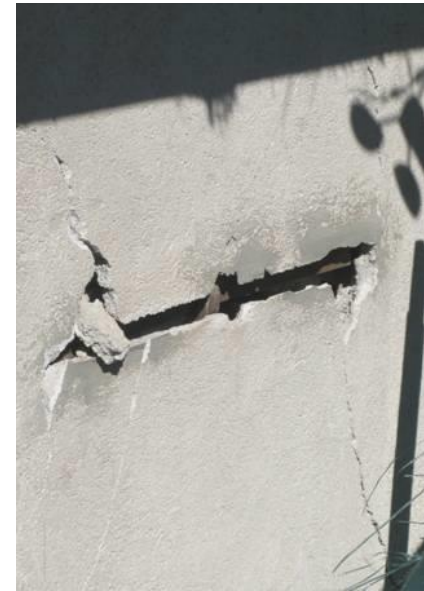
SPANISH  
FORTRESS,  
L'AQUILA

## DAMAGE DUE TO PAST INTERVENTIONS: ABSENCE OF TIES

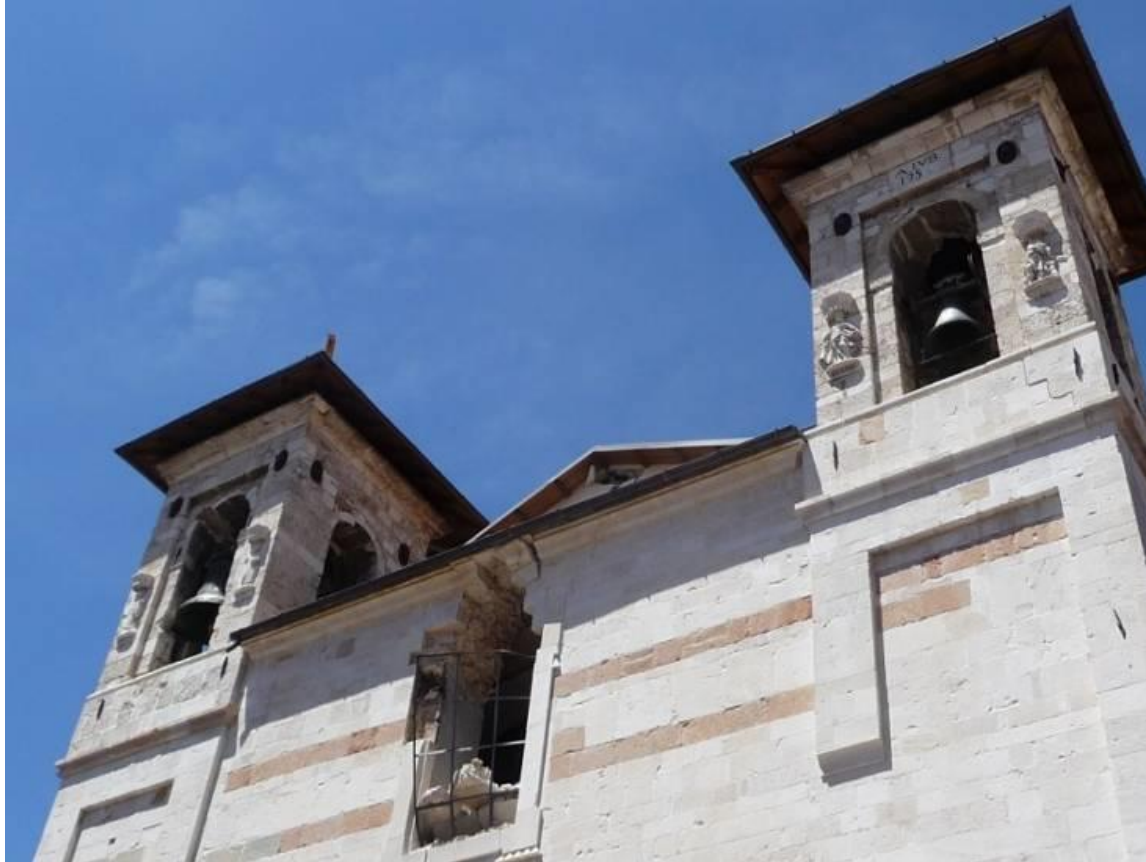
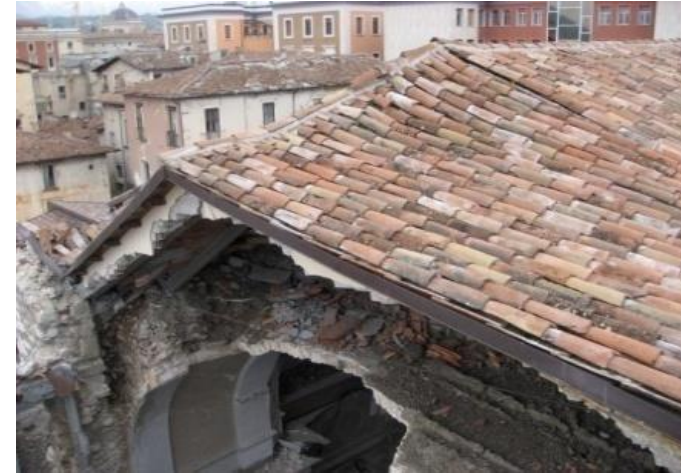
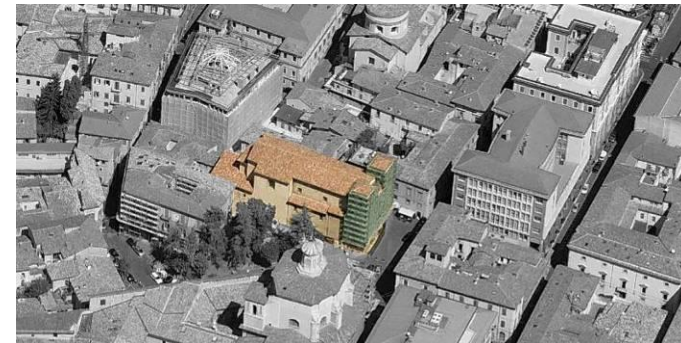
### SAN MARCO, L'AQUILA

## USE OF REINFORCED CONCRETE

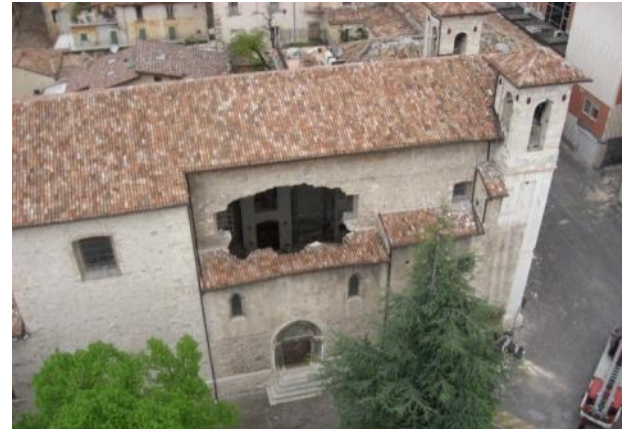
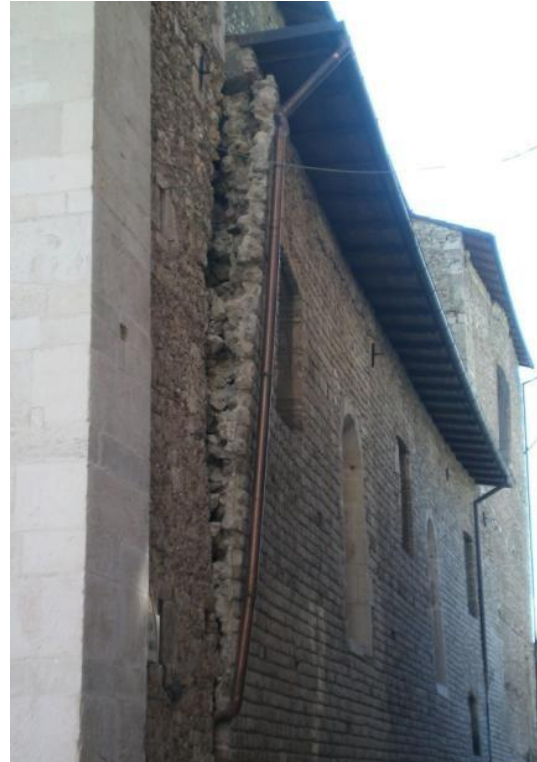
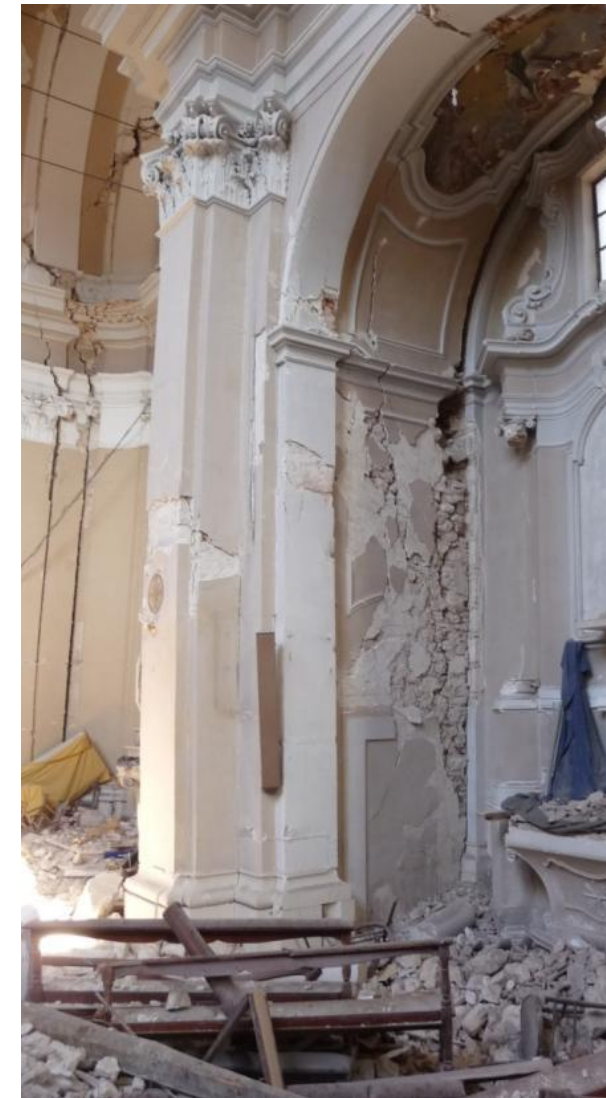
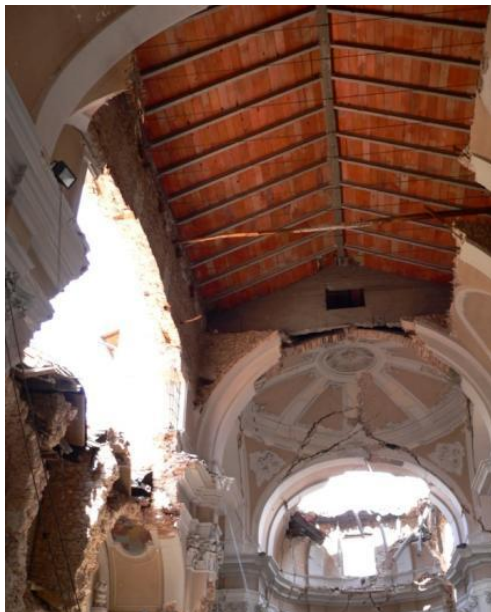
### SAN MARCO, L'AQUILA

## USE OF REINFORCED CONCRETE

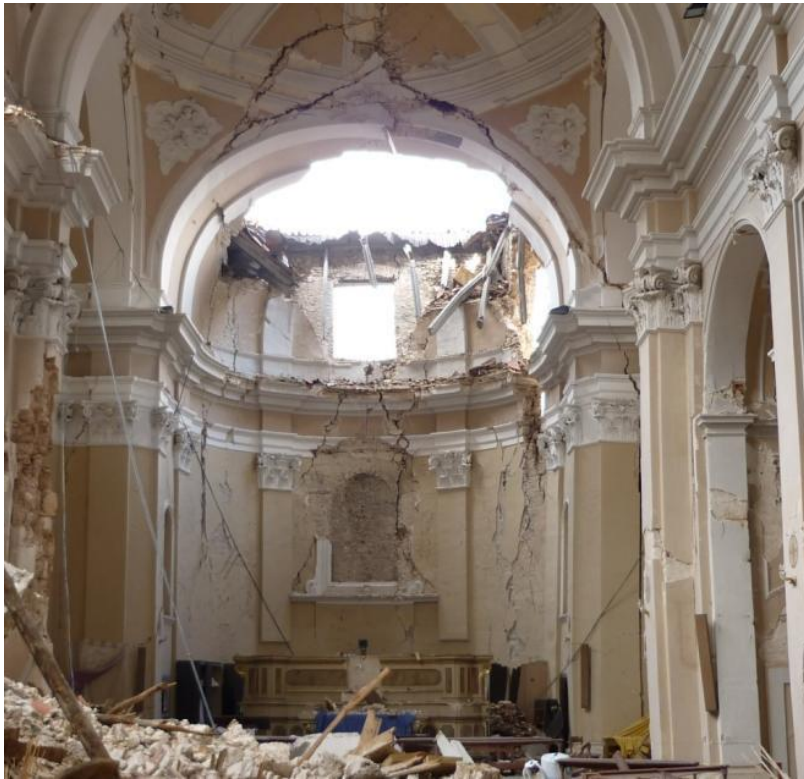
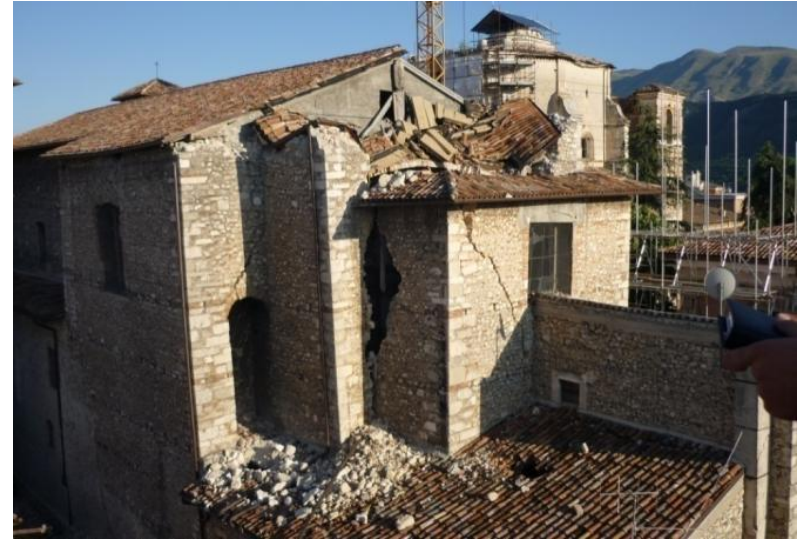
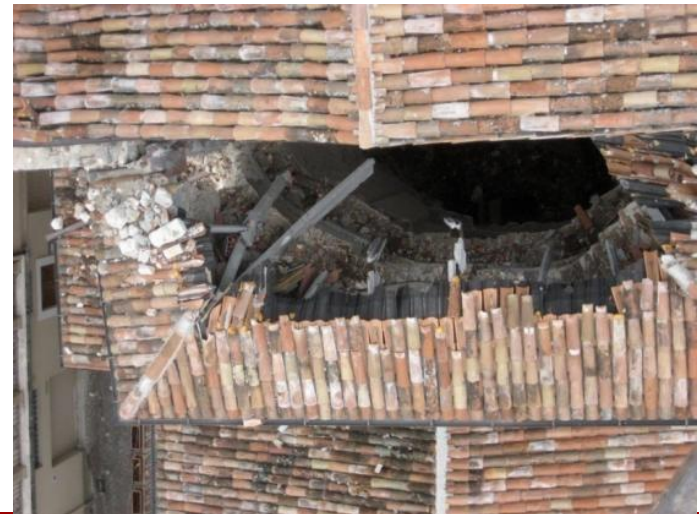
### SAN MARCO, L'AQUILA

## USE OF REINFORCED CONCRETE

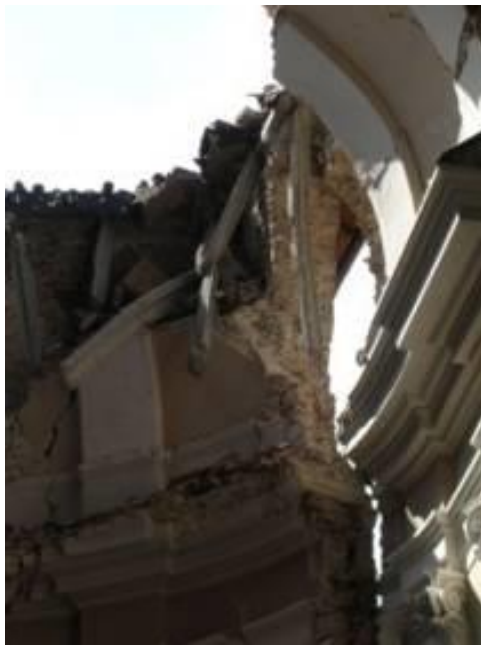
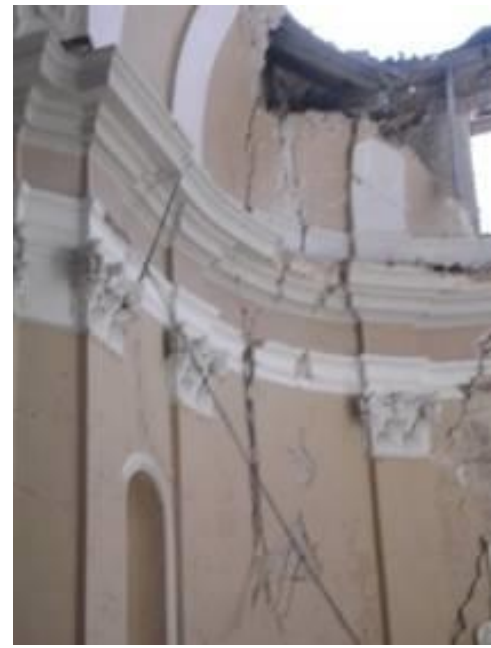
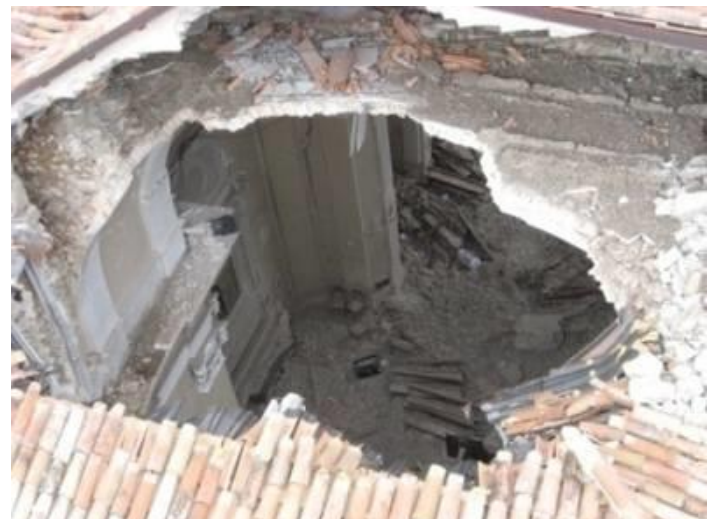
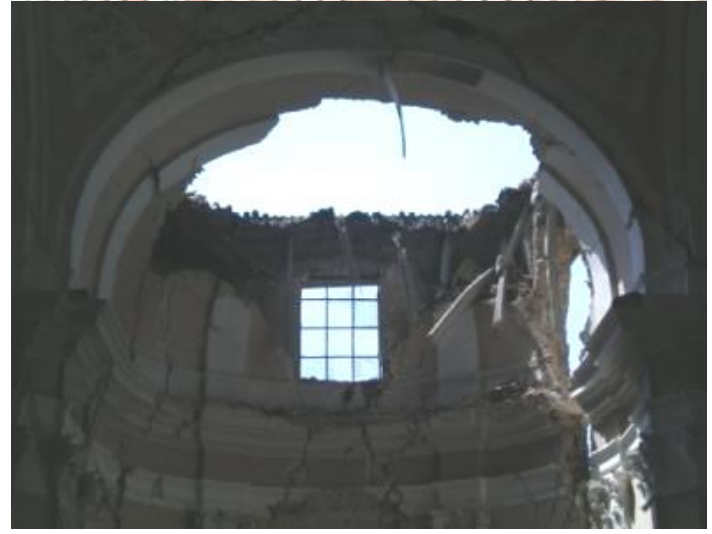
## SAN MARCO, L'AQUILA

# USE OF REINFORCED CONCRETE

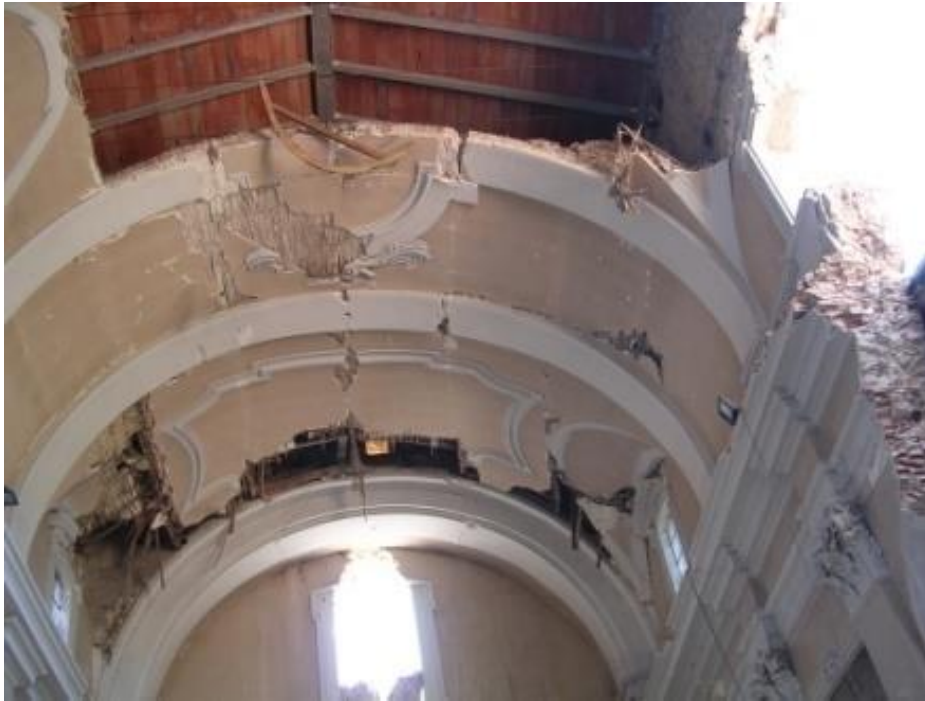
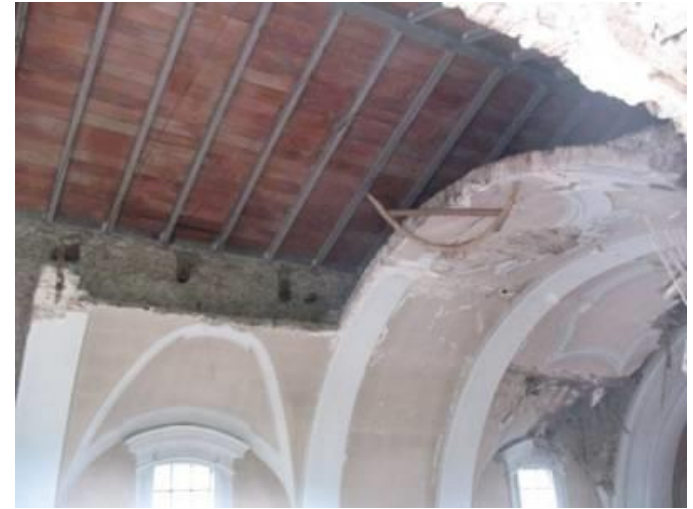
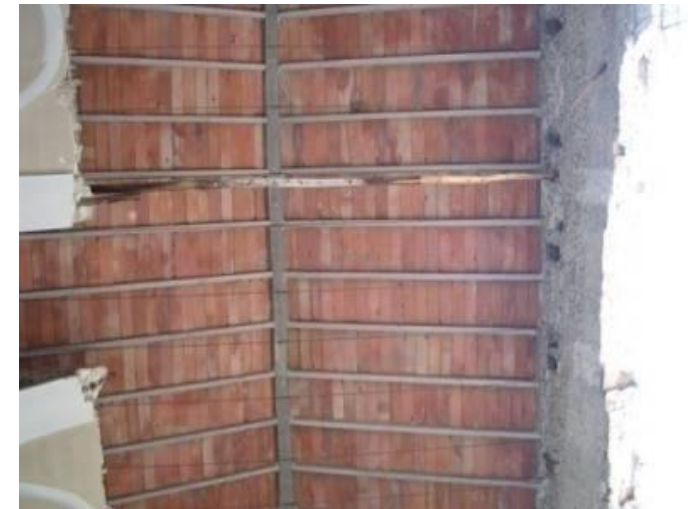
### SAN MARCO, L'AQUILA

## USE OF REINFORCED CONCRETE

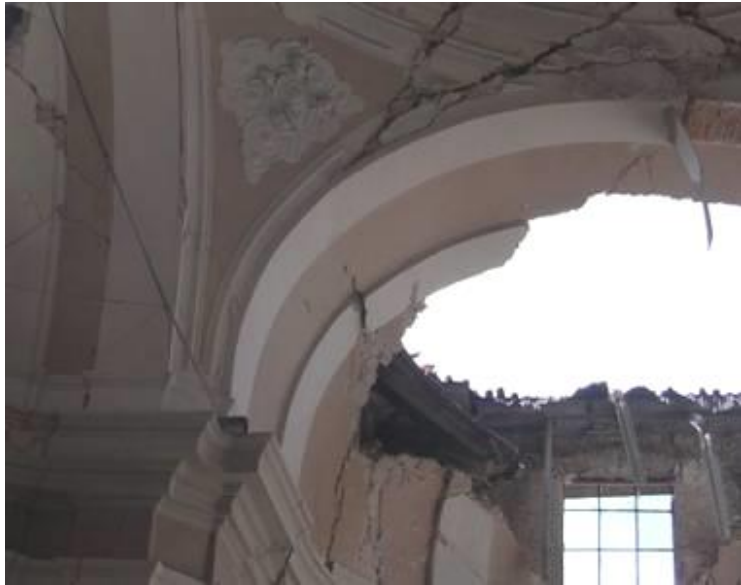
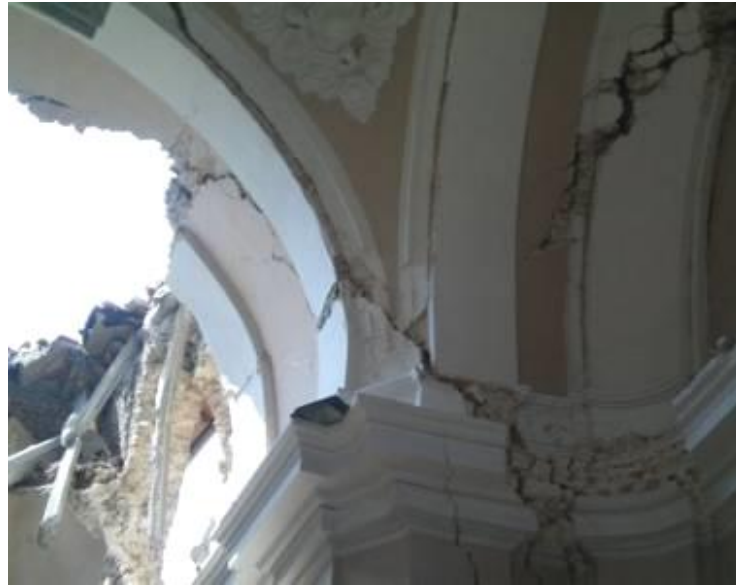
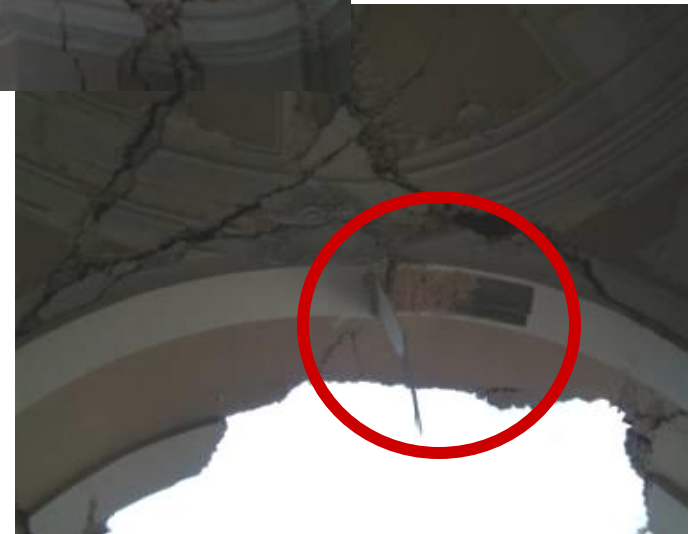
### SAN MARCO, L'AQUILA

## USE OF FRP
