SEISMIC RETROFIT  
OF UNREINFORCED  
MASONRY HERITAGE  
CHURCHES IN THE  
PHILIPPINES

JANUARY 13 – 14, 2016

# Global Seismic Responses of Unreinforced Heritage Masonry Construction

prof. eng. Claudio Modena

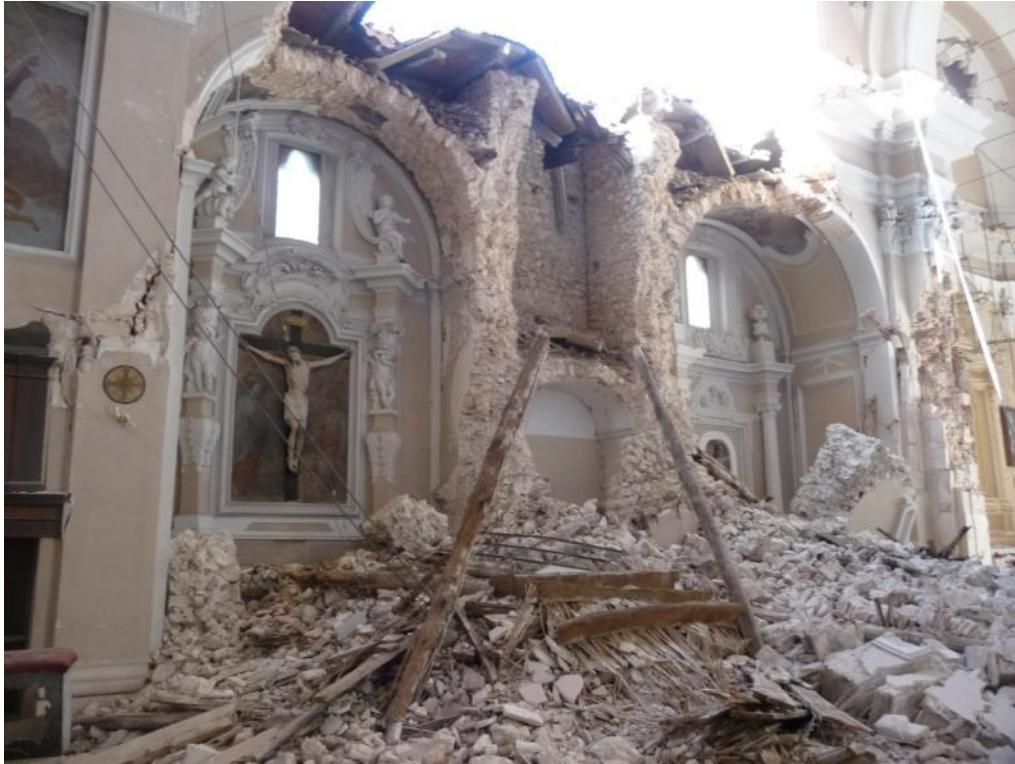
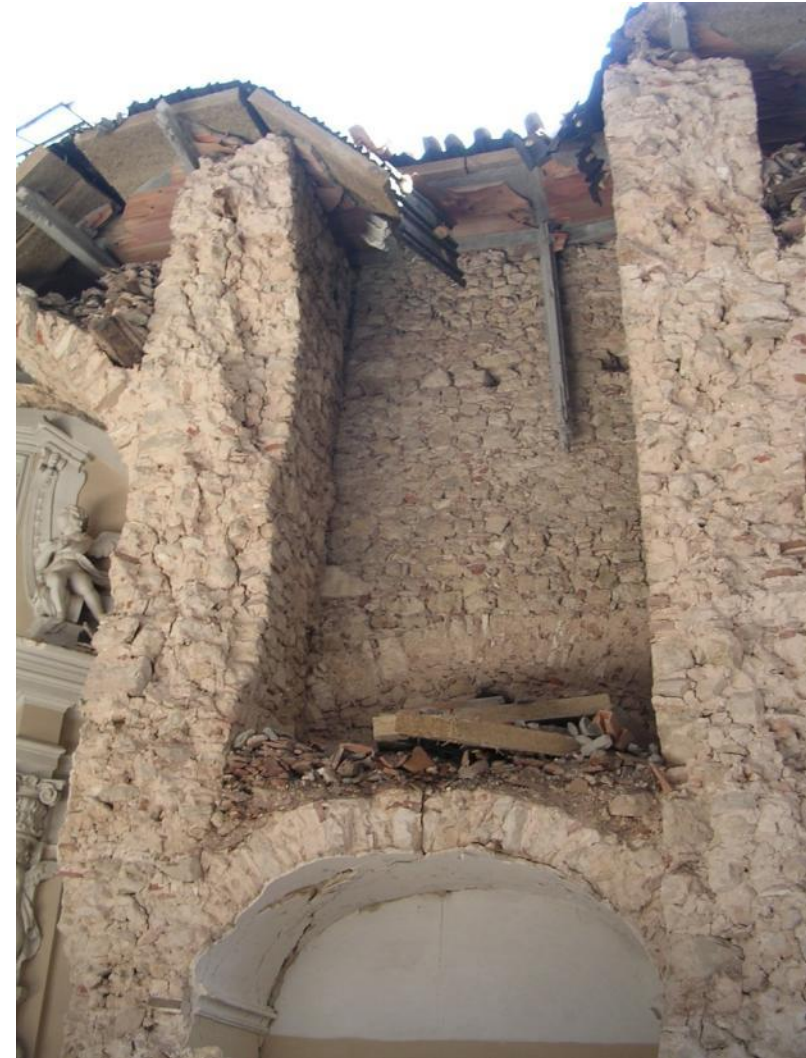
### SAN MARCO, L'AQUILA

## MASONRY QUALITY

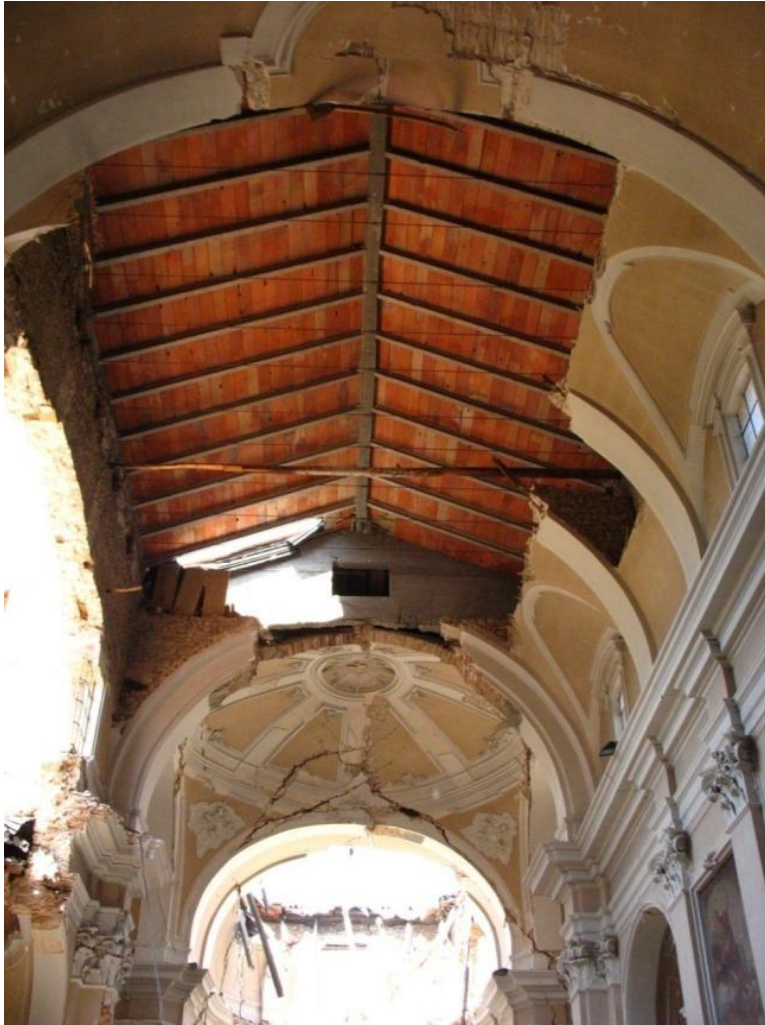
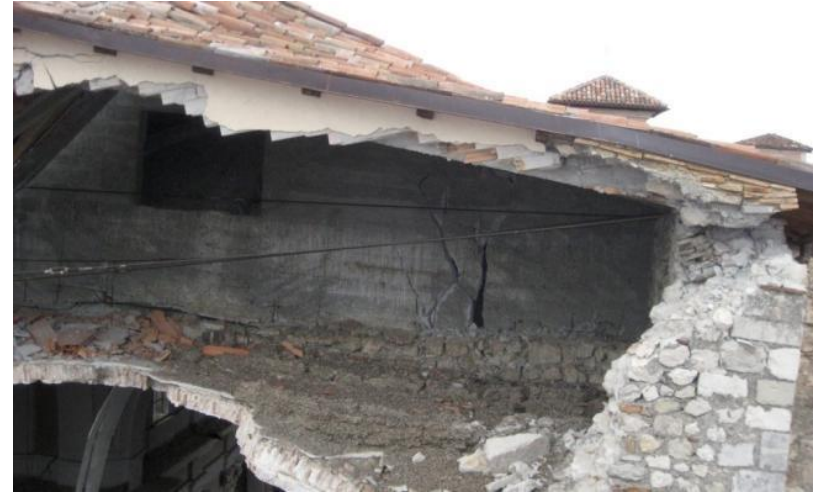
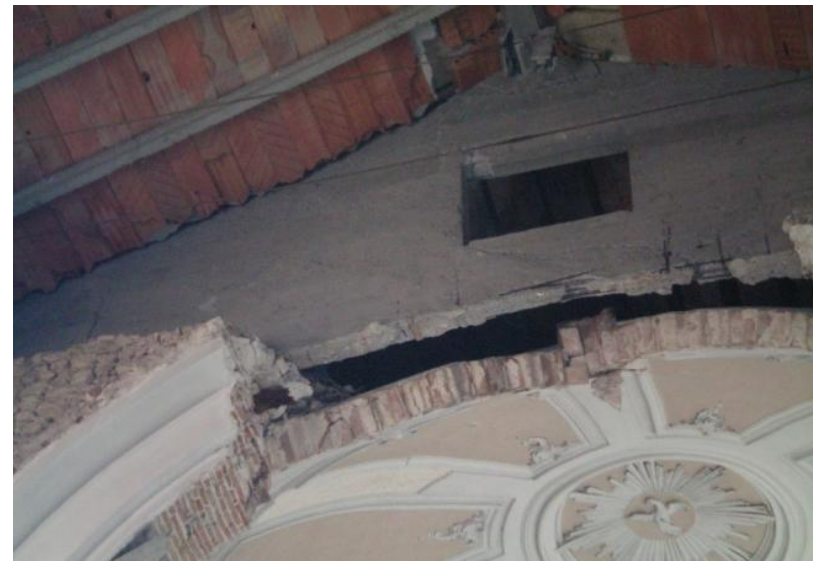
### SAN MARCO, L'AQUILA

## USE OF REINFORCED CONCRETE

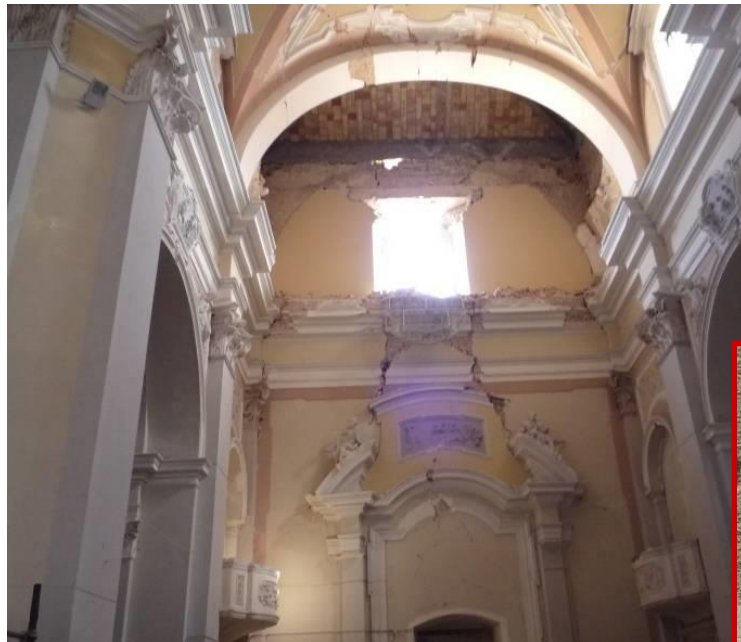
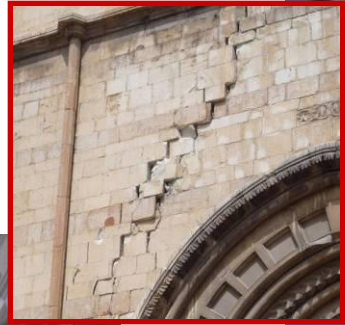
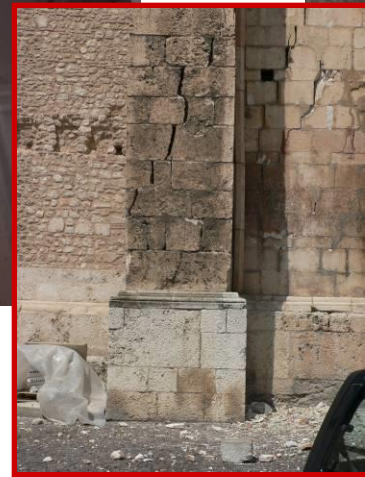
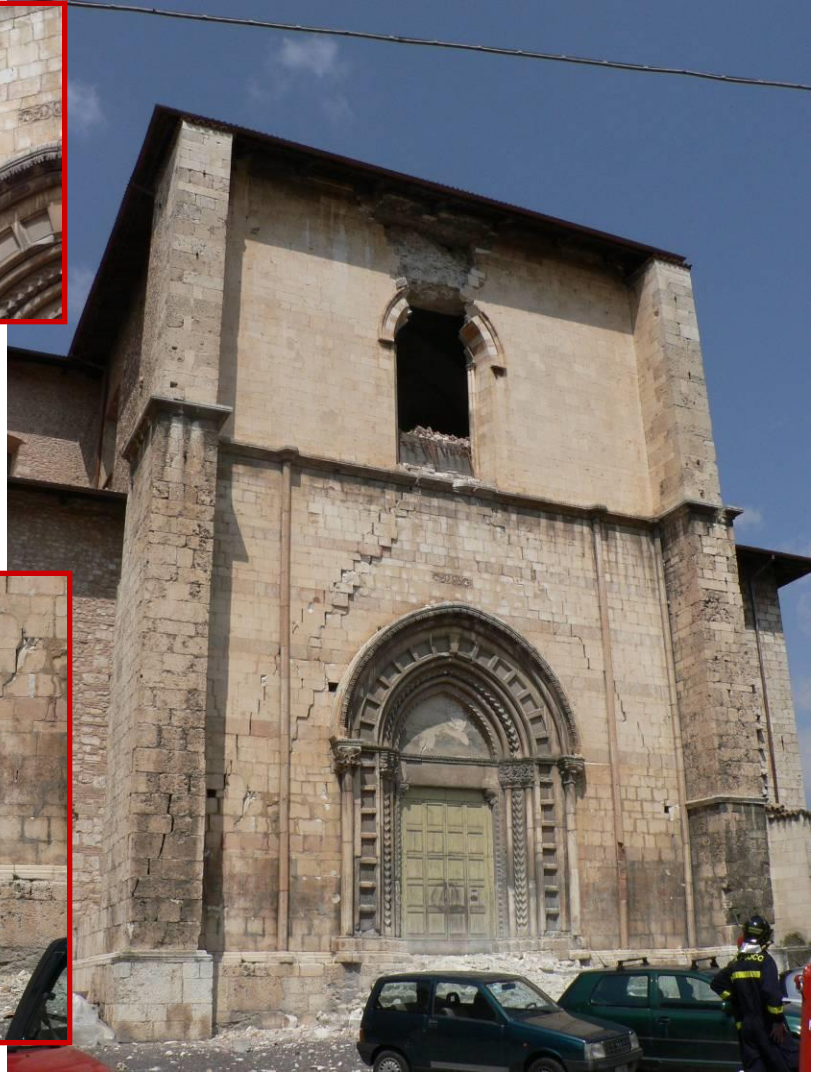
## SAN DOMENICO, L'AQUILA

# USE OF REINFORCED CONCRETE

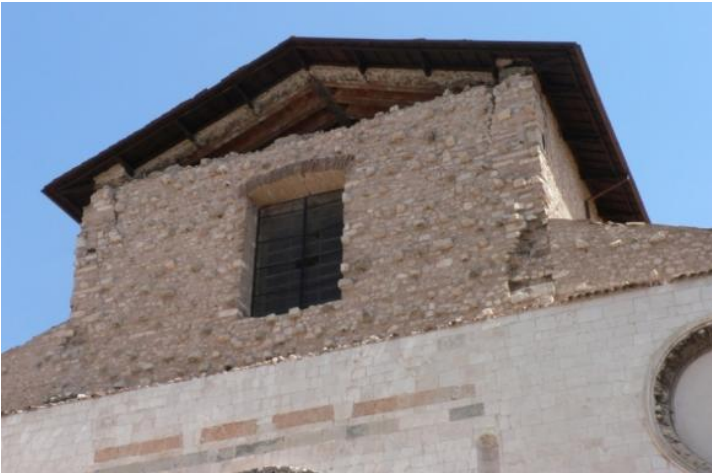
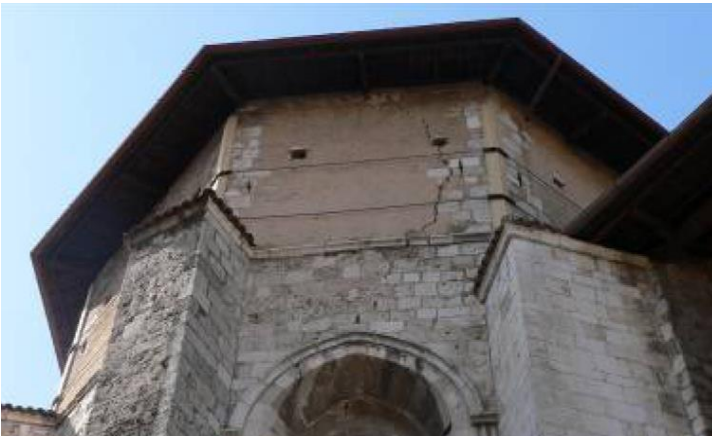
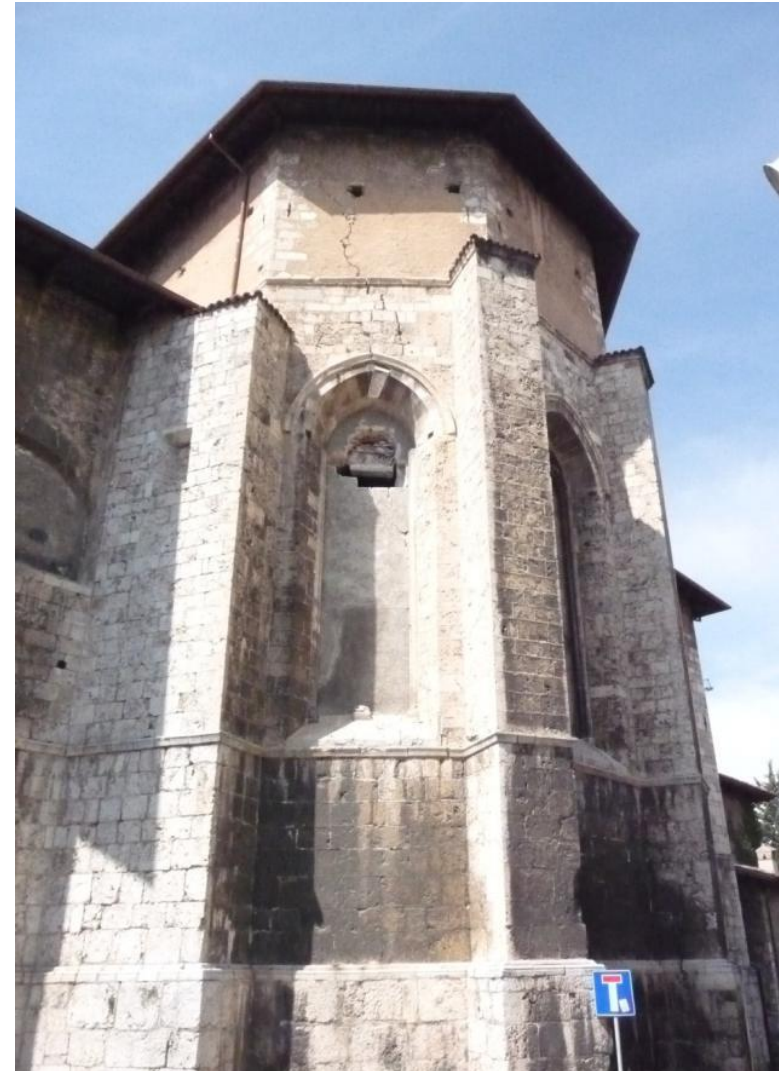
### SAN DOMENICO, L'AQUILA

## USE OF REINFORCED CONCRETE

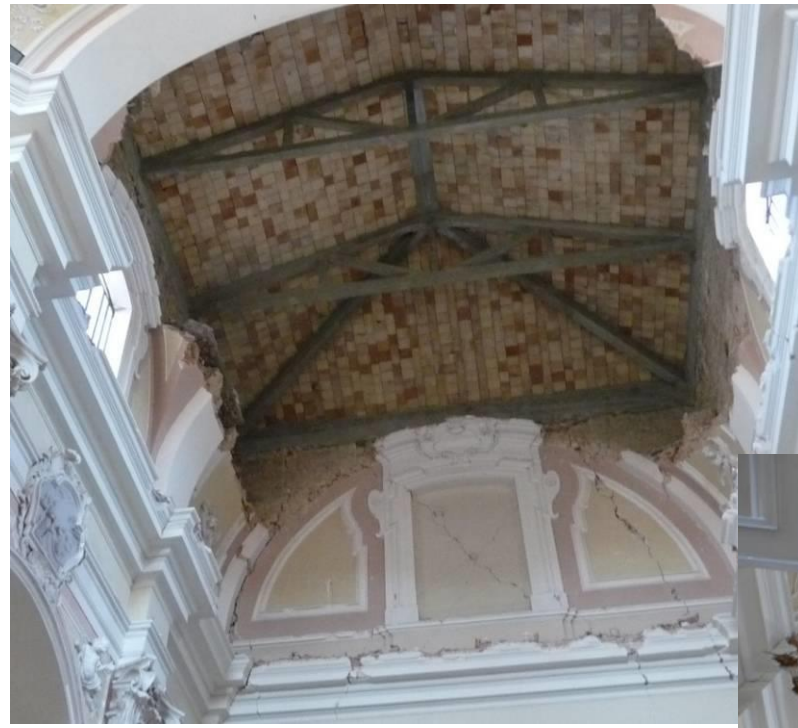
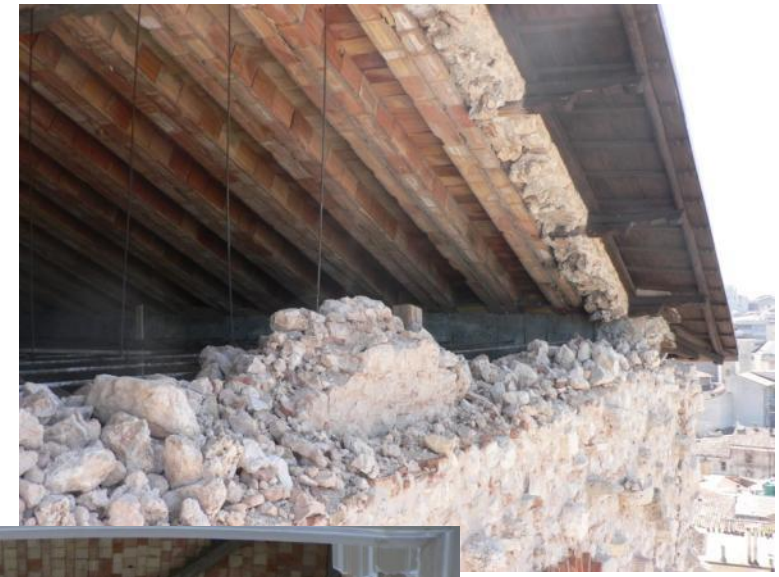
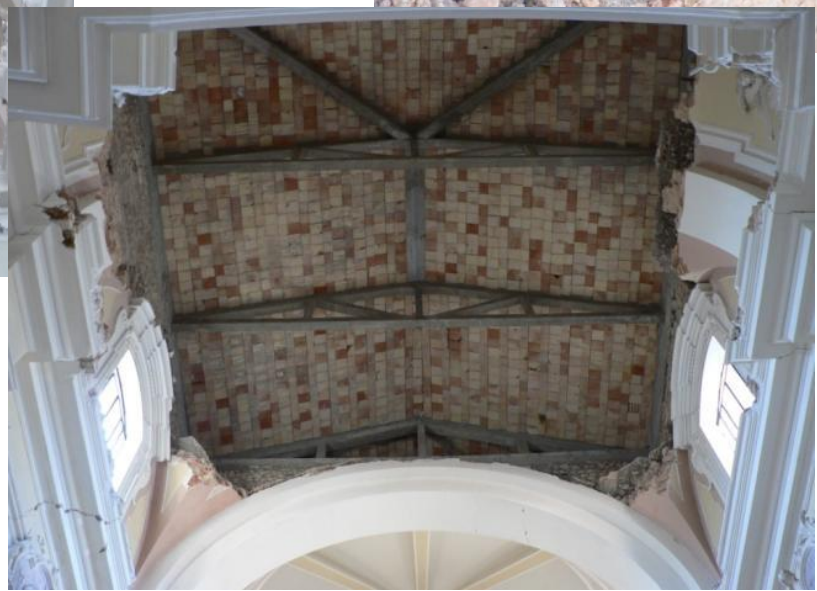
### SAN DOMENICO, L'AQUILA

## USE OF REINFORCED CONCRETE

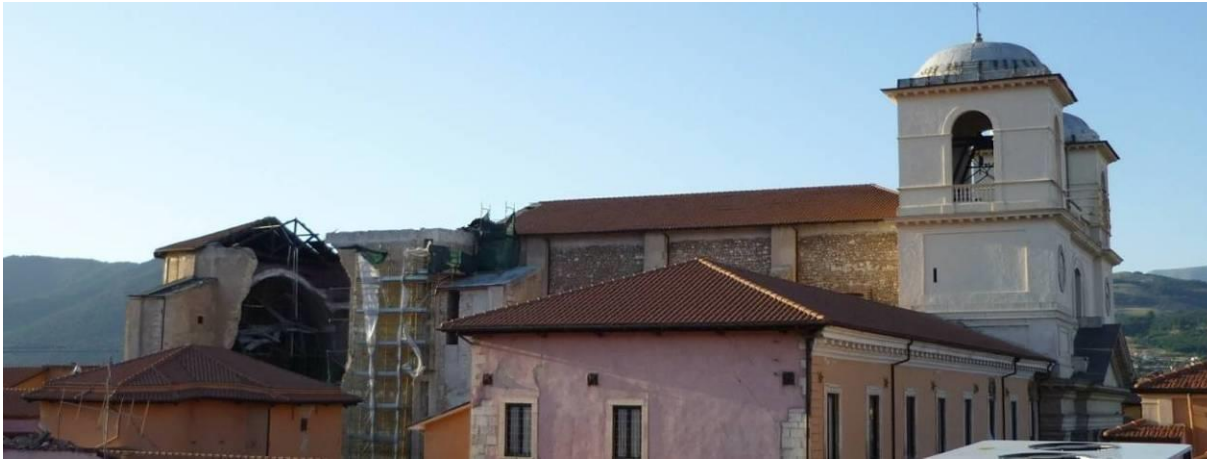
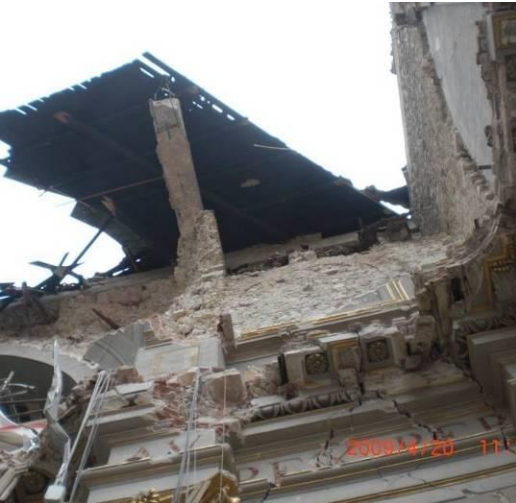
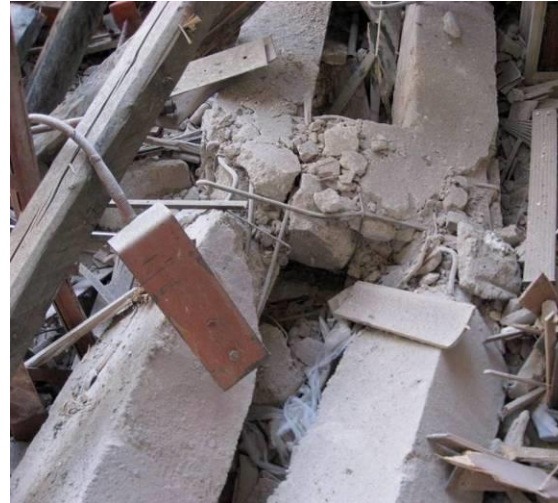
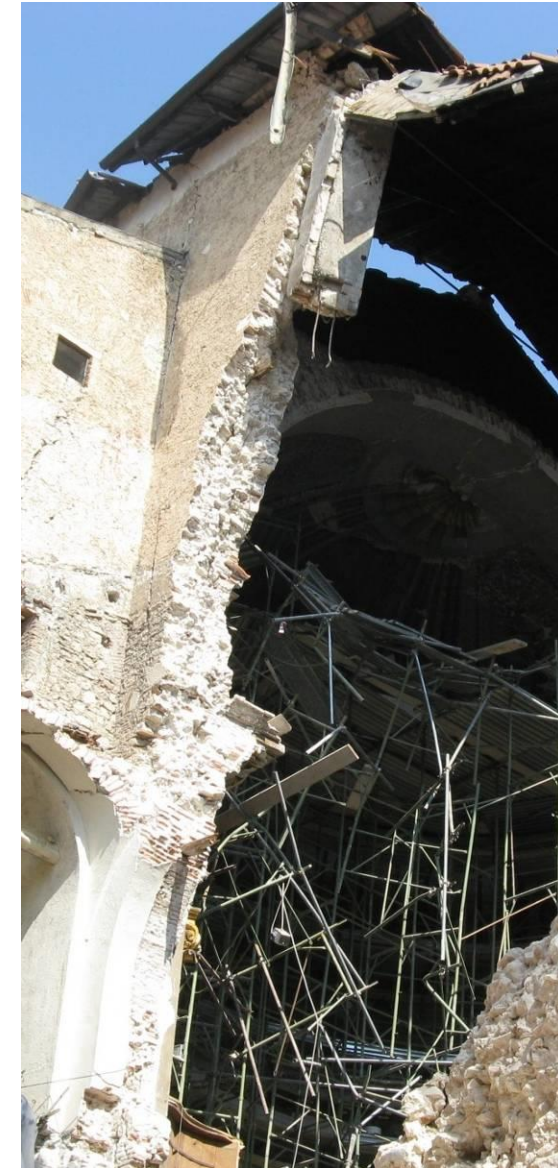
### CATHEDRAL, L'AQUILA

## USE OF REINFORCED CONCRETE

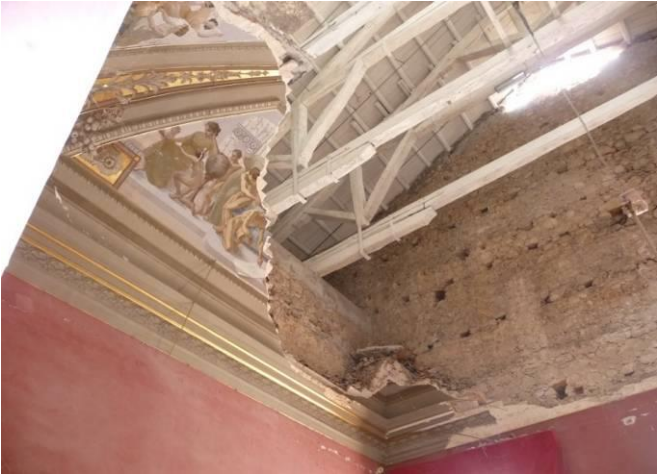
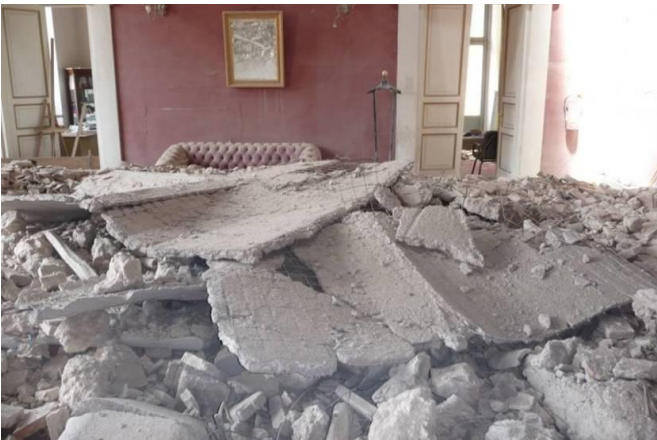
**THEATRE, L'AQUILA**

## USE OF REINFORCED CONCRETE

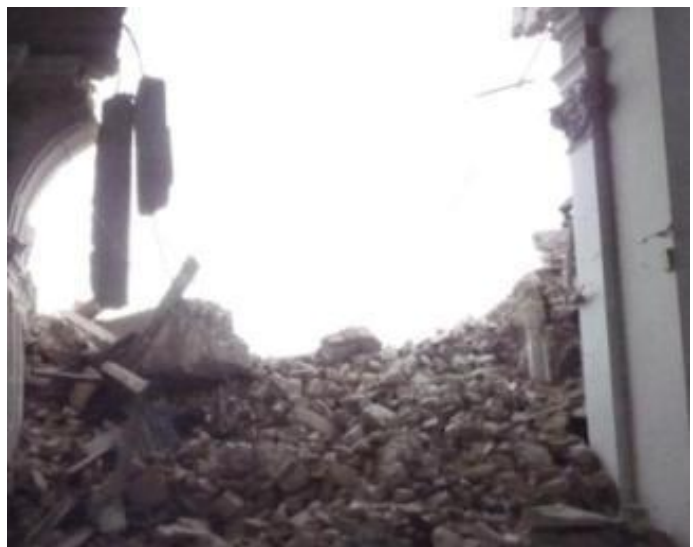
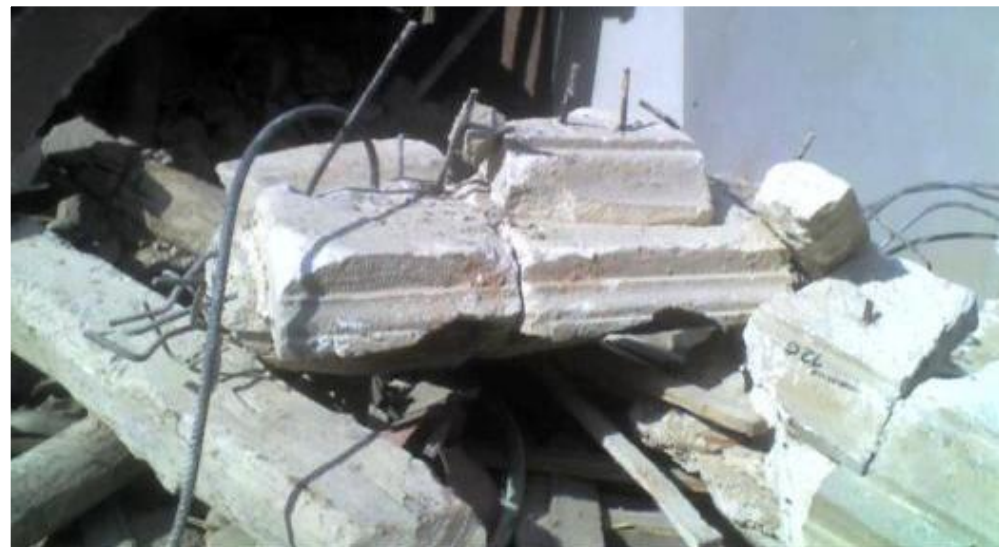
**SAN PIETRO  
APOSTOLO,  
ONNA**

## USE OF REINFORCED CONCRETE

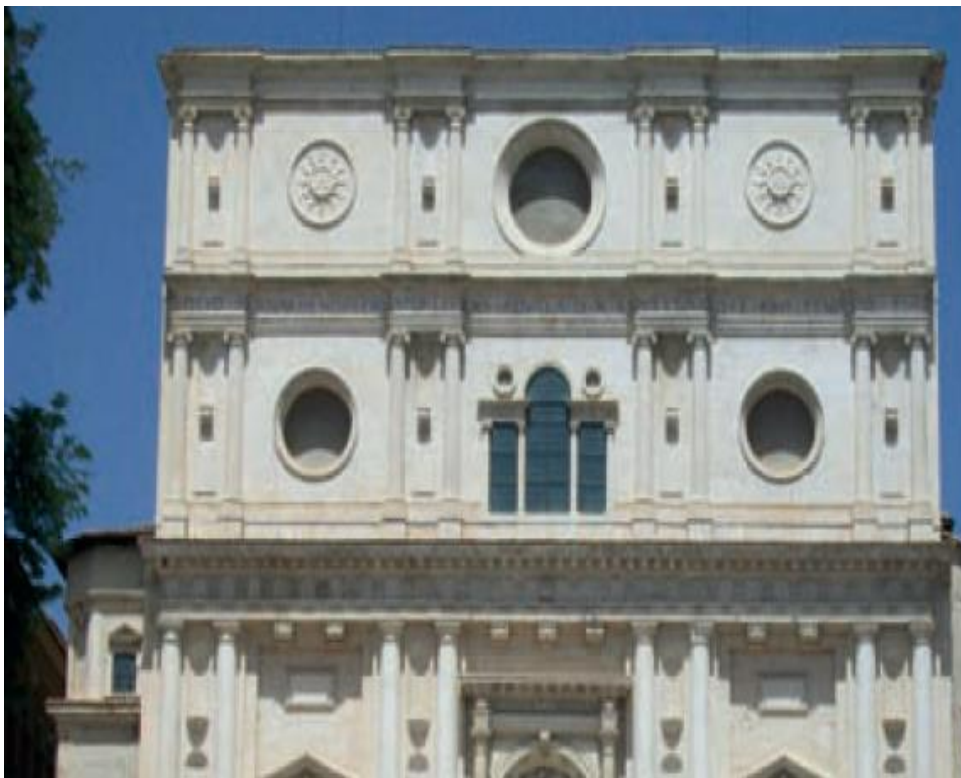
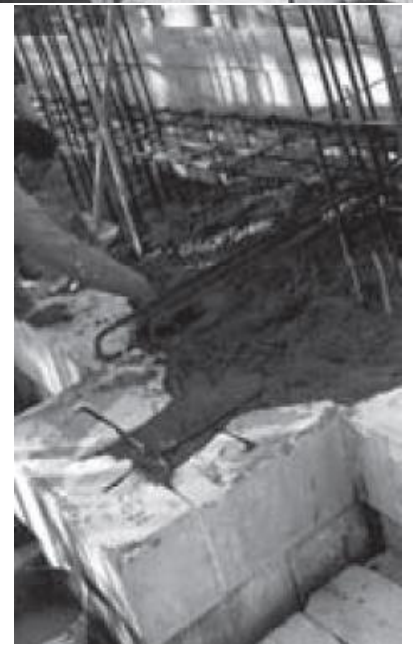
SAN BERNARDINO, L'AQUILA

# USE OF REINFORCED CONCRETE
