SCHOOL ZONE INFRASTRUCTURE AUDIT

DEL NORTE LOCAL TRANSPORTATION COMMISSION

JANUARY, 2014

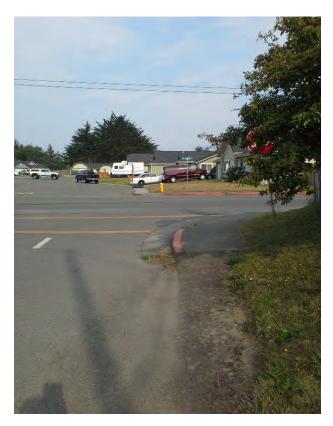
Unfinished sidewalk-Not compliant with ADA and poses a tripping hazzard.

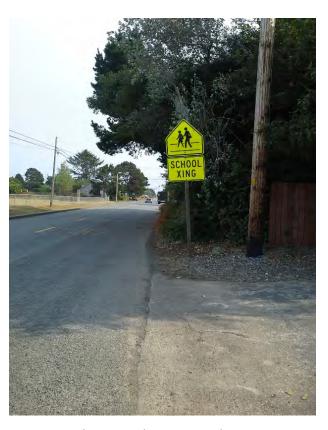
Absent Pedestrian Facilities

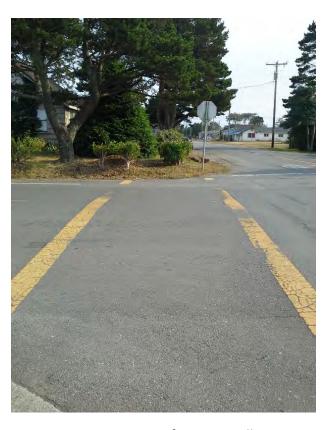
No Destination for Crosswalk

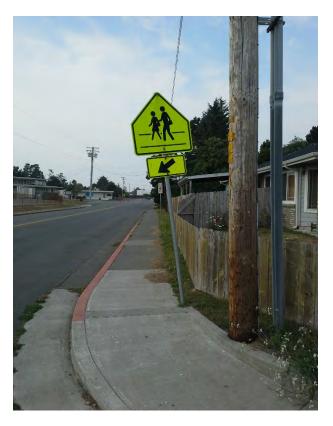
Compliant School Zone Signs-Leaning

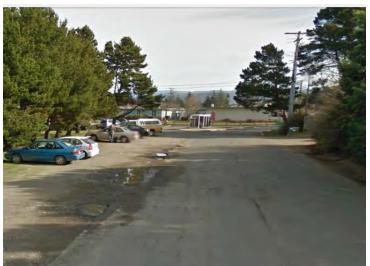
Cars parked along Small Ave

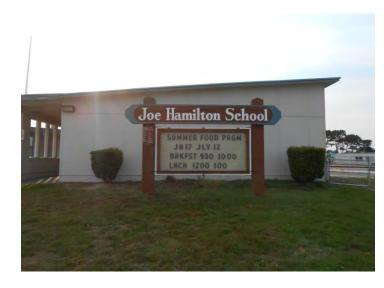
Signage is important to warn drivers, but the location of this sign makes the sidewalk too narrow for ADA compliance

- o Trim vegetation encroaching onto sidewalks.
- Relocate School Xing sign at north end of E St. sidewalk for ADA compliance.
- o Install curb ramps at 10th and E St. crosswalks.

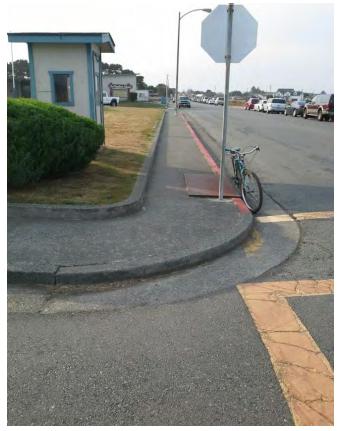
Sidewalk ends in front of school on 10th St between C and D St.

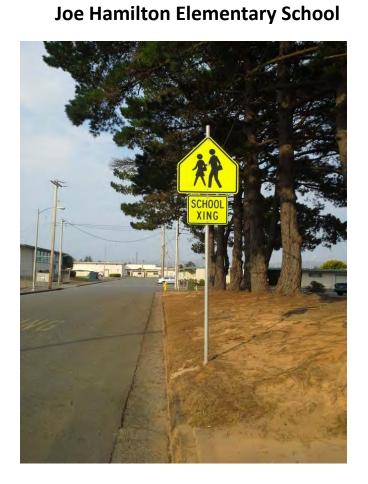
Overgrown vegetation is blocking access to the walkway

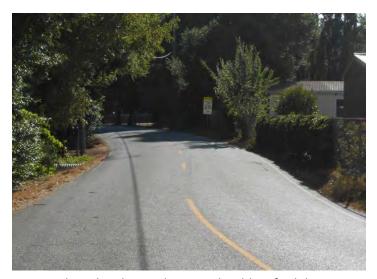
Rural road without adequate shoulders for bikes or pedestrians

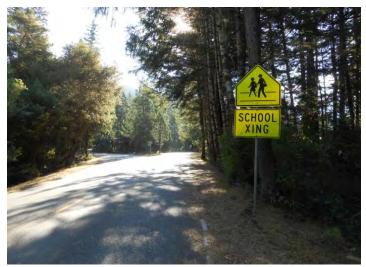
Rural roads with sufficient shoulder for pedestrians and bicyclists-needs maintenance

- o Sweep debris from shoulder areas along Gasquet Flat Rd.
- o Clear shoulder vegetation on Gasquet Flat Rd. on Smith River bridge.
- o Further analysis of school drop off area circulation.

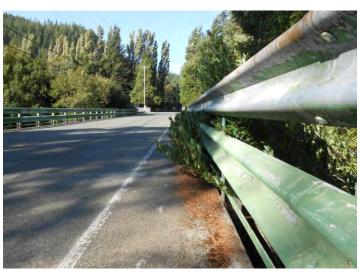
Vegetation obstructing the shoulder of the bridge

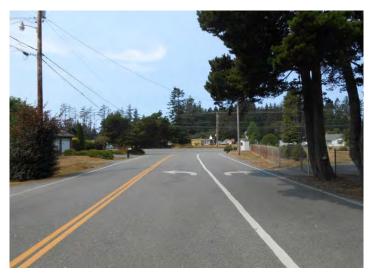
Cars park along road blocking right lane during drop off and pick up times

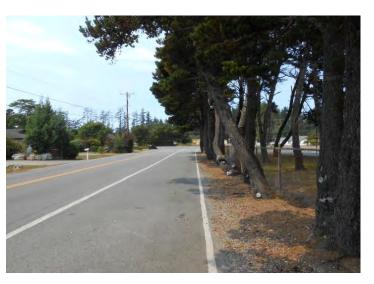
No walkway along Pine Grove Rd

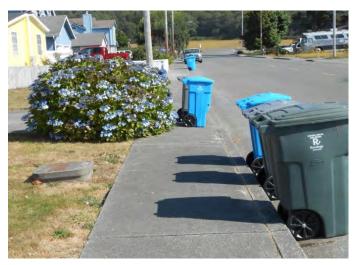
Sidewalk access blocked

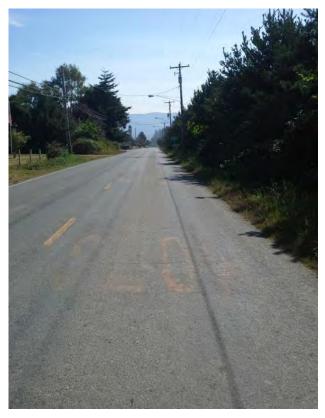
No sidewalks or bike lanes along 1st St west of the school

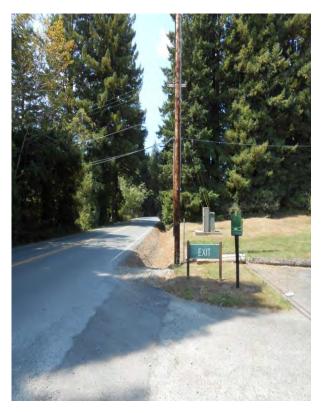
Limited shoulders and no turn pockets present safety concern
