Georgia Conference of Home Inspectors

Pre-Closing Property Inspection Report

Client(s): **Ms. Andrea Devries**
Property address: **2049 Hatteras Way NW**
Atlanta, Georgia 30318
Inspection date: **Thursday, December 10, 2015**

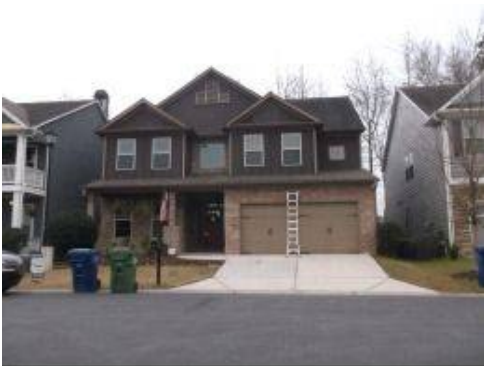
**Photo 3-3**

Street view. 2049 Hatteras Way NW

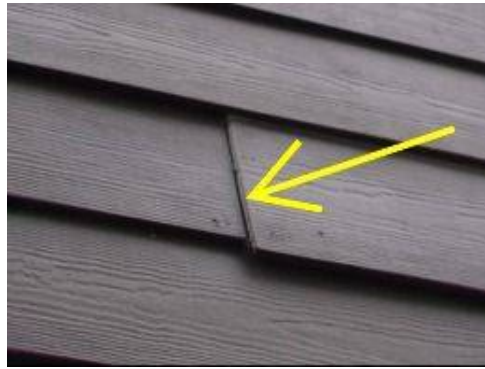
Photo 5-2

Siding butt joints have shrank and the spaces should be caulked and sealed periodically.

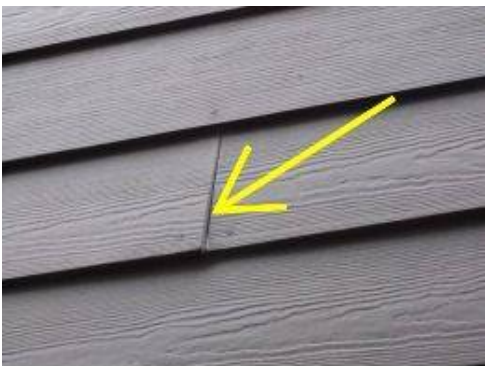
Photo 5-5

Siding butt joints need caulk and sealing with weather resistant caulk.

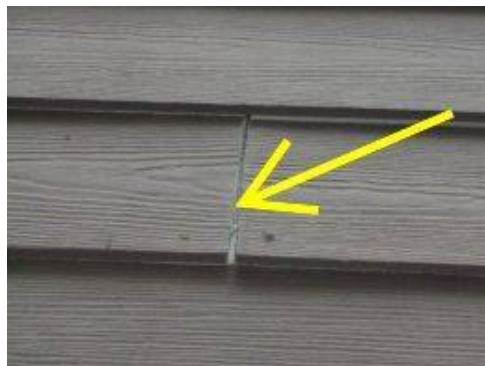
Photo 5-6

Siding butt joints with spaces between the members. Caulk and seal.

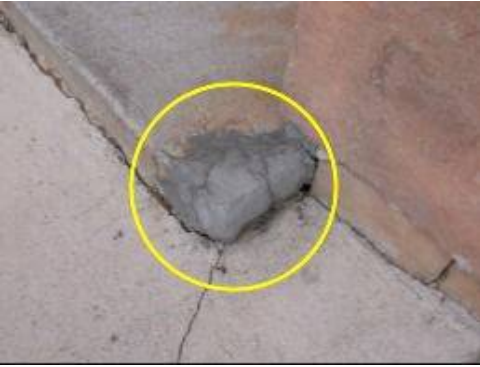
**Photo 6-3**

Front entrance walkway has been recently repaired at the corner. See photo.

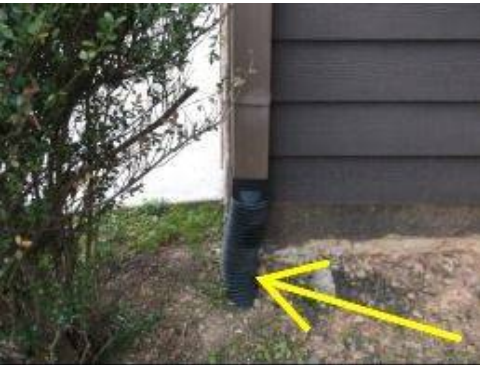
**Photo 9-1**

9) There are several 'french drains' observed at the downspouts which enter above ground, however, no discharge ends were found on the property. Inquire of the builder, if and where discharge pipes are located. Water flowing from the downspouts should be diverted away from the foundation.

French drain downspout empties into the ground. No discharge pipe was located during the inspection.

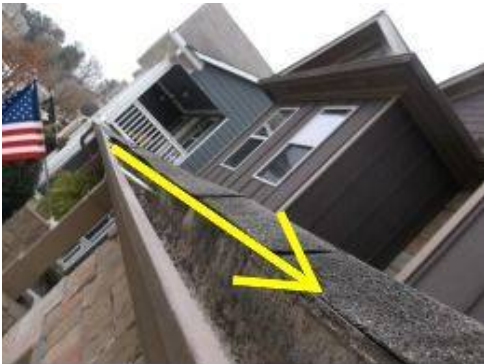
Photo 10-3

Water is standing inside the front gutters. The front gutters are improperly sloped.

One or more gutters had a substandard slope so that significant amounts of water accumulate in them rather than draining through the downspouts. This has caused debris such as leaves or needles to accumulate in them. Recommend that a qualified person repair as necessary. For example, by correcting the slope in gutters or installing additional downspouts and extensions.

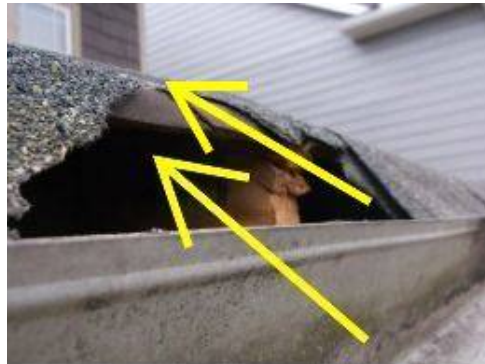
Photo 10-4

Roofing shingle at front entrance above garage has broken off and needs replacement. Contact qualified roofing company.

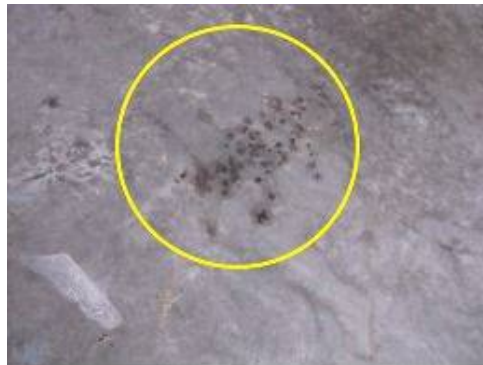
Photo 15-2

Oil stains on surface of concrete garage floor.

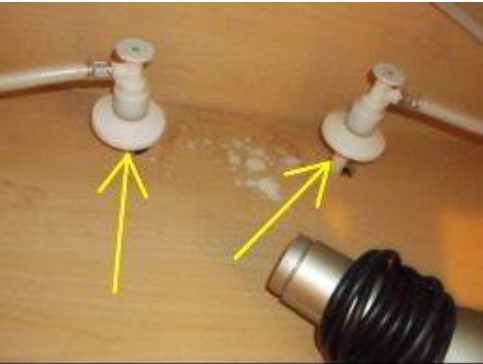
**Photo 18-3**

Escutcheon plates are not properly installed to prevent insects from entering by following the pipes from outside.

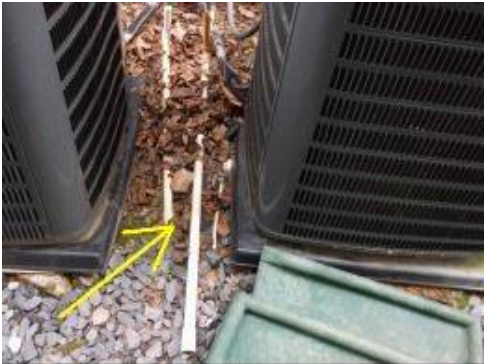
Photo 22-1

Condensate line for upstairs air handler is embedded in the ground and clogged with soil and debris. Repair as soon as practical, to prevent water from backing up into the handler.

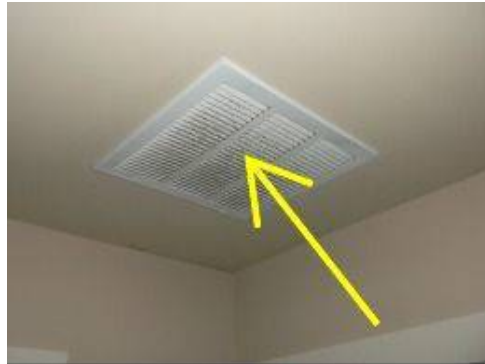
Photo 22-2

Upstairs hallway HVAC return grille is dust laden and needs cleaning.

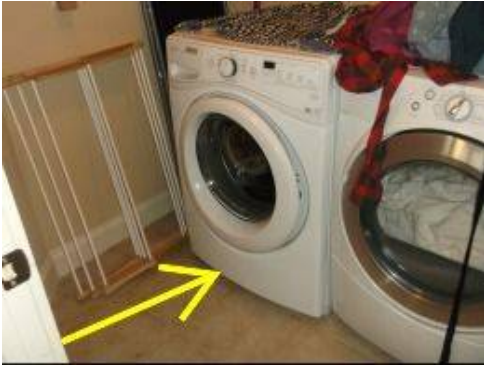
Photo 29-1

29) Overflow drip-pan was not installed in the laundry room. Drip pans should be installed below automatic washers. If the washer overflows or leaks, the water fills the drip pan and is diverted to the outside via the discharge pipe. This prevents water from leaking into the drywall ceilings below and causing moisture damage.

Laundry room should be equipped with a drip pan prevent water from entering the floor spaces below in case of an overflow.

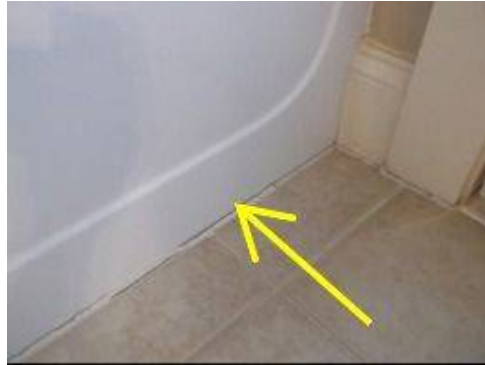
Photo 29-2

Caulk and seal around jacuzzi tub in master bathroom.

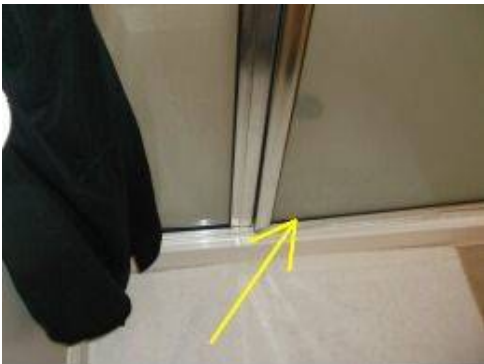
Photo 29-5

Master bathroom shower door is sticking and binding in the frame.

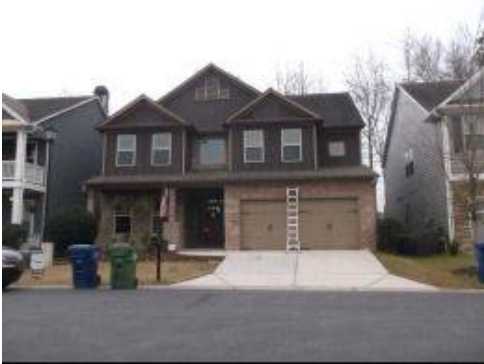
Photo 3-3
Street view. 2049 Hatteras Way NW

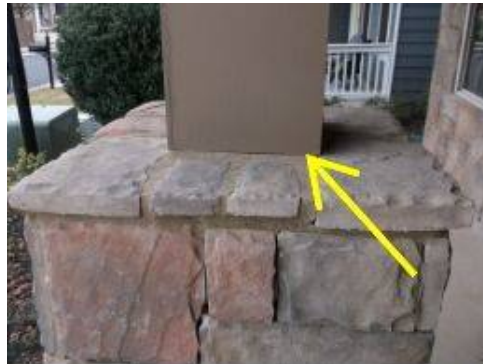
Photo 6-2
Minor cracks in the mortar joints at the front support columns.

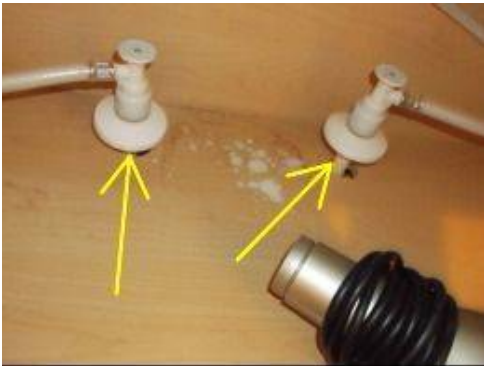
Photo 18-3

Escutcheon plates are not properly installed to prevent insects from entering by following the pipes from outside.

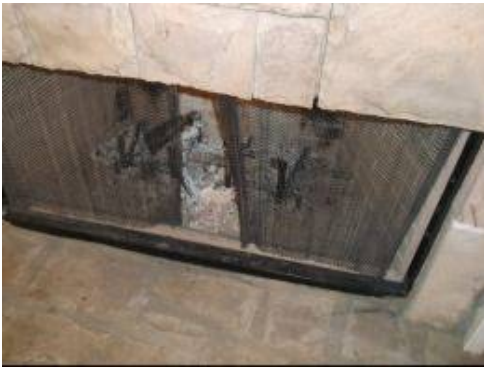
Photo 27-1

Fireplace is equipped with a gas starter and key. Inquire of current tenant the operation instructions.

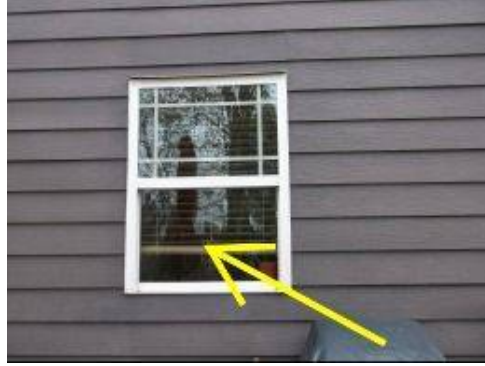
Photo 31-2

- Screens were missing from some windows. These windows may not provide ventilation during months when insects are active.
