**UNDERWATER BRIDGE INSPECTION REPORT
GROSSE ILE PARKWAY OVER
TRENTON CHANNEL
STR 12006**

WAYNE COUNTY

NOVEMBER 9, 2021

GLEG FILE No: 1020-2-704

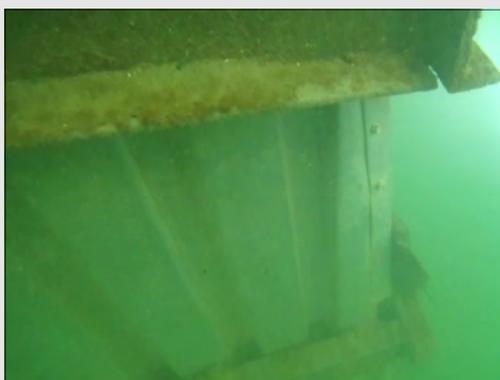
Steel stay-in-place forms and walers

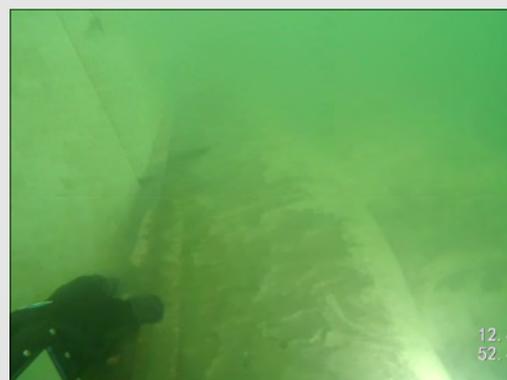
Grout bags and vinyl stay-place forms

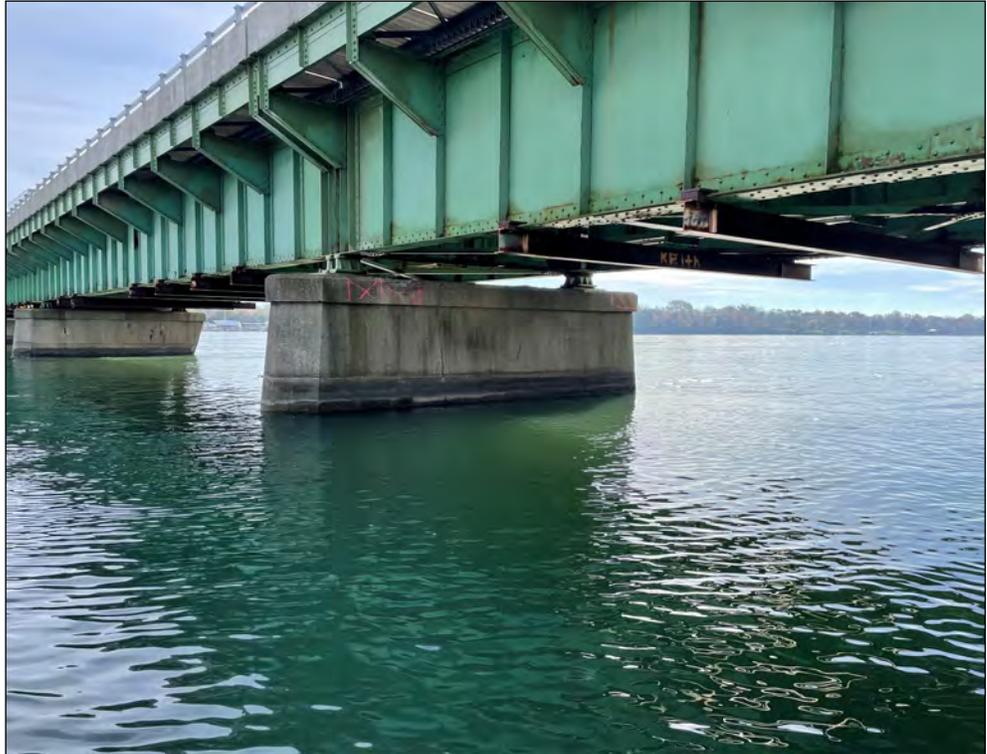
*Pier 1w,
west elevation*

Substructure Unit	Observations Below the Waterline	Observations Above the Waterline
<p style="text-align: center;">Pier 1w</p> <p>(Refer to Substructure Elevation Drawings and Soundings Section)</p>	<ul style="list-style-type: none"> • Vertical footing exposure on all sides of pier. Maximum vertical exposure was 7'-9" inches along the east side of pier. • No undermining of footing observed. • 5' tall band of 1/2" deep scaling of the concrete starting at the waterline. Scaling surrounds perimeter of pier. • 2 sft spall in the east face of pier, located approximately 4' below waterline. • Horizontal crack in the exposed footing at the southeast end. • Deep scaling of concrete on the exposed footing at the south (downstream) end, scaling 1" to 2" deep. • Full height vertical cracks in west and east elevations of pier, extending from the bolster area down to the top of footing. • Uniform algae growth on concrete surfaces up to 1" thick. • Channel bottom consists of sand and scattered rocks up to 1' diameter. 	<ul style="list-style-type: none"> • West elevation: 12 sft and 6 sft delamination in bolster area. Vertical and horizontal cracking in pier face. • East elevation: 24 sft and 4 sft spalls in bolster area. 16 sft and 6 sft spalls in pier face. Vertical and horizontal cracks in pier face and bolster area.

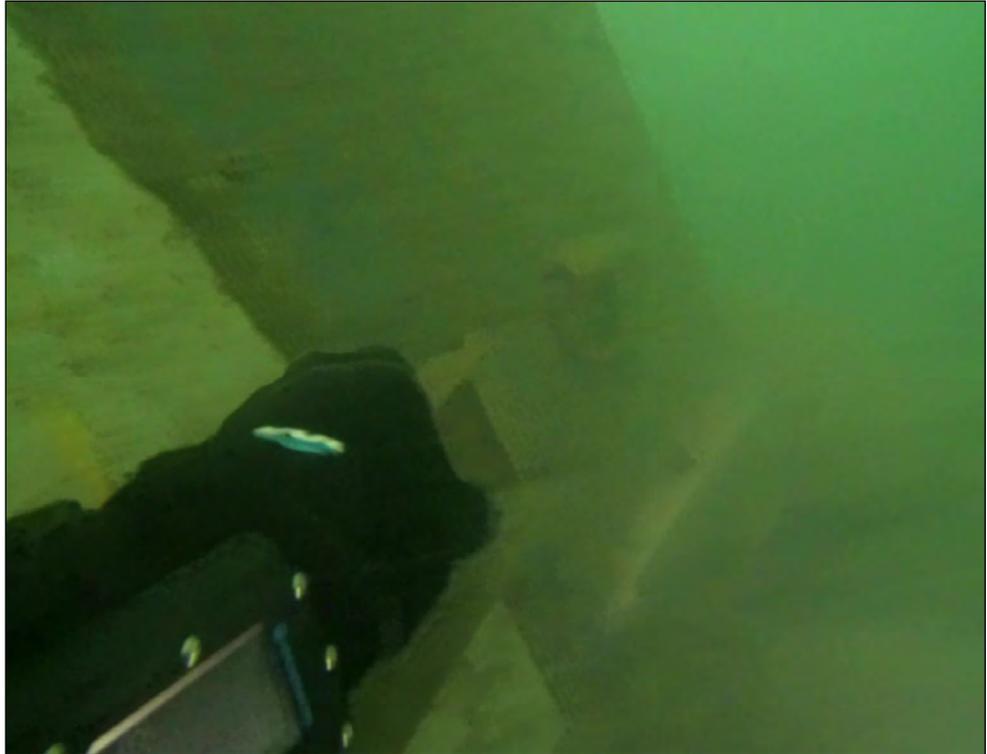
*Pier 2w, steel
ice breaker at
channel
bottom, typical*

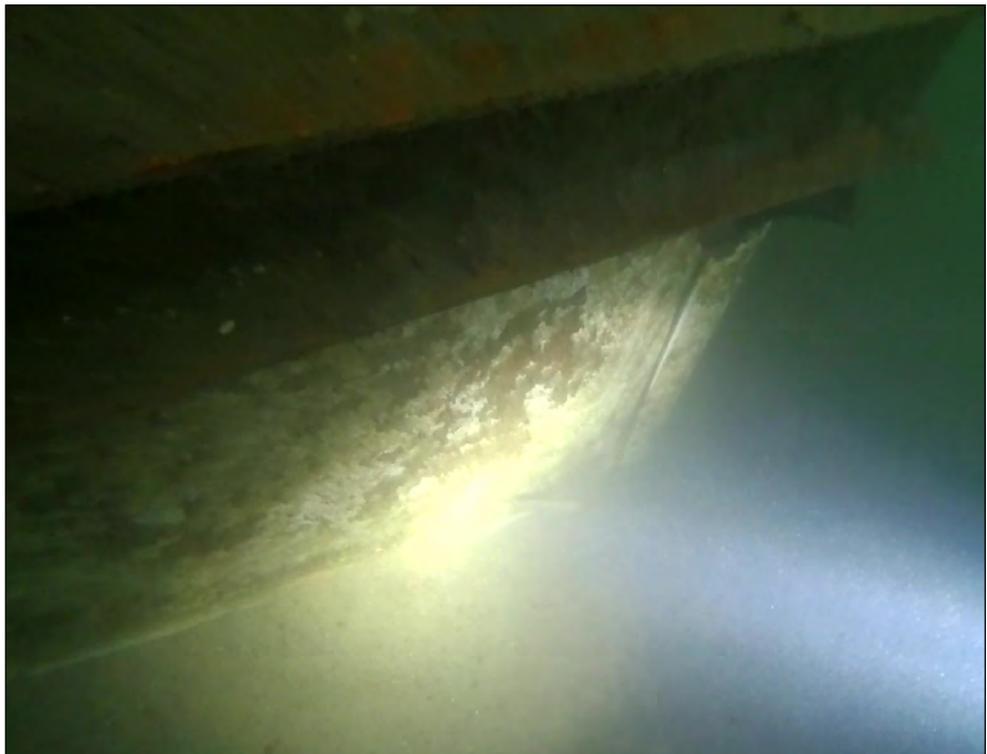
*Pier 2w, vinyl
sheeting and
steel waler,
typical*

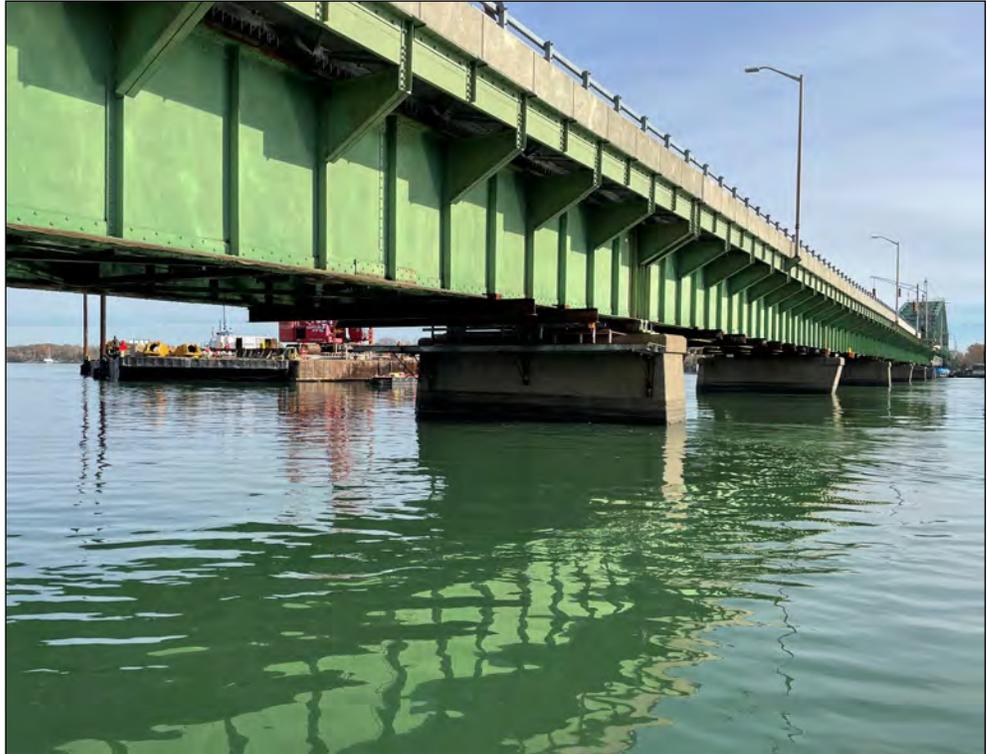
*Pier 3w,
west elevation*

<p>Pier 3w (Refer to Substructure Elevation Drawings and Soundings Section)</p>	<ul style="list-style-type: none"> • Vertical footing exposure on all sides of pier. Maximum vertical exposure was 6'-10" inches along the north end of pier. • No undermining of footing observed. • 3 sft spall at south end, extends below and above waterline. • 2' tall band of 2" to 4" deep scaling in the pier wall starting at the top of footing and extending up 2'. Scaling surrounds perimeter of pier. • 1" to 2" deep scaling at north end of pier, extending approximately 4' below waterline. • Horizontal cracks in the exposed footing along the west elevation, east elevation, and north end. • Full height vertical cracks in west and east elevations of pier, extending from the bolster area down to the top of footing. • Uniform algae growth on concrete surfaces up to 1" thick. • Channel bottom consists of sand and scattered rocks up to 1' diameter. 	<ul style="list-style-type: none"> • South end: 3 sft spall extends above and below waterline. • West elevation: 3 sft delamination in bolster area. Vertical and horizontal cracking in pier face. • East elevation: 4 sft spall in bolster area. Vertical and horizontal cracks in pier face.

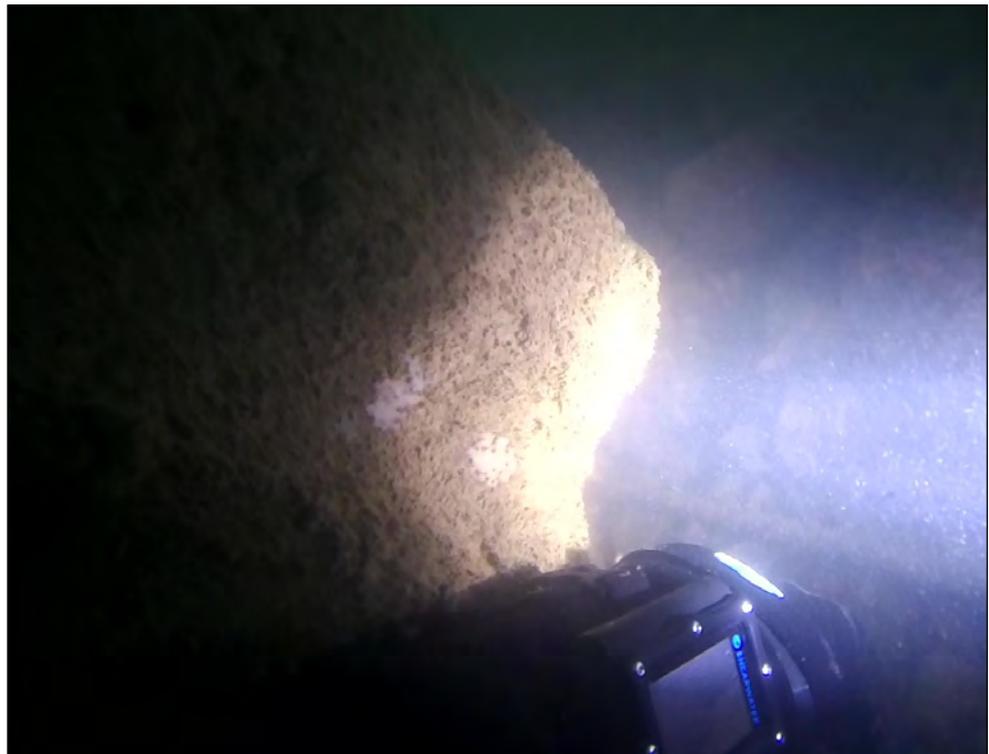
Based on the underwater inspection the piers are overall in **fair to poor condition**. Vertical footing exposure ranging from 1'-2" minimum to 10'-6" maximum was observed at piers 1w, 3w, 5w, 7w, and 11w. Although these piers are founded on bedrock, the footing exposure is an area of concern and should be continued to be monitored at increased frequency. Piers 1w, 3w, 5w, 7w, and 11w also exhibit extensive deterioration both above and below the waterline. Areas of spalling, delamination, 1/2" to 4" deep scaling, vertical and horizontal cracking, and map cracking is present in these piers. Piers 1w, 3w, 5w, 7w, and 11w are in overall **poor condition**.

*Pier 3w, typical
condition of
exposed footing*

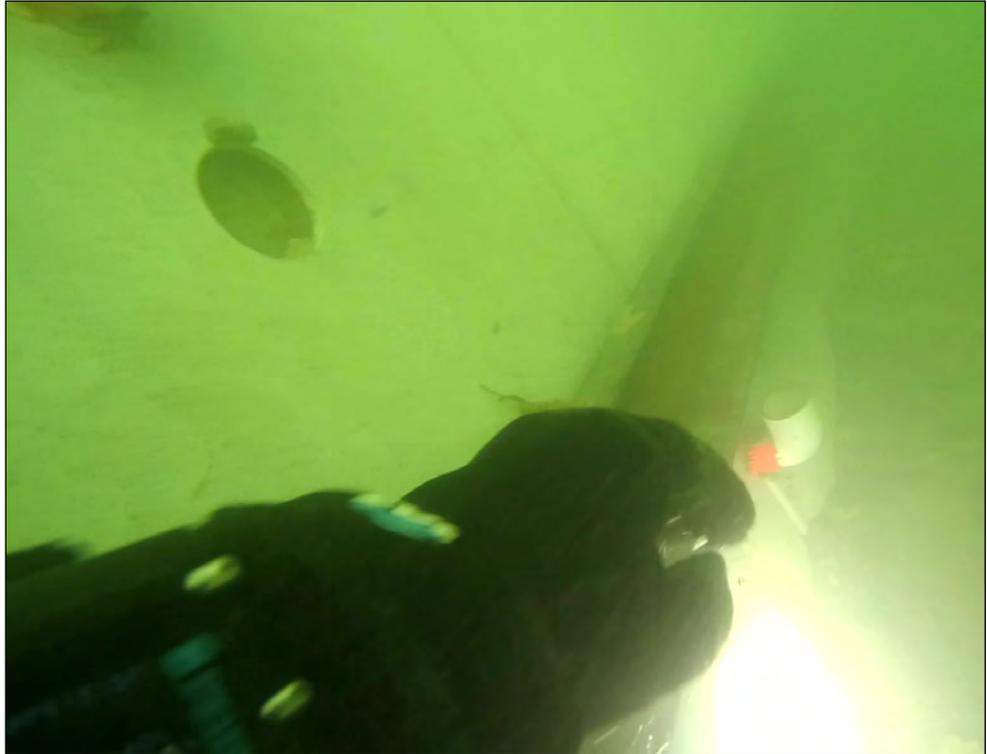
*Pier 4w, vinyl
sheeting and
grout bags at
channel
bottom, typical*

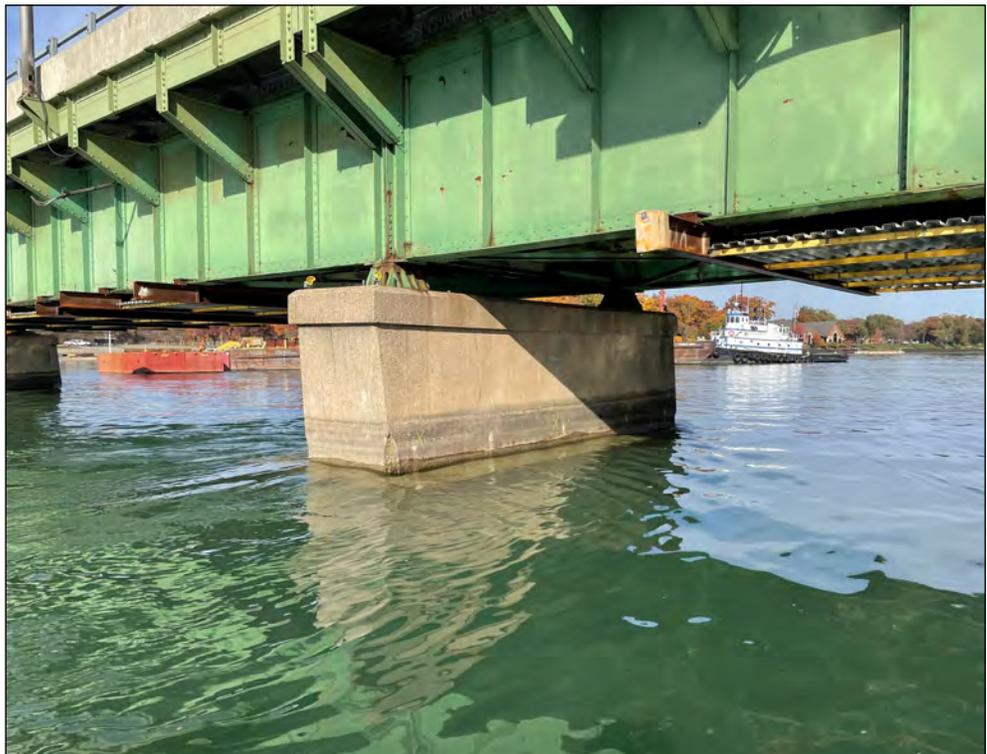
*Pier 6w, grout
bags and vinyl
sheeting at
channel
bottom, typical*

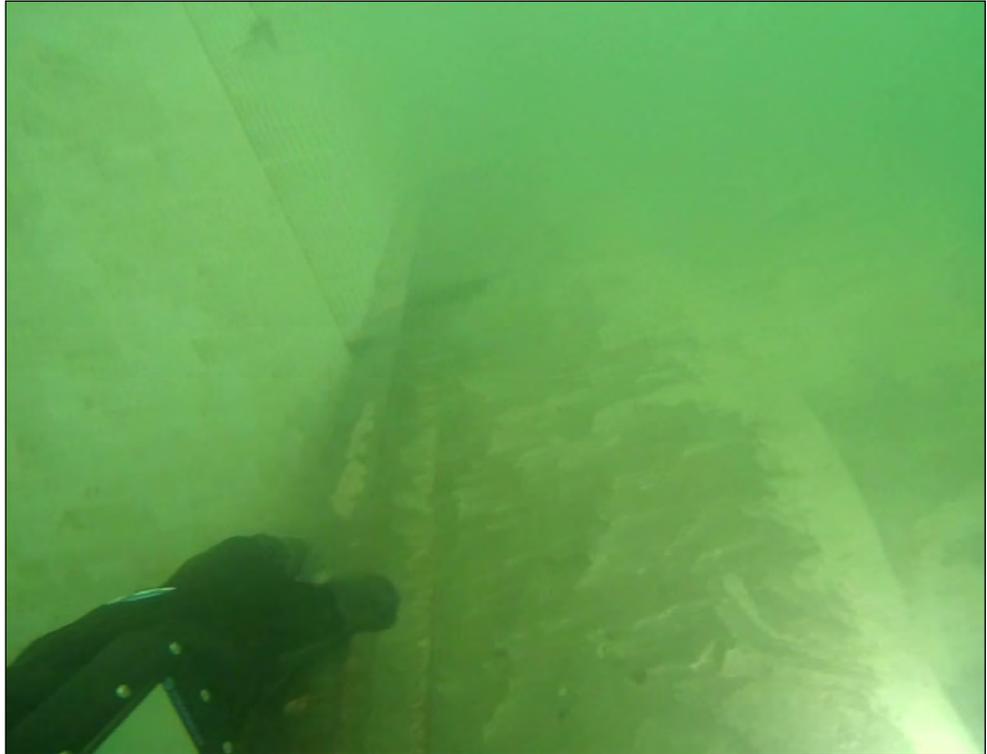
*Pier 6w, corner
of vinyl
sheeting, steel
walers and
grout bags at
channel
bottom, typical*

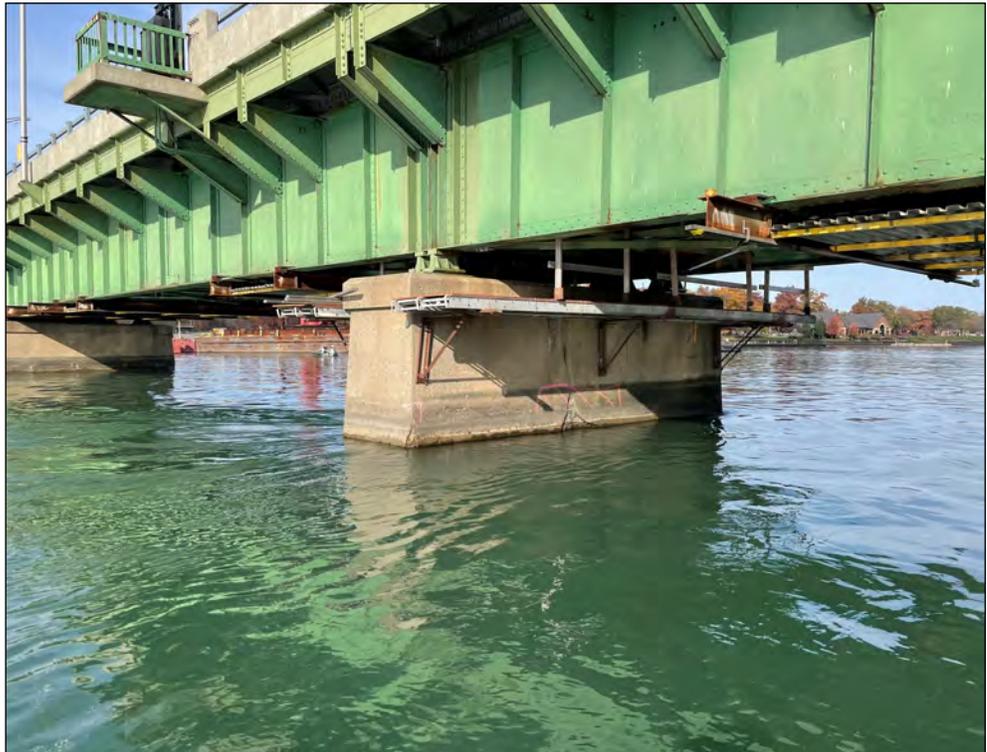
*Pier 7w,
footing
exposure at
upstream nose,
typical*

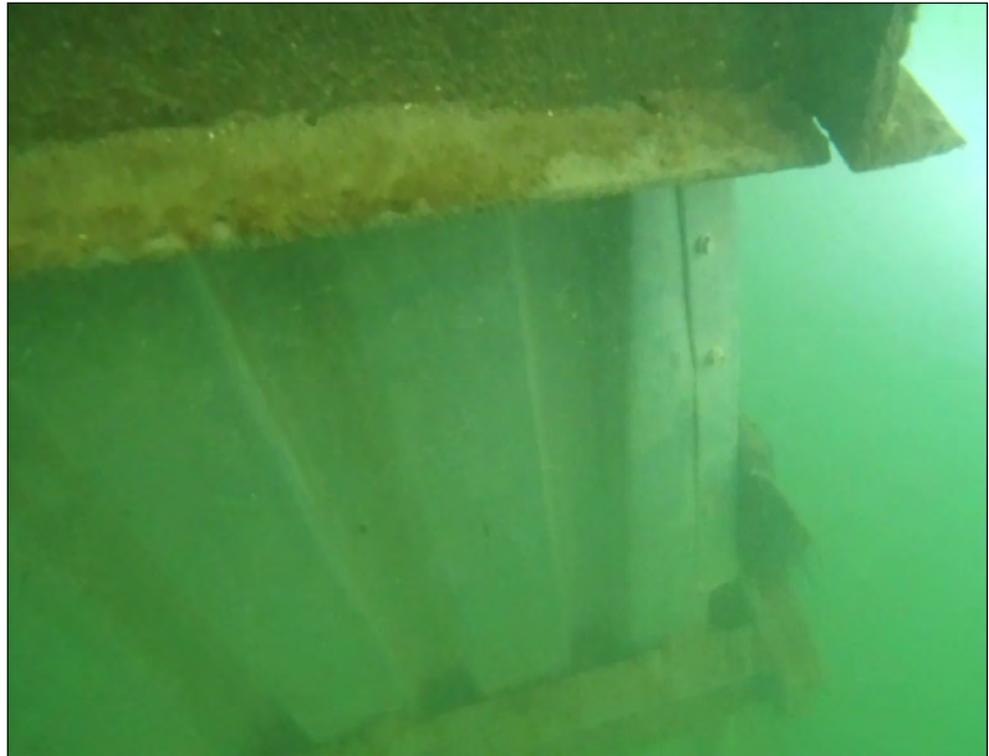
*Pier 8w, steel
sheeting and
steel walers at
channel
bottom, typical*

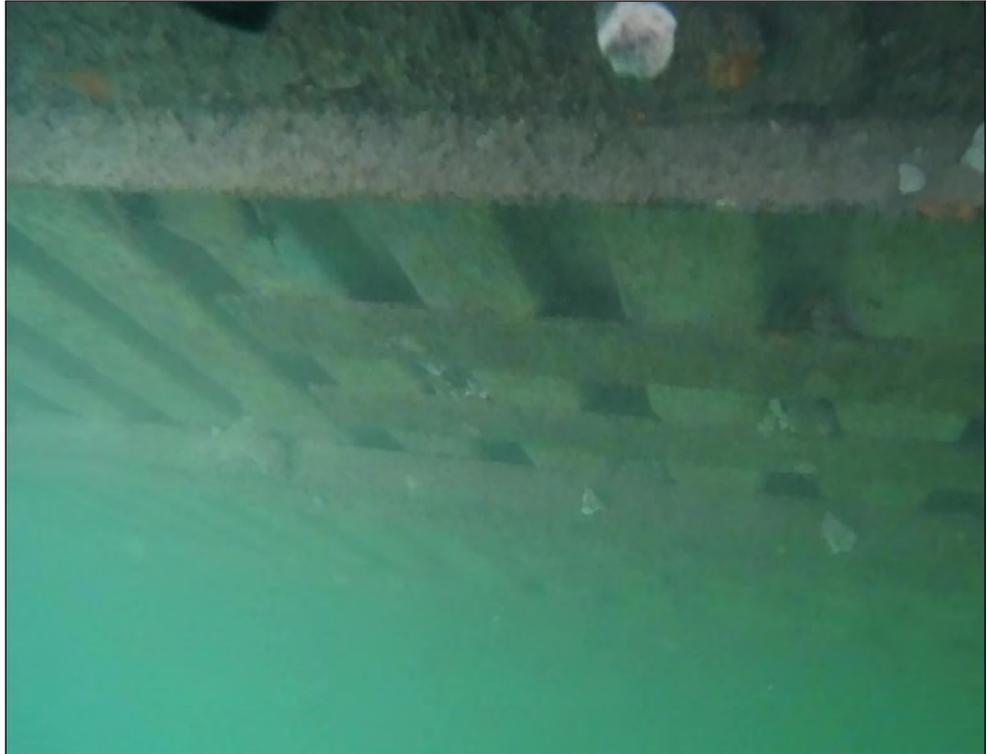
*Pier 9w, steel
sheeting and
steel walers at
channel
bottom, typical*

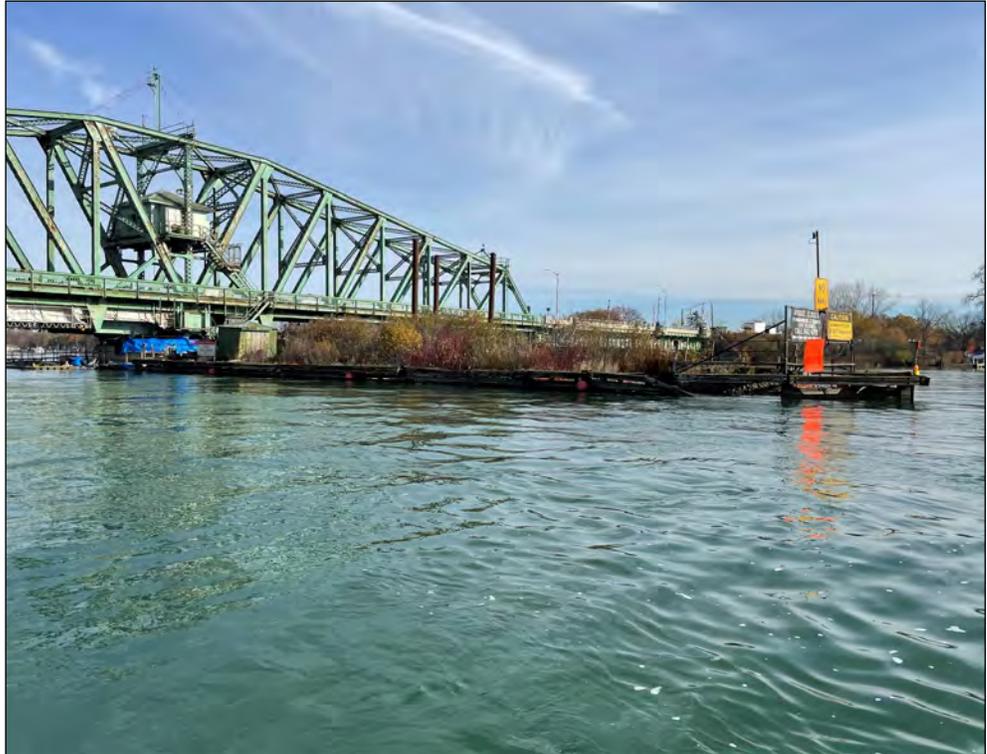
*Pier 9w,
southeast
timber fender*

H Replace or retrofit the pier protection system at the pivot Pier 9W, both north and south ends. Recommend destructive testing such as cores be taken for retrofit design.

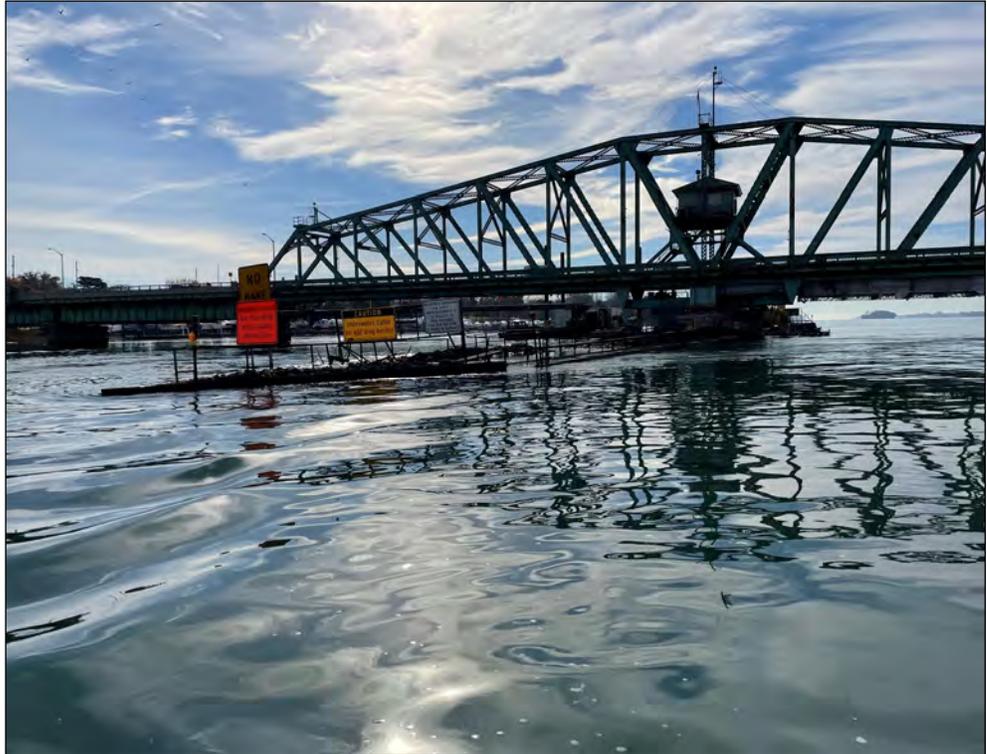
*Pier 9w,
northeast
timber fender*

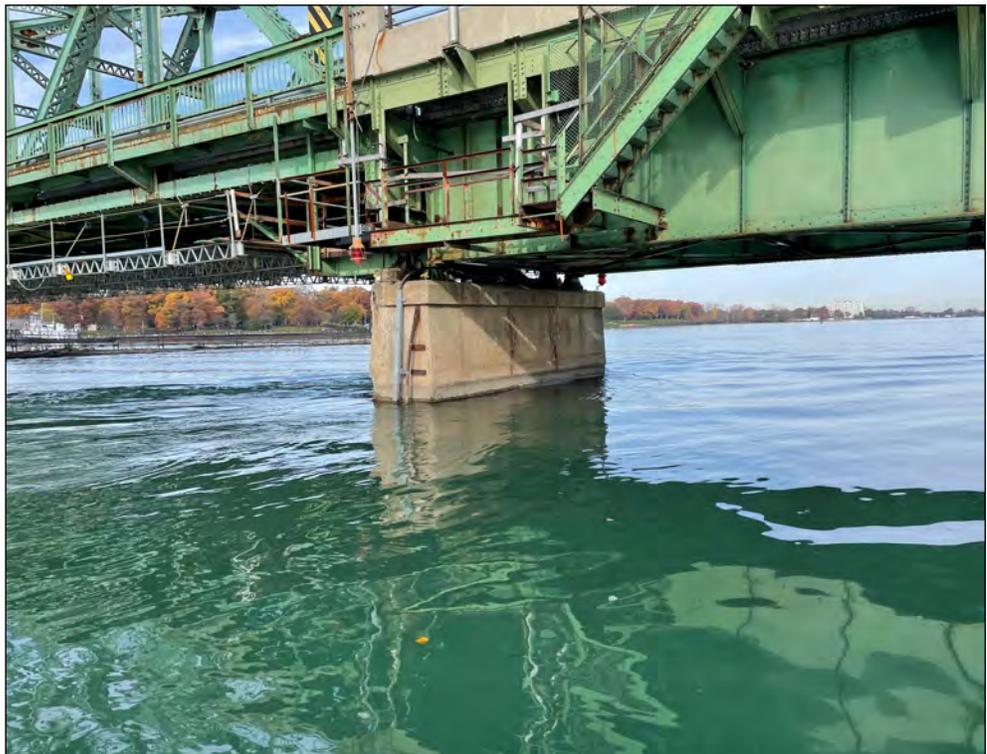
*Pier 10w, vinyl
sheeting and
steel walers,
typical*

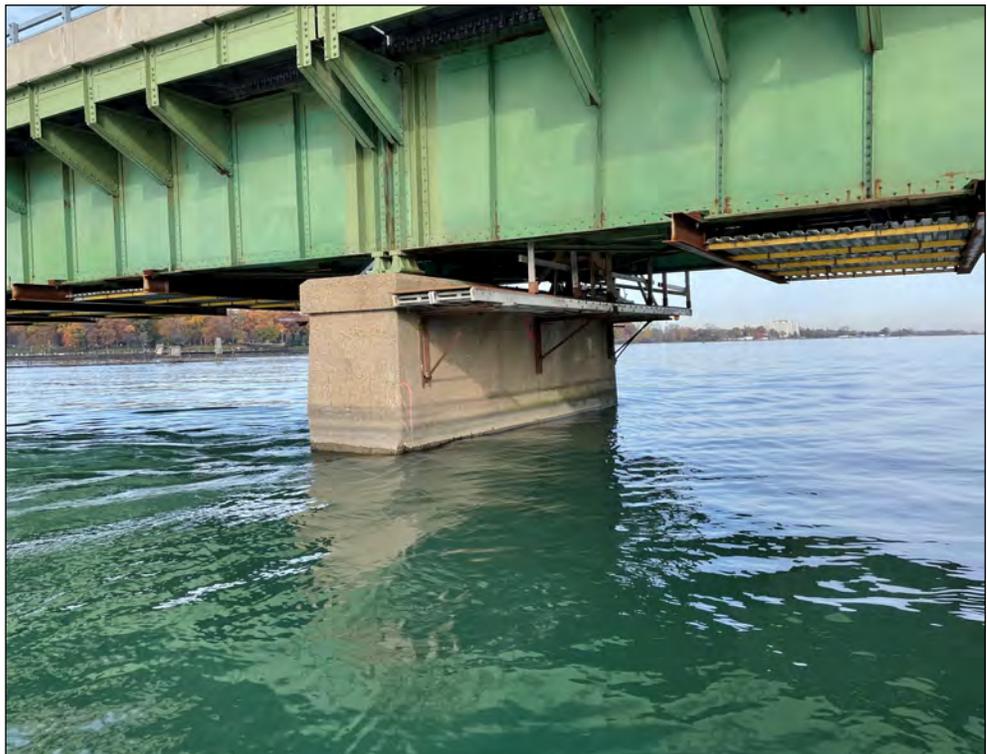
*Pier 11w,
footing
exposure and
channel
bottom, typical*

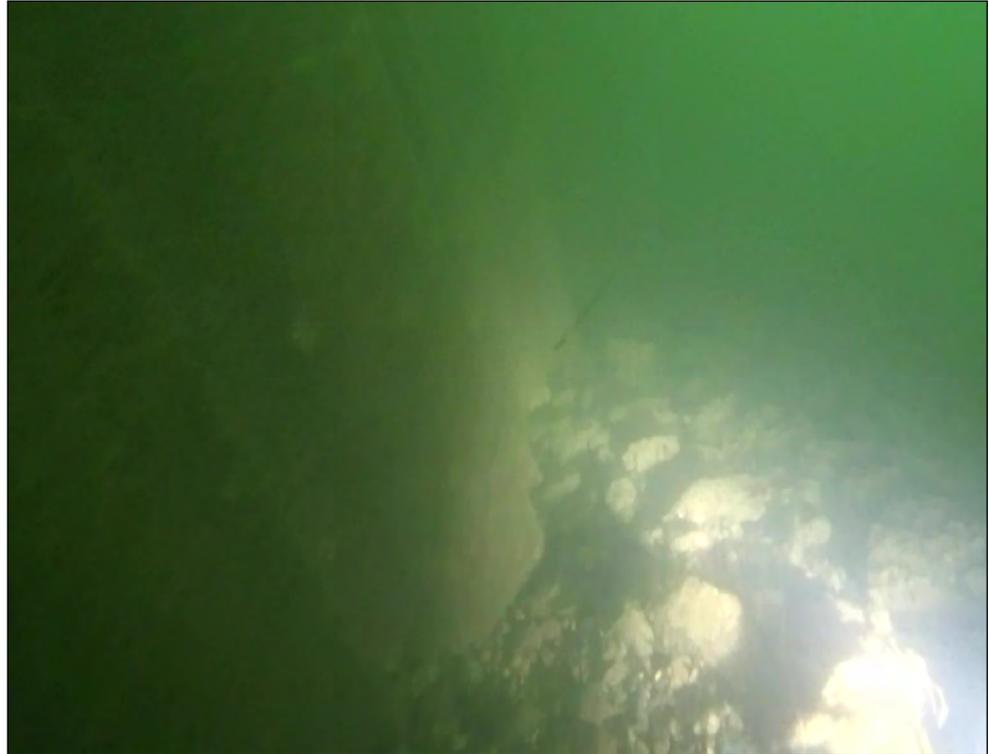
*Pier 11w,
footing
exposure and
channel
bottom, typical*
