Stapleton Rowhome Association
Hail Damage Evaluation
10045 Martin Luther King Boulevard
Denver, CO 80238
Farmers File: 5010168593
Haag File: 1121000002-128

Re: Stapleton Rowhome Association
Hail Damage Evaluation
10045 Martin Luther King Boulevard
Denver, CO 80238
Farmers File: 5010168593
Haag File: 1121000002-128

In accordance with your request, we inspected the Stapleton Rowhome Association buildings to determine the extent of hail-caused damage to the building exteriors and when the damage occurred. We inspected the sites on February 1, 2, and 3, 2021.

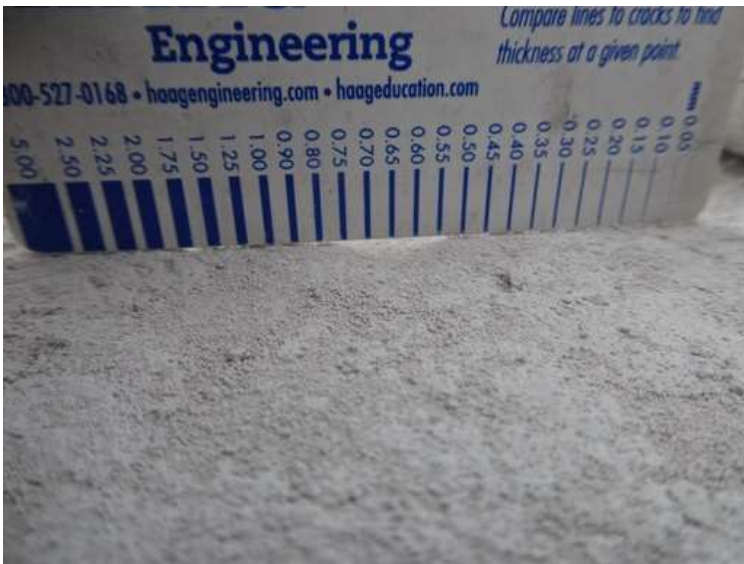
27. Building 01. Straight edge over a dent.

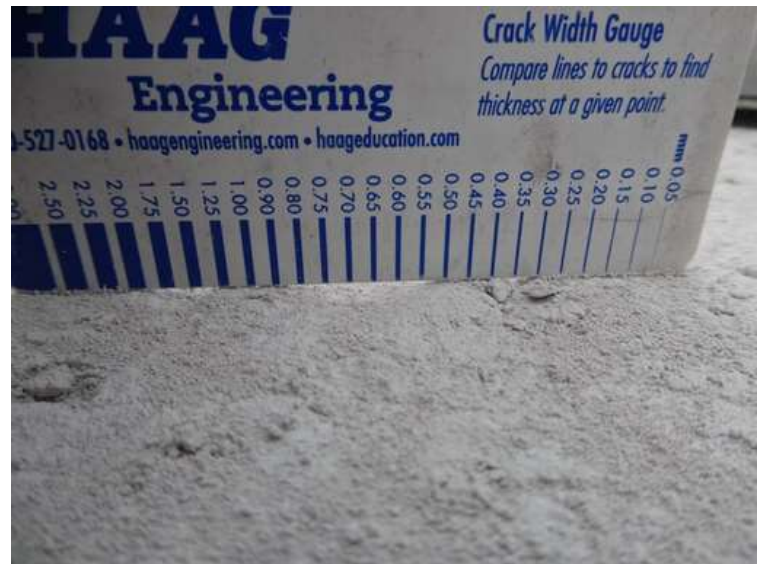
28. Building 01. Straight edge over a dent.

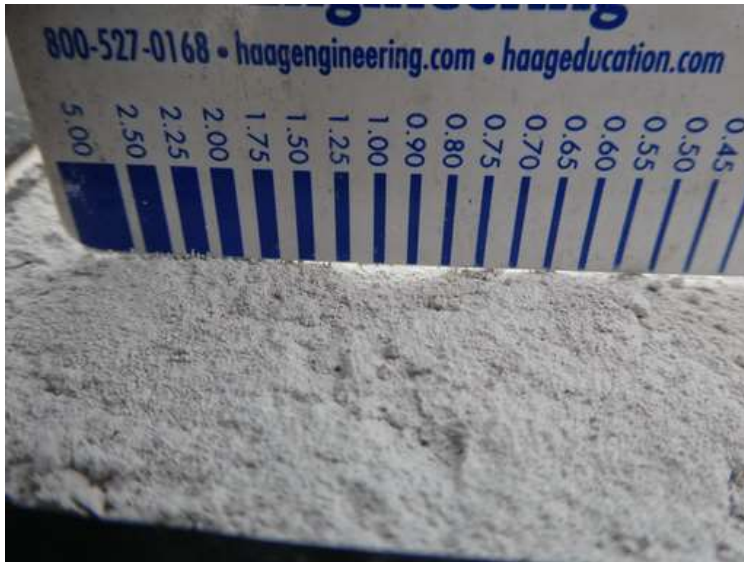
29. Building 01. Straight edge over a dent.

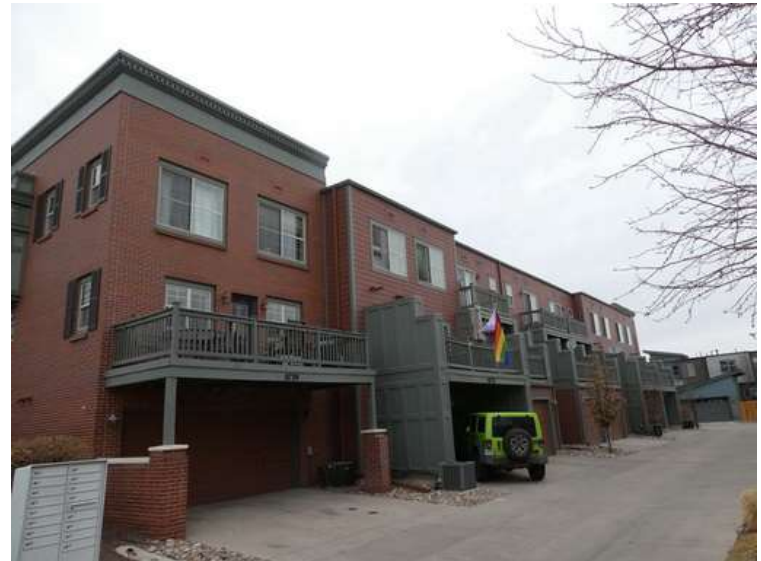
40. Building 02. East elevation.

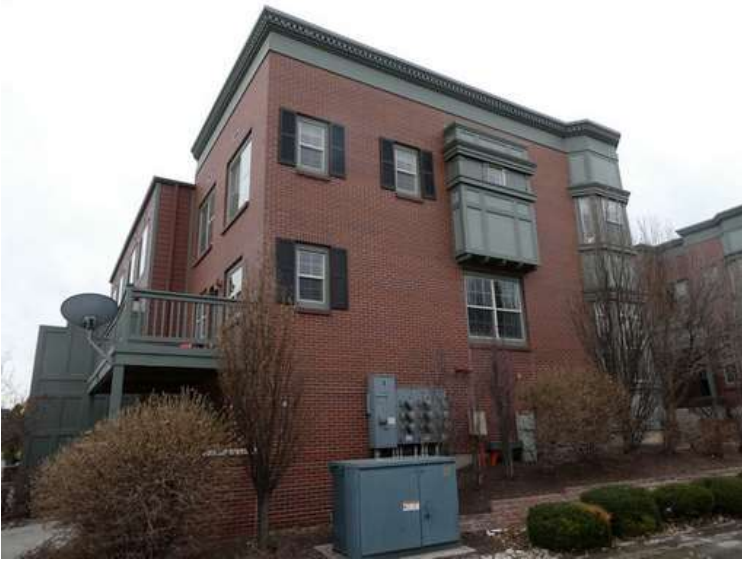
45. Building 02. North elevation.

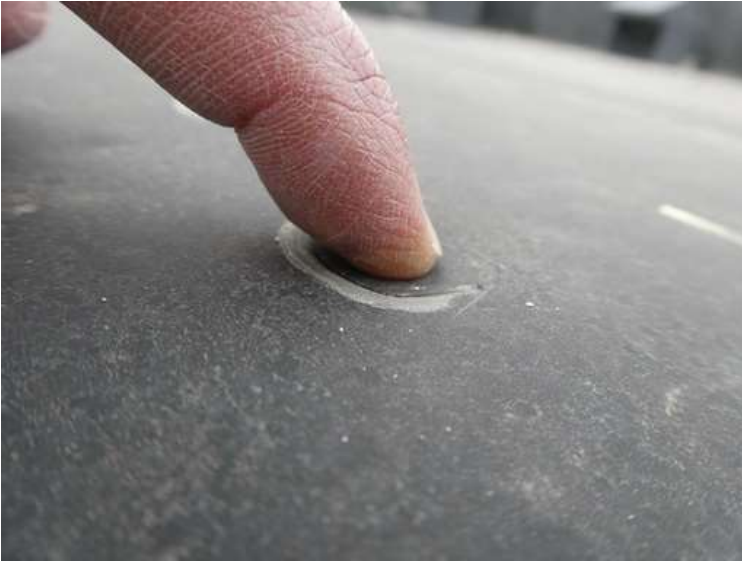
57. Building 02. Dent.

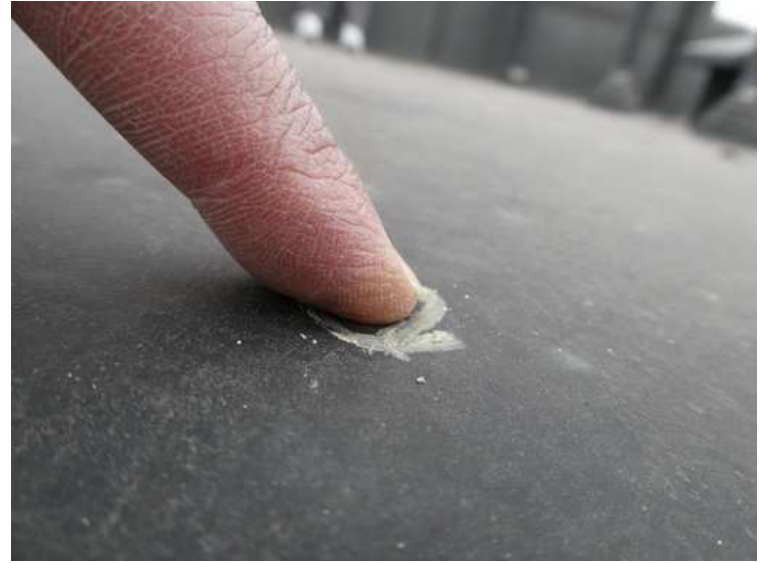
58. Building 02. Dent.

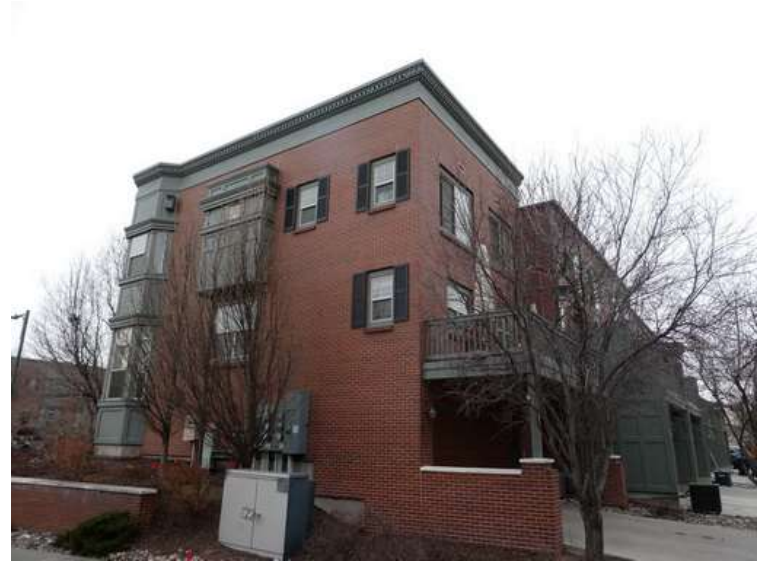
62. Building 03. North elevation.

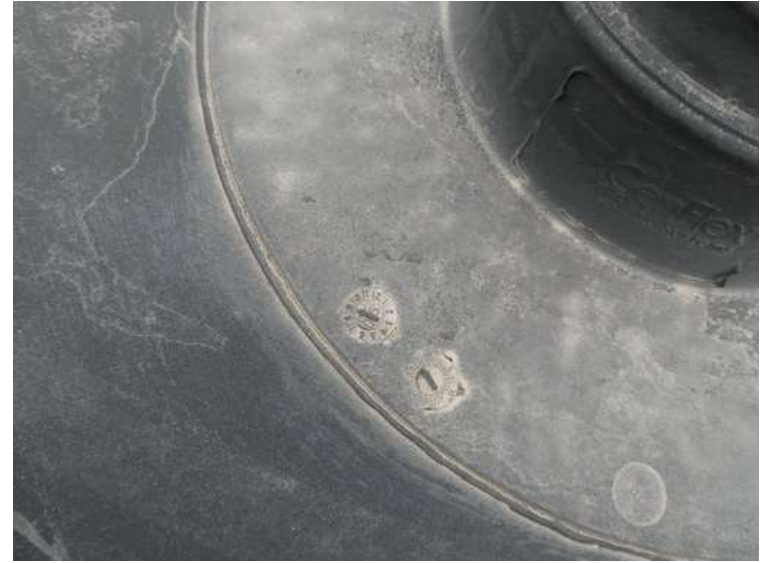
74. Building 03. Boot dated, '05'.

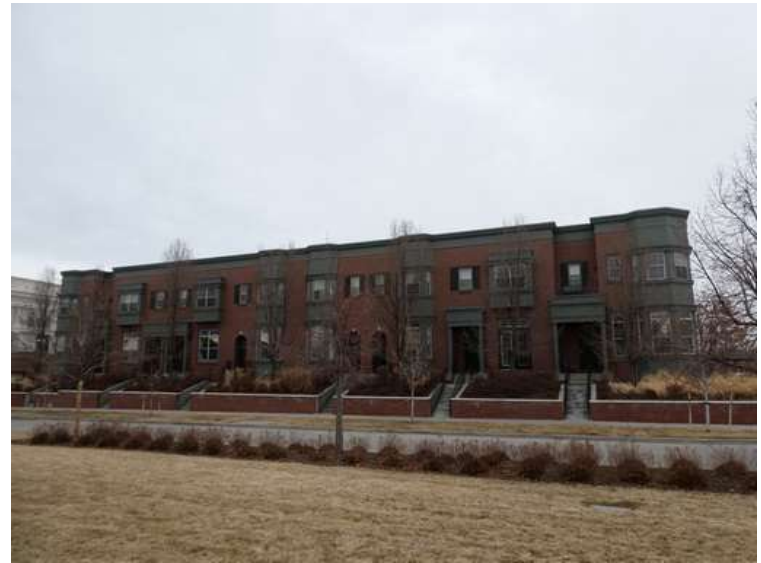
92. Building 04. West elevation.

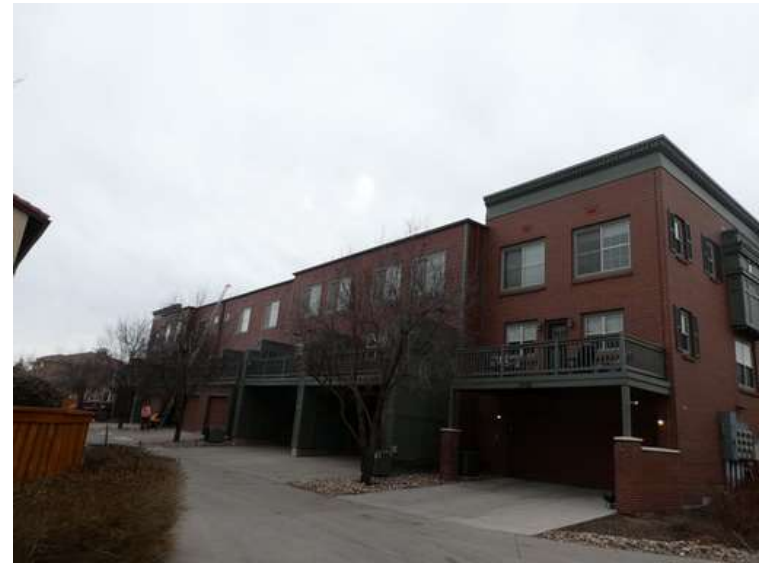
98. Building 04. East elevation.

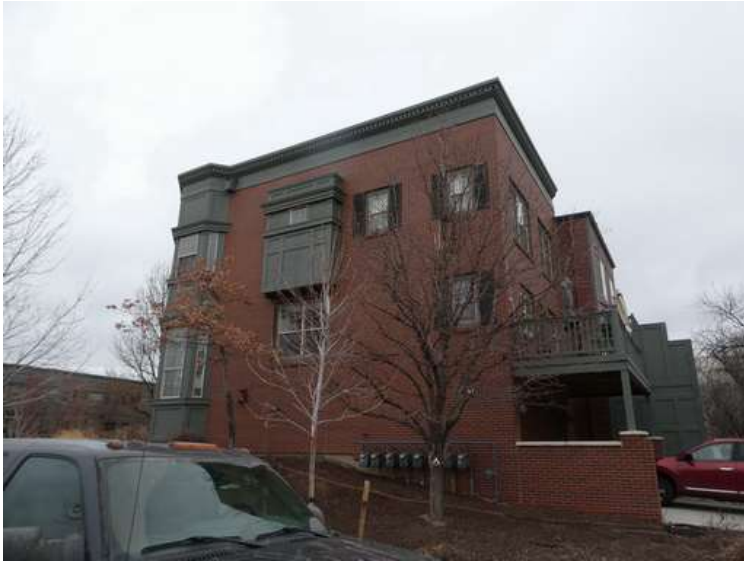
101. Building 04. South elevation.

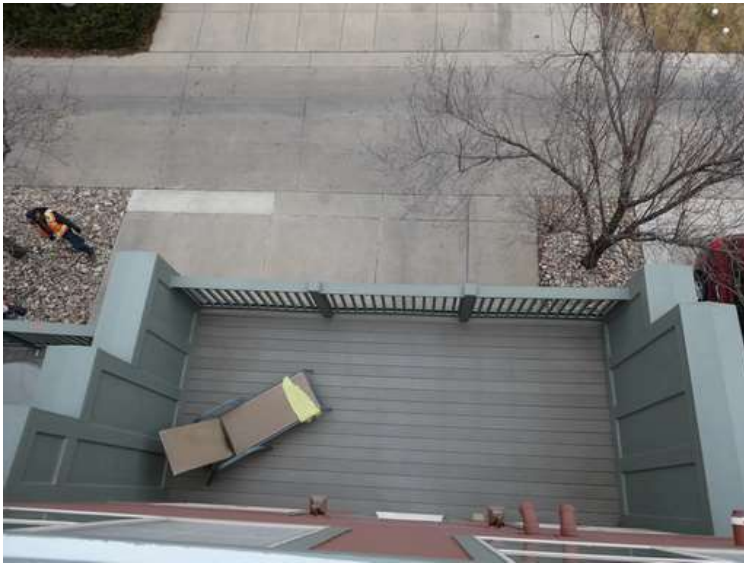
105. Building 04. Balcony.

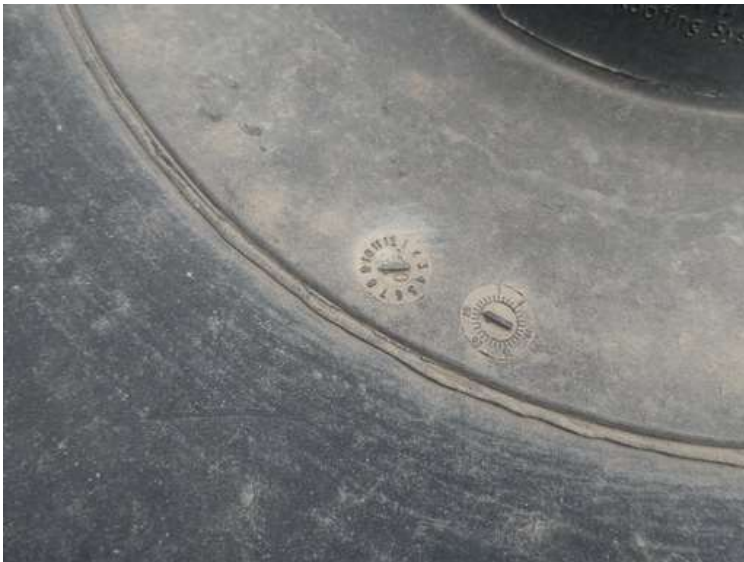
107. Building 04. Boot marked, '05'.

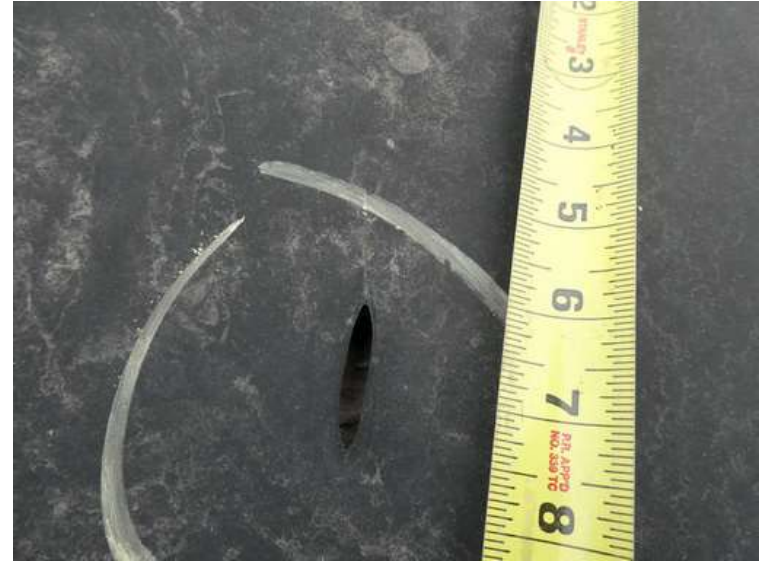
110. Building 04. Mechanical cut.

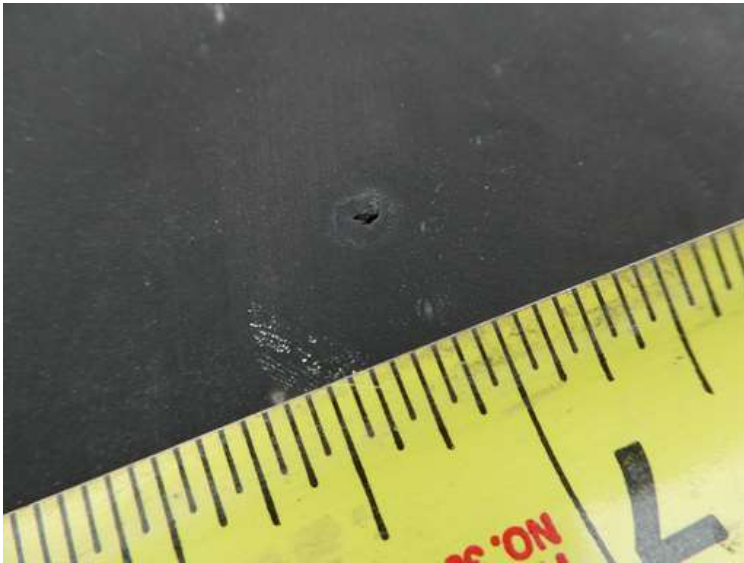
111. Building 04. Mechanical cut.

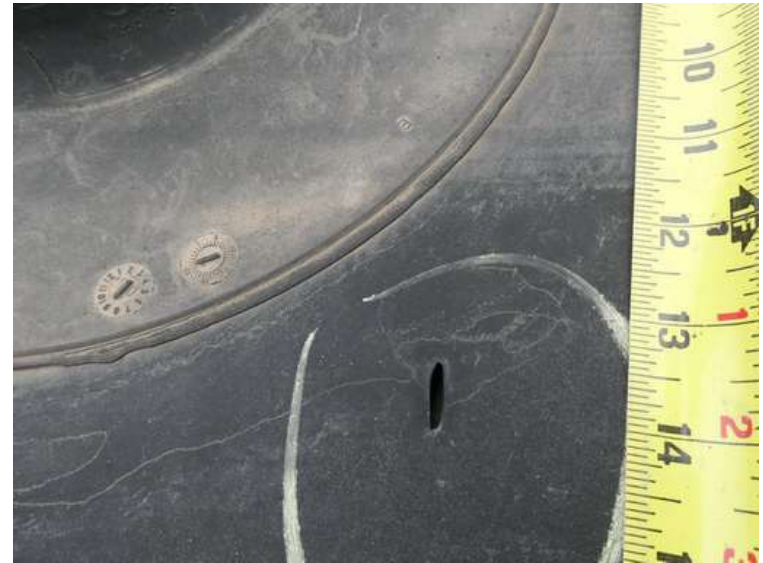
112. Building 04. Mechanical cut.

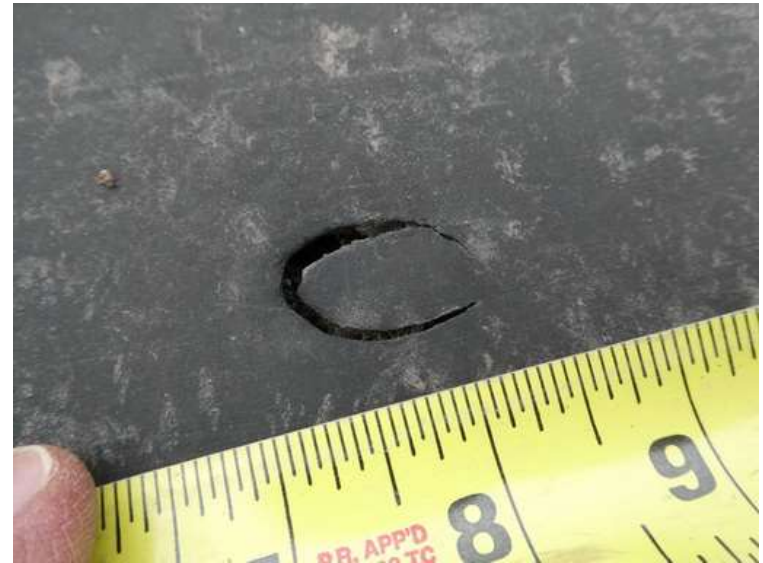
114. Building 04. Mechanical cut.

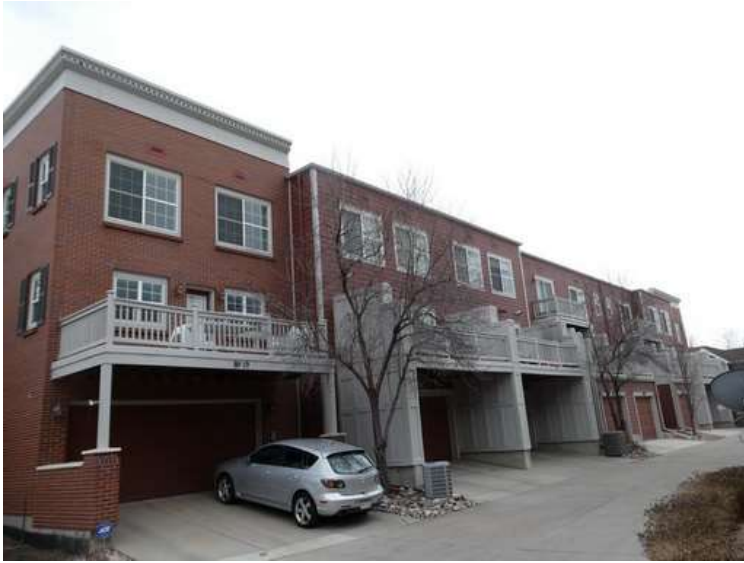
117. Building 05. West elevation.

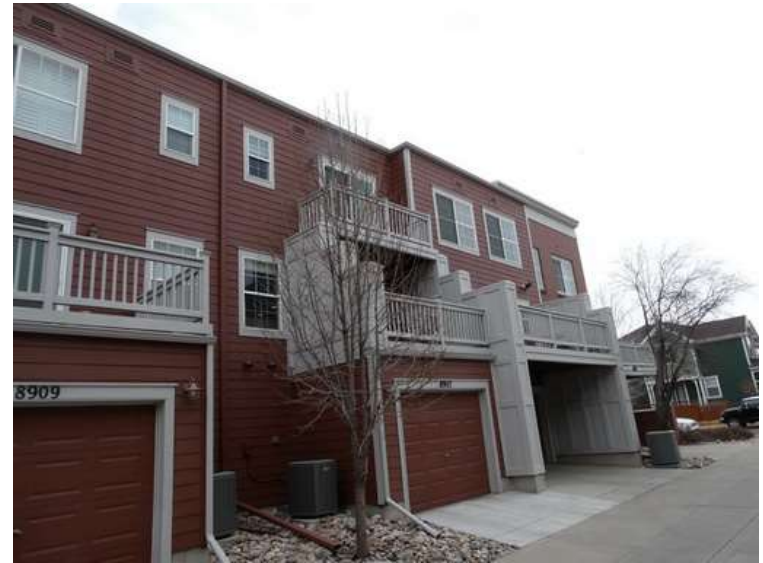
120. Building 05. Balconies.

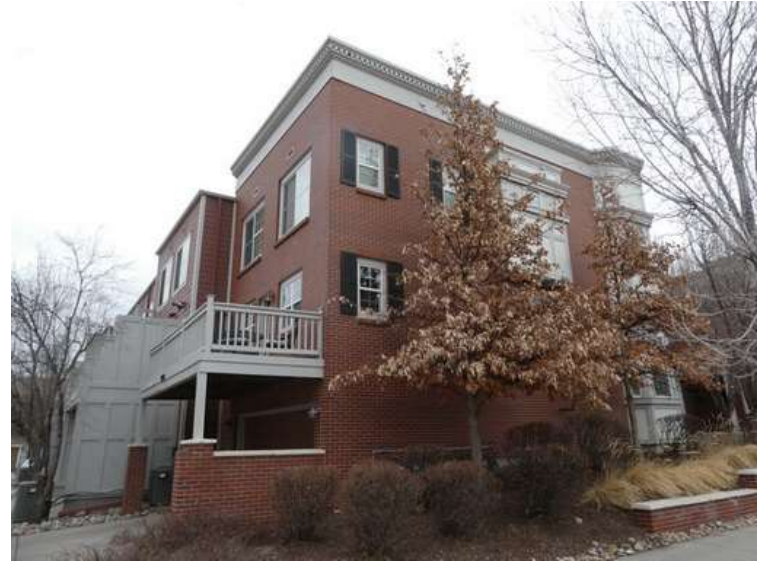
122. Building 05. South elevation.

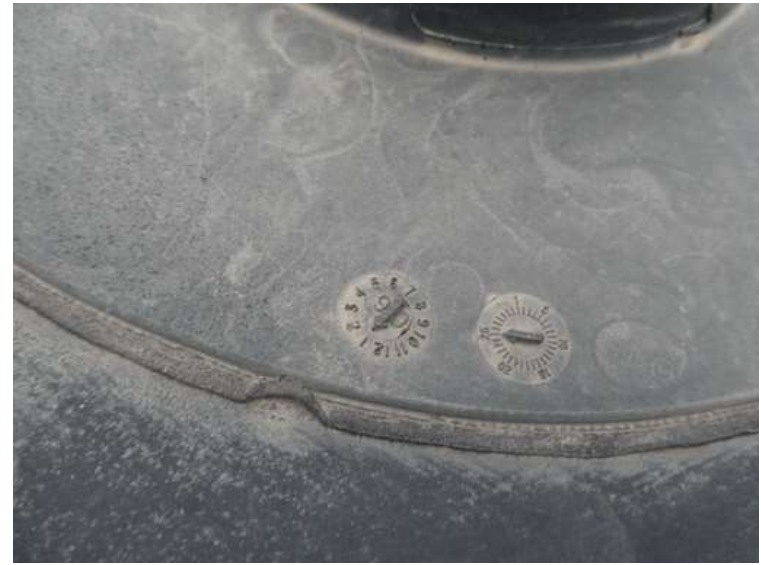
126. Building 05. Boot dated, '06'.

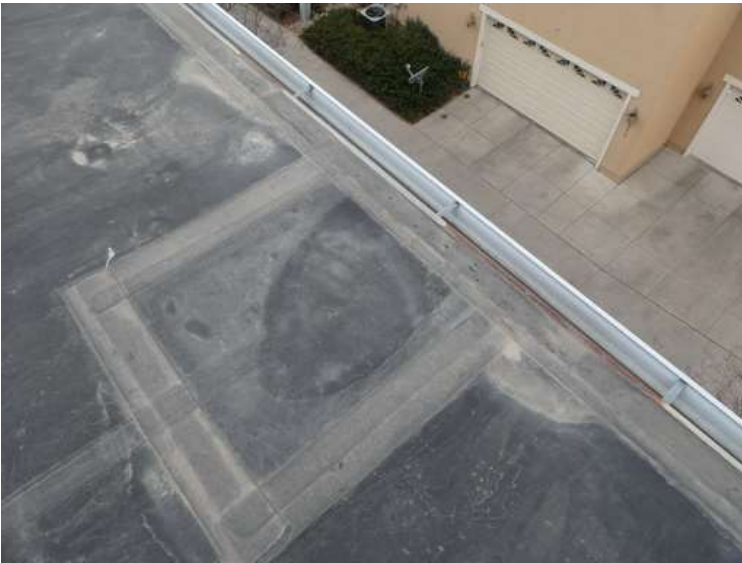
127. Building 05. Patch.

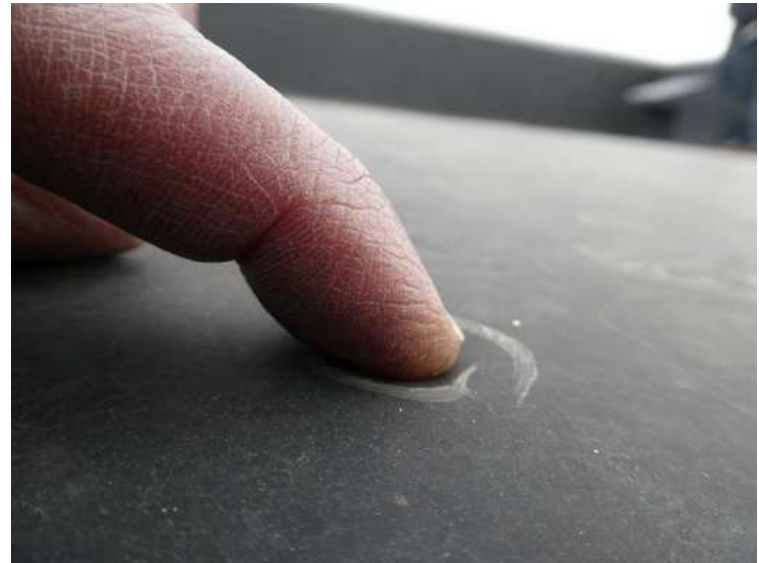
134. Building 05. Dent.

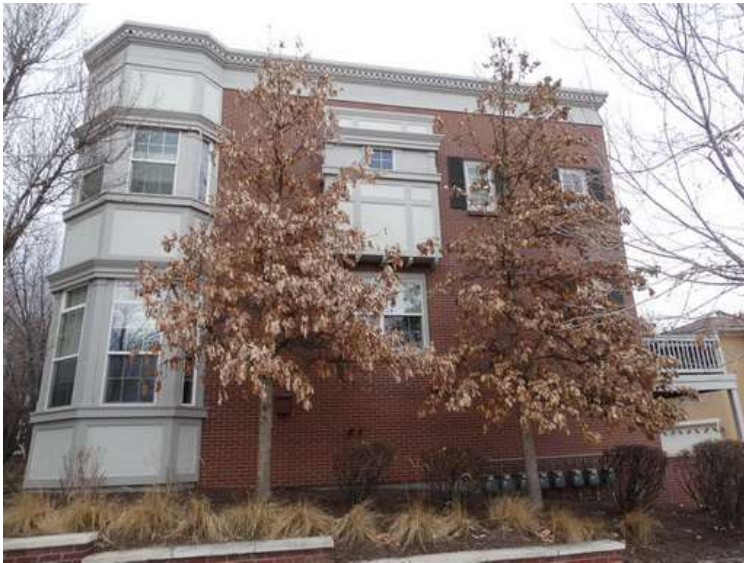
142. Building 06. Beading fractured by hail.

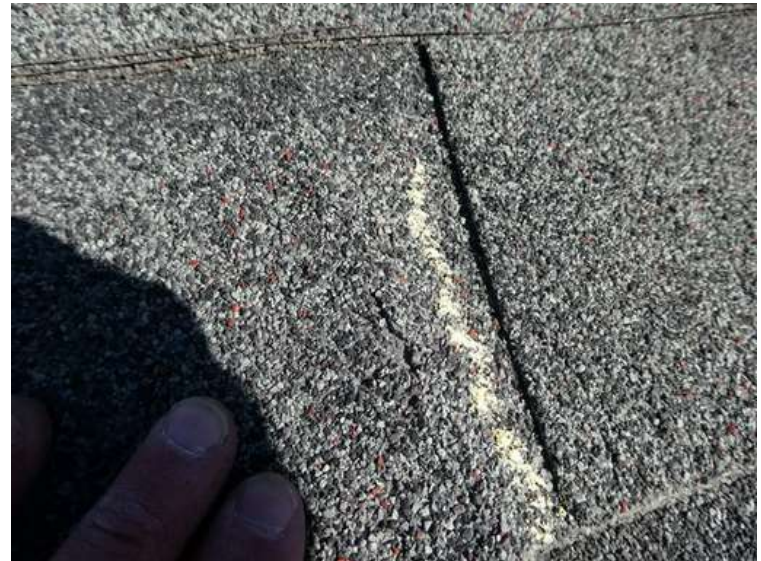
176. Building 07. Wrinkle.

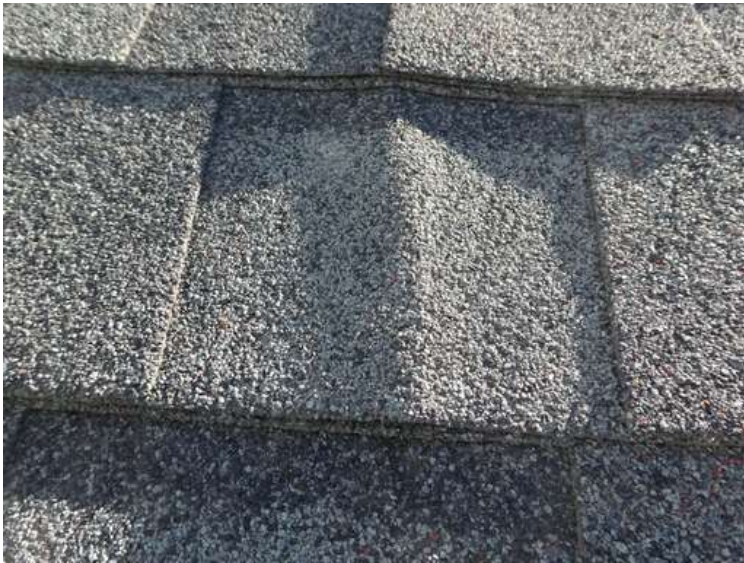
185. Building 07. Wrinkle.

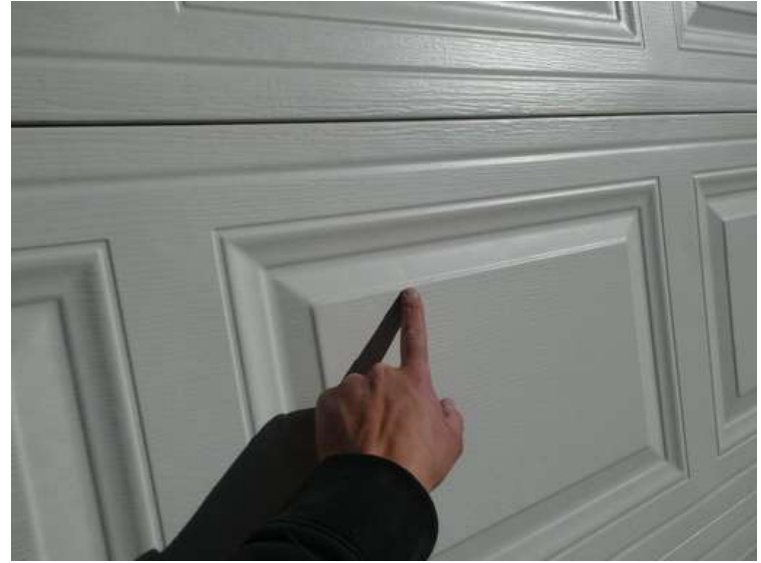
194. Building 08. Dent.

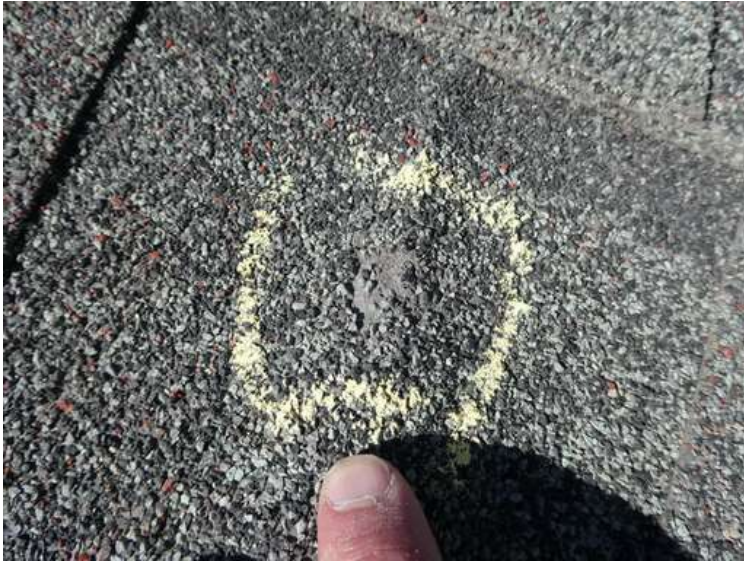
201. Building 08. Bruise in a wrinkle.

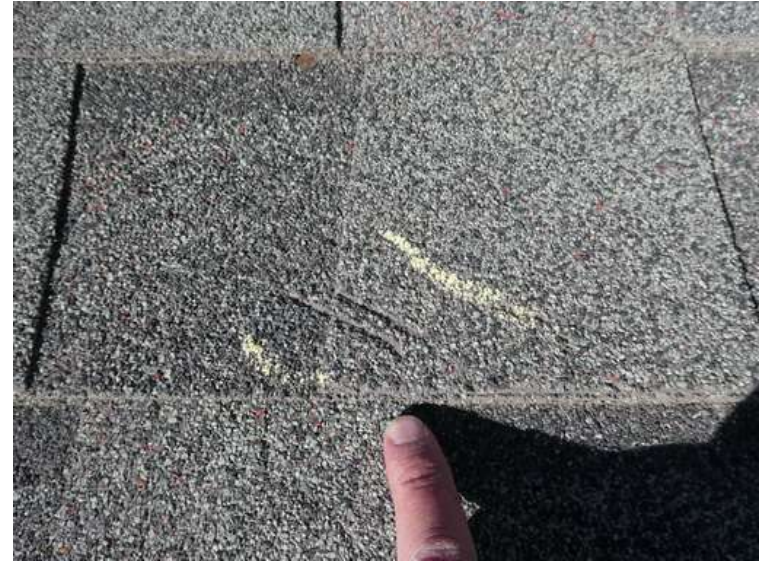
202. Building 08. Knife cut.

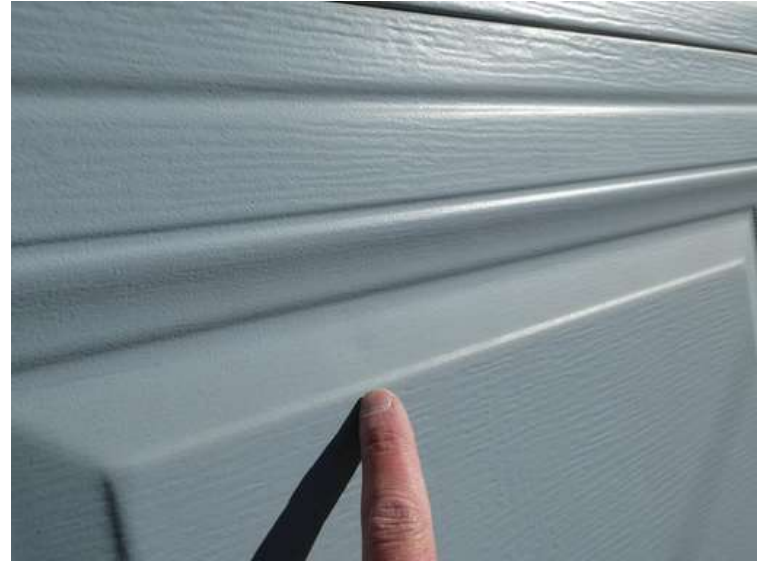
218. Building 09. Dent.

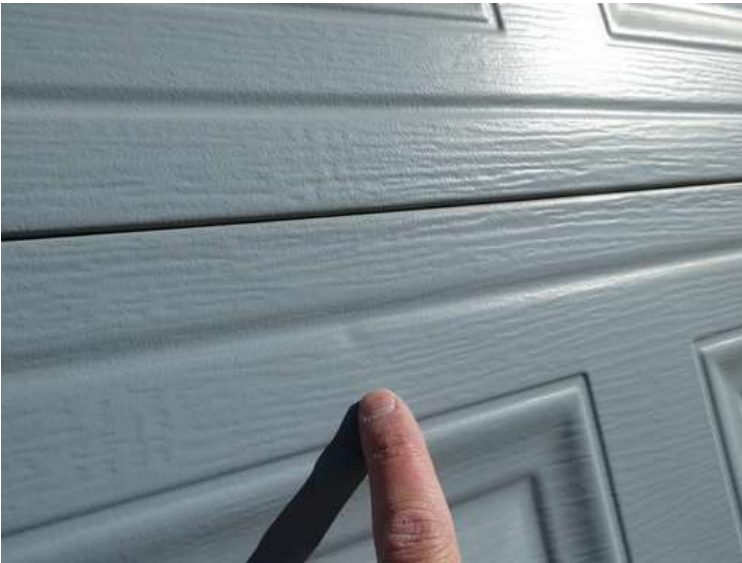
219. Building 09. Dent.

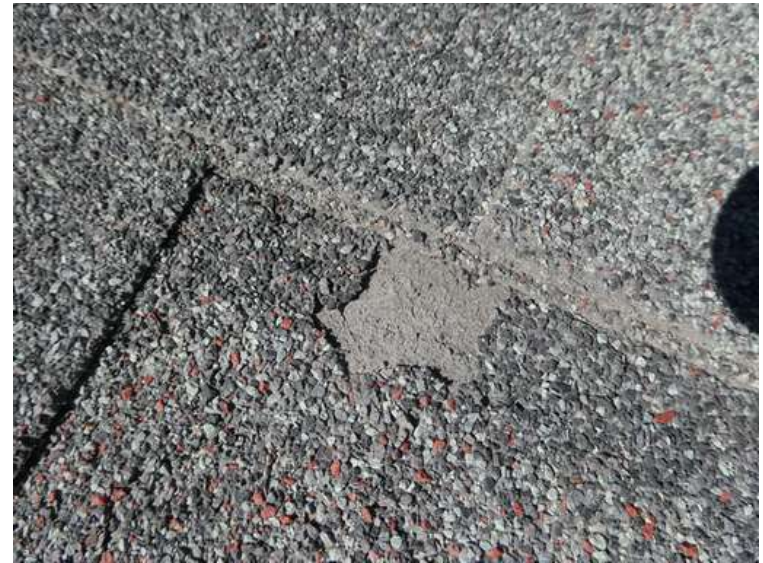
228. Building 09. Blister.

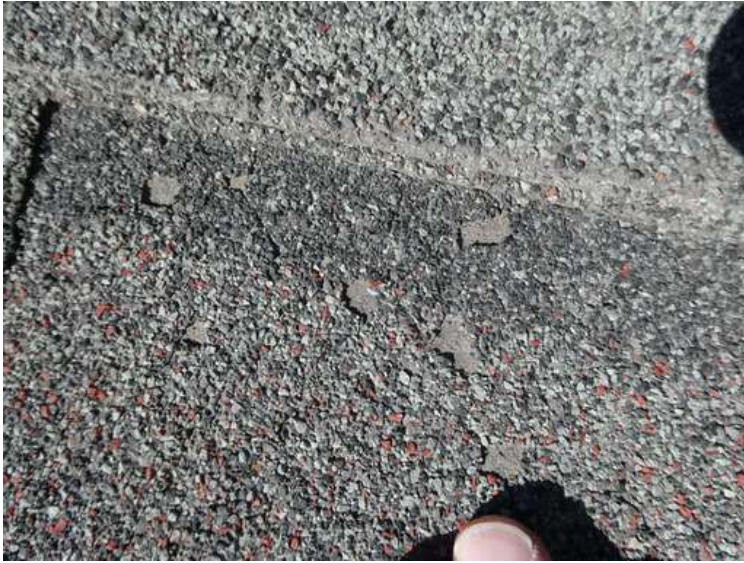
229. Building 09. Blisters.

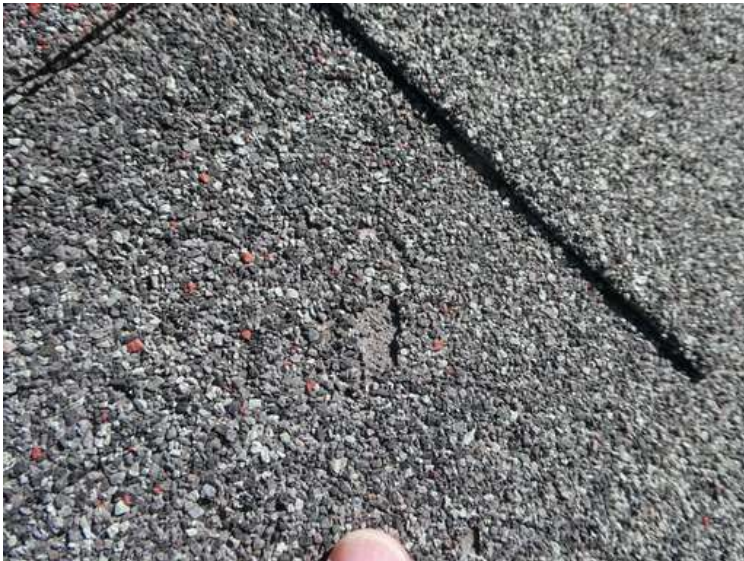
247. Building 10. Blister.

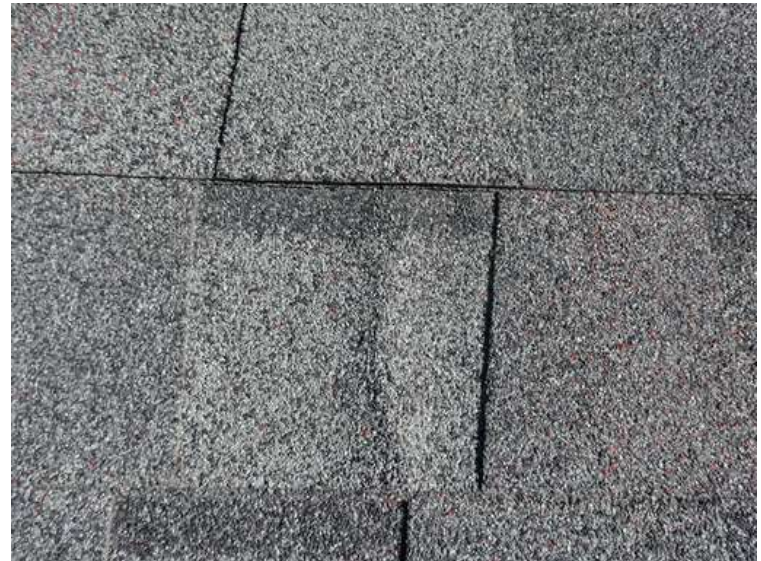
248. Building 10. Wrinkle.

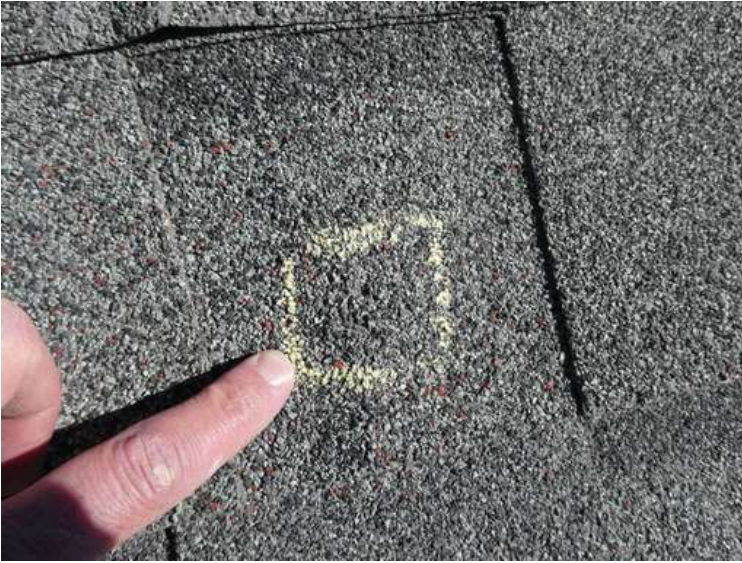
249. Building 10. Bruise in a wrinkle.

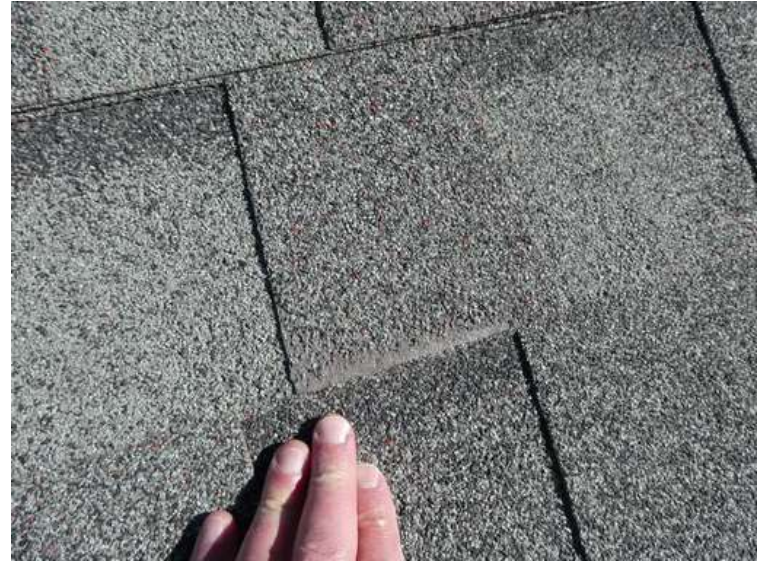
252. Building 10. Foot scuff.

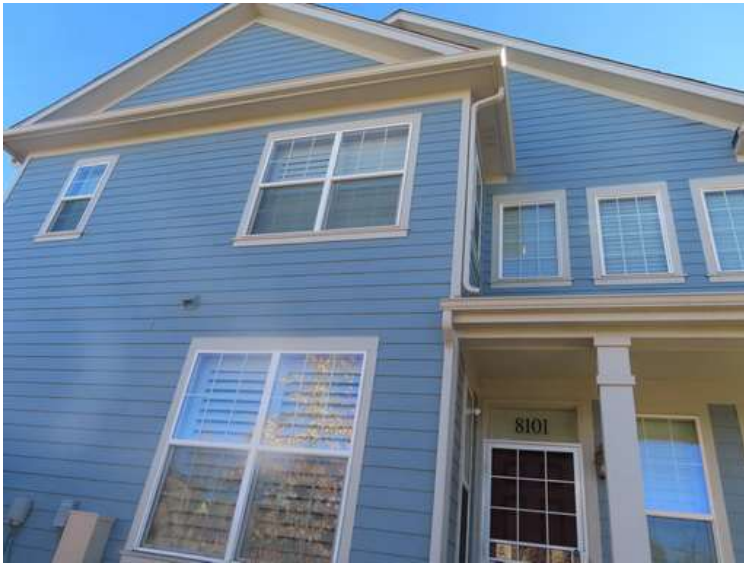
264. Building 11. Fracture in glazing bead from hail.

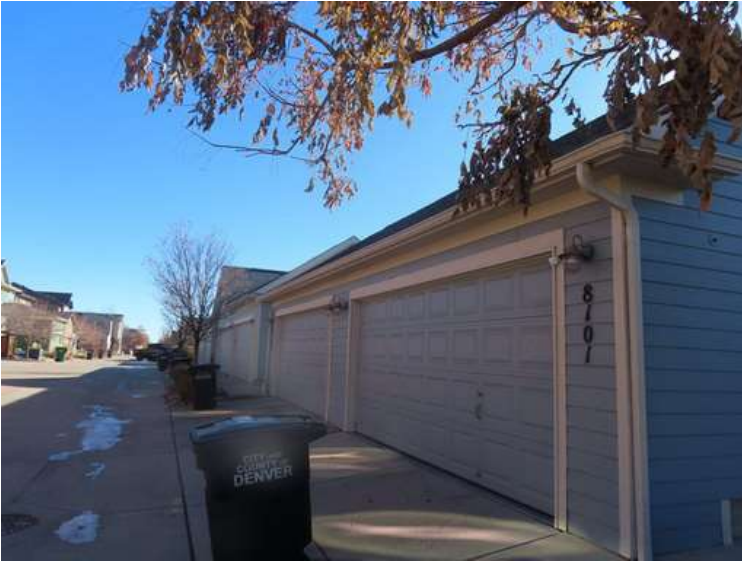
266. Building 11. Paint was not chipped from fiber cement siding.

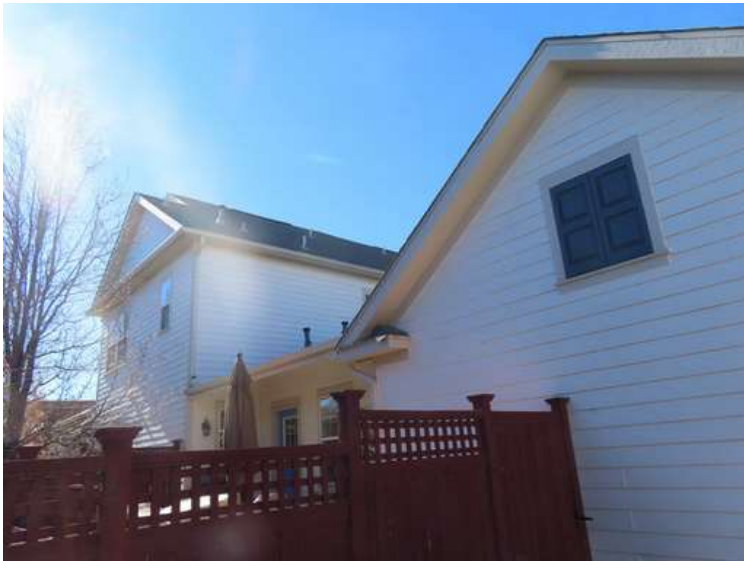
278. Building 12. Tears in a screen.

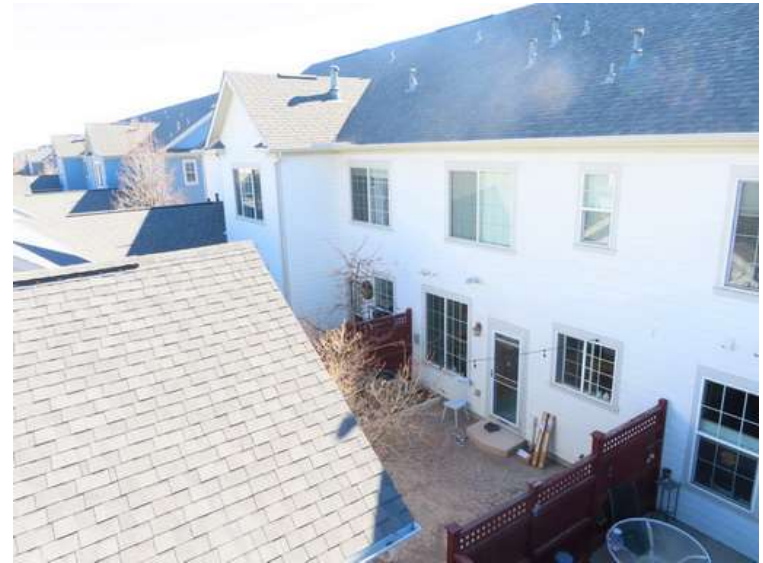
281. Building 12. Chips in paint on a rotted sill.

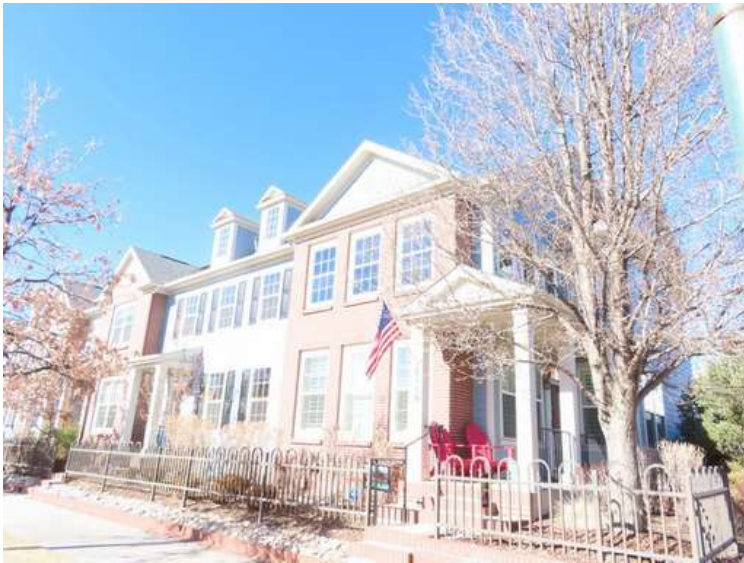
290. Building 12. Shingles draped over valleys were not bruised by hail.

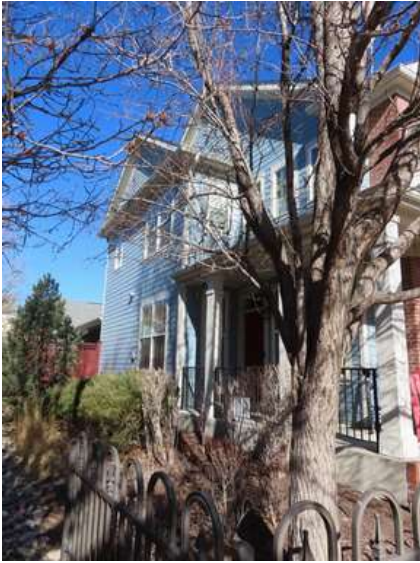
292. Building 13. Fractured glazing bead.

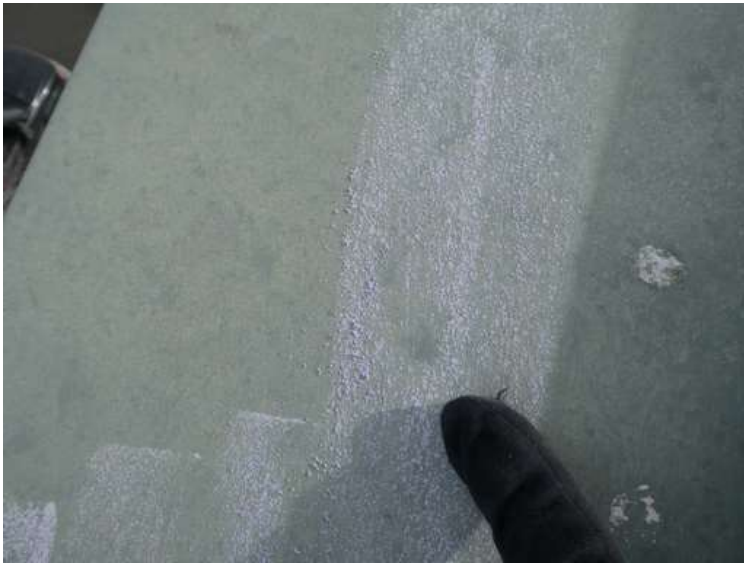
323. Building 14. Dent at a spatter mark.

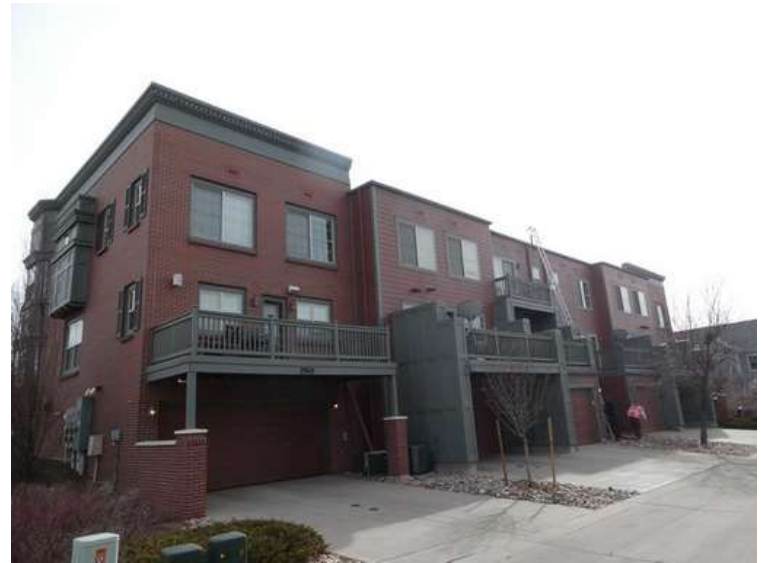
340. Building 15. West elevation.

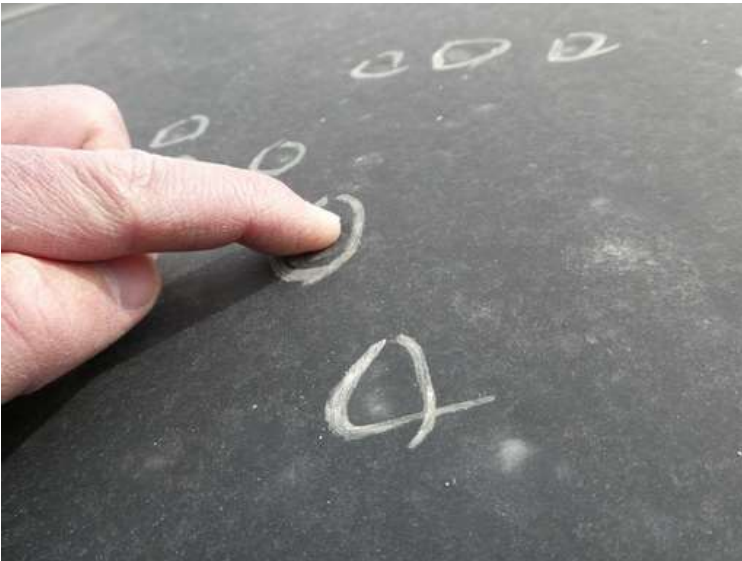
359. Building 15. Dent.

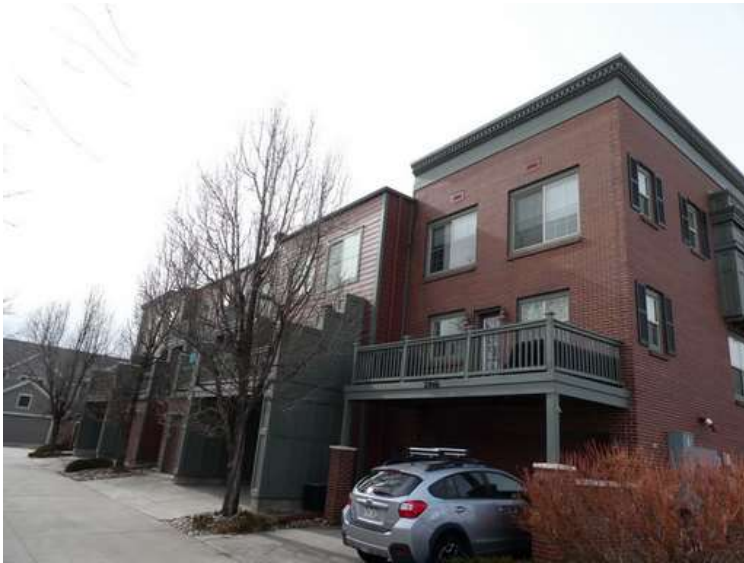
368. Building 16. Tears in a screen from hail.

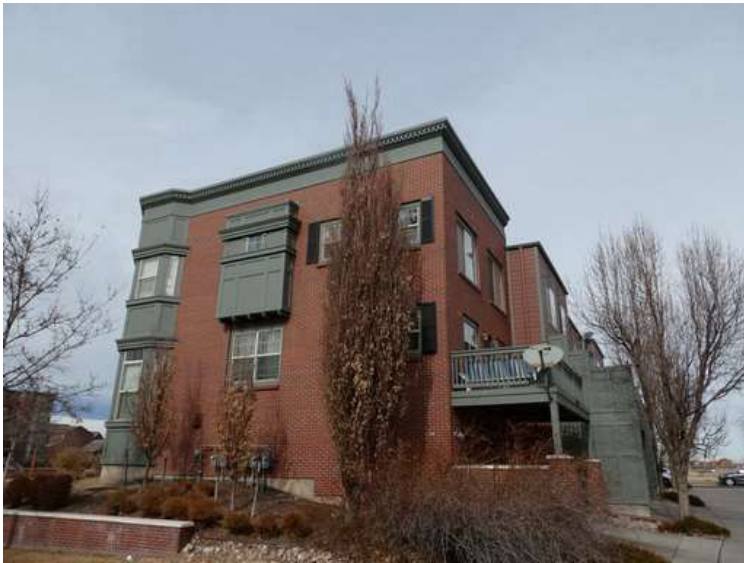
372. Building 16. Paint finishes on fiber cement siding was not fractured by hail.

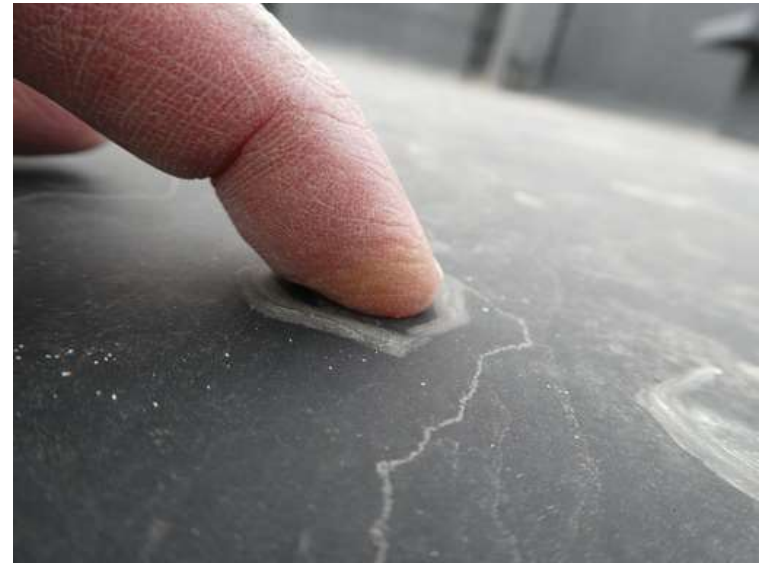
381. Building 16. Test area. Circular chalk marks denote dents in the substrate from hail.

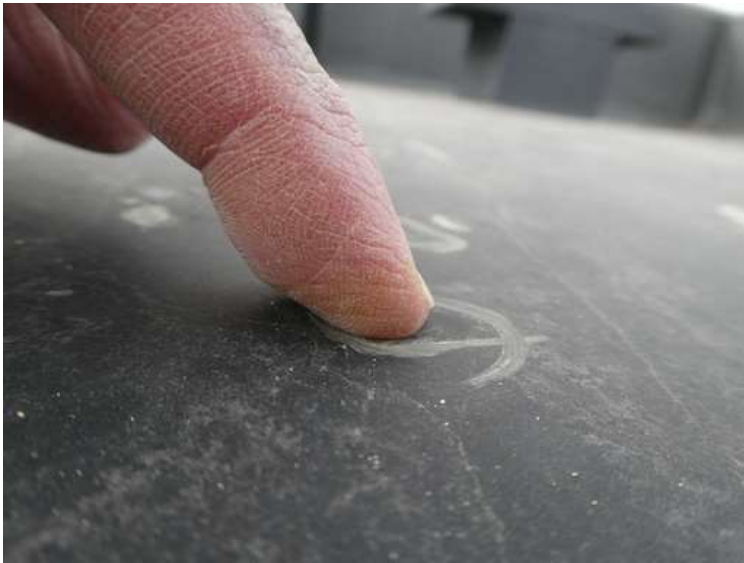
382. Building 16. Dent.

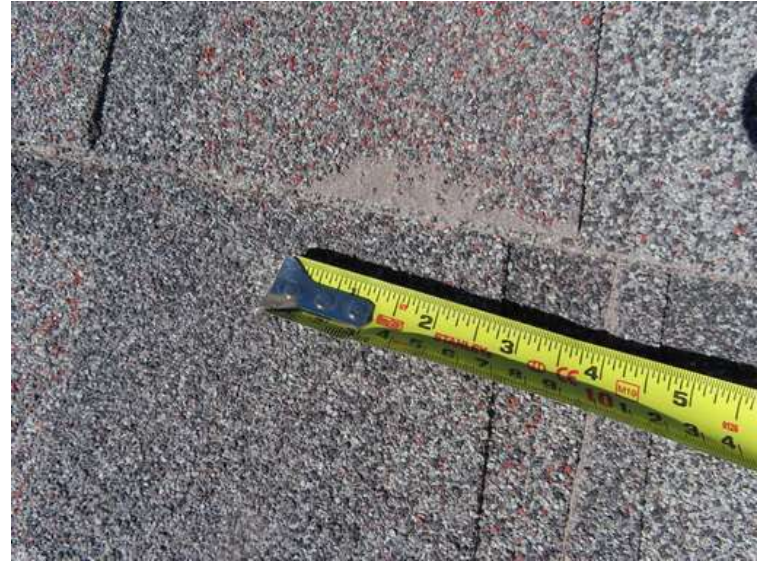
398. Building 17. Foot scuff.

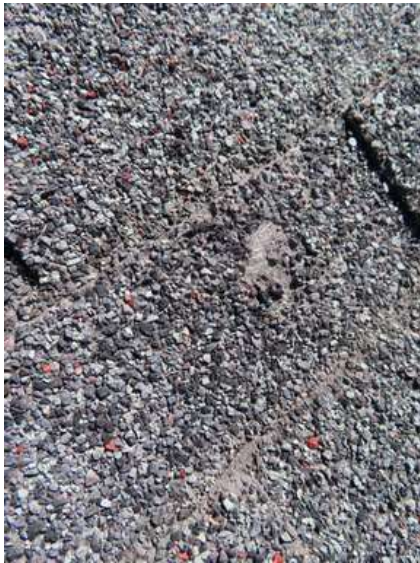
407. Building 18. Bruise at a wrinkle.

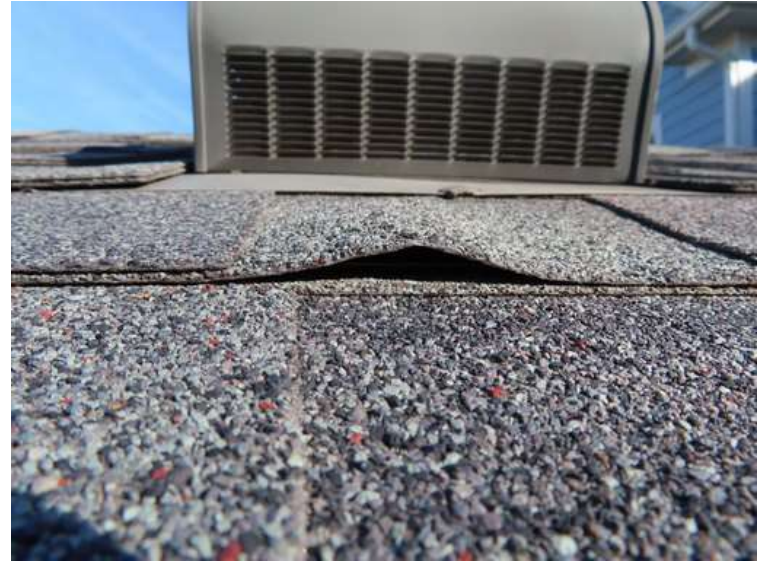
414. Building 18. Wrinkle.
