Stapleton Rowhome Association
Hail Damage Evaluation
10045 Martin Luther King Boulevard
Denver, CO 80238
Farmers File: 5010168593
Haag File: 1121000002-128

Re: Stapleton Rowhome Association
Hail Damage Evaluation
10045 Martin Luther King Boulevard
Denver, CO 80238
Farmers File: 5010168593
Haag File: 1121000002-128

In accordance with your request, we inspected the Stapleton Rowhome Association buildings to determine the extent of hail-caused damage to the building exteriors and when the damage occurred. We inspected the sites on February 1, 2, and 3, 2021.

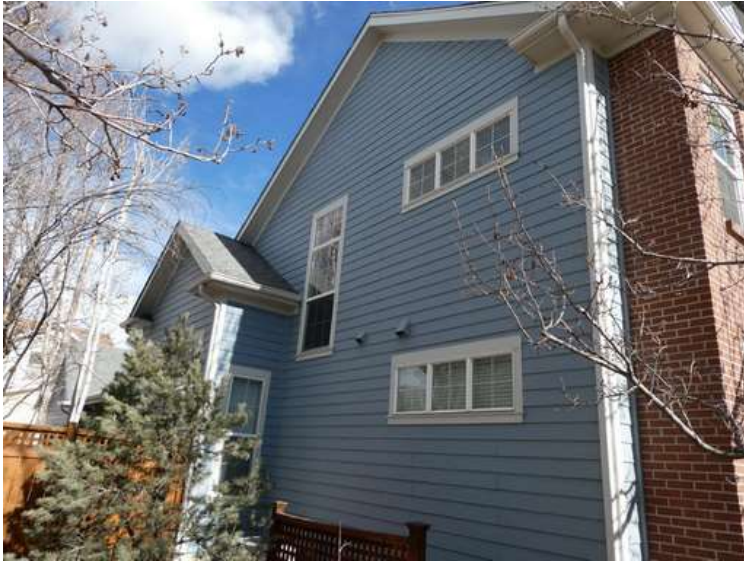
422. Building 19. Fractures in vinyl above the window.

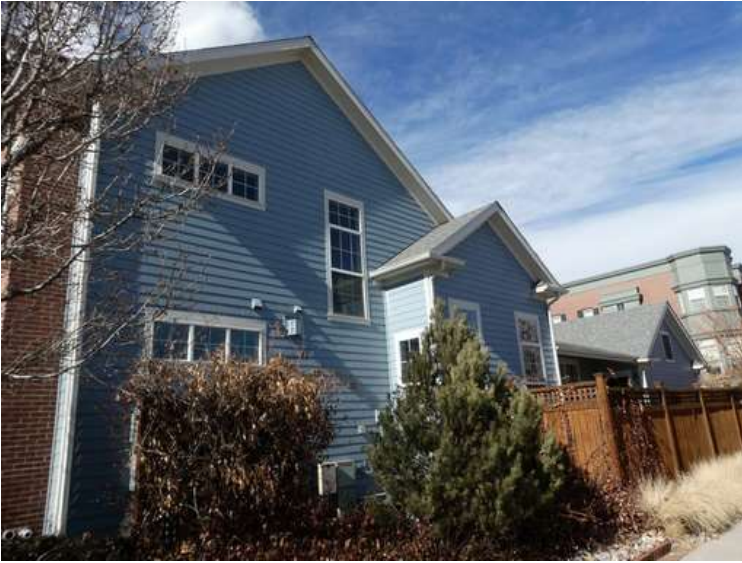
426. Building 19. Fractures in a vinyl window frame.

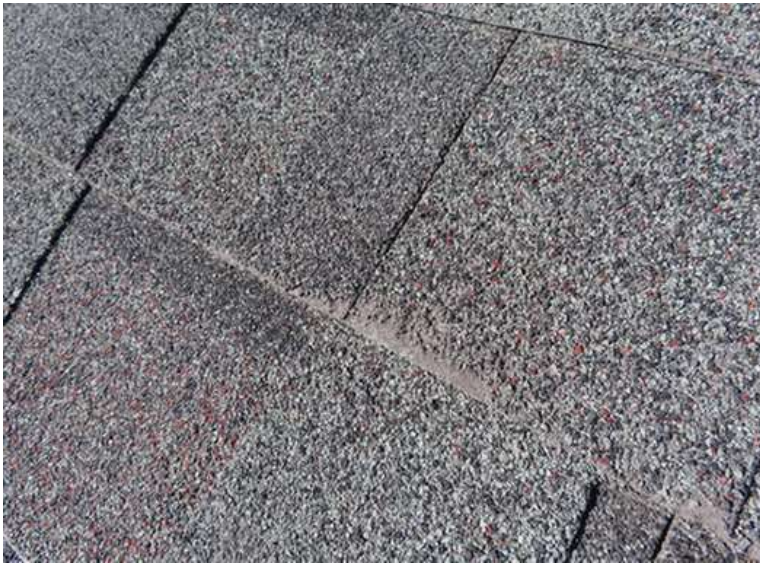
431. Building 19. Foot scuff.

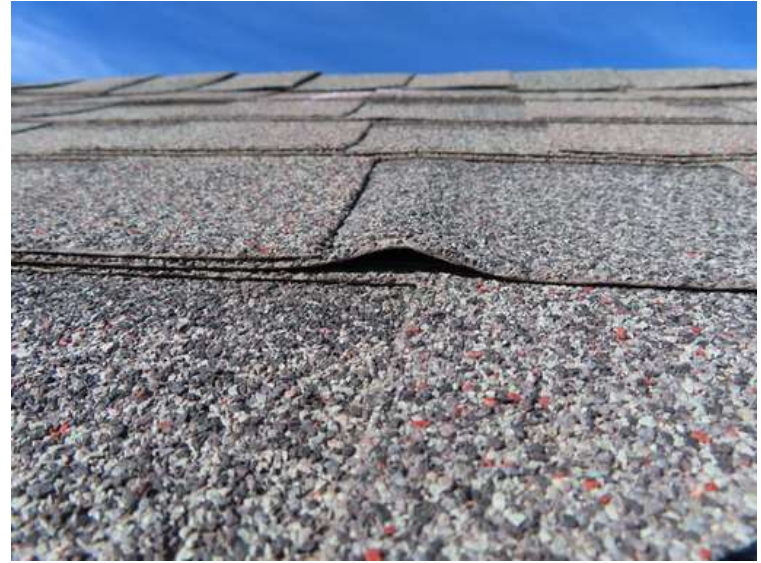
434. Building 19. Wrinkle.

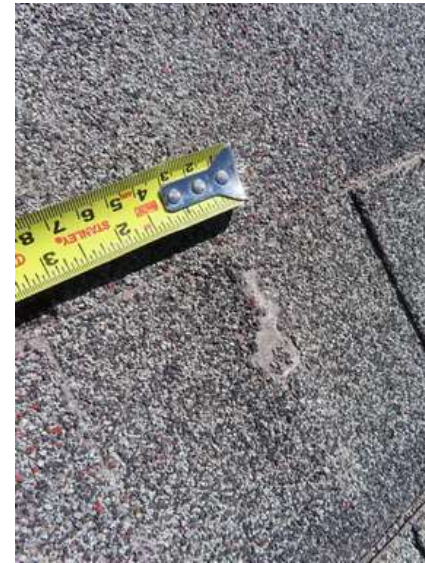
436. Building 19. Bruise at a wrinkle.

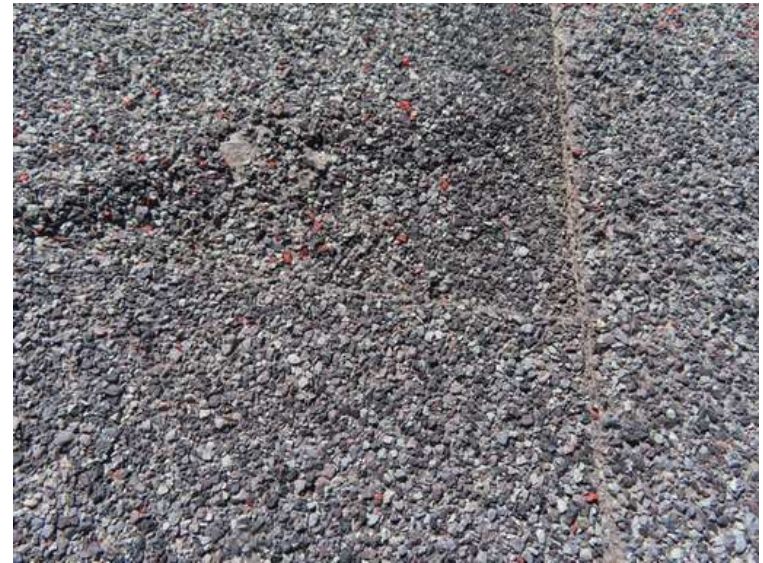
438. Building 19. Bruise at a wrinkle.

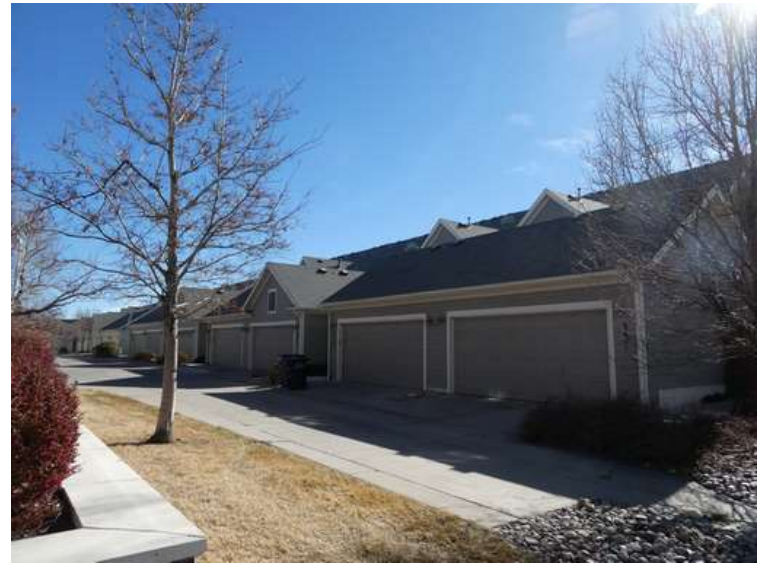
455. Building 20. Paint finishes on fiber cement siding were not fractured by hail.

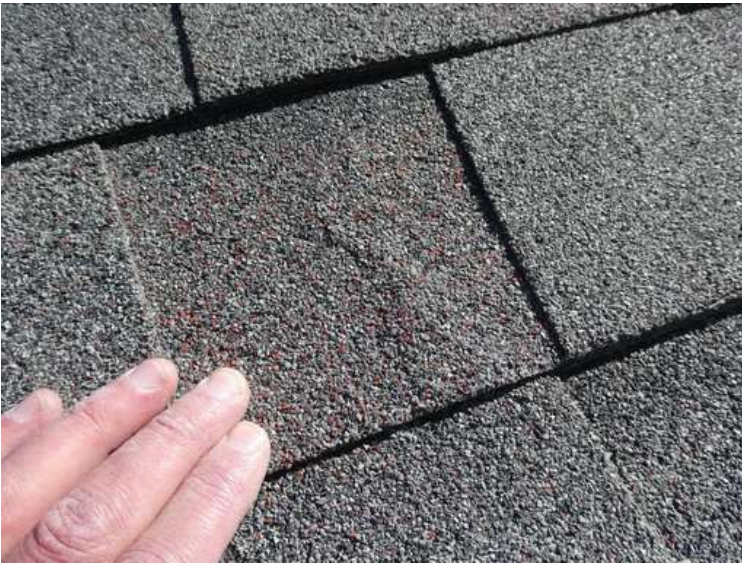
459. Building 20. Wrinkle.

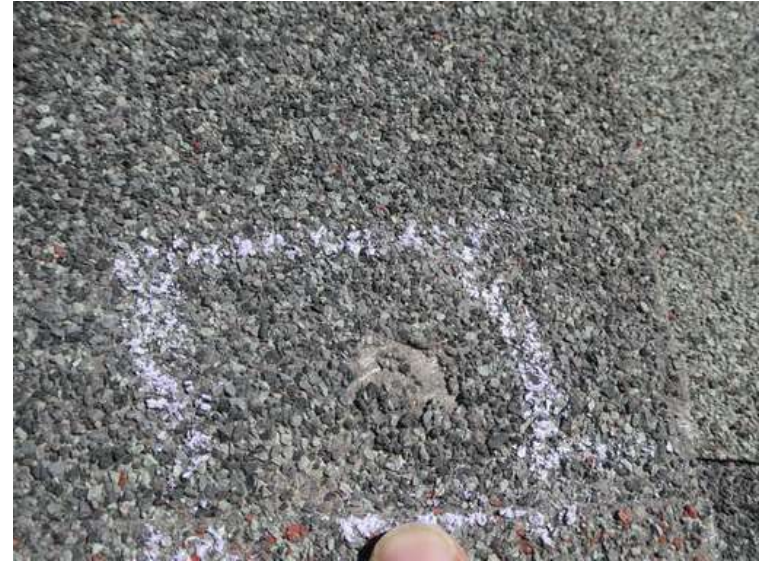
466. Building 20. Bruise at a wrinkle.

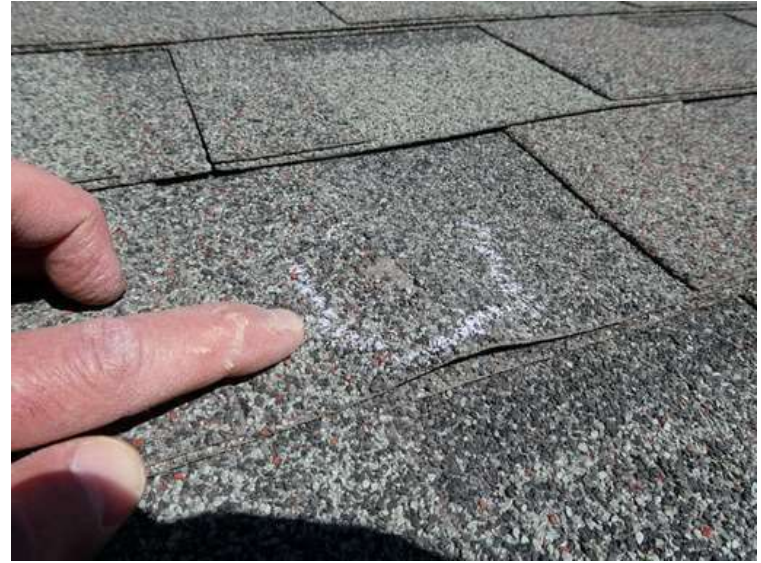
498. Building 21. Bruise at a wrinkle.

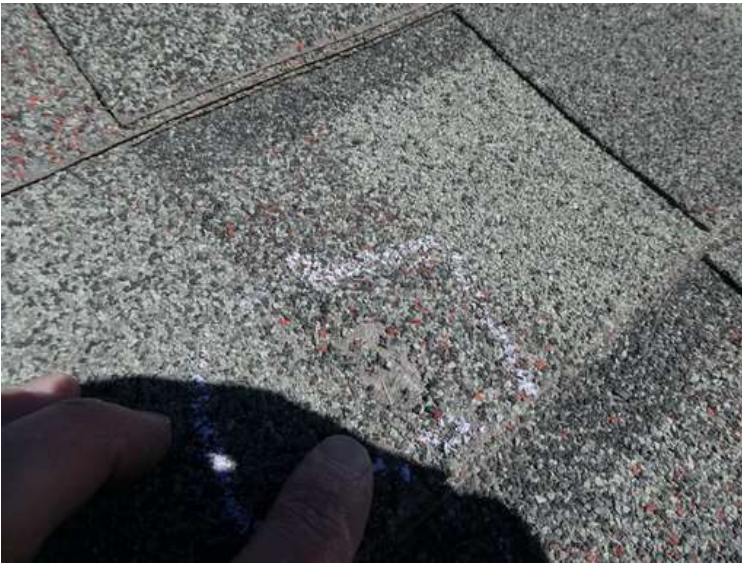
499. Building 21. Bruise at a wrinkle.

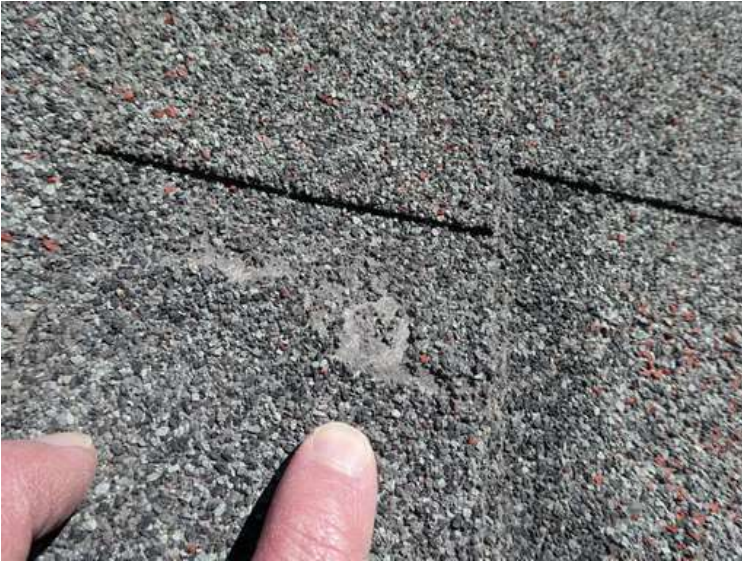
521. Building 22. Bruise in a wrinkle.

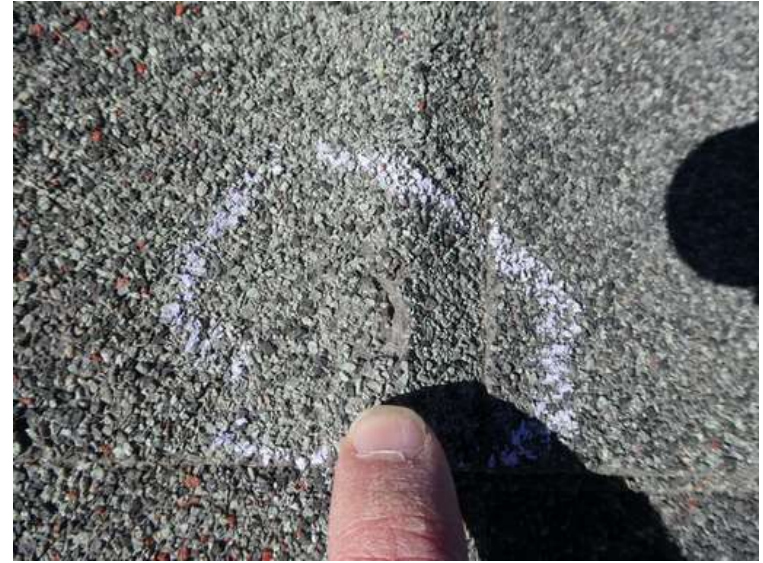
522. Building 22. Bruise in a wrinkle.

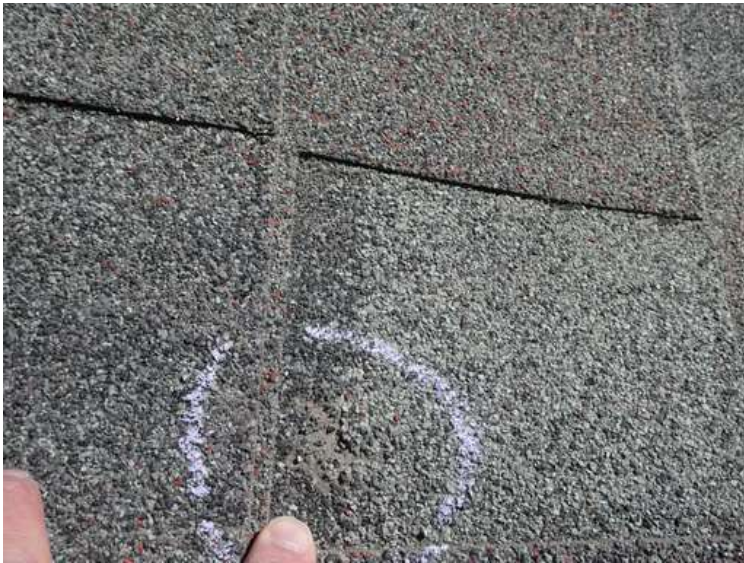
527. Building 22. Bruise at a wrinkle.

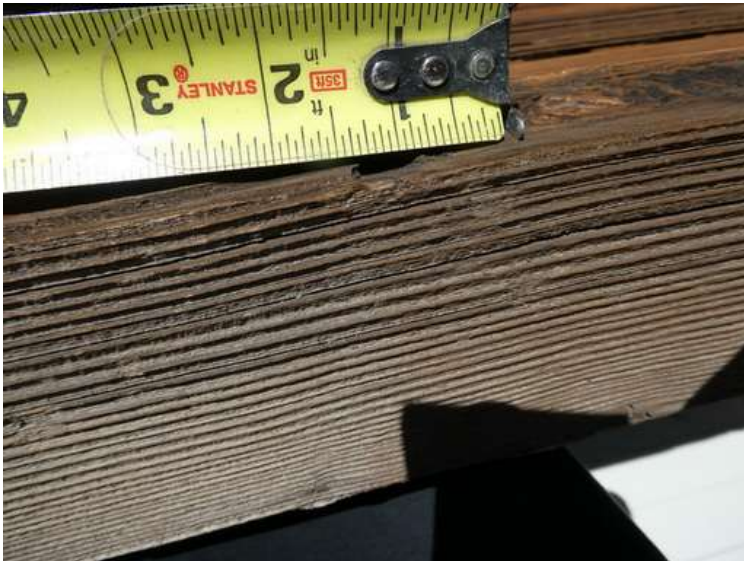
547. Building 23. Dent in a wood fence.

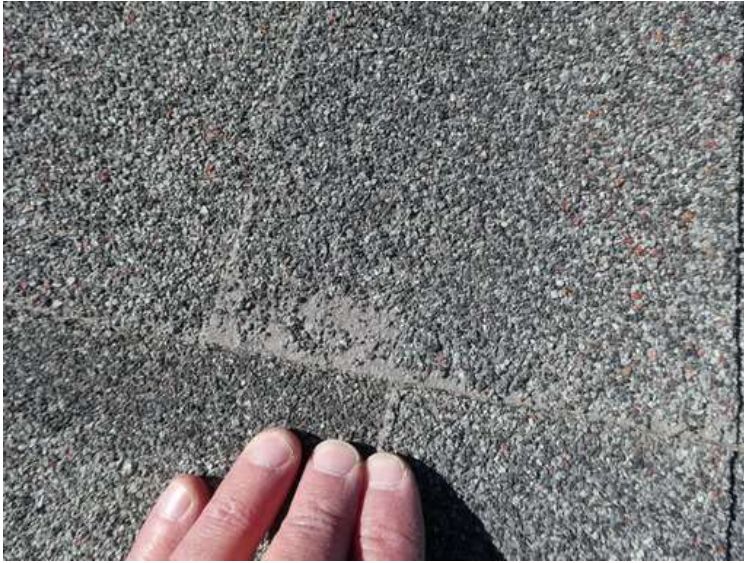
557. Building 23. Foot scuff.

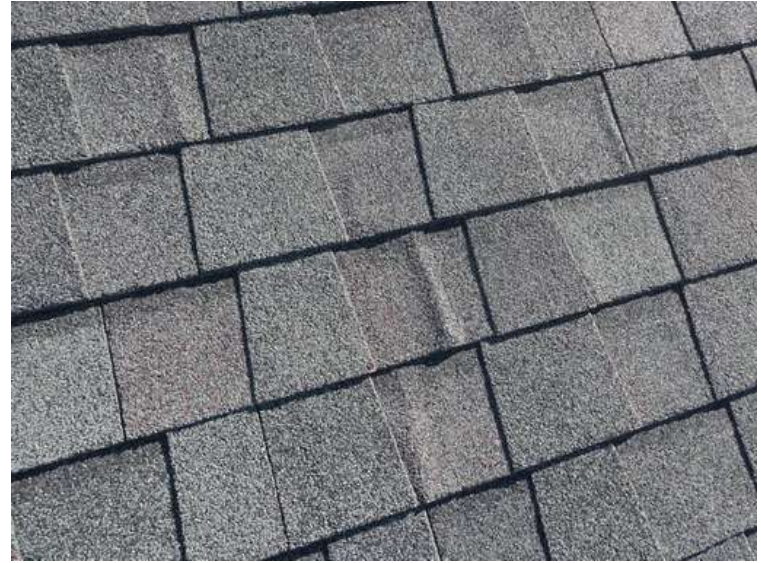
558. Building 23. Wrinkle.

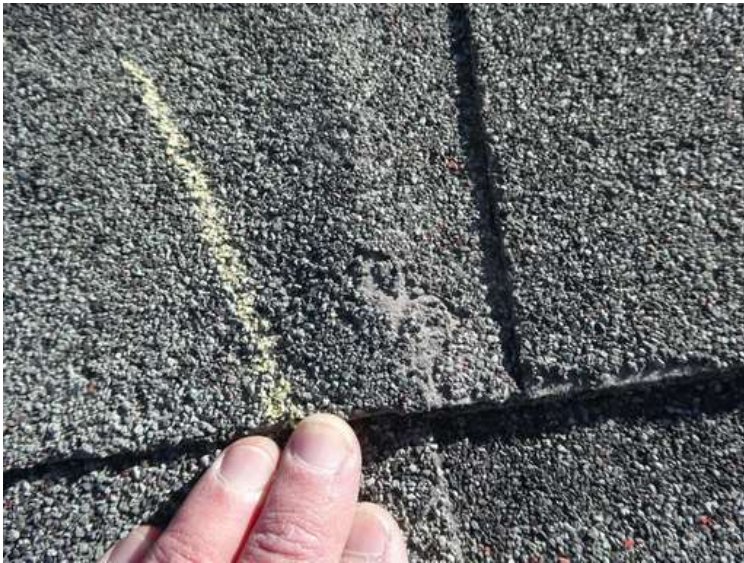
559. Building 23. Bruise at a wrinkle.

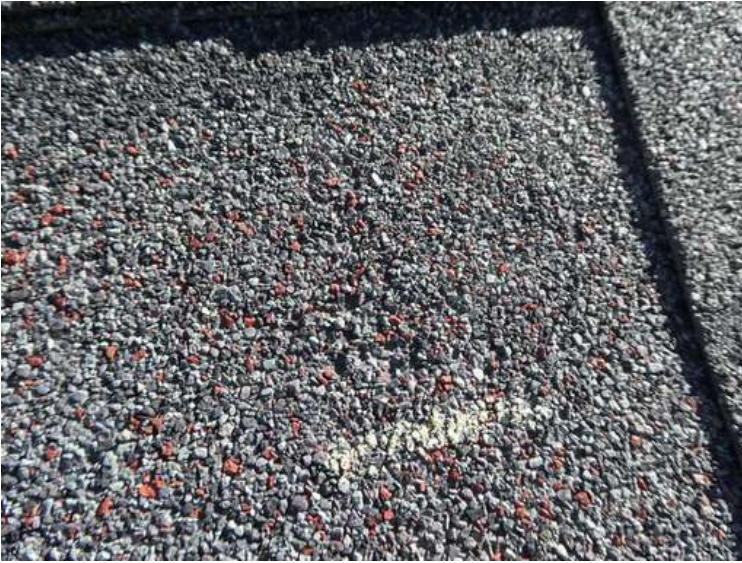
565. Building 23. Bruise in a wrinkle.

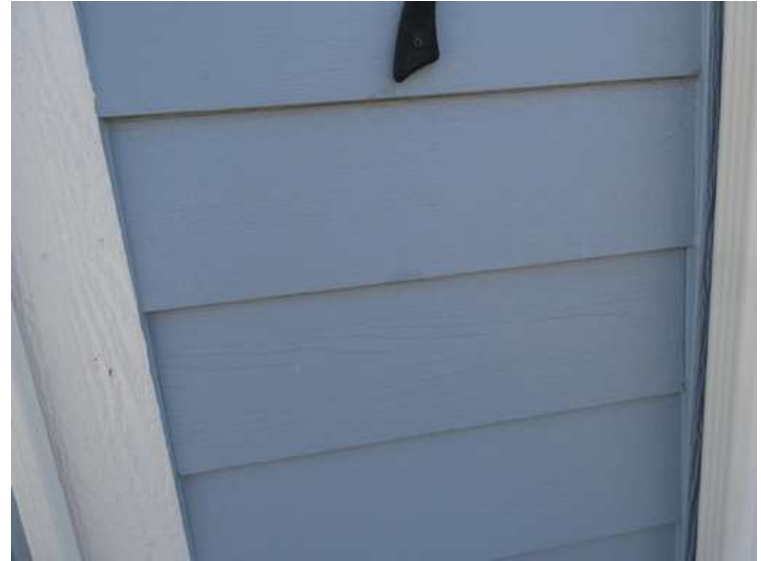
580. Building 24. Paint finishes on siding were not chipped by hail.

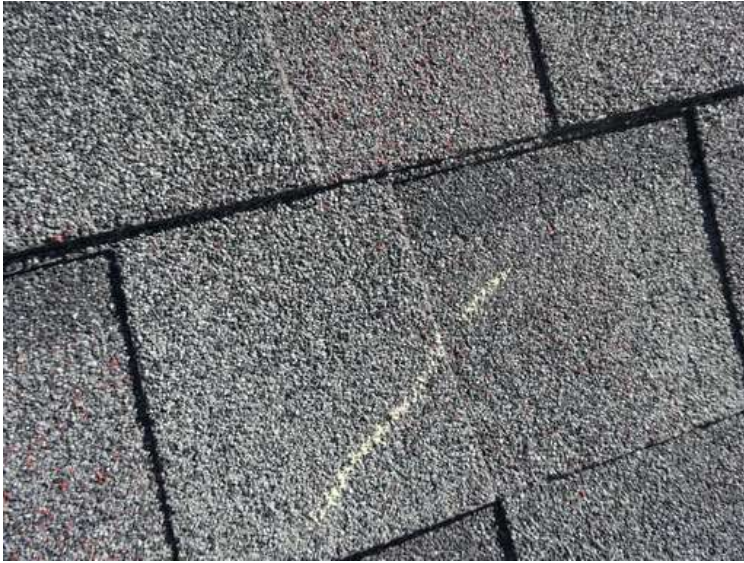
589. Building 24. Scuff.

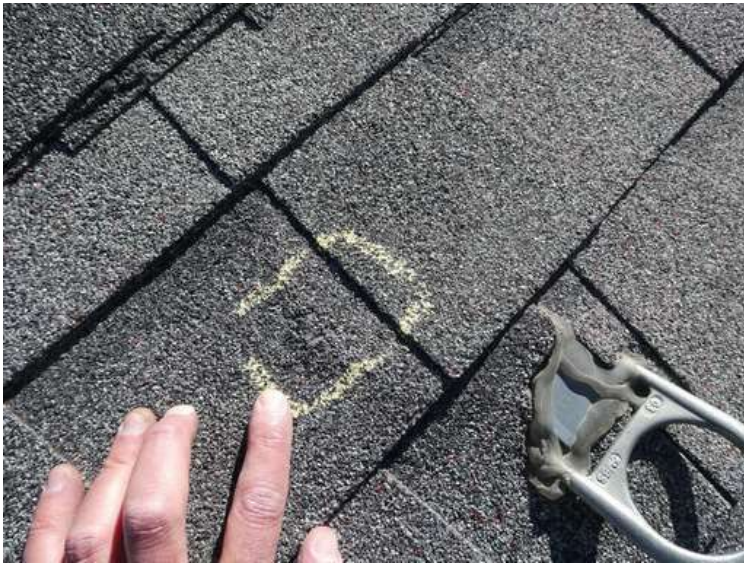
591. Building 24. Bruise in a wrinkle.

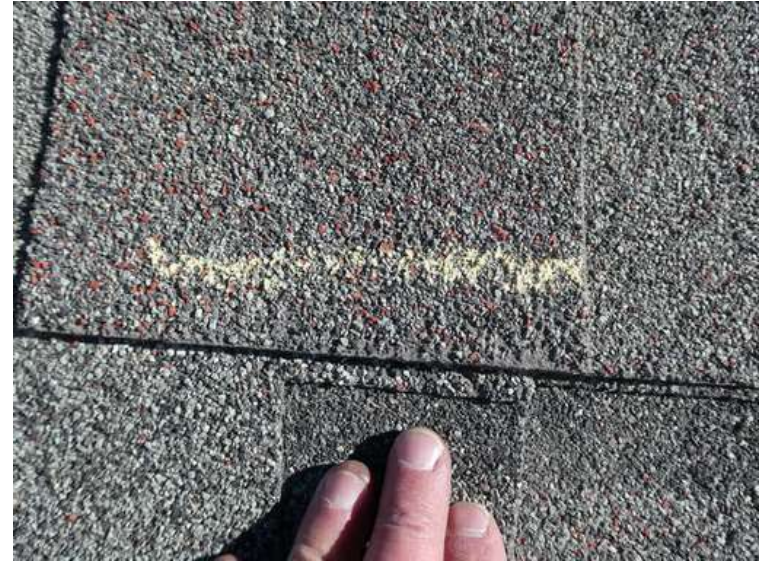
598. Building 24. Foot scuff.

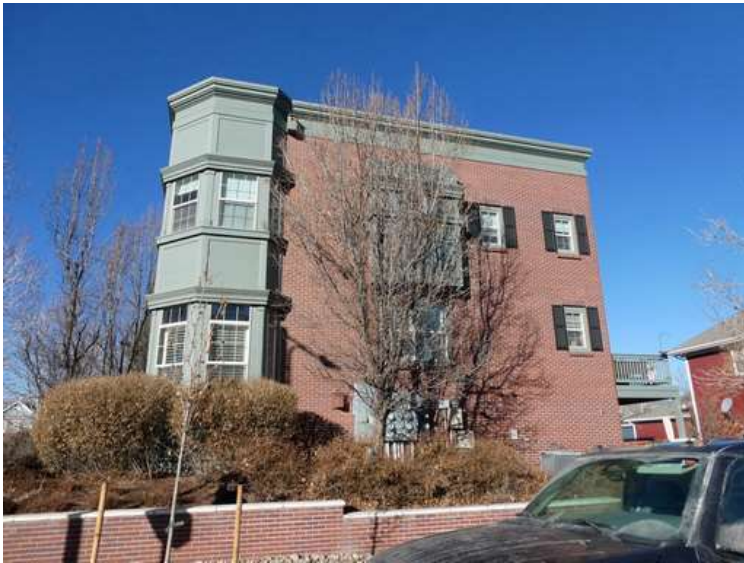
605. Building 25. East elevation.

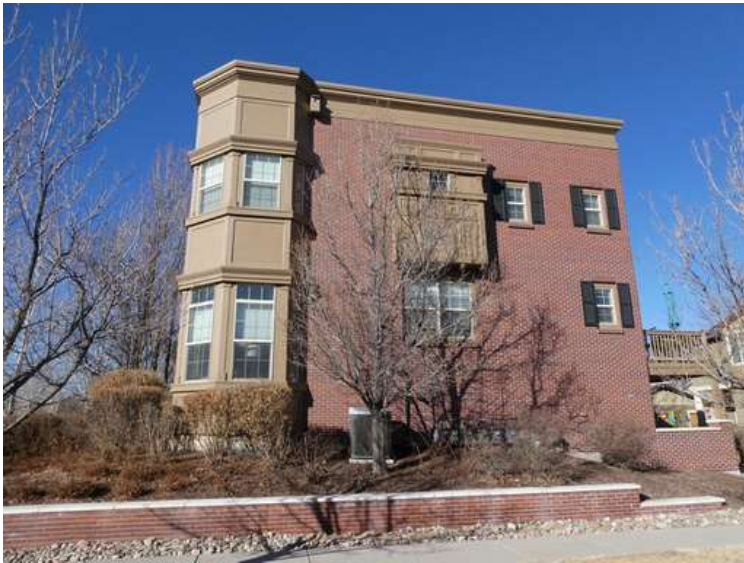
632. Building 26. Tears in a screen.

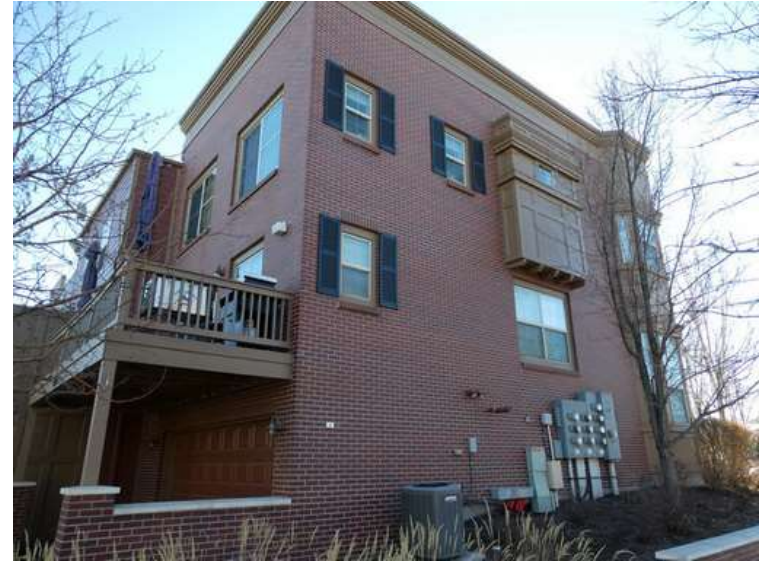
635. Building 26. Tears in a screen.

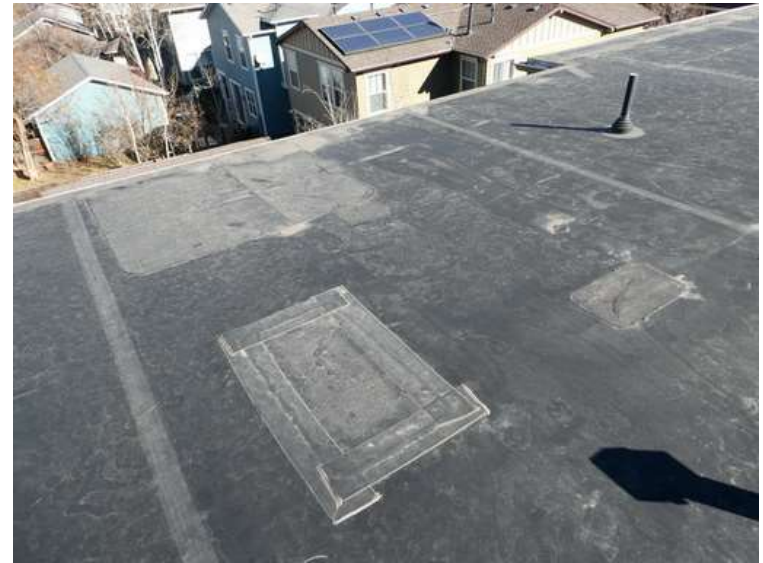
645. Building 26. Dent in coping from hail.

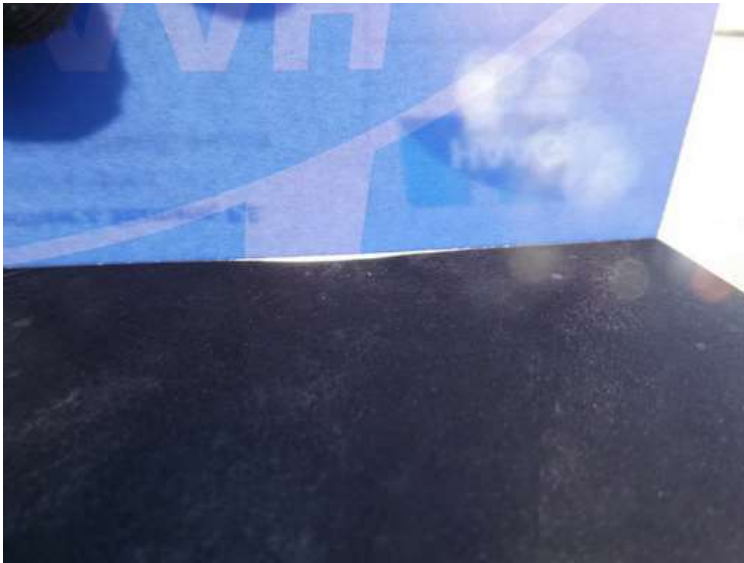
649. Building 26. Straight edge over a dent.

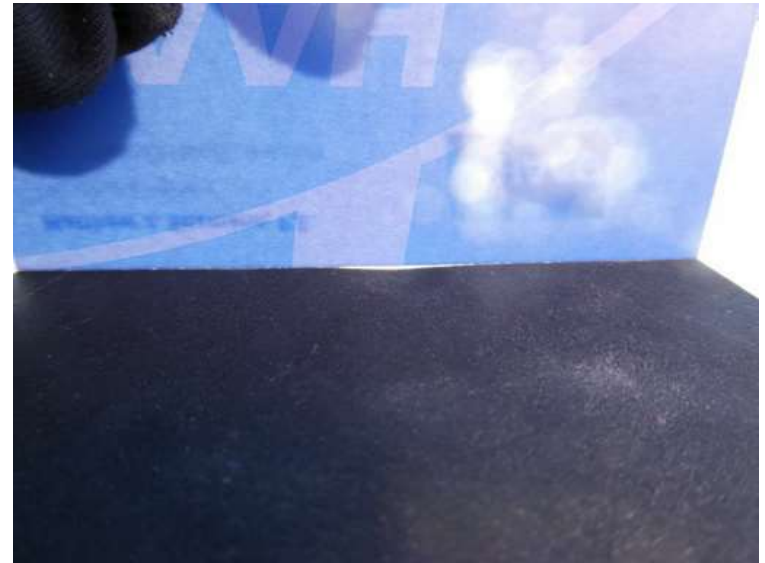
650. Building 26. Straight edge over a dent.

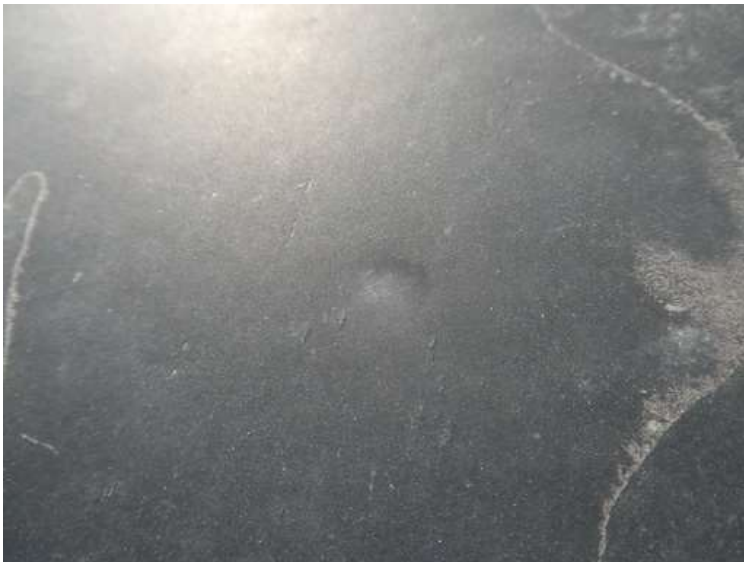
651. Building 26. Dent.

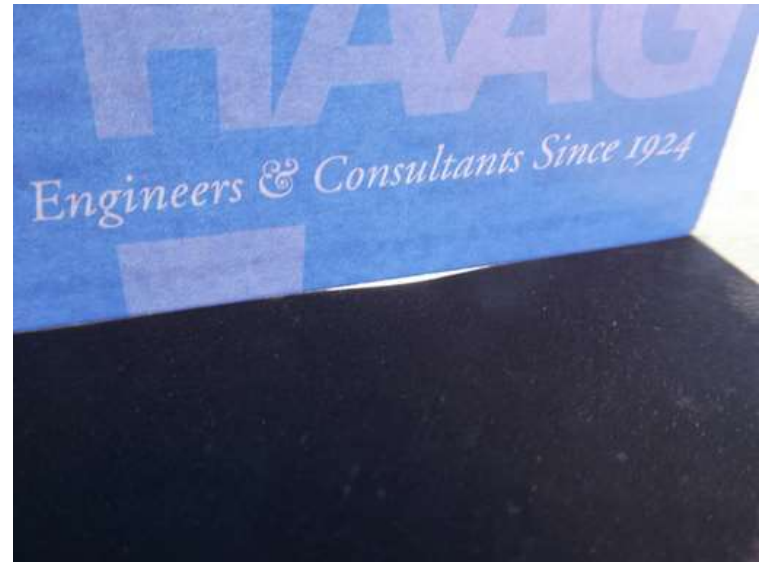
652. Building 26. Straight edge over the dent.
